Preliminary Arboricultural Impact Assessment

Prepared for
**Ulladulla Civic Centre
Princes Highway,
Ulladulla 2539 NSW**

For the proposed development at
**Shoalhaven City Council
36 Bridge Road
Nowra NSW 2541**

**Prepared: 20th July, 2012
Reference No: D1988**

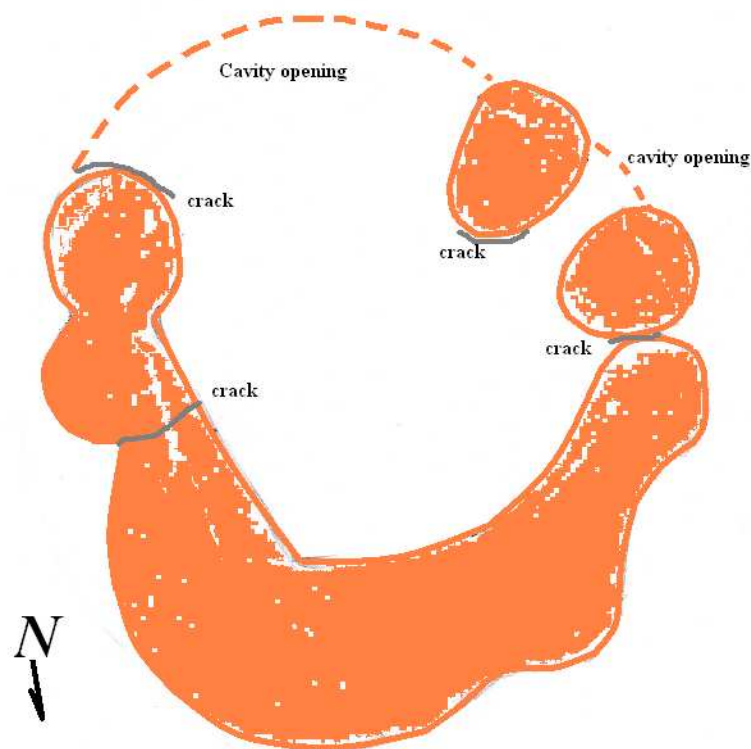
Figure 1; scaled representation of the stem cross-section 1.4 m above the ground

The size of the cavity openings were calculated as a proportion of the stems circumference, and provided a figure of 19%, which is beneath the threshold of 30% where a potential threat for failure can occur. However this will still provide an impact on the trees structural integrity due to the location of the cavity within the tension side of the stem.

The application of the 'Wood strength loss ratio', provides a ratio of the thickness of the remaining stem wall to the absolute value of the stem radius ($t/R \leq 0.3$)¹. This resulted in the approximate ratio value of 0.23. This figure is well within the bracket of values (that is below 0.3) indicating that the tree is susceptible to stem failure at the point where the soundings were taken.

Symptoms indicating that this stem has initiated failure exist. These include fibre buckling on the compression side of the stem and opposite the cavity opening, and structural cracks within the cavity and extending through that part of the stem dividing the existing leader from the failed.

This tree is considered to pose an existing hazard for failure and is not considered viable for retention regarding a modification to the design of the proposed Civic Centre around this tree.
