# **E S & A BANK**

### **Conservation Management Plan**

**PREPARED FOR**  
**Shoalhaven City Council**

**BY**  
**SIMPSON DAWBIN Associates Architects and Heritage Consultants**

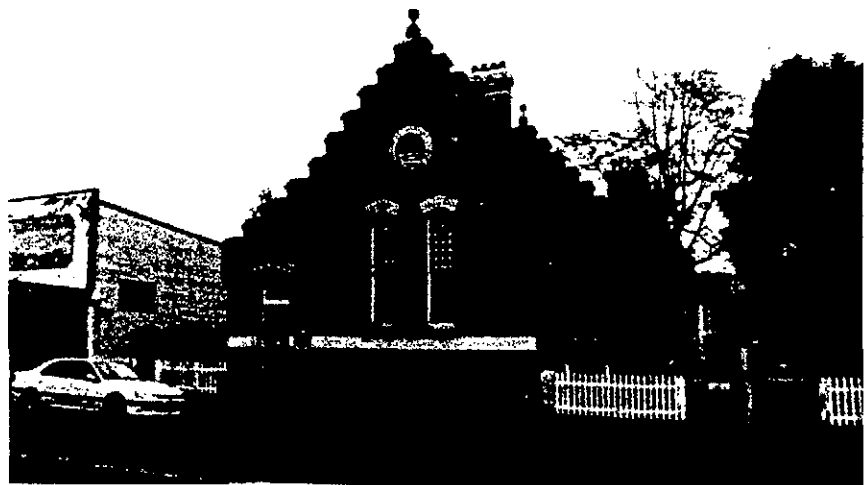
Fig 10:

South elevation to Queen Street

The main street elevation is generally in original condition and the recent repainting has sought to recreate the original colour scheme. Signage for the Museum instead of the Bank is the only significant new element to the façade. Stone step cappings to the parapets are in fair condition with some algae buildup, however failure in the stone joints indicates that repair work may be imminent. The ball finial should be checked for stability. The window joinery is deteriorating through breakdown of paint coatings

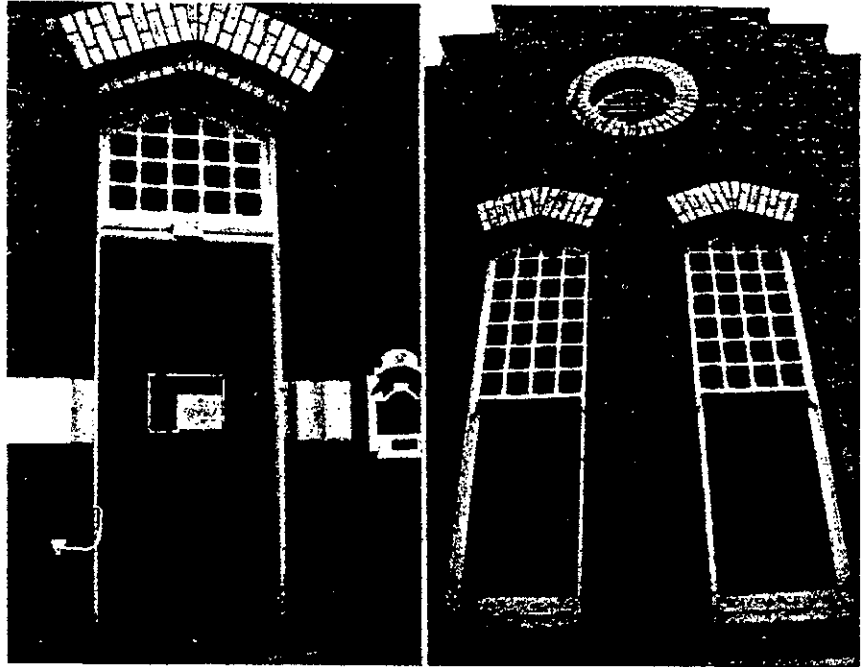
Figs 11,12:  
Façade, Main entry and window details

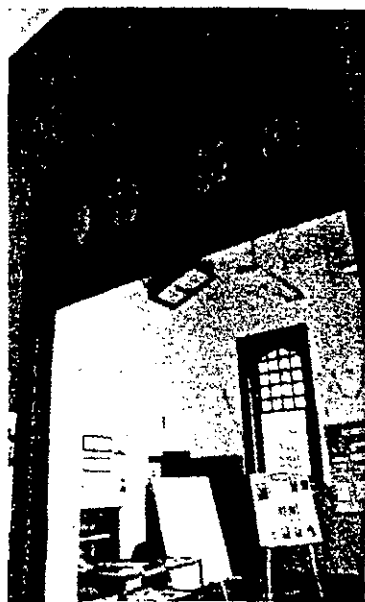
The shell of the Banking Chamber remains intact, however all joinery fittings have been removed. A distinctive desk with semicircular cutout left by the bank is now used as the front desk for the museum.

The fireplace hearth and mantelpiece have been removed and replaced with glass fronted cabinet, possibly installed during the 1940's. The original slate hearth remains under the carpet.

Fig 18:  
Banking chamber,  
pivot door frame

- Attempt to procure or purchase and reinstate original cedar pivot doors to entry lobby
- Remove cabinet from fireplace opening and reconstruct marble fireplace and mantelpiece
- Remove secondary door to Managers office and seal doorway with finishes to match original
- Replace fluorescent light fittings and replace with suspended fittings compatible with original.
- Determine original finish to board ceiling. Strip back and seal or paint accordingly
- Restore all original cedar joinery and finish to original stained finish. Joinery affected by removal or alteration should be reconstructed using Australian red cedar or equivalent, to original profile and finish. Joinery which originally was clear finished in stain, laquer or shellac should be stripped of paint and refinished as original.

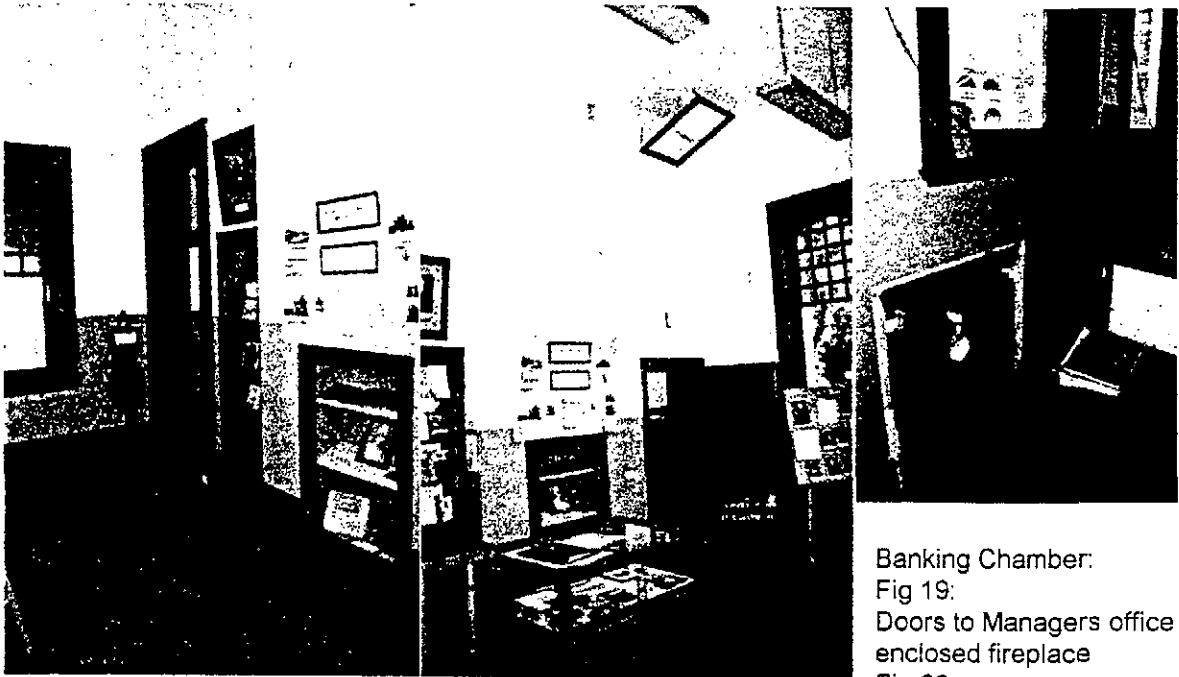
Fig 19:

The original cedar joinery counter has also been removed. The counter extended north-south across the chamber with a lifting flap at the fireplace ends and staff access to the Strong Room.

The original cedar joinery counter in the banking chamber existed up until the renovations of 1970, and its ultimate fate is unknown. A shadow profile in the paintwork on the south wall is the only remaining evidence of the detail of the counter. An area of the west wall has been scraped to reveal original paint finishes.

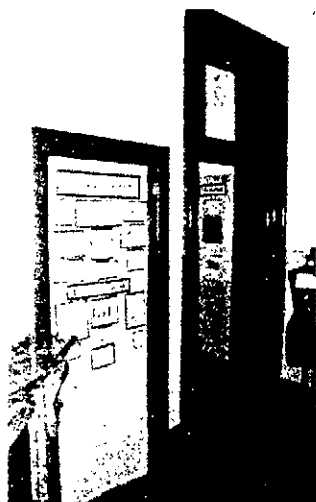
Located between the Banking Chamber and the manager's residence to the rear, this room generally retains its original form. An exception is the second door with meranti joinery opening into the public space. The purpose of this door was to enable staff access to the staff room and amenities at the rear via a screened off corridor separating it from the managers office. This screen was reportedly still in place in 1975 after the Museum occupied the Banking Chamber.<sup>24</sup>

Fig 22: Main door and infilled to managers office

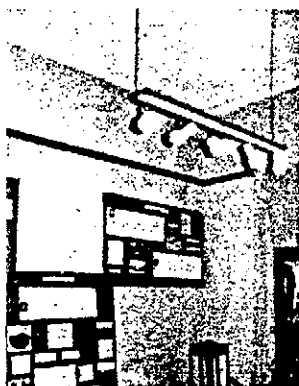
Fig 25: Coolangatta Room

Now the Coolangatta Room, this was the Bank Manager's main bedroom. A white/ grey marble mantelpiece remains but the fireplace has been removed. Damage to plasterwork and paint is evidence of past damp penetration, resulting from failed chimney flashings. This area is currently undergoing restoration.

- Repair damaged plasterwork and ceilings affected by damp penetration to rooms to north of hallway, and repaint.
- Seal flashings to rear dormer window

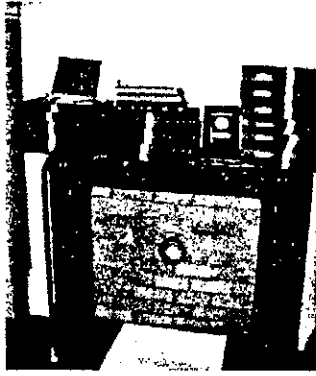
Now used as the office for the Museum known as the Bennett Room, this was formerly the Manager's Dining Room. The fireplace has been bricked up but the marble mantelpiece remains intact. Evidence of past

Fig 27:  
Mantelpiece to  
Dining Room

damp penetration through the wall by peeling paint above the fireplace and above the old sink

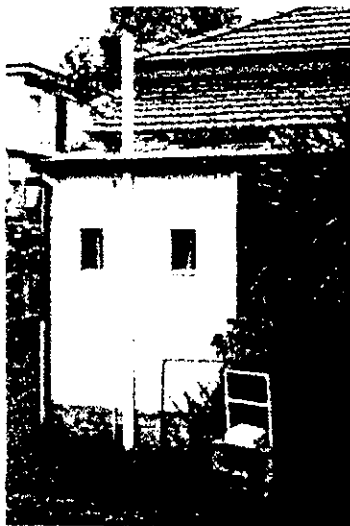
Two WC cubicles are accessed from the verandah, comprising a fibro lean-to structure in poor condition.

Condition of deck deteriorating with cupped boards and rotted ends. Verandah post plinths are lined with boards, possibly concealing rot damage.

Fig 28:  
WC enclosure to rear  
verandah

- Replace badly affected timbers to side and rear verandahs, repair rotted rafters, replace cupped floorboards to rear verandah, replace patched posts to rear verandah to original turned profile without cover boards, and replace sections of fascia to rear verandah.
- Remove sheet lining to front entry door and restore to original detail.
- Point up joints and repair stonework cappings and details to parapets and chimneys.
