Pryda Reference Number: 10430

Inspection Report

Address: Mollymook Surf ClubDate of inspection: Thursday, 26 July 2007

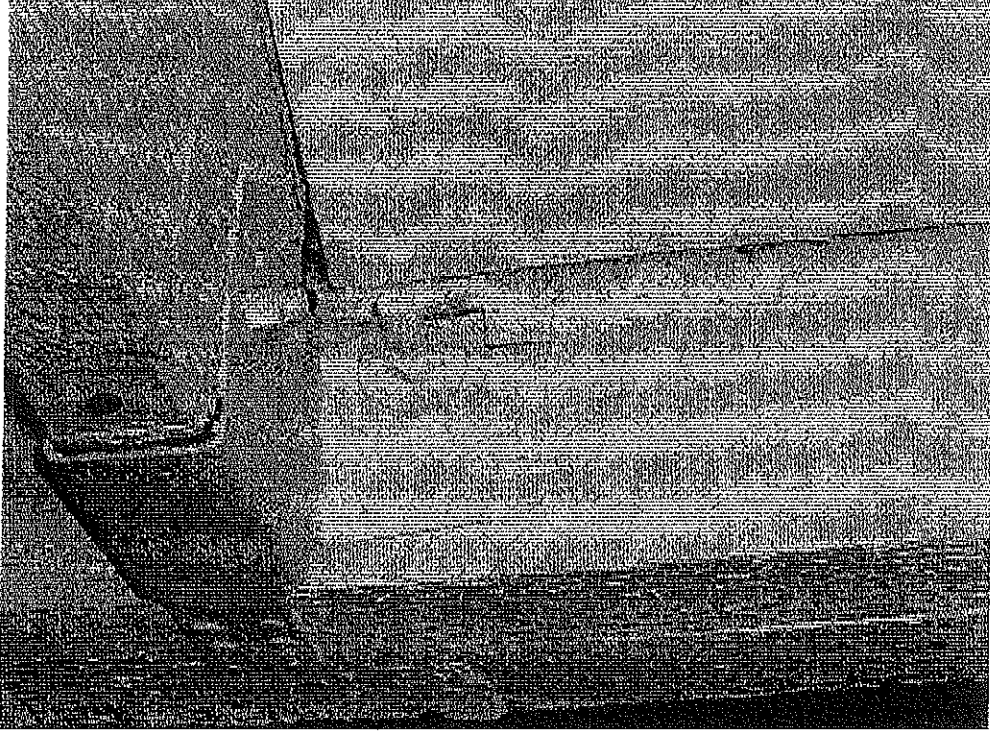
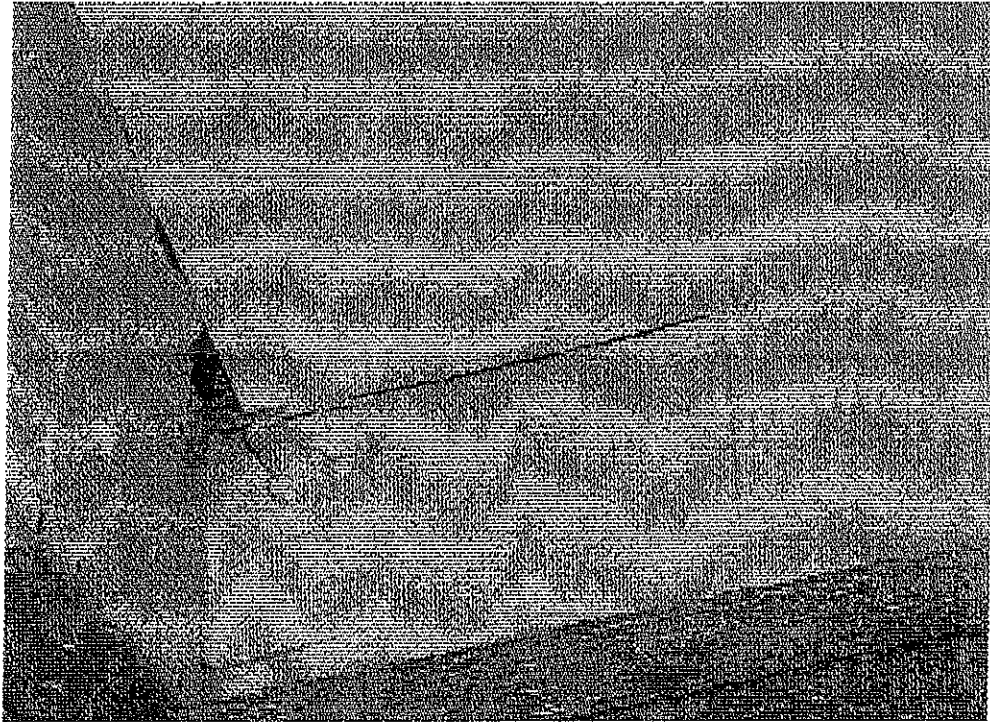
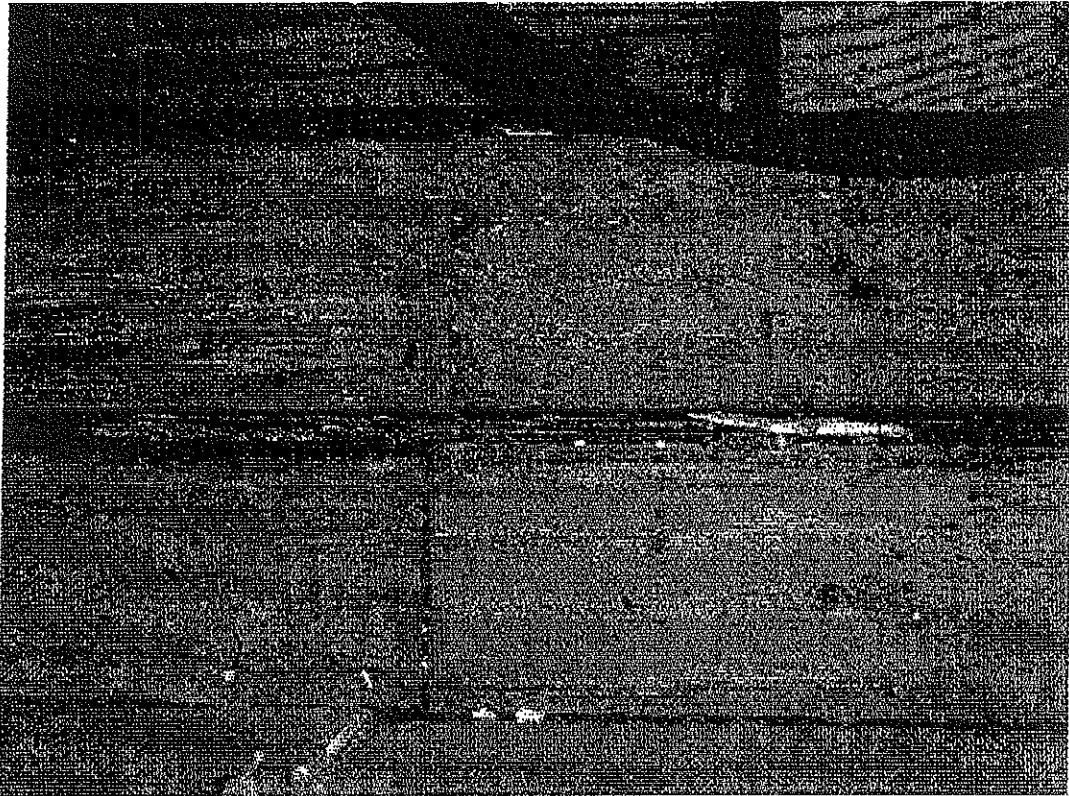
Appendix A

- Longitudinal Cracks in the bottom chord over the truss boots connecting the carrying trusses to the main girder truss.
- Rotation in the truss boots securing the carrying trusses to the girder truss
- Batten splicing of the carrying trusses did not meet the recommended requirements set out in the AS4440-2004
- Suitable fixing for the lamination of the members of the girder truss was not evident.
- Splice plate in the bottom chord has not been pressed in to a satisfactory depth
- There is evidence of some separation of the bottom chord from the top chord at the heel but it is difficult to see the entire joint due to restricted accessibility.

These issues represent a significant structural risk to the girder truss and it is recommended to prop the girder truss at the panel points along the bottom chord until suitable rectification measures can be made.

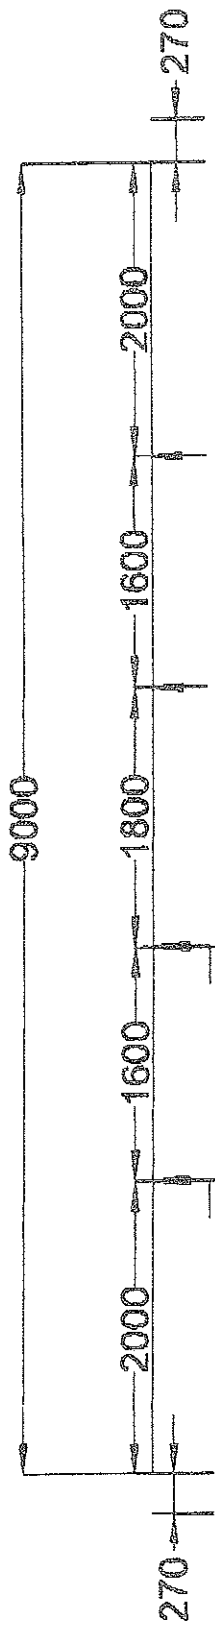
current location of props under pannel points

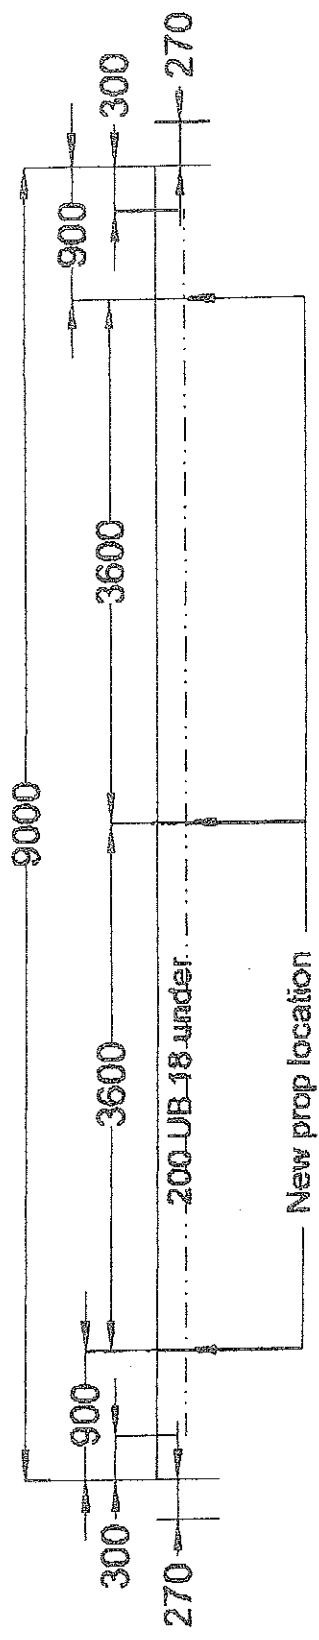
Bugel screws up into girder truss @ 600 centers

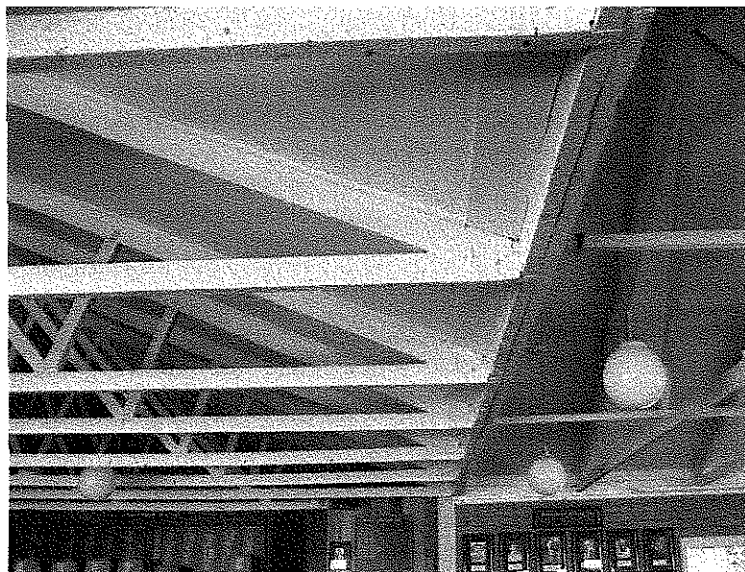
The existing roof over the function room suffers a number of leaks that require rectification. In reviewing repairs to the roof it is evident that the roof requires substantial rectification. Coupled with this is the desire for the Club to refurbish the function room in such a way that provides for high level ceiling displays, celebrating the surf life saving purpose of the Club.

The existing roof (as seen below) is currently constructed with exposed timber trusses. The low height of these trusses prevents high level ceilings, features and displays in a manner suitable for quality function spaces. Rather than continue to repair the existing roof, it is proposed to reconstruct the existing roof to

The existing function room structure.

- a) provide a clear span new structure, including steel framing and metal deck roof
- b) include new insulation and ceiling treatment
- c) provide feature coffers and bulkhead elements to accommodate feature surf life saving elements. At a minimum it is proposed to include a full size life saving boat and other supporting elements.
- d) Provide new covered pergola to the eastern façade of the function room to offer outdoor dining and outlook from the function room.
