SHOALHAVEN DAIRY INDUSTRY • STAGE 1
ARCHAEOLOGY OF THE MILTON & KANGAROO VALLEY AREAS

VOLUME 2 • PART 2
INVENTORY BASED DESCRIPTION OF DAIRY INDUSTRY SITES

PETER FREEMAN PTY LTD
CONSERVATION ARCHITECTS & PLANNERS

NOVEMBER 1997

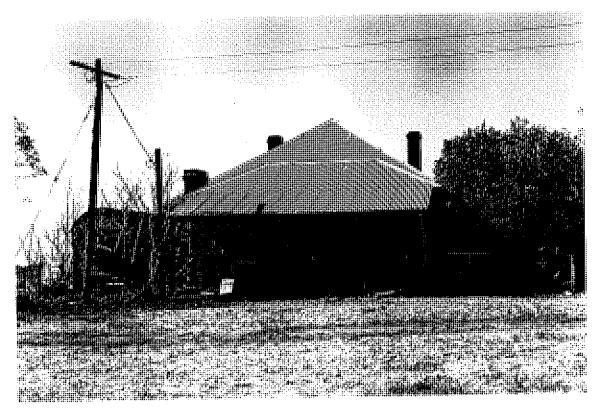
Mimosa Farm. House, formerly 'Darling Forest' faces east. Looking southwest MH 1997 photograph 9.7

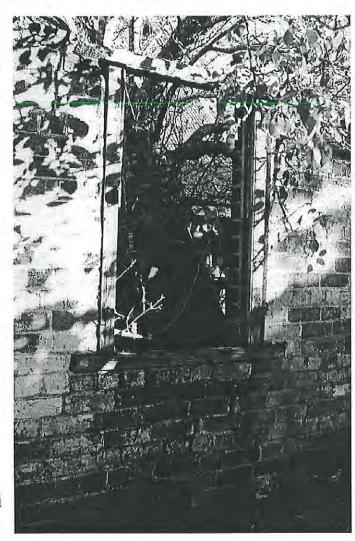
Right: Detail of timber framed window. MH 1997 photograph 9.10

Below: Concrete plinth and pump mount and water trough adjacent to south of well, used for dairy purposes. MH 1997 photograph 9.12

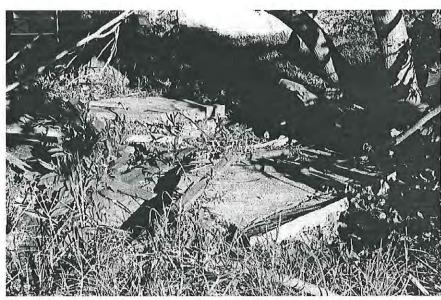
Concrete foundation for chaff cutting and fodder storage. Looking south-east MH 1997 photograph 9.21

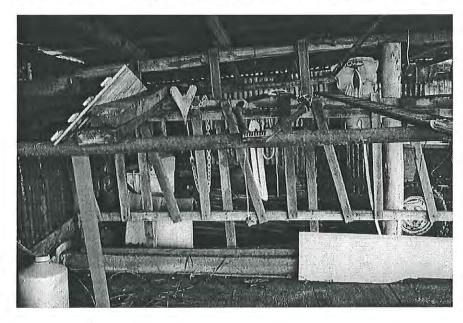
Feed stalls adjacent to chaff cutting area. Five bails, no boxes remain. Looking west MH 1997 photograph 9.22

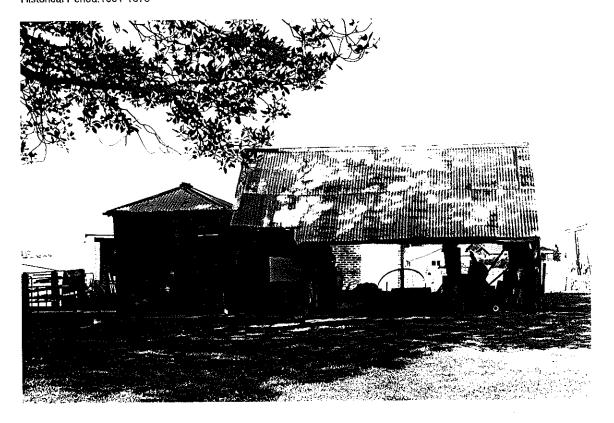
View of **Woodlands** from gate, eastern elevation. House, Morton Bay Fig, Garage, Bails (19th century) Bails (1950's) Looking west MH 1997 photograph 1.21

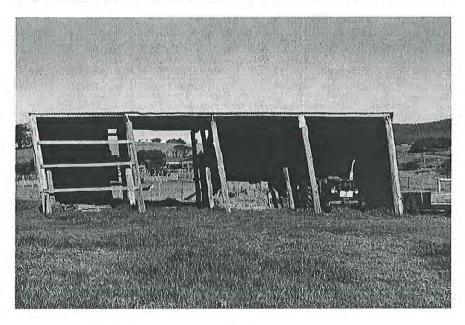
Hay shed Looking south MH 1997 photograph 2 2 19th century milking bails. 4x2 Natural round timber posts and beams, timber pegs in posts to restrain cow tail while milked. Concrete floor, dish drain along southern edge, cows entered from south, unprotected from prevailing winds, system later reversed. Sawn timber frame for corrugated iron roof sheeting. Problem with termites. Looking north MH 1997 photograph 2 3

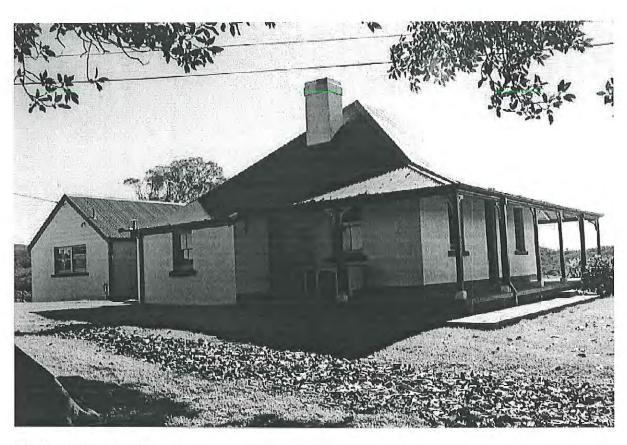
Woodlands house. Looking north-west. MH 1997 photograph 2 9

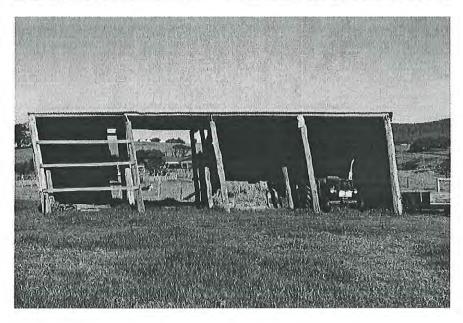
Hay shed Looking south MH 1997 photograph 2 2 19th century milking bails.
4x2 Natural round timber
posts and beams, timber pegs
in posts to restrain cow tail
while milked. Concrete floor,
dish drain along southern
edge, cows entered from south,
unprotected from prevailing
winds, system later reversed.
Sawn timber frame for
corrugated iron roof sheeting.
Problem with termites.
Looking north
MH 1997 photograph 2 3

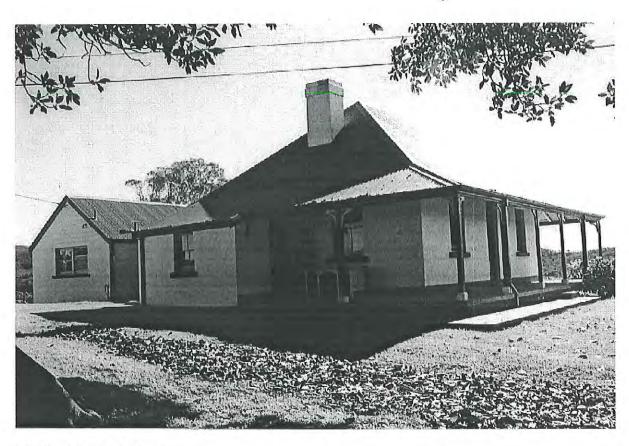
Woodlands house. Looking north-west. MH 1997 photograph 2 9

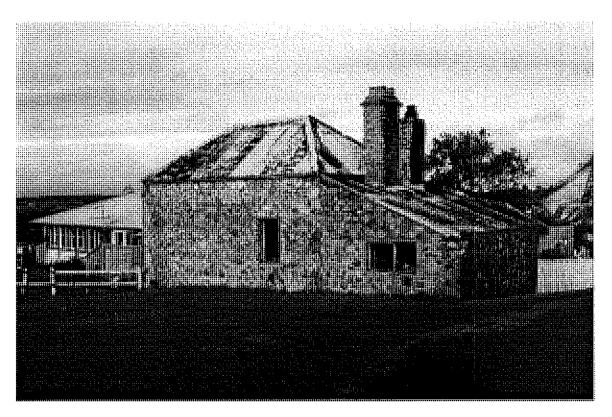
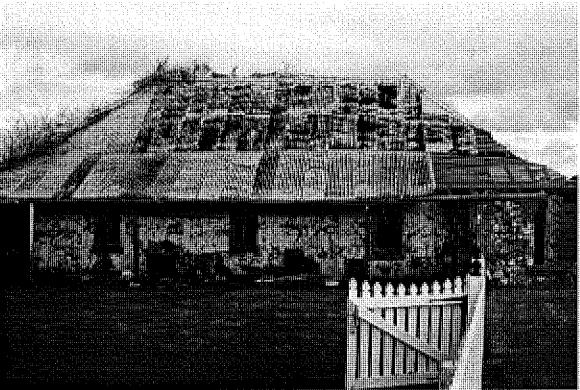
Above: 'Avenal', early kitchen, random local stone and mud mortar, scullery addition to. Kitchen and Maids room. Scullery chimney in brick, kitchen chimney in stone. Looking east. MH 1997 photograph 1.9

Below: Dairy (creamery), random local stone and mud mortar, whitewashed interior and exterior. Shingle battens exposed under corrugated iron roof sheeting. Six pane, timber framed windows, hinged at base, stone sills. . Looking north-west. MH 1997 photograph 1.10

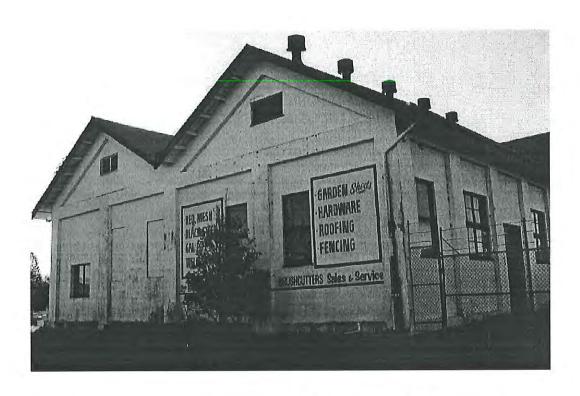
Above: Milton Butter Factory, Looking north-west MH 1997 photograph 3.4

Right: Open drain and grease trap adjacent to earlier, filled in doorway. Looking east MH 1997 photograph 3.5

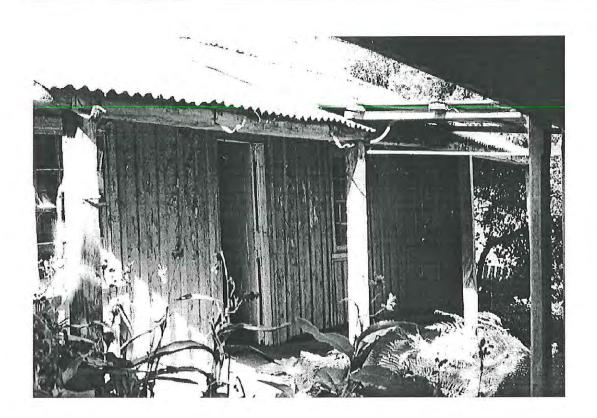
Above: Western elevation. Vertical sawn plank and batten house with timber 6 pane double sash windows, encircling timber verandah. Looking east MH 1997 photograph 7.5

Right: Clinton Park. Mid 19th century slab and batten kitchen, chimney removed form eastern wall, skillion link to vertical sawn plank and batten house. Looking north-west MH 1997 photograph 7.3

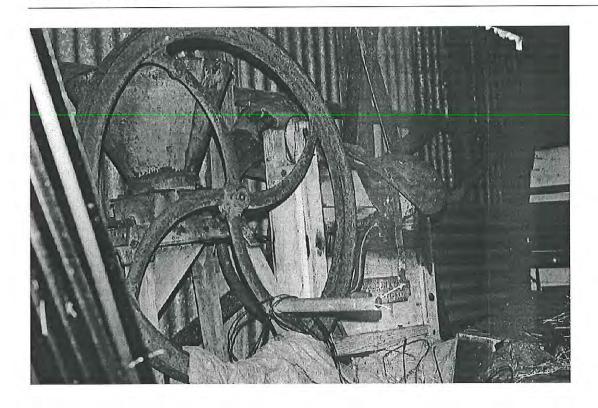
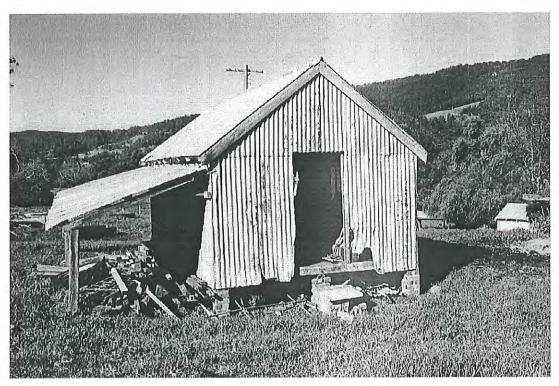
Top: Corn husker, 'James Martin & Comp'y, 101 York Street Sydney' and 'R. Hunt & Co.' manual driven machine (meal?). MH 1997 photograph 7.12

Bottom: Corn store, sawn timber frame, corrugated iron cladding on brick piers. Looking east MH 1997 photograph 7.13

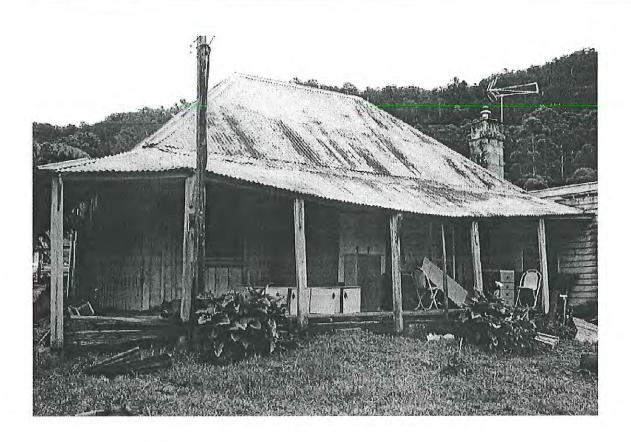
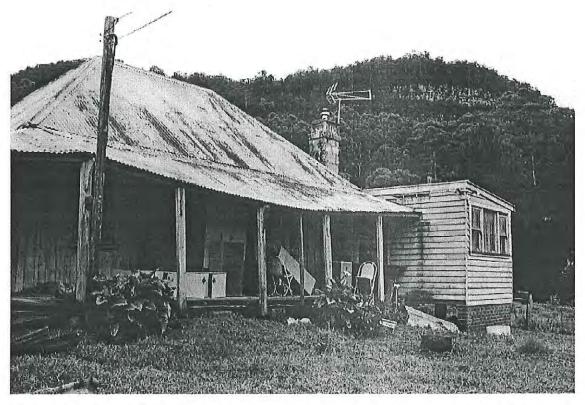
Top: 679 Upper River Road. Southern (front) elevation, vertical sawn plank and batten walls, 6 pane double sash windows. interior has cedar adzed lining boards. Looking north-west MH 1997 photograph 5.24

Bottom: Eastern (front) elevation with weatherboard extension Looking north-west MH 1997 photograph 5.25

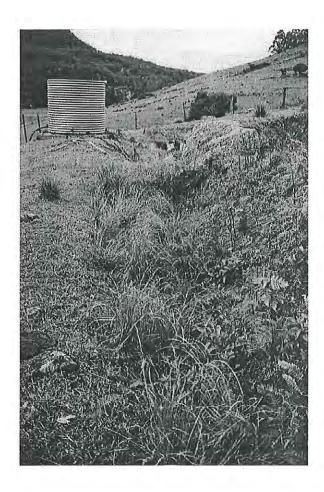
Right: Level platform and scattered paving stones or foundation from hand milking bails situated down hill from pond, up hill from house. Looking north. MH 1997 photograph 5.3

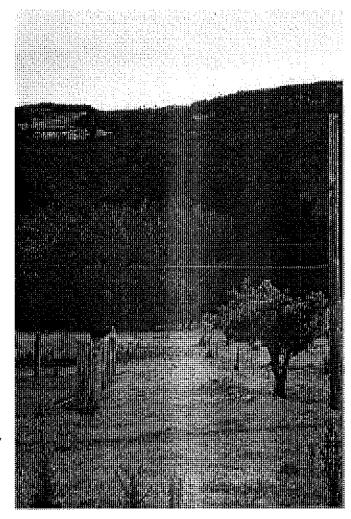
Laneway access for milk tanker to c.1940's milking shed Looking east MH 1997 photograph 5.11

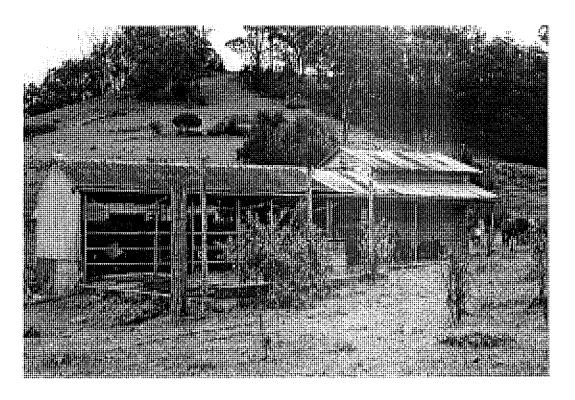
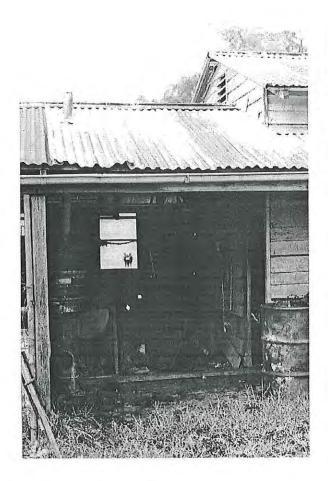
1940s milking shed, concrete holding yard, floor and foundation for weatherboard walls. Galvanised pipe bails, feed boxes, fencing. Engine room between bails and vat room. Milking ceased 1960's. Looking south MH 1997 photograph 5.12

Above: Engine room for Simplex Ideal milking machine, Moorehouse of Nowra hot water heater. Looking south MH 1997 photograph 5.15

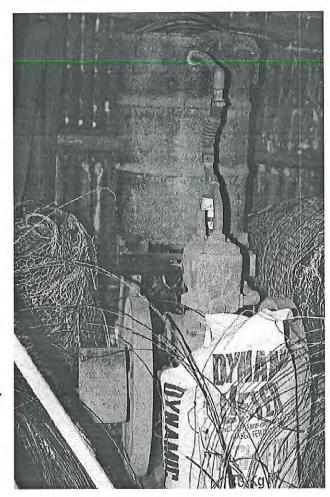
Right: The Lister donkey petrol engine, 44 gallon drum as radiator, in working order, used for wood cutting, Looking north MH 1997 photograph 3.22

Below: Wood cutting engine shed Looking north-west MH 1997 photograph 3.23

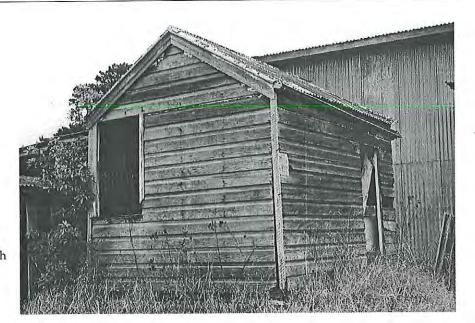
Weatherboard storage shed relocated from elsewhere, rusticated board profile, with remnant Indian Red, pale green paint. Looking southwest MH 1997 photograph 4.9

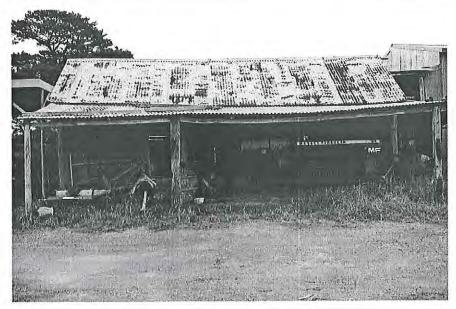
Timber slab, corn shed, indicating fodder cropping. Rebuilt, originally had loft. Looking west MH 1997 photograph 4.2

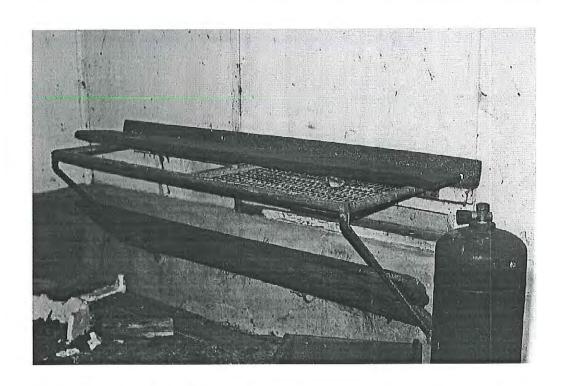
Above: Equipment rack, can room. MH 1997 photograph 4.18

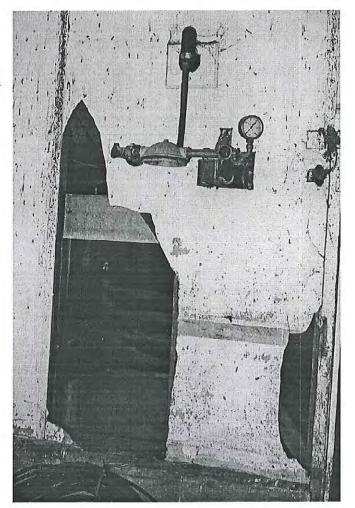
Right: Milk room end of milking machine, below which stood a water cooler for milk to run over. MH 1997 photograph 4.19

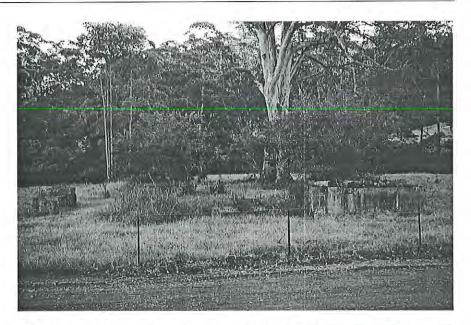
Barrengarry Butter Factory. Concrete foundations. Looking west MH 1997 photograph 7.20

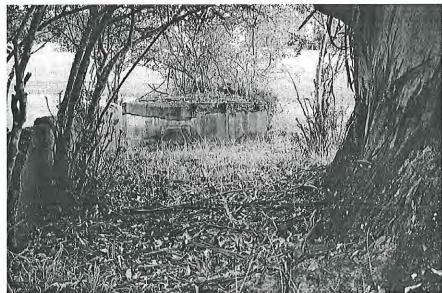
Concrete plinth showing recess for floor joists, concrete wall. Looking east MH 1997 photograph 7.21

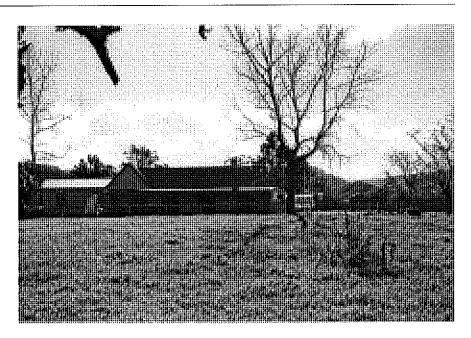
House, southern (front elevation). Looking north MH 1997 photograph 6.24

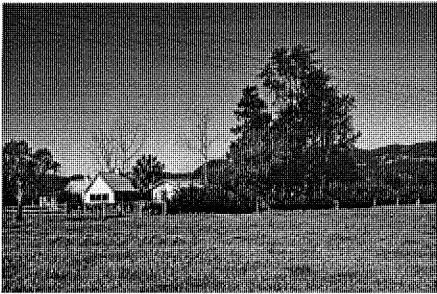
North western view of house, remnant win break old conifers and new conifers in replacement wind break. Looking south-east MH 1997 photograph 6.12

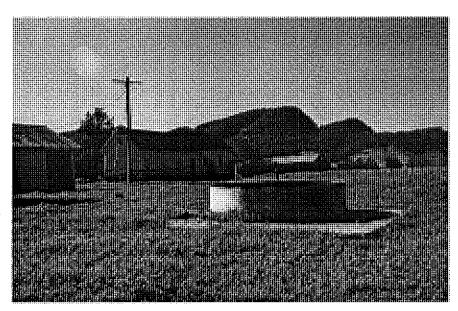
Steel water tank on concrete base, concrete block mount for a pump. Concrete base with post holes in corners, probably for windmill. Property gets water from spring. Looking north-east MH 1997 photograph 6.10

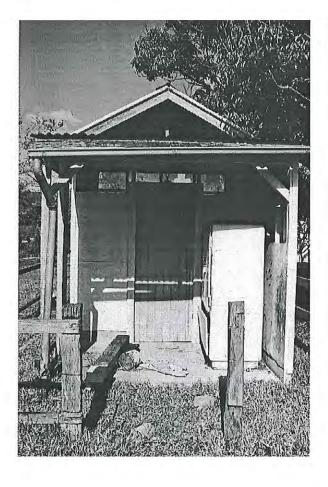
Right: Meat room eastern elevation. Looking southwest MH 1997 photograph 6.22

Right: Milking bails, 2' concrete base to timber framed weather board walls. Concrete holding yard. Refitted with 8 modern feed bins, only one double milking bail remains with recent closed skillion addition associated with feed stalls. Looking south-east MH 1997 photograph 6.14

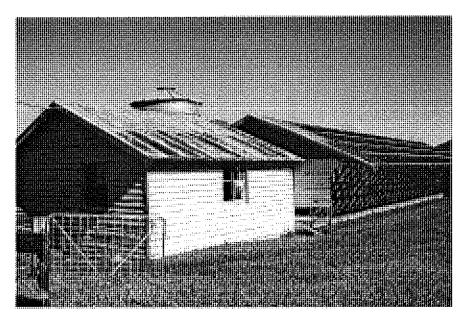
Ascot, chaff cutting shed and feedstalls. Roof sheeting recently removed and to be replaced with transparent material for structures re use as a plant nursery, otherwise intact. Looking south-west MH 1997 photograph 6.1

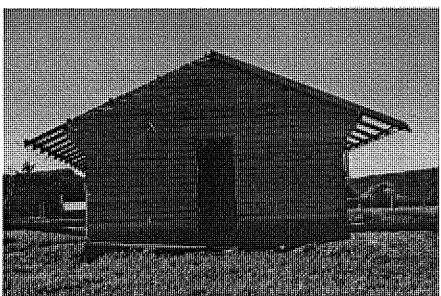
Western elevation feed stall, weatherboard, central door leads to aisle for feed trolley. Looking east MH 1997 photograph 6.3

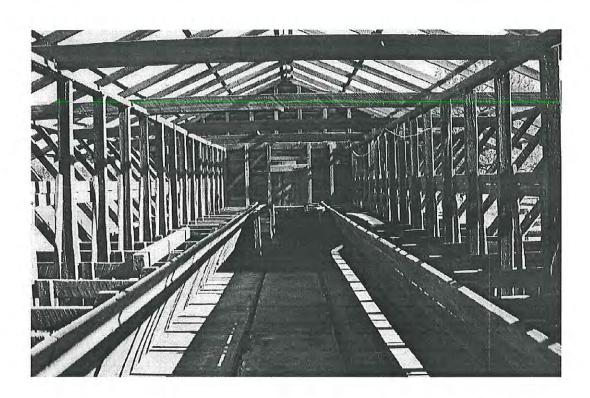
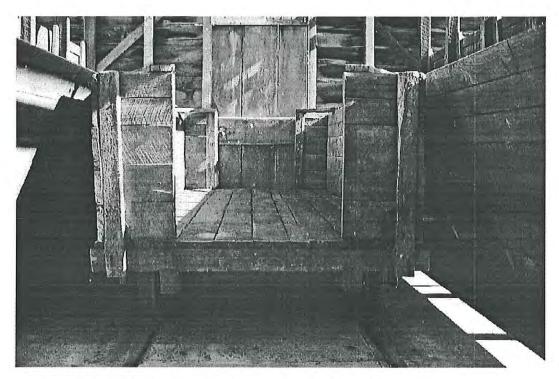
$\mbox{\bf Top:}$ Central aisle with timber trolley on rails to service feed bins. Looking west MH 1997 photograph 6.5

Bottom: Detail feed trolley. MH 1997 photograph 6.6
