2016 June 4 - 7 East Coast Low flood / coastal storm event impact report

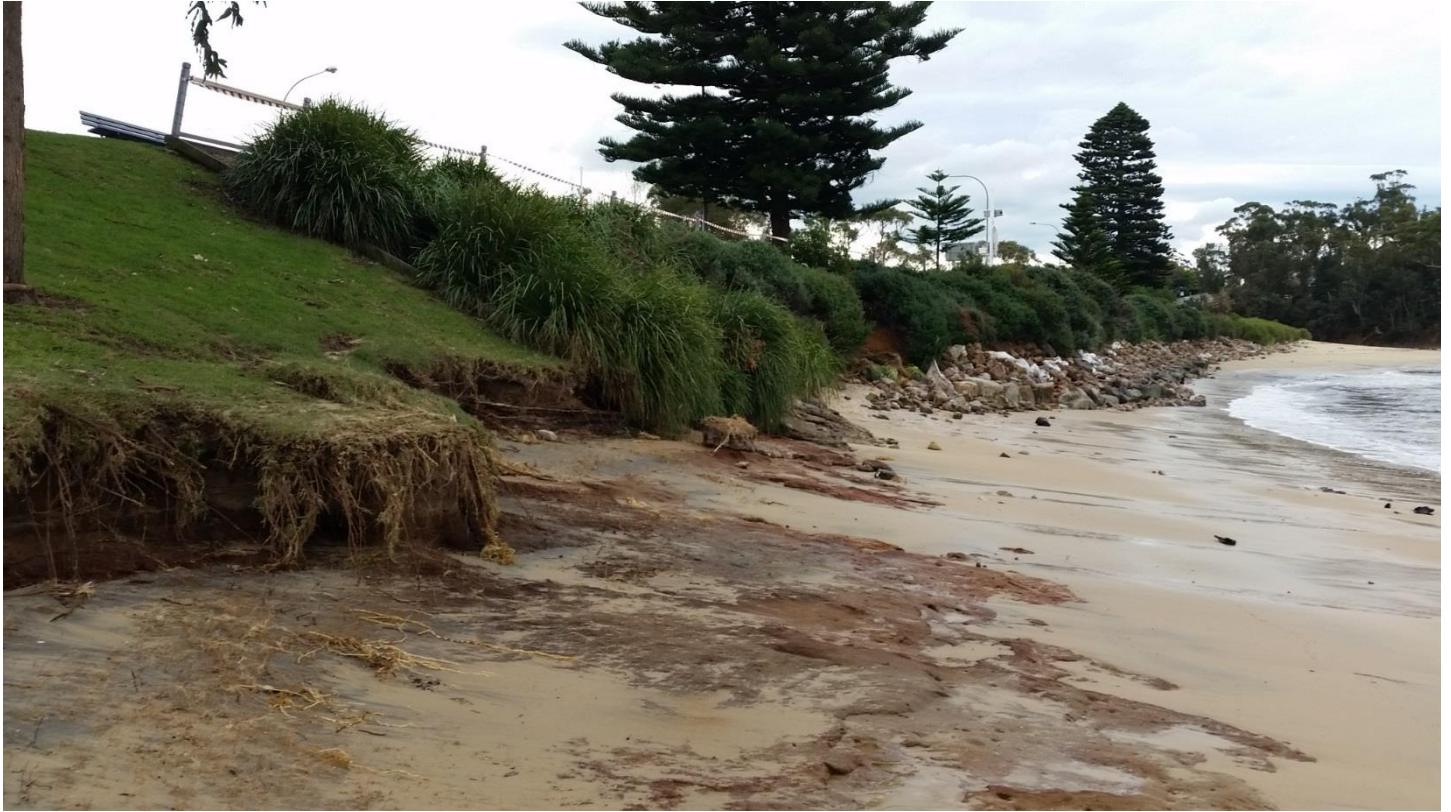
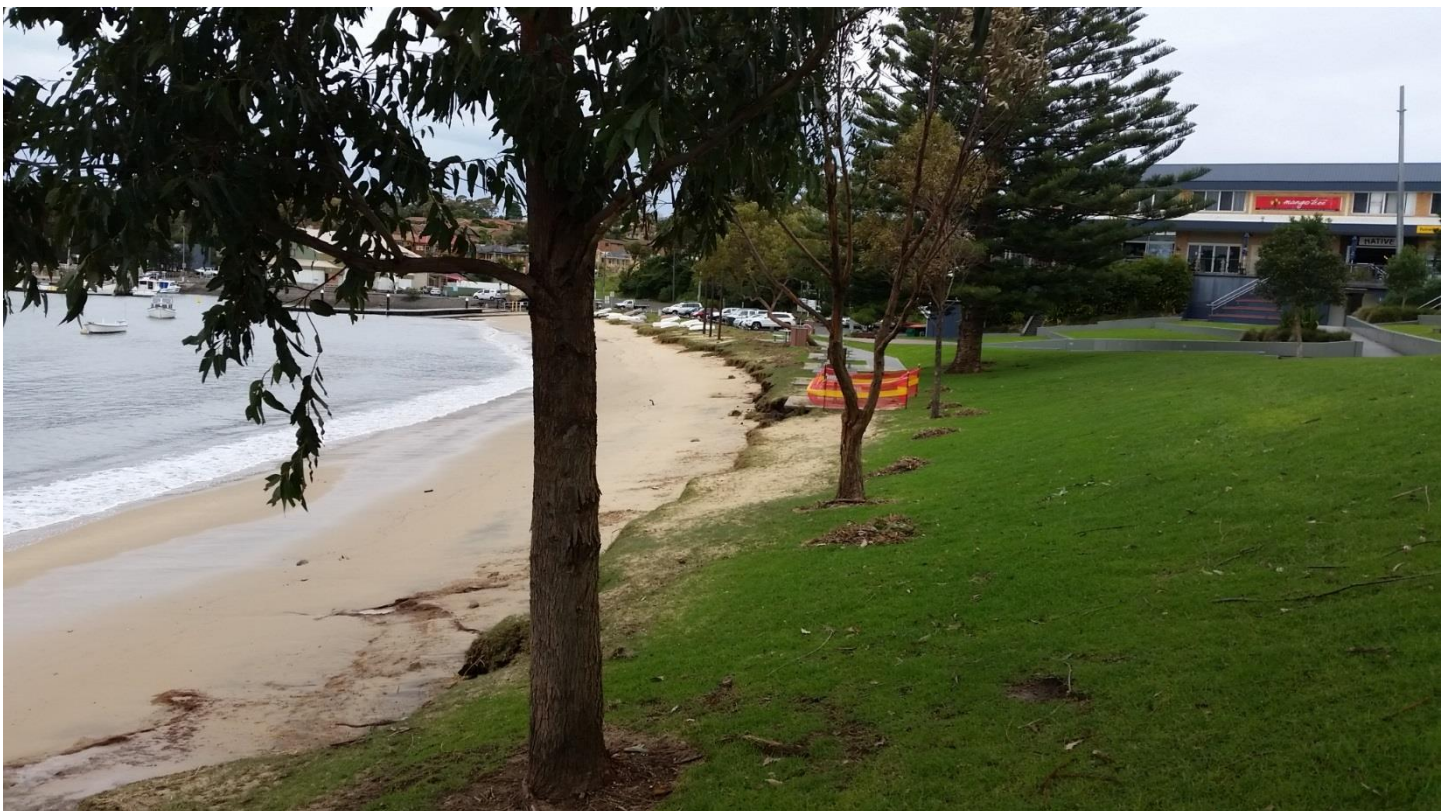
- **Ulladulla Harbour foreshore protection** – major erosion of 30metre section at the southern portion of the existing rear harbour revetment and the loss of the tidal beach affecting Park infrastructure.

Potential public risk from shared walkway and beach. Response includes temporary hazard fencing, engagement of geotechnical engineering advice to develop remediation strategy, relocation of Parks infrastructure, beach scraping to assist natural beach recovery

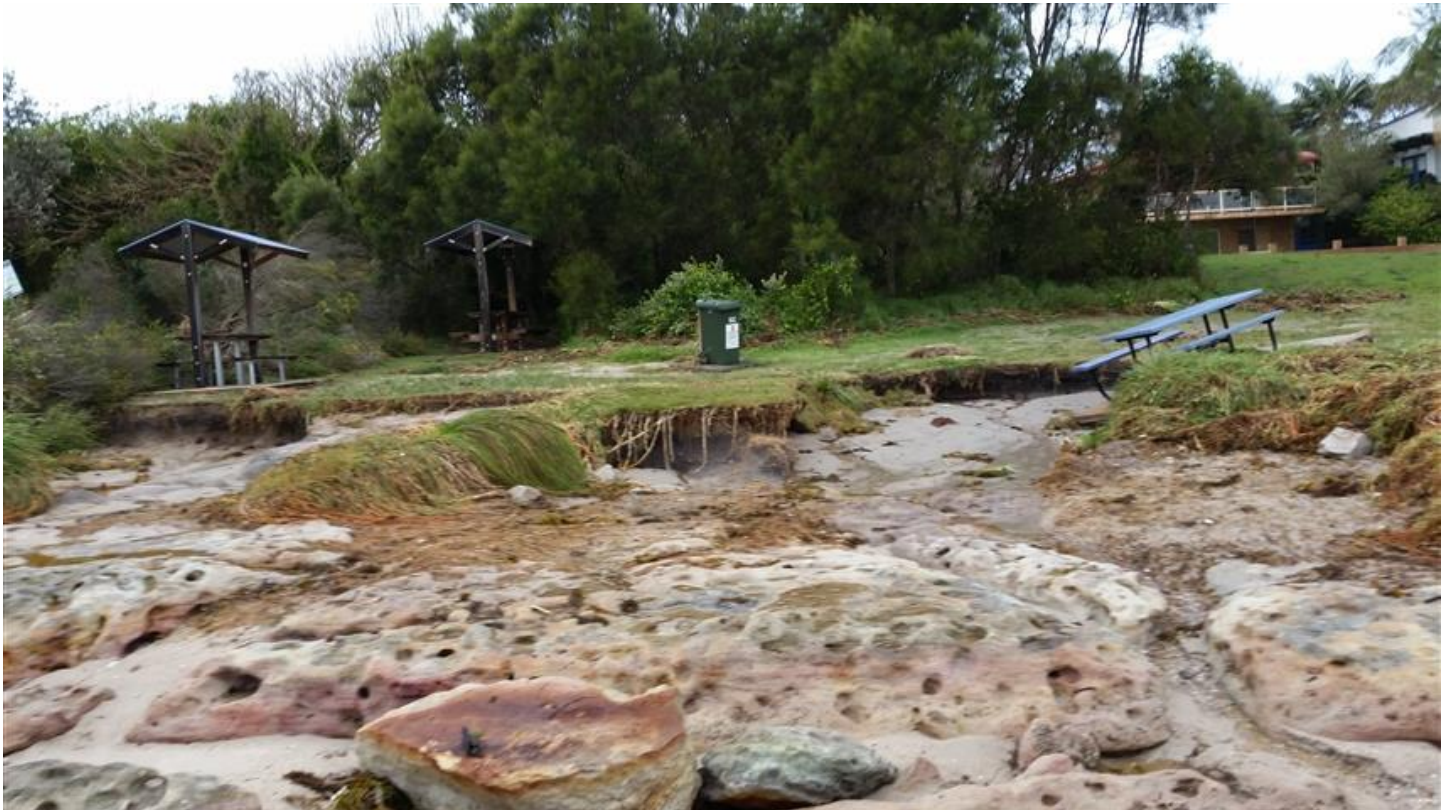
Currarong Beach moderate beach erosion damage along the Currarong beach frontage from Peel St to Abrahams Bosom beach includes 8 beach access ways lost, 3 major stair cases one with viewing platform destroyed. Significant beach sand loss under moderate ocean swell and elevated tide and storm level conditions with damage to Park assets at the Rock Pools and Dolphin Point reserve including a link walking track and boardwalk.

Responses include closure of unsafe Warrain Crescent beach access ways with hazard signage installation on Tuesday 7/6/2016. Removal of staircase debri from the beach, assessment of dangerous trees, beach closure considered, reshaping and stabilisation needed Currarong – foreshore protection works next to boat ramp damaged

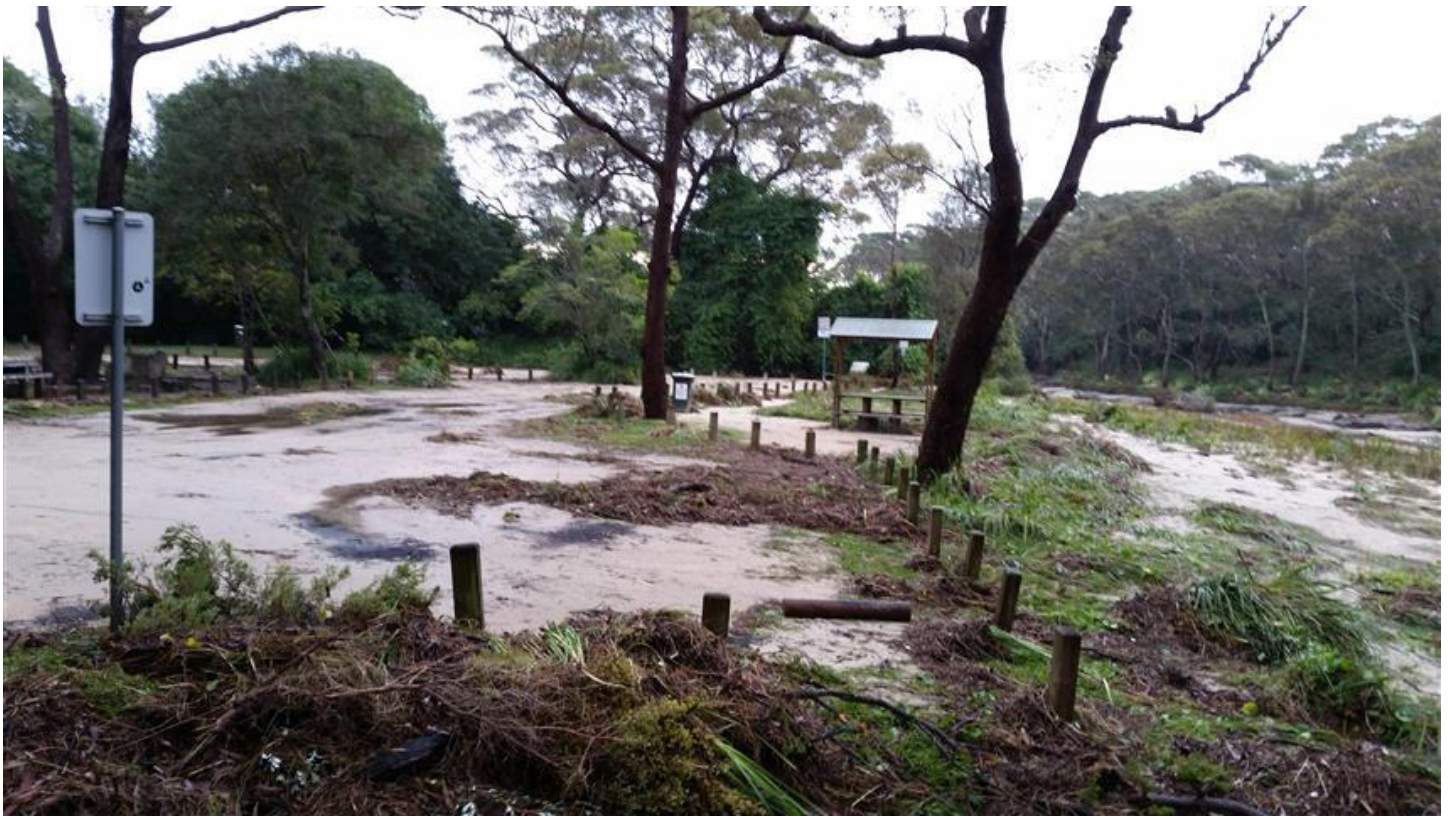
Currarong Rock Pools; sand loss and park asset damage

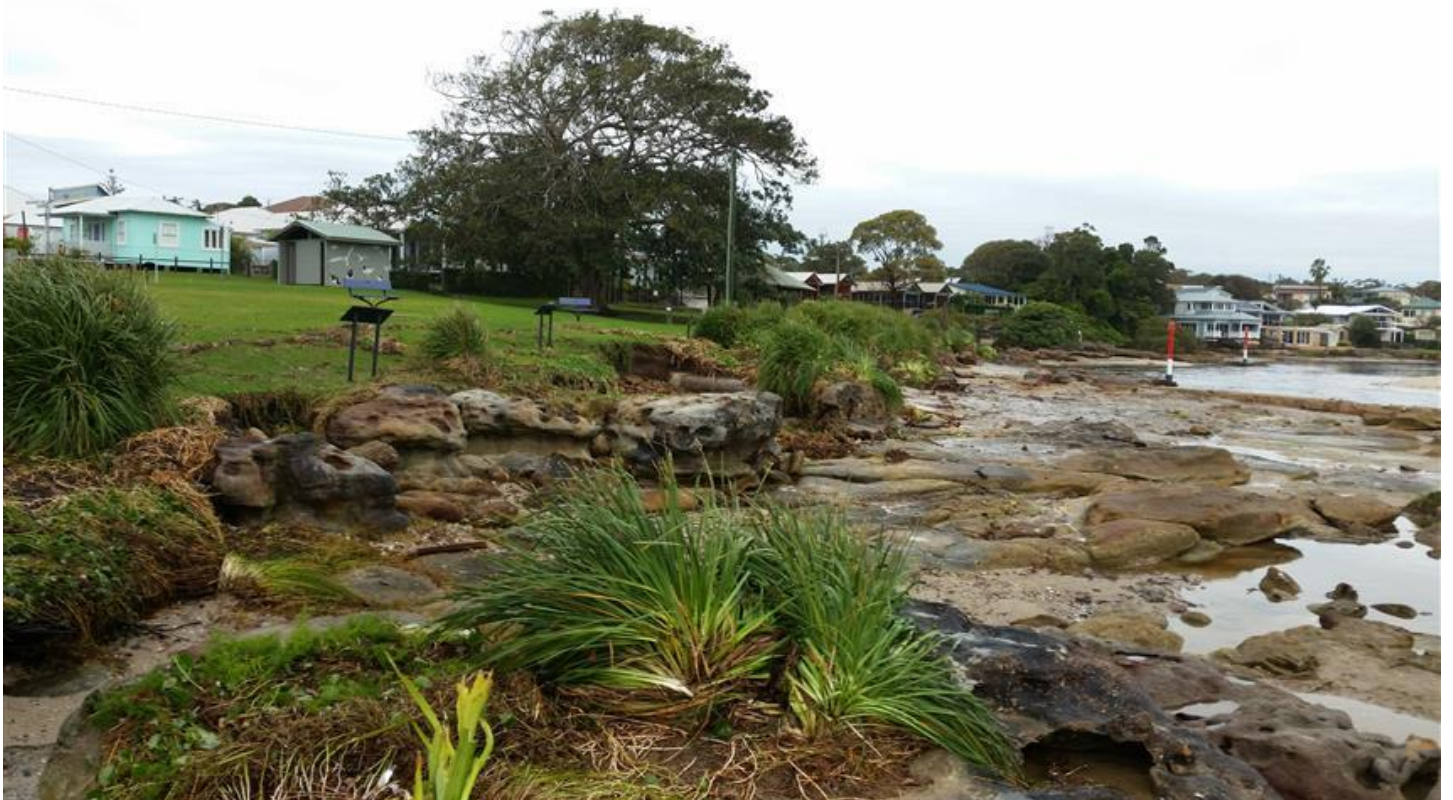
Abrahams Bosom carpark; major debri clean up and Park asset damage

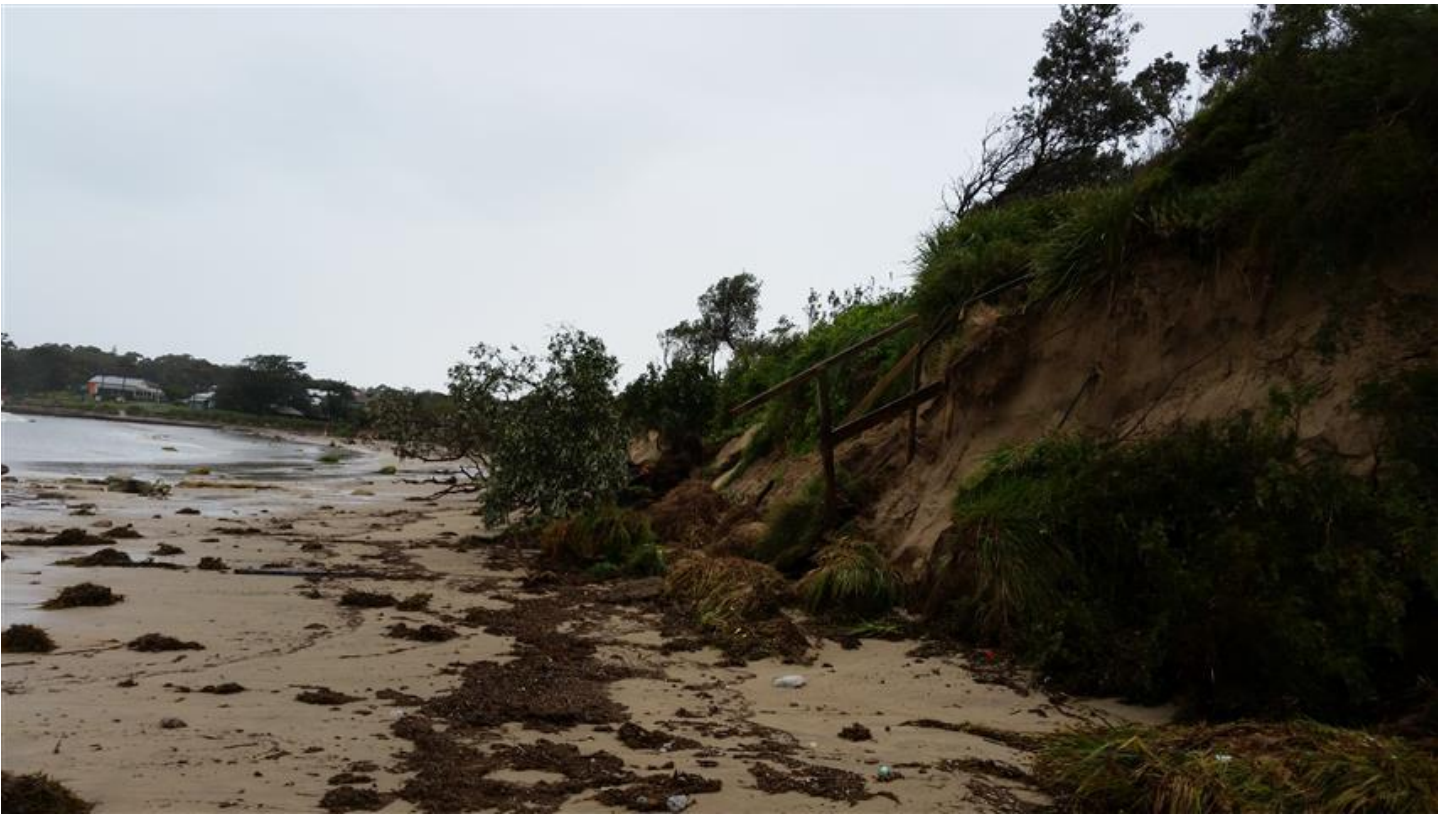
Dolphin Reserve; park asset damage, foreshore erosion

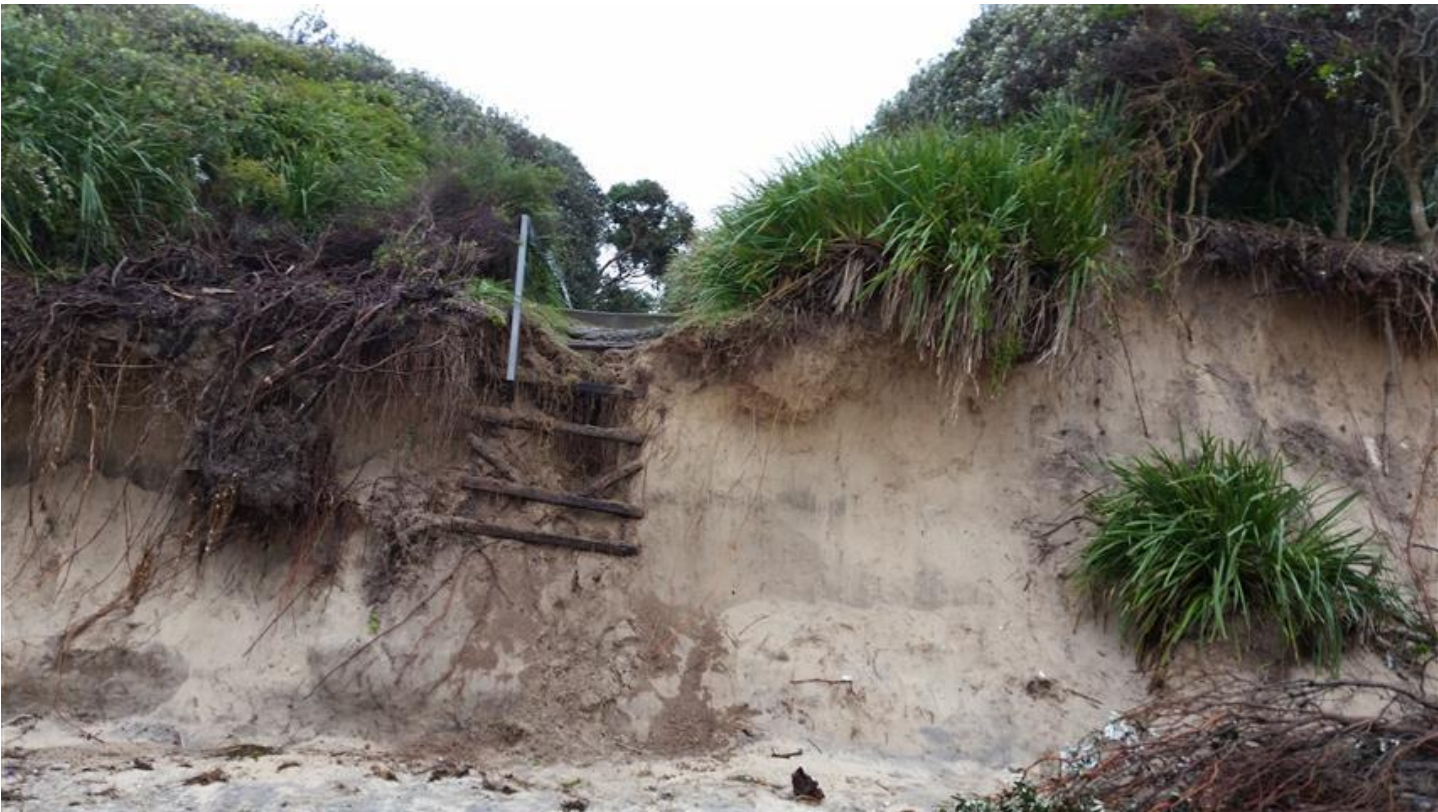
Warrain Crescent; beach access loss, dangerous tree assessment and remediation of Peel St and Curarrong Creek access points

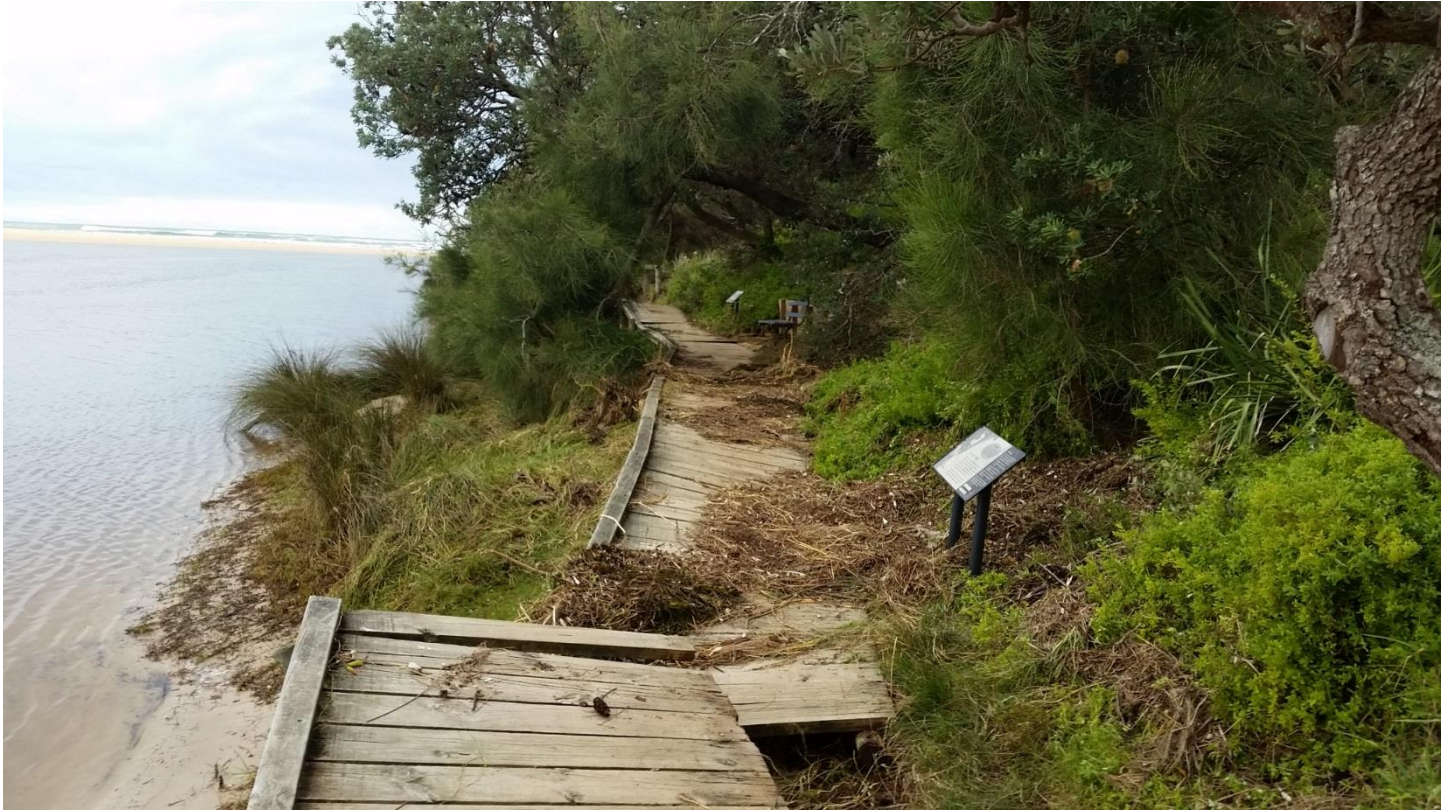
Lake Tabourie

The foreshore boardwalk approximately 80m destroyed during flood with the combined ocean, storm surge impact lifting and breaking apart the aged sub structure beyond repair. Responses included hazard signage temporary fencing with removal of the structure completed on 8/6/2016

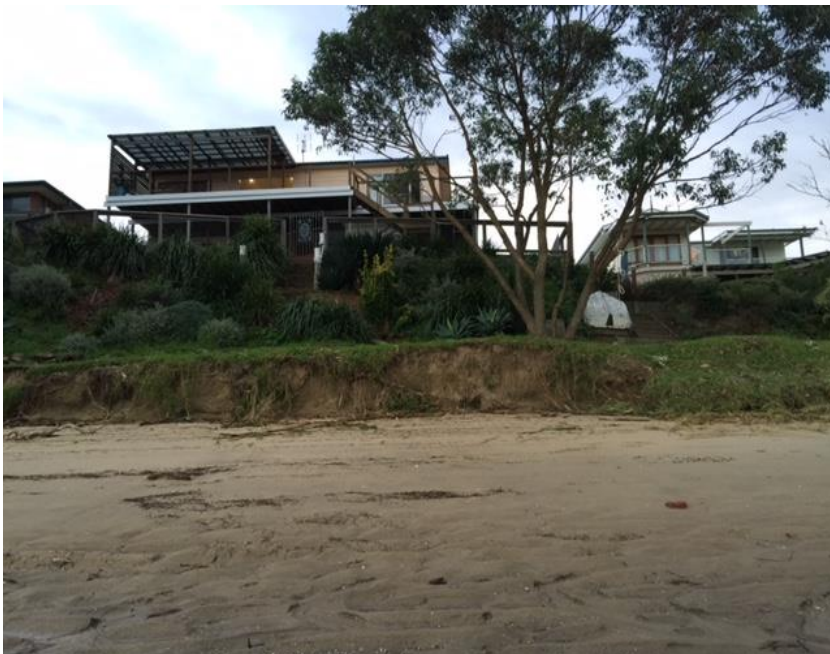
Shoalhaven Heads: the River Rd estuary foreshore has minor erosion impacts with the potential for private properties threats since the river flood notch breached allowing significant ocean swell / king tide to enter combining with local flooding.

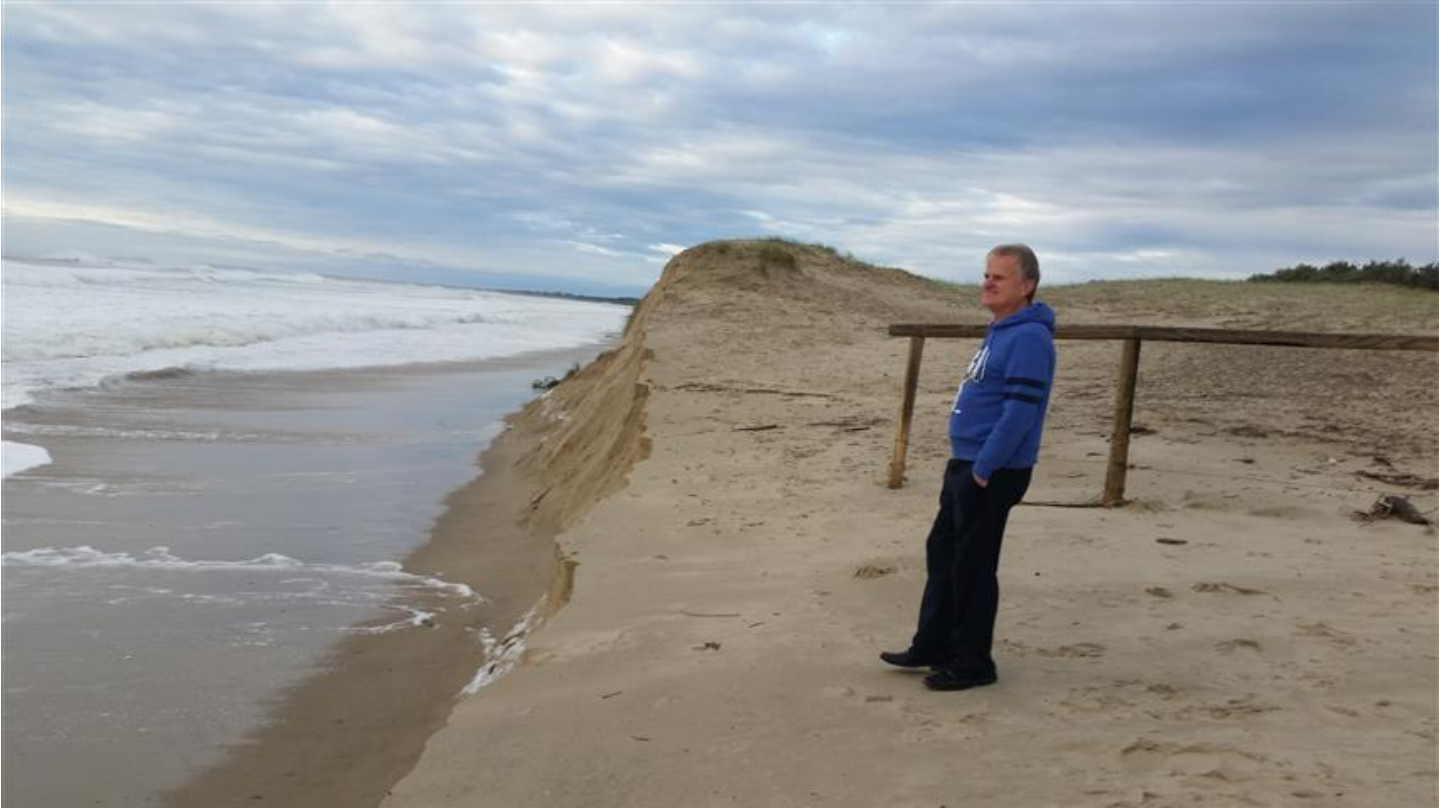
Shoalhaven Heads beach access were damaged with Beach Erosion warning signs still in place since the 2015 event and contactors engaged to reshape the main beach access points for public safety.

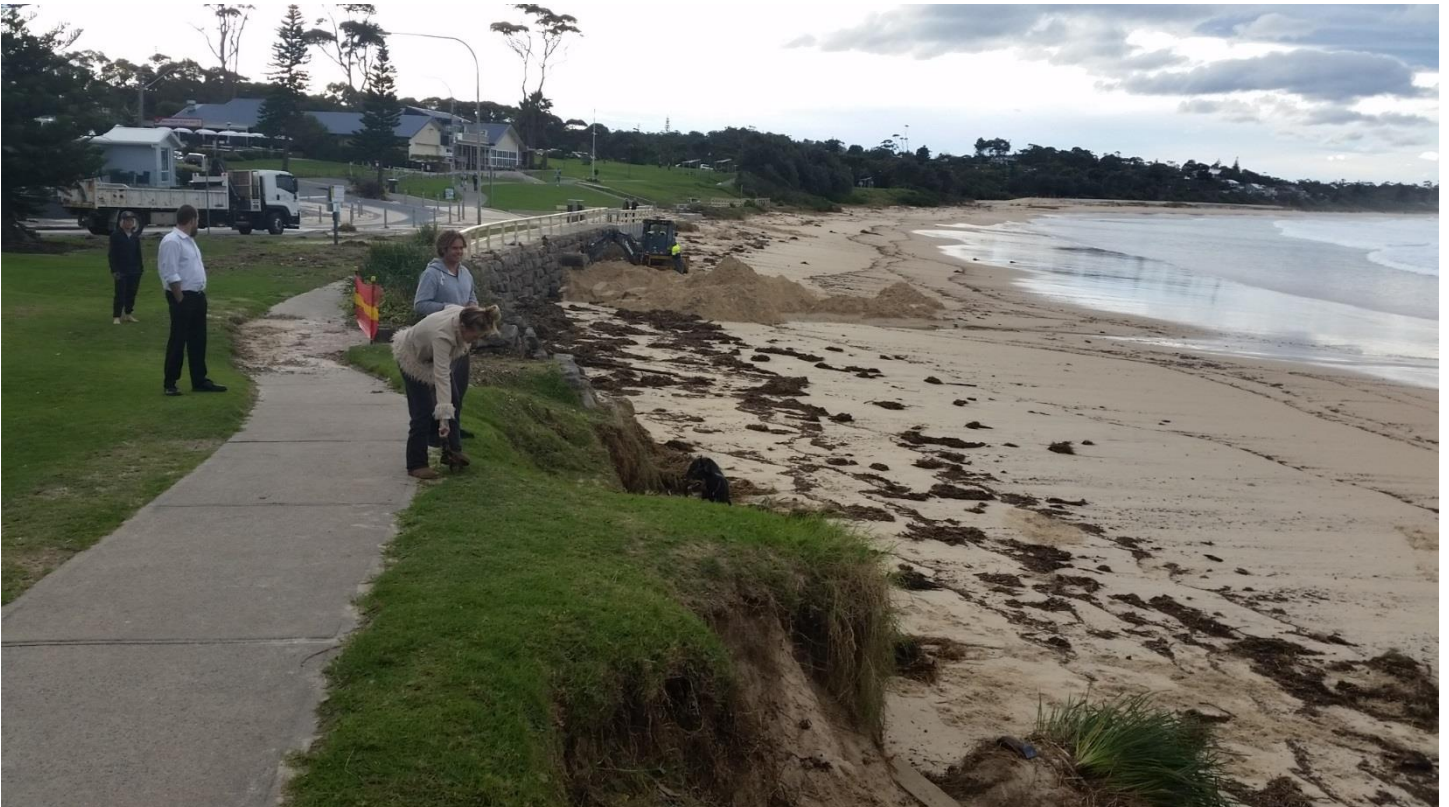
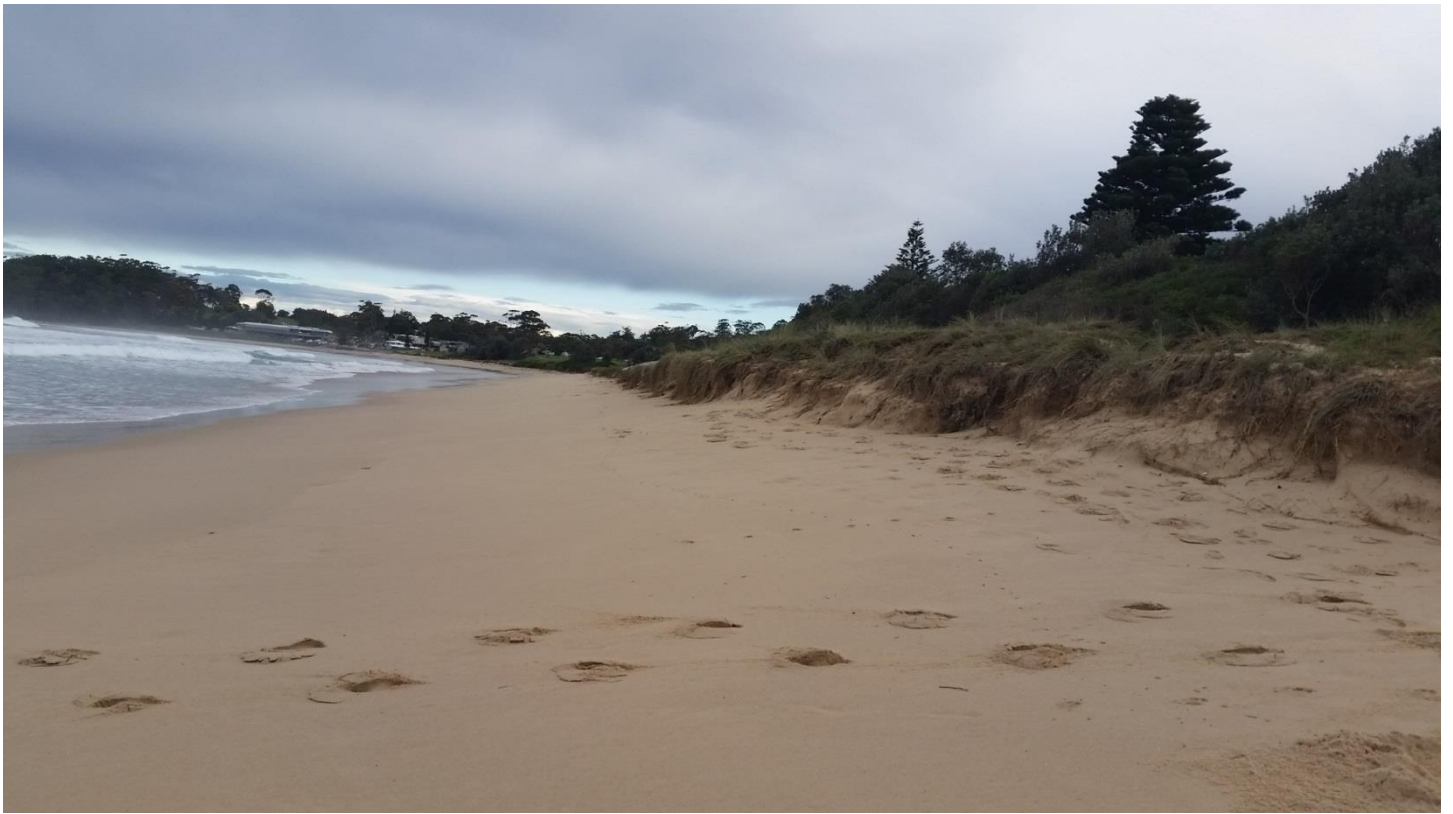
Mollymook beach the sandstone sea wall at the end of Ocean St was damaged, exposing the gabions at Golf Club frontage, sand blockage of the road stormwater system, creek training walls damaged at north and south ends of the beach.

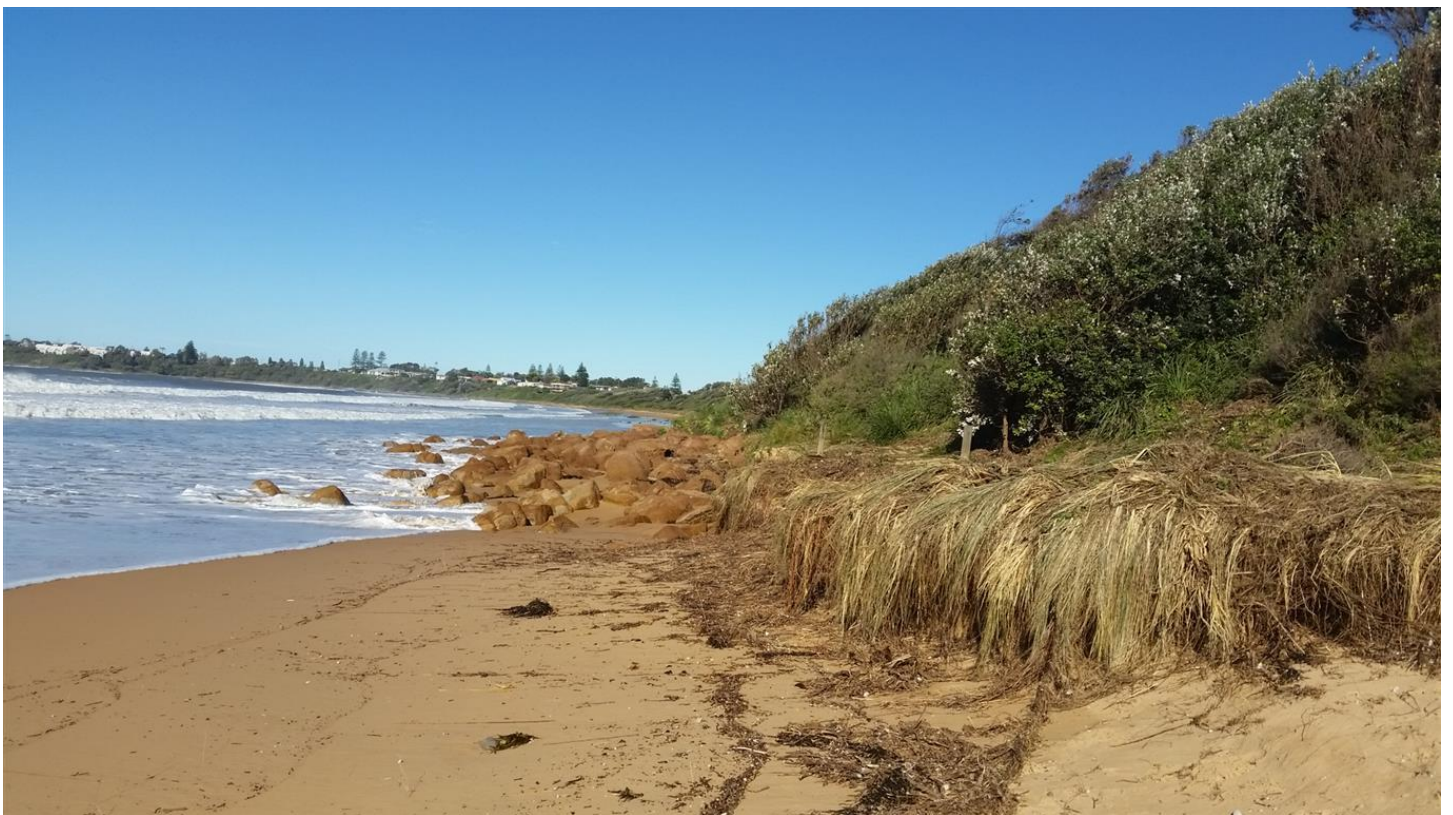
Culburra Beach, beach access damaged from Ocean St north along the entire beach with some rock outcrops uncovered. Responses include preliminary staff inspection and engagement of contractors to inspect and clear tree debris and reshape beach access points where feasible.

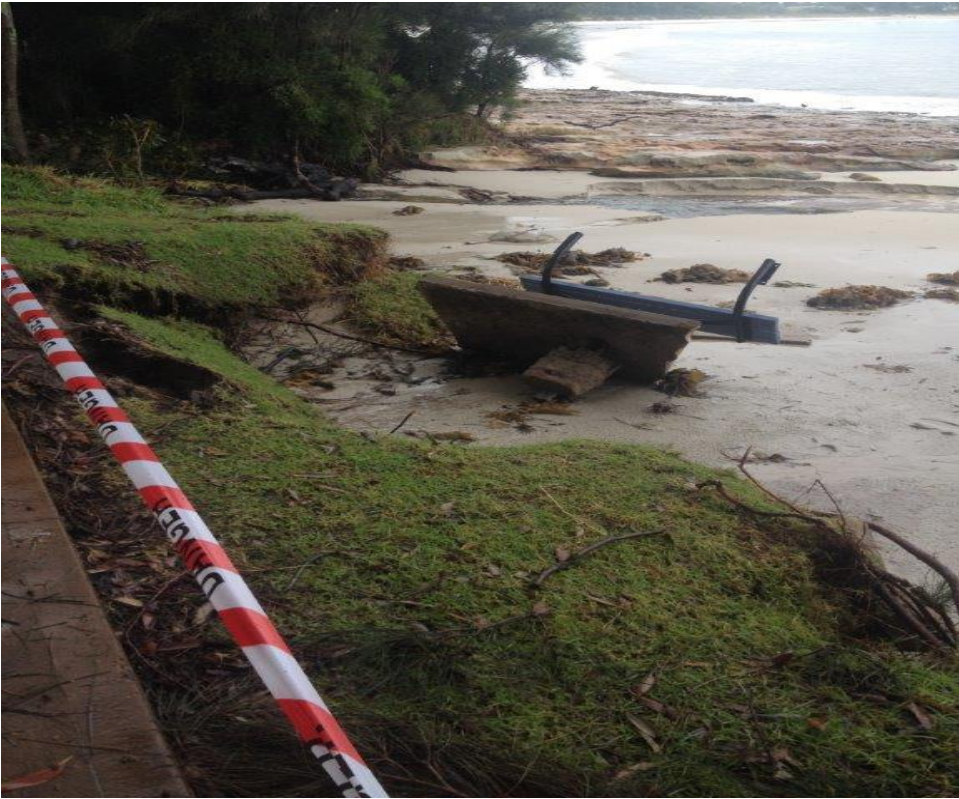
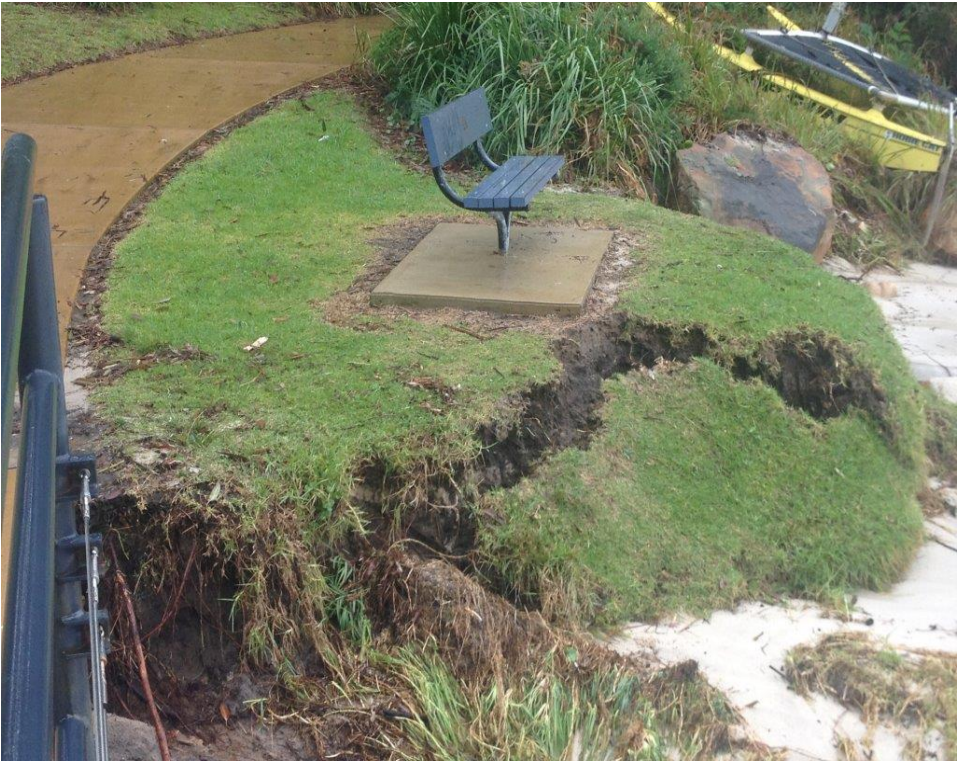
Vincentia, stormwater outlets eroded and erosion fronting shared pathway along Collingwood Beach

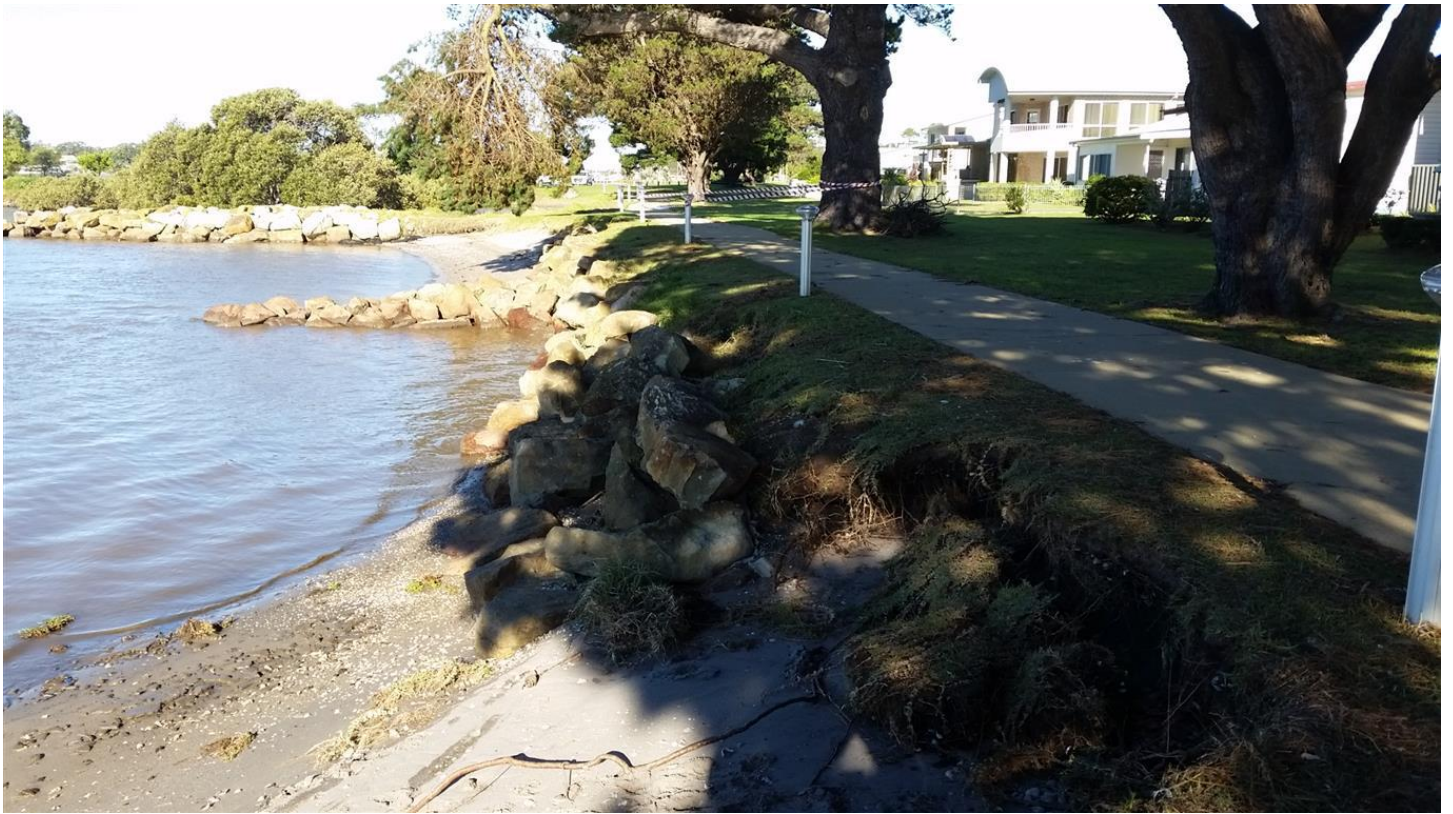
Foreshore protection Greenwell Point – minor erosion

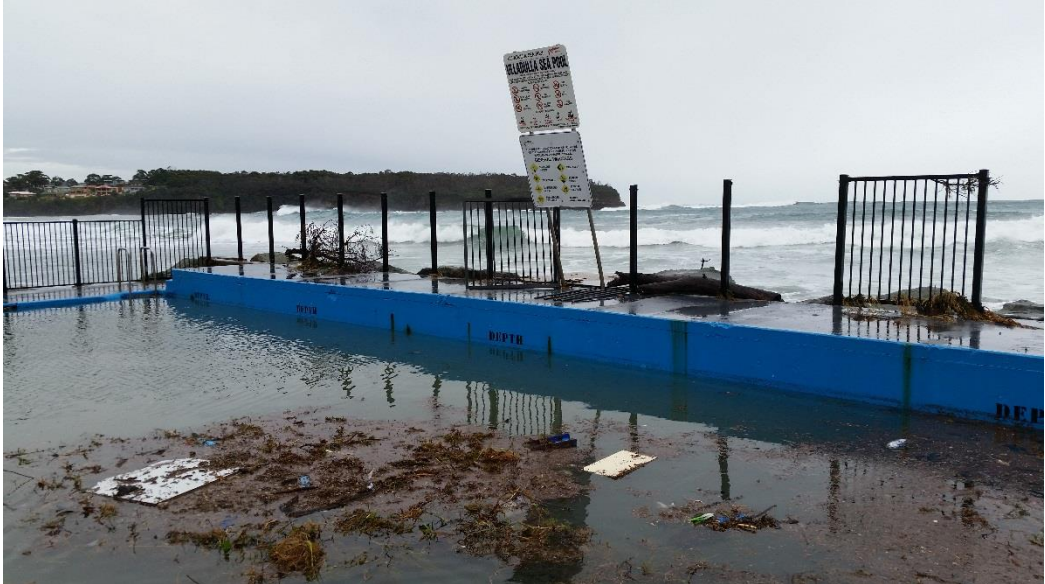
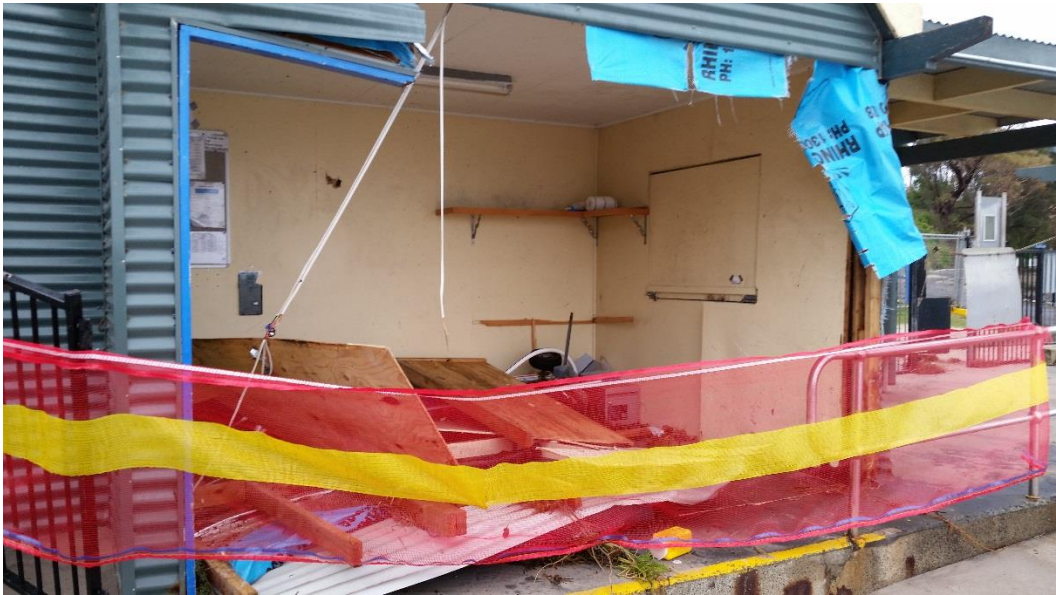
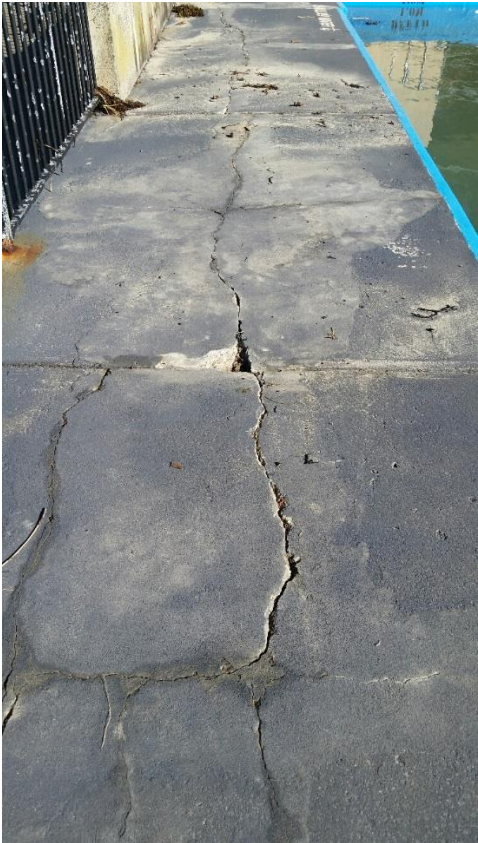
Re-inspection of all foreshore protection structures and walking tracks – damages currently unknown, fishing platforms, access ways
Significant clean up of foreshore debris required
