2016 June 4 - 7 East Coast Low Flood / Coastal Storm Event Remediation Assessment

Shoalhaven City Council
Shoreline Protection Condition Assessment
5 Year Update
Final Report

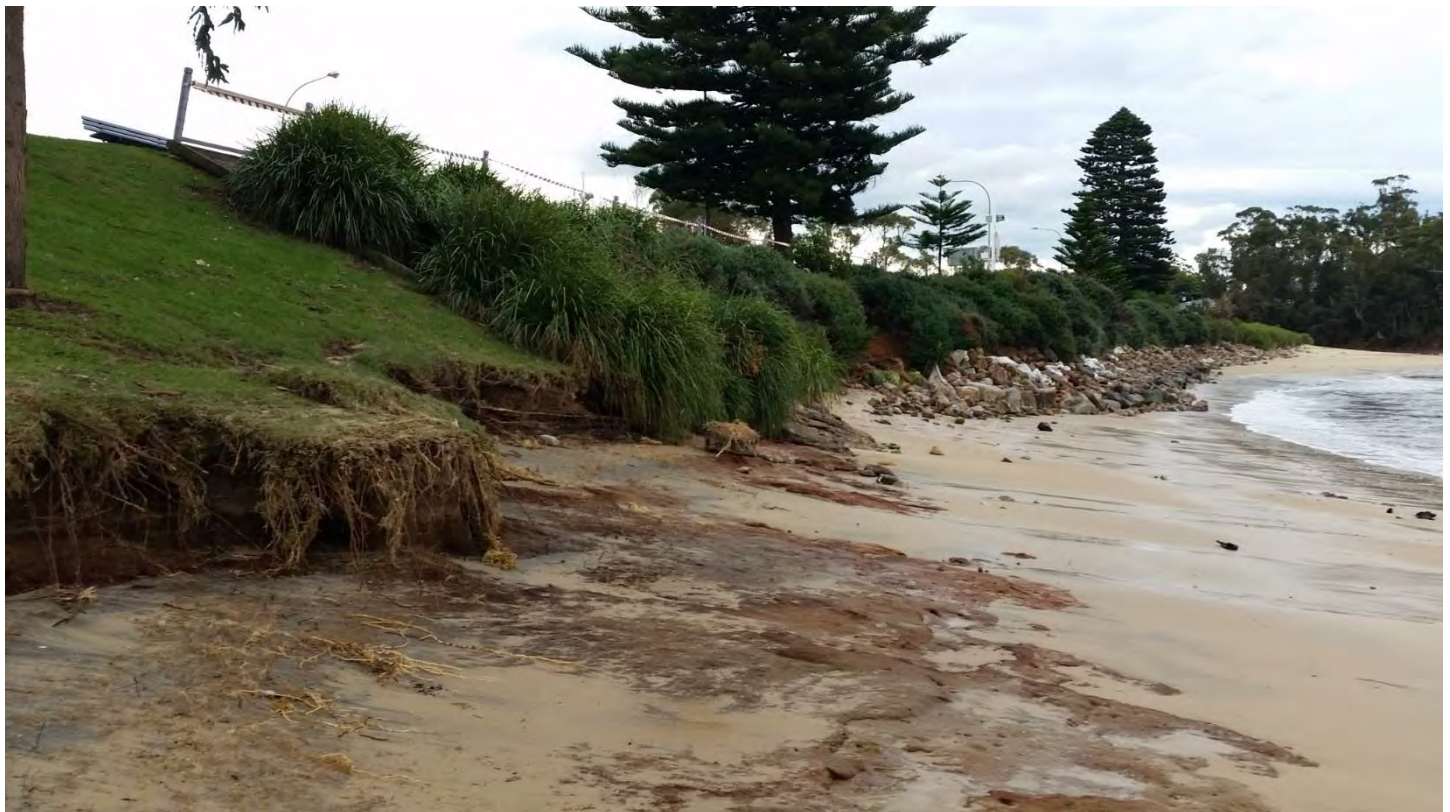
1. **Ulladulla Harbour foreshore protection** – major erosion of a 30 metre section of the existing rear harbour revetment and the loss of the tidal beach affecting park infrastructure and public amenity.

Proposed remediation \$50,000:

- Investigation \$2500 survey
- Remediation \$45,000 based on 2012 works including extension of protection and rock fill of the upper embankment and beach scraping. Relocating sand from the northern beach and nourishing the southern beach.

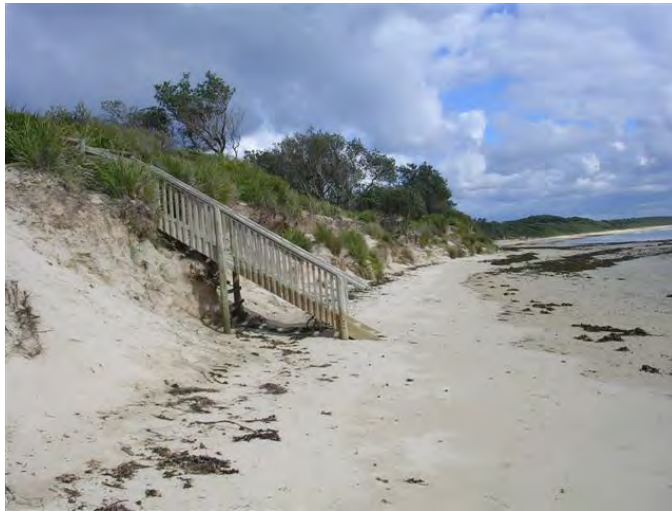
Beach access at Currarong before event. There were 8 beach access ways at Currarong Beach.

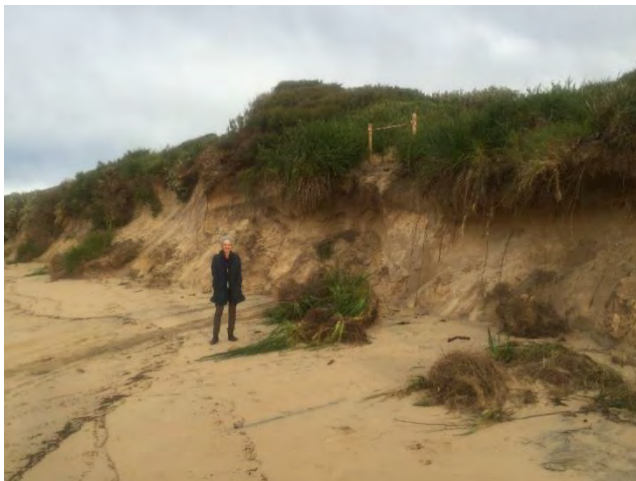
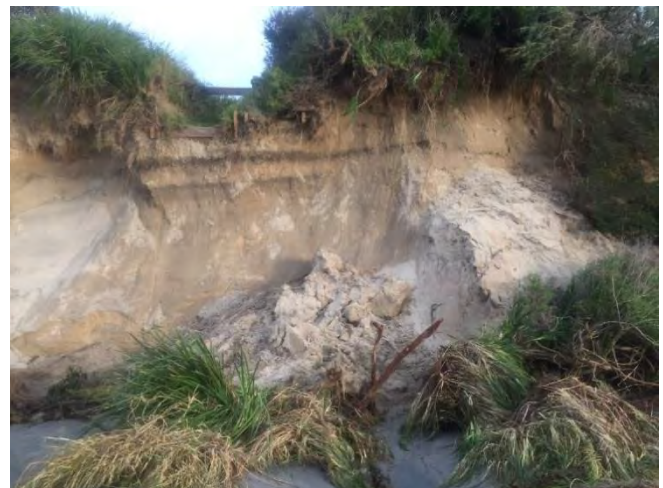
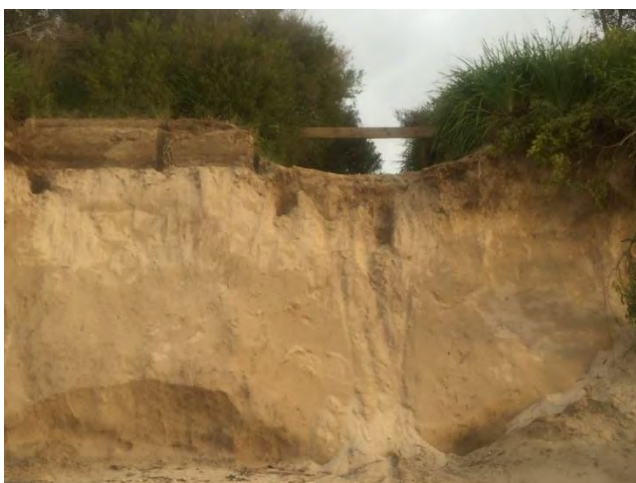
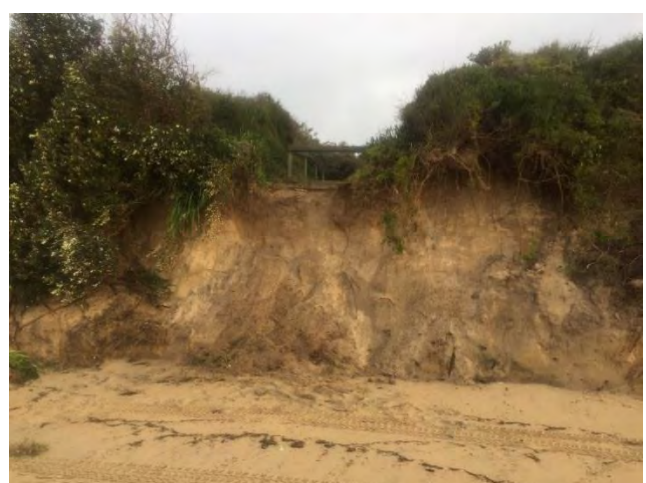
The sand tracks that led to each of the accesses, now finish at a 4 to 5 metre high sand cliff

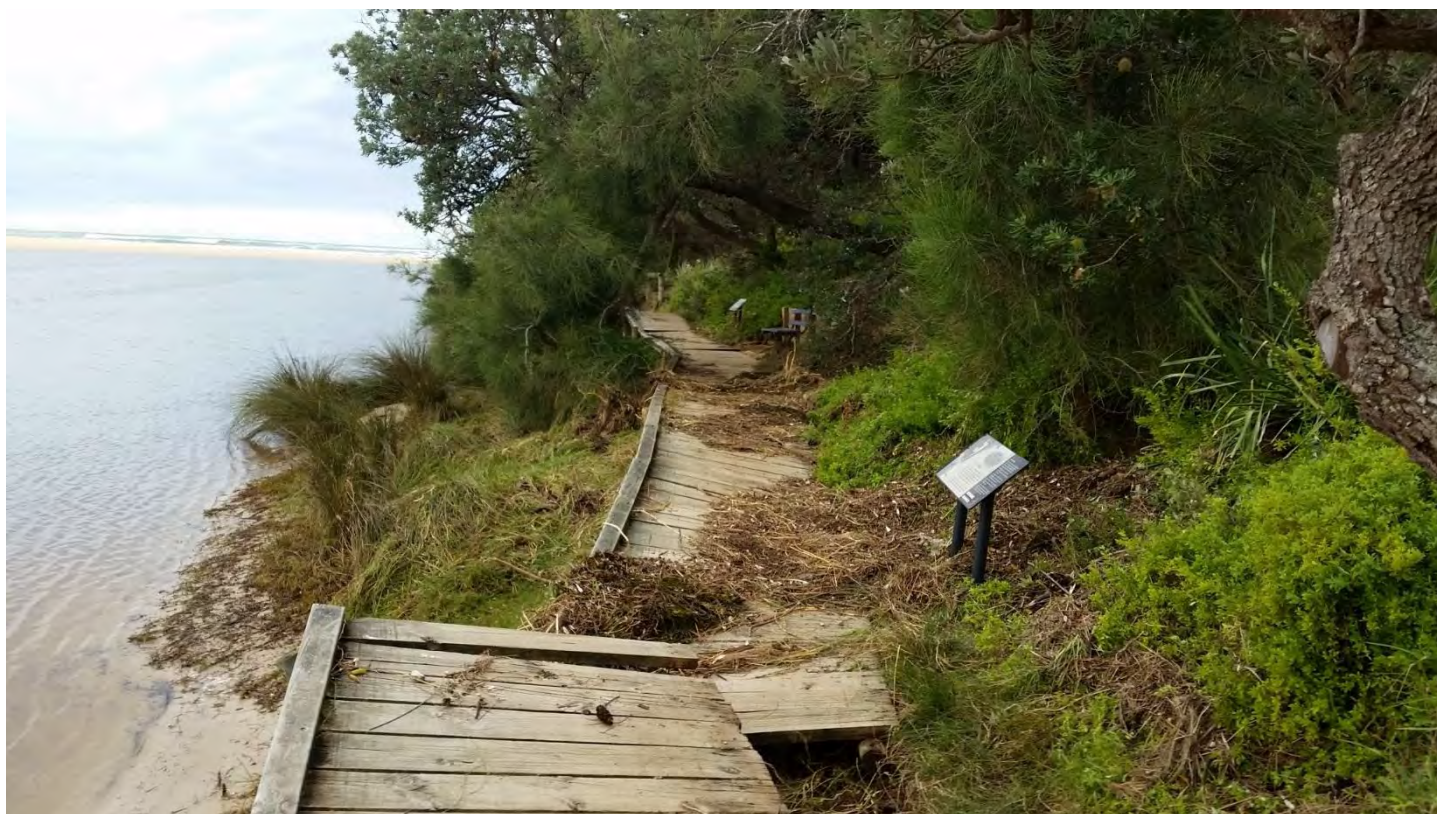
The 80m foreshore boardwalk was lifted during the combined ocean storm / flood event and damaged beyond repair.

Short term responses included hazard signage temporary fencing with the removal of the structure completed on 8/6/2016 approximately **\$5,000**.

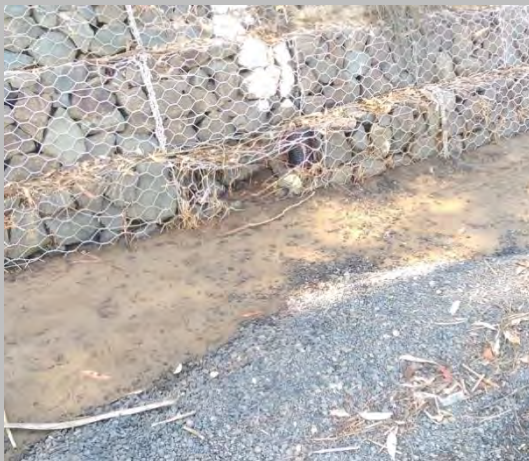
Photo 3 Damaged Gabion Mattress

Exposed Geotextile material is located along the revetment at multiple points. At the base of the gabion wall a failure point has occurred as shown in Photo 3. Areas of minor erosion behind the revetment are occurring causing loss of topsoil and bank instability as shown in Photo 4.

Monitor cracking in Photo 4 located under the bridge and vegetate eroded areas to match adjacent existing vegetation behind the revetment to prevent further bank erosion and reduction in bank stability. Fill any voids and cover exposed geotextile material with armour rock to match existing. Remediate damaged gabion highlighted in Photo 5 located at the artificial beach to match existing to prevent further collapse of the gabion mattress.

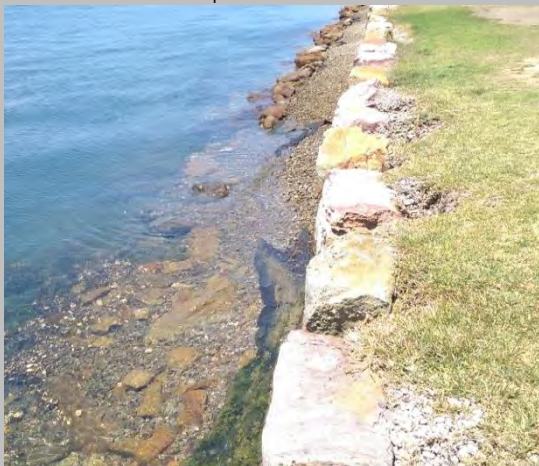
Photo 11 Toe protection failure

The rock groynes along the foreshore are in good condition. Multiple areas of exposed geotextile material are located along the retaining wall structure. Failure of toe protection and displacement of small armour rock has led to erosion of the bank and exposure of geotextile material (Photo 11). Sections of beach are experiencing bank erosion due to lack of coastal protection putting the pathway at risk (Photo 12).

Remediate damage to toe protection by using larger armour rock to prevent further erosion, loss of gravel and further exposure of geotextile material. Cover exposed geotextile material with gravel to match existing. Fill voids behind large armour rock with secondary armour rock to prevent erosion.

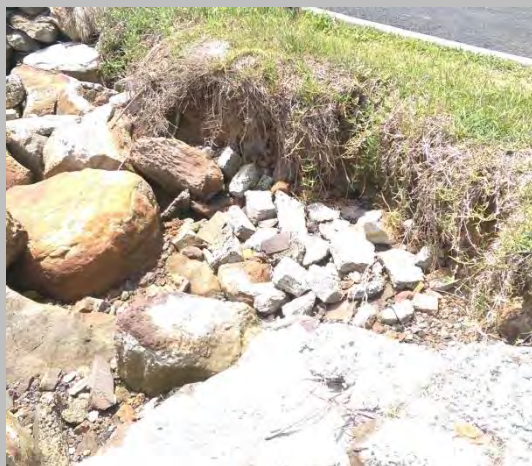
Photo 13 Minor erosion

As highlighted in Photo 13, minor erosion has occurred on the southern side of the boat ramp due to displacement of the medium armour rock. Areas of minor scour on the northern hand side of the boat ramp are present. However, the asset is working as intended and is in generally good condition.

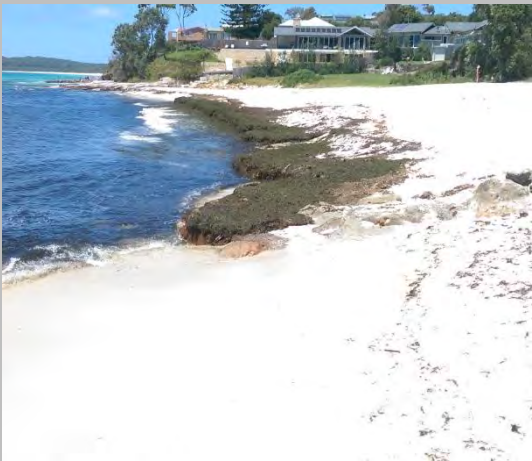
Co-ordinates Boat ramp 035° 05' 59.7" S 150° 41' 35.8" E IS THIS OURS?	Site Condition Significant beach erosion and scour occurring at the bottom of the boat ramp as shown in Photo 25. Multiple voids forming in armour rock between large and smaller armour rock at the toe of the shoreline protection causing slumping.	
Description Hyams Beach boat launching ramp is a watercraft access point protected either side by randomly placed armour rock. This protection runs adjacent to the boat ramp structure and extends along the back of the bank.	Photo 25 Erosion

Recommendation and SOW Remediate adjacent armour rock to the boat ramp and extend into a groyne-like structure to prevent beach erosion, improve usability and prevent further scour of the boat ramp. Remediate voids in existing rock revetment with primary armour to match existing along the bank to prevent further slumping failure and erosion. Consider limiting the use of the boat ramp at low tide due to drop off at the end of the ramp until remediation has been implemented.

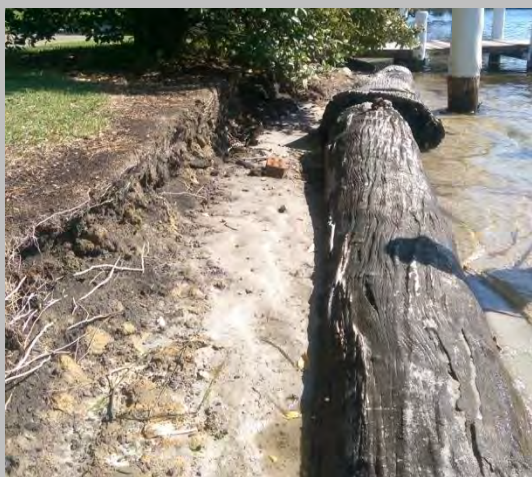
Photo 28 Displacement of Protection

Components of the timber log retaining wall located along the foreshore have displaced causing significant erosion and undercutting highlighted in Photo 28. Other areas along the foreshore are experiencing inundation due to failure and displacement of the shoreline protection techniques employed. The shoreline is also experiencing erosion and undercutting in unprotected areas.

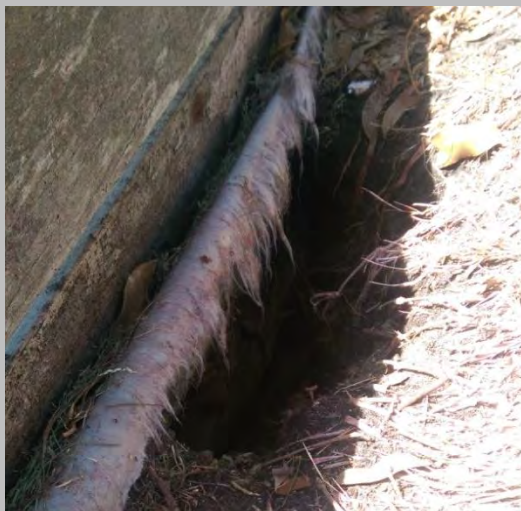
Photo 32 Erosion behind retaining wall

The shoreline protection asset is in good condition along Lions Park and around the Lions Park boat ramp. One area has experienced erosion behind the wall as shown (Photo 32). The structure is operating effectively and is in good condition in all other locations.

Remediate erosion behind timber plank retaining wall as identified in Photo 32 above by filling to match existing to prevent further erosion. Cover exposed geotextile material to prevent further degradation.

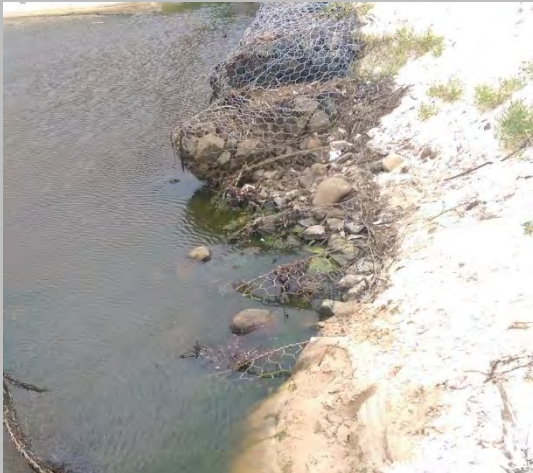
Co-ordinates River training wall 035° 19' 31.6" S 150° 28' 45.6" E	Description The Beach Rd creek protection consists of a gabion training wall to prevent the creek from swinging to the north, threatening the road embankment and sewerage infrastructure.	
Site Condition The end section of the gabion wall has failed - Photo 46 and Photo 45 causing the training wall to be potentially less effective.		Photo 46 Failed Gabion Mattress close up

Recommendation and SOW Remediate approximately six failed gabion baskets to prevent further damage to existing structure . Monitor following large rain events until remediation has been undertaken.
Priority	Medium	Cost estimate: \$ 24,000
