St Andrews Way, Coolangatta

Effluent Disposal Assessment and Cost Analysis

Project No. 1530
Date: March 2016

Prepared for: Shoalhaven City Council

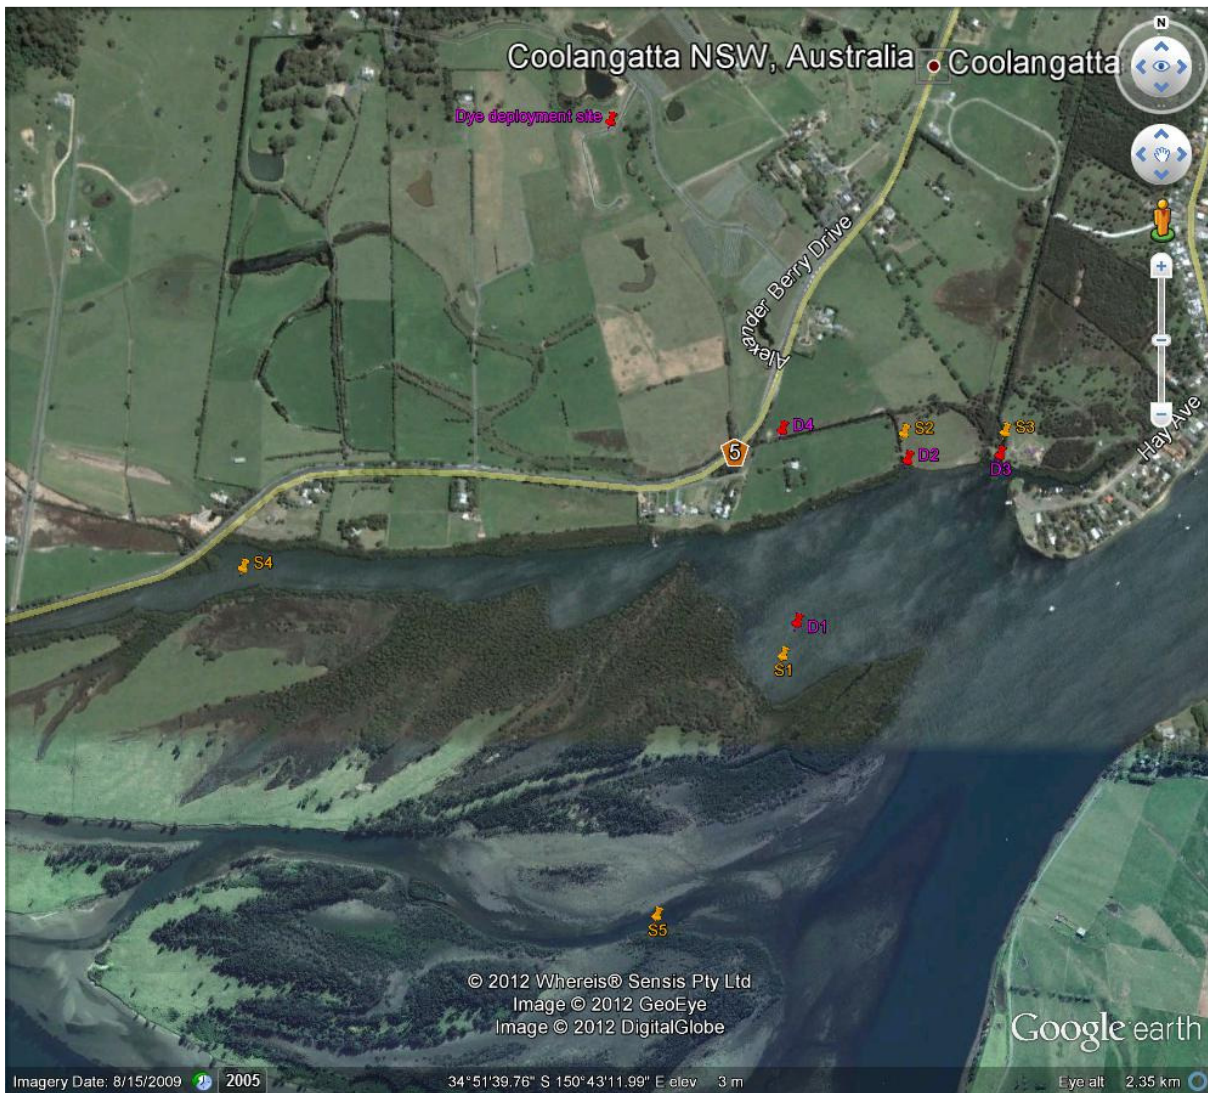
Figure 2.1: Water Quality Testing Sampling Sites

Test results are summarised below with sampling site locations shown in Figure 2.1. The general theme is that there is a hydraulic link between septic tank/s on the site and the stormwater outlet at the bottom of the site. Faecal contamination is occurring at this location which is likely to be the result of failing on-site wastewater systems.

Dye test results showed a hydraulic connection between the septic dosing location, the stormwater outlet at the lower end of the St Andrews Way Estate (D2), and the outlet of the Berry's Bay catchment to the Shoalhaven River (D4) suggesting that there is a hydraulic connection between the dosing point and these locations.

Coprostanol is the key sterol indicator of potential human faecal contamination. Faecal sterol testing showed that for the sample site at lower end of the St Andrews Way Estate (S2) there is evidence of human faecal contamination, and that contamination was likely fresh/recent and unlikely from extensively treated wastewater. Coprostanol was also detected in other samples, but all below the threshold for indication of significant faecal contamination.

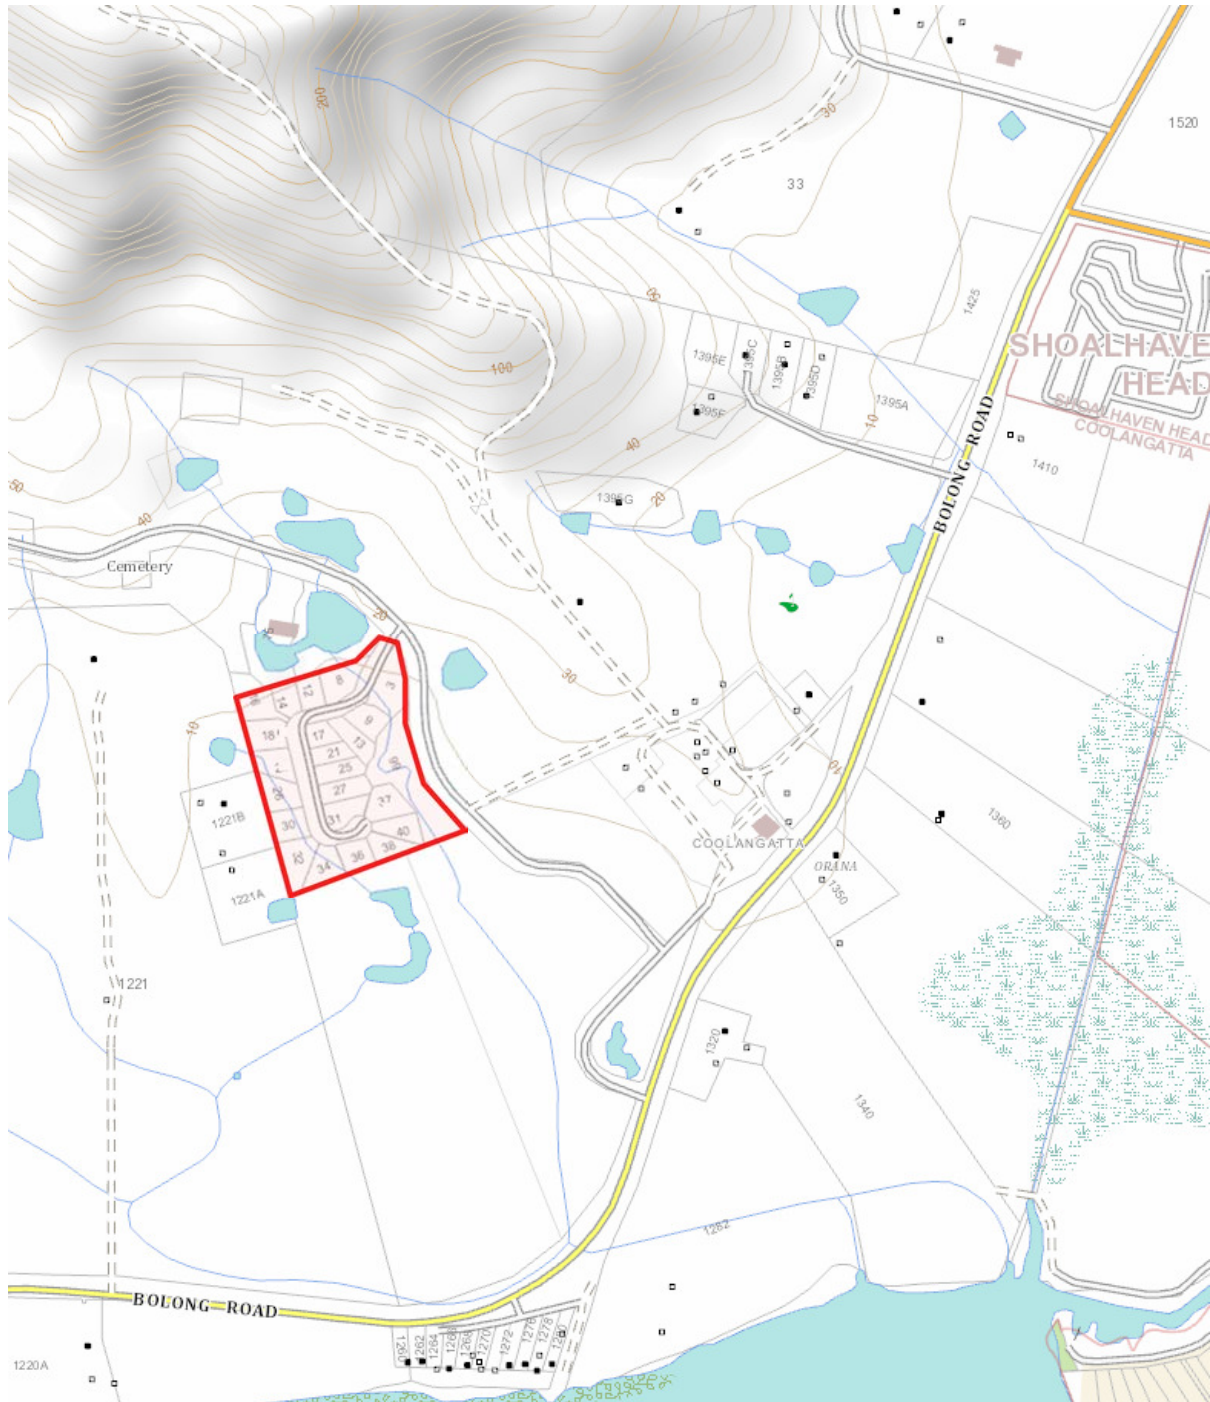
Figure 2.2: Development (red) context in landscape. Note location in low lying drainage plain at base of steep hillside and watercourses mapped through the site.

The location of disposal areas is generally high to very high risk in relation to surface waters, groundwater or general drainage and land form. Prior to development of the site the area contained two distinct drainage lines (Figure 2.2), one of which has been retained, the other diverted. A number of treatment systems and disposal areas are located in very close proximity to these drainage lines, or in areas that were previous low points. This leads to the very high risk of pollutant transfer to surface waters and shallow ground waters in the case of system failure and increased risk system failure in areas that are characteristically prone to wetness and waterlogging.

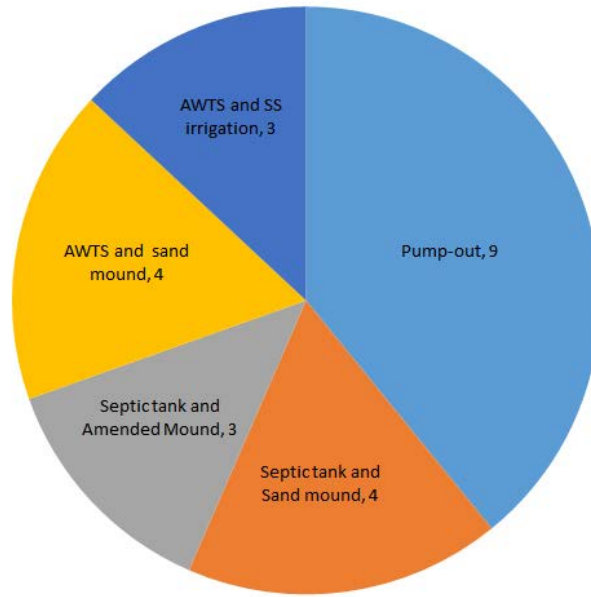
Figure 3.1 and Figure 3.2 show the breakdown of on-site sewage management systems (OSSM) type and failure type as recorded by Council during inspections in February and March 2015, after a period of heavy rain. A detailed summary of the existing OSSM (including recorded failures) for each lot is included in Appendix B.

Figure 3.1: Breakdown of main treatment and disposal approach over the subdivision, March 2015.

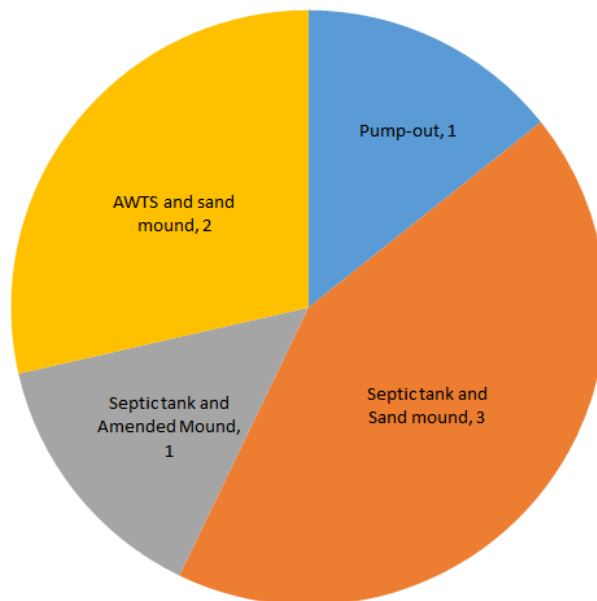
All mound systems were inspected in February 2015 and all remaining systems were inspected in March 2015. 70% of system failures were from primary treatment systems, and more than half (55%) of on-site mound systems failed. Neither of the two AWTS systems with subsurface irrigation registered a failure. The recorded wet weather pump out failure was associated with the pump for the grey water system.

Figure 3.2: Breakdown of systems that recorded failure after heavy rain in February and March 2015
