## **Shoalhaven Coastal Cliffs and Slopes Risk Management Recommendations Report**

Client: Shoalhaven City Council

Reference: M&APA1474R001F0.3

Date: 11 May 2018

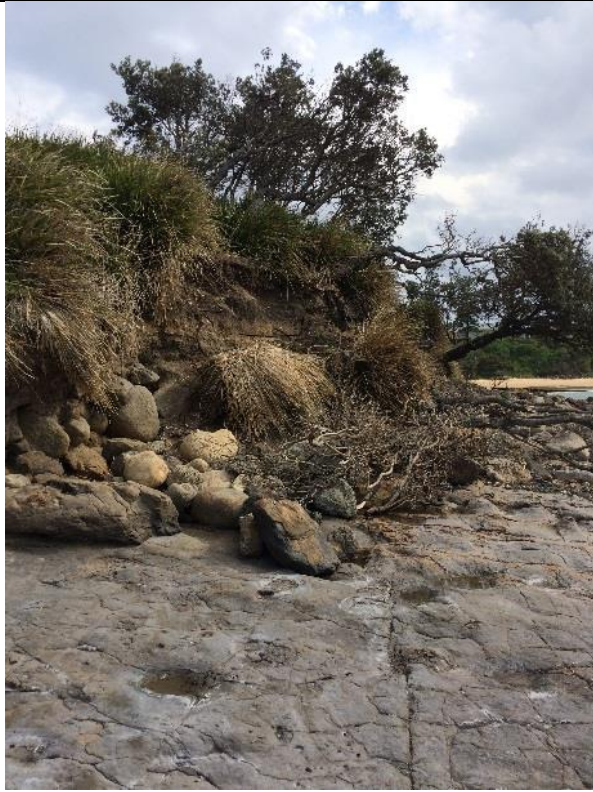
Image 1

The 'boulder armour' described by Douglas Partners (DP) to be 5m to 10m wide and covering the base of the cliff around the north-western portion of the Penguin Head site was observed. Over the western end of the northern cliff face the 'boulder armour' was generally missing or a maximum width of about 4 metres in places. Localised erosion of the fill batter slope over this area was evident (see Image 1). Localised, less

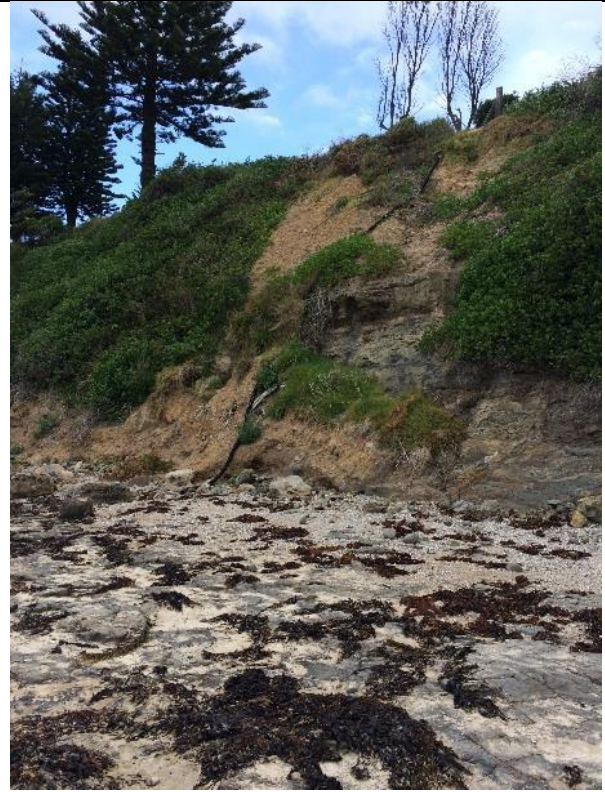
Image 2

than 0.5m<sup>3</sup> soil slumps were noted with 'ag' pipes extending down the cliff face from the yard area above (see Image 2).

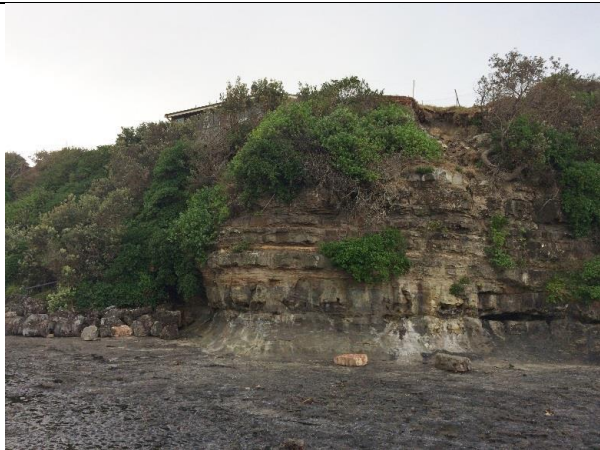
Image 6

A recent soil slump (about 8 m<sup>3</sup>) had impacted the rear yard area at the crest of the cliff. Sections of the damaged brick fence were located on the wave cut platform (see Image 6).

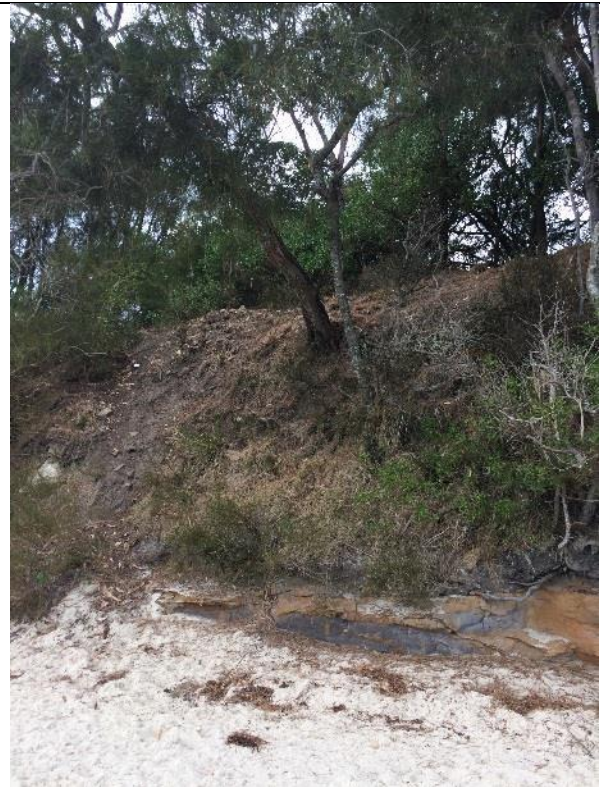
Image 7

Over the western portion of the north facing cliff face, there were signs of run-off erosion impacting the soil profile. Some trees were leaning over or had curved bases, suggesting creep of the soil profile (see Image 7). Over the eastern portion of the north facing cliff face, there were signs of fretting and spalling of the upper residual clay soil profile (see Image 8).

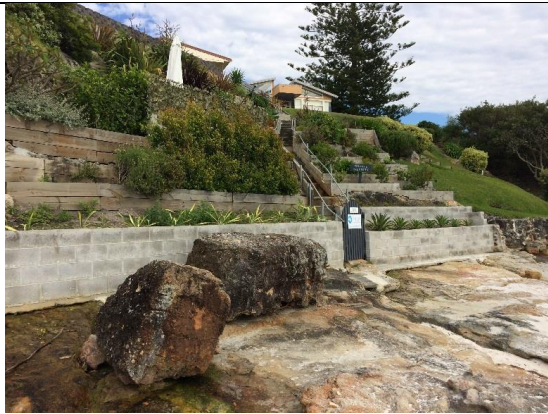
Image 12

The area described by DP as 'concrete faced slope, cracked and spalling' appears to have been remediated and now comprises a concrete block seawall founded on the bedrock wave cut platform. The terraced rear yard above the seawall has been formed using timber landscape retaining walls (see Image 12).

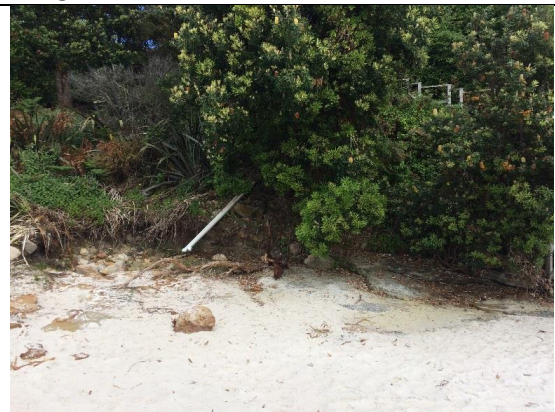
Image 15

To the south of the old landslip, two 90mm diameter PVC stormwater pipes discharge at the toe of the soil slope. The ends of the pipe have been orientated to the north and south and the discharge of the pipes appears to have eroded the toe of the soil slope. The sub-vertical erosion face was about 0.5 metres high and the erosion had caused the toe to recede landward about 3 metres (see Image 15).

It is recommended based on the geotechnical assessment of the risk areas that all water carrying pipelines discharging on to slopes and cliff faces should be piped to the base of the slope/cliff and discharged such that flow is directed away from the slope. All existing surface (including roof) and subsurface drains, pool backwash systems, septic tanks, water tanks etc, should be subject to ongoing and regular maintenance by property owners. It is recommended that within the a 12 month period following the issue of this report that property owners (private property, Council and utility owners) within the identified risk areas check all water carry pipelines/water storing systems for leaks and/or other damage and repair as necessary. These checks should be undertaken by a licensed plumber or other similarly experienced professional.

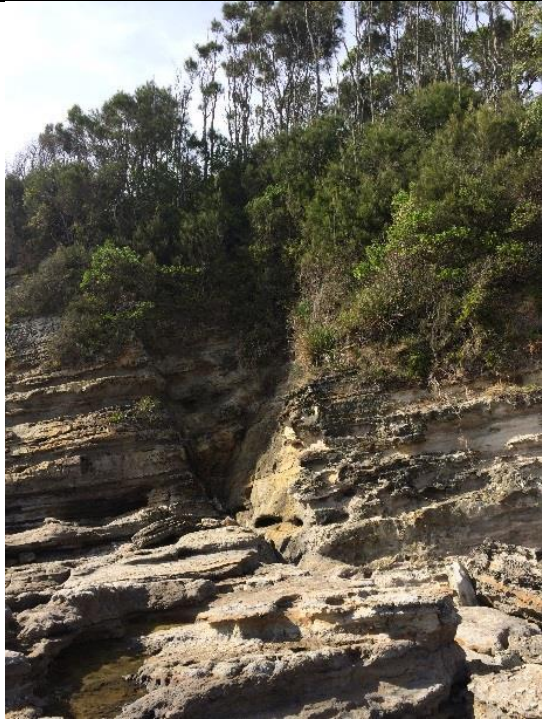
Image 38

The north-east facing portion of the cliff face (below the car park area to the north of Bannisters) exposed sandstone (maximum height about 6 metres) below the vegetated colluvium slope. Occasional joint controlled wedge failures were evident (see Image 38).

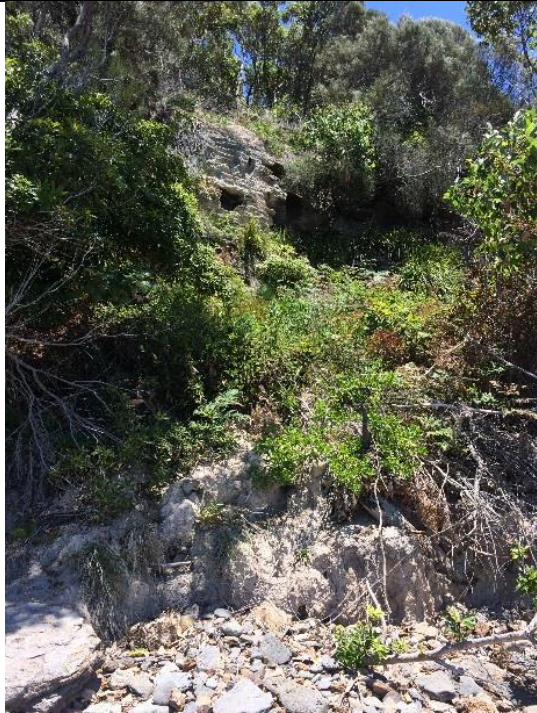
Image 44

To the south-east of Image 43, there were signs of recent slumping of the lower colluvial soil slopes (maximum about 5m<sup>3</sup>) and some sub-vertical toe erosion faces (maximum height about 2 metres). A sandstone cliff face that was unravelling and spalling was evident landward of the lower colluvial soil slope (see Image 44).

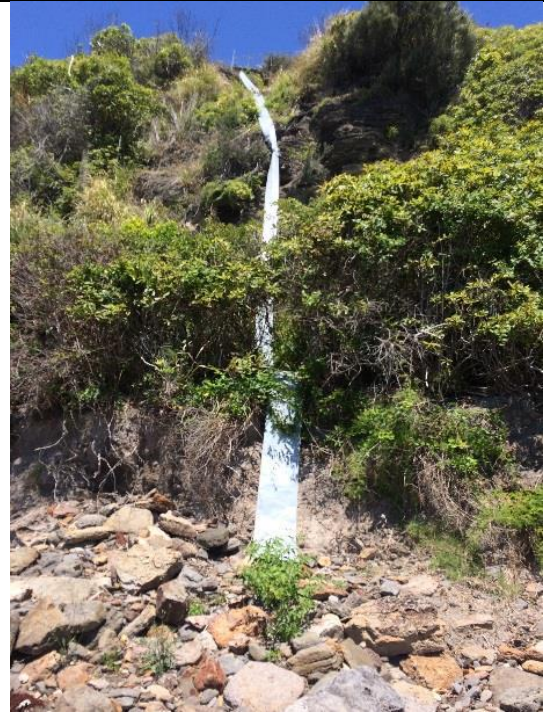
Image 45

A new plastic stormwater pipe extended down the full height of the cliff adjacent to an area of fractured and undercut sandstone (see Image 45). This area was inferred to be below about 61 to 65 Nurrawallee Street.

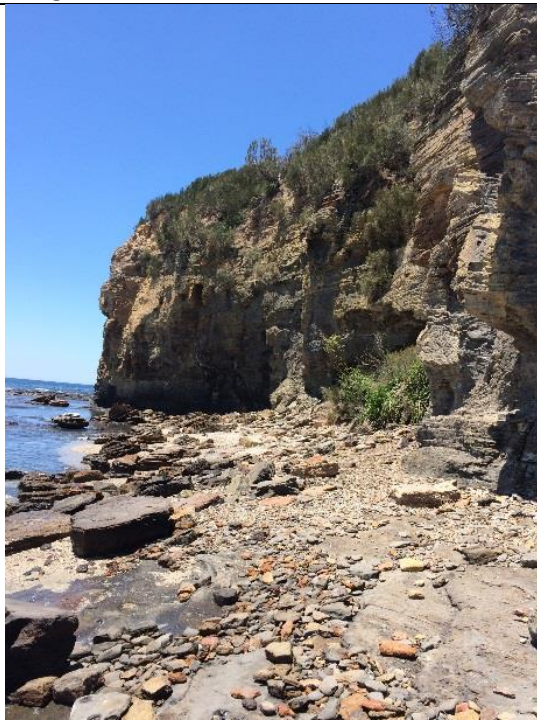
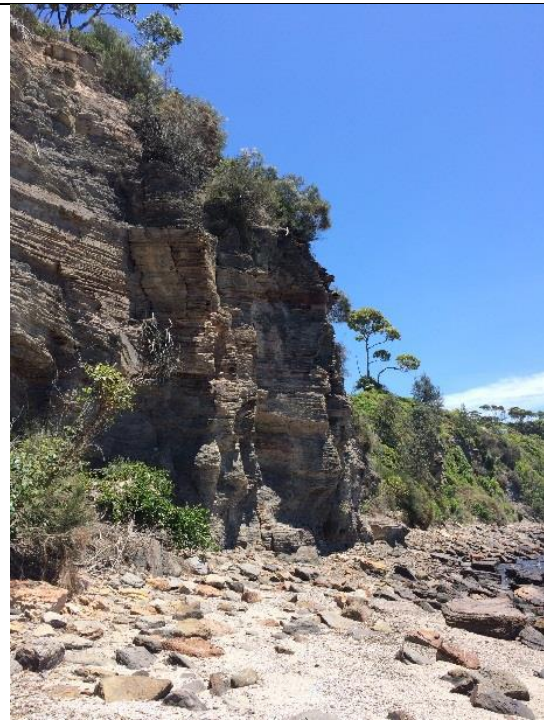
The cliff face at the south-western end of the site continues to erode and spall along the face and toe with potentially unstable blocks of sandstone evident on the cliff face (see Images 46 and 47).

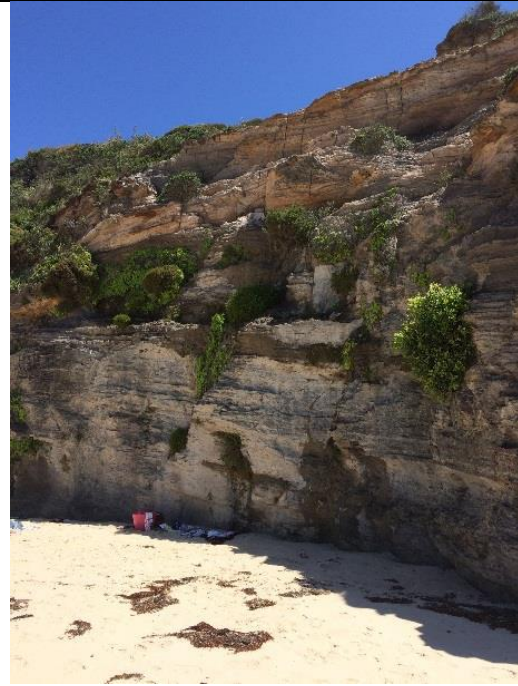
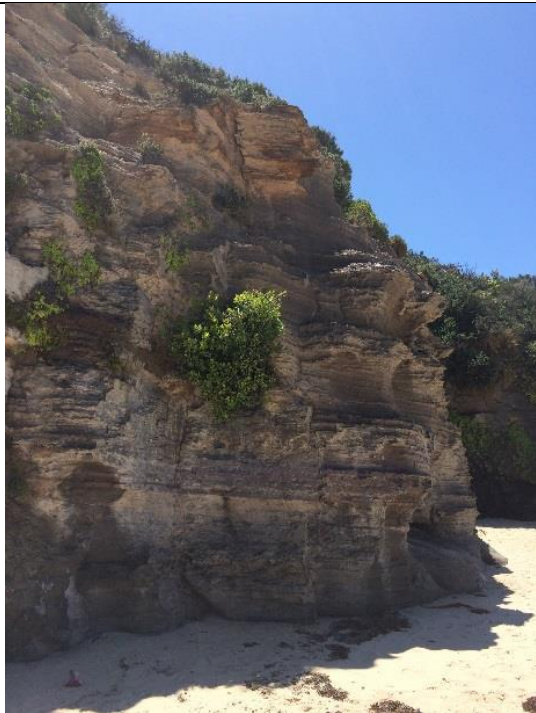
The upper portion of the cliff face over the area was unravelling and spalling with small blocks caught on ledges of the cliff face. The sandstone was fractured and maximum 1m x 1m x 1m, potentially unstable blocks were evident (see Images 49 and 50).
