### **Covering Note**

If you have any questions about how Council manages sensitive information, please contact Council on 1300 293 111.

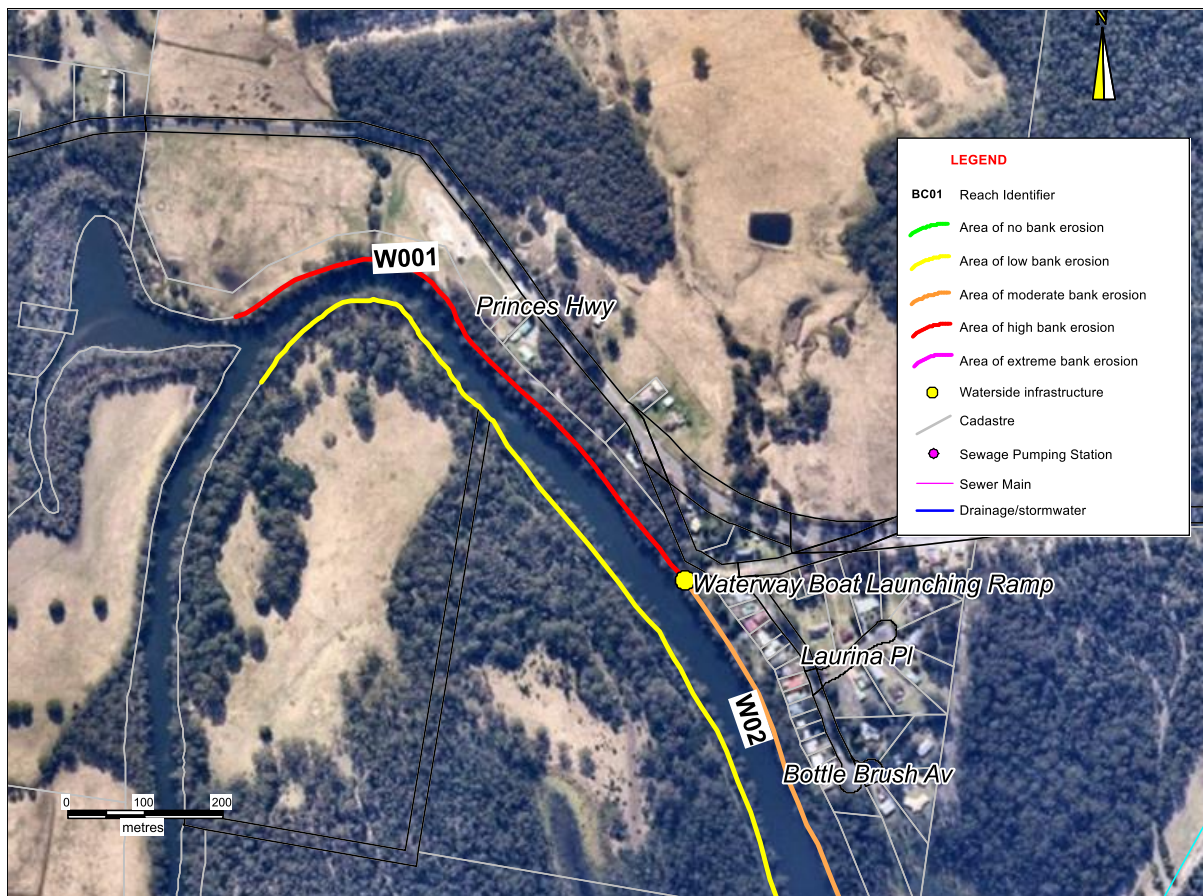
Figure 3-2 – Detail of W001 site at Wandandian Creek assessed as having erosion of high severity

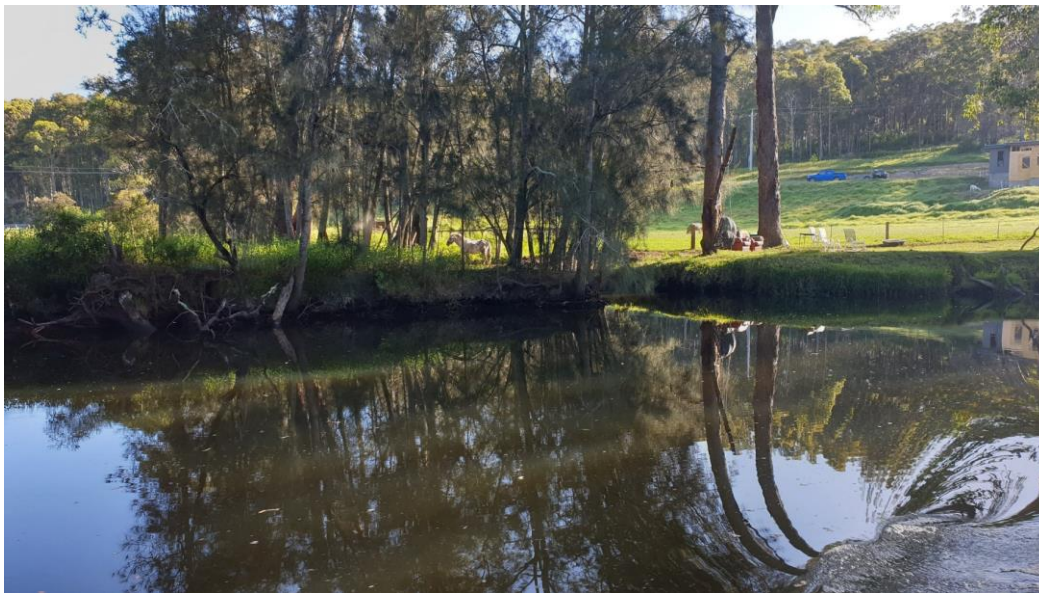
*Figure 3-3 – Wandandian Creek at Bewong (site reference W001). Note direct access to foreshore by stock and lack of riparian vegetation along bank at right hand side of photo (16 February 2022).*

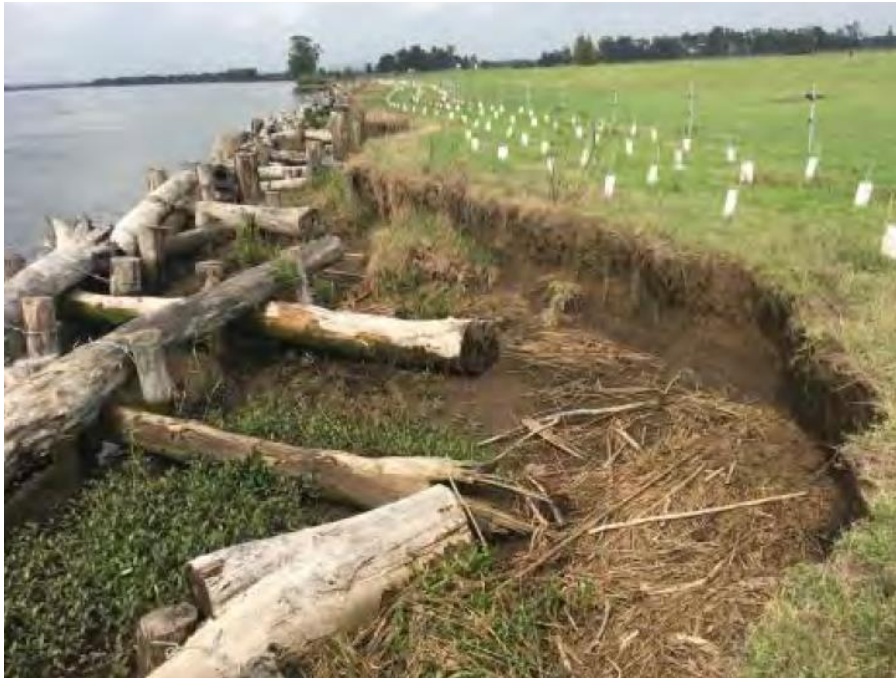
Figure 3-5 – Application of large woody debris at Hunter River, NSW. (Hydrosphere Consulting, 2020).

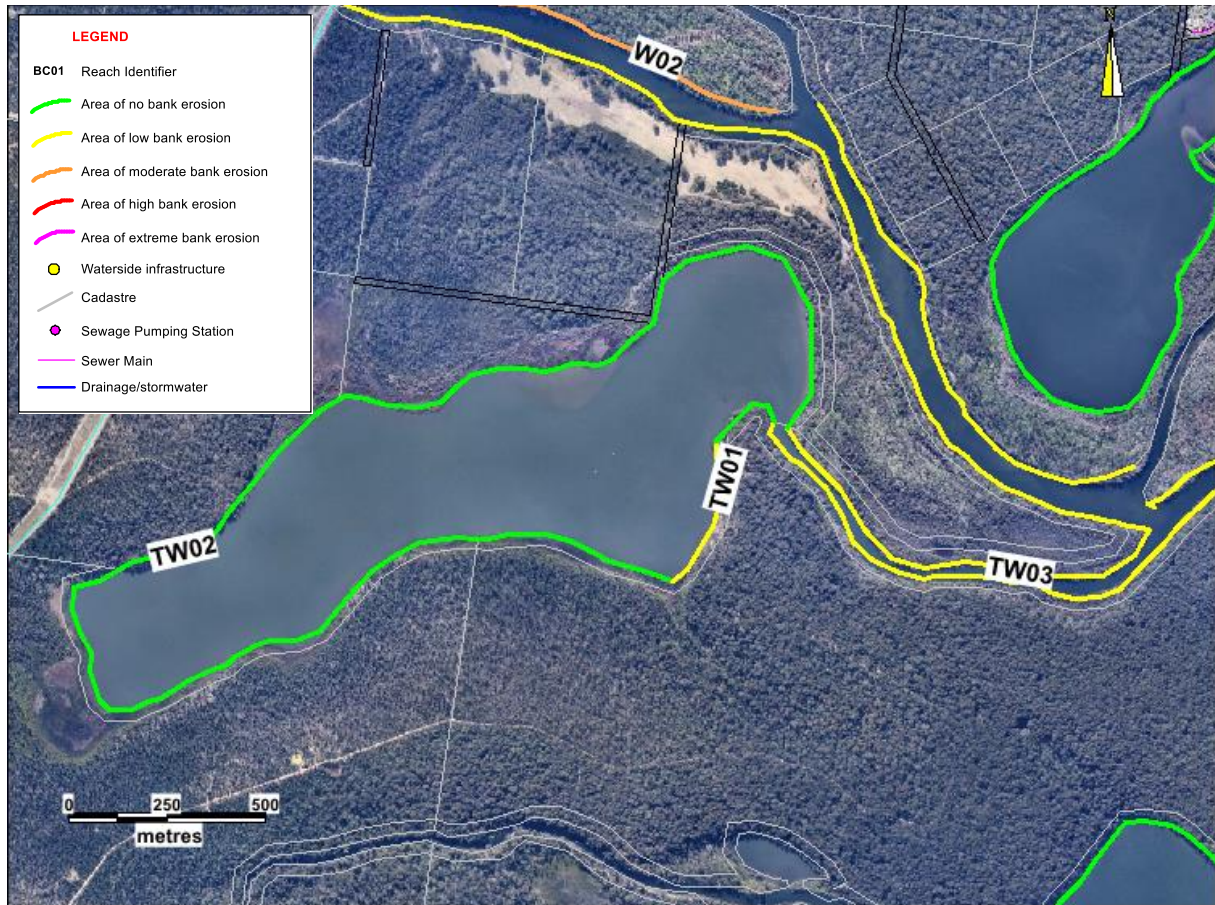
Figure 3-6 – Detail of observed erosion at Tullarwalla Lagoon

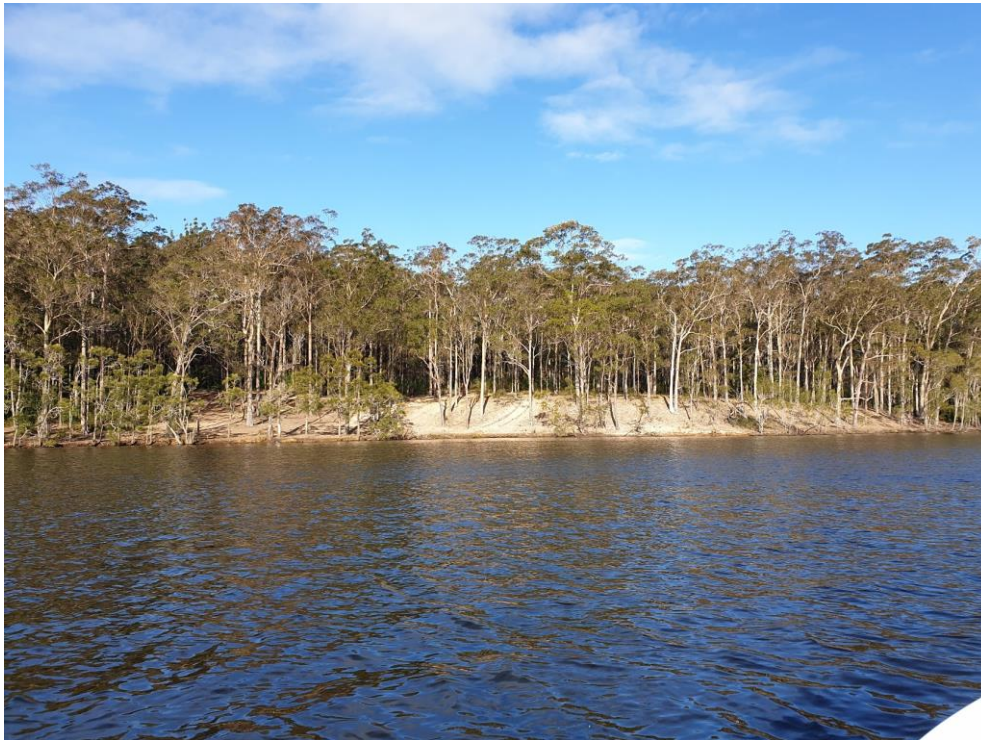
*Figure 3-7 – Area at Tullarwalla Lagoon where foreshore vegetation has been cleared and vehicles access the foreshore (17 June 2022). Site reference TW01*

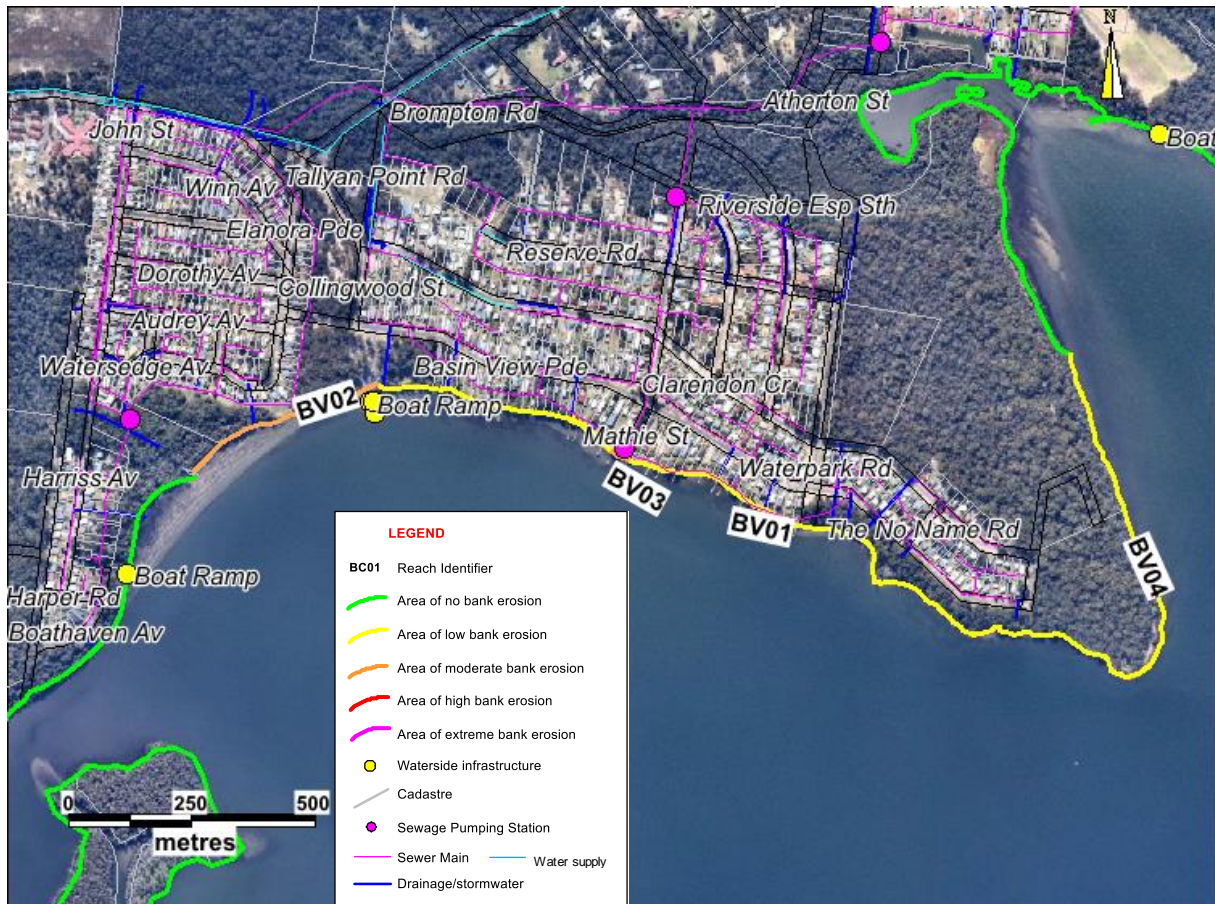
Figure 3-11 – Mapped foreshore erosion at Basin View

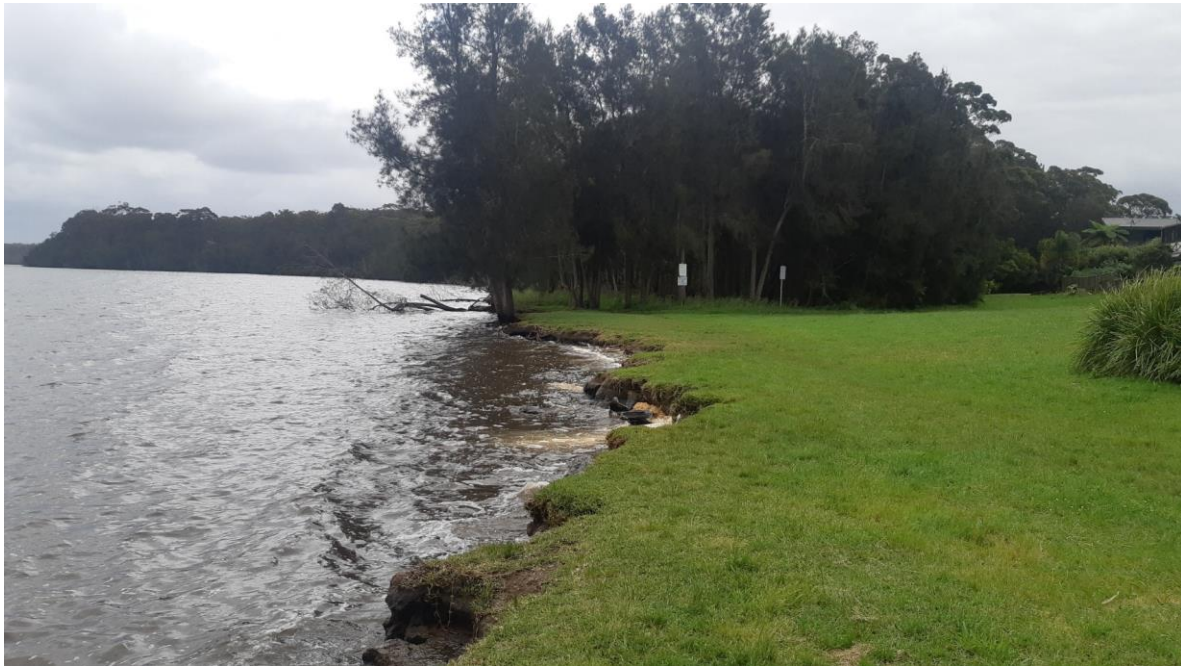
*Figure 3-12 – Basin View foreshore looking west from boat ramp. Note lack of riparian vegetation and undercutting of casuarinas in the background (28 November 2021). Site reference BV02.*

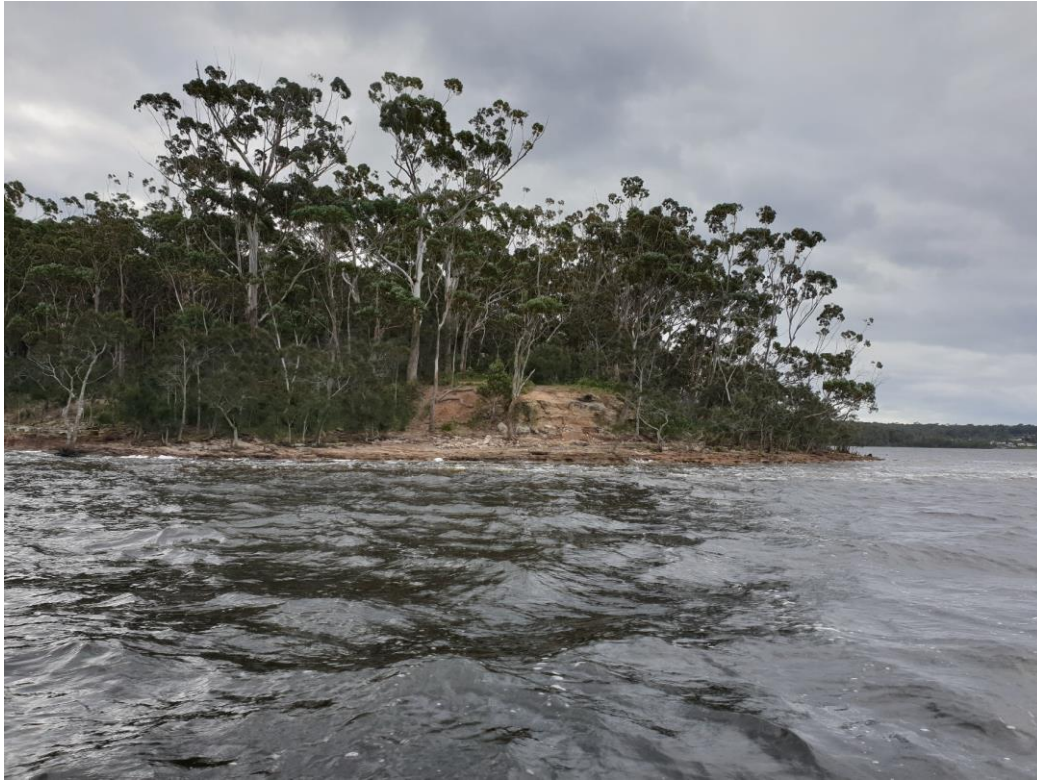
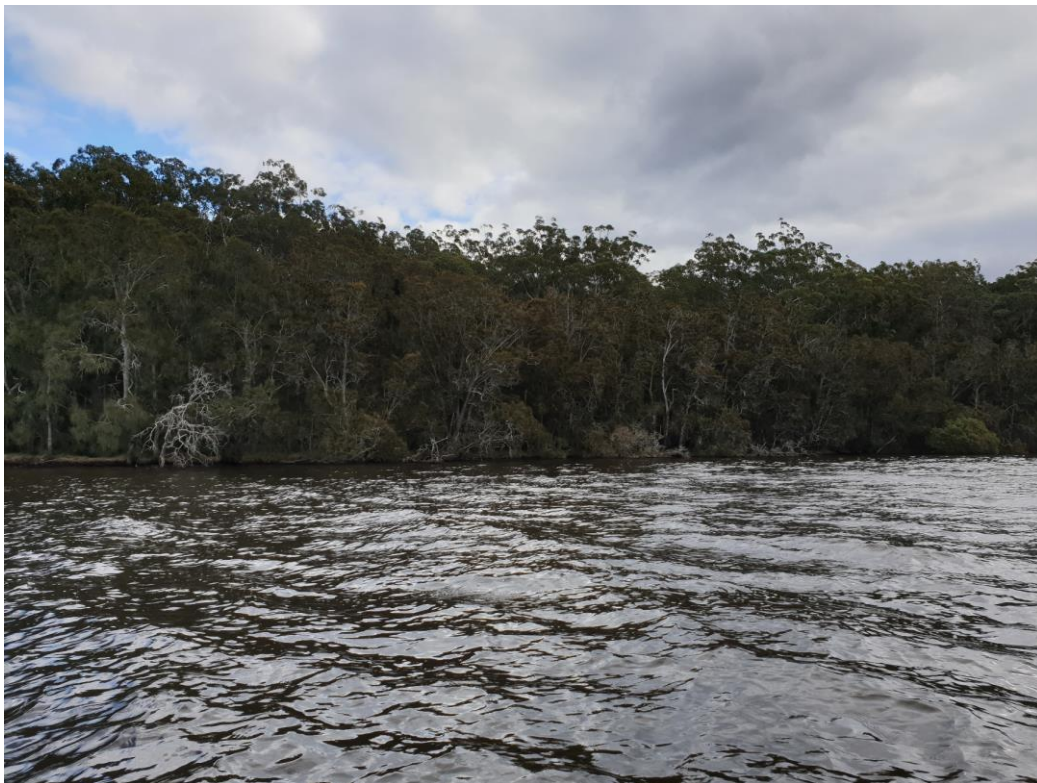
*Figure 3-14 – Observed erosion at Tallyan Point. Top – western side of Point, erosion of slope due to clearing of vegetation. Bottom – undercutting of riparian vegetation. Site reference BV04. (17 June 2022)*

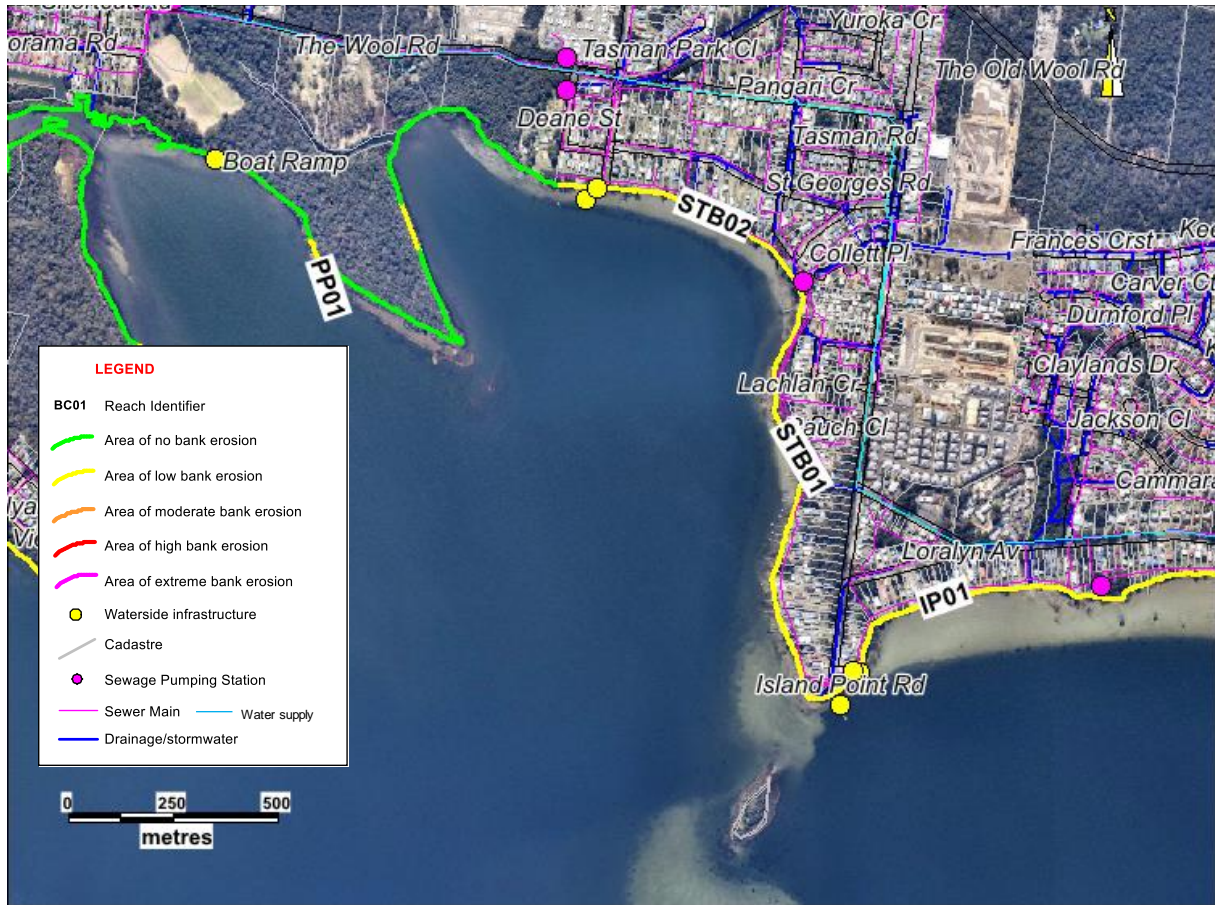
Figure 3-17 – Mapped foreshore erosion at St Georges Basin village, including Blackett Reserve and Pelican Point

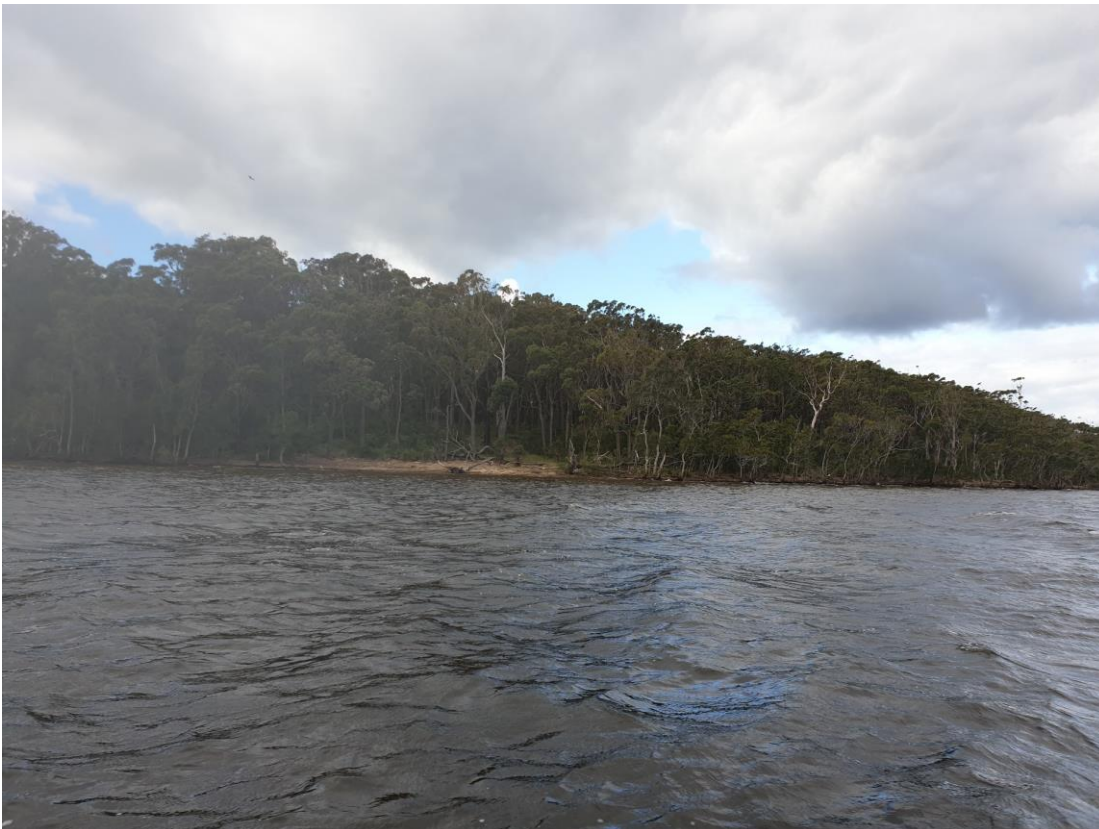
Figure 3-23 – Minor erosion observed at Pelican Point, 17 June 2022. Site reference PP01.

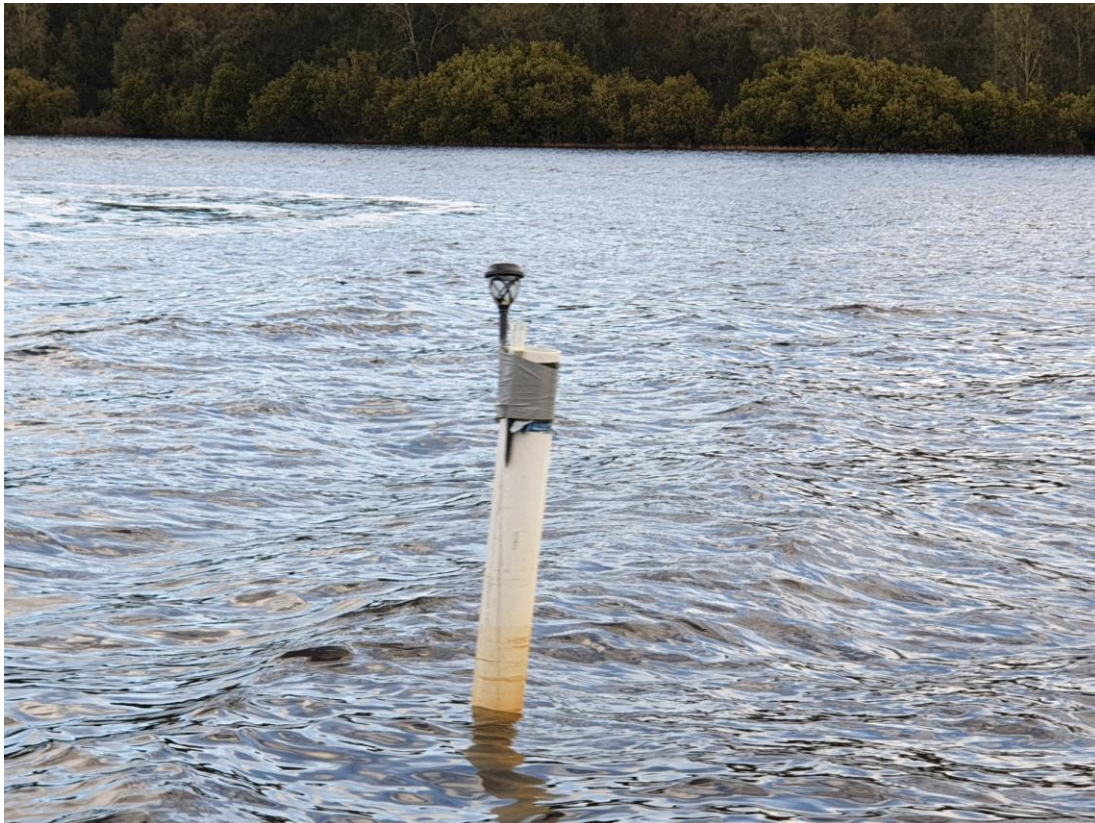
Figure 3-24 – Ad-hoc navigation aid installed at Home Bay near Panorama Road (17 June 2022). Site reference PP01.

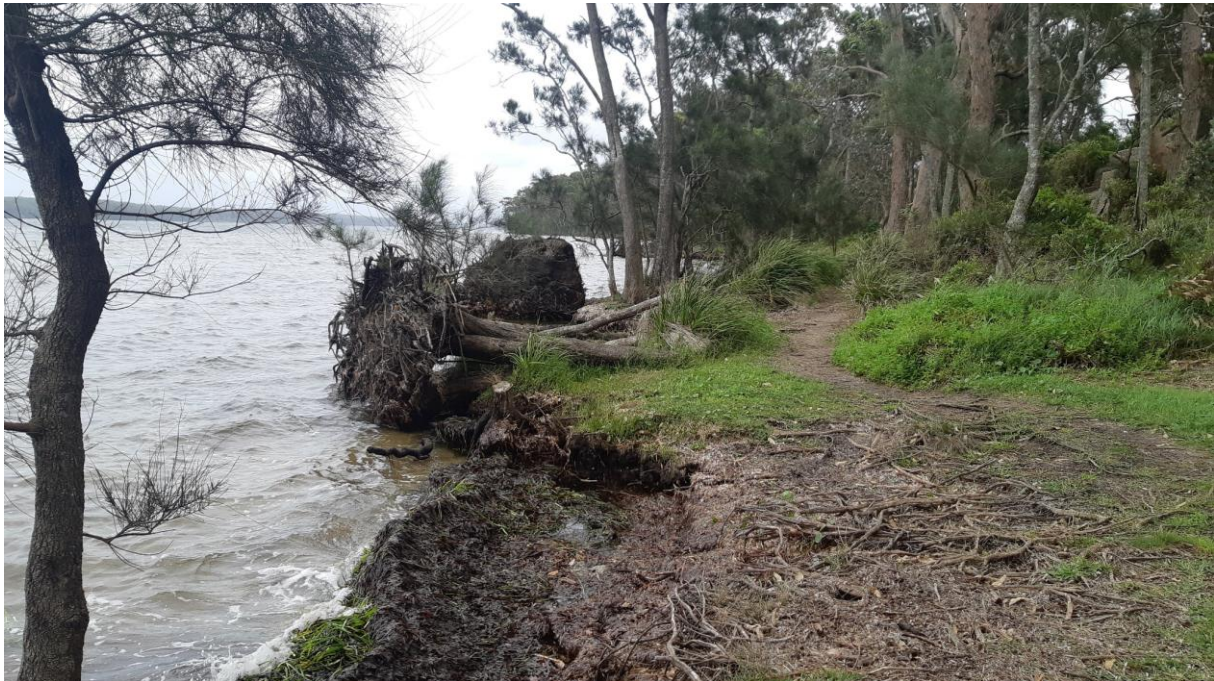
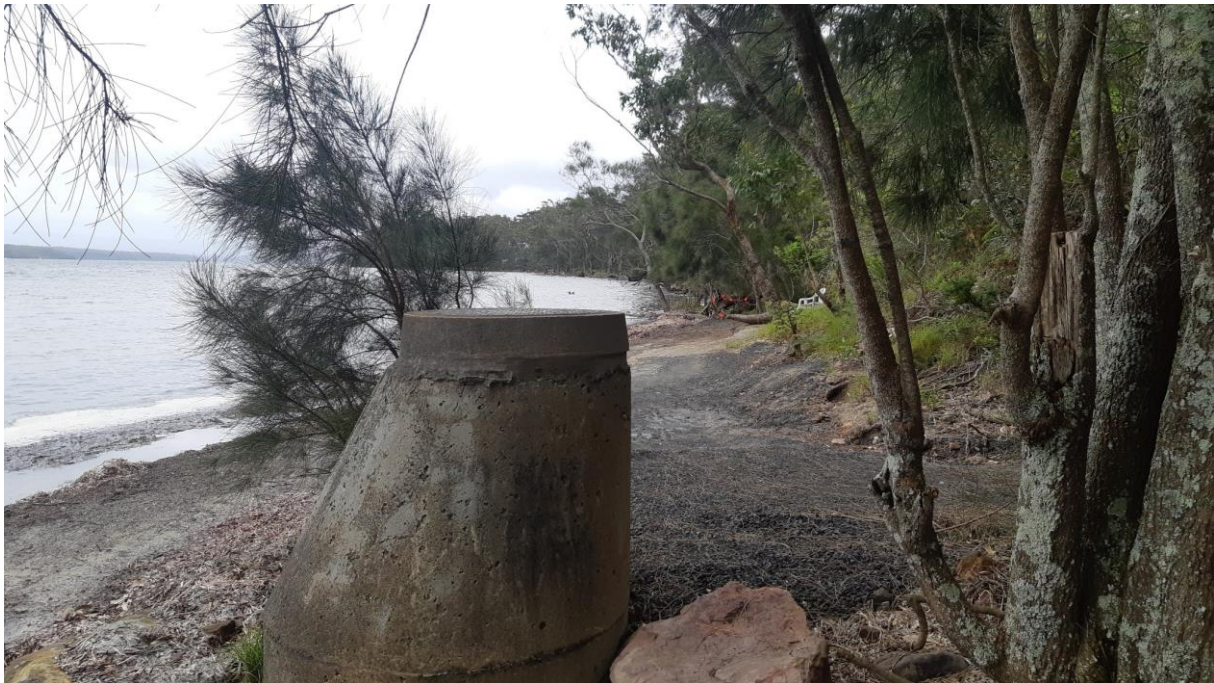
*Figure 3-26 – Macleans Point foreshore looking west (28 November 2021). Top – area of active bank erosion where established riparian vegetation has been undermined. Bottom – sewer infrastructure and Basin walking track within area subject to inundation. Site reference MP01.*

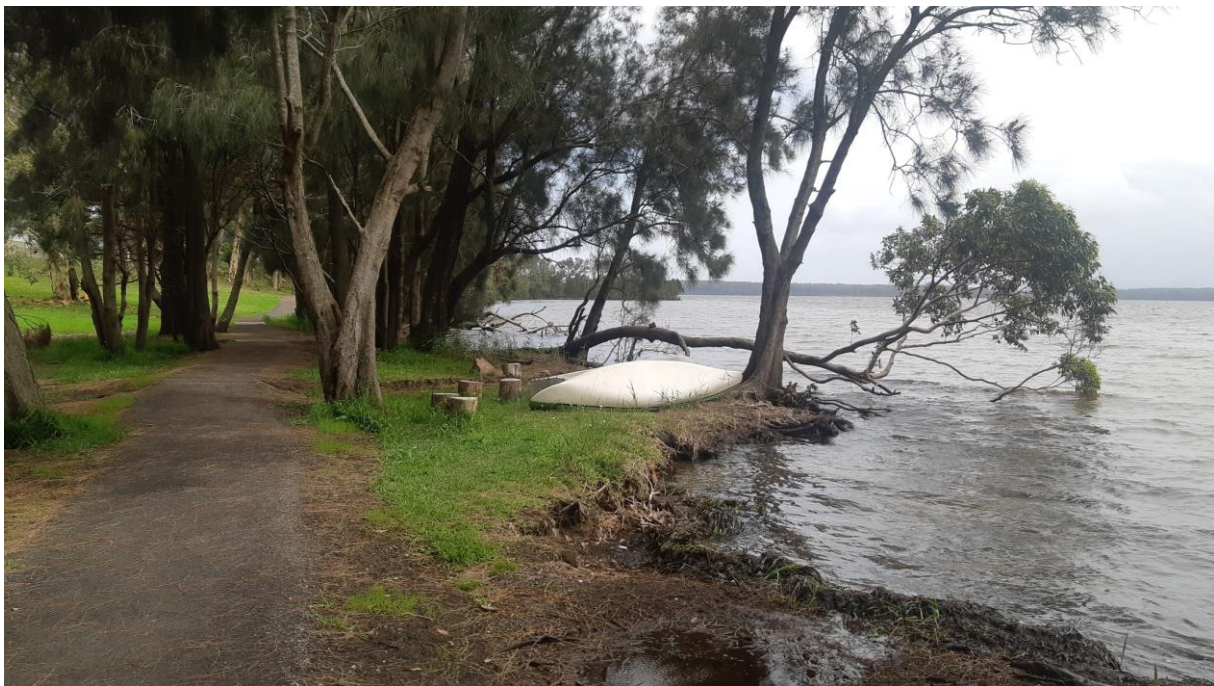
*Figure 3-27 – Erosion at Lorilyn Avenue. Note adhoc storage of kayaks on the foreshore (28 November 2021). Site reference LAW01.*

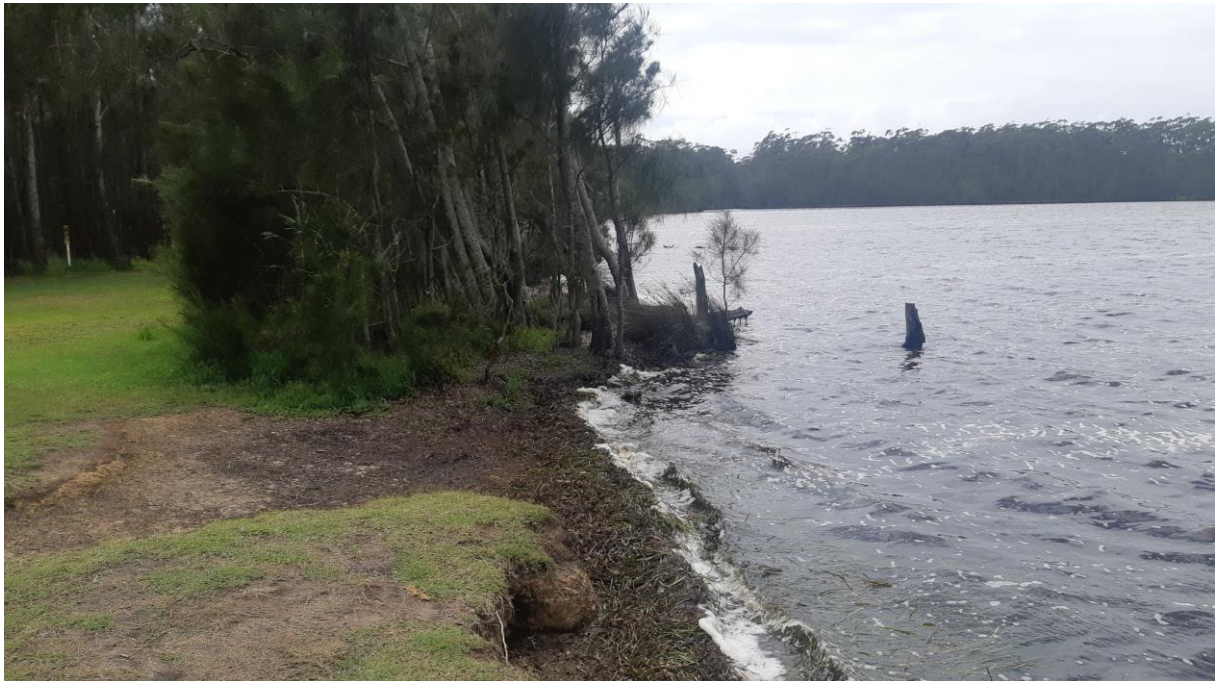
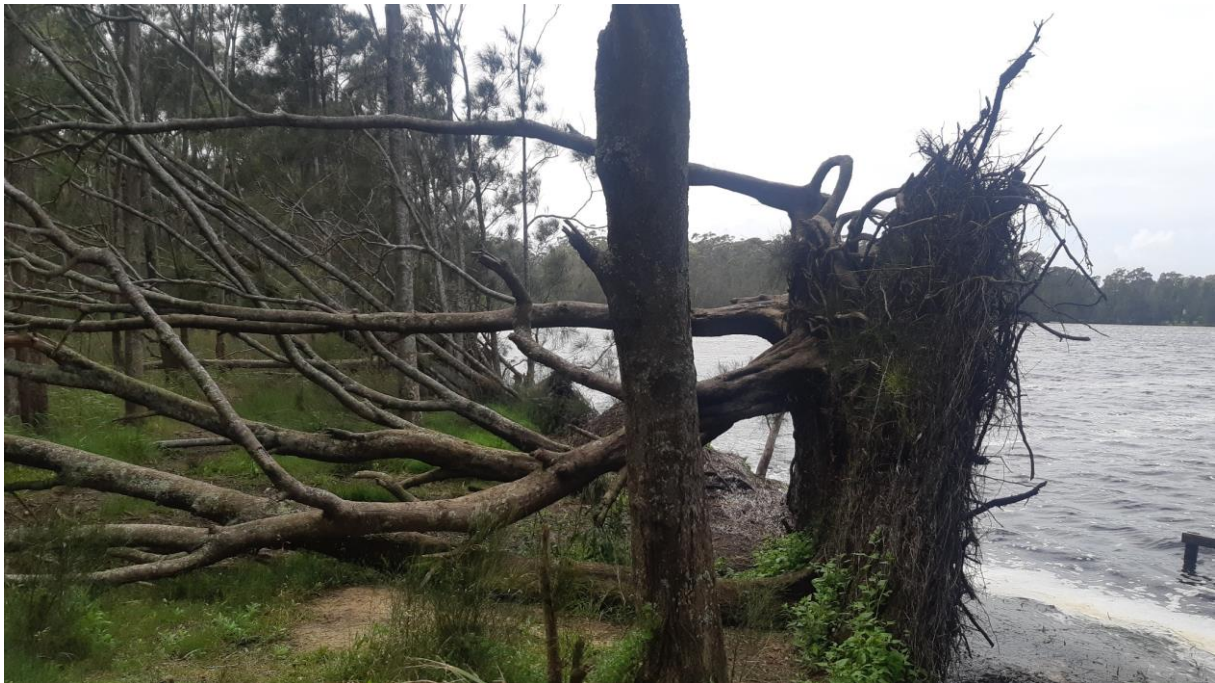
*Figure 3-34 – Old Erowal Bay foreshore. Top – at Prentice Avenue Reserve, bottom - looking east along foreshore from reserve area. Note undercutting of casuarinas leaving them vulnerable to toppling and loss of root ball leading to soil loss from the bank (28 November 2021). Site reference OEB01.*

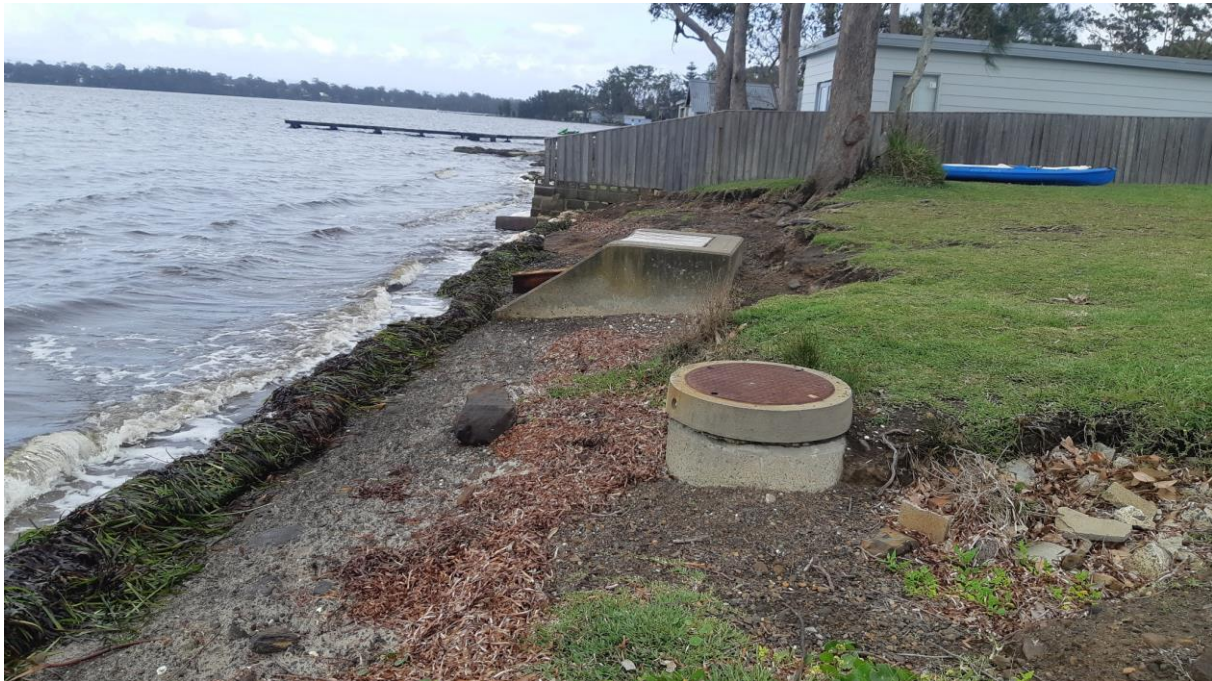
Figure 3-37 – Erowal Bay foreshore at Wharf Road (28 November 2021). Site reference EB01.

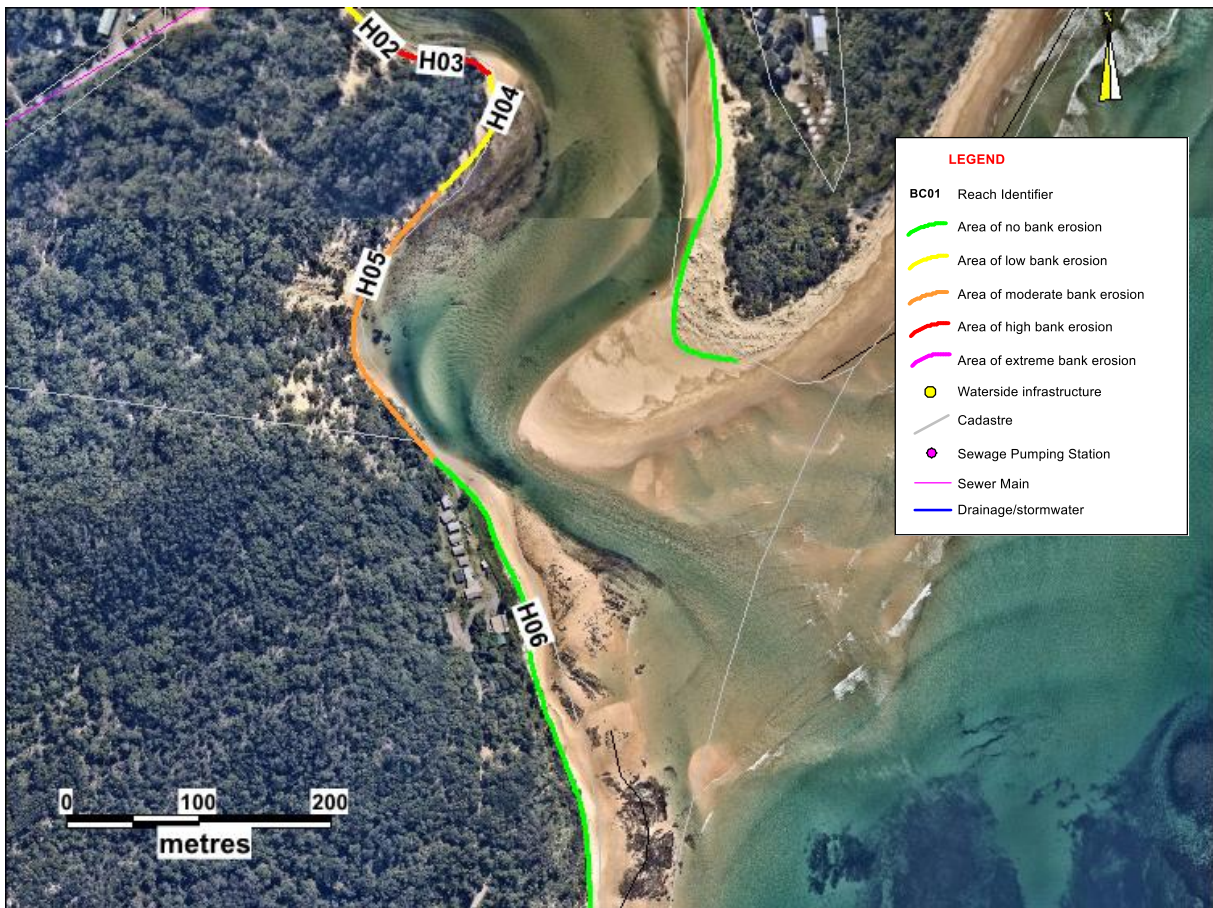
Figure 4-2 – Detail of H05 site at Croppers Cabins assessed as having erosion of moderate severity

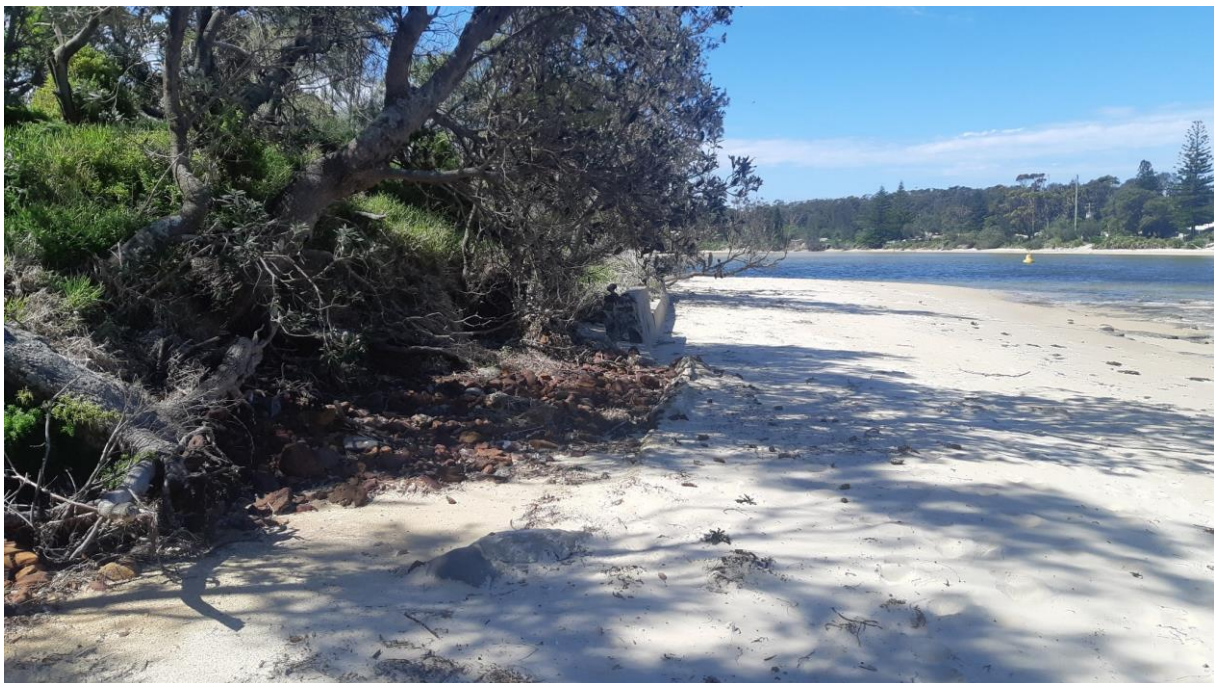
*Figure 4-3 – Erosion at northern end of Croppers foreshore (H04), caused by edge effect from concrete seawall and the site exposure to ocean waves through the entrance (1 December 2021)*

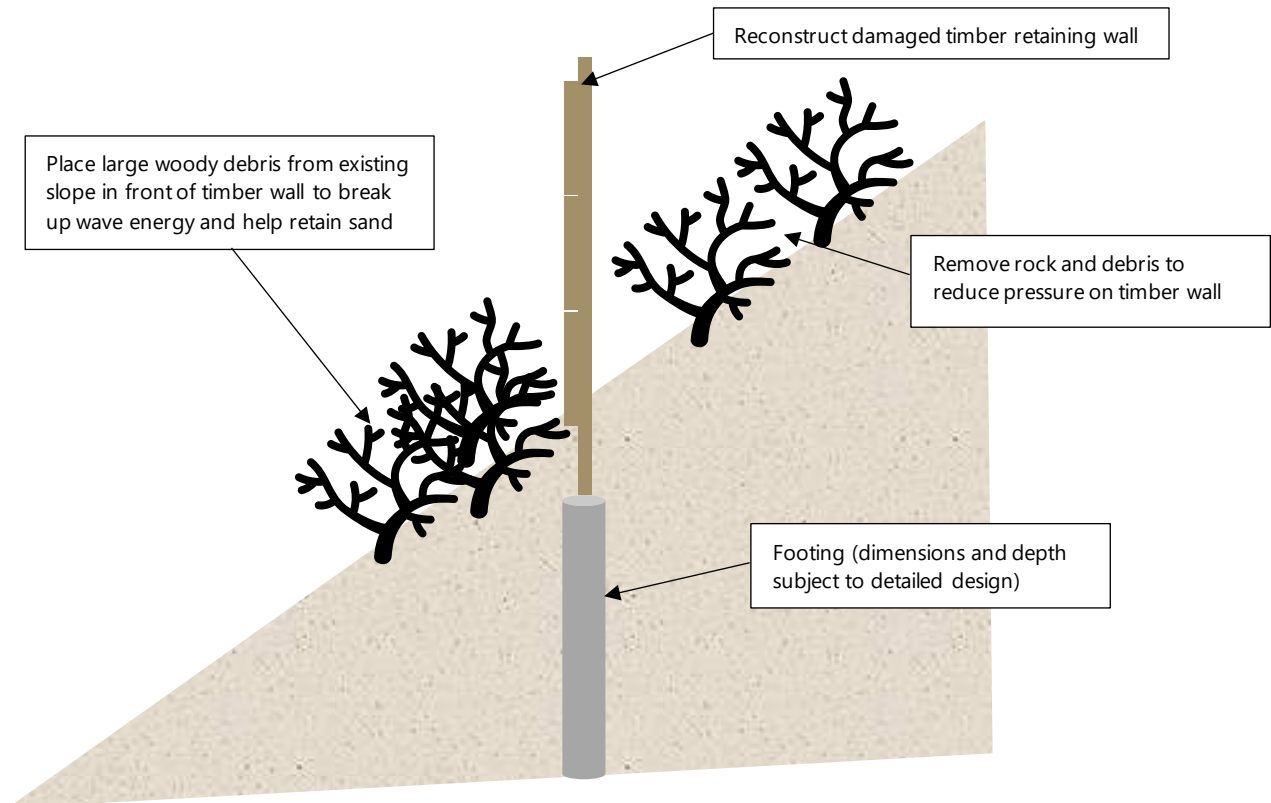
Figure 4-4 – Concept for repair of existing timber toe retaining wall

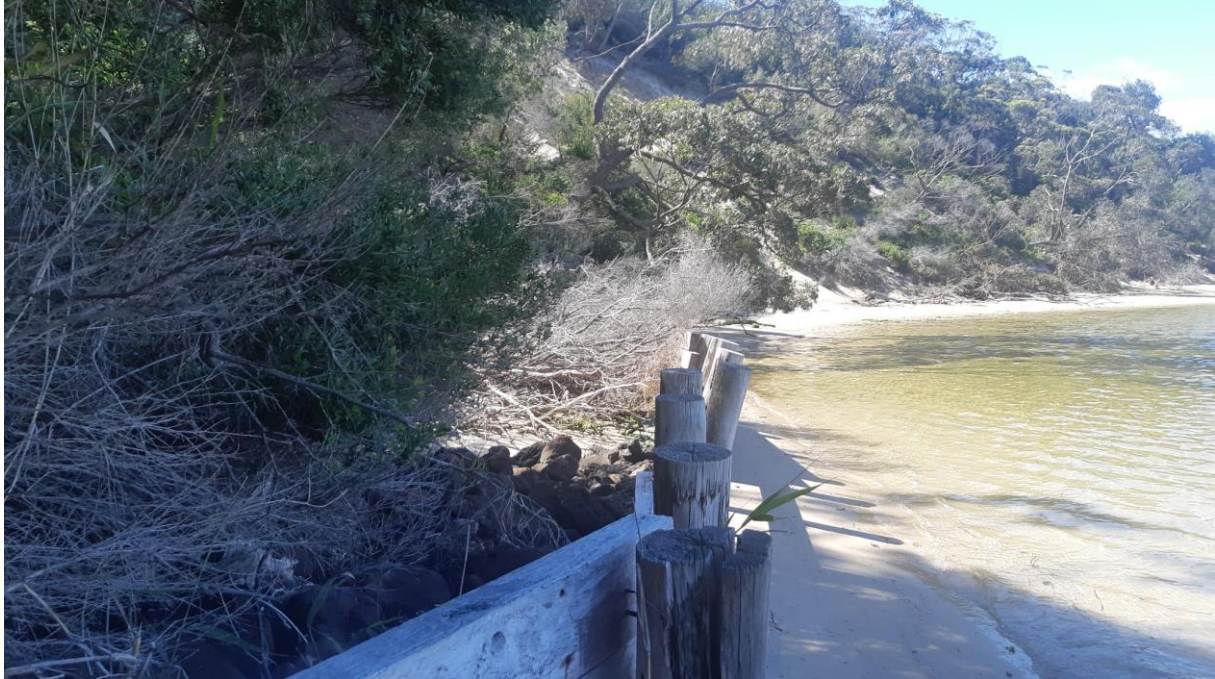
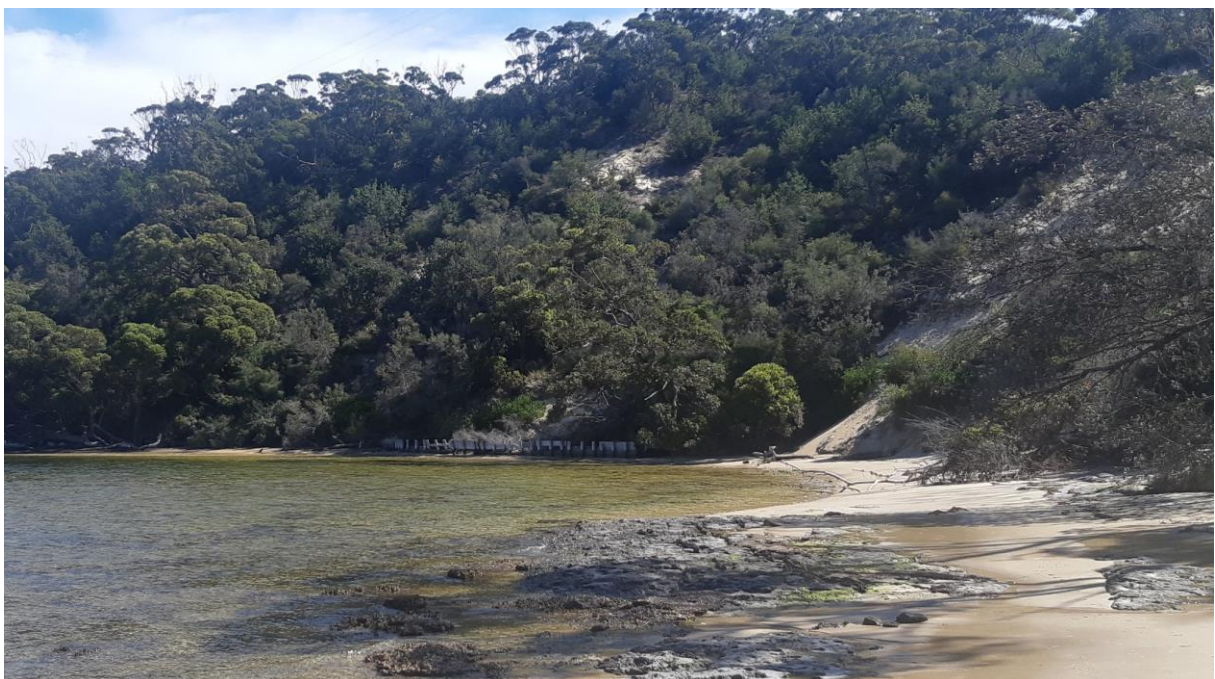
*Figure 4-5 – Timber toe protection wall damaged due to overturning, caused by high earth pressures (detail on top) (1 December 2021). Site reference H05.*

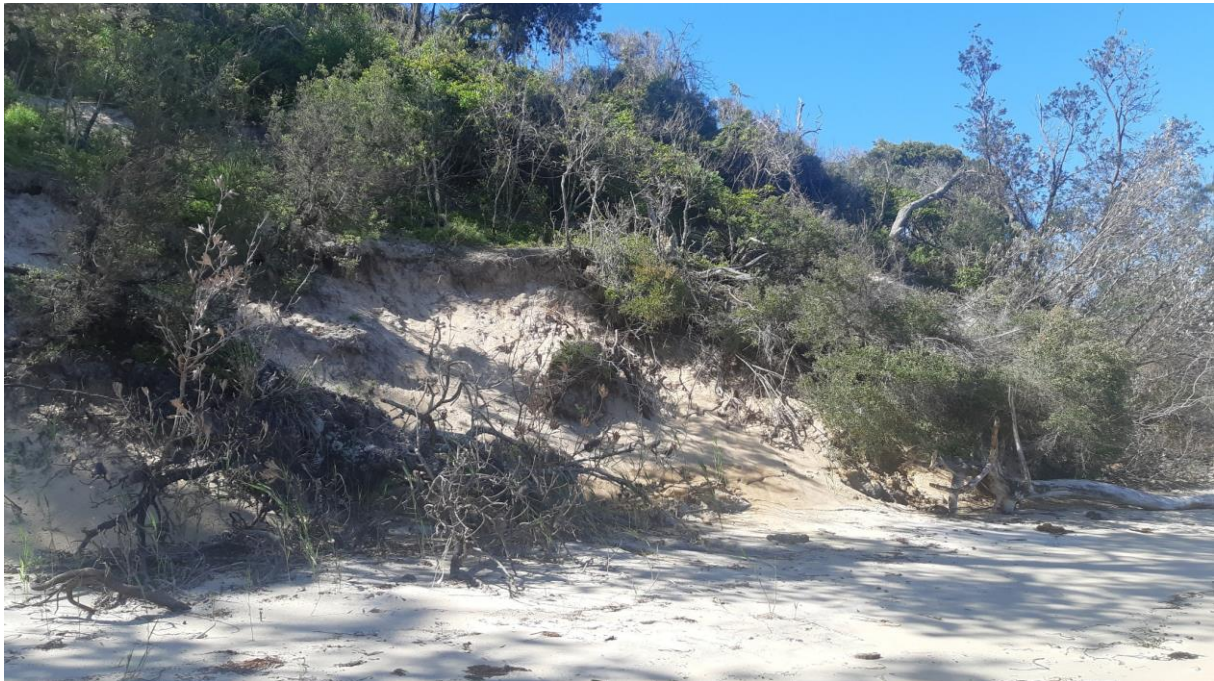
Figure 4-6 – Erosion at The Haven shoreline north from Croppers Cabins (1 December 2021). Site reference H05.

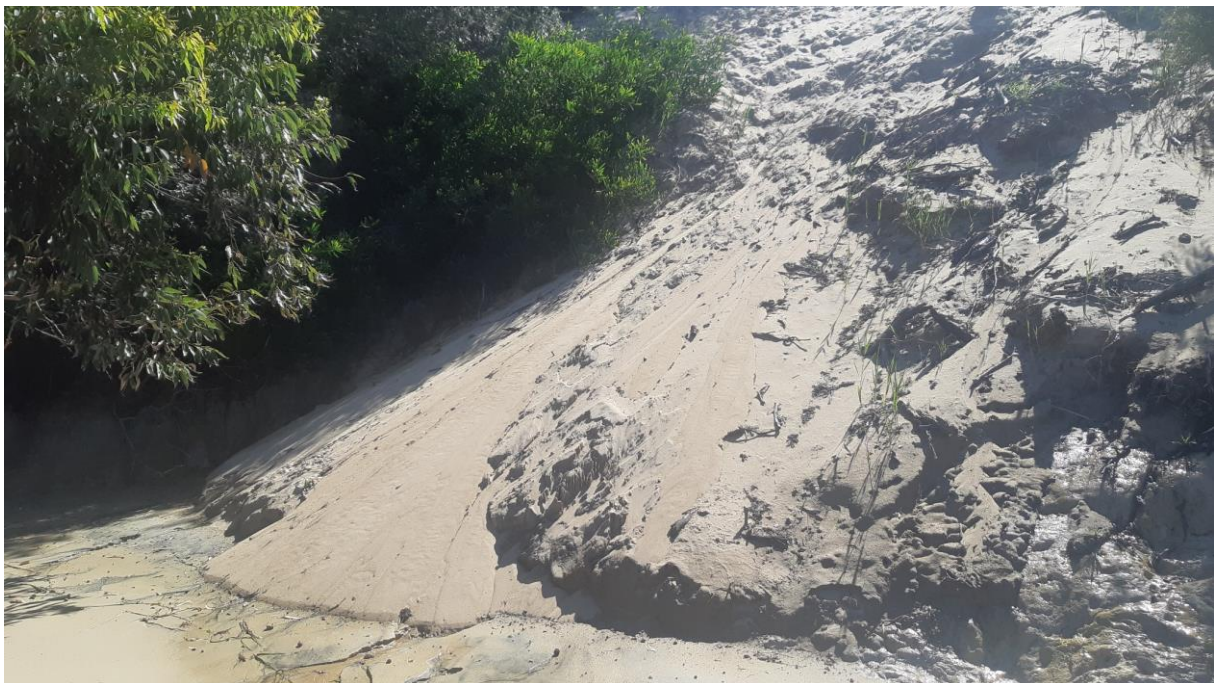
Figure 4-7 – Evidence of dune slumping caused by slope instability (1 December 2021). Site reference H05.
