### **Covering Note**

If you have any questions about how Council manages sensitive information, please contact Council on 1300 293 111.

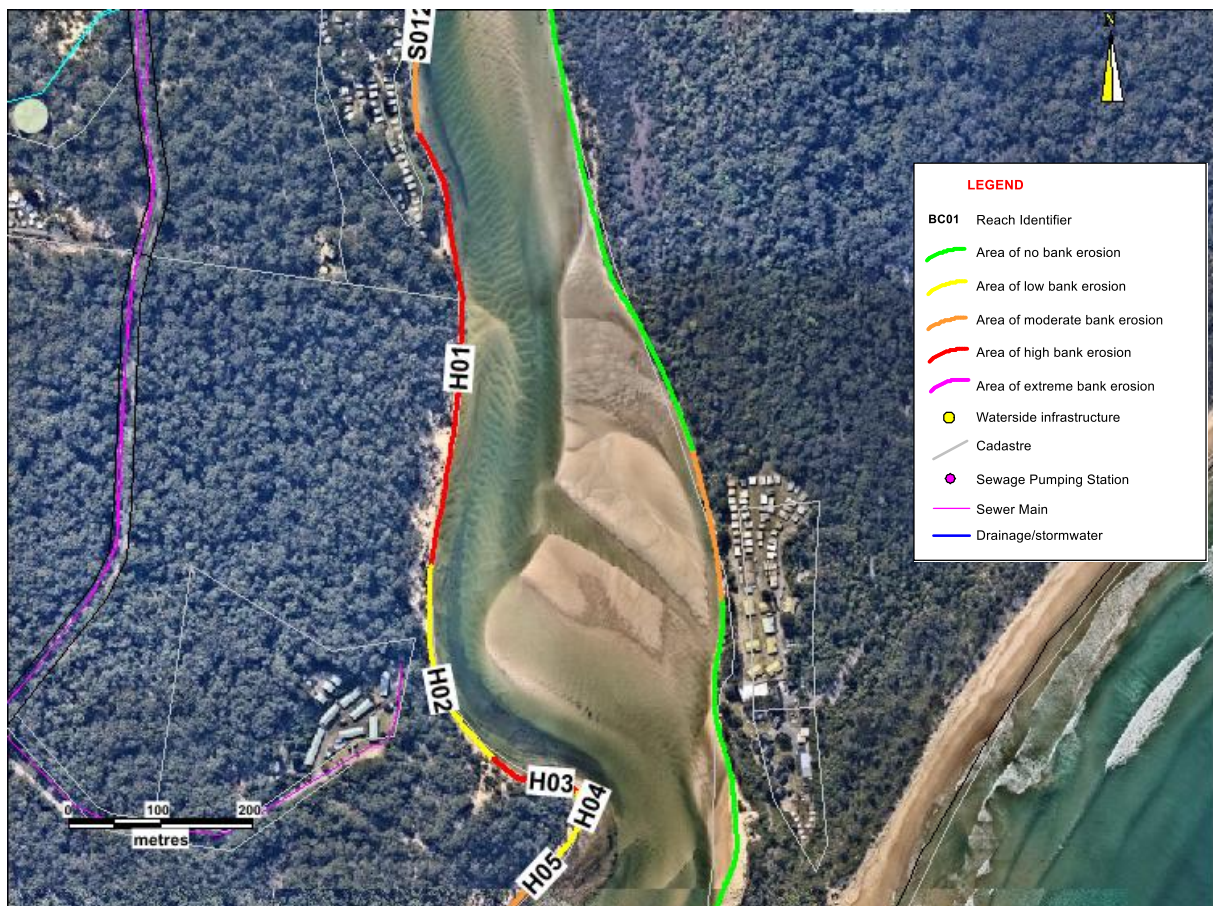
Figure 4-8 – Detail of H01 and H03 site at The Haven assessed as having erosion of high severity

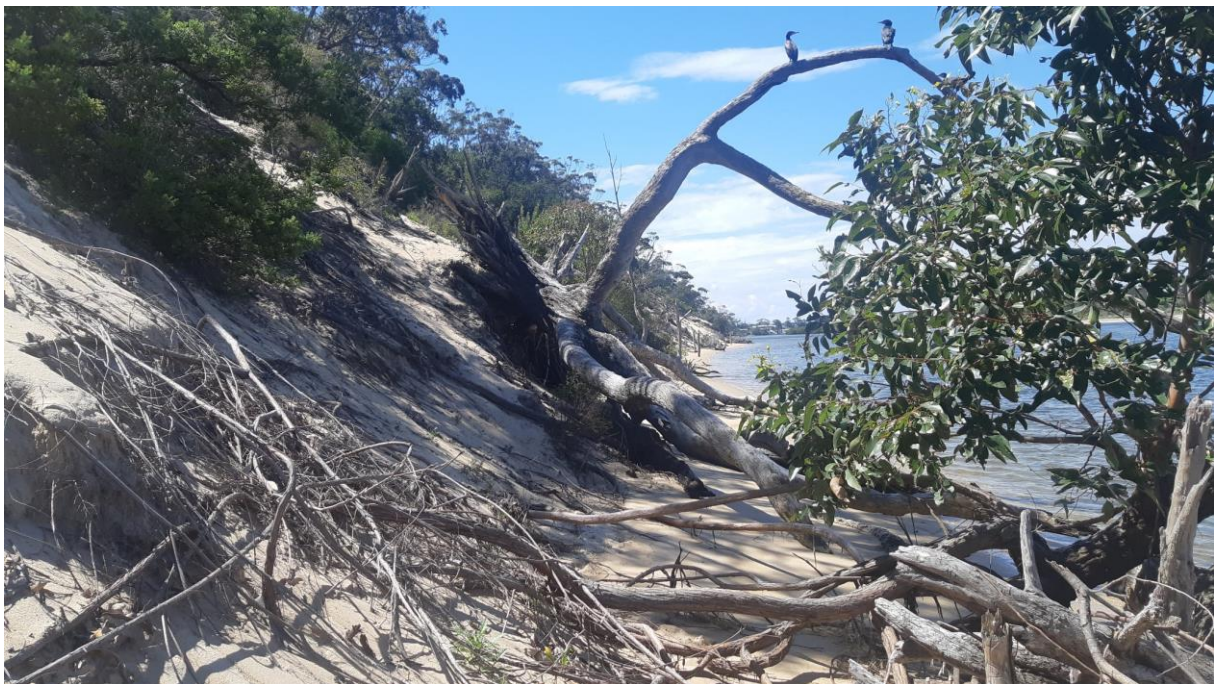
*Figure 4-9 – Foreshore at The Haven, looking north (1 December 2021). Site reference H01.*

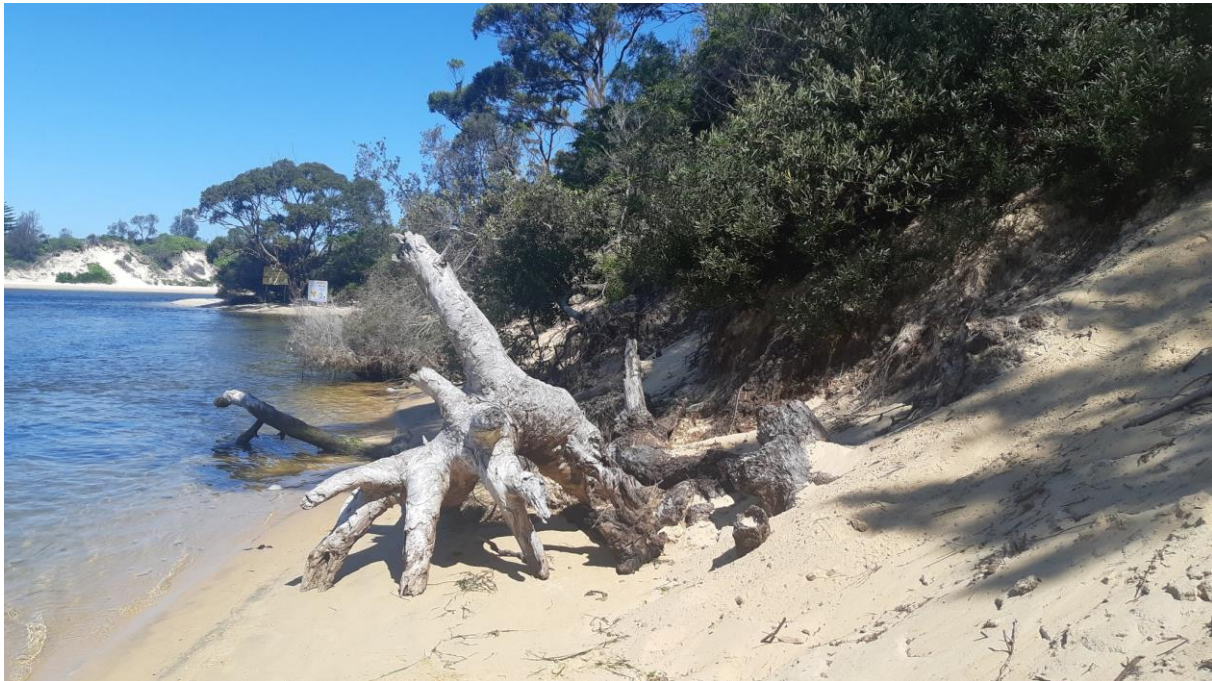
Figure 4-11 – The Haven, southern end, looking south. Note erosion occurring due to slope instability and wave action at the toe of the slope (1 December 2021). Site reference H03.

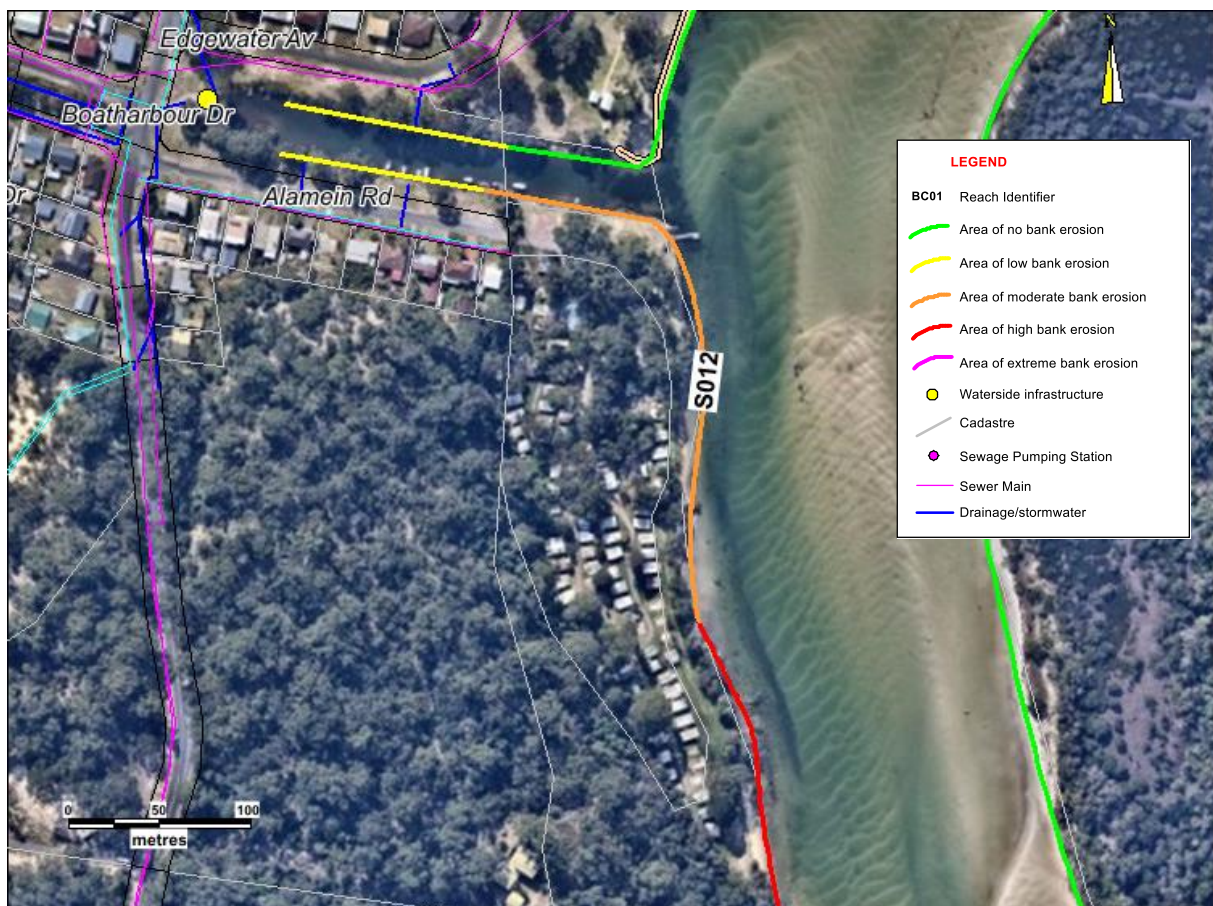
Figure 4-14 – Detail of S012 site at Alamein caravan park assessed as having erosion of moderate - high severity

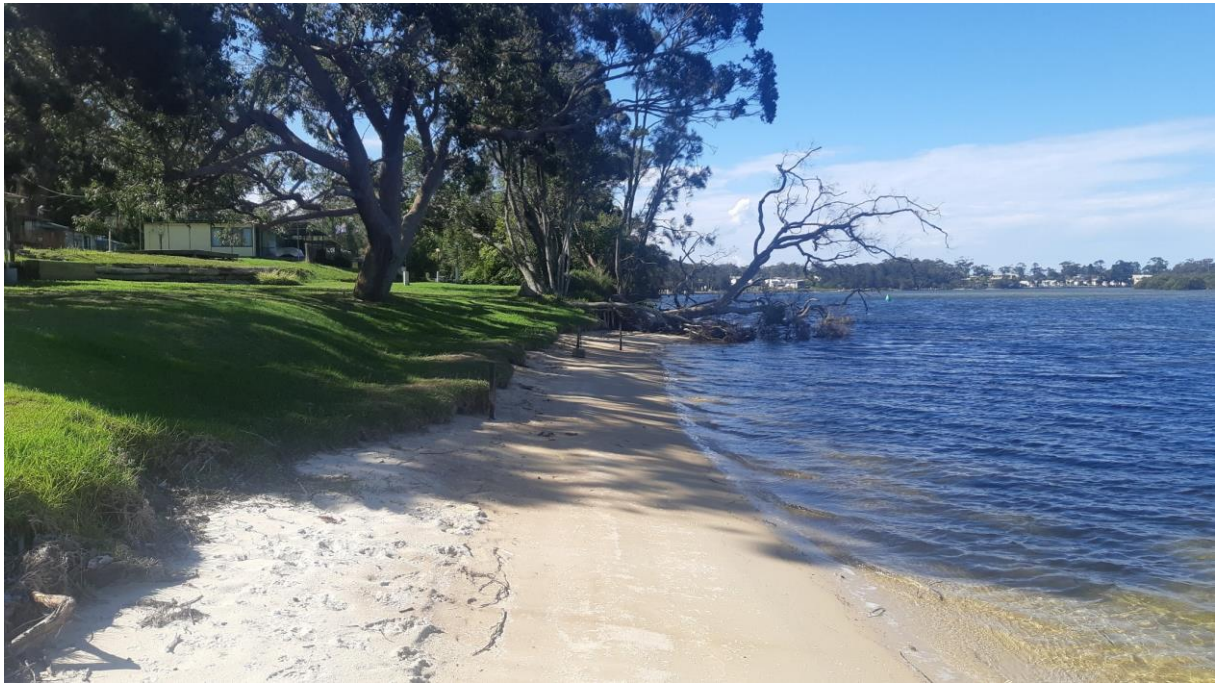
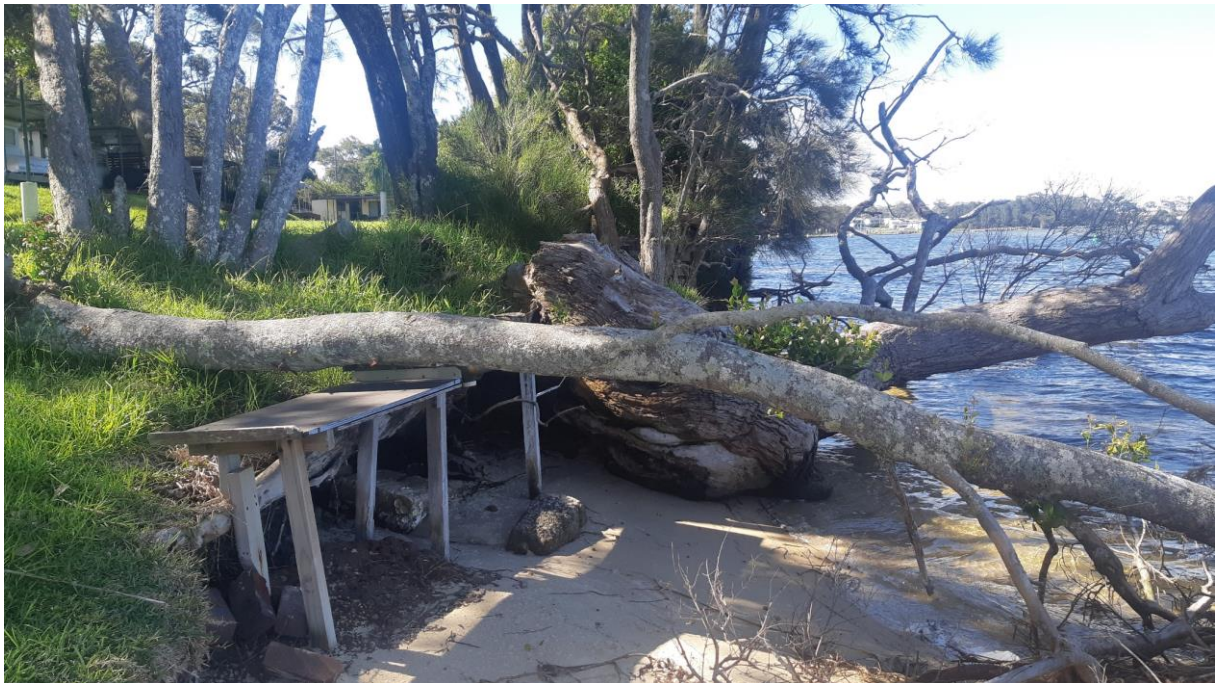
*Figure 4-15 – Top: Alamein foreshore at Sussex Inlet, looking north. Bottom: detail of eroded area showing undercutting of slope (1 December 2021). Site reference S012.*

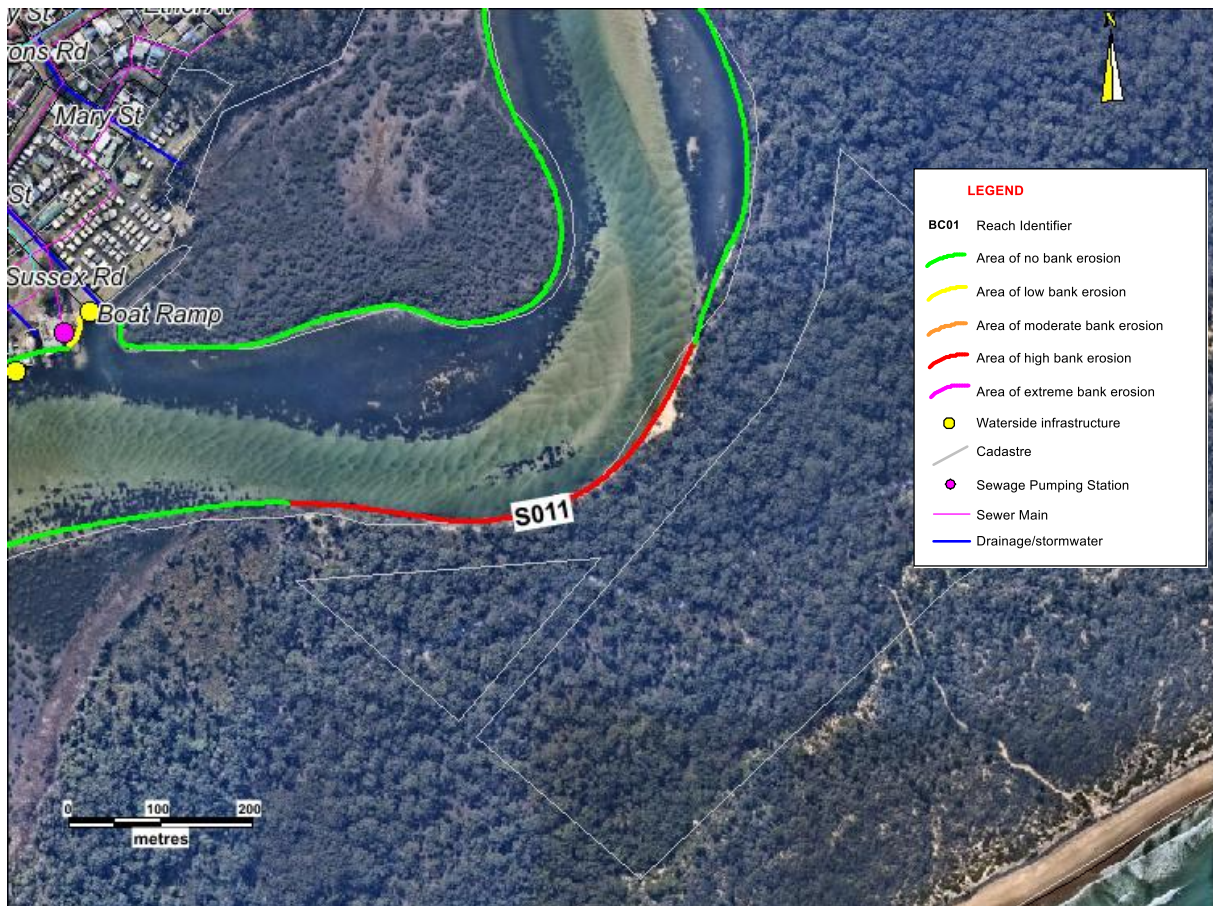
Figure 4-17 – Detail of S011 site at Little Manly assessed as having erosion of high severity

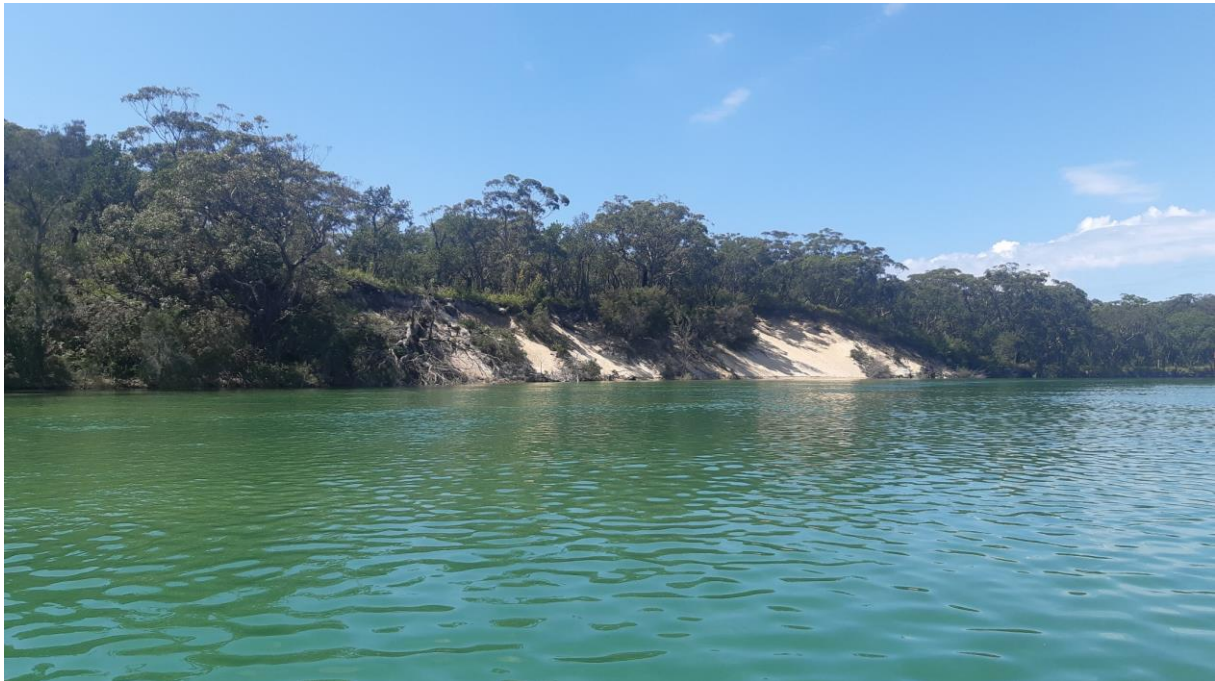
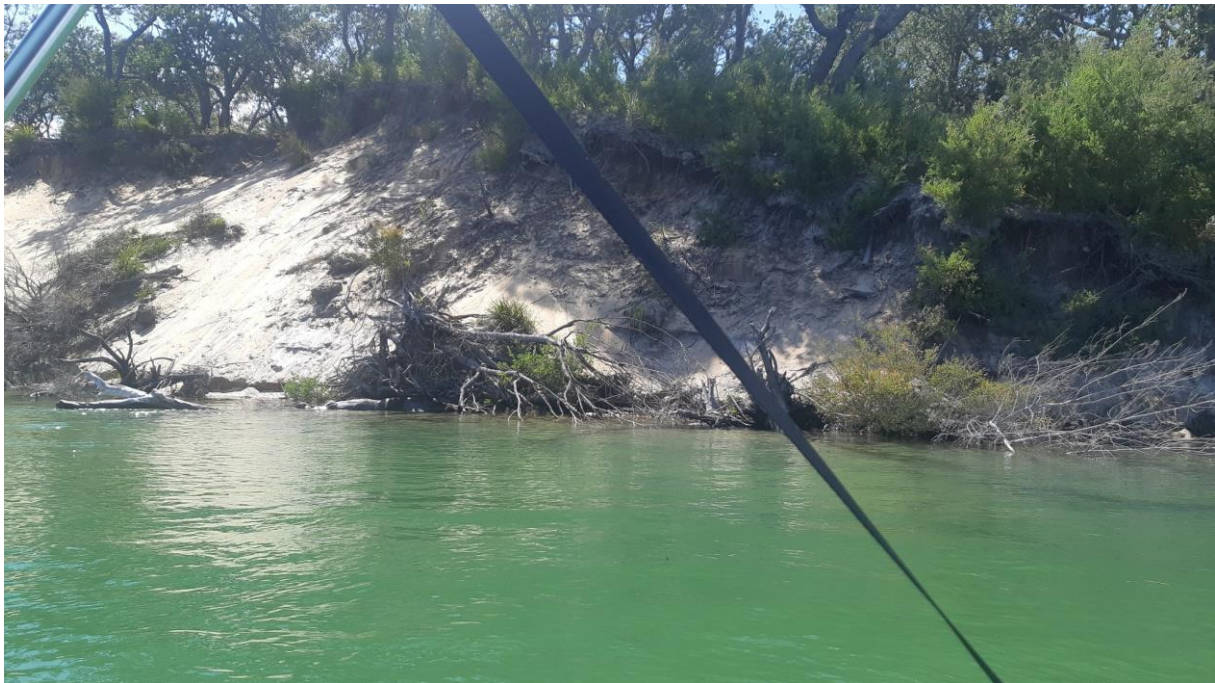
*Figure 4-18 – Active slope instability at Little Manly from afar (top) and close up (bottom) (7 December 2021). Site reference S011.*

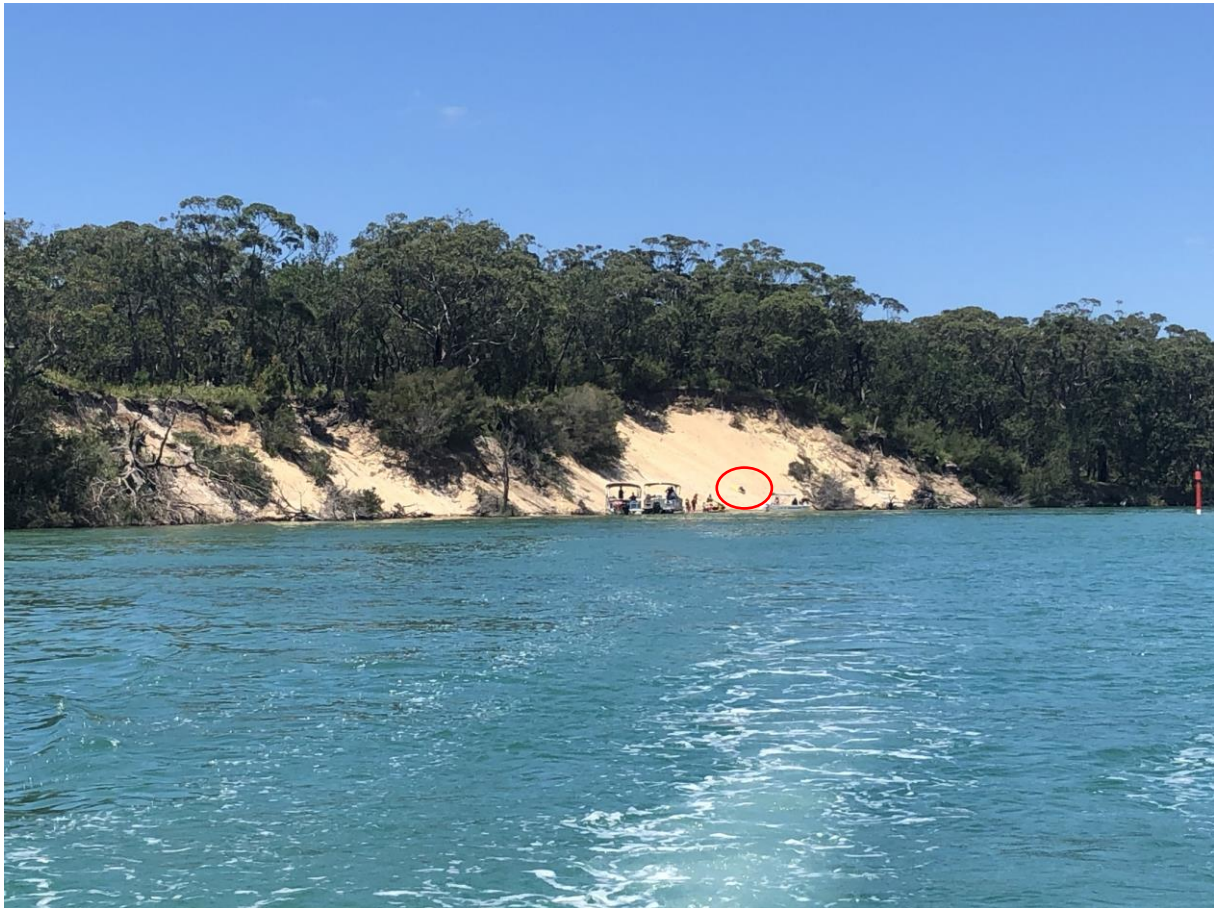
*Figure 4-20 – Area at Little Manly is popular for recreation, unstable slope could be a safety hazard (7 December 2021). Note slope being used for sand-boarding. Site reference S011.*

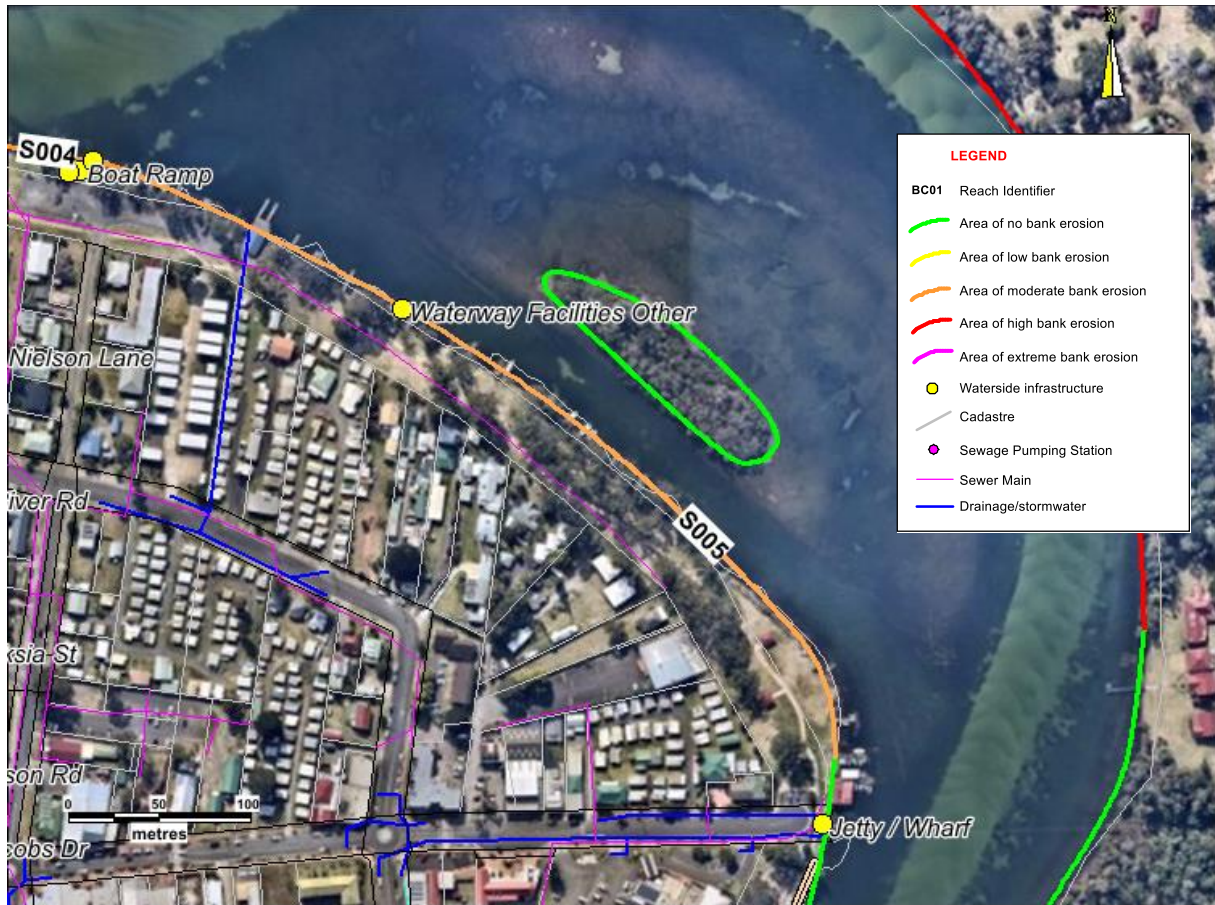
Figure 4-22 – Detail of S005 site between Nielson Lane and Sussex Marine Centre at Jacobs Drive assessed as having erosion of moderate severity

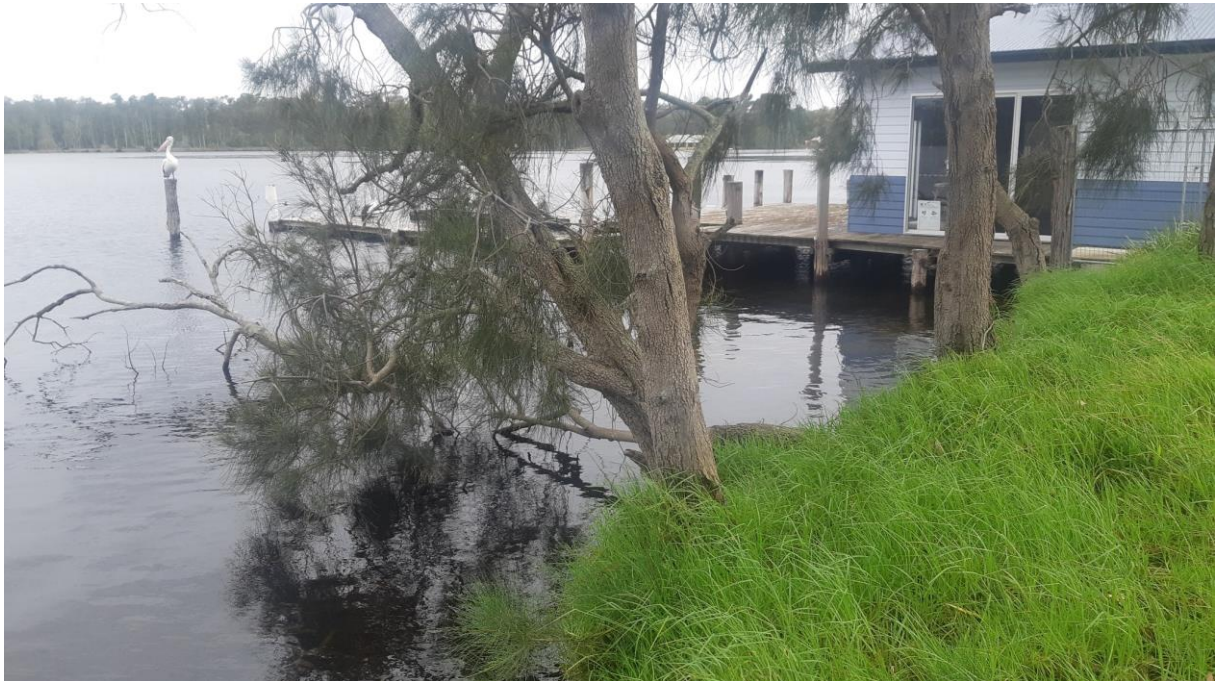
Figure 4-23 – Undermining of trees and instability due to weeds, just east of Neilson boat ramp (27 November 2021). Site reference S005.

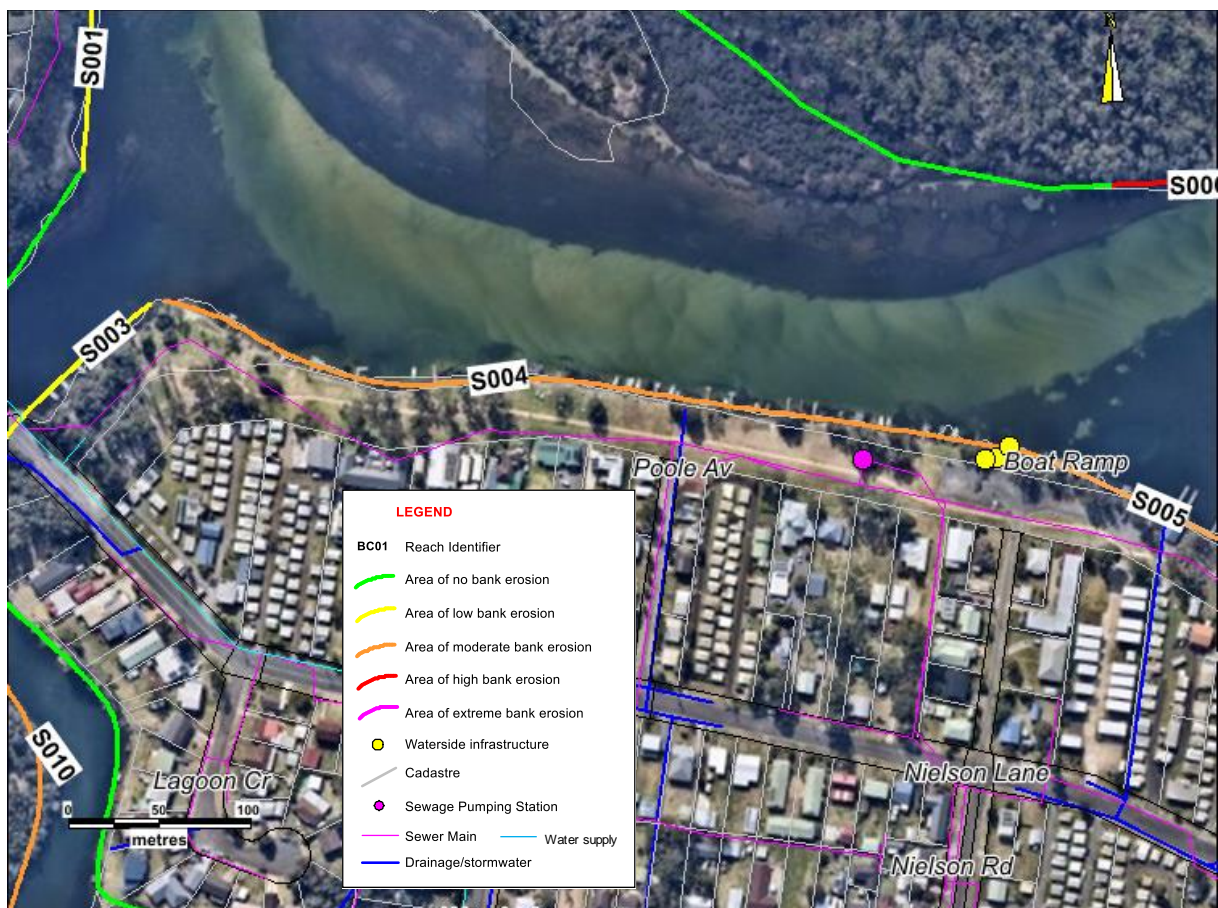
Figure 4-26 – Detail of S004 site at upstream from Nielson Lane boat ramp assessed as having erosion of moderate severity

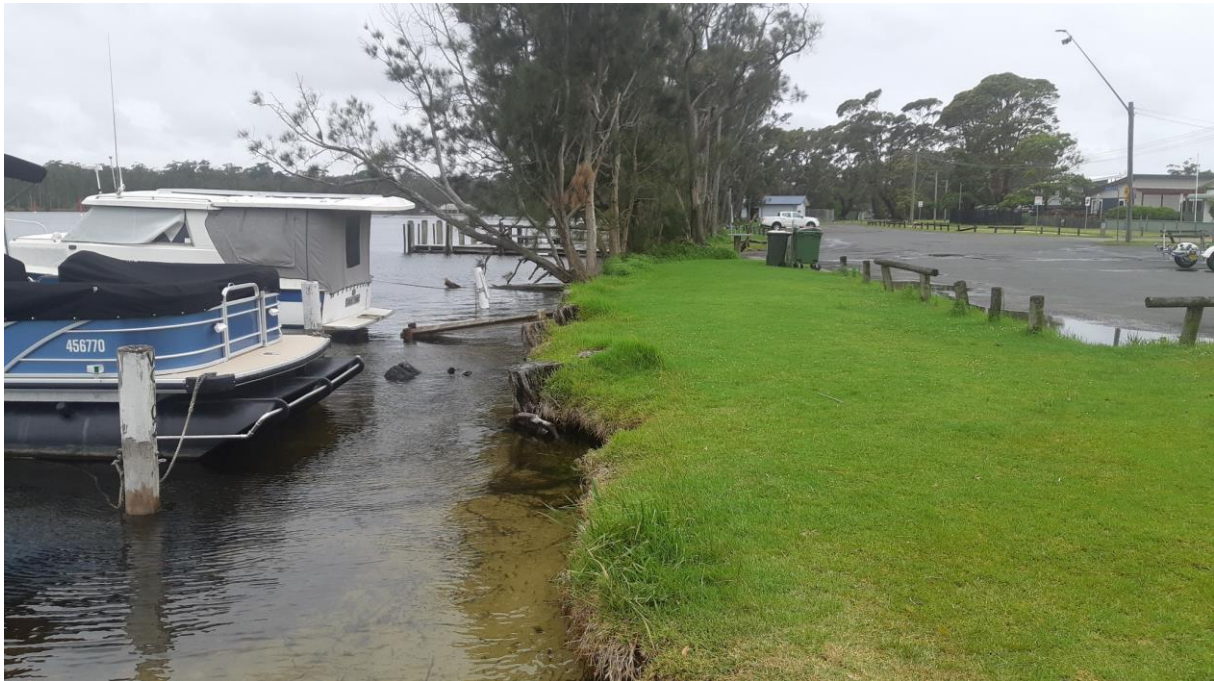
Figure 4-27 – View of the foreshore looking east (27/11/2021). Site ref S004.

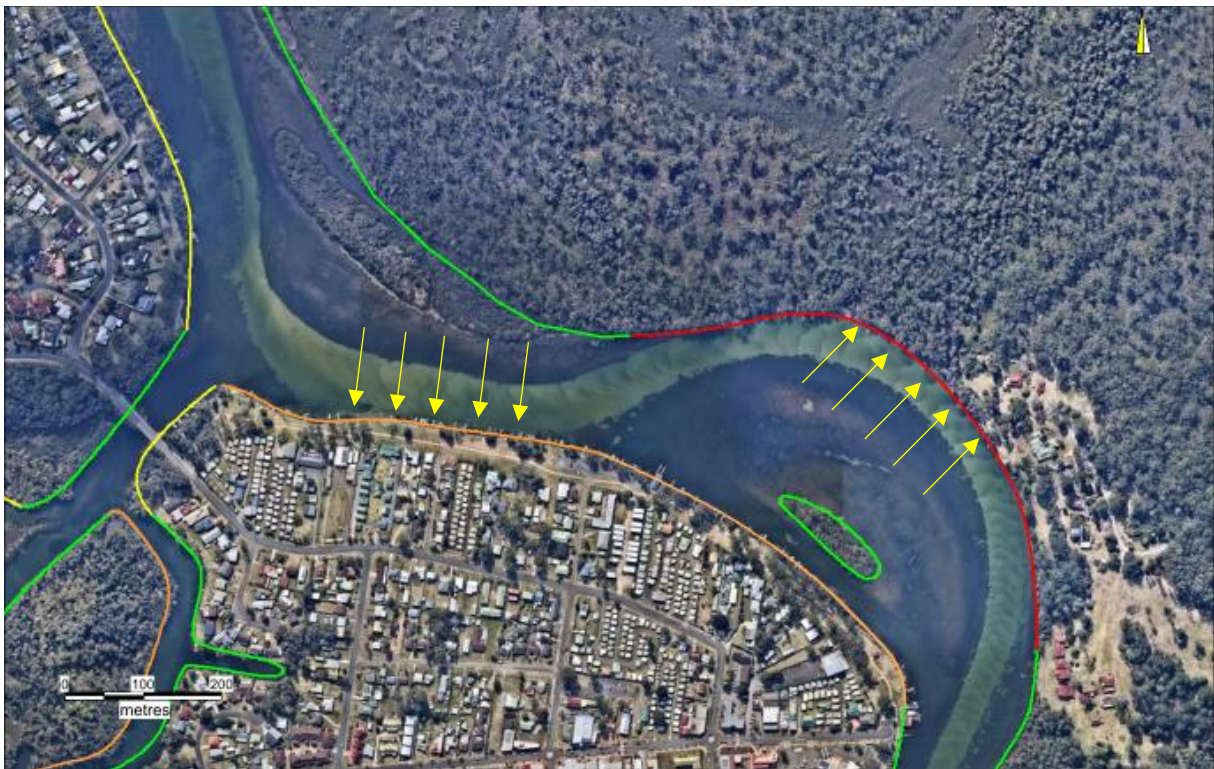
Figure 4-28 – Meandering of channel mechanism for foreshore erosion along the Sussex Inlet foreshore

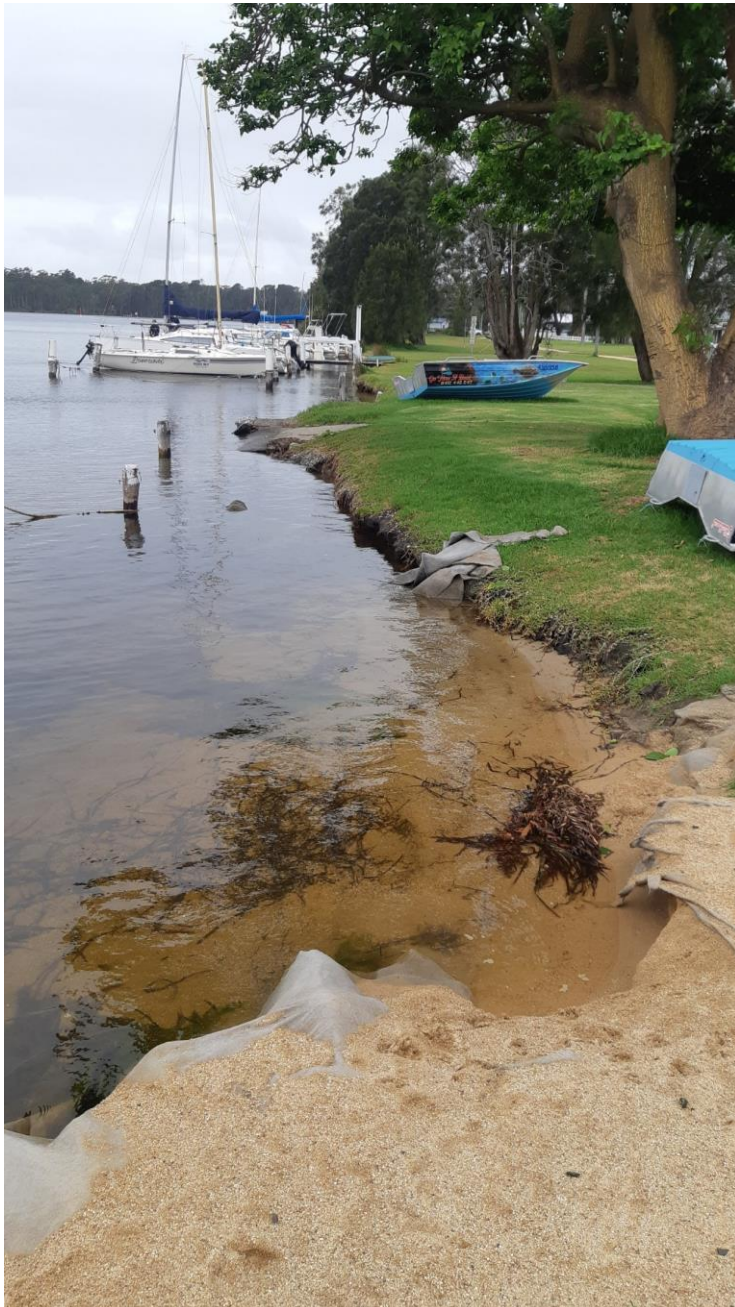
*Figure 4-29 – Typical foreshore area upstream of Nielson Lane boat ramp, looking east. Note private mooring and vessel launching structures and failed geotextile bank protection (27 November 2021). Site reference S004.*

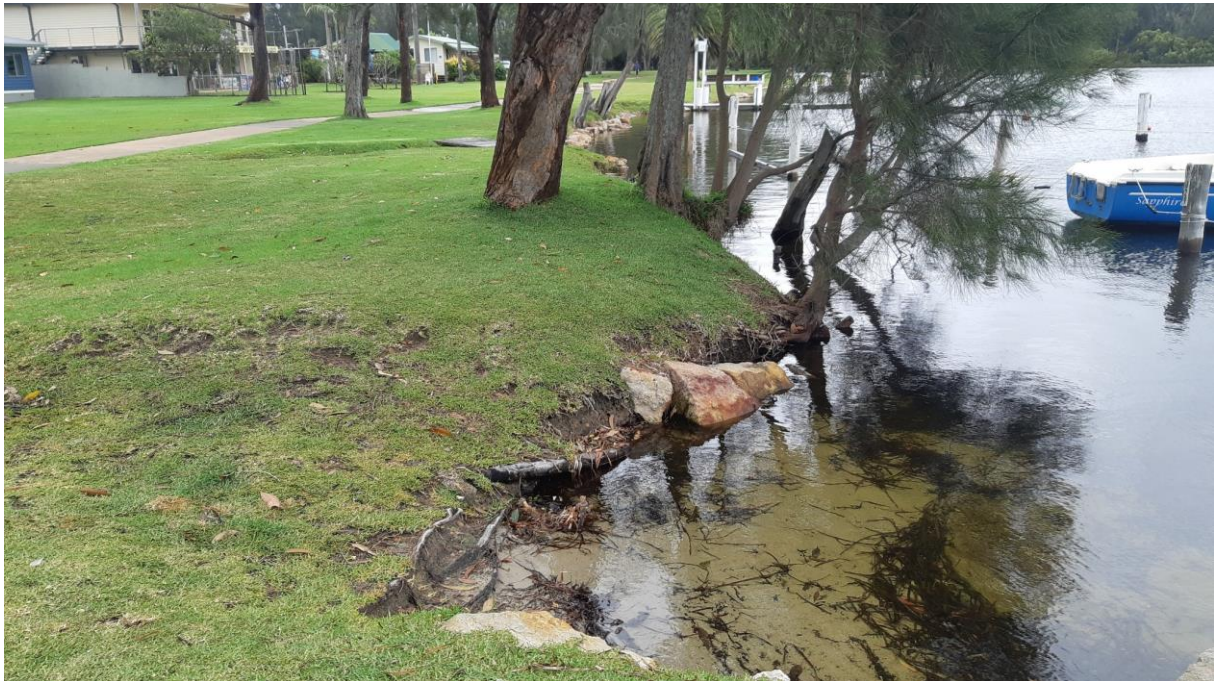
Figure 4-30 – Foreshore protection works at Sussex Inlet, upstream of Nielson Lane boat ramp, looking west (27 November 2021). Site reference S004.

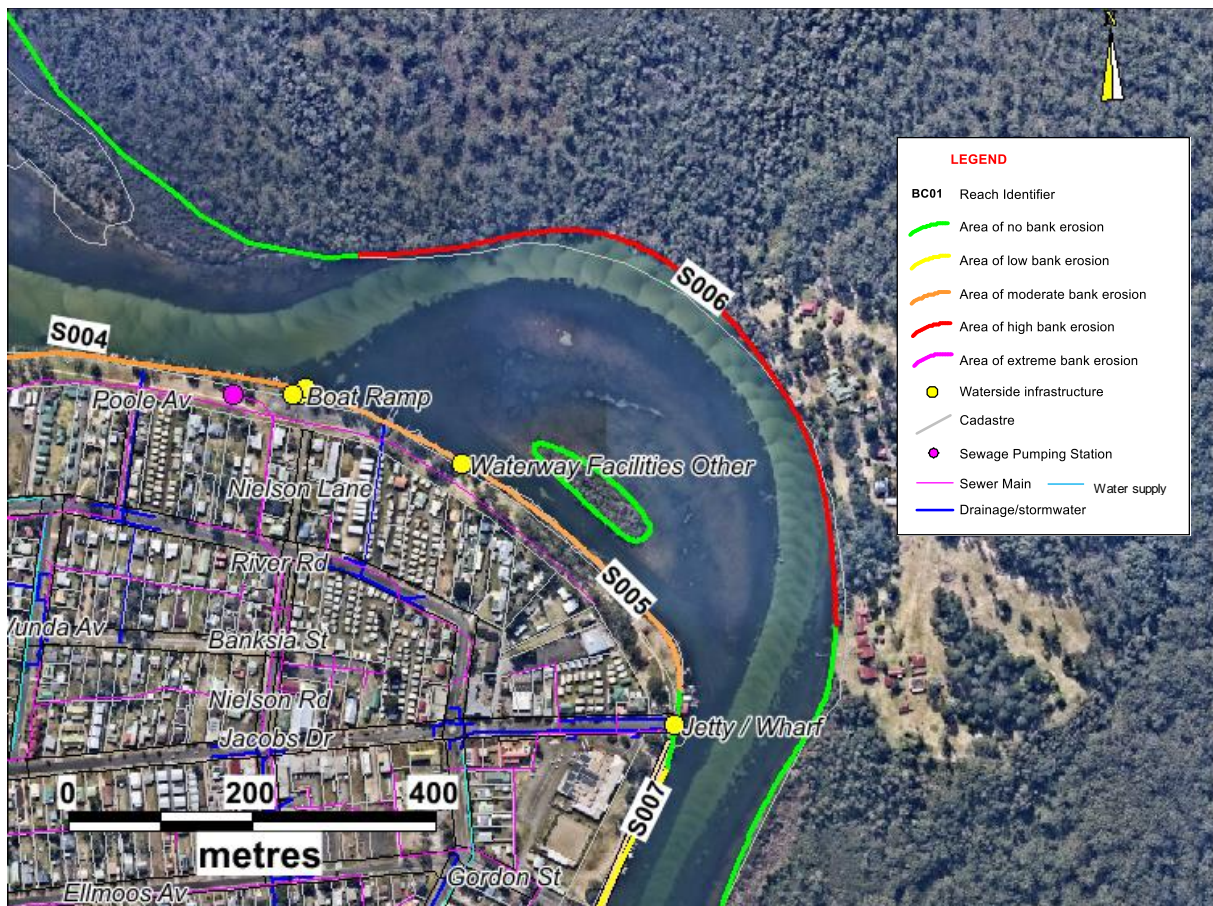
Figure 4-32 – Detail of S006 site at Christian’s Minde assessed as having erosion of high severity

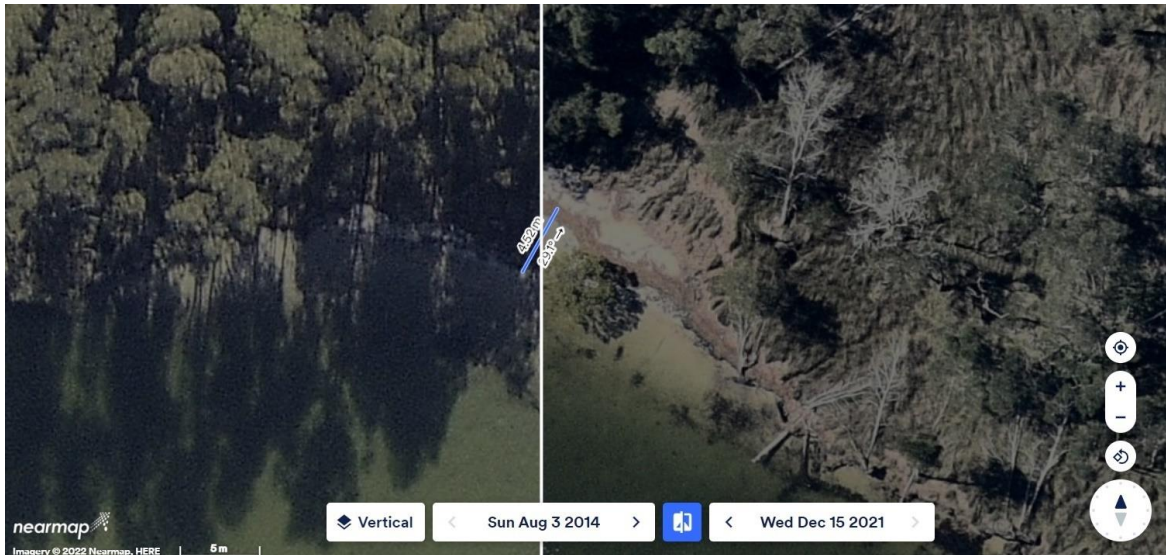
Figure 4-33 – Measured retreat of shoreline upstream from Christian’s Minde, August 2014 – December 2021 (Nearmap, 2022). Site reference S006.

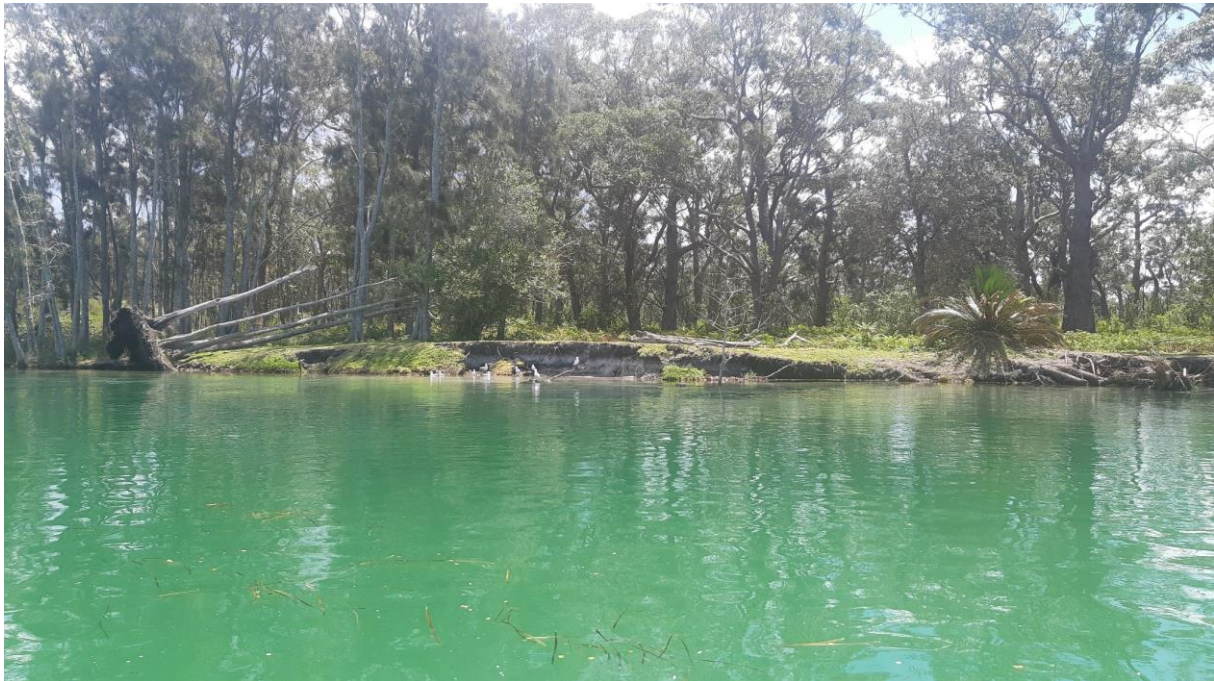
Figure 4-34 – Area upstream of Christian’s Minde. Note undermining of large trees and formation of vertical erosion scarp (7 December 2021). Site reference S006.

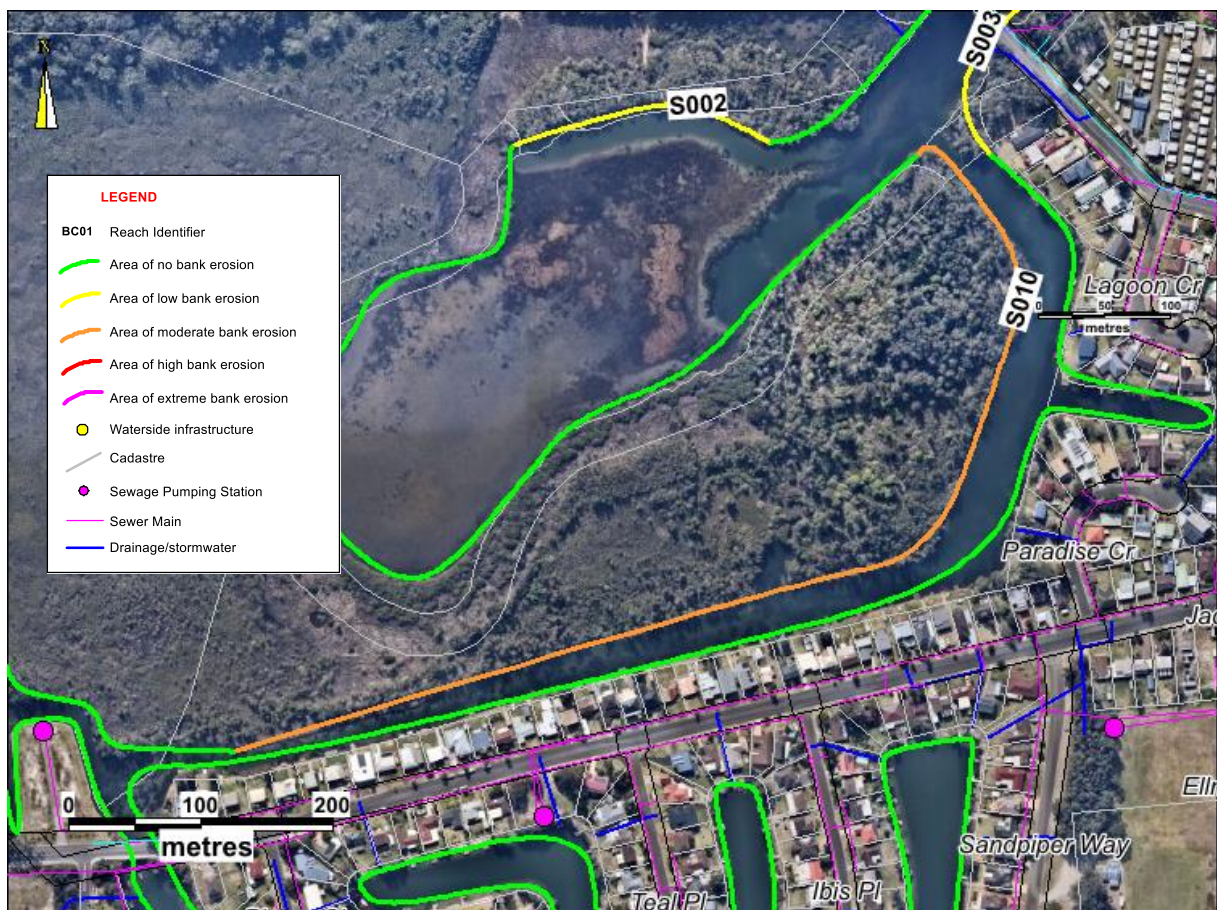
Figure 4-36 – Detail of S010 site at Ralph Lucas Waterway assessed as having erosion of moderate severity.

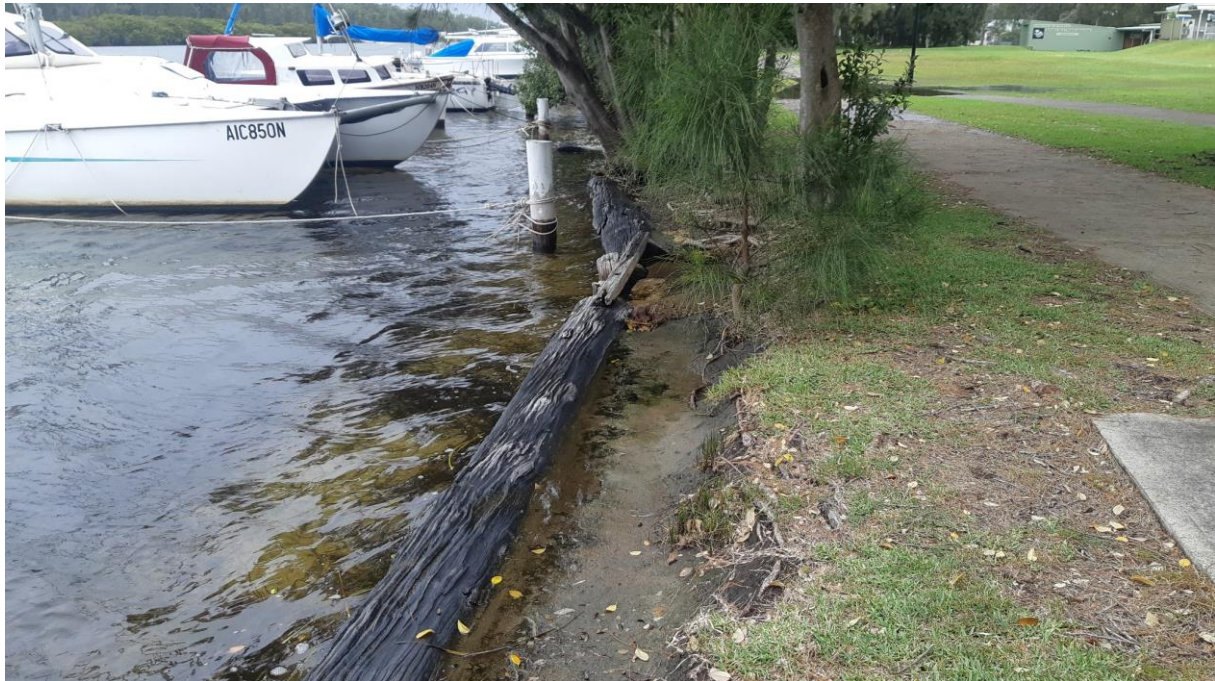
*Figure 4-39 – Foreshore near Sussex Inlet RSL club showing erosion behind timber log bank protection (27 November 2021). Site reference S007.*

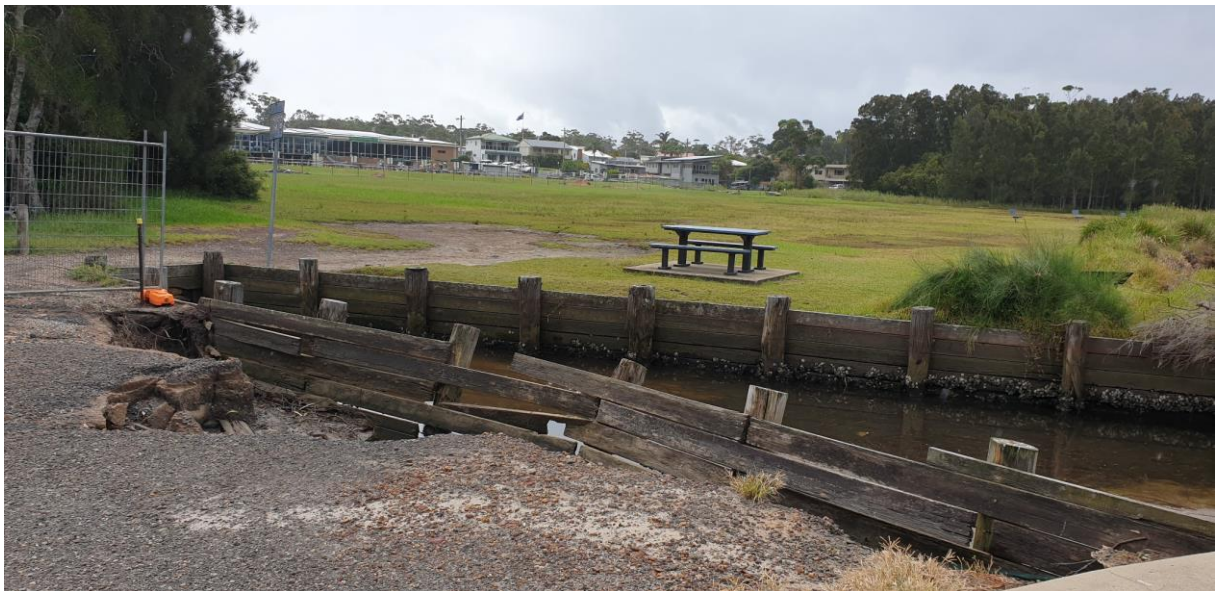
Figure 4-42 – Lions Park foreshore with erosion damage to timber retaining wall at boat ramp fishing table (16 March 2022). Site reference S013.

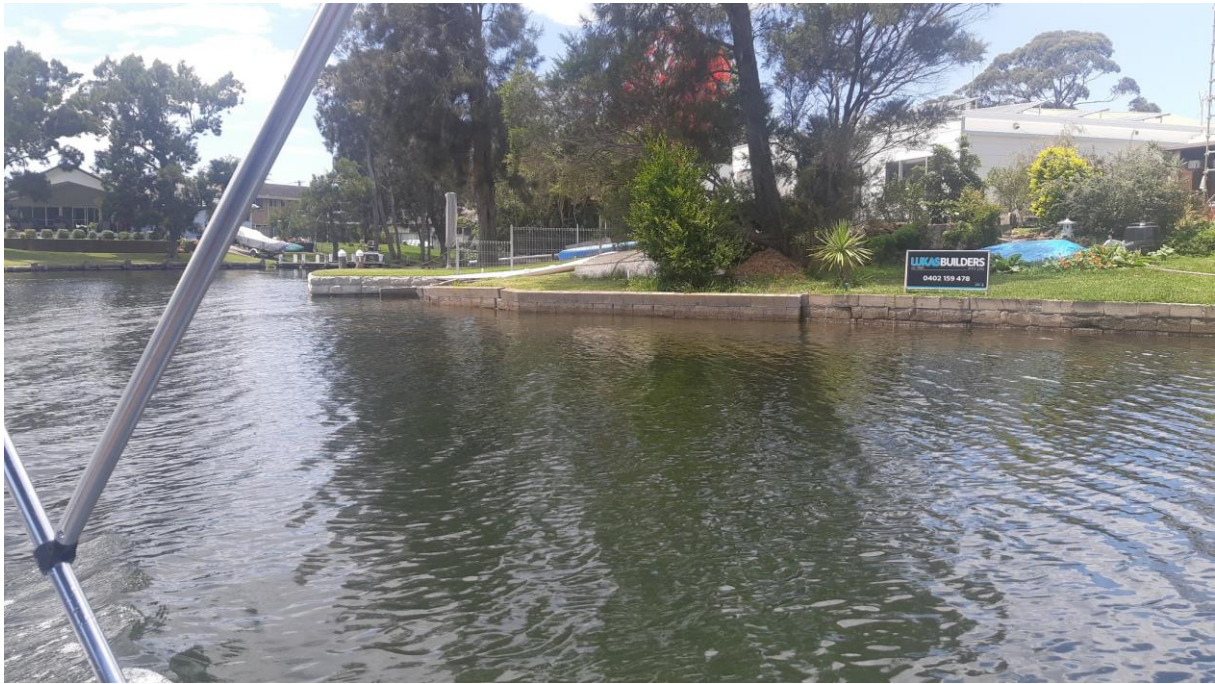
Figure 4-43 – Damaged retaining wall at Sussex Inlet Quays (7 December 2021) Site reference S010.
