### **Covering Note**

If you have any questions about how Council manages sensitive information, please contact Council on 1300 293 111.

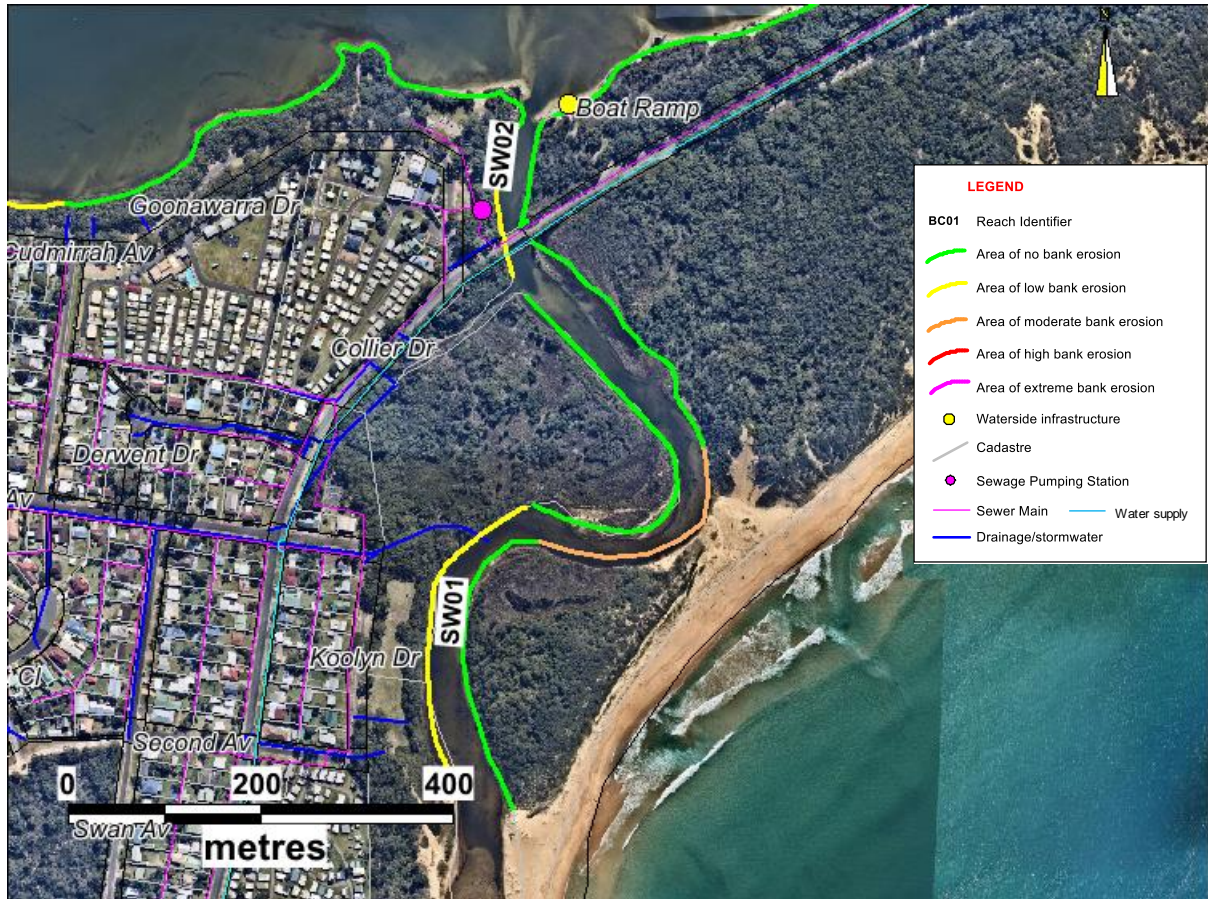
Figure 5-2 – Detail of Swan Lake entrance channel assessed as having erosion of low severity

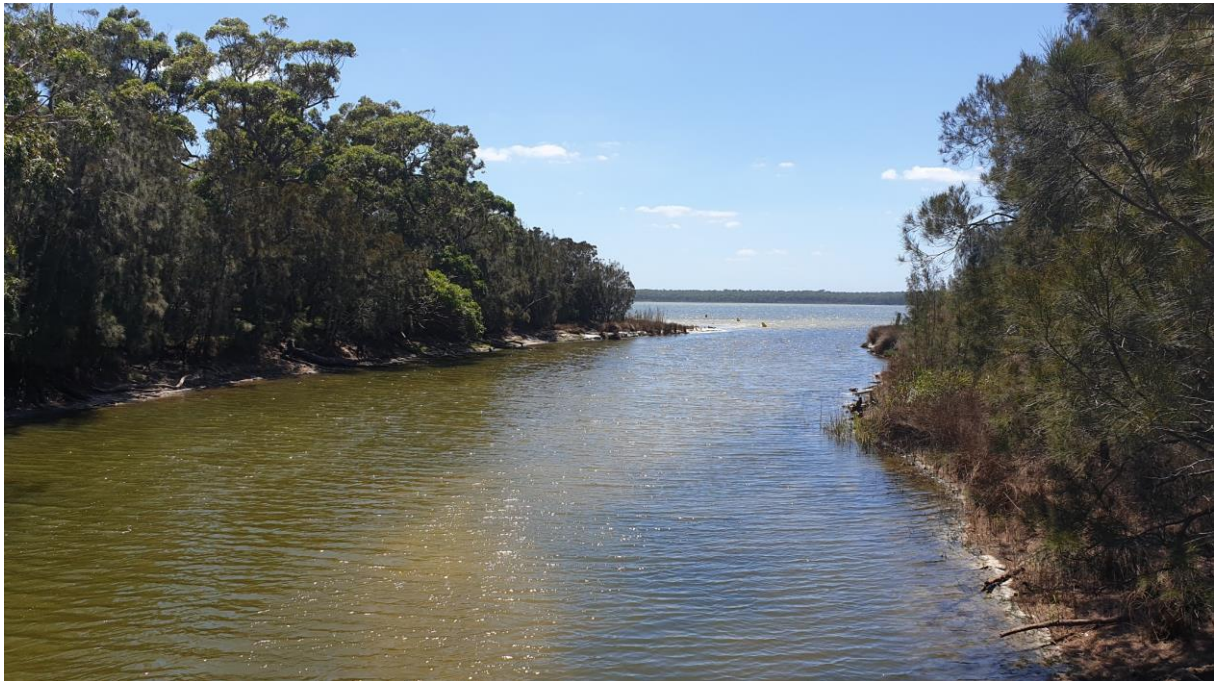
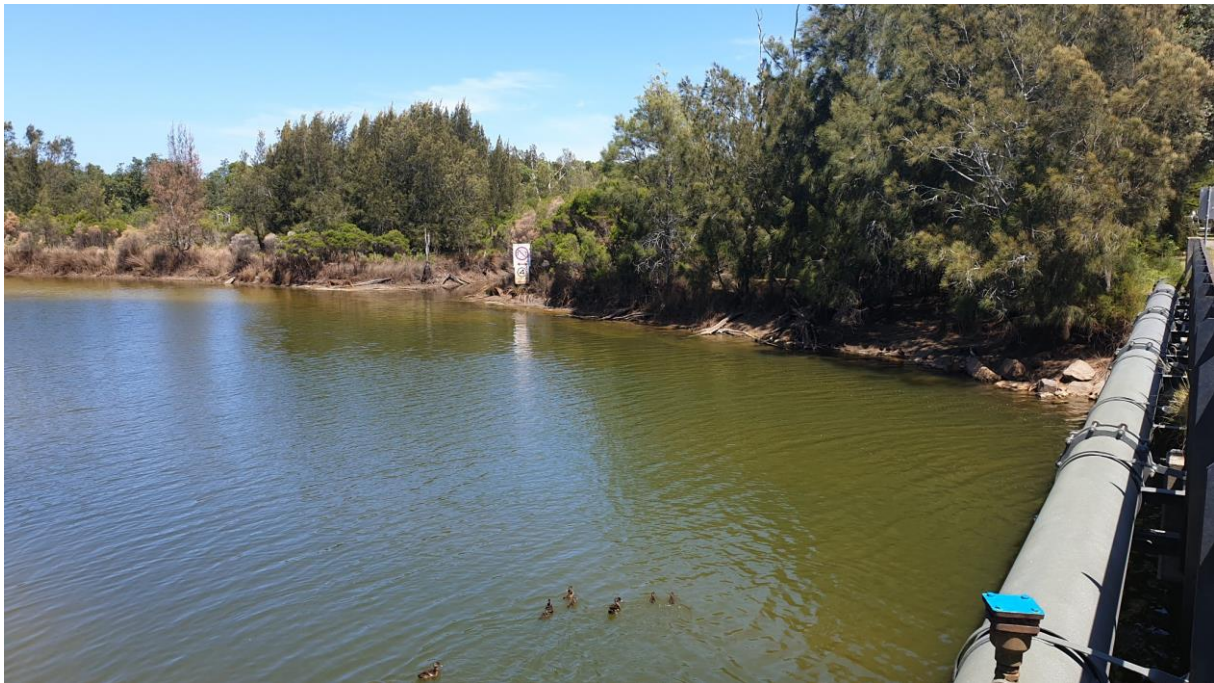
Figure 5-4 – Minor bank erosion on southern bank of upper Swan Lake channel. Top: Looking upstream from bridge, bottom: Looking downstream from bridge (7 December 2021). Site reference SW02.

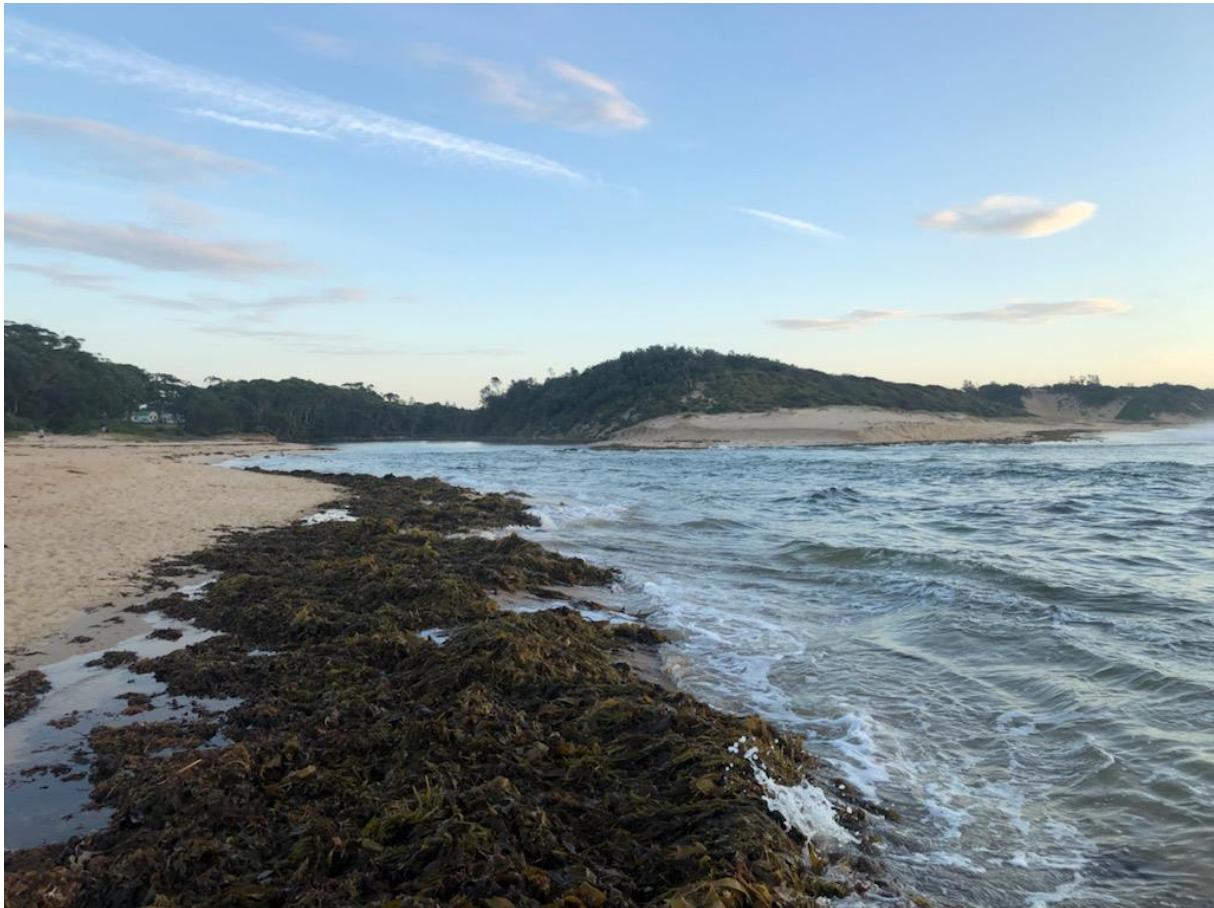
Figure 5-5 – Swan Lake lower entrance channel when entrance is open (18 March 2022). Site reference SW01.

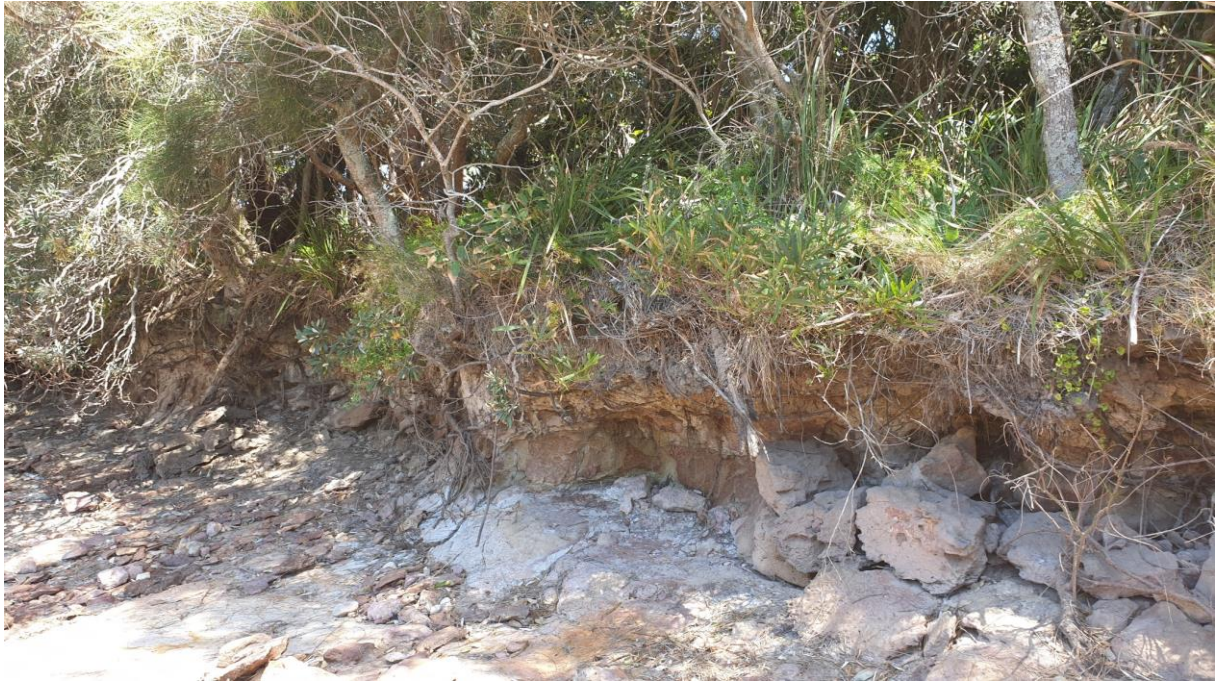
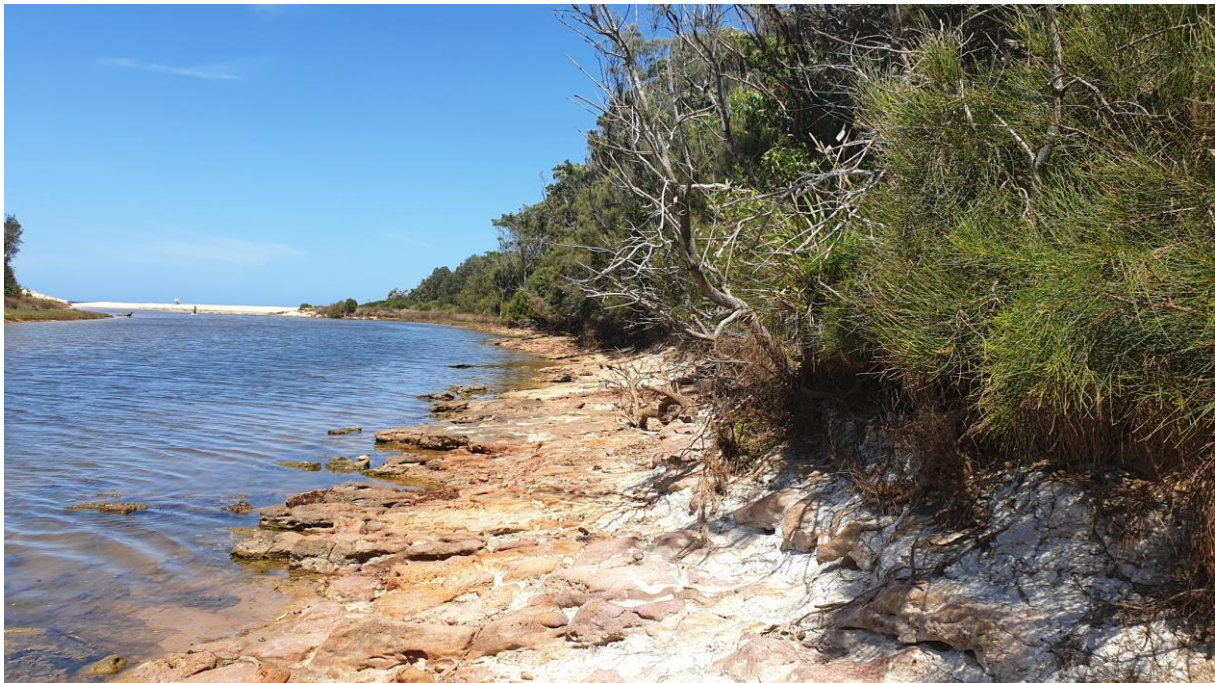
*Figure 5-6 – Minor bank erosion at lower Swan Lake channel (16 February 2022). Site reference SW01.*

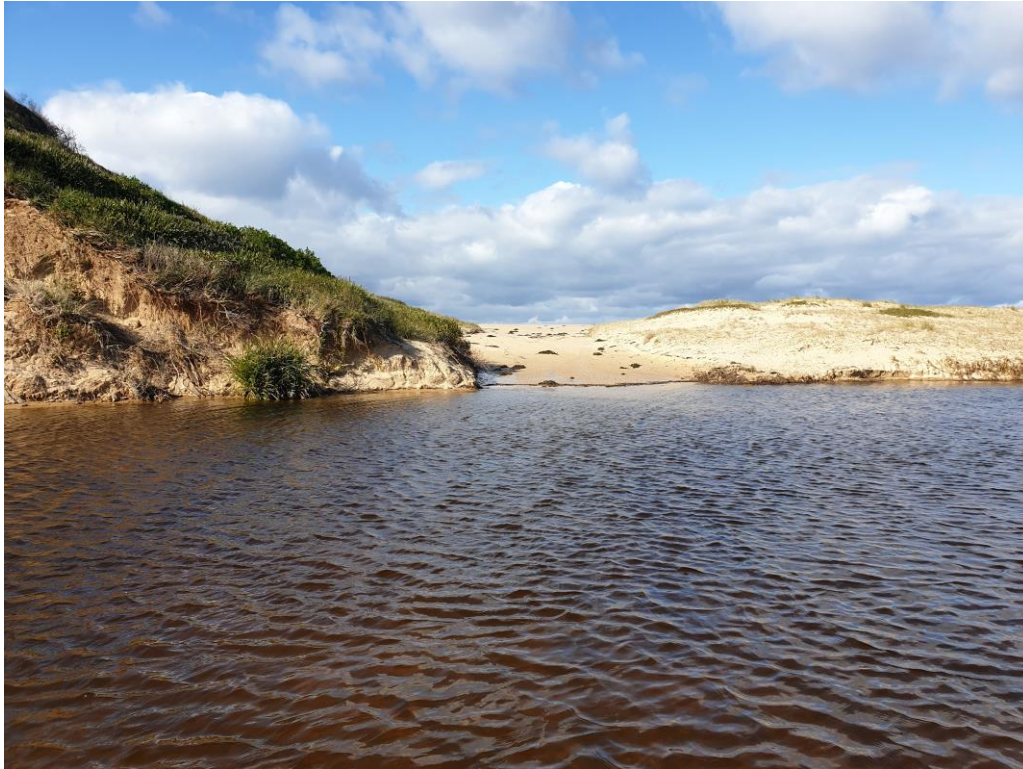
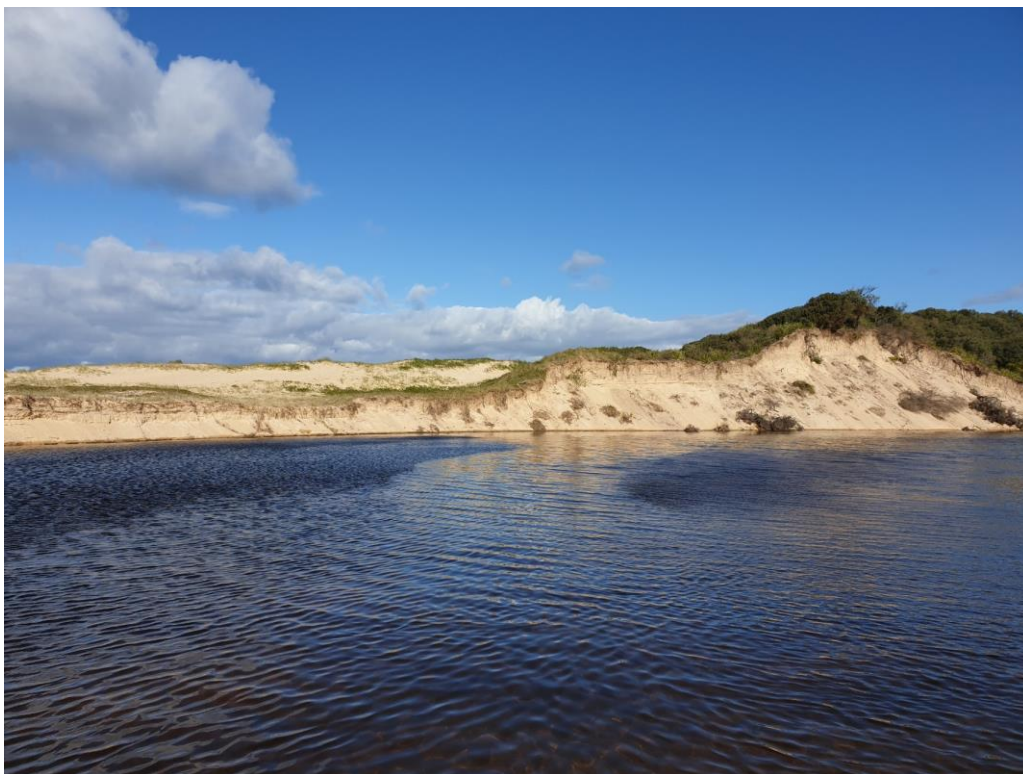
*Figure 5-7 – Erosion occurring at “The Gap”, caused by seaward migration of inlet channel bend toward relict beach dunes. Note evidence of wave overtopping of the beach berm at this location (top), 17 June 2022. Site reference SW03.*

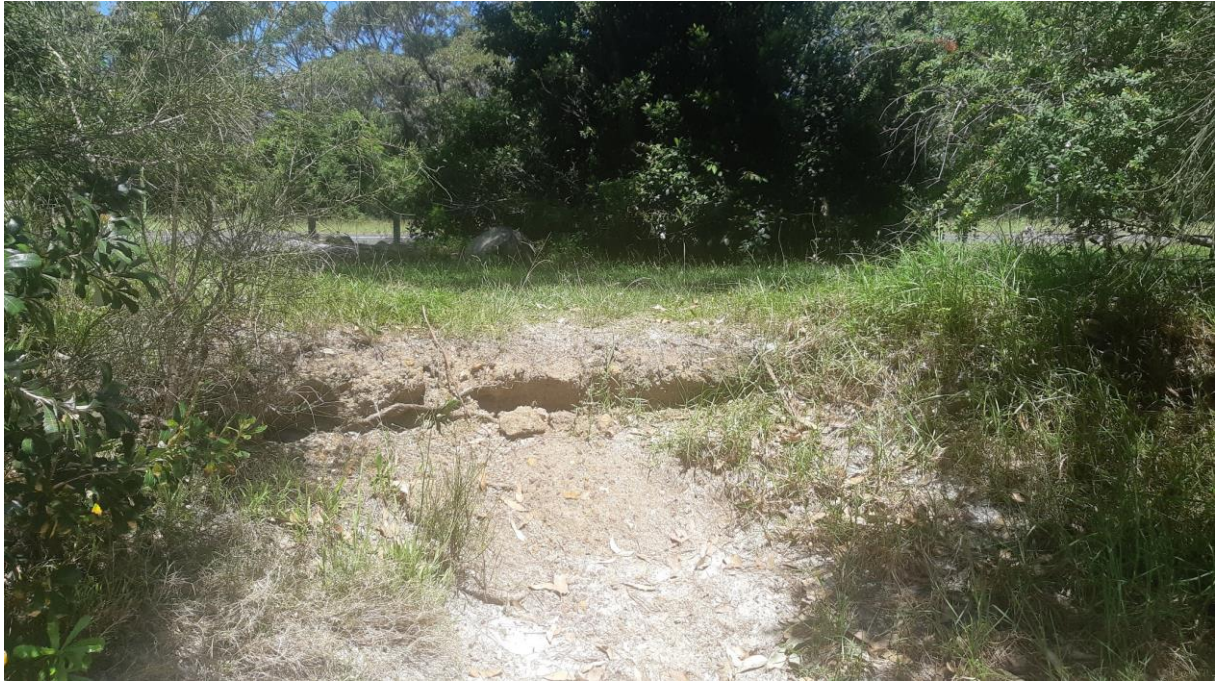
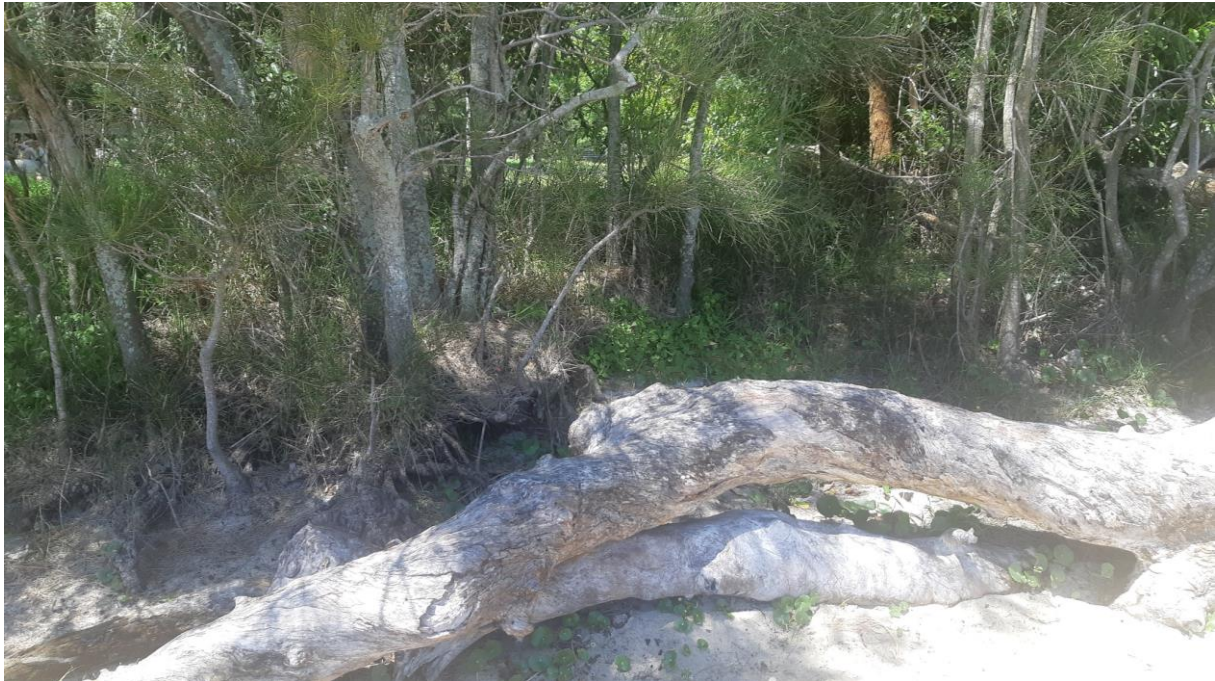
*Figure 5-8 – Minor bank erosion at upper bank at Swan Lake Ski Beach (top, site reference SW05), Dyball Reserve (bottom, site reference SW02), 1 December 2021*

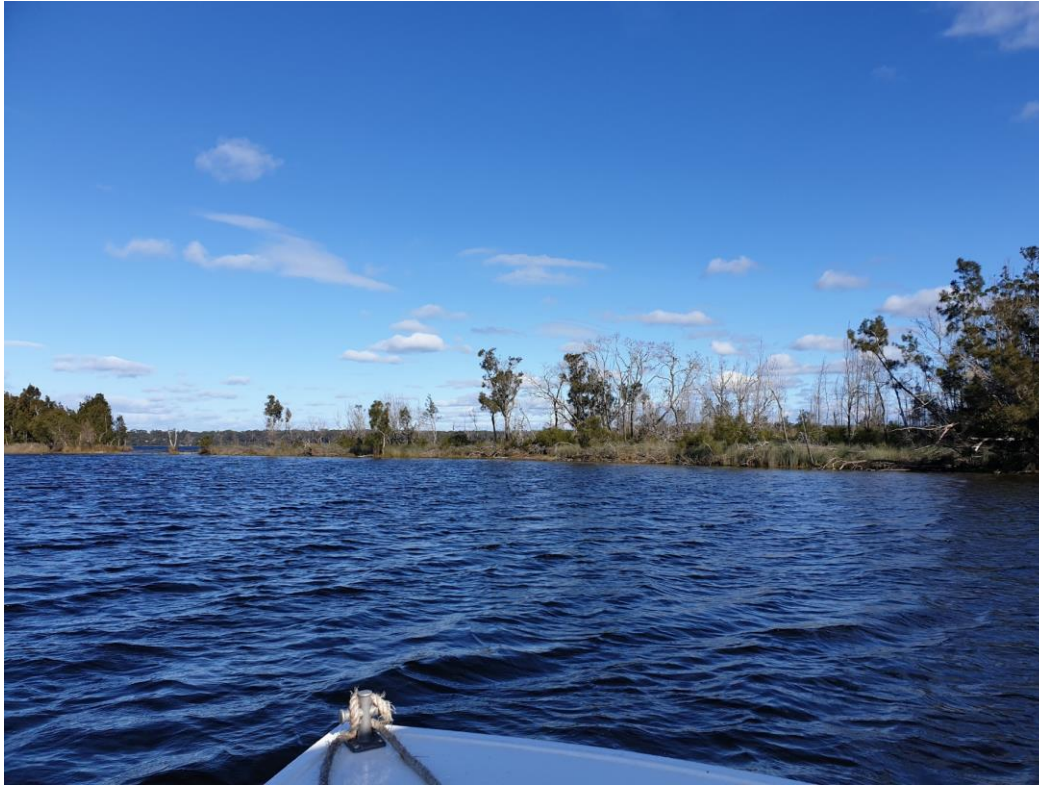
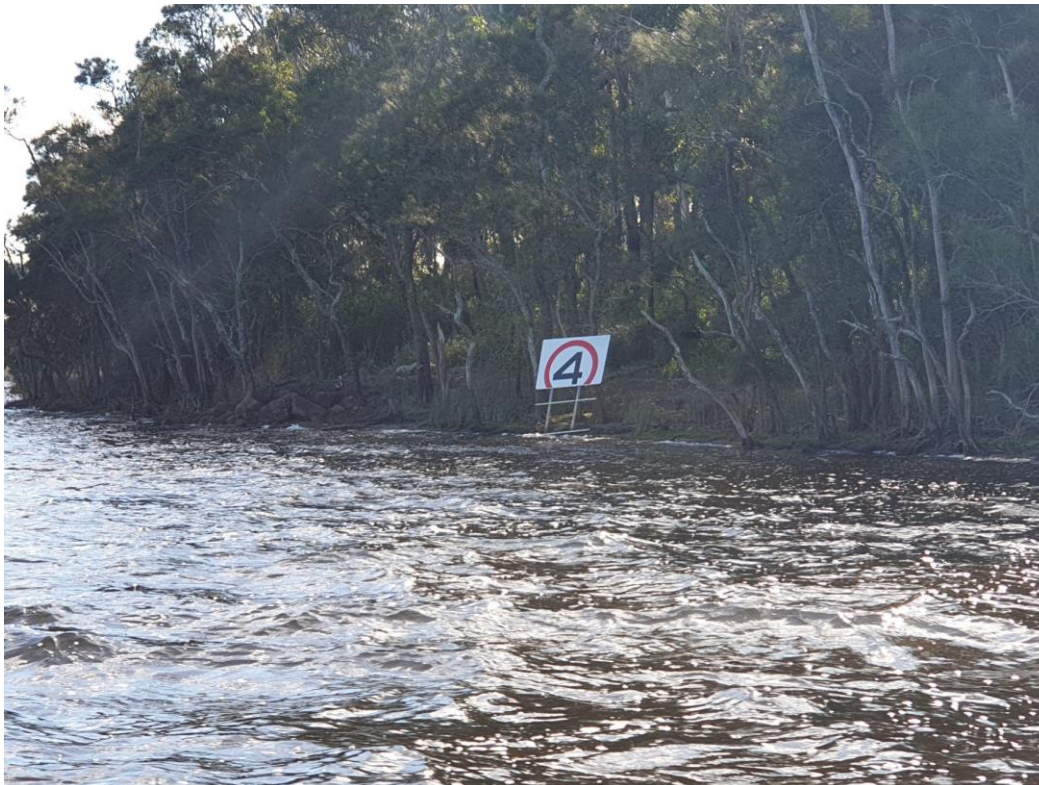
Figure 5-11 – Bushfire-impacted areas at island on northern foreshore experiencing undermining of vegetation. Note damage to speed limit sign caused by bank erosion (17 June 2022). Top: Site reference SW06, bottom: Site reference SW07.

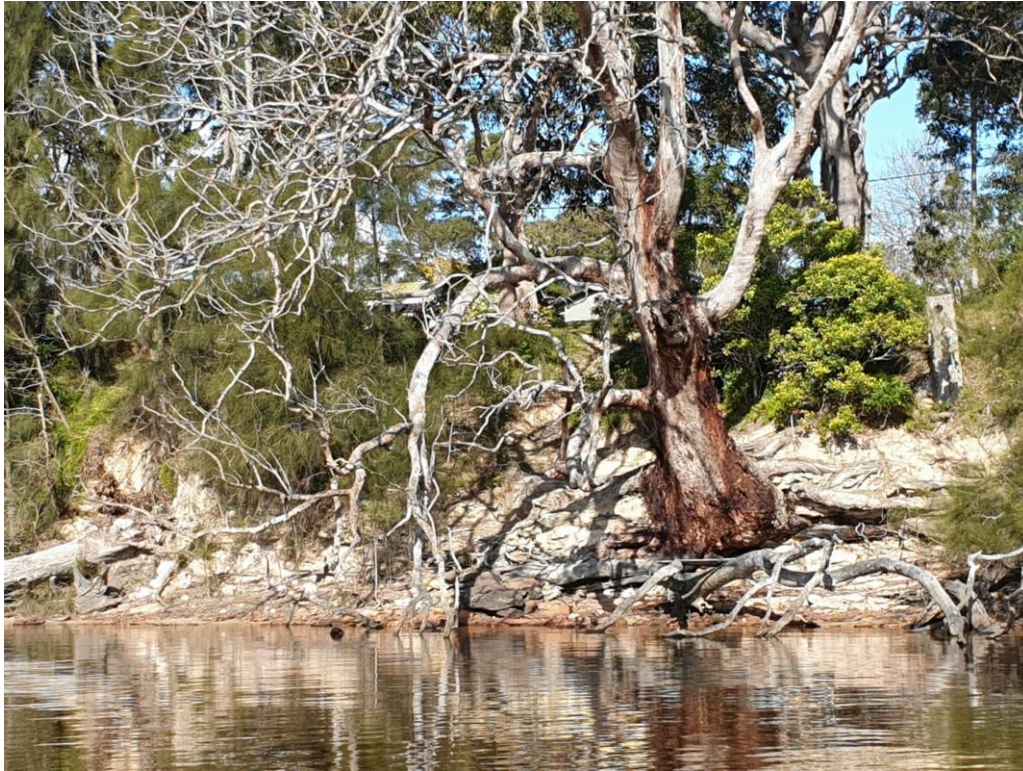
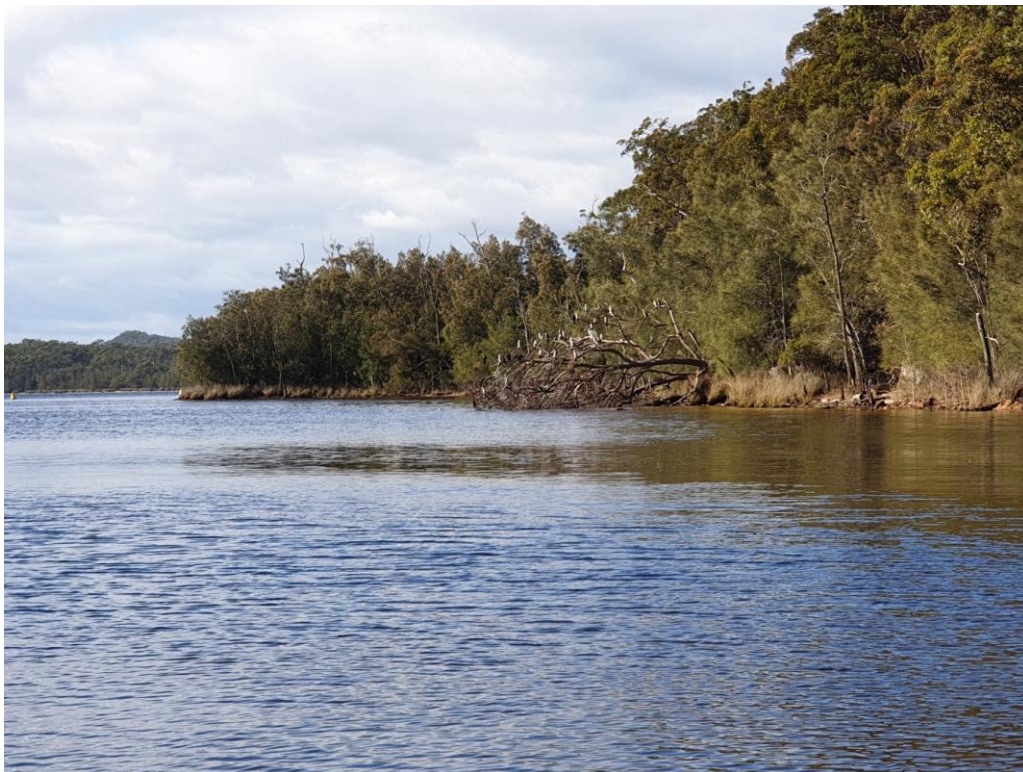
Figure 5-12 – Dead trees at risk of toppling causing destabilisation of bank. Note that these trees are used as roosting habitat for birds (17 June 2022). Top: site reference SW04, bottom: site reference SW08.

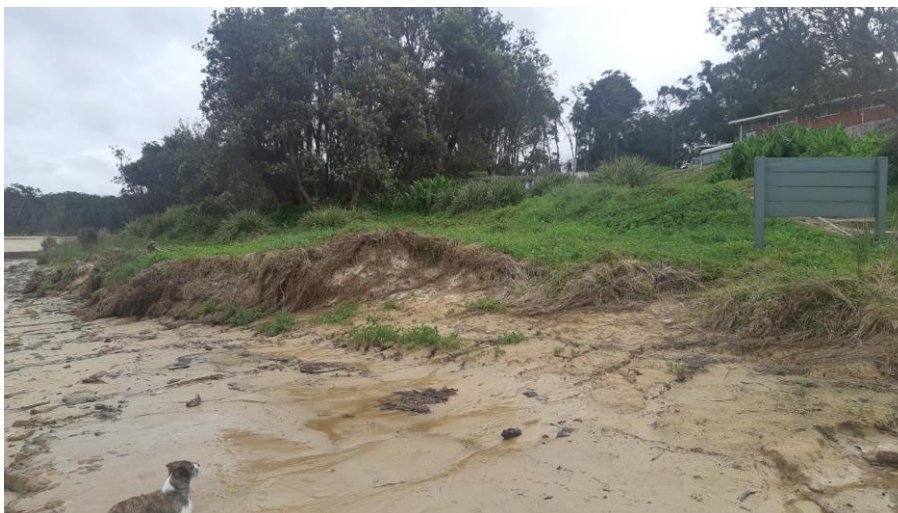
Figure 6-2 – Erosion looking upstream from Berrara Creek beach access (1 December 2021). Site reference BC01.

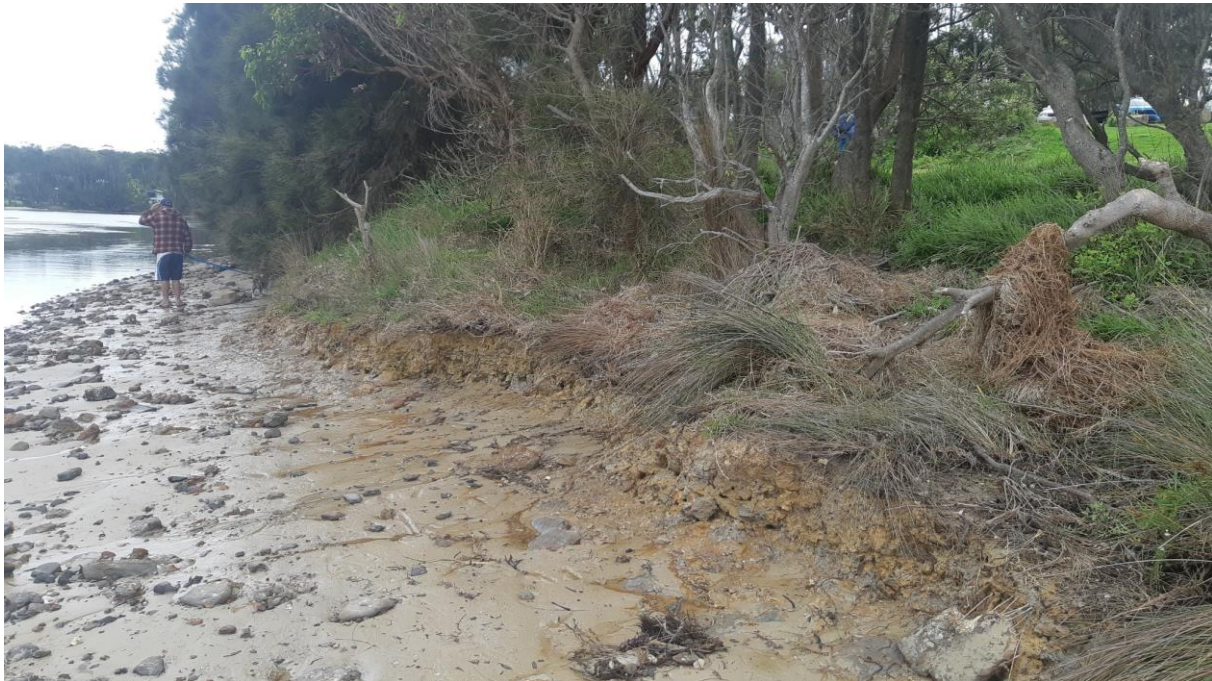
Figure 6-4 – Active bank erosion upstream of beach access from carpark (1 December 2021). Site reference BC02.

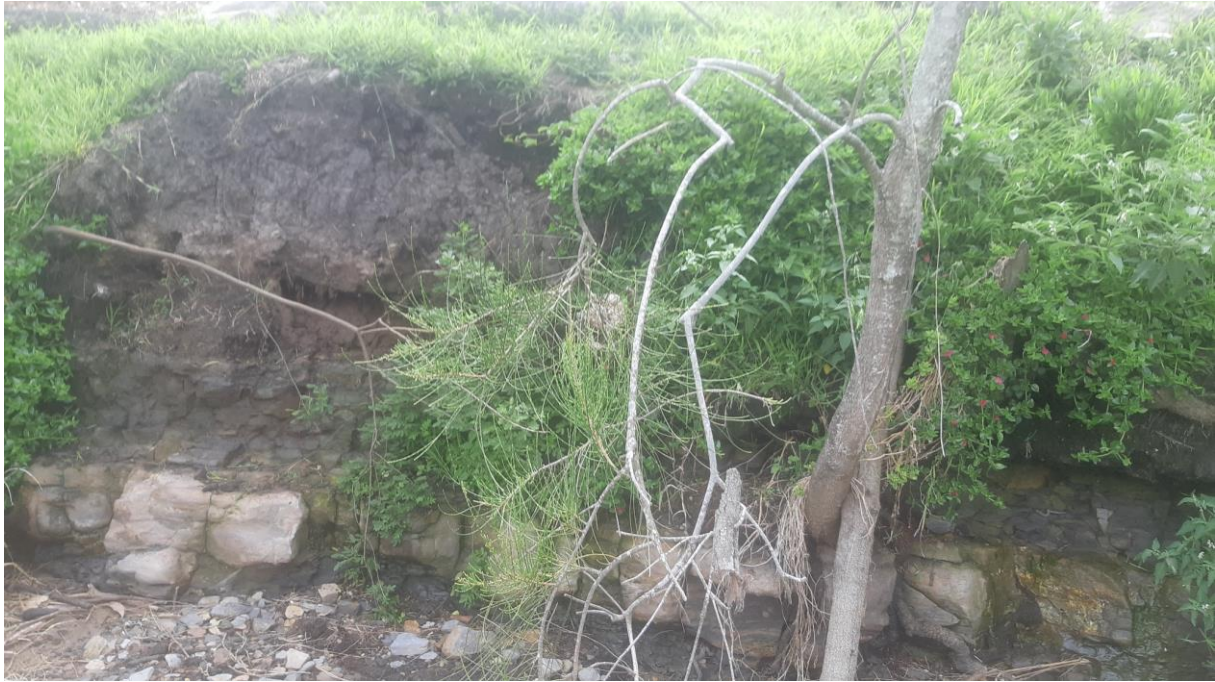
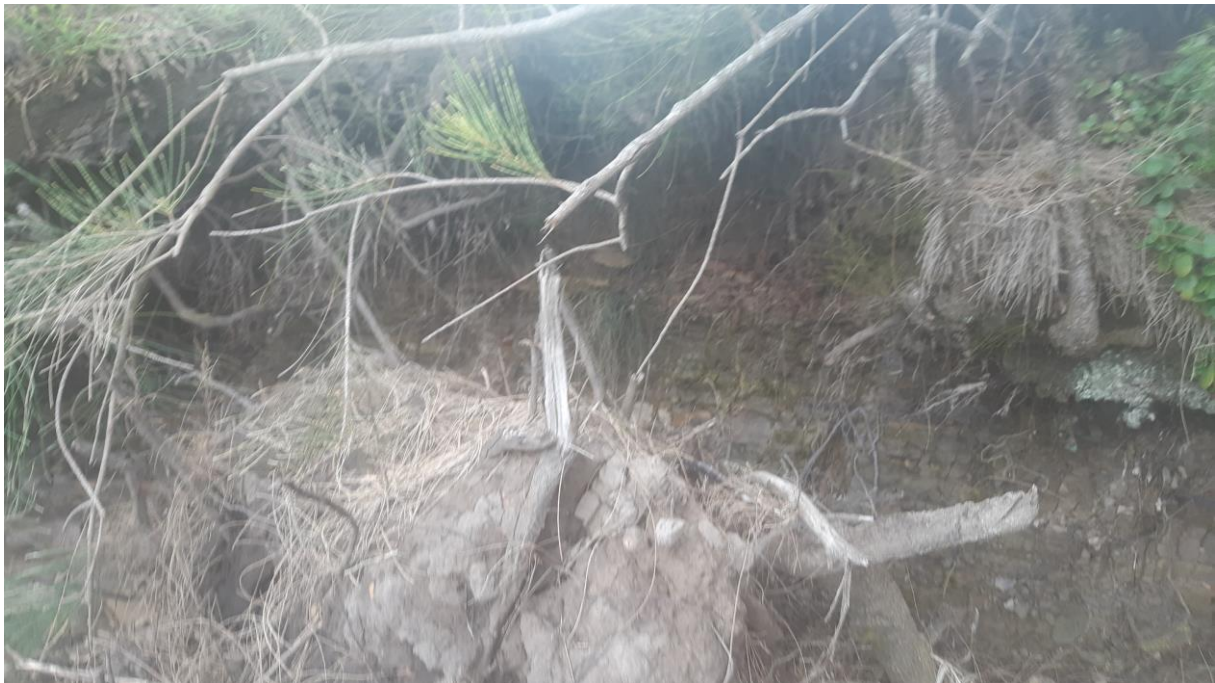
*Figure 6-5 – Bank erosion showing sections of bank detaching from foreshore and high vertical erosion scarp (1 December 2021). Site reference BC03.*

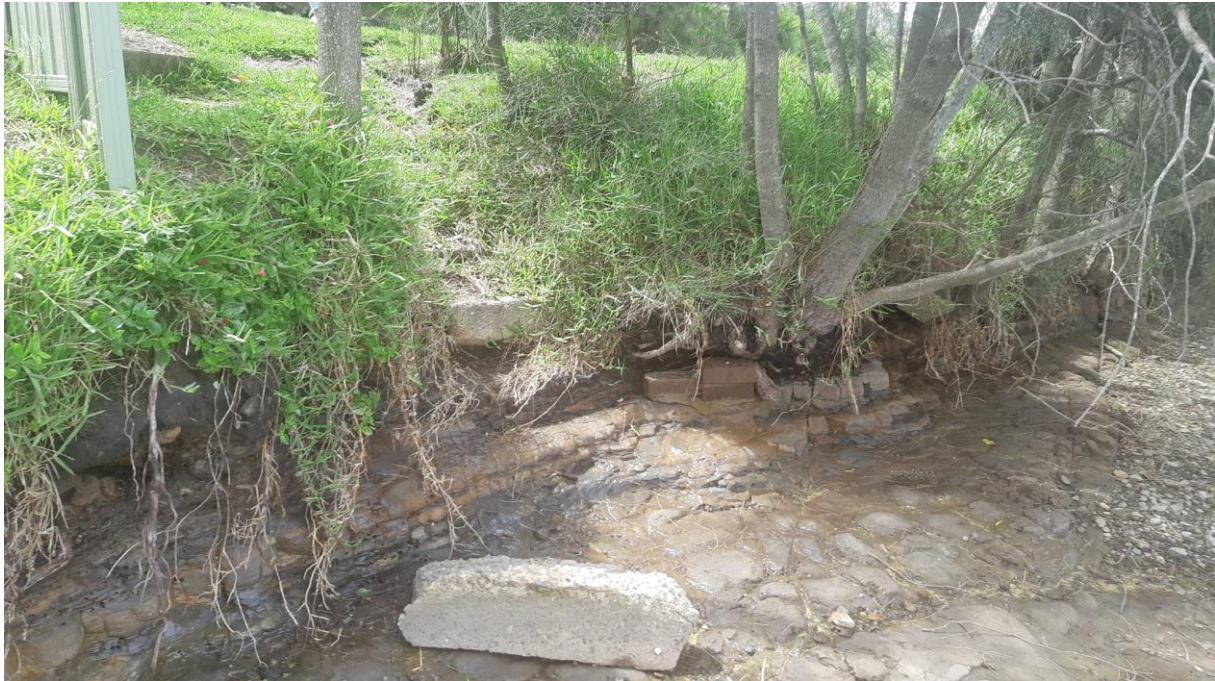
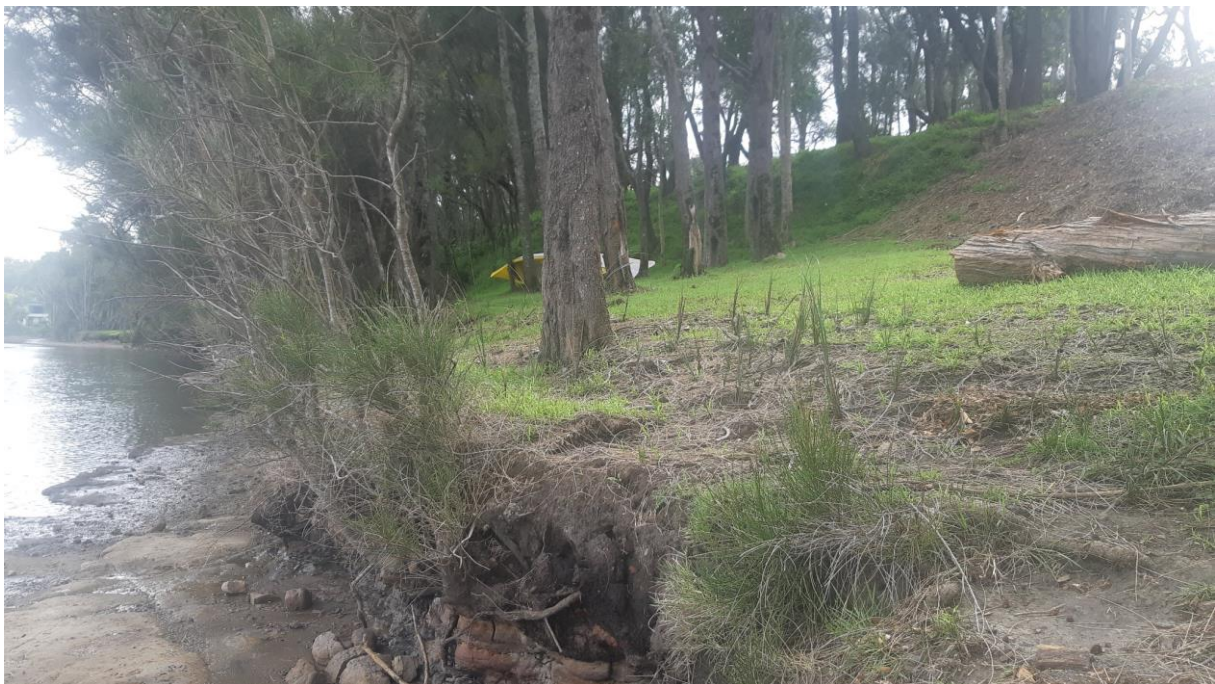
*Figure 6-7 – Minor erosion and vertical scarp at Berrara Waters foreshore with use of adhoc building rubble to contain erosion (1 December 2021). Site reference BC04.*

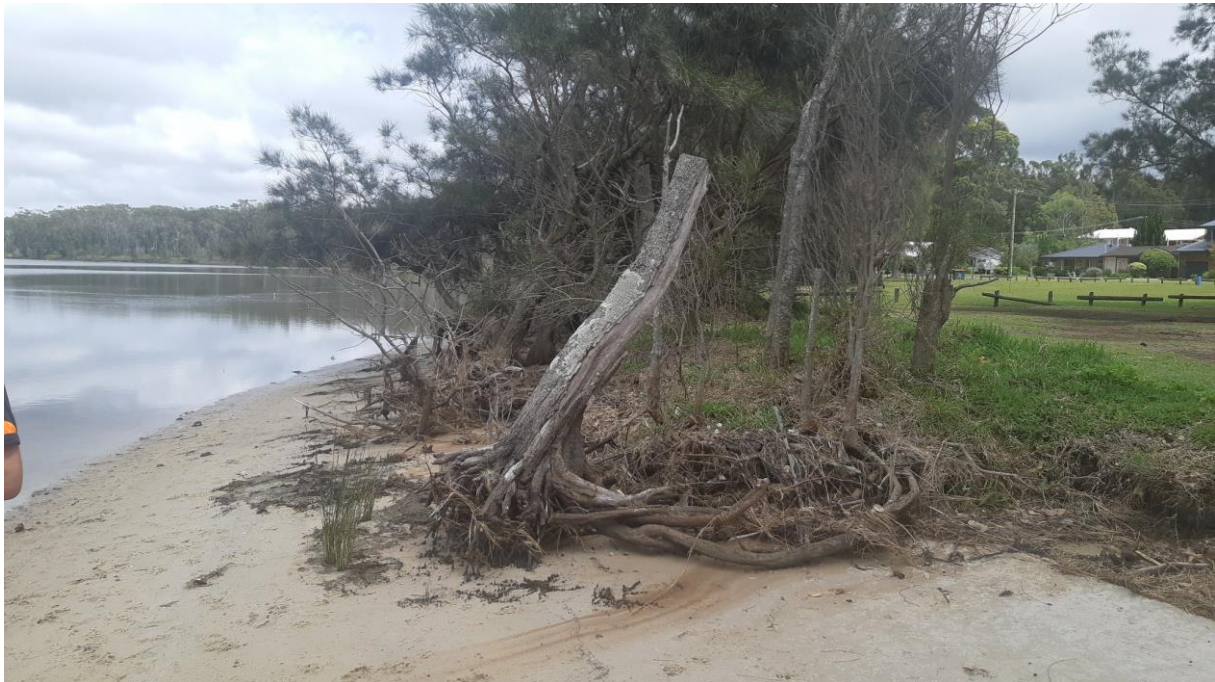
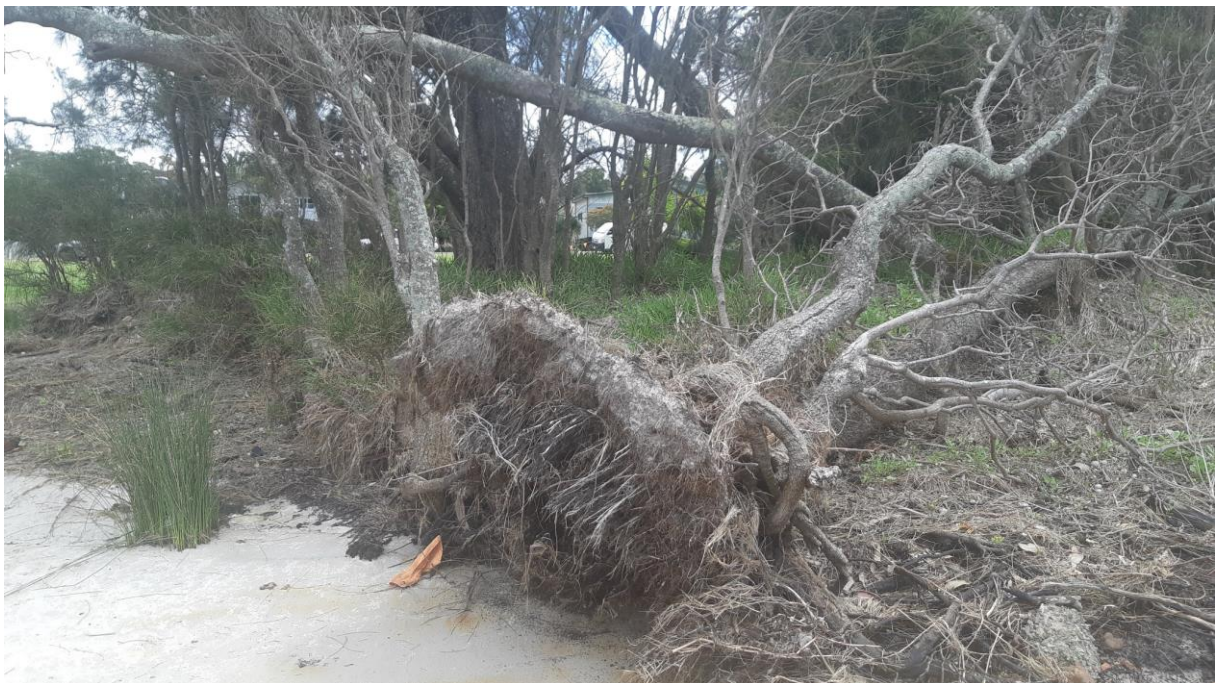
*Figure 6-8 – Loss of mature trees due to erosion at Berrara Lagoon Reserve (1 December 2021). Site reference BC05.*

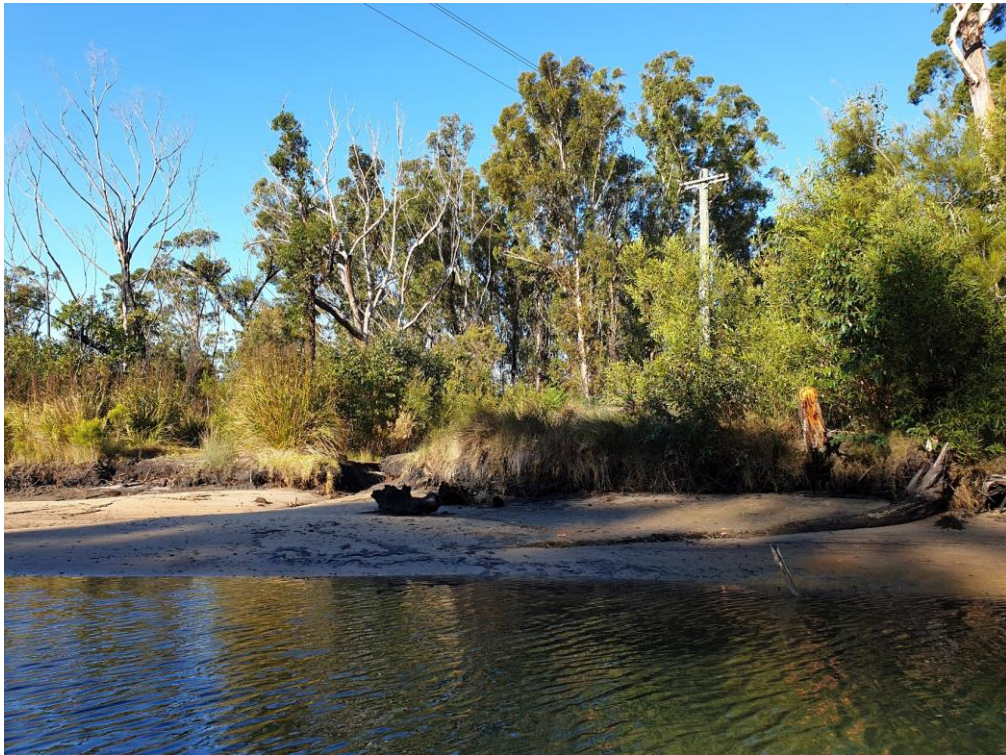
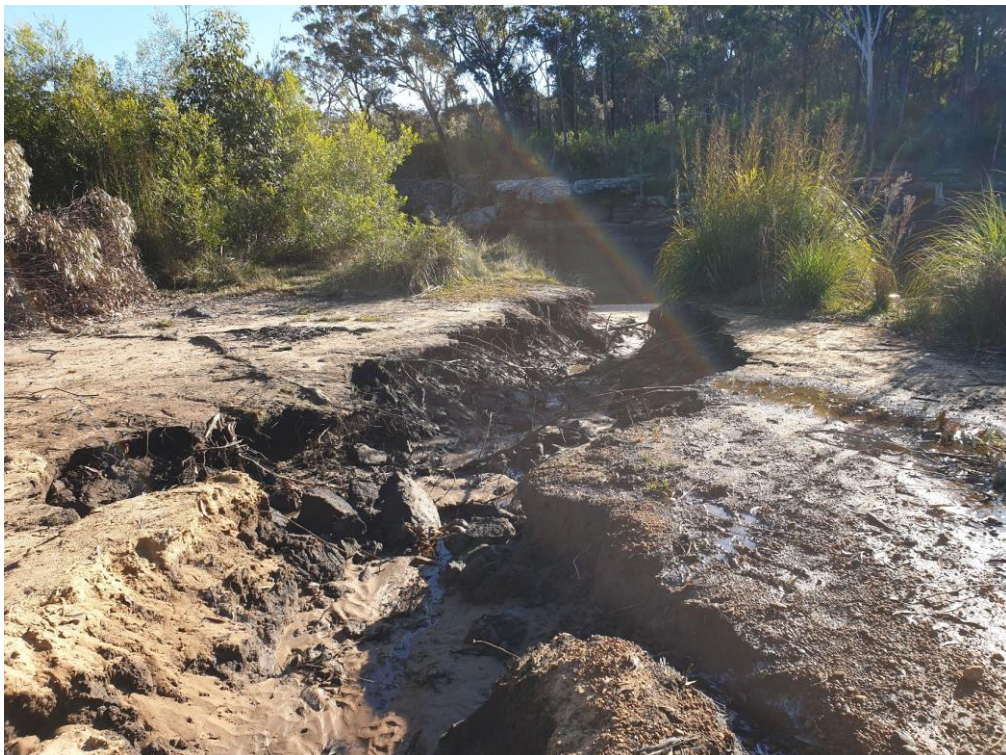
*Figure 6-11 – Erosion at BC07, opposite Fishermans Rock, 17 June 2022. Site reference BC07.*
