### **Covering Note**

If you have any questions about how Council manages sensitive information, please contact Council on 1300 293 111.

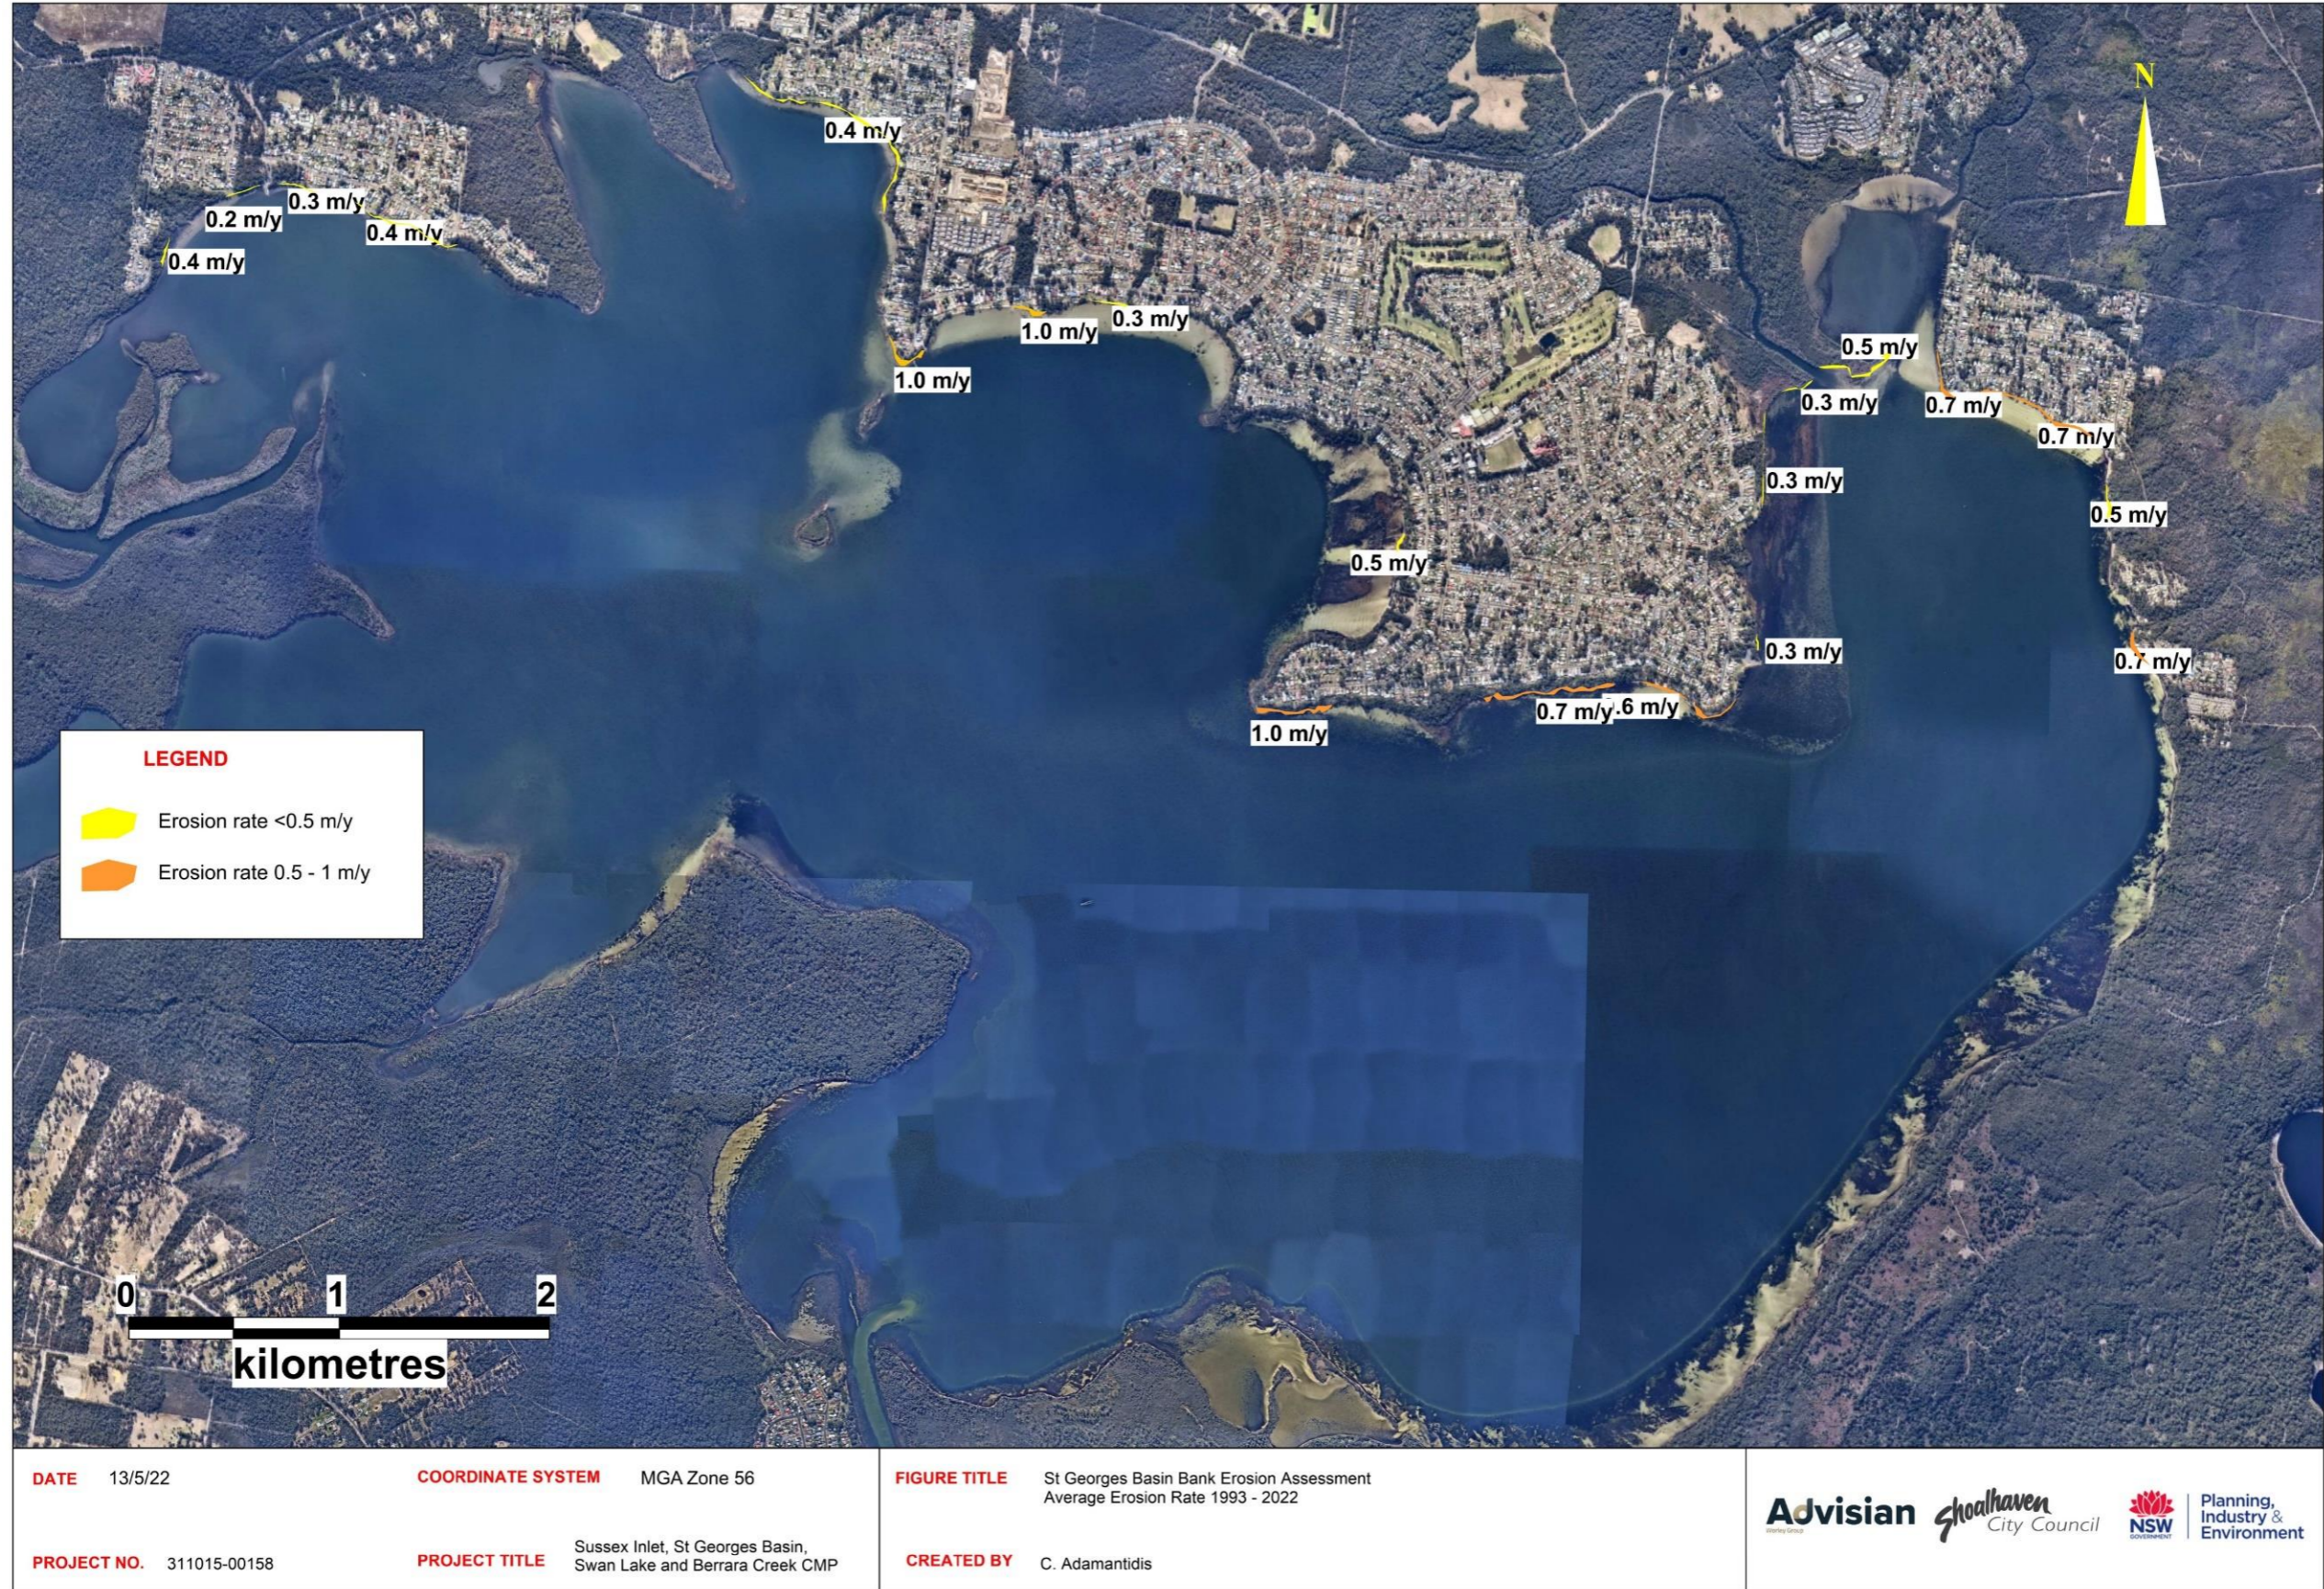
Figure 7-2 – St Georges Basin Erosion Rates

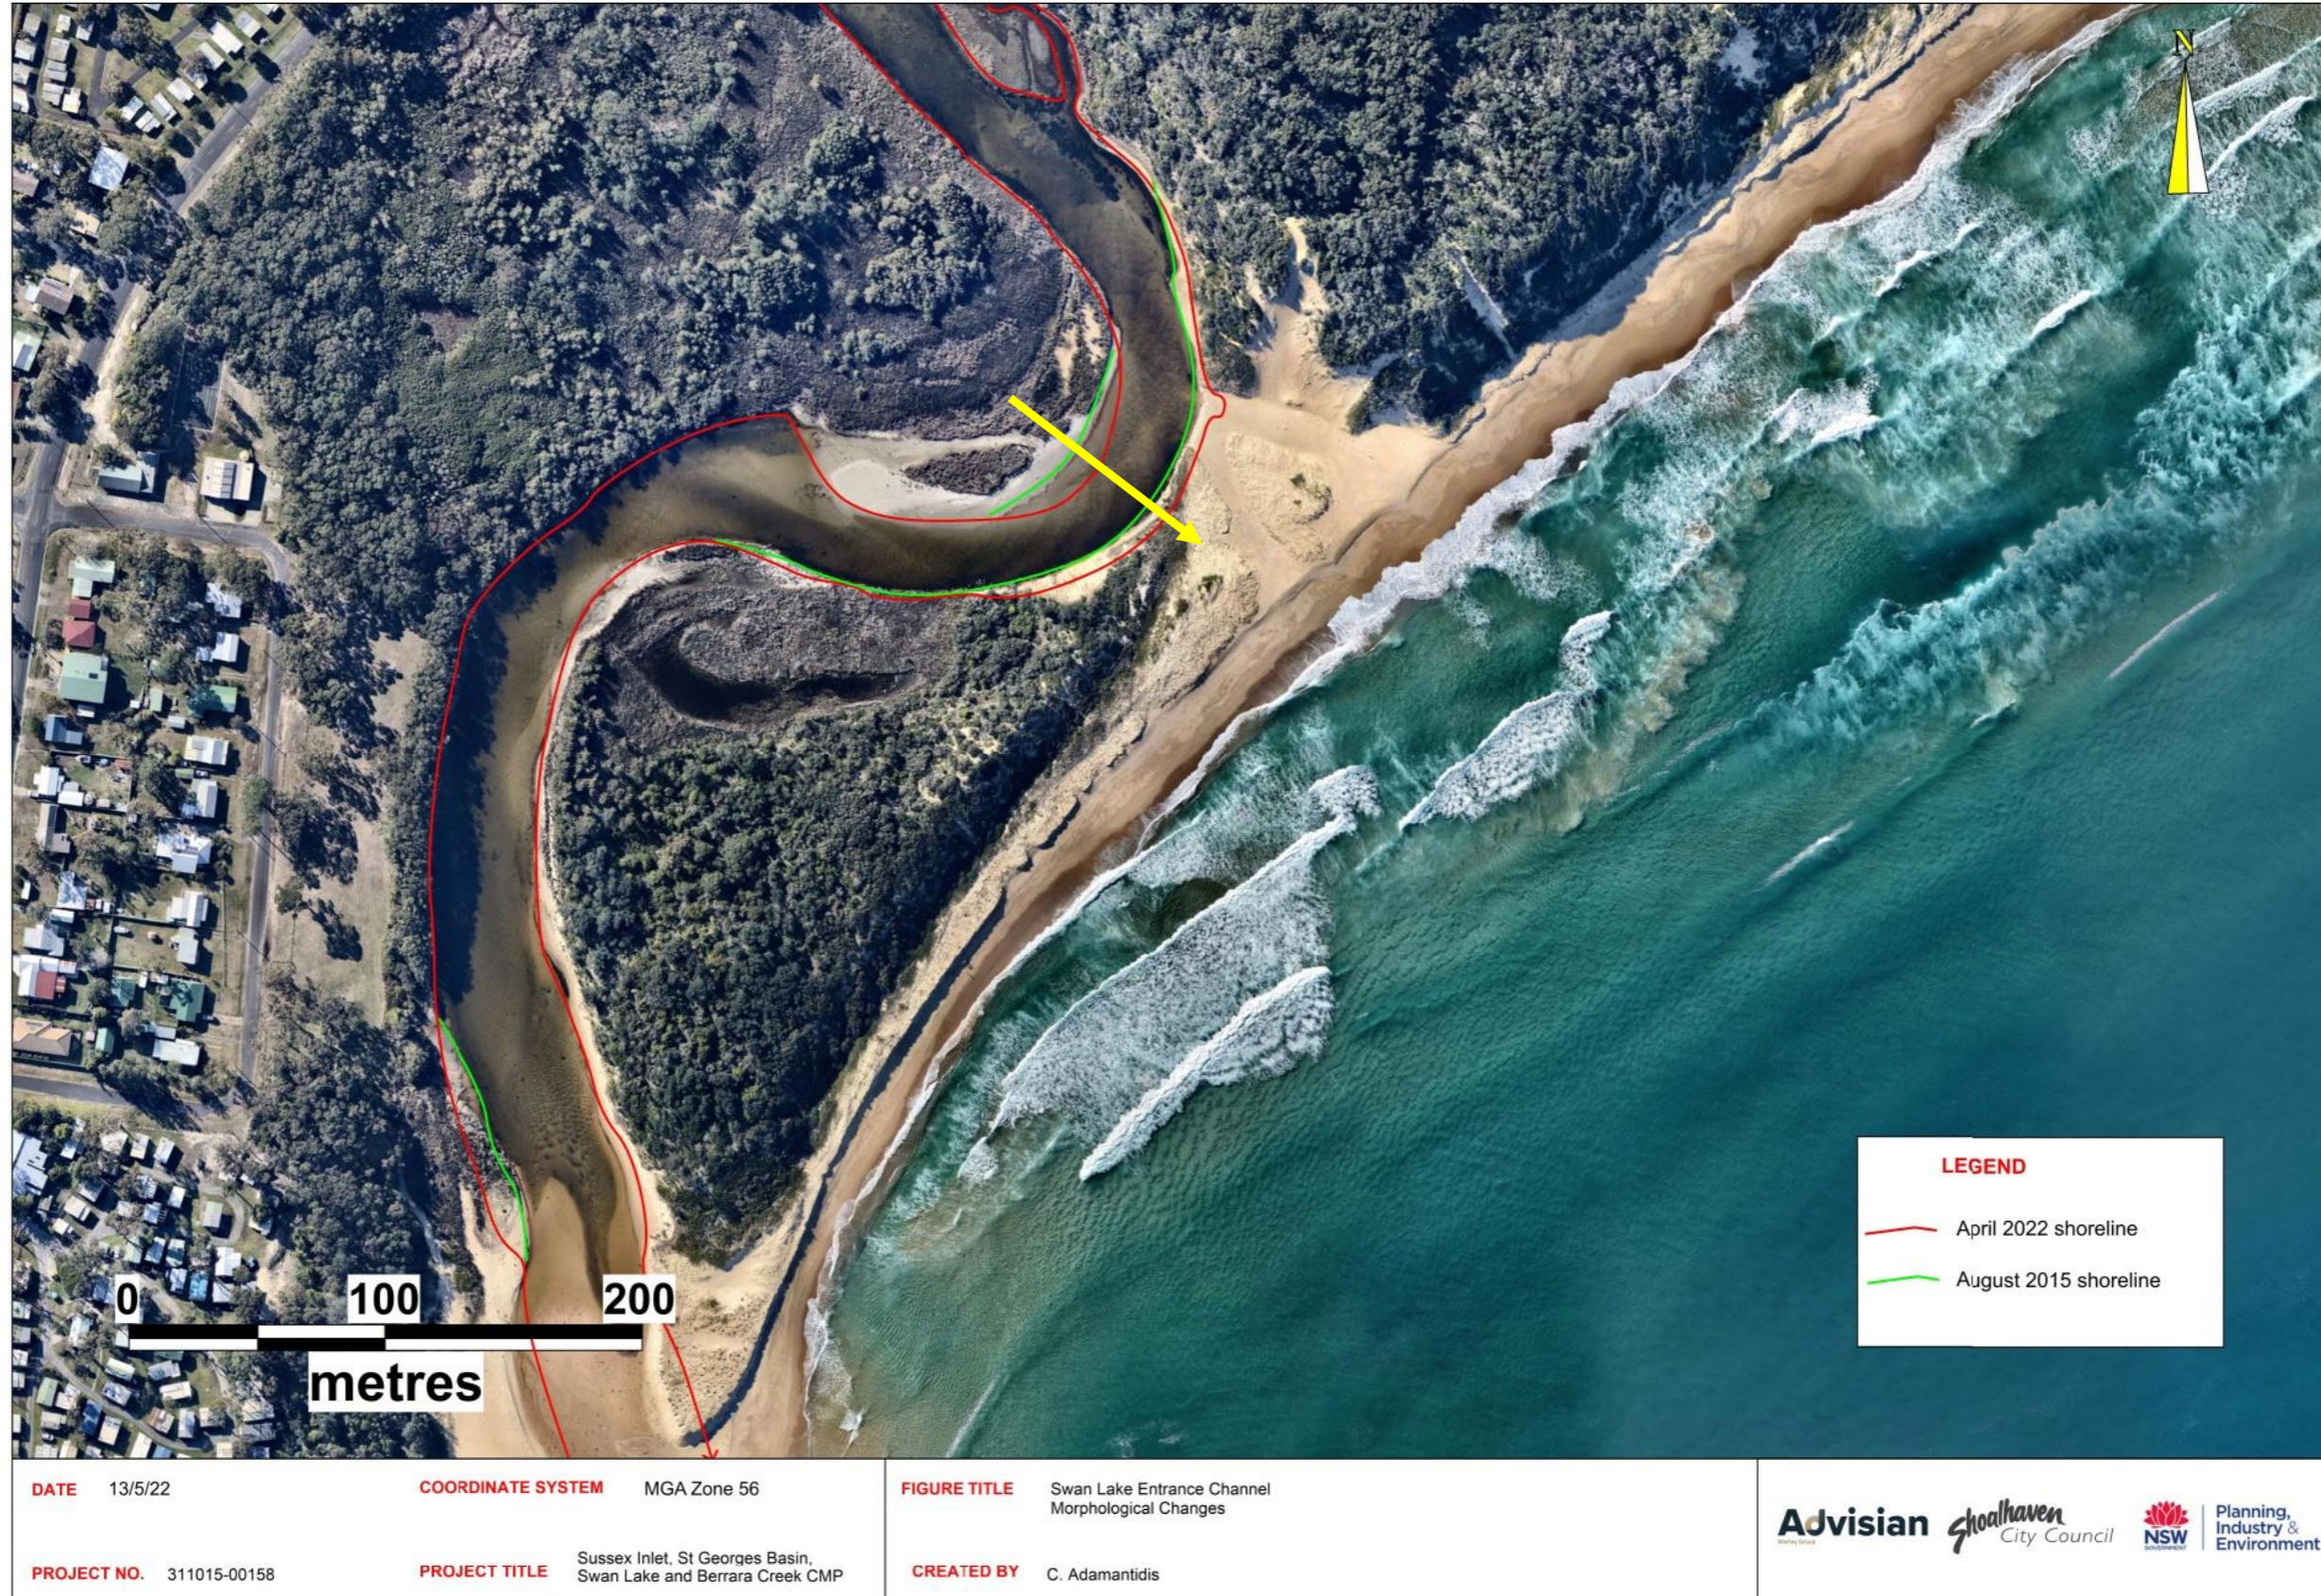
Figure 7-3 – Swan Lake Entrance Channel Morphological Change, 2015 – 2022 (aerial photography Nearmap, August 2015)

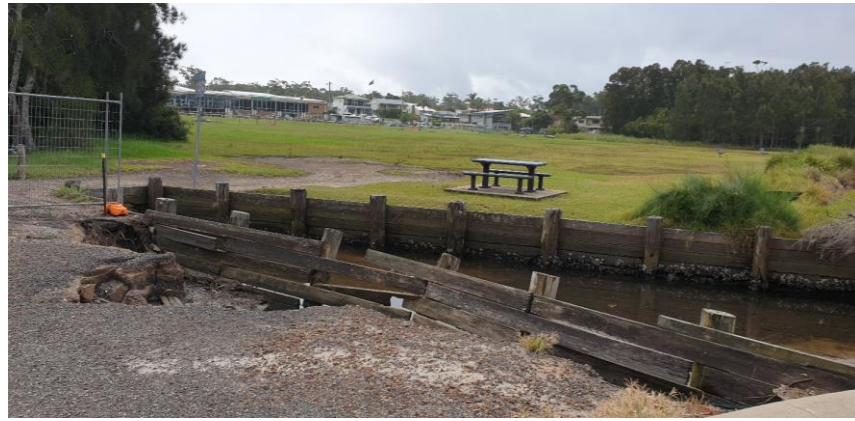
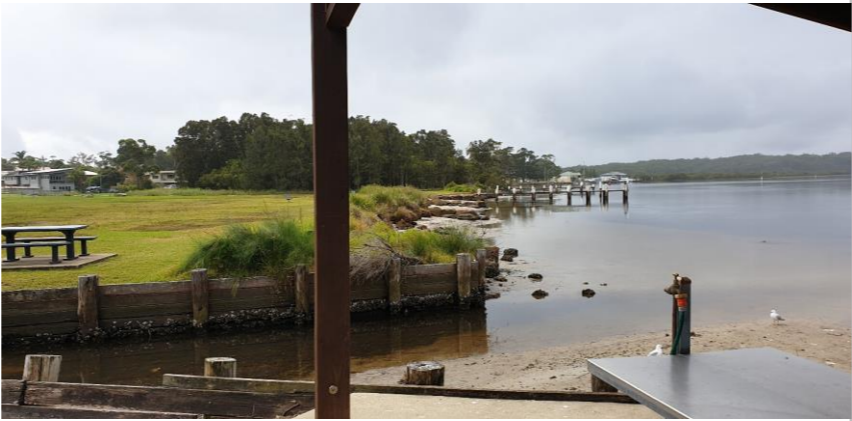
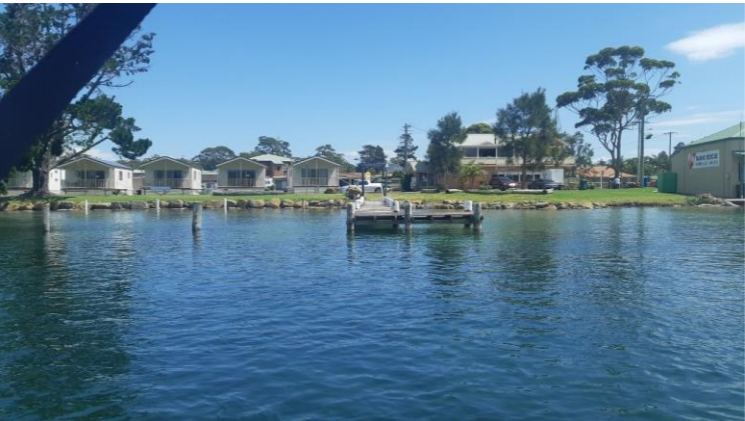
<p>Erosion damage from March 2022 East Coast Low near Lions Park boat ramp fish cleaning table Site Ref S013</p>	<p>Looking north from Lions Park boat ramp, with groyne field and sandy foreshore in background Site Ref S013</p>	<p>Rock-lined foreshore on south side of Marine Rescue building Site Ref S013</p>

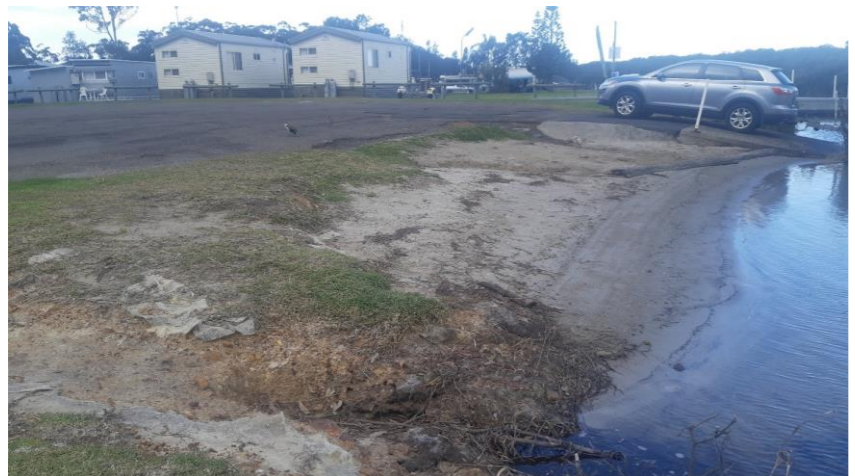
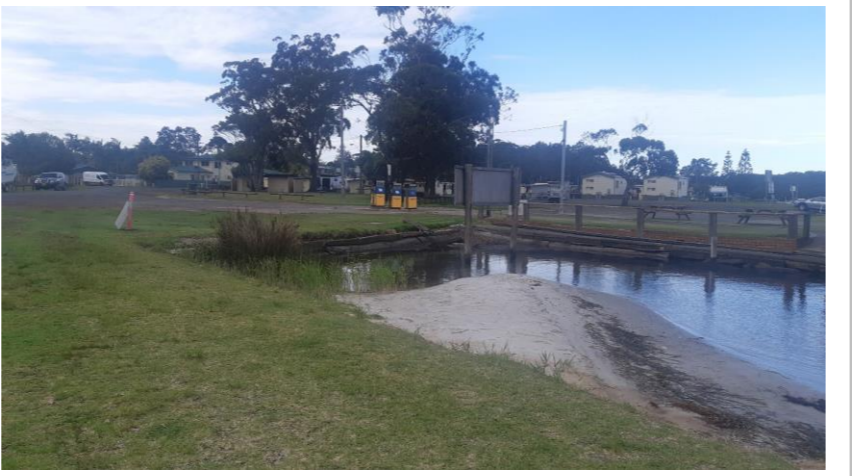
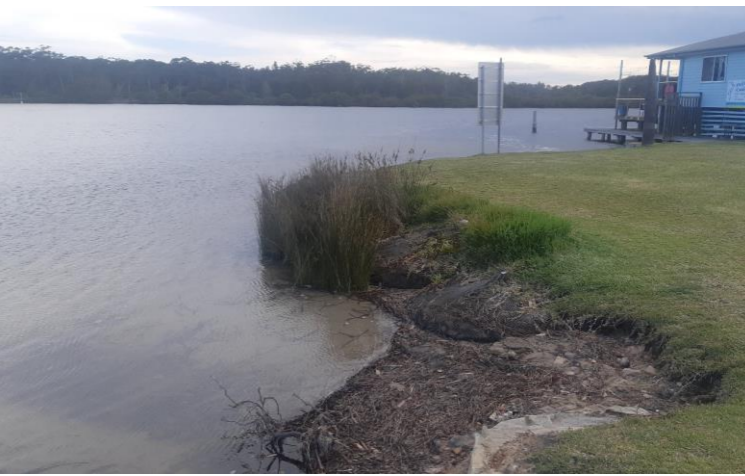
<p>Foreshore adjacent to boat ramp near Pelican Shores Site Ref S013</p>	<p>Collapsing concrete-lined foreshore between Pelican Shores and Marine Rescue Site Ref S013</p>	<p>Kyowa bags at foreshore adjacent to Pelican Shores boat ramp Site Ref S013</p>

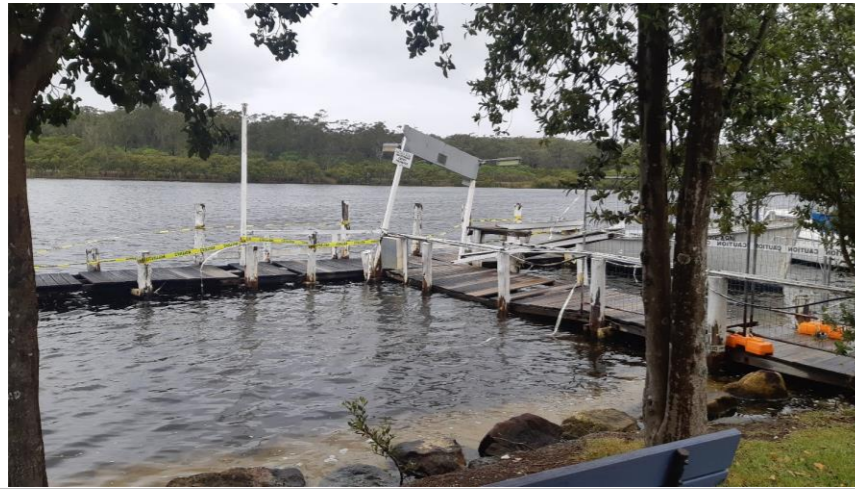
Damaged mooring structures near Sussex Inlet RSL

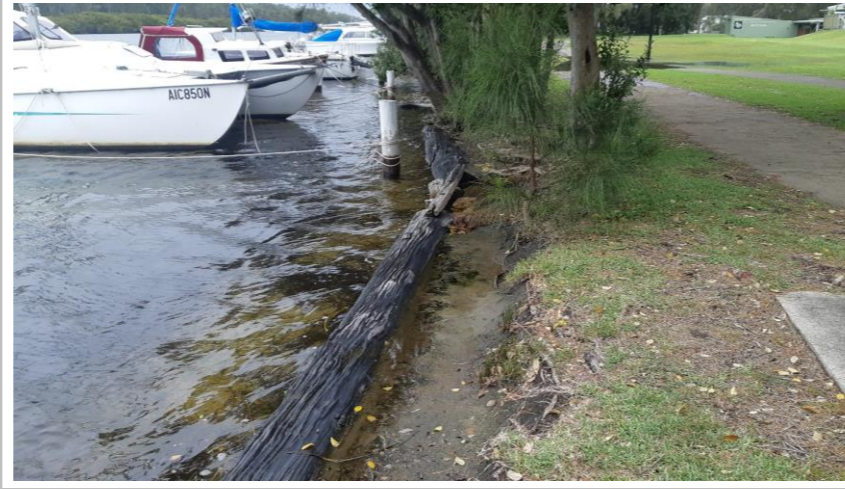
Timber log foreshore protection with erosion behind, near Sussex Inlet RSL

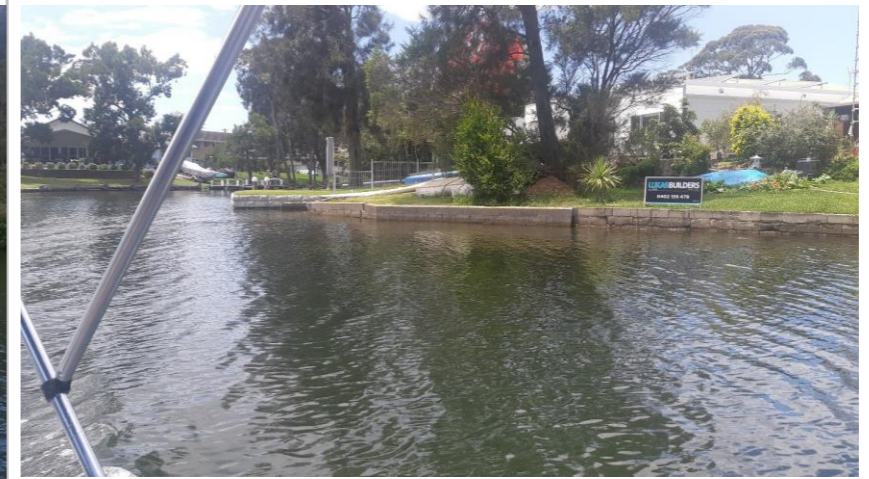
Damaged seawall at The Quays Site Ref S010

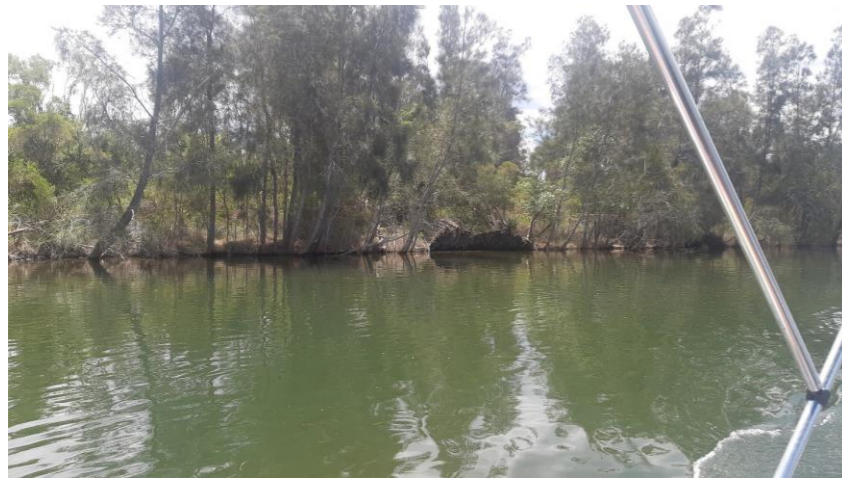
Ralph Lucas Waterway undermining of trees Site Ref S010

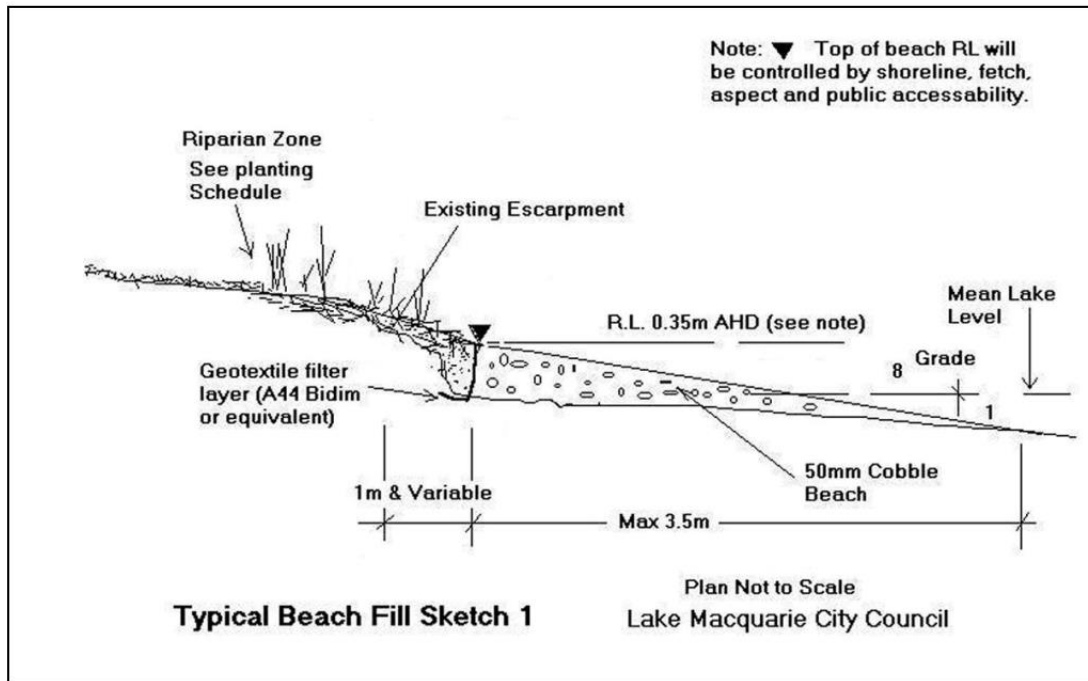
Figure 10-2 – Typical application of cobble beaches suggested to address erosion at Basin View (Walpole et al, 2009)
