**REPORT TO  
ROYAL HASKONINGDHV  
ON  
GEOTECHNICAL ASSESSMENT  
OF  
EXISTING FORESHORE CLIFF FACES  
AT  
VARIOUS LOCATIONS BETWEEN CULBURRA  
BEACH AND RACECOURSE BEACH, SHOALHAVEN  
CITY COUNCIL LOCAL GOVERNMENT AREA, NSW**

Date: 12 September 2019

Ref: 30016Rrpt

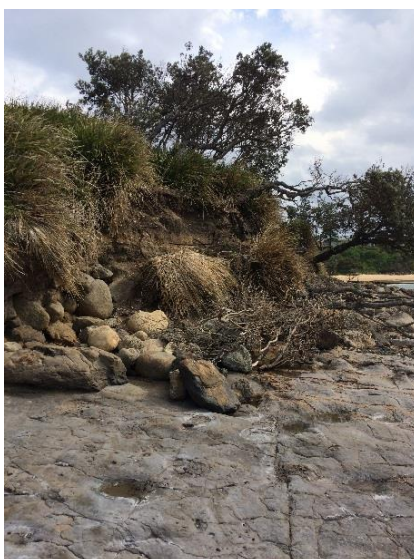
**Plate 1**

The 'boulder armour' described by DP to be 5m to 10m wide and covering the base of the cliff around the north-western portion of the Penguin Head site. Over the western end of the northern cliff face the 'boulder armour' was generally missing or a maximum width of about 4m in places. Localised erosion of the fill batter slope over this area was evident (see Plate 1).

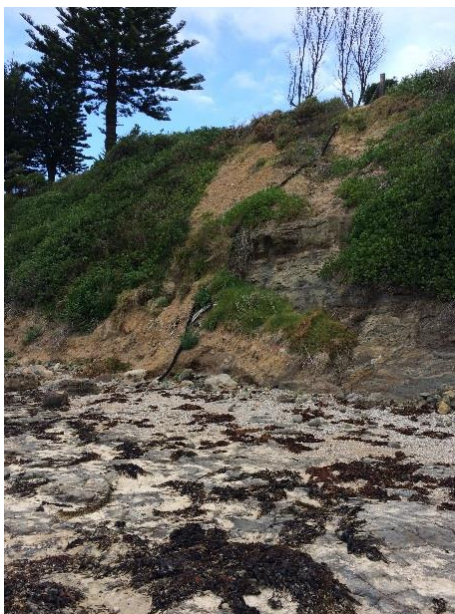
**Plate 2**

Localised less than  $0.5\text{m}^3$  soil slumps in the vicinity of DP Photo 37 with 'ag' pipes extending down the cliff face from the yard area above (see Plate 2).

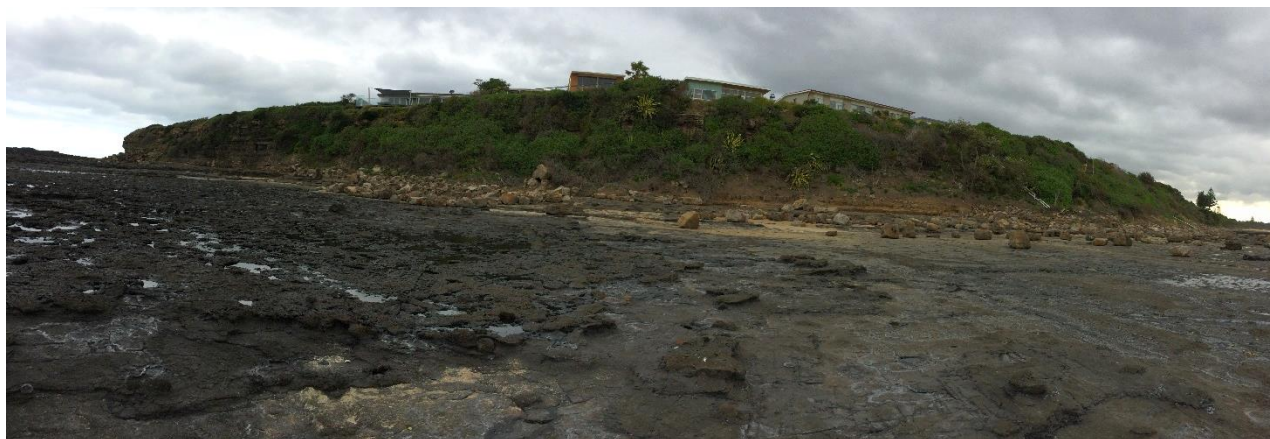
**Plate 3**

The 'armour zone' 5m to 8m wide described by DP over the base of the central eastern portion of the northern cliff face was intermittently present and a maximum width of about 4m (see Plate 3).

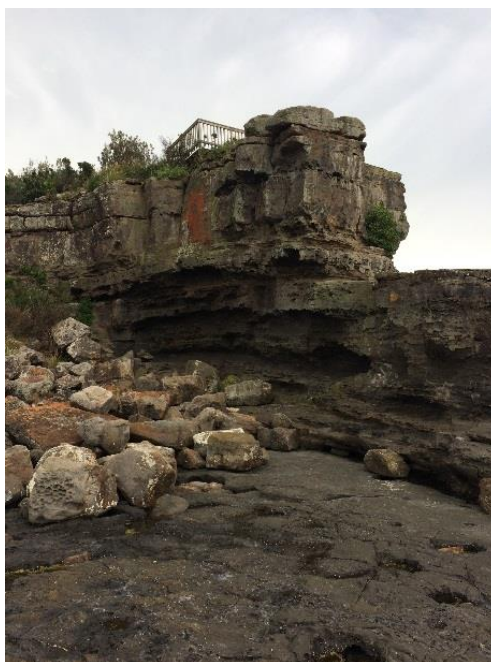
**Plate 4**

The timber lookout at the crest of the cliff at the eastern end of the headland was set-back between about 1m and 1.5m from the crest of the cliff. The base of the cliff face below south-eastern side of the lookout was undercut (maximum height 3.5m and 'depth' 1.8m). The sub-vertical joints in the sandstone above the undercut were open a maximum width of about 0.1m.

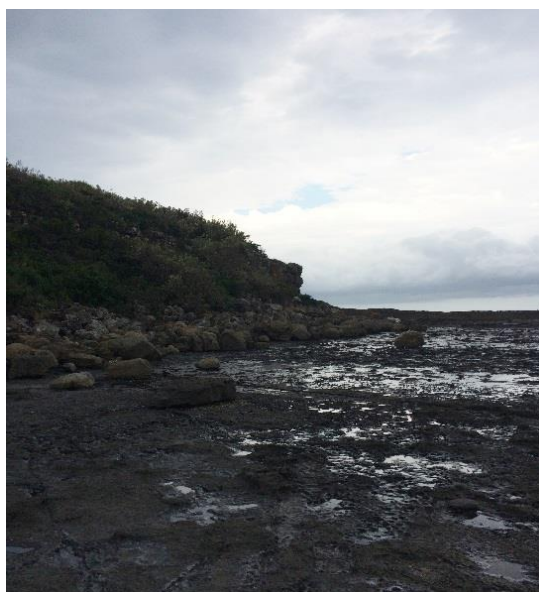
**Plate 5**

The 'dense cover of rock armour' described by DP over the base of the eastern end of the southern cliff face was intermittently present and a maximum width of about 4m (see Plate 5).

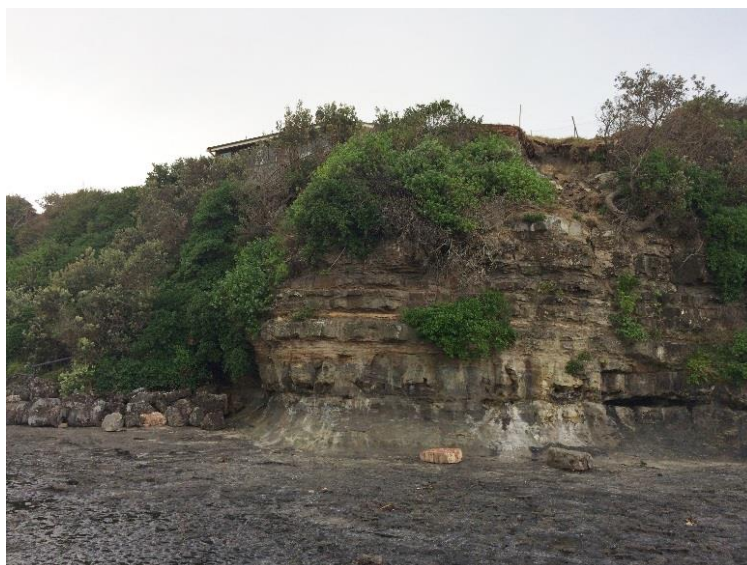
**Plate 6**

A recent soil slump (about 8m<sup>3</sup>) had impacted the rear yard area at the crest of the cliff (assessed to be 203 Penguin Head Road). Sections of the damaged brick fence were located on the wave cut platform (see Plate 6).

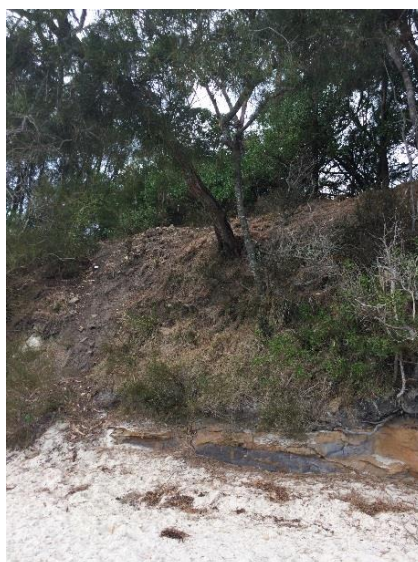
**Plate 7**

Over the western portion of the north facing cliff face, there were signs of run-off erosion impacting the soil profile. Some trees were leaning over for vertical or had curved bases, suggesting creep of the soil profile (see Plate 7).

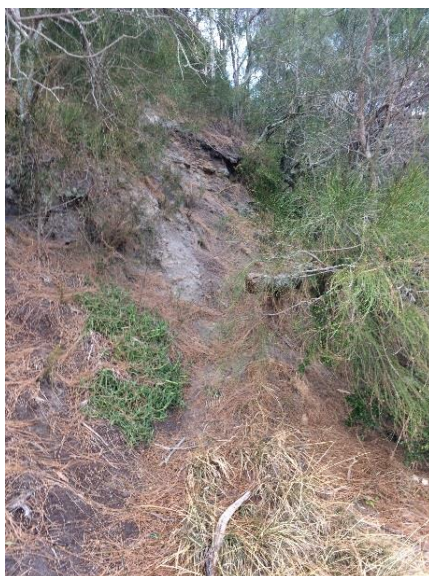
**Plate 8**

Over the eastern portion of the north facing cliff face, there were signs of fretting and spalling of the upper residual clay soil profile (see Plate 8).

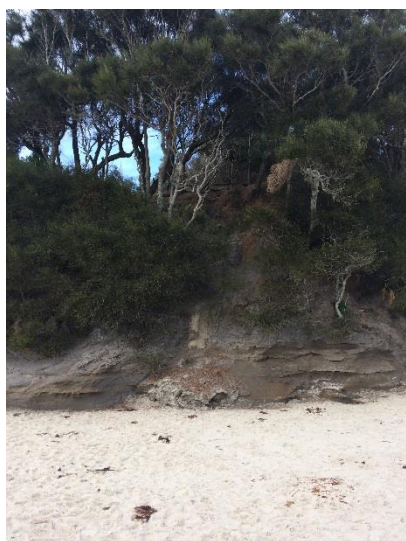
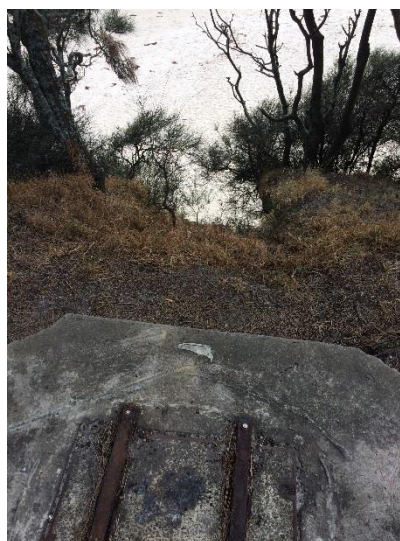
A concrete man hole cover was present at the crest of the north-eastern portion of the cliff and an erosion gully (maximum 2m wide and 1.5m deep) was present down the cliff face with traces of concrete on the cliff face and at the toe of the cliff (see Plates 9 and 10).

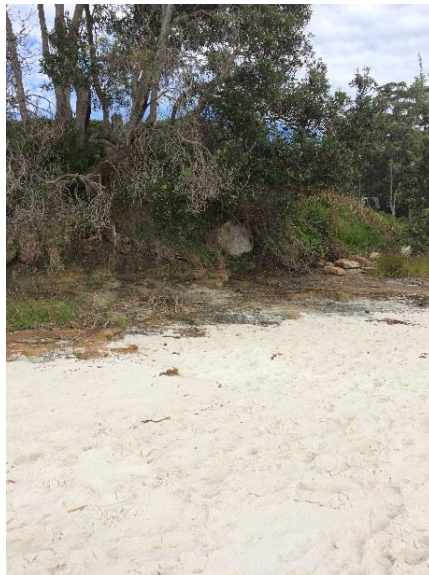
**Plate 11**

The toe of the vegetated slope at the northern end of the site had been eroded to form a maximum 1m high sub-vertical face (see Plate 11).

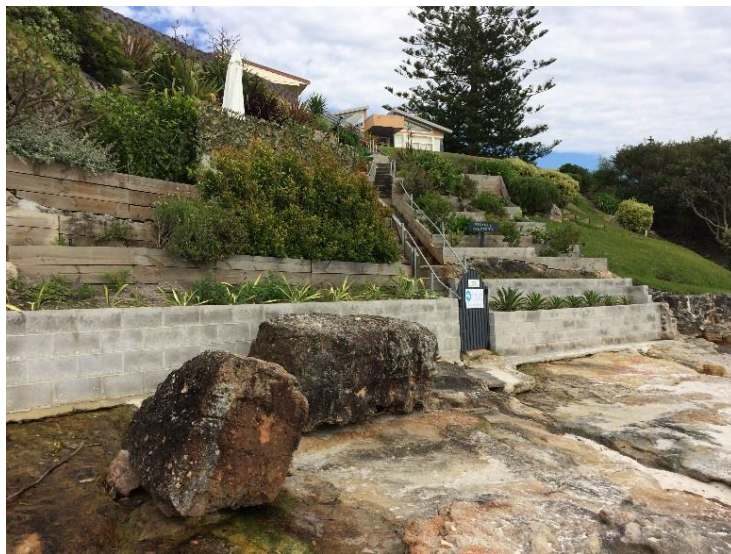
**Plate 12**

The area described by DP as ‘concrete faced slope, cracked and spalling’ appears to have been remediated and now comprises a concrete block seawall founded on the bedrock wave cut platform. The terraced rear yard above the seawall has been formed using timber landscape retaining walls (see Plate 12).

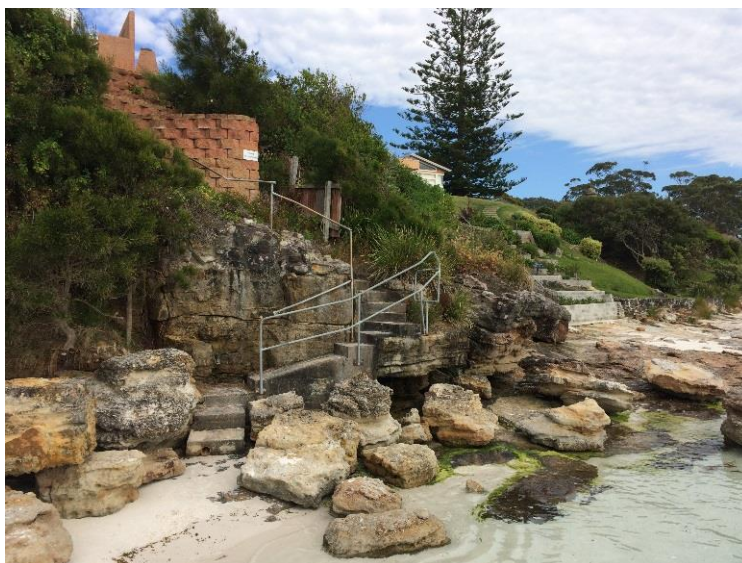
**Plate 13**

The discharge area of the stormwater pipe within the east-west orientated easement over the central portion of the site was overgrown (seer Plate 13).

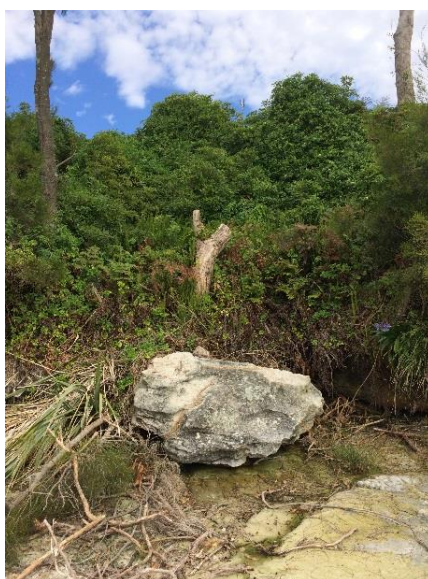
**Plate 14**

At the southern end of the site there appeared to be arcuate area within the overgrown soil slope that probably represents an old landslip, maximum size about 40m<sup>3</sup> (see Plate 14).

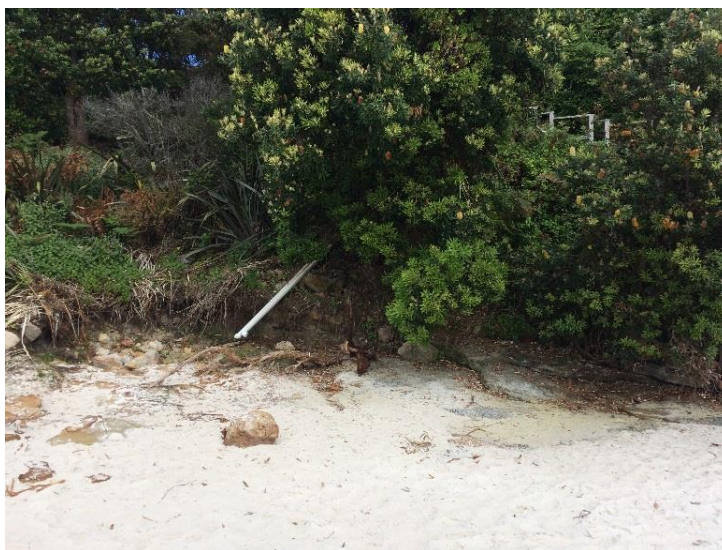
**Plate 15**

To the south of the old landslip, two 90mm diameter PVC stormwater pipes discharge at the toe of the soil slope. The ends of the pipe have been orientated to the north and south and the discharge of the pipes appears to have eroded the toe of the soil slope. The sub-vertical erosion face was about 0.5m high and the erosion had caused the toe to recede landward about 3m (see Plate 15).

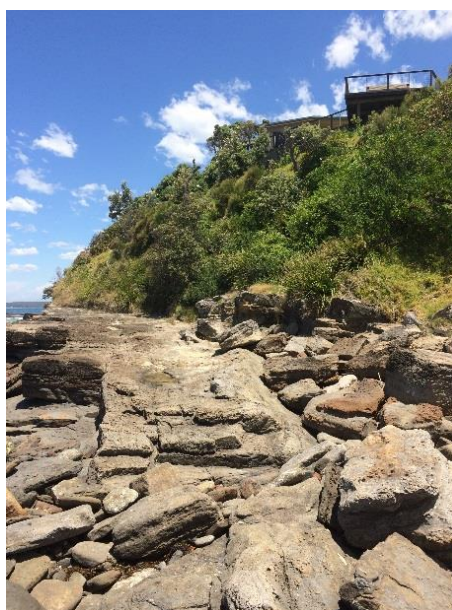
**Plate 16**

A timber deck was located close to the crest of the cliff within the rear yard of 16 Myrniong Grove. The upper section of the cliff comprised an uneven overgrown surface inferred to represent colluvial soils (see Plate 16).

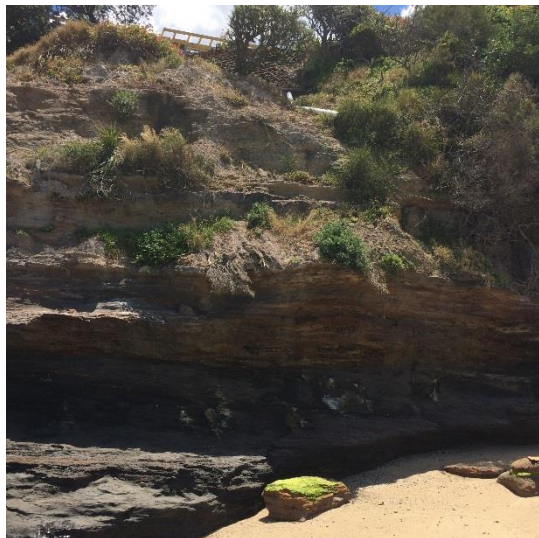
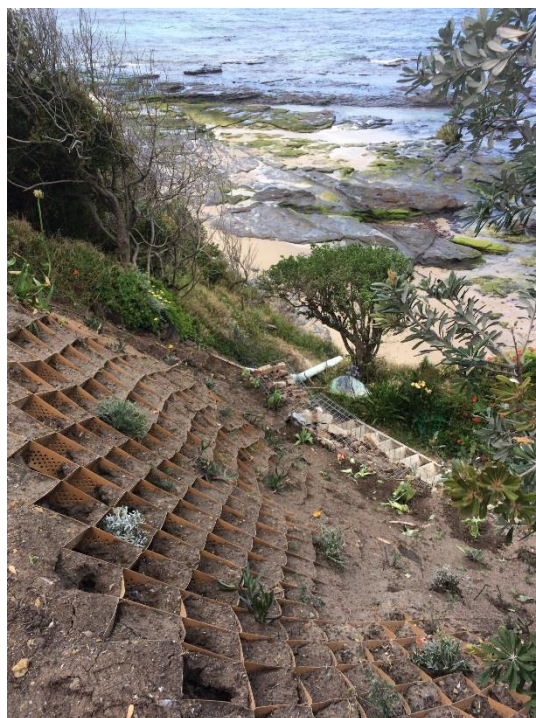
The recent landslip area over the upper portion of the cliff face at 20 Myrniong Grove had been remediated with gabion retaining wall supporting a steep (50°) slope (3m high) which had been provided with erosion control matting that incorporated cells for soil (see Plates 18 and 19).

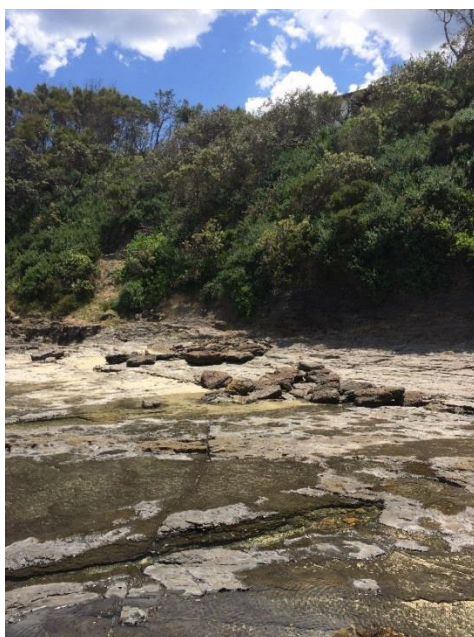
**Plate 19**

The soil slope at the crest of the cliff below 28 Myrniong Grove was concave and sloped down to the south-west at a maximum of about 50°. Patches of residual clay soils and extremely weathered bedrock were evident through the vegetative cover which are assumed to be the result of run-off erosion. This area has been interpreted to represent an old landslide feature (see Plate 19).

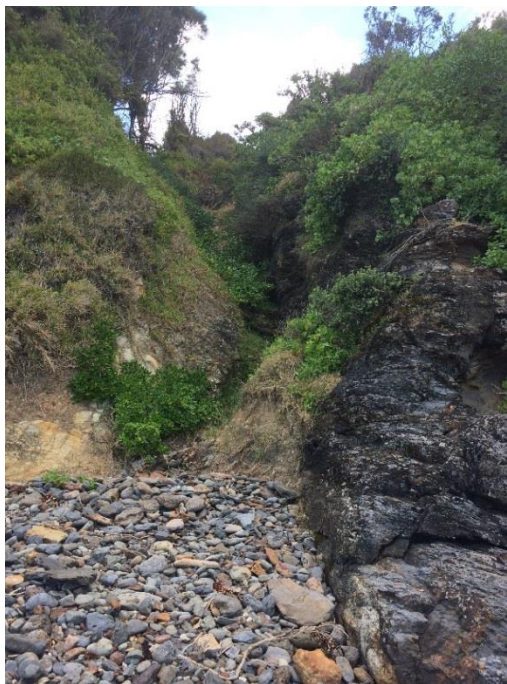
**Plate 20**

The gully, orientated approximately north-west to south-east, at the southern end of the site appeared to be at the location of a stormwater easement discharge point. An igneous dyke (orientated approximately north-west to south-east) was exposed in the wave cut platform and cliff face immediately to the south west of the gully. We have inferred that fractured and altered bedrock at the margin of the dyke has been preferentially eroded by both wave action and run-off from the stormwater easement and/or run-off from the road above. A similarly orientated gully in the wave cut platform seaward of the gully was also noted.

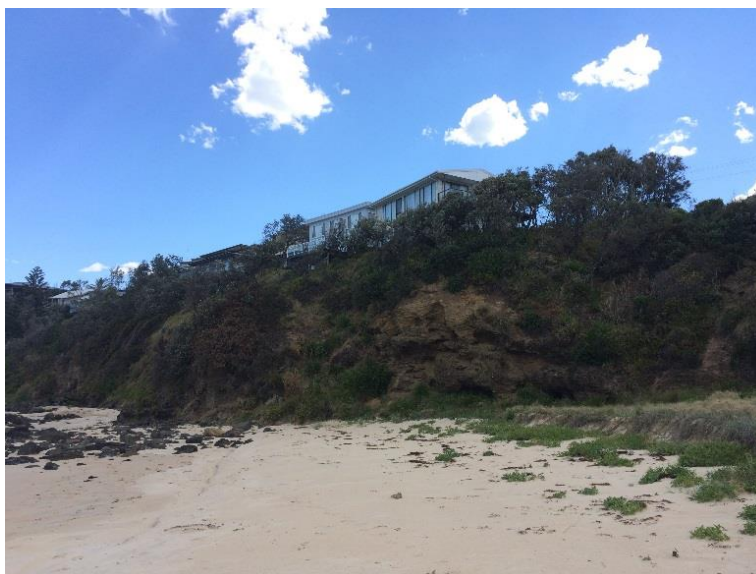
**Plate 21**

At the northern end of the site (below the northern end of Sunset Strip) the cliff face (maximum height about 7m) exposed a steep soil slope overlying an intermittent vertical sandstone cliff face. There was evidence of near surface slumping of the soil profile and erosion of the sandstone. Some soil erosion debris was present at the toe of the cliff (see Plate 21). The four northernmost properties (1, 3, 5 and 7 Sunset Strip) were identified by DP as 'most at risk from cliff erosion' (DP Photo 20).

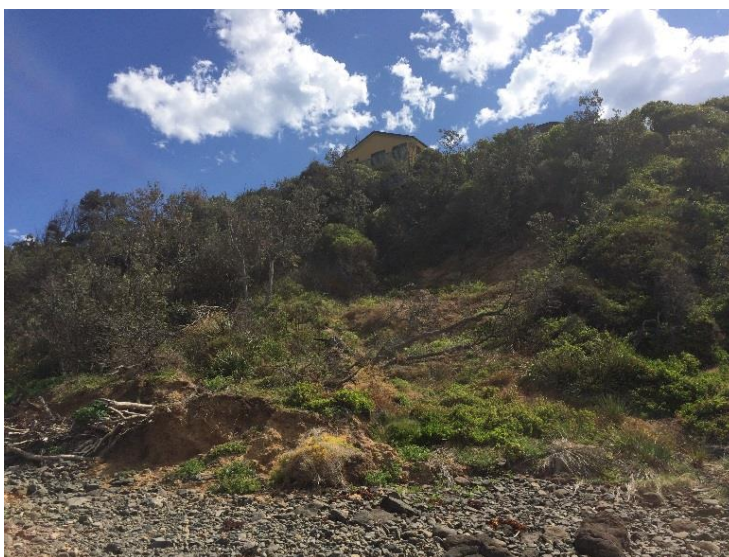
**Plate 22**

The east facing vegetated foreshore slope was inferred to comprise colluvial soils and was typically a maximum of about 30°. There was evidence of traces of old landslide features and what appeared to be a more recent landslide below 27 Sunset Strip (see Plate 22).

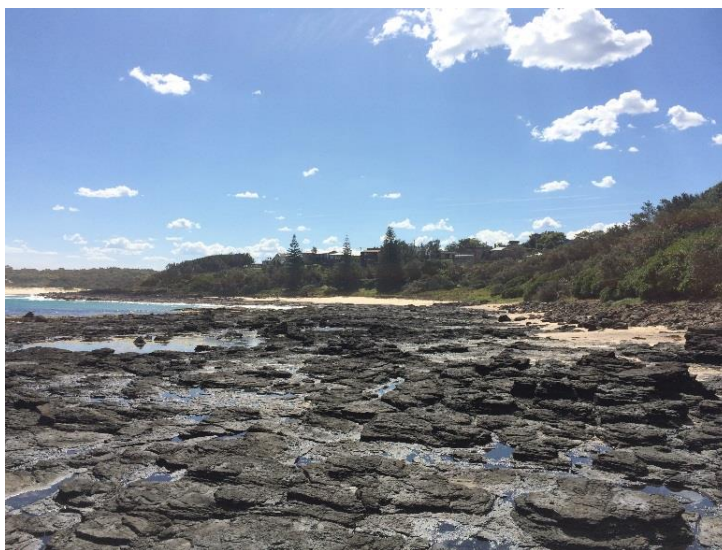
**Plate 23**

To the west of Inyadda Point, DP previously described a 5m to 10m wide rock armour covering the wave cut platform. The rock armour lining the south facing foreshore slope was either absent or was a maximum width of about 4m (see Plate 23).

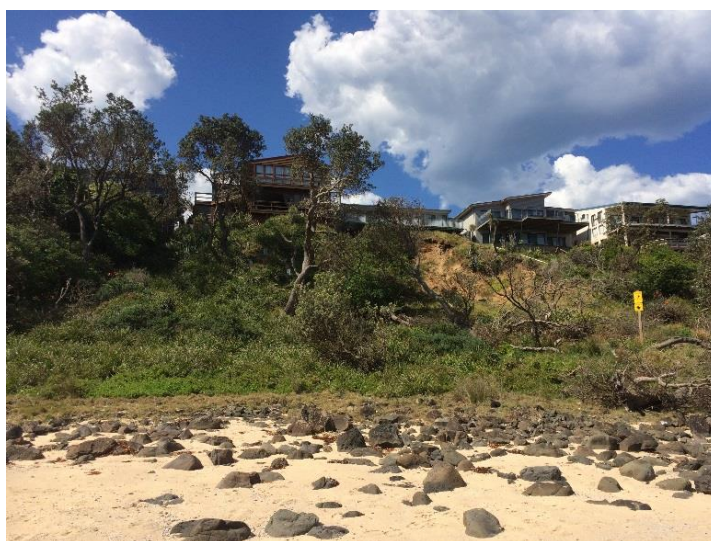
**Plate 24**

The south facing foreshore slope was a maximum of about  $35^{\circ}$  and a number of erosion gullies were evident and colluvium was exposed in the gully sides. The recent landslip that impacted 65 Sunset Strip in August 2015 was evident (see Plate 24).

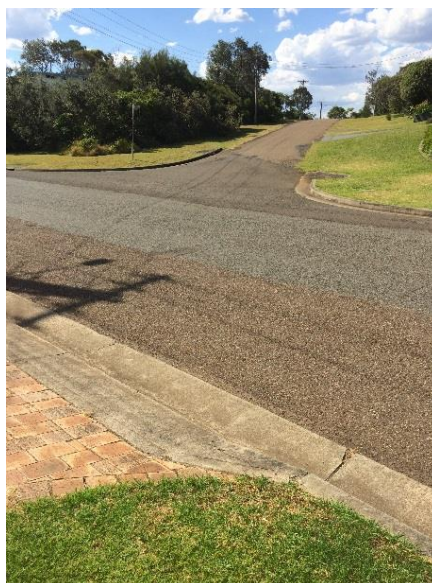
**Plate 25**

There appeared to be an erosion gully on the western boundary of 69 Sunset Strip. The section of Sunset Strip above had been provided with a kerb and gutter but the catchment area included the slope above (see Plate 25).

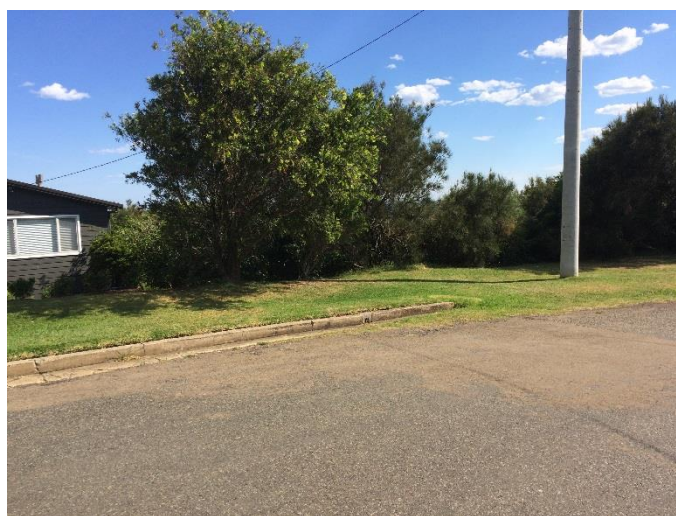
**Plate 26**

At the south-western end of the site, 'erosion/slump chutes' described by DP were evident but overgrown. The kerb and gutter lining the seaward side of Sunset Strip above (adjacent to 113 Sunset Strip) ended at the property boundary (see Plate 26).

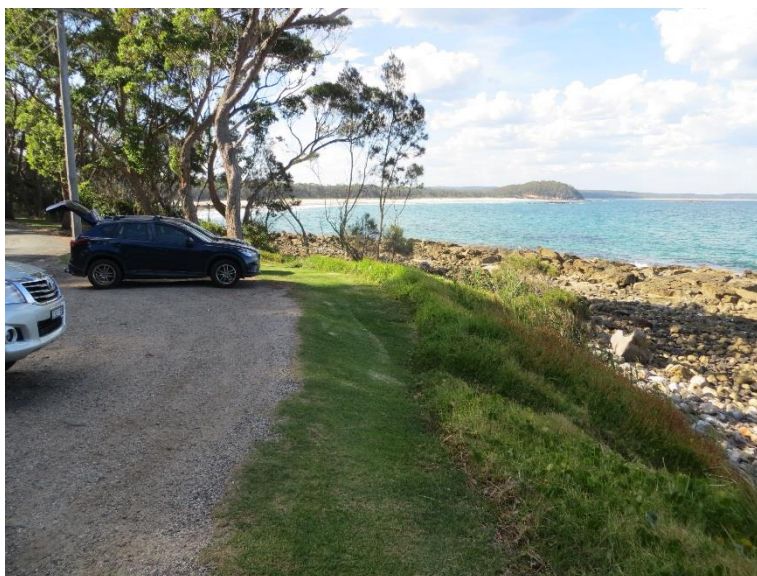
**Plate 27**

The seaward side of Surfers Avenue was lined by a concave slope with a sub-vertical lower portion (maximum overall height about 2.5m high) which generally exposed colluvial clayey soils with gravel and cobbles of sandstone. A localised area of fill appears to have been placed to form the car parking area which was set-back 2m from the crest of the slope (see Plate 27). The seaward side of the road was set-back at least 7m from the crest of the slope.

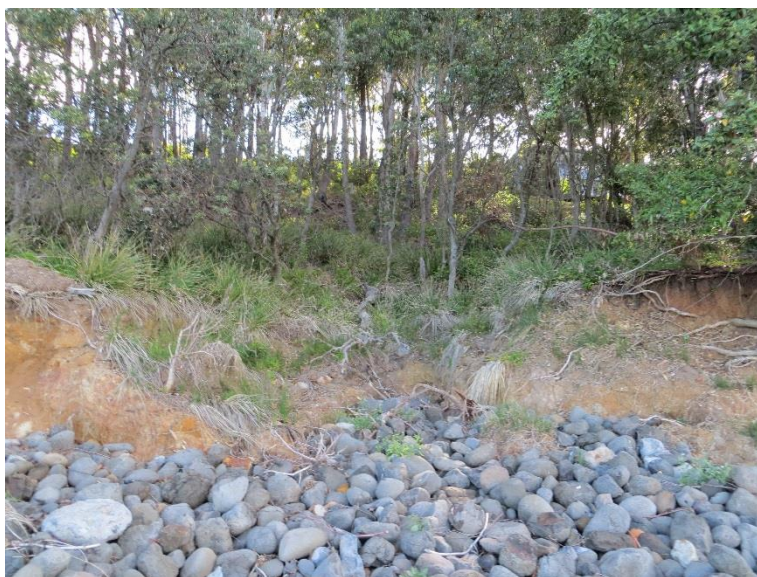
**Plate 28**

To the south of the car park area, the colluvial soils have been eroded to form sub-vertical faces (maximum 2m high) and the tree root systems formed overhangs. Some trees had collapsed onto the wave cut platform. The trees covering the old landslip in the reserve area above were leaning over or had curved bases (see Plate 28).

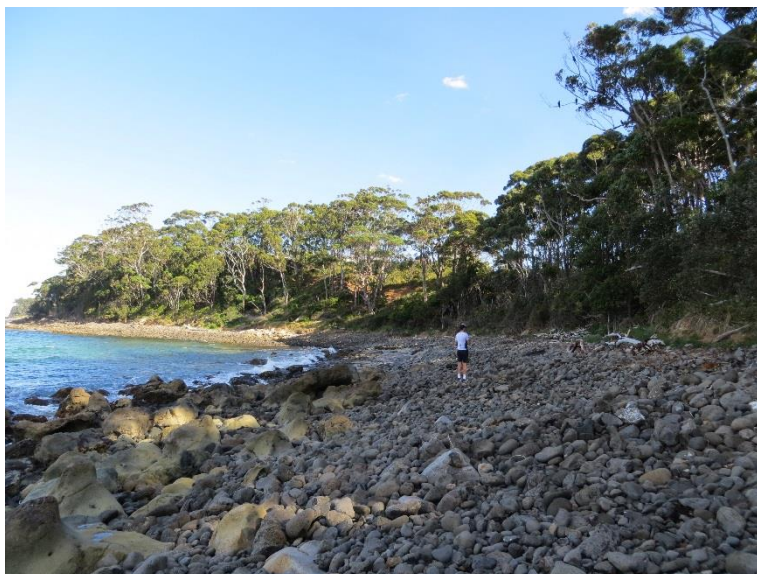
**Plate 29**

The tree covered slope at the southern end of the site sloped down to the east at a maximum of about 35°. The slope surface was uneven and the trees were leaning over or had curved bases. The slope appears to have been previously impacted by a number of landslips (see Plate 29).

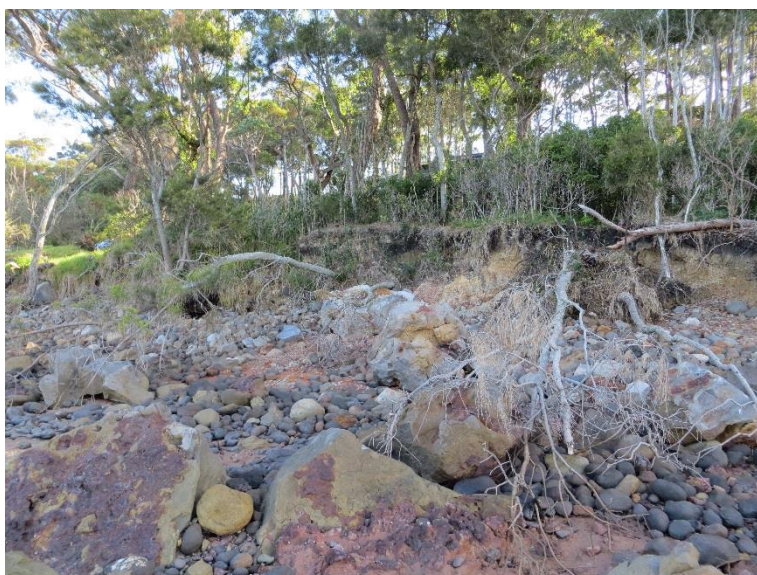
**Plate 30**

To the north-west of the car park area, the colluvial soils have been eroded to form sub-vertical faces (maximum 2m high) and the tree root systems formed overhangs. Some trees had collapsed onto the wave cut platform (see Plate 30).

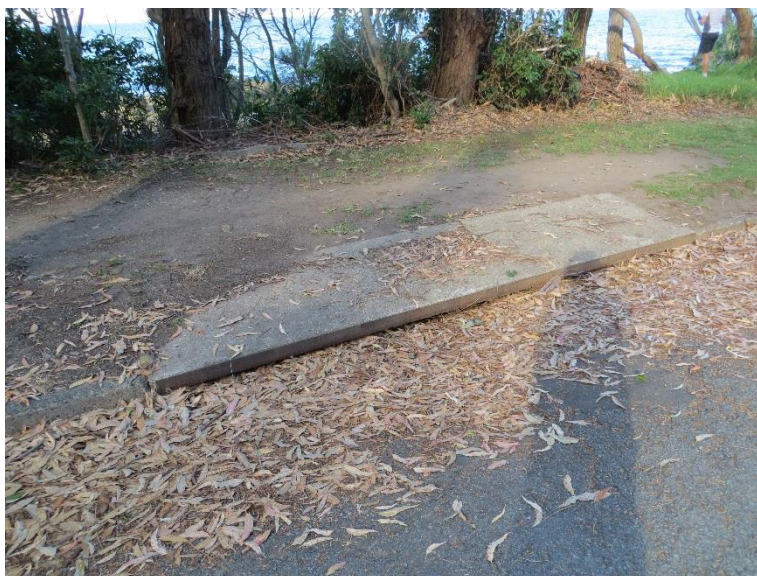
**Plate 31**

The roadside stormwater drain inlets were typically infilled with leaf debris (see Plate 31).

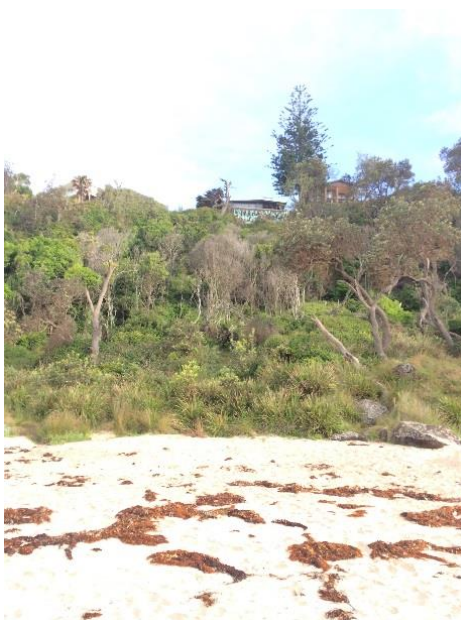
**Plate 32**

At the crest of the cliff, the rear yard of what was inferred to be 168 Mitchell Parade, there appeared to be a gabion retaining wall at the crest of the cliff face and a newly planted soil slope below (see Plate 32).

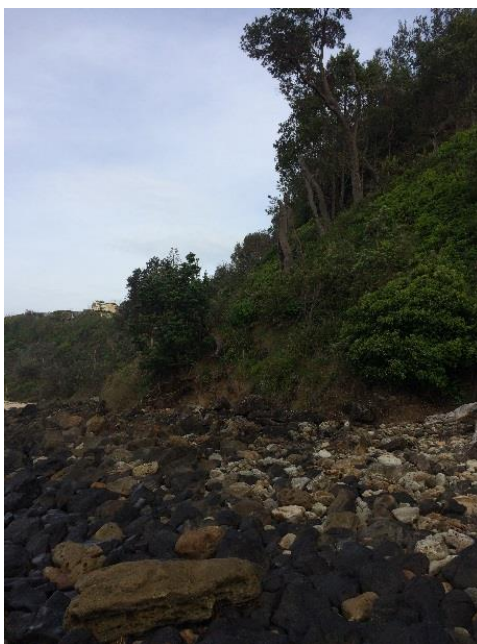
**Plate 33**

Some toe erosion of the old rock fall has exposed colluvium over the area of the old rock fall indicated on DP Photo 15 and to the west and east typically forming 1m high sub-vertical faces (see Plate 33).

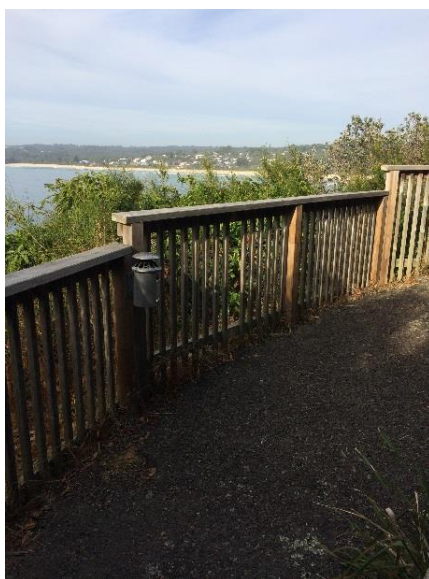
**Plate 34**

At the north-eastern end of the Mollymook Beach, at crest of the slope affected by the 'large ancient slump' identified by DP, a timber lookout was set-back about 2m from the crest of the cliff face (see Plate 34).

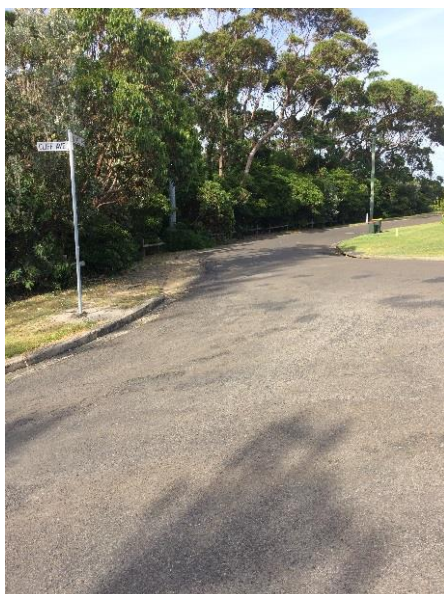
**Plate 35**

The section of Mitchell Parade above the eroded back scarp described by DP (DP Photo 16), was not provided with kerb and guttering. This supports the DP inference that the erosion was associated with 'uncontrolled discharge' (see Plate 35).

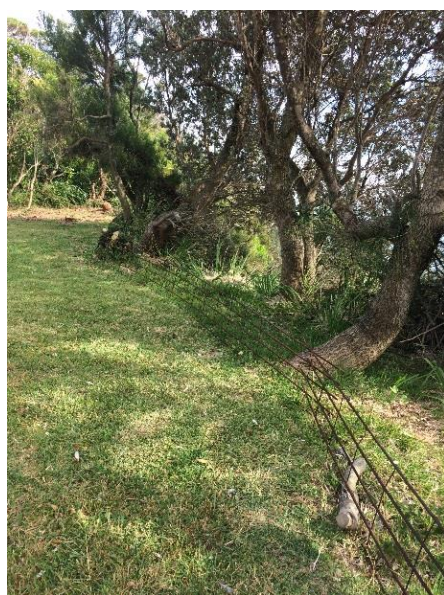
**Plate 36**

Where access to the crest of the cliff face was possible between 199 and 215 Mitchell Parade, the profile (in plan) was undulating with steep, uneven, overgrown slopes and a number of trees with curved bases (see Plate 36).

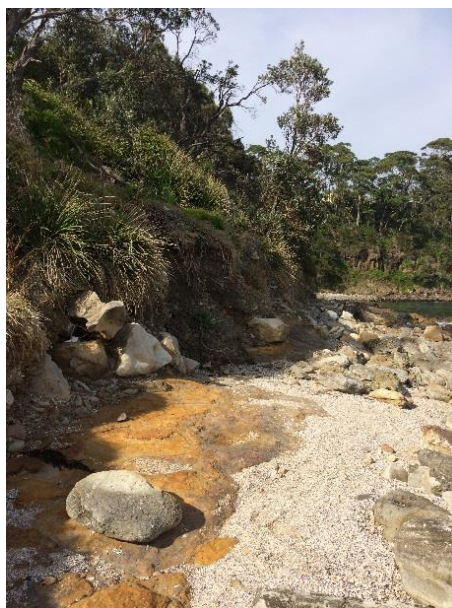
**Plate 37**

The northern end of the headland comprised an uneven vegetated slope and colluvium had been exposed by erosion at the toe of the slope at the interface with the sandstone bedrock wave cut platform. The sub-vertical erosion faces were a maximum height of about 3m (see Plate 37).

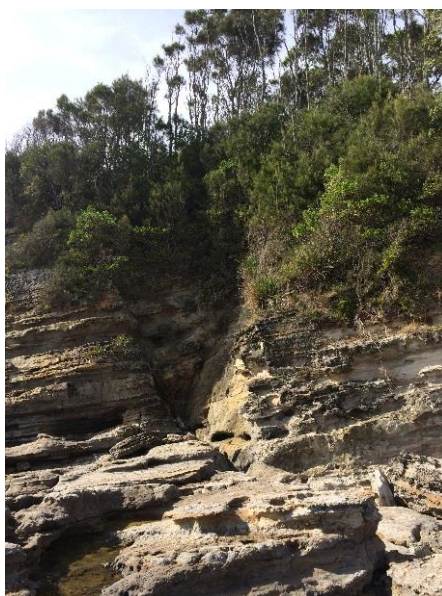
**Plate 38**

The north-east facing portion of the cliff face (below the car park area to the north of Bannisters) exposed sandstone (maximum height about 6m) below the vegetated colluvium slope. Occasional joint controlled wedge failures were evident (see Plate 38).

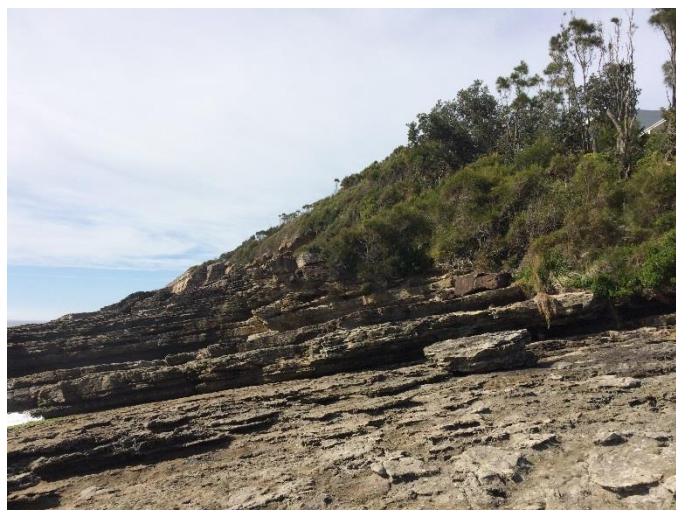
**Plate 39**

To the south, the cliff face appeared to have a stepped profile comprising; a gently dipping stepped wave cut platform, a lower vertical sandstone bedrock face with a limited soil cover, a vegetated bench area, then a further steep colluvial slope above that sloped back up to the rear yards of the property on Mitchell Parade (see Plate 39).

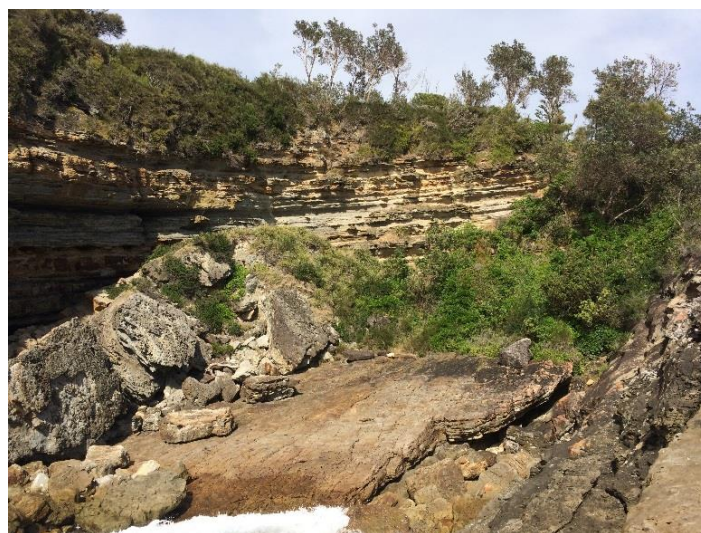
**Plate 40**

The wide gully in the wave cut platform (orientated approximately  $100^{\circ}$ ) was lined by sub-vertical joints and what appeared to be a recent rock fall (approximately  $100\text{m}^3$ ) had impacted the southern side of the gully (see Plate 40).

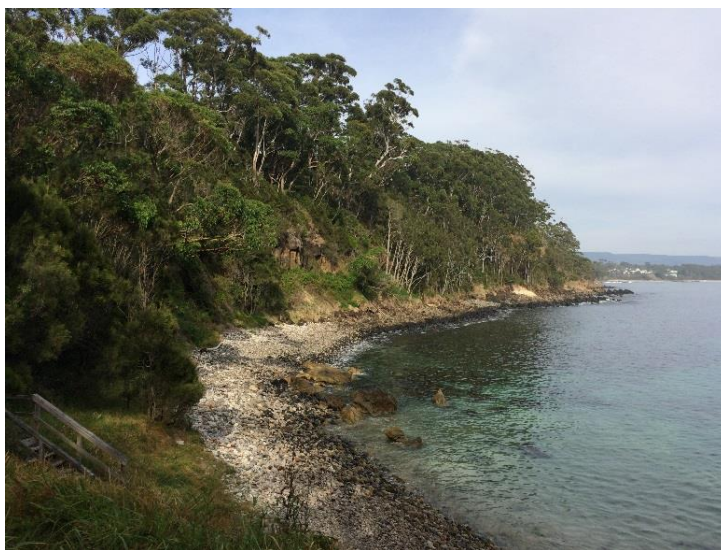
**Plate 41**

The cliff face that extended north-west from the northern end of the headland exposed sub-vertical basalt overlying extremely weathered claystone with numerous angular and 'blocky' basalt blocks (maximum 1m dimension) and rounded sandstone gravels and cobbles covering the shoreline (see Plate 41).

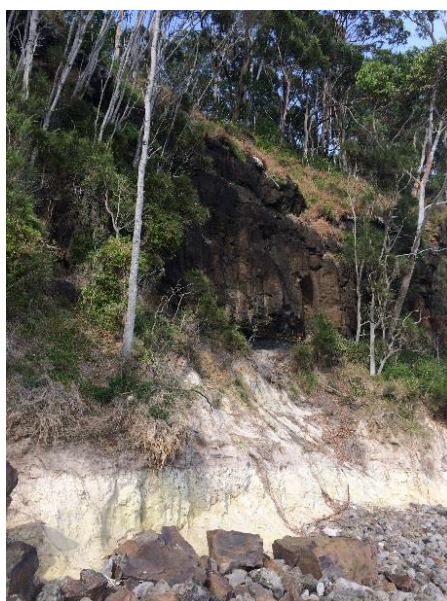
**Plate 42**

The upper steep slope was tree covered; leaning trees and curved tree bases indicating creep was impacting the upper soil profile. The claystone at the base of the cliff was being eroded, resulting in undercutting of the basalt and block collapses (see Plate 42).

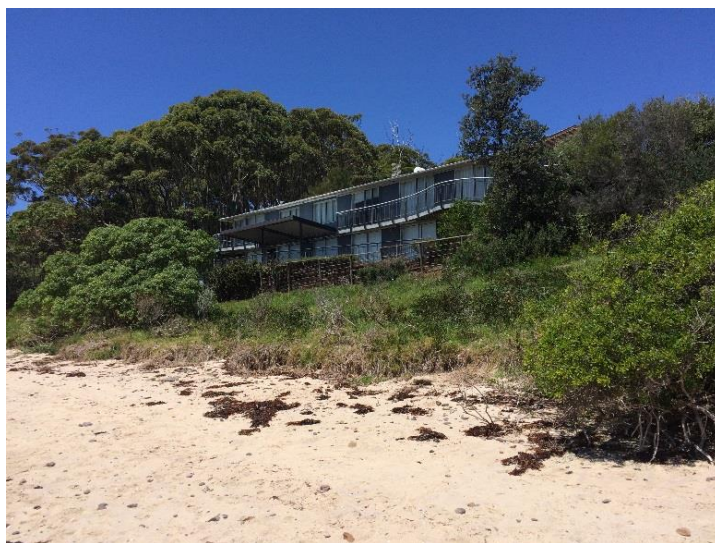
**Plate 43**

At the north-western end of the site, the house identified by DP as being '2m to 3m above the wave cut platform' corresponded to 17 Shipton Crescent (see Plate 43).

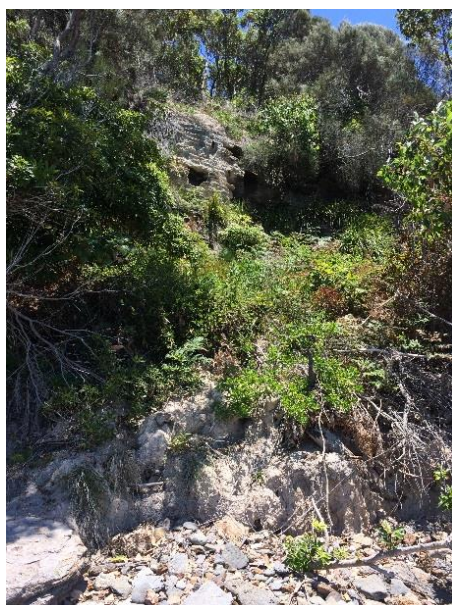
**Plate 44**

To the south-east of Plate 43, there were signs of recent slumping of the lower colluvial soil slopes (maximum about 5m<sup>3</sup>) and some sub-vertical toe erosion faces (maximum height about 2m). A sandstone cliff face that was unravelling and spalling was evident landward of the lower colluvial soil slope (see Plate 44).

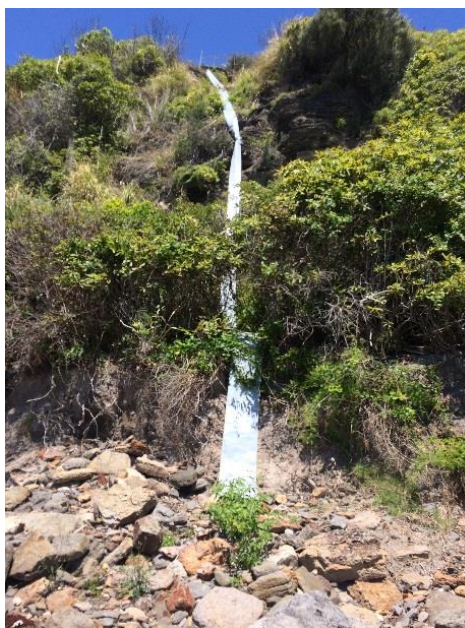
**Plate 45**

A new plastic stormwater pipe extended down the full height of the cliff adjacent to an area of fractured and undercut sandstone (see Plate 45). This area was inferred to be below about 61 to 65 Nurrawallee Street.

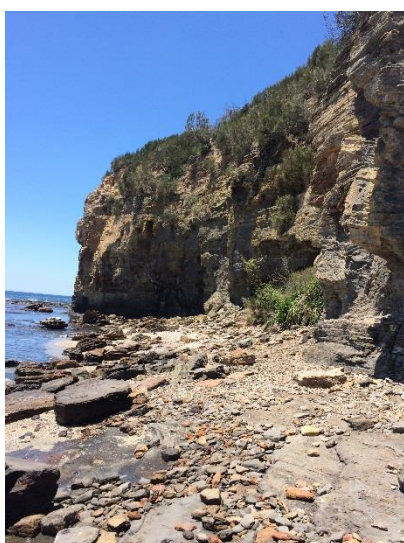
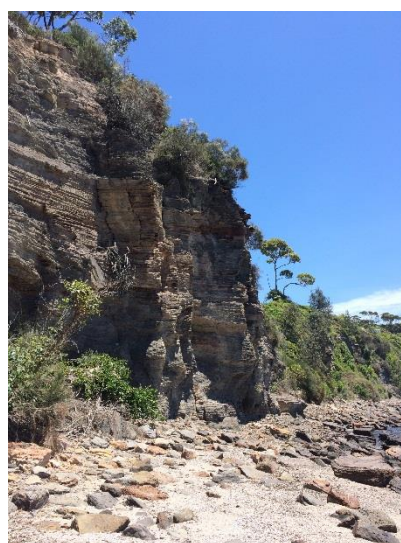
The cliff face at the south-western end of the site continues to erode and spall along the face and toe with potentially unstable blocks of sandstone evident on the cliff face (see Plates 46 and 47).

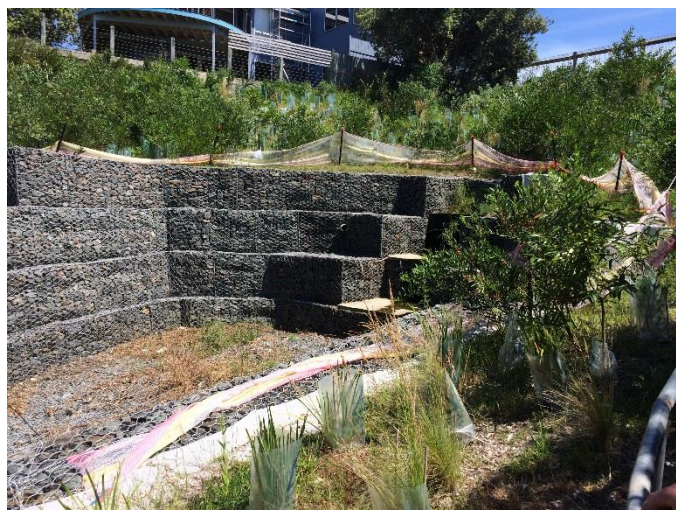
**Plate 48**

The landslip area adjacent to the eastern boundary of 7 Rennies Beach Close and downslope of the adjacent public car park has been remediated using a gabion retaining wall (maximum 4m high) with a maximum 27° vegetated sloping backfill surface above. The stormwater pipe discharged onto a concrete base and a reno mattress had been provided over the majority of the base of the remediated area (see Plate 48).

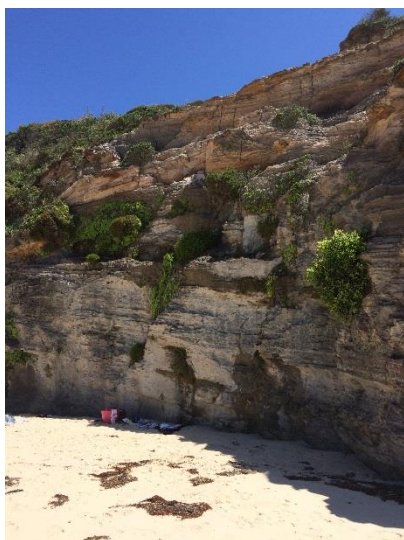
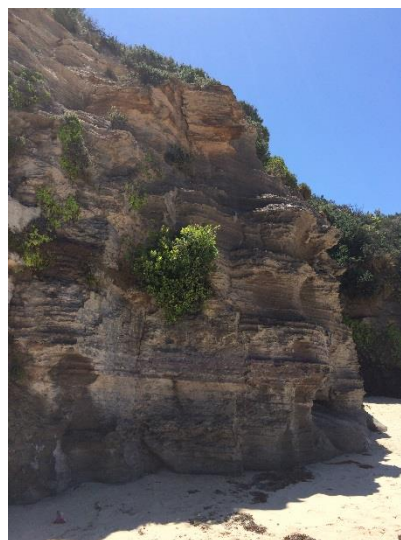
The debris from the rock falls identified by DP was missing. There were overhanging sandstone blocks at the locations of DP Photos 7 and 8.

The upper portion of the cliff face over the area of DP photo 7 was unravelling and spalling with small blocks caught on ledges of the cliff face. The sandstone was fractured and maximum 1m x 1m x 1m potentially unstable blocks were evident (see Plates 49 and 50).

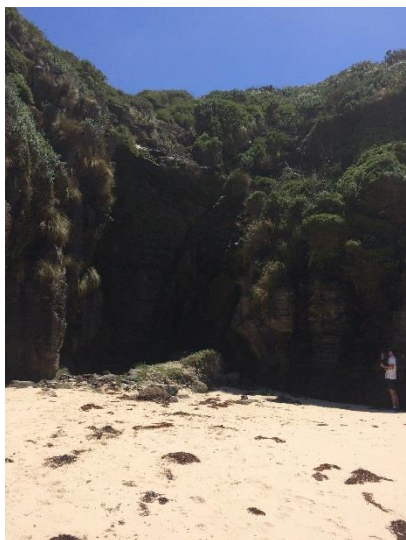
**Plate 51**

The upper section of the cliff face within the gully to the east of DP Photo 8 had been impacted by a small slump, about 5m<sup>3</sup> (see Plate 51). The area of detachment appeared to be controlled by a 45° joint sloping down to the south and seepage was evident. There was no kerb and gutter at the eastern end of Rennies Beach Close above and there were signs of run-off erosion (see Plate 52).
