Figure 17 EEC Mapping of Lands - Bawley Point

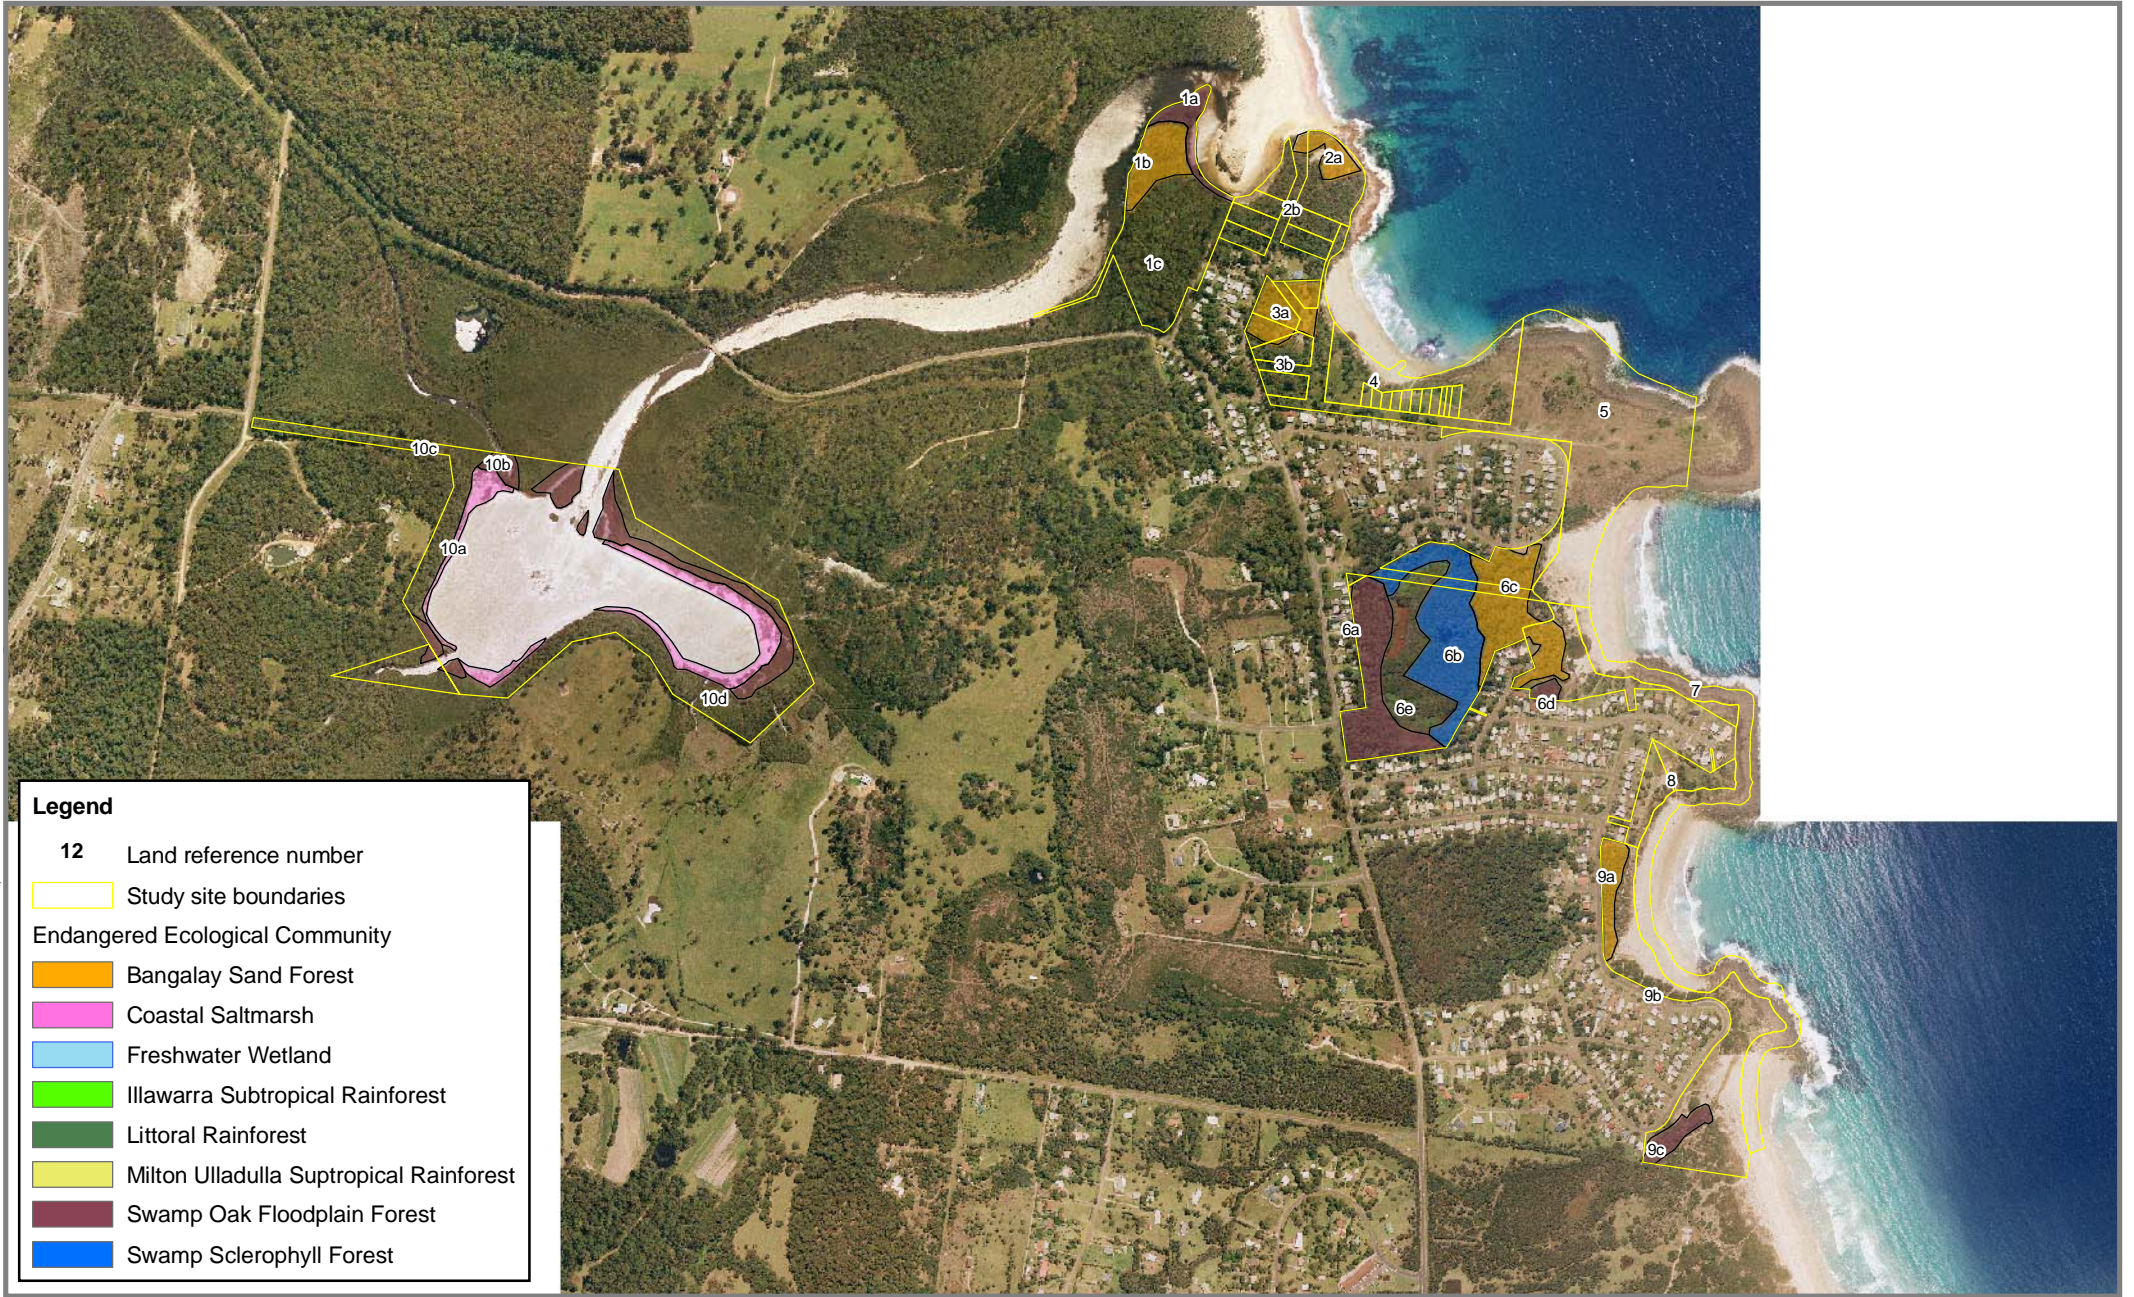
BAWLEY POINT				
Land Number	Vegetation Community	Description	Broad Condition / Value	Threat
1a	Swamp Oak Floodplain Forest - EEC	A Swamp Oak community with a weedy understorey. Buffalo Grass dominates in sections and Sea Rocket is also common.	<b>Fair condition.</b> Weed invasion and tracks around the edges. Provides a buffer to Willinga Lake entrance.	Ongoing weed invasion.
1b	Bangalay Sand Forest - EEC	Swamp Oak grades into a Bangalay dominated community. Also occurring are Common Silkpod, Sweet Pittosporum, Lomandra, Coast Banksia, Blady Grass and Common Bracken. Garden plants are also scattered throughout.	<b>Fair condition.</b> Some tracks, dumping and weed invasion. Provides an important vegetated link to Willinga Lake entrance.	Ongoing impacts of urbanisation.
1c	Spotted Gum tall forest	This diverse community supported Bordered Panic, Bonnet Orchid, Burrawang, <i>Glycine tabacina</i> , Climbing Guinea Flower, Prickly Beard-heath, Silver Banksia. Garden plants become more common in the south and south-east.	<b>Fair condition.</b> Some tracks, dumping and weed invasion. Provides an important vegetated link to Willinga Lake entrance.	Ongoing impacts of urbanisation.

2a	Modified/Bangalay Sand Forest - EEC	Willinga Point car parking area supports remnant and stunted Bangalay Sand Forest.	<b>Poor condition.</b> Impacted from clearing and high visitor usage. Provides an important vegetated link and stabilises the headland.	Ongoing impacts of urbanisation and high visitor usage.
2b	Spotted Gum tall forest	This Spotted Gum community appears to have been partially cleared in the understorey. Remaining are Coastal Wattle, Sweet Pittosporum and Asparagus Fern.	<b>Fair condition.</b> Edge effects and the pressures of urbanisation and high visitor usage. Away from the edges the condition improves. Provides an important vegetated link around Willinga Point.	Ongoing impacts of urbanisation and high visitor usage.
3a	Bangalay Sand Forest - EEC	Bangalay dominates in this area with Spotted Gum still present in low numbers throughout.	<b>Fair condition.</b> Predominately poor condition due to edge effects and the pressures of urbanisation and high visitor usage. Away from the edges the condition improves. Provides an important vegetated link around Willinga Point.	Ongoing impacts of urbanisation and high visitor usage.

3b	Spotted Gum tall forest	Spotted Gum community grades back in this area of slightly higher elevation.	<b>Poor condition.</b> This is a high use area that is impacted by visitor usage. Tracks, trampling and rubbish are common. Provides an important vegetated link around Willinga Point.	High usage area.

Land Number	Vegetation Community	Description	Broad Condition / Value	Threat
4	Cleared / Coastal scrub	This is a cleared picnic area. May once of been representative of Bangalay Sand Forest. Weeds dominate throughout.	<b>Very poor condition.</b> Predominately poor condition due to edge effects and the pressures of urbanisation and high visitor usage. Provides an important coastal link.	Ongoing impacts of urbanisation and high visitor usage.
5	Cleared / Coastal scrub	Badly degraded area on Bawley Point.	<b>Very poor condition.</b> Predominately poor condition due to edge effects and the pressures of urbanisation and high visitor usage. Provides an important coastal link.	Ongoing impacts of urbanisation and high visitor usage.
6a / 6d	<b>Swamp Oak Floodplain Forest - EEC</b>	Swamp Oak dominates the western edge and southern corner. Both patches are badly degraded. Western patch supports Tall Saw-sedge, Kidney Weed, Common Silkpod. Swamp Oak has been cleared throughout. The southern patch occurs in a drainage channel which is degraded through modification and garden plants.	<b>Very poor condition.</b> Much of this area has been modified through clearing, weed invasion and changes to drainage patterns. Provides a buffer to Cormorant Beach and stepping stone habitat with areas to the west.	Ongoing impacts of urbanisation and lack of management.

6b	<b>Swamp Sclerophyll Forest - EEC</b>	Bangalay are scattered throughout this dense and badly degraded community. Tall Saw-sedge is also common. It grades into Bangalay Sand Forest to the east.	<b>Very poor condition.</b> Much of this area has been modified through clearing, weed invasion and changes to drainage patterns. Provides a buffer to Cormorant Beach and stepping stone habitat with areas to the west.	Ongoing impacts of urbanisation and lack of management.
6c	<b>Bangalay Sand Forest - EEC</b>	This Bangalay Sand Forest has an open understorey and shows signs of clearing and changes to drainage patters.	<b>Very poor condition.</b> Much of this area has been modified through clearing, weed invasion and changes to drainage patterns. Provides a buffer to Cormorant Beach and stepping stone habitat with areas to the west.	Ongoing impacts of urbanisation and lack of management.
6e	Modified	This central section contains dried ponds and the majority of vegetation within these ponds appears dead. Saltwater Couch and Swamp Paperbark occur on the edges	<b>Very poor condition.</b> Much of this area has been modified through clearing, weed invasion and changes to drainage patterns. Provides stepping stone habitat with areas to the west.	Ongoing impacts of urbanisation and lack of management.

7-Aug	Cleared / Coastal scrub	Areas throughout are maintained as lawn. Coastal Wattle is dominant in this area.	<b>Very poor condition.</b> Predominately poor condition due to edge effects and the pressures of urbanisation and high visitor usage. Rabbits are also present. Provides a buffer to Cormorant and Gannet Beach from urbanisation.	Ongoing impacts of urbanisation and high visitor usage.

Land Number	Vegetation Community	Description	Broad Condition / Value	Threat
9a	<b>Bangalay Sand Forest - EEC</b>	A narrow strip of Bangalay occurs behind the frontal dune and Malibu Drive.	<b>Poor condition.</b> This is a narrow strip affected by edge effects and tracks. Provides a buffer to Gannet Beach.	Ongoing impacts of urbanisation and high visitor usage.
9b	Cleared / Coastal scrub	Patches of coastal vegetation remains although it is likely that substantial clearing has occurred.	<b>Poor condition.</b> This is a narrow strip affected by edge effects and tracks. Provides a buffer to Gannet Beach.	Ongoing impacts of urbanisation and high visitor usage.
9c	<b>Swamp Oak Floodplain Forest - EEC</b>	This narrow and badly degraded EEC is dominated by Swamp Oak with a Kikuyu understorey	<b>Very poor condition.</b> This area is weed infested and drainage patterns have been changed. Provides habitat for birds and amphibians.	Lack of management of this site as an EEC.

10a	<b>Coastal Saltmarsh - EEC</b>	Dominated by <i>Sarcocornia quinqueflora</i> , Creeping Brookweed and the introduced <i>Atriplex prostrata</i> .	<b>Fair condition.</b> This community is reasonably well protected although a number of tracks through the saltmarsh are evident where development is adjacent. Provides a buffer to Willinga Lake.	Weed invasion. With current levels of adjacent development threats are minimal.
10b	<b>Swamp Oak Floodplain Forest - EEC</b>	This community is present along areas where drainage lines enter the lake.	<b>Fair condition.</b> This community is reasonably well protected although a number of tracks through the EEC are evident where development is adjacent. Areas around the south-west drainage line have recently been burnt. Provides a buffer to Willinga Lake.	Weed invasion. With current levels of adjacent development threats are minimal.
10c / 10d	Turpentine - Spotted Gum Tall Forest	Black She-oak is co-dominant in this community. Blackbutt and Thin-leaved Stringybark also occur in patches.	<b>Fair condition.</b> This community is reasonably well protected from development. Areas around the south-west drainage line have recently been burnt. Provides a buffer to Willinga Lake.	Weed invasion. With current levels of adjacent development threats are minimal.
