Figure 2 EEC Mapping of Lands - Bomaderry

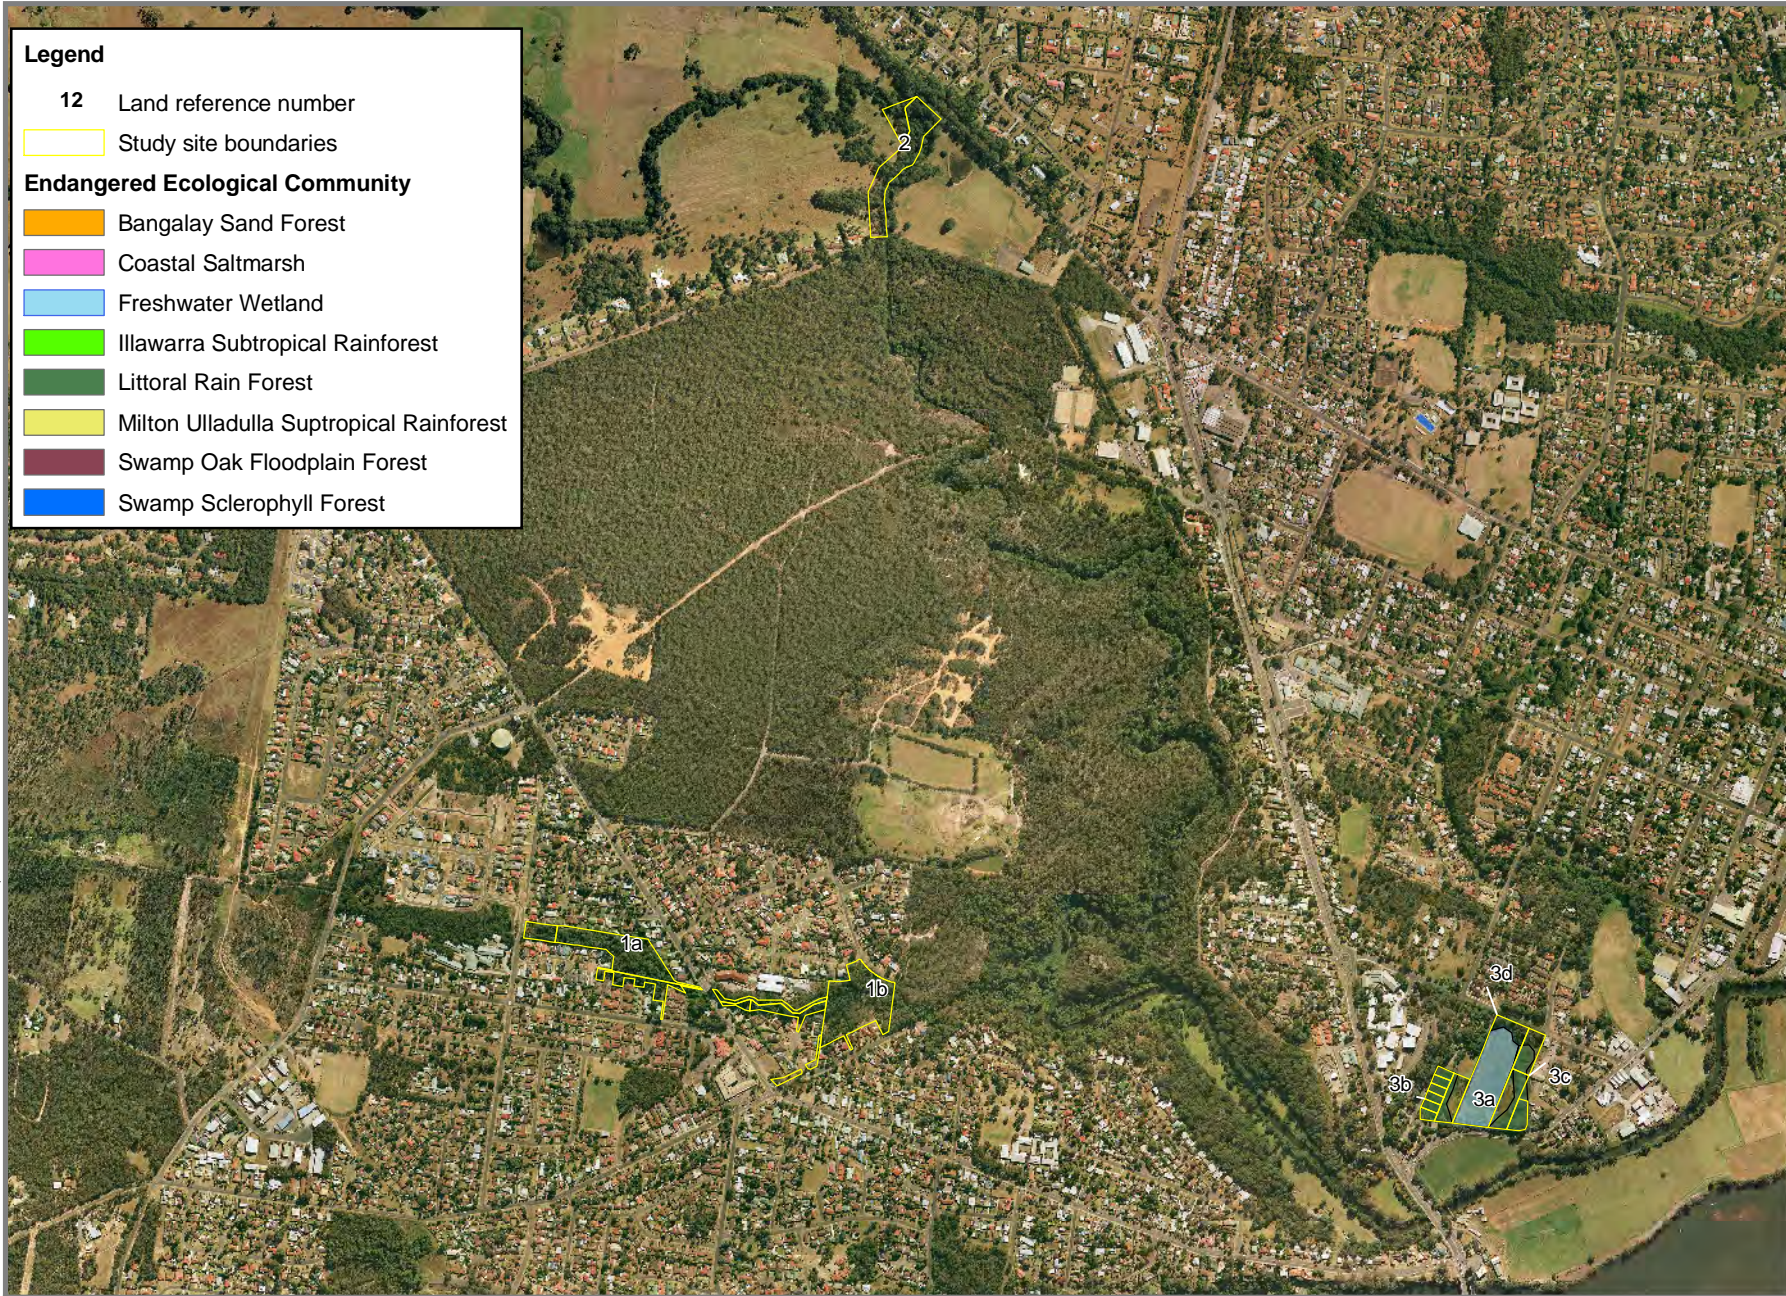
BOMADERRY & NORTH NOWRA				
Land Number	Vegetation Community	Description	Broad Condition / Value	Threat
1a	Modified and rehabilitated - West of Illaroo Rd	Quality decreases closer to Illaroo Rd. Blackbutt, Grey Gum, Bangalay, Swamp Mahogany dominate the canopy. Callicoma, Brush Cherry and Bleeding Heart occur in the midstorey. Understorey dominated by sedges and rushes. Lantana & garden escapes on edges.	Fair condition to Good Condition. Condition improves away from the edges and some substantial vegetation occurs especially in the areas of rehabilitation. Provides an important east-west link with Bomaderry Creek.	West of Illaroo Road - Inconsistent follow up of rehabilitation. Weeds encroaching.
1b	Modified - East of Illaroo Rd	Some canopy species remain. The understorey is dominated by Lantana and garden species. Creek banks are badly eroded, nutrient enrichment of creek, dumping of household refuse.	Poor condition. This section has not been rehabilitated and is being impacted by numerous factors. Provides an important east-west link with Bomaderry Creek.	East of Illaroo Road - Continued degradation through expansion of weeds, ongoing erosion, further dumping. Requires major restoration works.

2	Spotted Gum – River-oak Forest	Large, old River-oak dominate the banks, with tall Spotted Gum with Blue Gum back from the top of bank. The shrub layer contains Lantana, Black Wattle, Coffee Bush, Water Gum and Grey Myrtle. Groundcover has scattered Lomandra and Carex .	Poor condition. Cleared to the top of bank. Banks are eroded, weedy in sections. Livestock has access in sections. High nutrient run-off from adjacent agricultural practices.	Further weed invasion, erosion and pollution of Bomaderry Creek.
3a	Constructed - Freshwater Wetland - EEC	Illowra Wetlands and Rainforest Reserve. Freshwater wetlands. This area has been artificially created after closure of a dump. It is dominated by <i>Persicaria strigosa</i> , Tall Spike-rush and Couch.	Fair condition. This artificial wetland is densely vegetated with little weed incursion. Provides wetland habitat.	Weed invasion.
3b / c	Constructed rainforest	Illowra Wetlands and Rainforest Reserve. Rainforest species have been created around the boundaries of the wetland.	Fair condition. This artificial rainforest is densely vegetated especially with canopy species and weeds species are limited to the edges especially along car park and road.	Requires consistent follow up of these rehabilitation works.

3d	Cleared	Illowra Wetlands and Rainforest Reserve. The higher elevation areas in the north of the site are largely unrehabilitated areas.	Poor condition. This section is partially cleared with numerous weed species.	Further weed invasion.
