Figure 4 EEC Mapping of Lands - Currarong

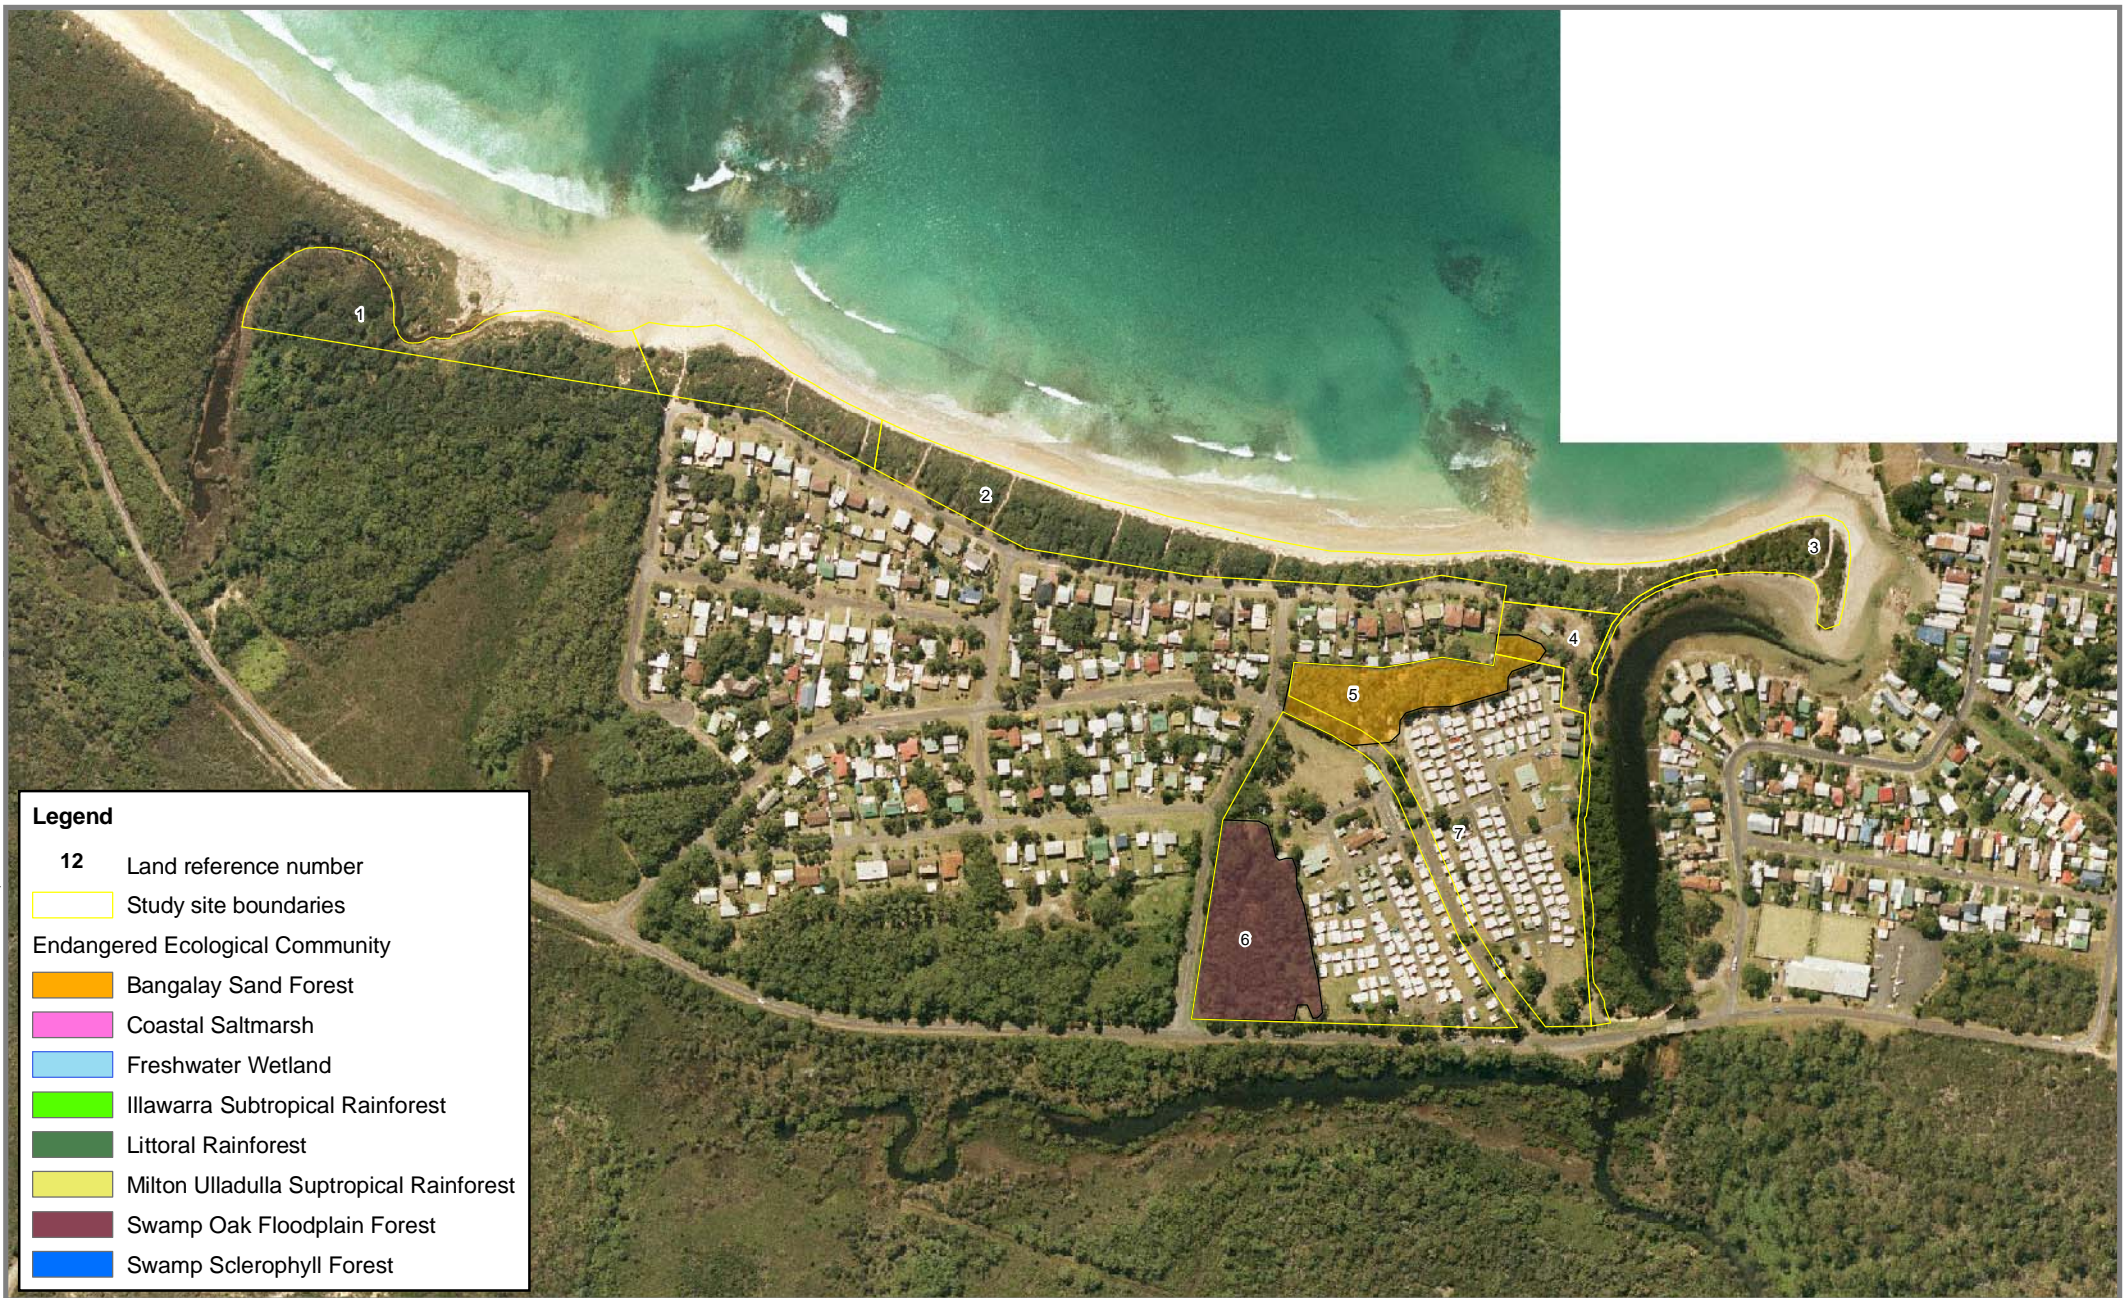
CURRARONG				
Land Number	Vegetation Community	Description	Broad Condition / Value	Threat
1	Open Coastal Scrub / Woodland	This area borders an unnamed creek and the Crookhaven Bight. It is dominated by Coast Banksia and Lomandra although Common Bracken, Swamp Oak, Oplismenus aemulus are also present.	Fair condition. This community is fairly well protected from everyday impacts of urbanisation. Vegetation appears to have reached senescence due to lack of fire. A cool fire would assist in rejuvenation of this area. Stabilises the frontal dune and creek, and is part of a contiguous area of vegetation.	Lack of fire, tracks weeds and erosion.
2	Coastal Scrub	Coastal scrub dominates the frontal dune area where it adjoins Crookhaven Bight. Area dominated by Coast Banksia, Coast Wattle, <i>Monotoca elliptica</i> and Coast Teatree.	Fair condition. This area has been fenced and rehabilitated in the past although tracks and weed are present. Stabilises the frontal dune.	Inconsistent follow up of rehabilitation. Weed invasion and erosion.

3	Coastal Scrub	Coastal scrub dominates the frontal dune area at the river entrance. Area dominated by Coast Banksia, Coast Wattle, <i>Monotoca elliptica</i> and Coast Teatree.	Fair condition. Coastal dune systems have largely been impacted through human encroachment and clearing. This area has been fenced in sections and rehabilitated in the past. Weeds are encroaching from nearby urbanisation. Stabilises the frontal dune.	Inconsistent follow up of rehabilitation, erosion and weed invasion.
4	Cleared	This reserve area has been cleared and a car park and amenities block constructed.. Some trees remain. May once have been part of the Bangalay Sand Forest to the south.	Poor condition. The area is cleared and grassed and is impacted by high levels of human activities. Provides some canopy for common arboreal fauna and birds.	Weed invasion. Senescence of trees with no replacement trees being planted.

5	Bangalay Sand Forest – EEC	This section of the caravan park has been cleared with only scattered trees representative of Bangalay Sand Forest remaining. Sweet Pittosporum and Asparagus Fern are also present in the understorey.	Poor condition. The area is cleared and grassed and is impacted by high levels of human activity. A sewer line runs along the back fences of the properties which border the area to the north. Provides canopy for common arboreal fauna and birds.	Weed invasion. Senescence of trees without planting of replacement trees.
6	Swamp Oak Floodplain Forest - EEC	Swamp Oak Floodplain Forest dominates across this triangular section of vegetation adjacent to the caravan park and to the south of the Bangalay Sand Forest. It is densely vegetated. Swamp Oak is dominant but other canopy species which occasionally occur include Cheese Tree, Woollybutt and Blueberry Ash.	Poor condition. Impacts are mostly associated with edge effects as a consequence of the proximity of the caravan park and roads. Provides stepping stone habitat between Crookhaven Bight and large areas of intact vegetation to the south.	Edge effects and human encroachment.

Land Number	Vegetation Community	Description	Broad Condition / Value	Threat
7	Caravan Park	The remaining area is comprised of a caravan park with only the occasional scattered shrub remaining.	Very poor condition. This area has been cleared. It provides little ecological value to the surrounding area.	Edge effects.
