Figure 14 EEC Mapping of Lands - Mollymook

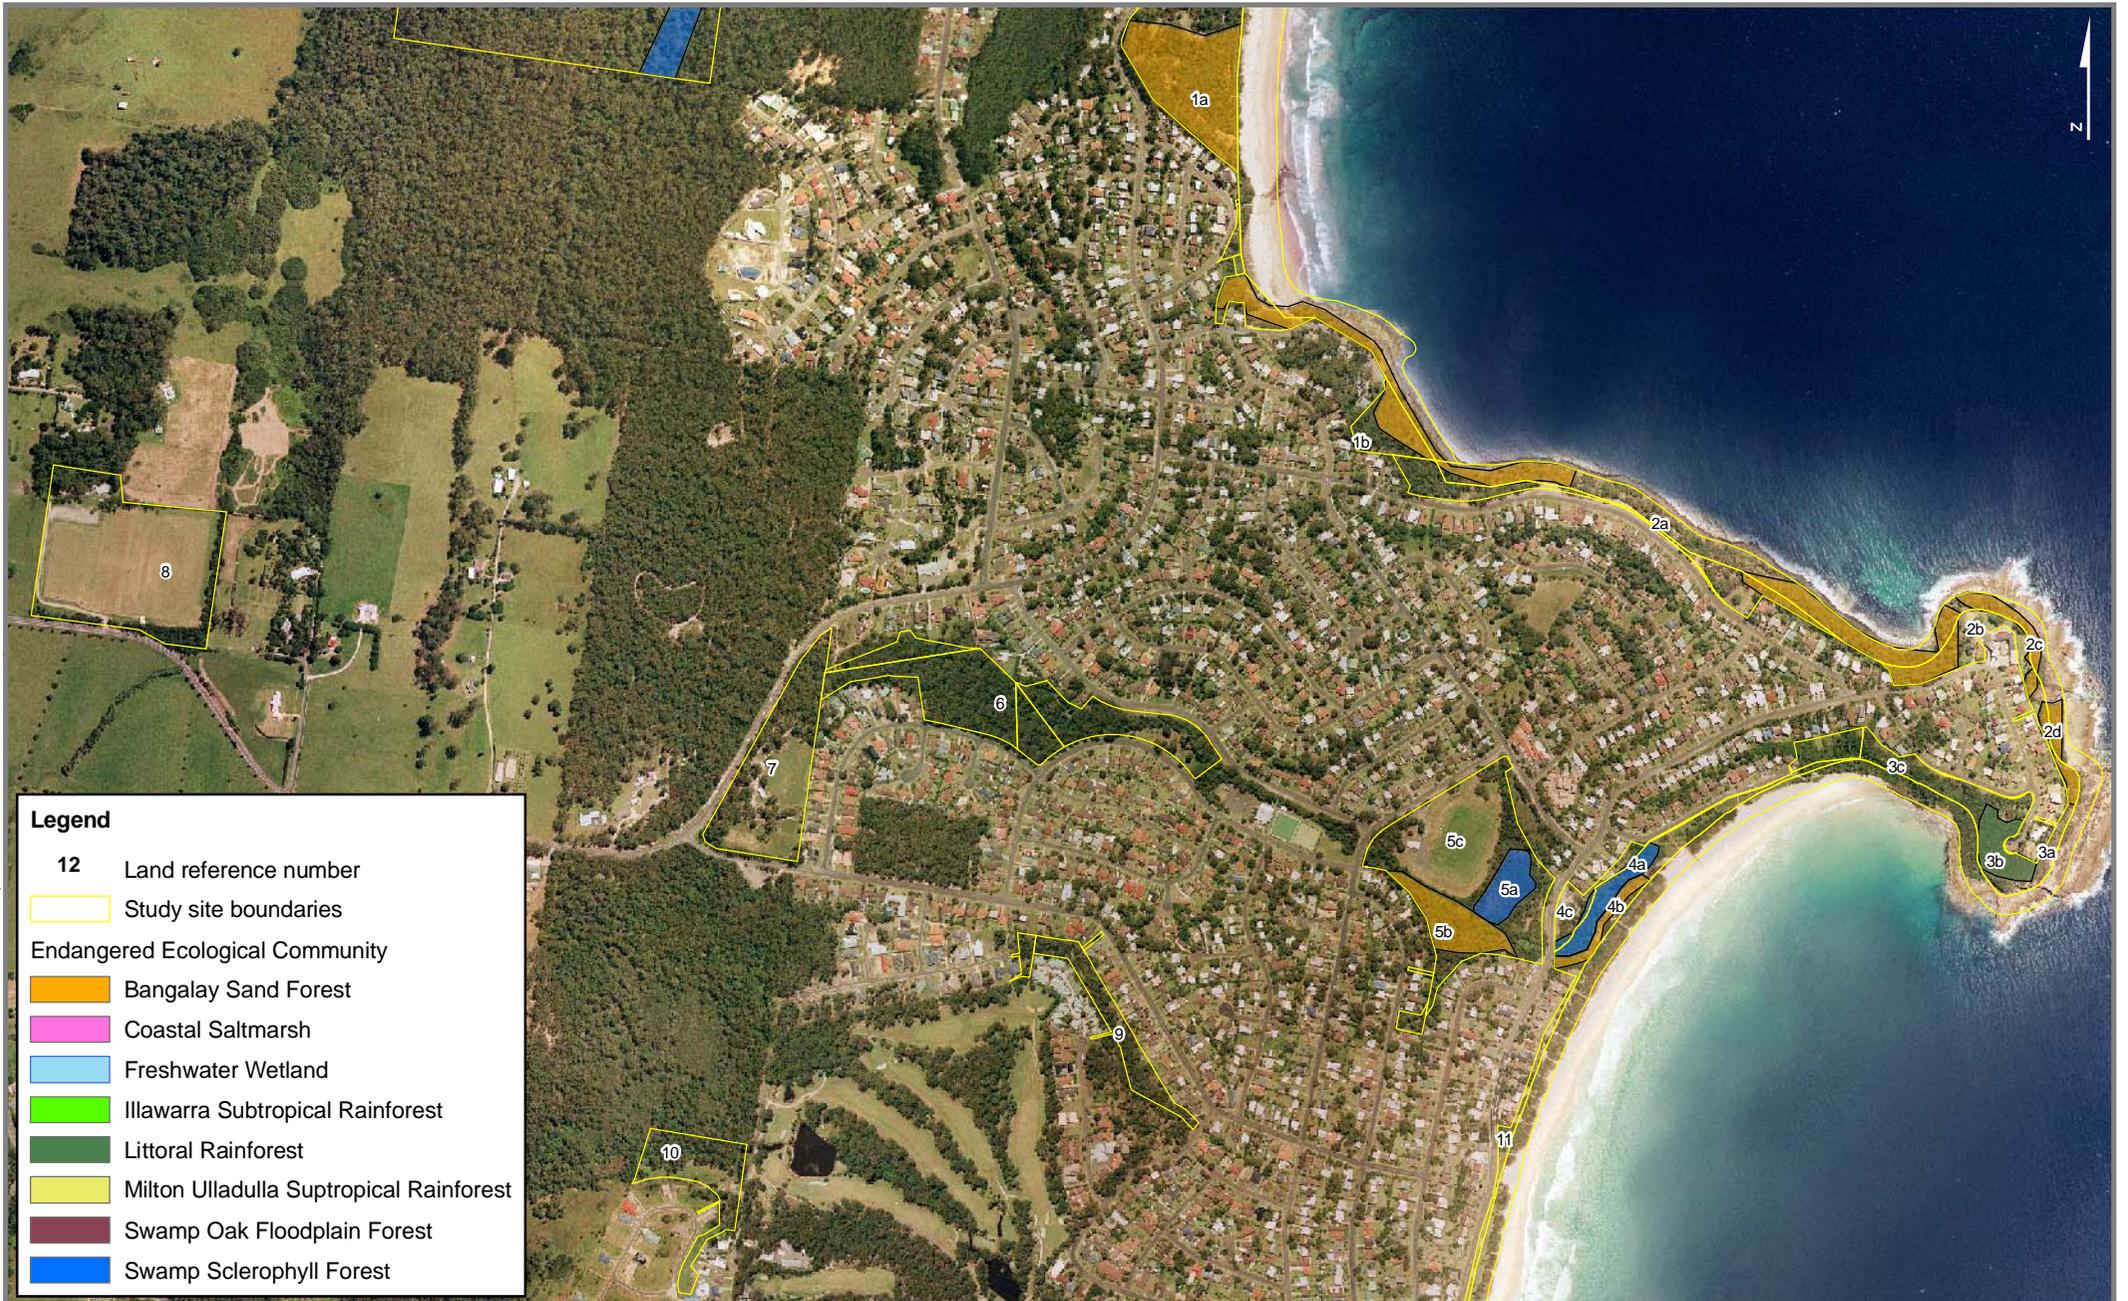
MOLLYMOOK				
Land Number	Vegetation Community	Description	Broad Condition / Value	Threat
1a	<b>Bangalay Sand Forest - EEC</b>	This strip of remaining coastal vegetation is representative of Bangalay Sand Forest even though cleared and modified in sections.	<b>Poor condition.</b> The strip is mostly in poor condition due to it being a narrow band of vegetation experiencing edge effects. Erosion of the cliff line in steeper areas is also a problem. Provides an important vegetated link along the coastline.	Lack of management. Clearing and overuse are the major impacts. Poisoning and removal of trees may also be an issue. Planting of garden plants was also evident in sections.
1b	Eucalypt woodland	This drier section of woodland is set back from the cliff line.	<b>Fair condition.</b> Impacts from adjacent dwellings. Clearing, dumping and weeds. Provides a buffer to the coastline.	Weed invasion, clearing and dumping.

2a	Coastal vegetation	Very steep landform with only scattered vegetation clinging to the cliff face.	<b>Fair condition.</b> Impacts from adjacent dwellings and clearing of trees to maximise views. Trees provide habitat for arboreal fauna and the sparse vegetation provides a buffer to the coastline.	Tree removal and erosion.
2b	<b>Bangalay Sand Forest - EEC</b>	This quite steep section of coastline continues along to Bannisters Point. Blady Grass dominates the understorey in flatter sections. Also present are Coast Banksia, Red Bloodwood and Lomandra. There is a gap in the canopy where clearing has occurred for a pump station and in front of the Bannister's Resort. These areas are primarily grassed.	<b>Fair condition.</b> Impacts from adjacent dwellings and clearing of trees to maximise views. Remaining trees provide habitat for arboreal fauna and the sparse vegetation provides a buffer to the coastline.	Vegetation modification and erosion.

2c / 2d	<b>Bangalay Sand Forest - EEC</b>	These areas are located along the exposed coastal edge of Bannisters Point and vegetation is reduced in stature.	<b>Fair condition.</b> Impacts from adjacent dwellings and clearing of trees to maximise views. The vegetation provides a buffer to the coastline.	Clearing and erosion of the cliff face.
3a	Coastal vegetation	Cliff face is very steep and vegetation is scarce along this section.	<b>Fair condition.</b> Impacts from adjacent dwellings and clearing of trees to maximise views. The vegetation provides a buffer to the coastline and would stabilise the cliff face.	Clearing and erosion of the cliff face.

Land Number	Vegetation Community	Description	Broad Condition / Value	Threat
3b	Littoral Rainforest	This area of Littoral Rainforest is managed by Council. The understorey is sparse and the occasional sedge, New Zealand Spinach and Common Silkpod occur sporadically throughout. Sweet Pittosporum, Swamp Oak and Grey Myrtle are the most common canopy species.	<b>Poor condition – very poor condition.</b> This patch of rainforest is degraded through weed invasion and lack of ongoing rehabilitation. In the Shoalhaven the majority of Littoral Rainforest has been cleared so this patch is an important remnant.	Inconsistent follow up rehabilitation.
3c	Coastal vegetation	Swamp Oak and Coast Banksia dominate this section.	<b>Poor condition.</b> This vegetation is degraded and trees appear stressed. Provides a vegetated link along the coastline.	Weed invasion and impacts which are causing this vegetation to appear stressed.

4a	Swamp Sclerophyll Forest - EEC	Narrow Swamp Sclerophyll Forest follows the unnamed creek. The creek banks are bare and eroded.	<b>Poor condition.</b> Modified and impacted due to the pressures of urbanisation. Provides a vegetated link along the coastline.	Water quality, changes to drainage patterns and weed invasion.
4b	Bangalay Sand Forest - EEC	4a merges into a degraded narrow strip of Bangalay Sand Forest which has been cleared and is currently mown along the edges. The eastern edge merges into low coastal scrub.	<b>Poor condition.</b> Modified and impacted due to the pressures of urbanisation. Provides a vegetated link along the coastline.	Water quality, changes to drainage patterns and weed invasion.
4c	Turpentine – Blackbutt Forest	Behind 4a and 4b, Turpentine and Blackbutt Forest occurs.	<b>Poor condition.</b> Modified and impacted due to the pressures of urbanisation. Provides a vegetated link along the coastline.	Water quality, changes to drainage patterns and weed invasion.

5a	Swamp Sclerophyll Forest - EEC	This community occurs around a ponded area and has wetter influences such as Grey Myrtle. The area is weed infested and the ponded area is full of rubbish and is covered in brown algae.	<b>Very poor condition.</b> Modification, poor water quality and severe weed invasion have badly degraded this area. Is a part of a vegetated link to the west.	Water quality, changes to drainage patterns and weed invasion.
5b	Bangalay Sand Forest - EEC	This forest is badly degraded and weed infested especially with Japanese Honeysuckle, <i>Senna</i> sp. and Asparagus Fern.	<b>Very poor condition.</b> Modification, poor water quality and severe weed invasion have badly degraded this area. Is a part of a vegetated link to the west.	Water quality, changes to drainage patterns and weed invasion.
5c	Cleared	A large cleared and ponded area occurs in the north of the reserve where it borders Carroll Avenue.	<b>Very poor condition.</b> Modification, poor water quality and severe weed invasion have badly degraded this area. Would potentially provide habitat for a range of water dependent species.	Water quality, changes to drainage patterns and weed invasion.

Land Number	Vegetation Community	Description	Broad Condition / Value	Threat
6	Blackbutt –Turpentine Forest	This community follows an unnamed creek. Black She-oak, Large-leaf Hop-bush and Red Bloodwood also occur with the Blackbutt and Turpentine.	<b>Fair condition.</b> Even though this area has tracks throughout and minor dumping it is still in fair condition with good biodiversity values. Provides a relatively intact vegetated link along the unnamed creek.	Water quality, dumping and weed invasion from surrounding development.
7	Blackbutt –Turpentine Forest / Cleared	Blackbutt – Turpentine Forest continues from 6 in to this reserve. The southern 75% has been cleared and only trees along the road edges remain.	<b>Poor condition.</b> Clearing and modification have degraded this area. Trees along the boundaries provides a vegetated link to areas west.	Weed invasion and lack of rehabilitation.
8	Modified	This sporting oval is fringed by vegetation. Swamp Oak and <i>Acacia</i> sp. occur along the southern edge and Bangalay in the north-west corner. This area is mown.	<b>Poor condition.</b> Cleared and mown. Also dumping and weed infestations in sections. Few ecological values.	Further weed invasion.

9	Blackbutt –Turpentine Forest	Occurs as small patches of trees interspersed with mown areas.	<b>Poor condition.</b> Dumping and garden plants common throughout. Provides stepping stone habitat for mobile species.	Further impacts from adjacent dwellings.
10	Blackbutt –Turpentine Forest / Cleared	Large section cleared for the pump station. Mollymook Creek flows along the northern boundary of this site and vegetation shows wetter influences, with Tall Saw-sedge and <i>Callicoma</i> becoming common.	<b>Poor condition.</b> Clearing of vegetation. Provides narrow vegetated buffer upslope of Mollymook Creek.	Poor water quality, spread of weeds.
11	Coastal Scrub	This area is typical of coastal scrub on the frontal dunes. Dominated by Coast Banksia and Coastal Wattle.	<b>Poor condition.</b> Tracks and clearing. Provides a vegetated coastal link .	Track formation, erosion, tree clearing and weed spread.
