TERRA INSIGHT

Sealark Road, Callala Bay NSW Lot 5 DP 1225356  
Report on Geotechnical Investigation

Our Ref: TERRA19258.Rep1.Rev1

21 August 2019

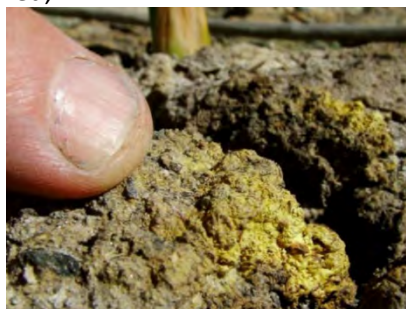
Image 1: Example of Jarosite staining

- To facilitate off-site disposal, all material for offsite disposal should be treated at a rate of 3kg/tonne, with the lime mixed well into the spoil. For small volumes of spoil and for ease of treatment and disposal, spoil can be contained and treated within skip bins. Verification testing should be undertaken to confirm the acid generating capacity of the spoil has been adequately neutralised prior to off-site disposal.
- If the soils are to be stockpiled on site for a period exceeding 2 weeks, further advice shall be sought from a competent ASS professional. Stockpiles shall be observed for obvious signs of oxidation, such as jarosite staining (an example is shown in image 1). Advice should be sought from an environmental professional if such staining or signs of oxidation are observed;

- Excavated soil that is to remain on the site shall be treated at a rate of 2kg/tonne.
- Materials excavated for service trenches etc, should be replaced within 48 hours.
- The sides and bases of excavations should be treated with lime (sprinkled across the exposed faces). In the case of the sedimentation basin, the sides should be lined with clay soils with a neutral pH or alternatively, they could be lined with a layer of crushed concrete.

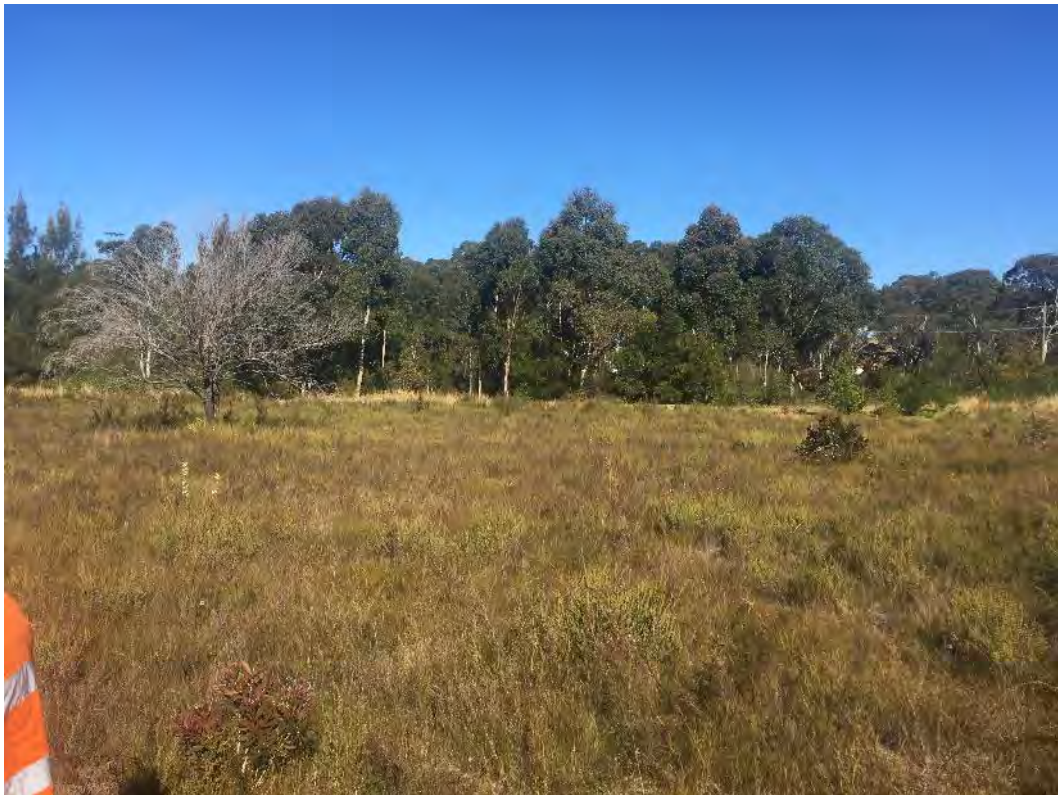
Photograph 2: View of northern portion of site looking east from around lot 9. Creek is located along and east of tree line.

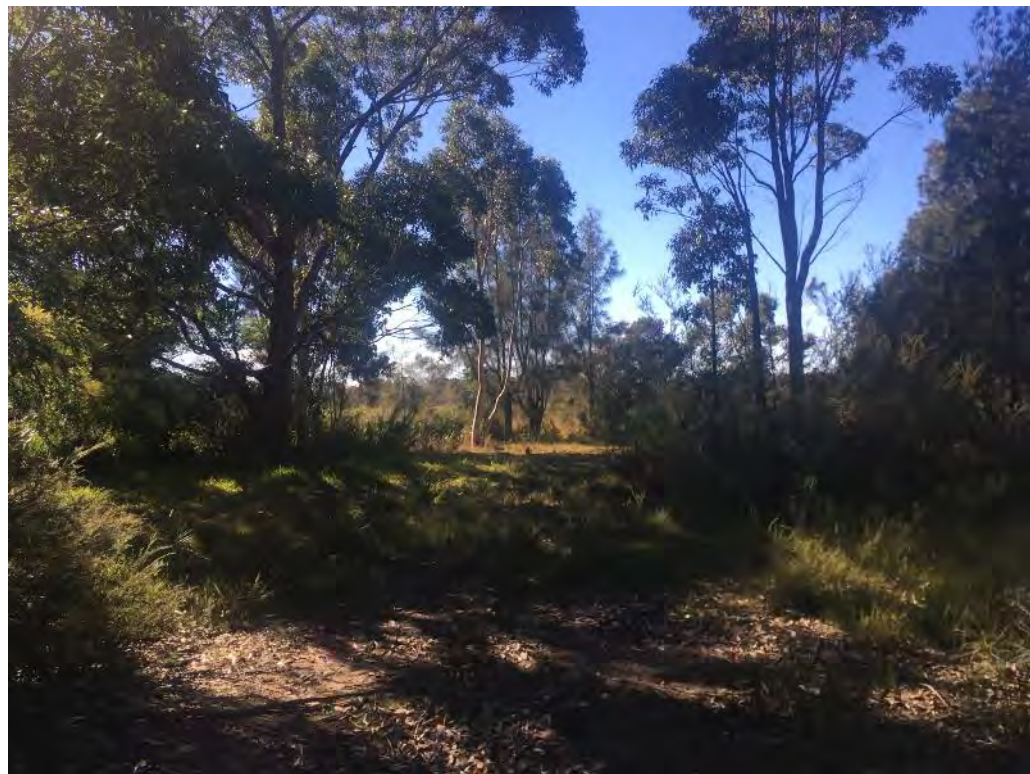
Photograph 12: Slight clearing to the north east of creek.

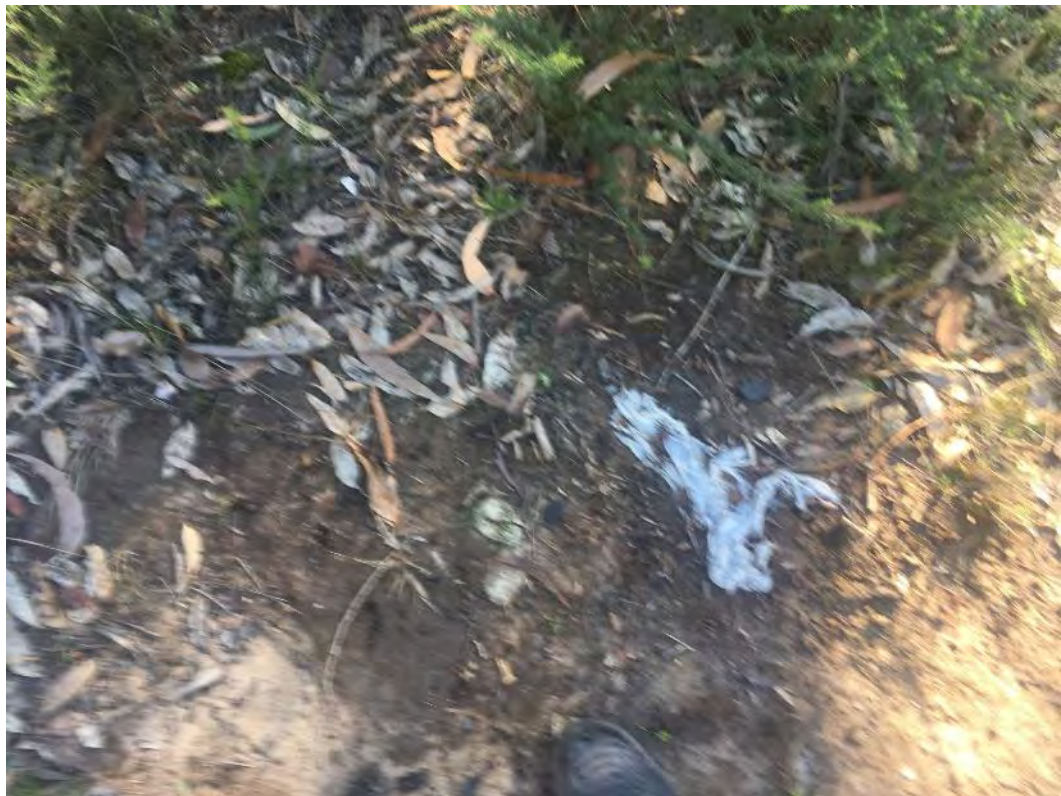
Photograph 13: Minor rubbish found on the surface, within the south-western corner of the site (plastic, glass bottles, tin cans).
