# Osborne Park Kangaroo Valley Showground

Moss Vale Road, Kangaroo Valley

## Conservation Management Plan

March 2004  
REF: 0354: CMP

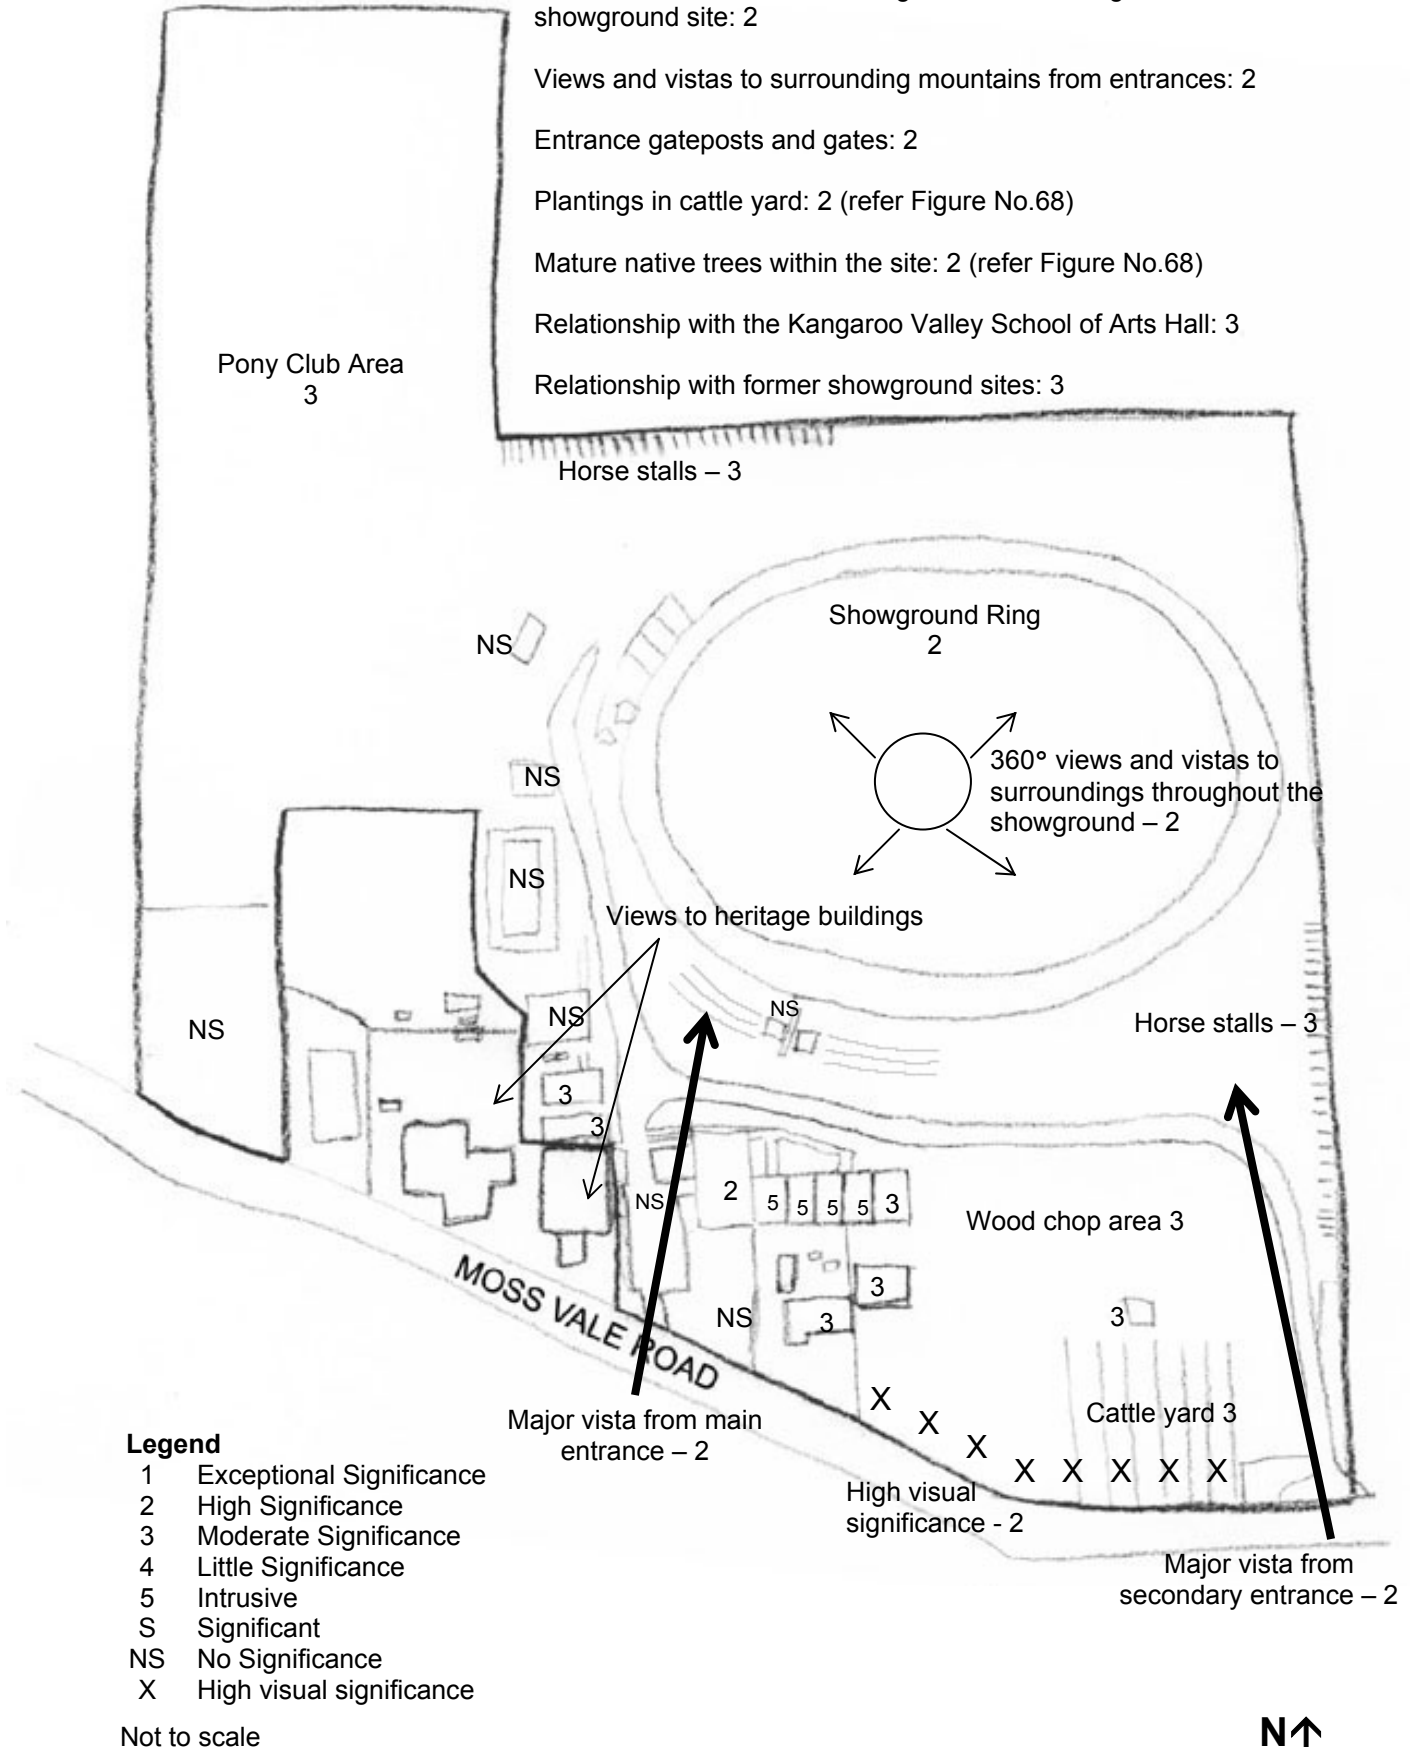
Generally:  
 Views and vistas to surrounding mountains throughout the showground site: 2  
 Views and vistas to surrounding mountains from entrances: 2  
 Entrance gateposts and gates: 2  
 Plantings in cattle yard: 2 (refer Figure No.68)  
 Mature native trees within the site: 2 (refer Figure No.68)  
 Relationship with the Kangaroo Valley School of Arts Hall: 3  
 Relationship with former showground sites: 3

Figure No.67: Levels of Significance – Subject Site

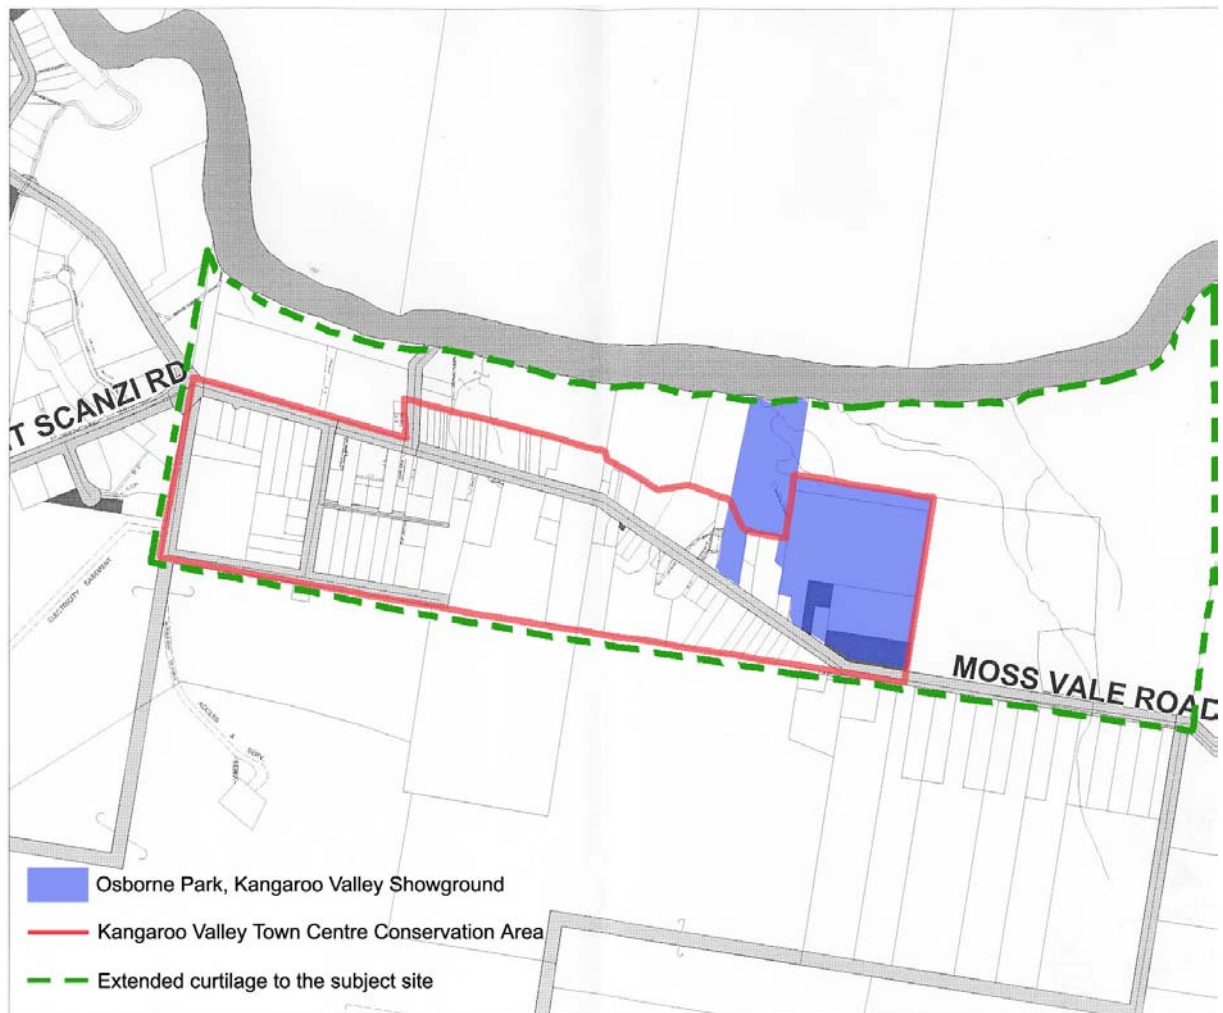
Figure No.69: Extended curtilage of the Kangaroo Valley Showground, Osborne Park.

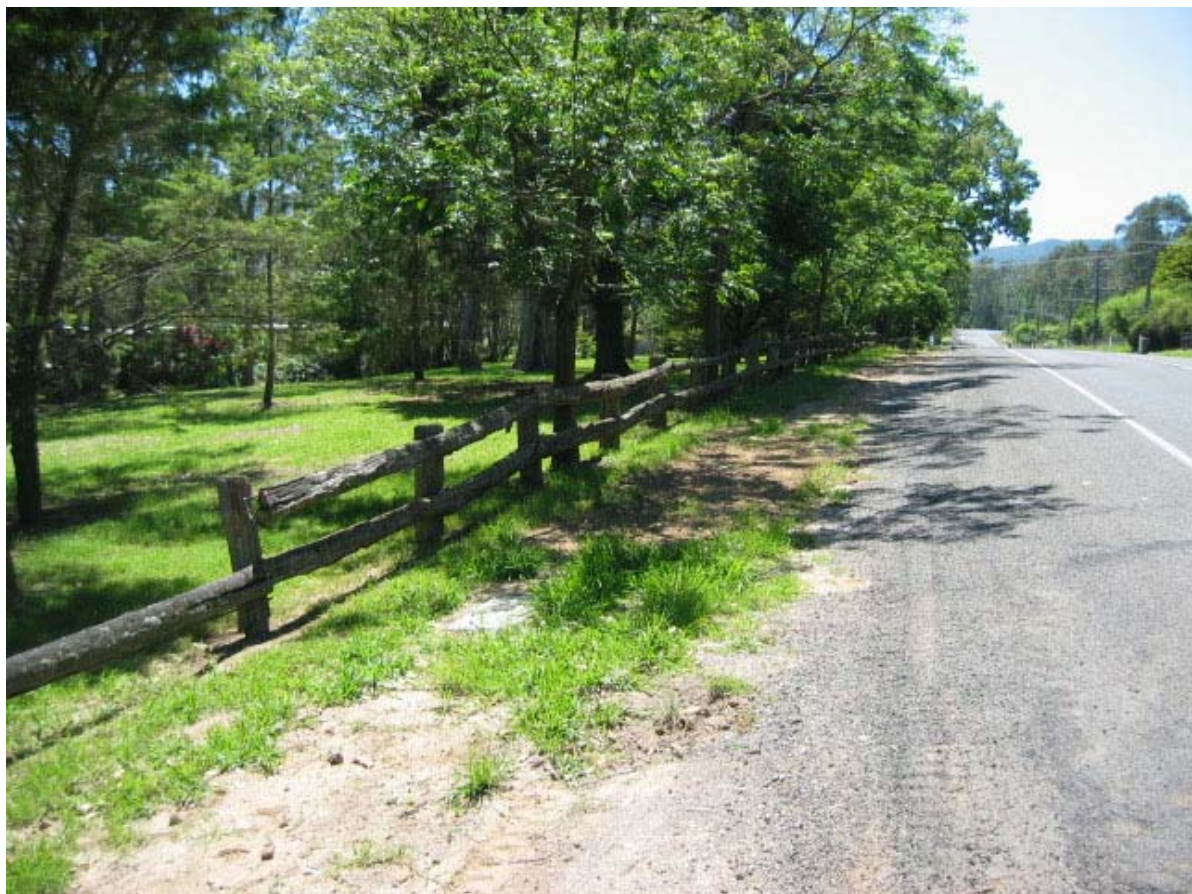
Figure No.B6: Fence to the caravan park along Moss Vale Road. The existing fence to Osborne Park could possibly be replaced with a fence similar to this.

- 7.2.1.10 *The lighting to the site should be checked over and upgraded where necessary.*
- 7.2.1.11 *The fence to the perimeter of the subject site should be replaced, ideally with a timber post and rail fence in keeping with the rural nature of the area.*
- 7.2.1.12 *The existing metal fence to the perimeter of the Caretaker's Cottage is intrusive and should be removed. A timber picket fence should be constructed in its place.*

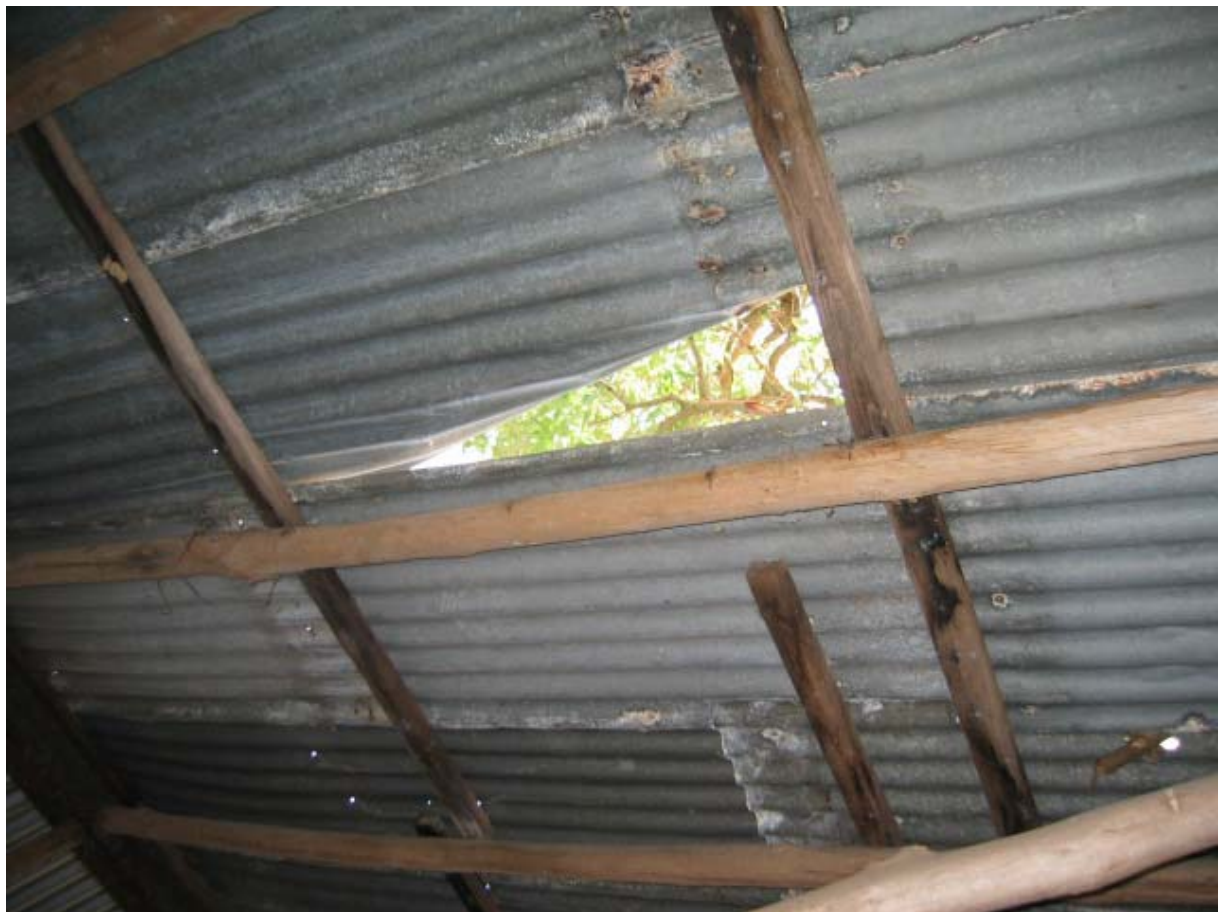
Figure No.B60: Poultry Pavilion, interior.  
Figure No.B61: Damage to roof of Poultry Pavilion.

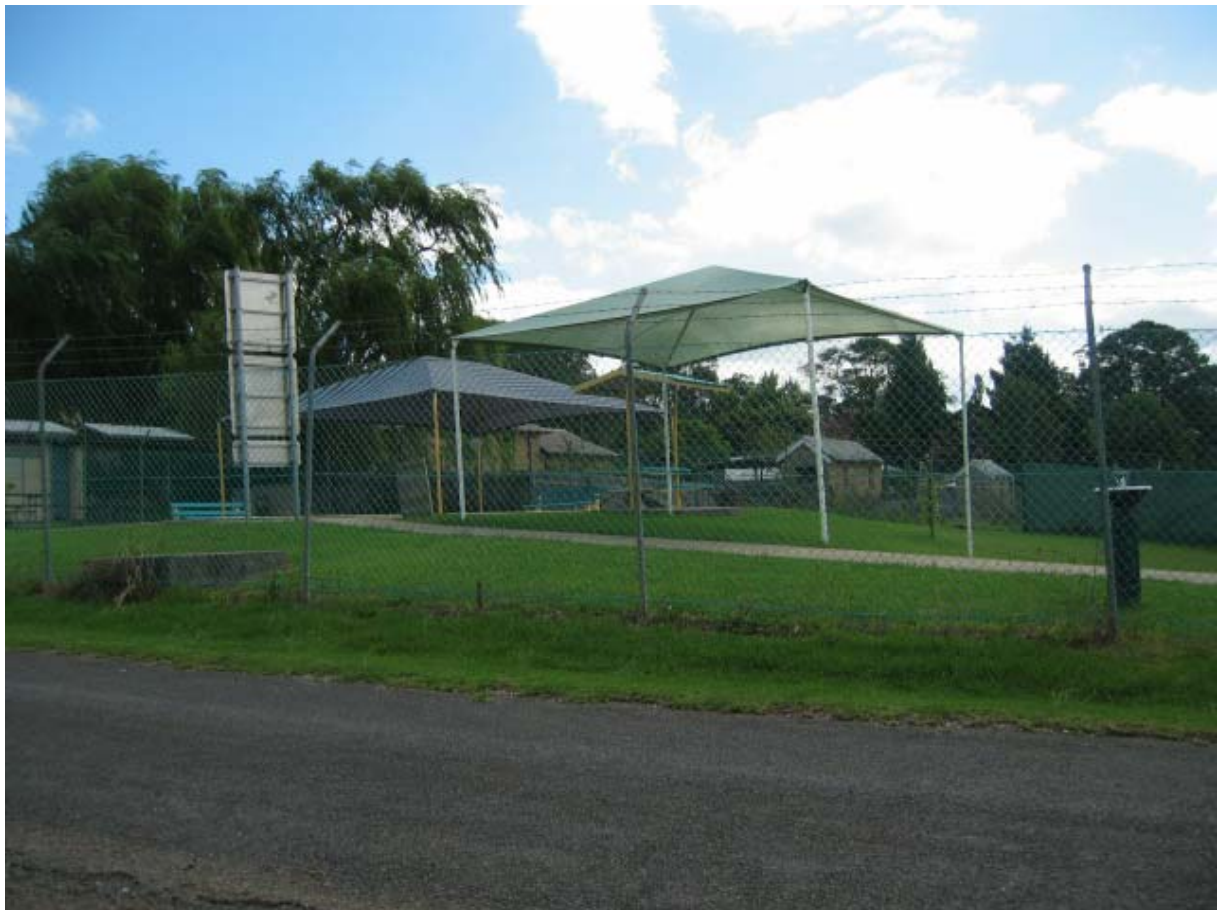
Figure No.B92: General view of the swimming pool area.  
Figure No.B93: Shade structures over the swimming pools.
