KANGAROO VALLEY SCHOOL OF ARTS

Conservation Management Plan

PREPARED FOR
Shoalhaven City Council

BY
SIMPSON DAWBIN Associates
Architects and Heritage Consultants

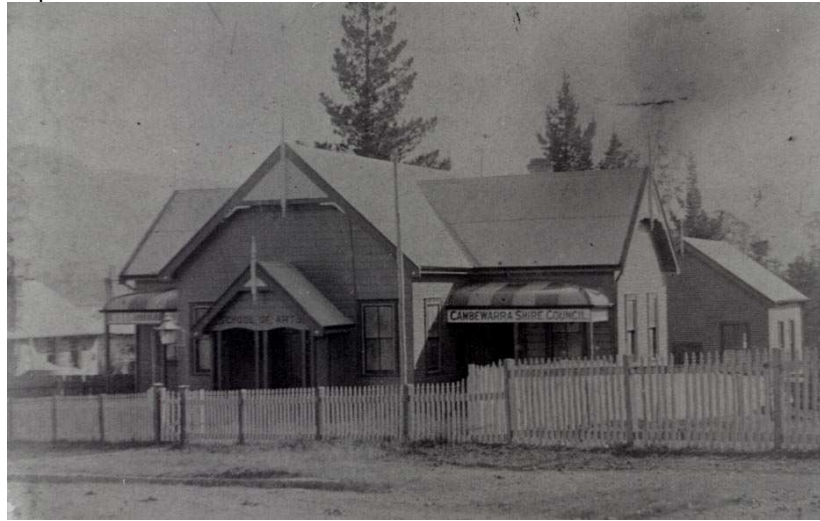
*School of Arts and Cambewarra Shire Office, 1919
with detached building to rear
(Kangaroo Valley Historical Society)*

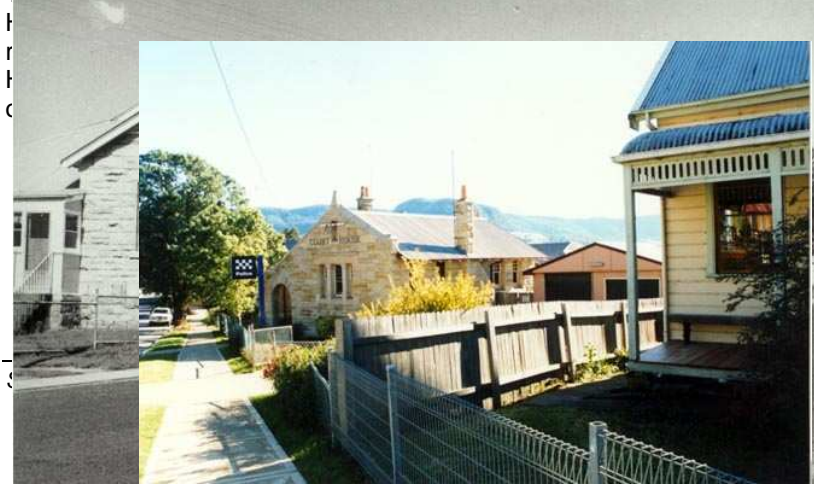
The present Police Station was originally the Kangaroo Valley Court

Court House (Police Station)) and School of Arts, 1953 and 2000

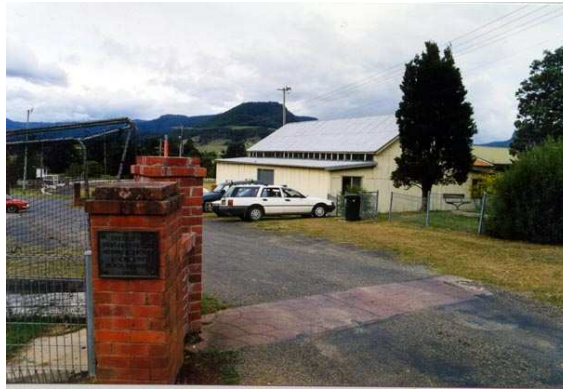
A5 Gates to car park,

Memorial brick pillars were erected in 1956 when Osborne Park was officially opened as a showground, comprising a pair of pillars each at the entry from Moss Vale Road with bronze plaques commemorating the pioneers of Kangaroo Valley. Gates were originally installed but are now removed. Lights were installed at that time but were later removed. The piers were extended with another attached brick pier with provision for lighting.

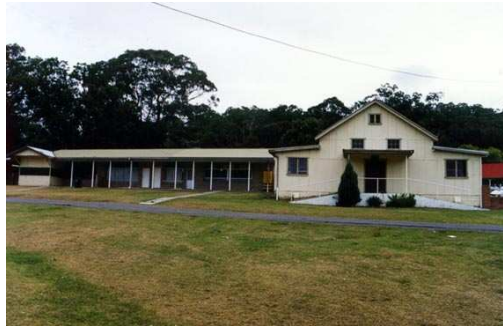
The main element of the showground is the oval used for most show events. A field track and timber rail fence extend around the perimeter of the oval. The pavilion is the largest building, and open areas to the east are used by spectators and visitors during events at the showground.

*Showground
Pavilion in Osborne
Park*

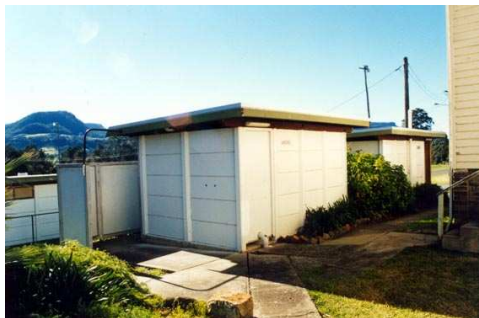
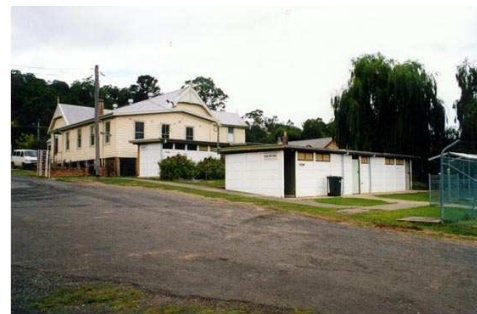
Public toilets and dressing sheds to rear of School of Arts

Male and female public toilets were constructed as separate pre cast concrete pavilions in 1956. They continue to be heavily used by visitors to the showground, swimming pool, the general public including coach tours to the village who frequently use the facilities, and often picnic in the adjacent park. Patrons and staff at functions within the Kangaroo Valley Hall also have no choice but to use these external facilities.

The public toilets are in run down condition and suffering from spalling concrete to precast elements.

Construct new male and female toilets within the building, beneath the stage area, modify store for access corridor and convert to disabled toilet.

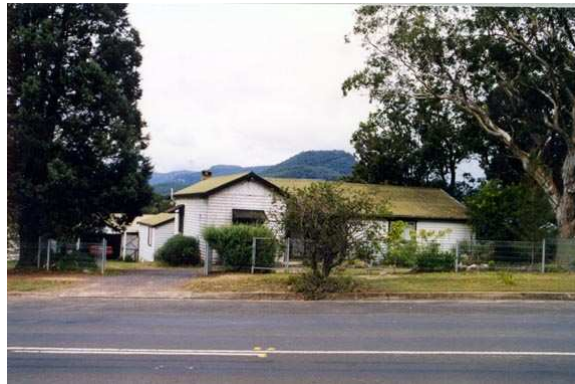
A12 Caretakers Cottage

This simple timber and fibro cottage was built in 1934 apparently from timber salvaged from the demolition of the Presbyterian church opposite. It has deteriorated in condition in recent years, and is currently occupied by the caretaker of the Hall and Osborne Park and her family.

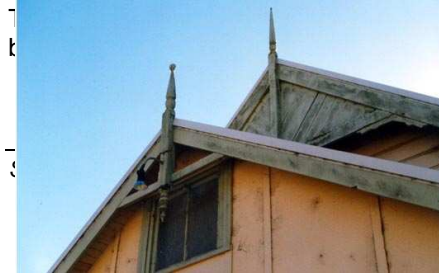
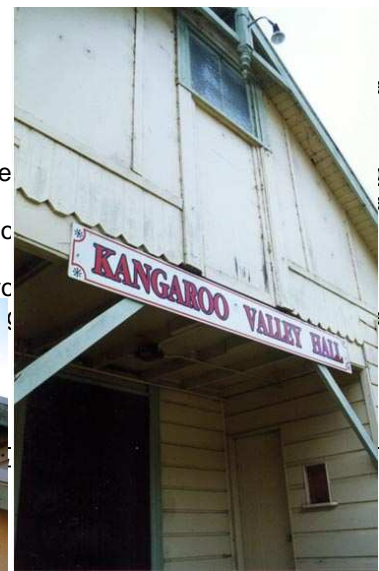
B1.1 South west verandah

Bullnose roof structure appears to be original, features a decorative fretworked frieze

Deck boards have been recently replaced.

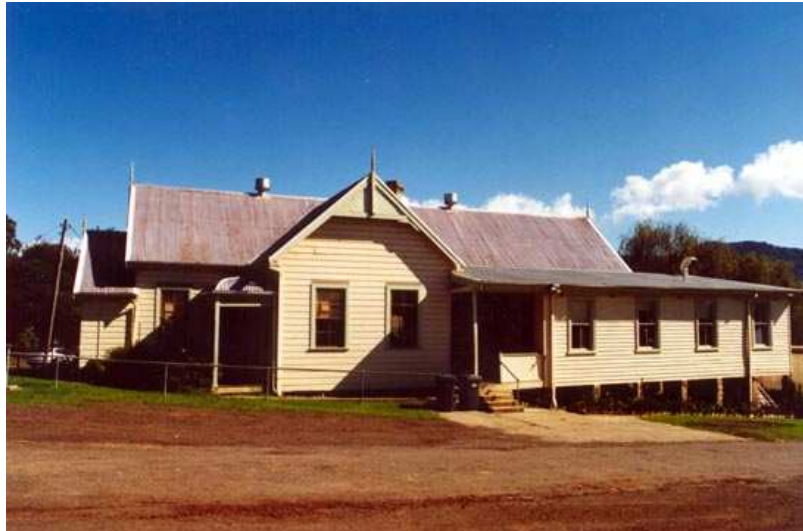
East elevation

The steps to the east entry porch are in poor condition.

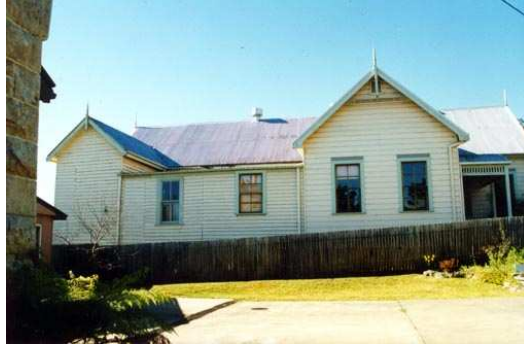
West Elevation (above)

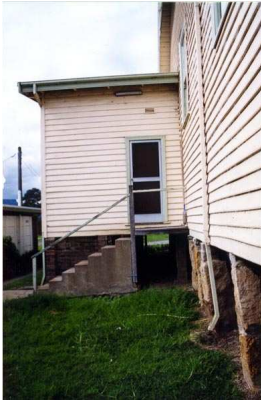
North elevation (left)

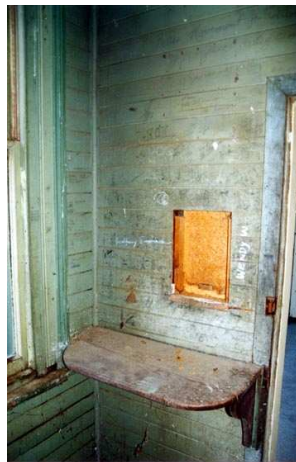
Ticket window

C1B Stair to Projection Booth

The narrow stair leads to the projection room at the mezzanine level. This is now empty space and is permanently locked off for security reasons

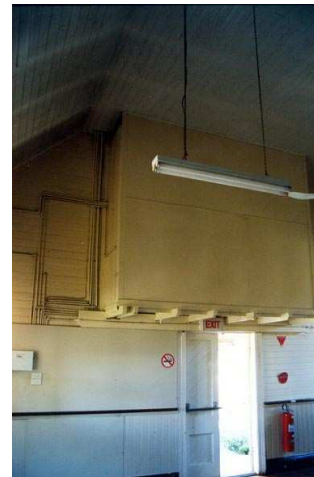
Projection Box within Hall

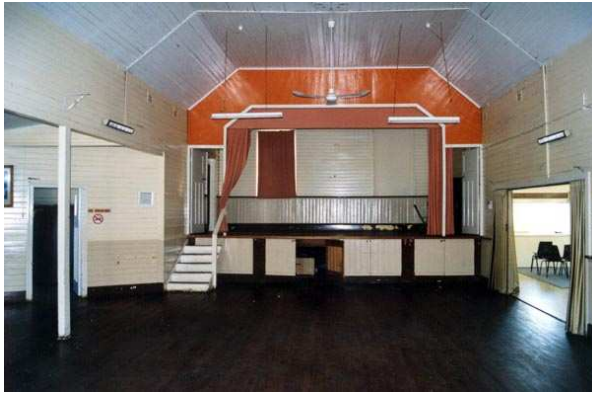
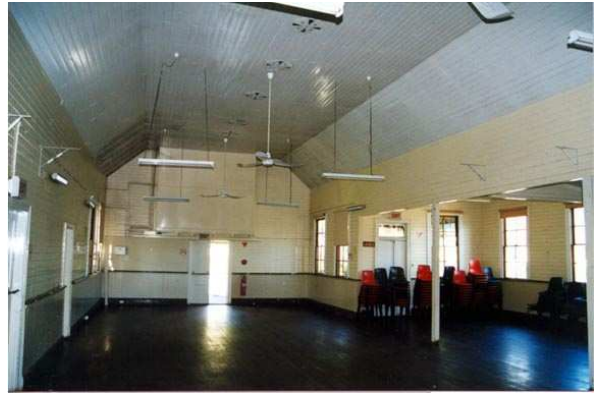
Top
Hall interior

C2 Hall

The ceiling is wide timber lining boards, with wide timber cornice. A join in the ceiling 13.8 metres from the front defines the junction of the 1928 hall extension. Similar profile boards line the full extent of the hall, and a dado at 1.1 metres with vertical timber and bolection moulding to the top define the extent of the original 1907 space, and in addition extend around the internal stage area.

Lighting is modern suspended fluorescent fittings

Policy (10.2): Replace fluorescent light fittings to all function areas with selected fittings of traditional character.

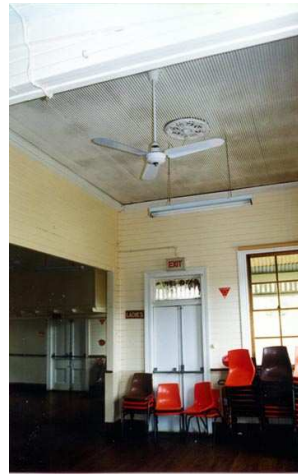
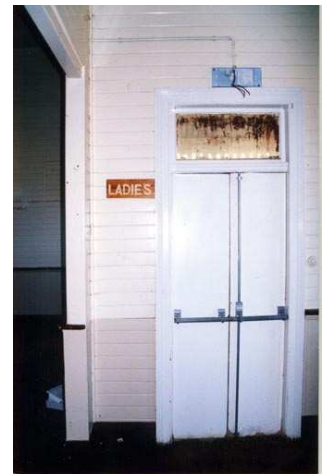
C2.1 Hall annexe

Originally the Library wing to the west of the building, this space subsequently became the 'Ladies room' and the first Supper Room. It was opened up into the Hall in 1964. It retains intact many original finishes including ripple iron ceiling and decorative rose vent, timber panelled dado and timber wall lining.

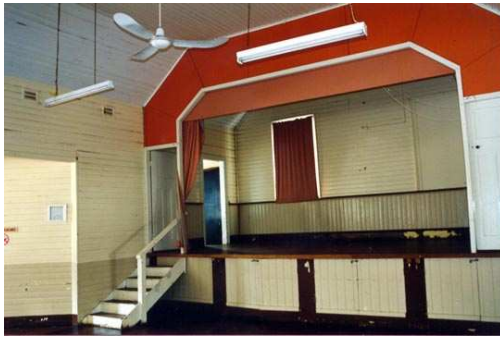
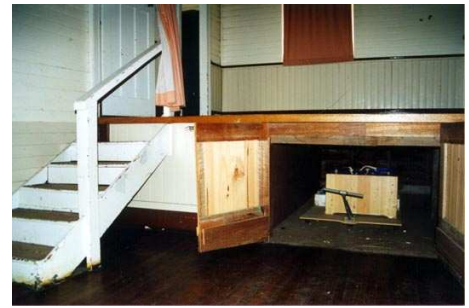
Under Stage Storage

The stage, originally timber is now oversheeted with particleboard. The proscenium arch appears adequate if not somewhat temporary.

A set of unsafe stairs access the stage from the hall.

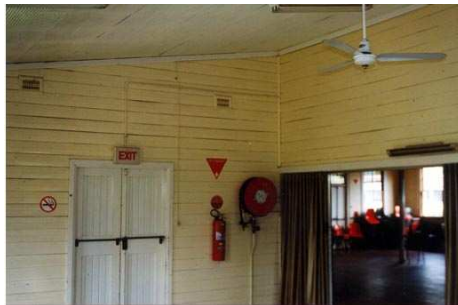
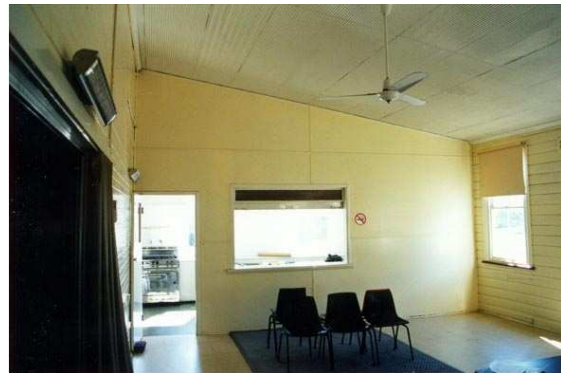
C6 Supper Room

The Supper Room provides an annexe off the Hall and milling and serving space for refreshments from the kitchen. A concertina door provides some separation from the hall. Double doors lead directly onto the eastern entry porch. The interior is in fair condition, requiring some new finishes.

The kitchen is a well equipped commercial standard kitchen but is let down by the deteriorating condition of much of the benches and cupboards.

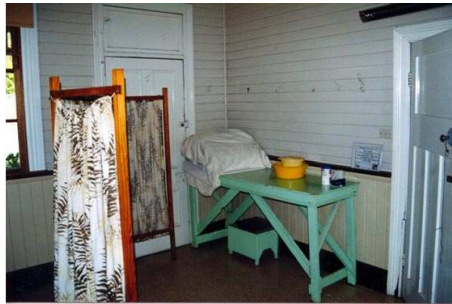
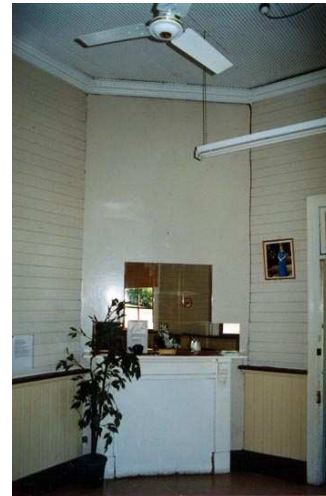
Doctor's Room

Now known as the 'Doctor's' room due its regular use as a medical clinic, the old meeting room is a multi purpose space which frequently doubles as the main entry point into the Hall for functions due to the lack of

The fireplace hearth and mantelpiece remain intact but the hearth has been closed off since 1964.

A complete examination table and screen dating from the 1950's remains intact and continues to be used by medical staff.

The Meeting room is the only space retaining complete finishes from original construction including ripple iron ceiling with decorative ceiling vent, timber lining boards, and complete dado configuration, fireplace and two panelled doors. The doors also retain their original rimlocks, (together with several later lock replacements.)

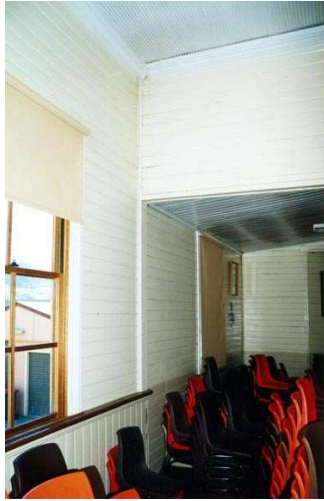
Dado to C2.1

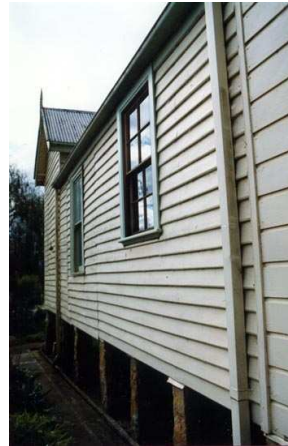
Junction of weatherboards

Variations to the size and profile of weatherboards also indicate progressive stages of development, 200mm to the original section and 145mm to subsequent extensions. Alterations to openings are also clearly visible in the fabric. The status of each room is reflected in the standard of finishes, ripple iron ceilings, rose vents and timber dados defining the more important spaces.

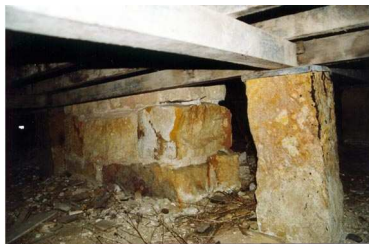
Footing to chimney
C2.1

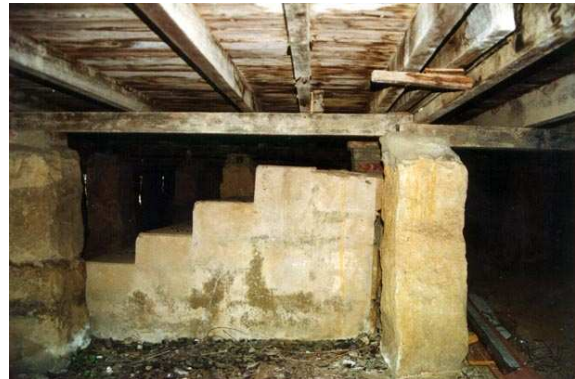
Steps to C2.2

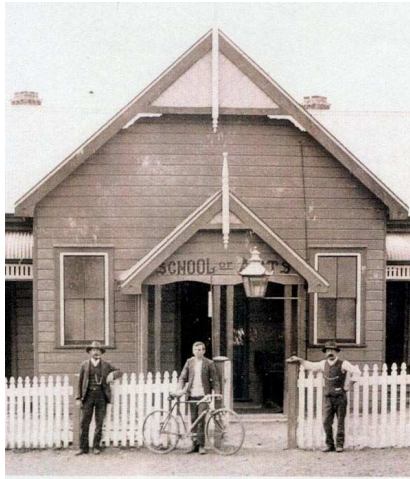
With construction of the new porch, ticket office and projection booth, the building lost a well proportioned elevation and finely detailed porch. However the new addition represents an important stage in the history of the School of Arts

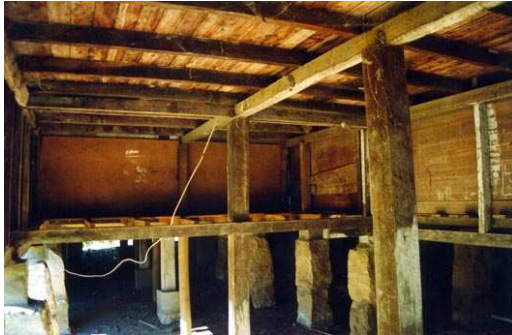
Space available for internal toilets in void under Stage area

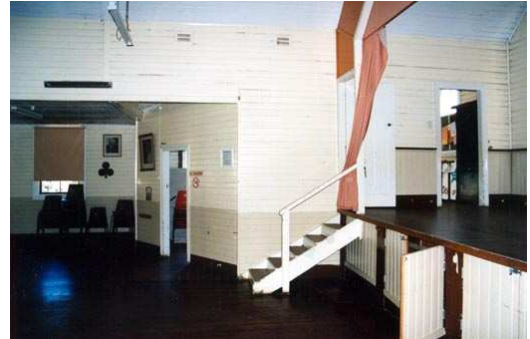
Store Room adjacent Stage suitable for use as disabled toilets
