MILTON TOWN HALL (former School of Arts)

Conservation Management Plan

PREPARED FOR
Shoalhaven City Council

December 1999

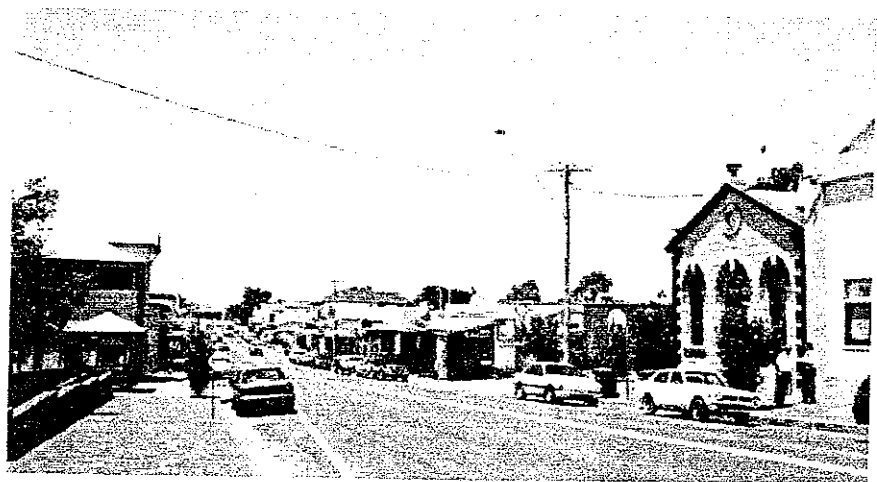
Fig 4:
Milton Main Street ca 1890
and 1999

The main street of Milton in its early history, showing T. Mitchell's store, a slab hut where the Westpac Bank is today and the School of Arts building.

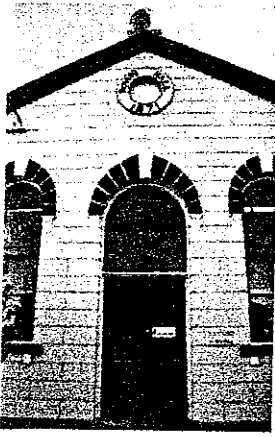
Fig 9:
Facade

External walls of the building are rendered 225mm brickwork, in simulated stone ashlar coursing with distinctive rusticated quoins at corners to front elevation only. Window openings feature keystone

mouldings and sills. The upper panes are as original with intermediate glazing bars, lower panes are glass to the full pane.

Substructure of the building is rusticated sandstone. Lime jointing has deteriorated in many places

The front parapet features Italianate details with three decorative masonry orb finials in original condition, however the apex ball finial may be missing its top section.

- Structural evaluation required to ensure no further settlement of Ante Room or rotation of footings
- Stonework to plinth generally, needs repointing with lime mortar
- Repair weathered stone to front elevation
- Seal and repoint stonework along side lane
- Check chimney flashings
- High paving and insufficient drainage possible causes of rising damp to front elevation
- Replace square window above double entry doors with solid panel as original
- Joinery, especially windows need repriming and painting
- Replace side porch with more appropriate structure
- Replace flush lined front side entry door with solid timber panelled door

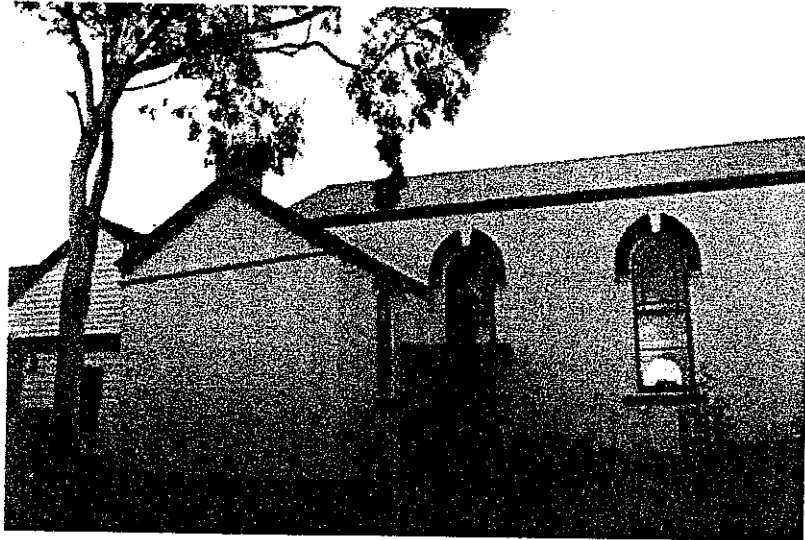
Fig 10:
Entry porch to Library

The front entry doors are now permanently closed, and the entry to the library is gained through a side door constructed within an old window opening: A small flat roofed porch provides shelter

A recently constructed small flat roofed porch provides shelter at the main public entrance.

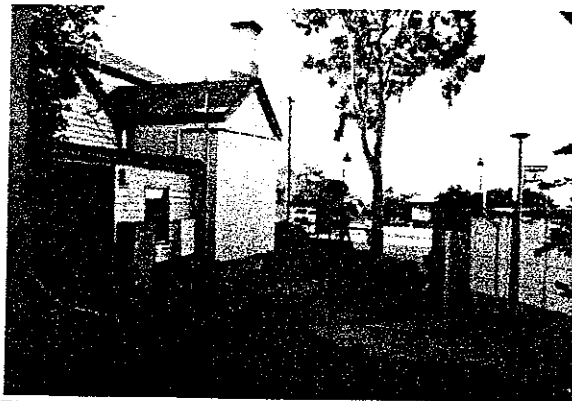
Fig 11: Landscaped court between Town Hall
and public toilet blocks

Landscaping is an important feature of the external precinct of the site, and the garden to the south east side of the building is now an important element in the streetscape, complimentary to the Town Hall

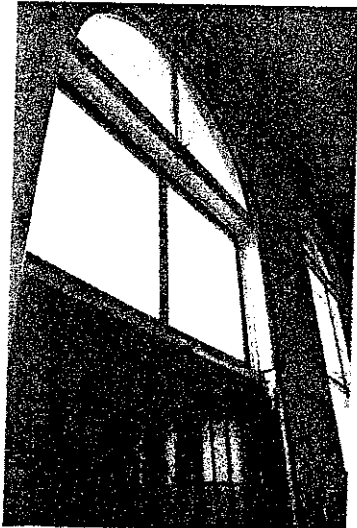
Fig 14:
Entry doors, internal

The pair of front entry doors is a solid cedar framed door with timber panels of vertical boarding. The glazed panel above replaces door extension panels, and is surmounted by an arched highlight. The doors are no longer used for public access.

- Repair damaged plasterwork to walls and ceilings affected by damp penetration and repaint. Patch and paint cracked plaster
- Restore double doors and replace broken glass highlight
- Remove new slate tiles inside front entry
- Remove all redundant power conduits, cables and replace fluorescent fittings with appropriate style of fitting. Conceal services
- Remove glass panel from opening to north west side and replace with window to original detail, including sill.
- Replace all flush doors to rear corridor, archives and rear office and replace door furniture.
- Remove screen to tea prep area

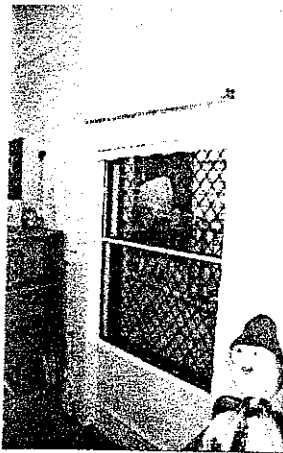
Fig 16.
Infilled doorway, north
west elevation

Public access is gained via the side door. This opening was originally a window, and is fitted with a modern flush door with an intrusive aluminium screen door.

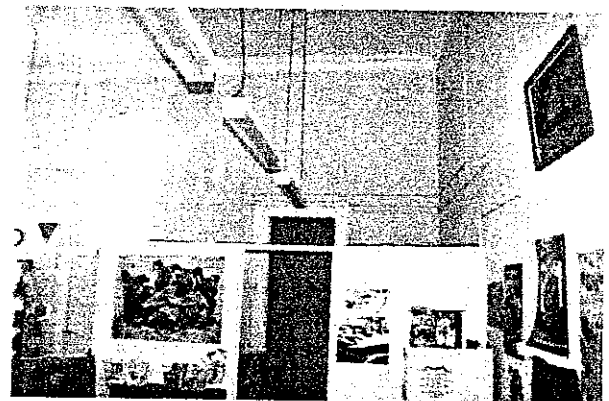
Fig 18 :
South western corner of Library
Screen to staff area

A 2 metre high lightweight partition screens off the rear corner of the Library as a tea preparation area for staff, a recent and intrusive alteration

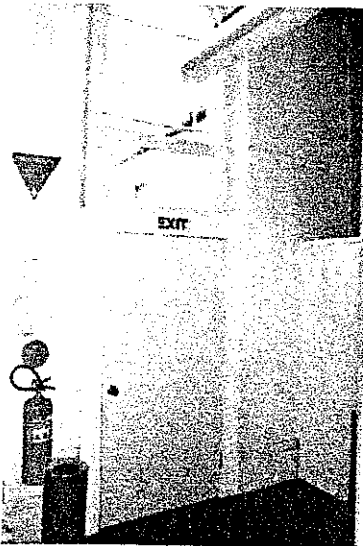
Fig 19.

Walls are extensively cracked near the cornice and above the rear door. There is evidence of footing rotation, with the Ante Room pulling away from the main structure

Cracking in walls, Hallway

- Repair/ patch cracking at cornice and in plasterwork above internal doorway.
- Water staining on wall, check roof for leak

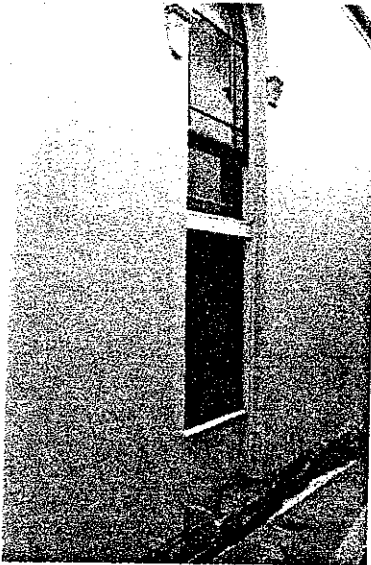
Fig 21.
Damp in
substructure
NW elevation

Much of the interior has been degraded by deterioration of fabric, alterations to joinery, and intrusion of services. Settlement in the footings is evident through cracking in walls, particularly in the Ante Room area. Rising damp has affected finishes to the north east and north west walls.

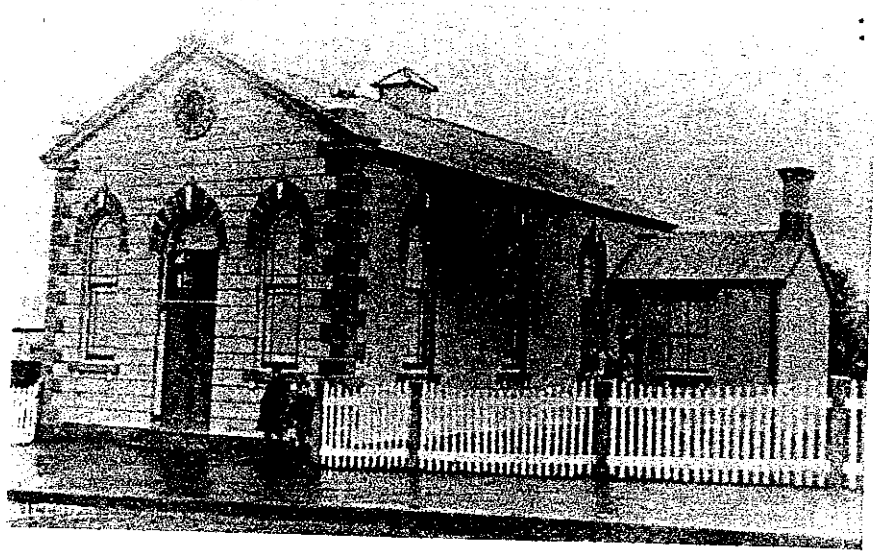
Fig 22:
Milton School of Arts, ca 1900

Early photographs of the building indicate a picket fence to either side of the building but very little planting except for trees at the rear. The park has been created by Council as a public space between the Highway, rear car park, Milton Village Cultural Centre and the Town Hall. The space is dominated by two public toilet blocks.
