FORMER PYREE SCHOOL
PYREE NSW

**CONSERVATION MANAGEMENT
PLAN**

SHOALHAVEN CITY COUNCIL
BRIDGE ROAD NOWRA NSW

AUGUST 2001
REF: 0101: CMP

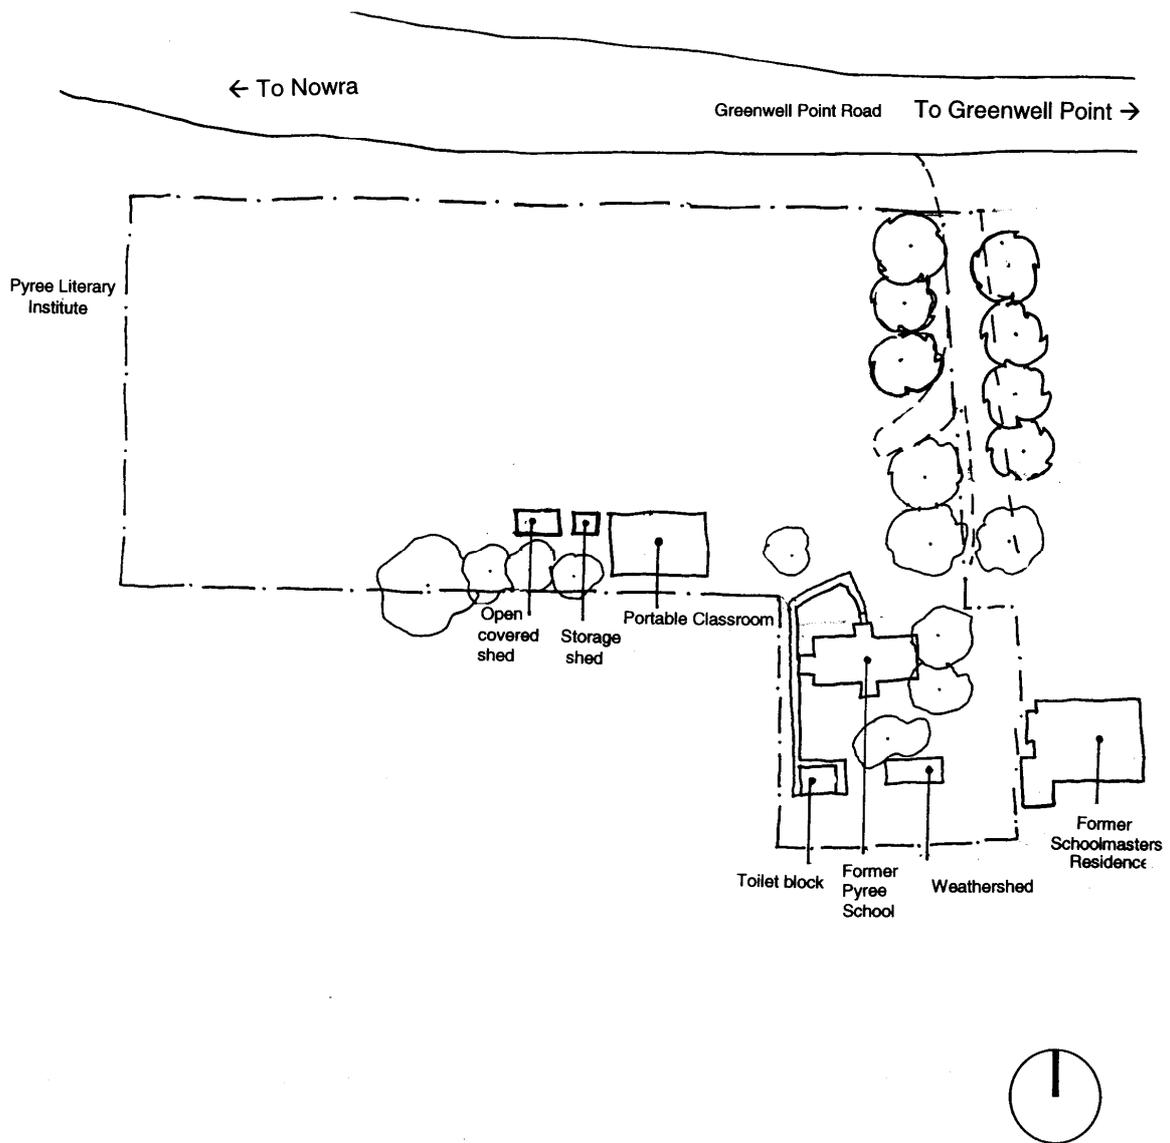
Figure No. 2: Subject Site

There are a number of areas within the subject site which hold archaeological potential including the following:

- The areas to the south east and south west of the subject building which contained toilet facilities (Note: the area to the south west has lower archaeological potential through its disturbance in order to construct the existing toilet facilities).

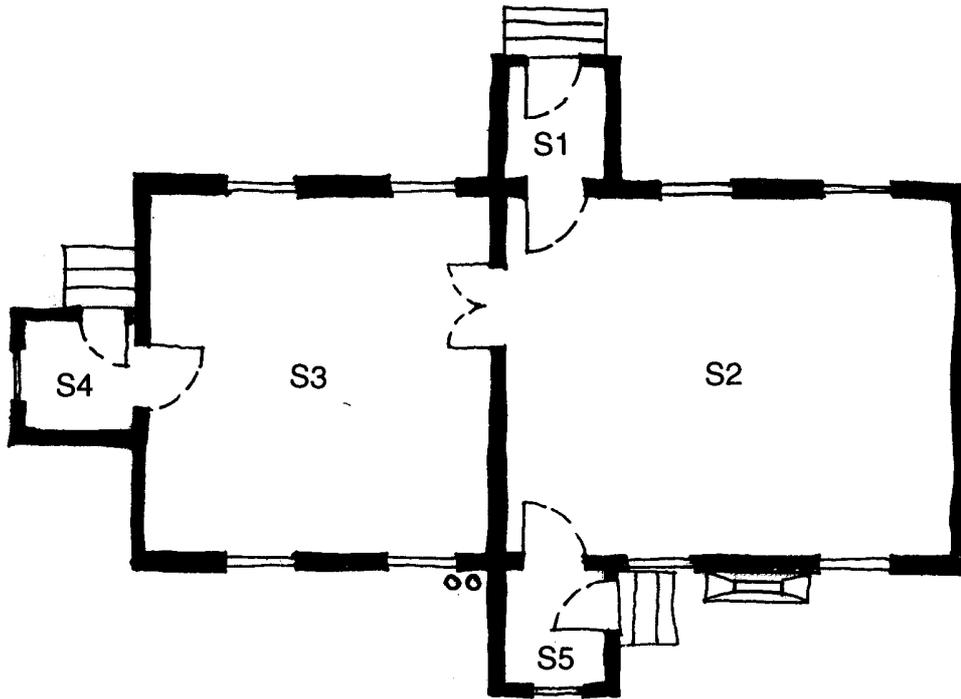
Figure No. 3: Subject Building

Please refer to Figure No.3 – Subject Building

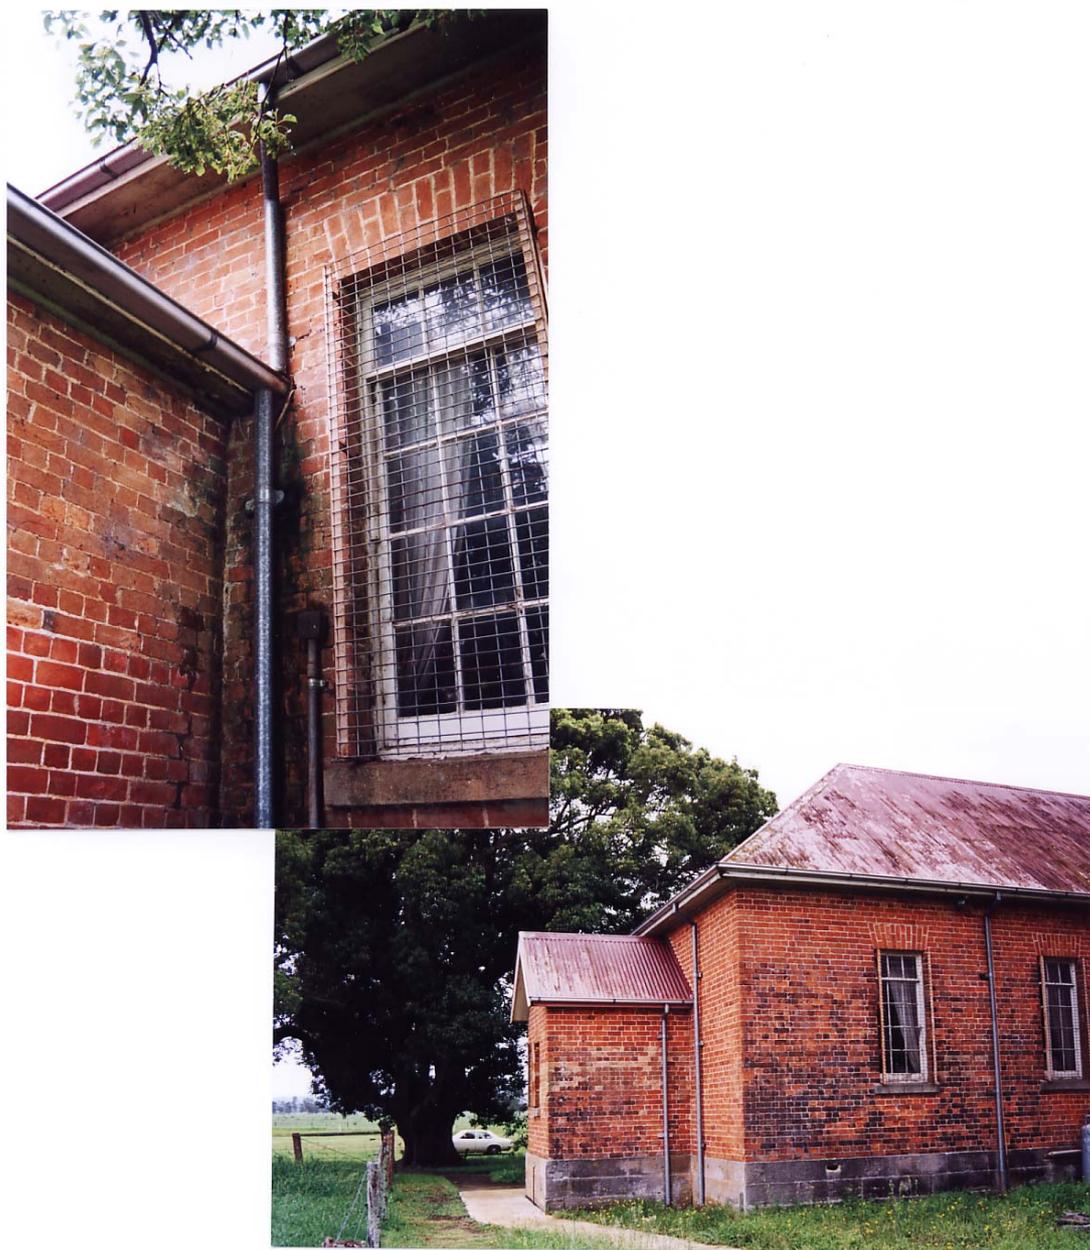
Figure 9 Detail of faulty drainage to the western side of the entry.
Figure 10 South/West corner of school building

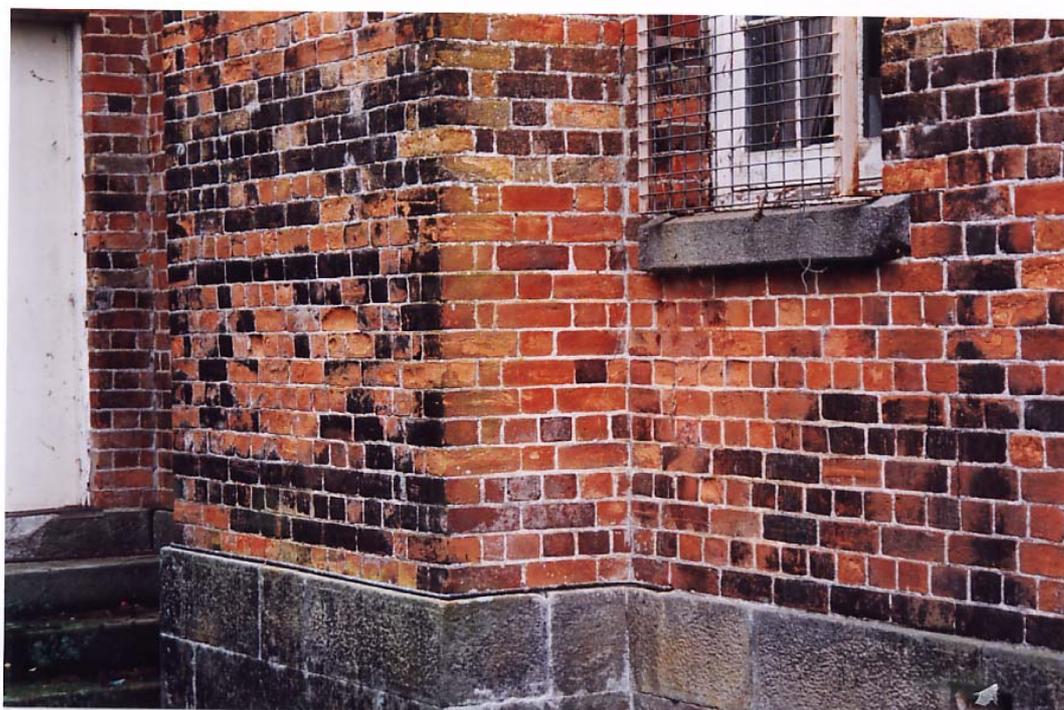
Figure 14 Detail of south-western side of school building, showing eroding brickwork.

This study in brief concludes that the Former Pyree School is in relatively good condition however there is evidence of water damage from a faulty gutter and the brickwork of the subject building requires urgent attention. The building's original form and interior configuration can be clearly understood.

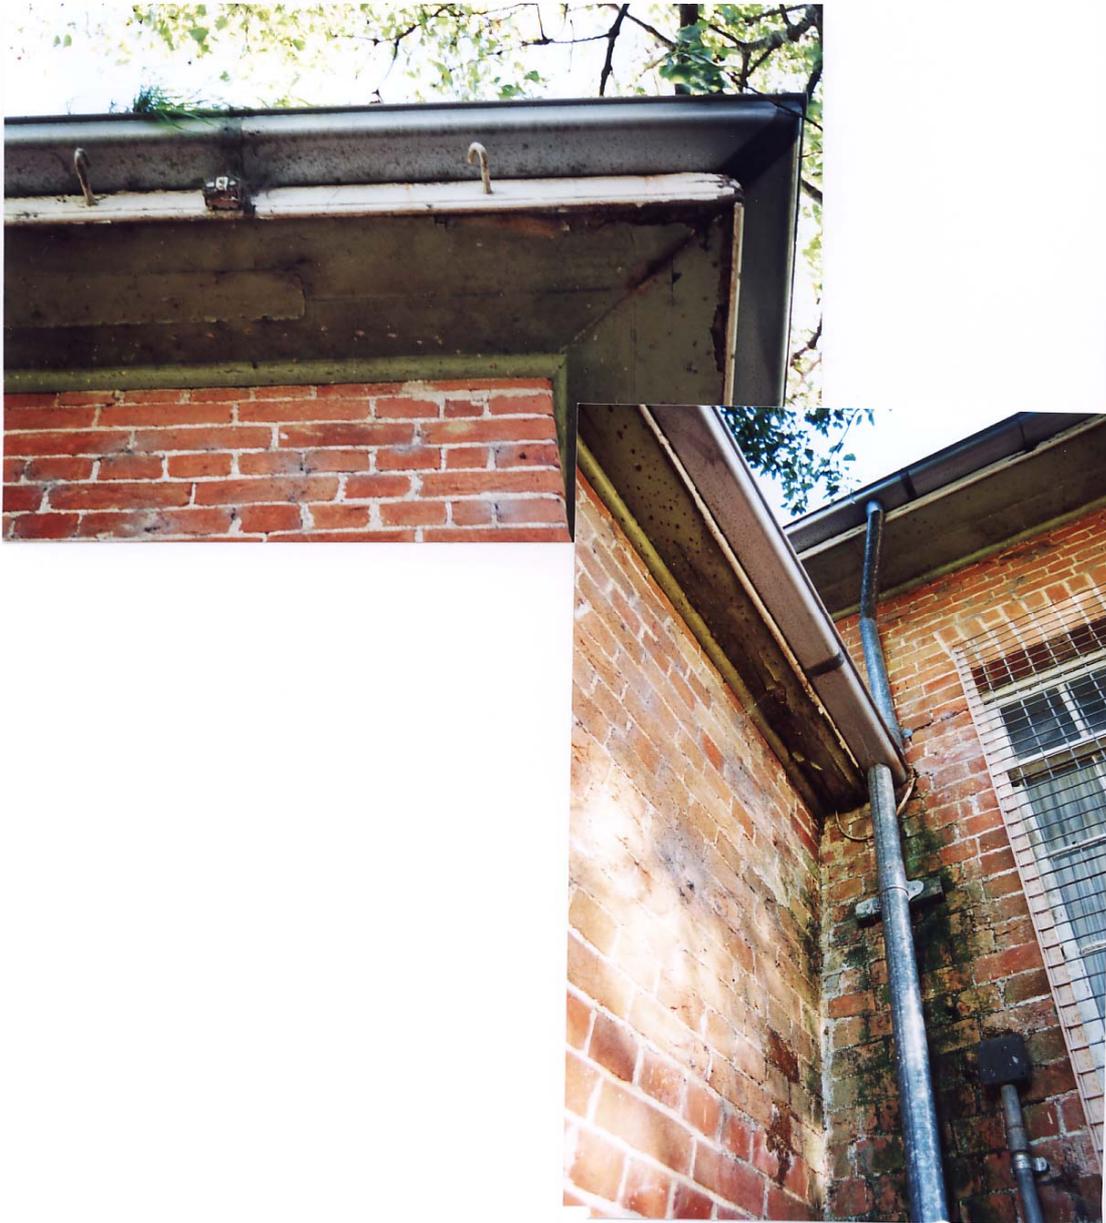
Figure 22 Gutter detail. Note water damage + vegetation growing from uncleared gutters.
Figure 23 Faulty gutter and down pipe detail.

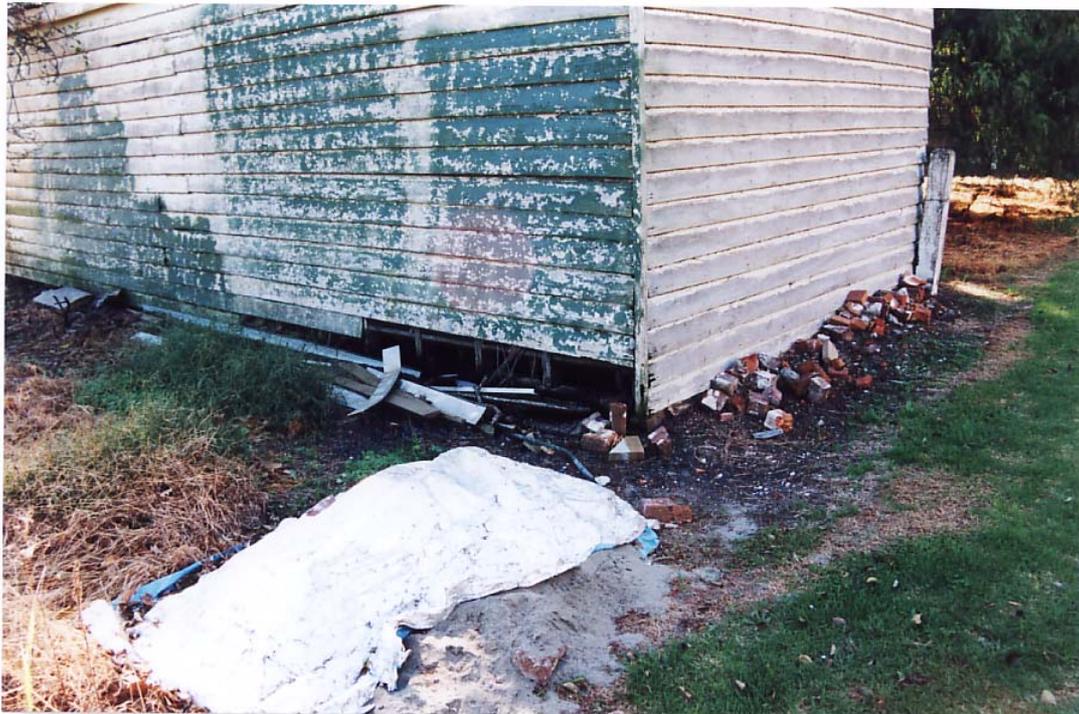
Figure 39 Damage to south wall of weather shed.

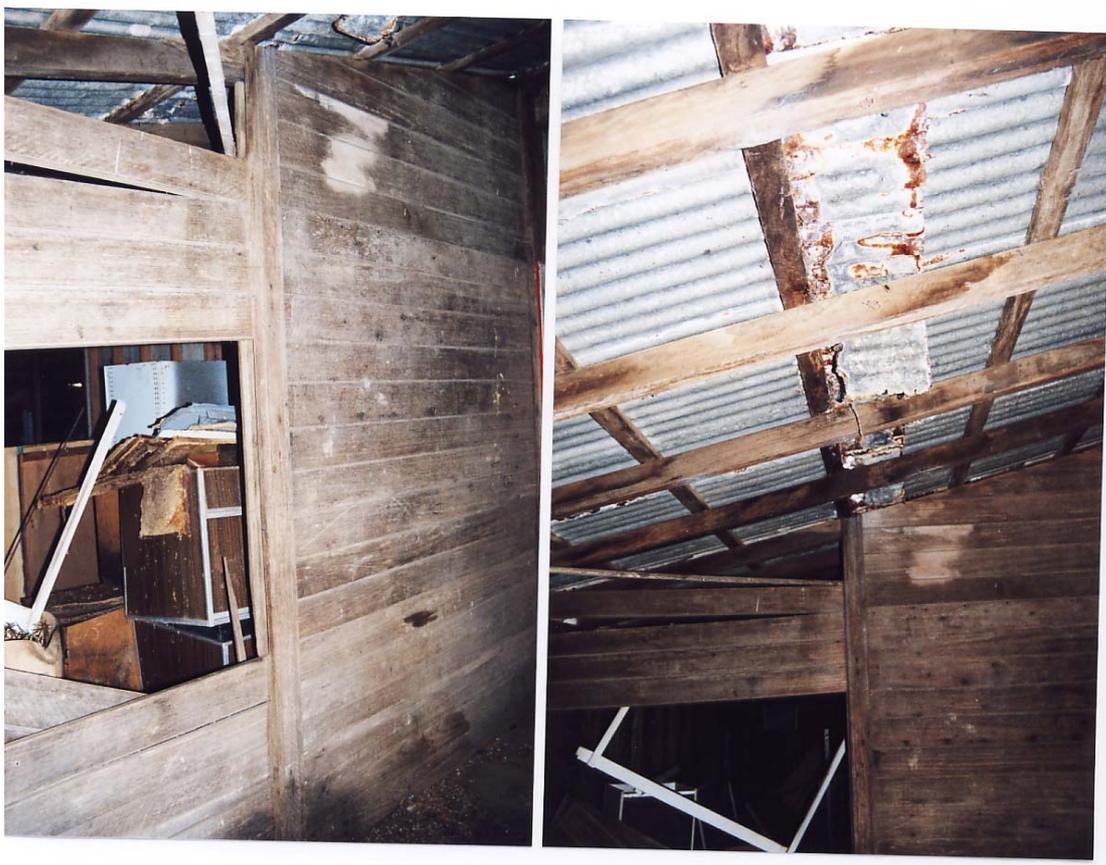
Figure 42 Weather shed interior – Note internal timber board, sliding dividing wall.
Figure 43 Sheet roof detail. Note rusting.

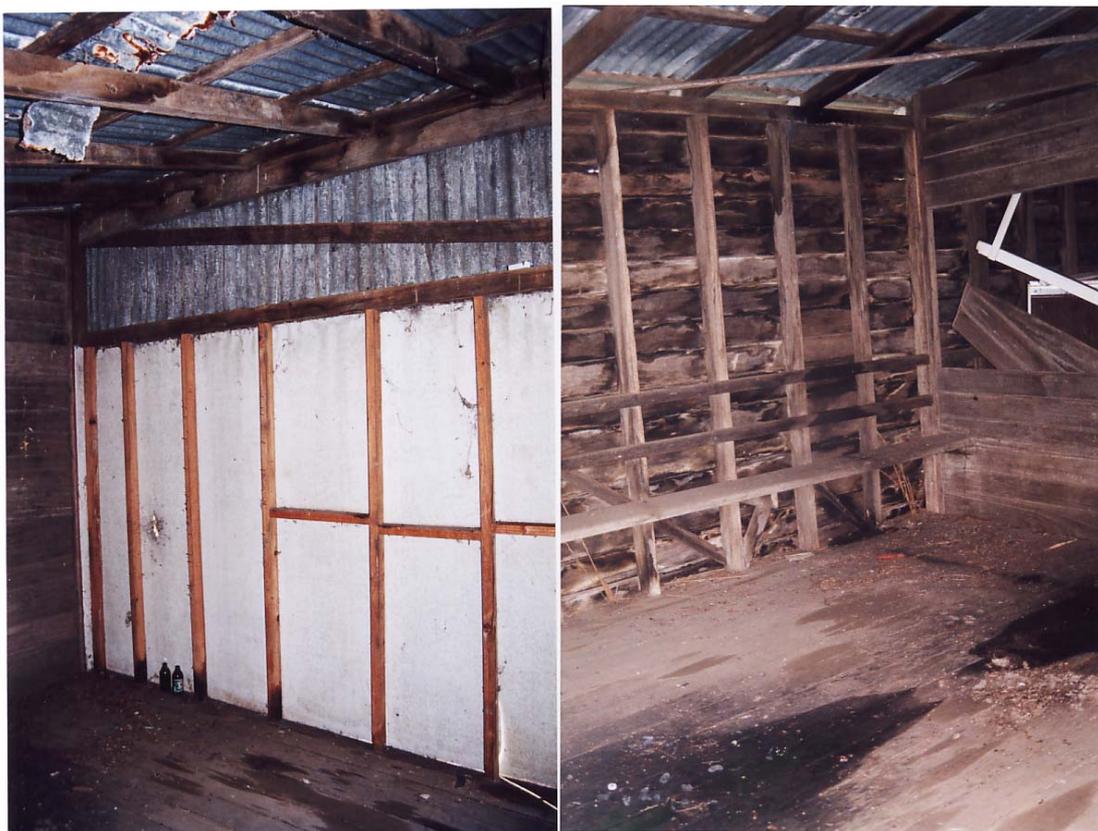
Figure 44 Weather shed interior – exposed stud wall.
Figure 45 Timber wall with attached seating.
