An initial assessment of the archaeological heritage of *Greenhills* Nowra, NSW.

September 1999

Heritage Archaeology

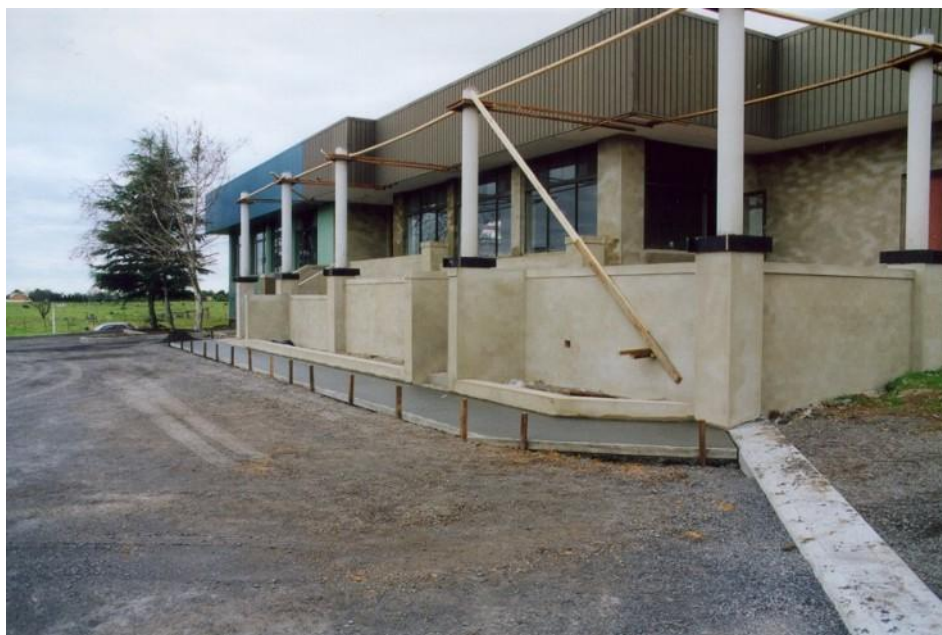
(f) Modifications to the remaining structure of the NBLC to provide handicapped access for the proposed Tourist Information Centre had been completed prior to archaeological assessment (Figure 2). Trenches for footings for foundations had been excavated, backfilled or had concrete poured for footings or floors prior to archaeological assessment.

Figure 2: Additions to the Tourist Information Centre to provide disabled person's access (8th September 1999).

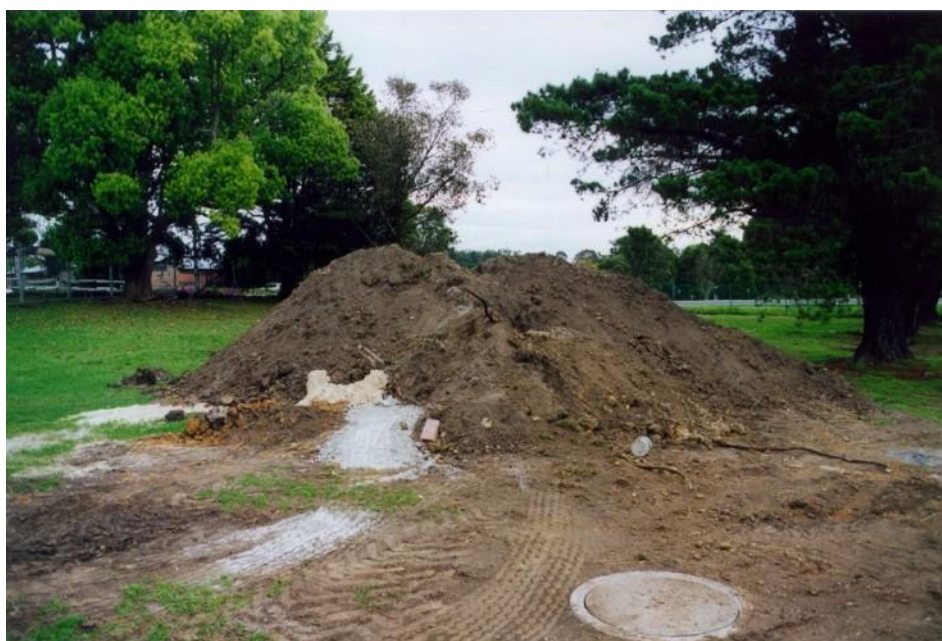
(h) Soil from the trenches dug for the footings of the building to construct the disabled persons entrance for the Tourist Information Centre had been deposited on the western side of the building on a grassed area. This grassed area contains archaeological relics and is considered to be the original ground surface associated with *Graham Lodge* (Figure 3).

Figure 3: Soil from footings for additions to the Tourist Information Centre to provide disabled person's access (8th September 1999).

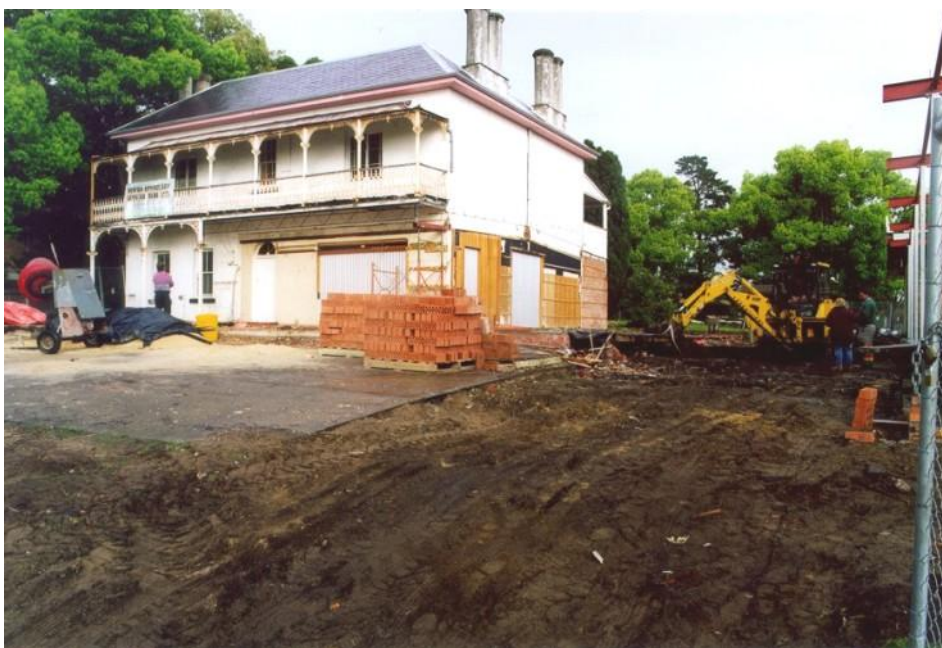
Construction work had commenced on the redevelopment of NBLC to the Tourist Information Centre. Demolition was also in progress of the remainder of *Prague Lodge* and the NBLC prior to the commencement of any archaeological assessment (Figure 4).

Figure 4: *Graham Lodge* site on commencement of initial archaeological assessment 7th September 1999.

Construction work and excavation dug for footings for foundations and floors, and utilities had caused considerable ground disturbance and had impacted upon or destroyed areas where archaeological relics were identified.

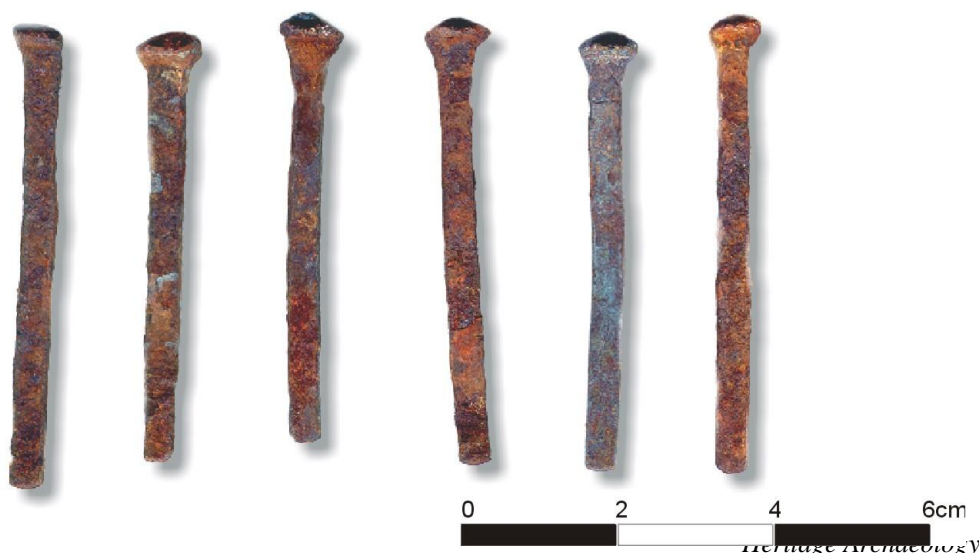
Nails from Roof - Located on GH09, GH10 and GH13

Rose-head nails were observed on the surface of unbroken ground on all perimeters of *Graham Lodge*. The nails are valued diagnostic material evidence that would have provided information as to working methods during the construction stage of the

Figure 5: Nails from roof and possibly the front verandah of *Graham Lodge*.

building. The nails are hand drawn steel, approximately 60 x 5 x 3 mm, with square heads (Figure 5).

Nails were obviously removed during the replacement of the slate roof, and were dropped onto the ground. This, in turn, has biased the integrity of archaeological evidence near the building. It has been confirmed on 15th September 1999, by Phil Gant, Architect, Vincentia, that the roofing material removed from *Graham Lodge* has been dumped in the Nowra rubbish tip. Further advice indicates that the original cedar battens used for securing the slate were also removed and replaced (Figure 6).

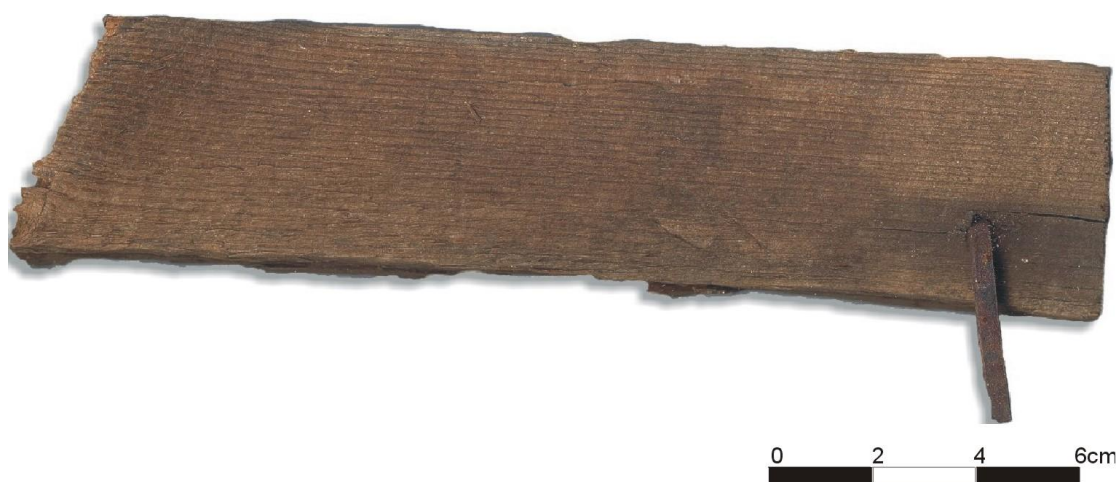
Batten and nail from Roof - Located on GH06

Figure 6: A remnant of a cedar batten with nail from roof of *Graham Lodge*.

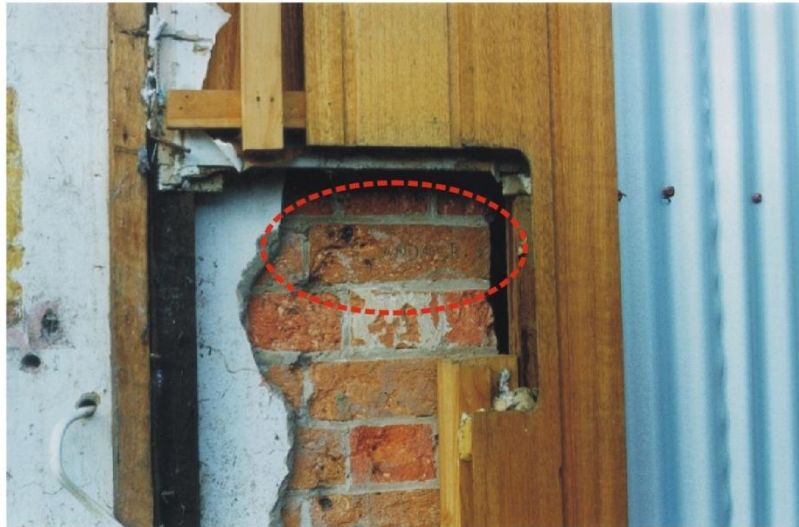
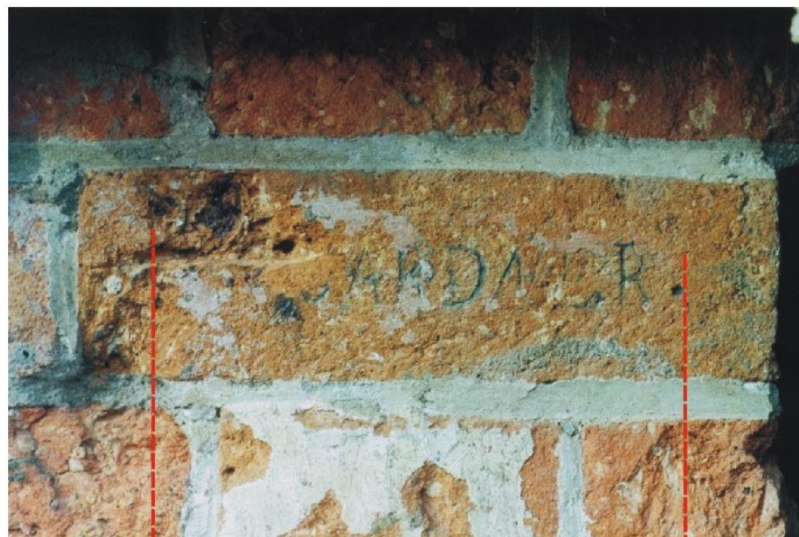
Possible dedication brick *Graham Lodge GH02/1*

The lettering appears to have been incised into the brick surface while the clay was damp and before firing.

Also within in the area of the brick damaged by the drilling for the fastening, it was possible that an initial 'M' for Mary Gardner or 'R' for Robert Gardner was also incised into the brick's surface.

It is important that this brick is conserved *in-situ*. It is recommended that the brick not be re-rendered, and that it be made an historical feature of *Graham Lodge* for educational and interpretive purposes of the building. It is suggested that the brick be covered with an appropriate protective glass cover to prevent damage from weathering. The glass may be drilled and held in place on the wall by suitable fixing screws and locks. As this will require further drilling of holes into the surrounding brickwork for mounting purposes, further archaeological investigation of the surrounding bricks is necessary.

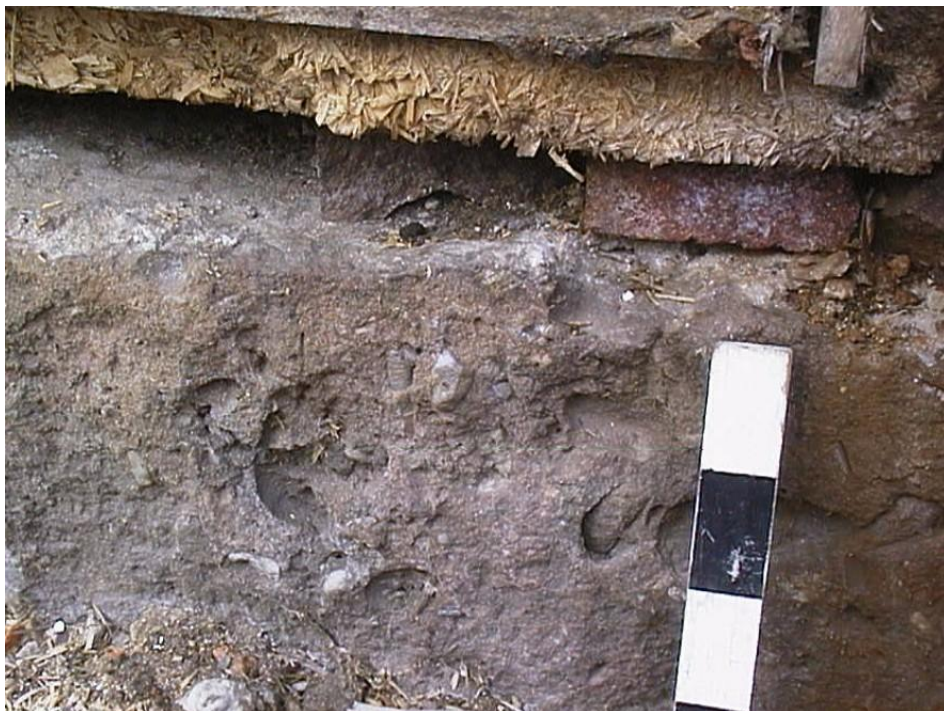
Investigation revealed that *Graham Lodge* was constructed upon foundations or footings of cut sandstone blocks. The source of the sandstone is obviously from a local quarry as the geology of the area supports extensive sandstone deposits. As a project in association with the later research on the construction of *Graham Lodge*, an effort should be made to locate the quarry used for early quarrying purposes. This has been achieved at *Retreat Farm* where the present *Murramarang House* was built in 1841. This house is also within the SCC area and is in private ownership. The sourcing of the sandstone quarry has, in this instance, led to a more complete interpretation of the construction methods adopted in the building of *Murramarang House* and the skills of the convict tradespersons.

The sandstone blocks in the foundations of *Graham Lodge*, apart from their importance as an indicator of early construction methods, contain various fossils such as brachiopods (Figure 8). This feature needs to be given important consideration as to its educational qualities.

Figure 8: Fossils in the sandstone footings of *Graham Lodge*. An interesting

It was reported that these foundations were to be covered by backfilling and possible landscaping during the redevelopment of the Tourist Information Centre. Backfilling that would cover these foundations is not advised, and should not be undertaken. Backfilling and retention of moisture may lead to a situation of rising damp that would eventually cause deterioration of the sandstone foundations. When the archaeological assessment is completed, it is suggested that the backfilling be taken to the level of the concrete retaining wall that was poured as part of the 1960s additions *Prague Lodge*.

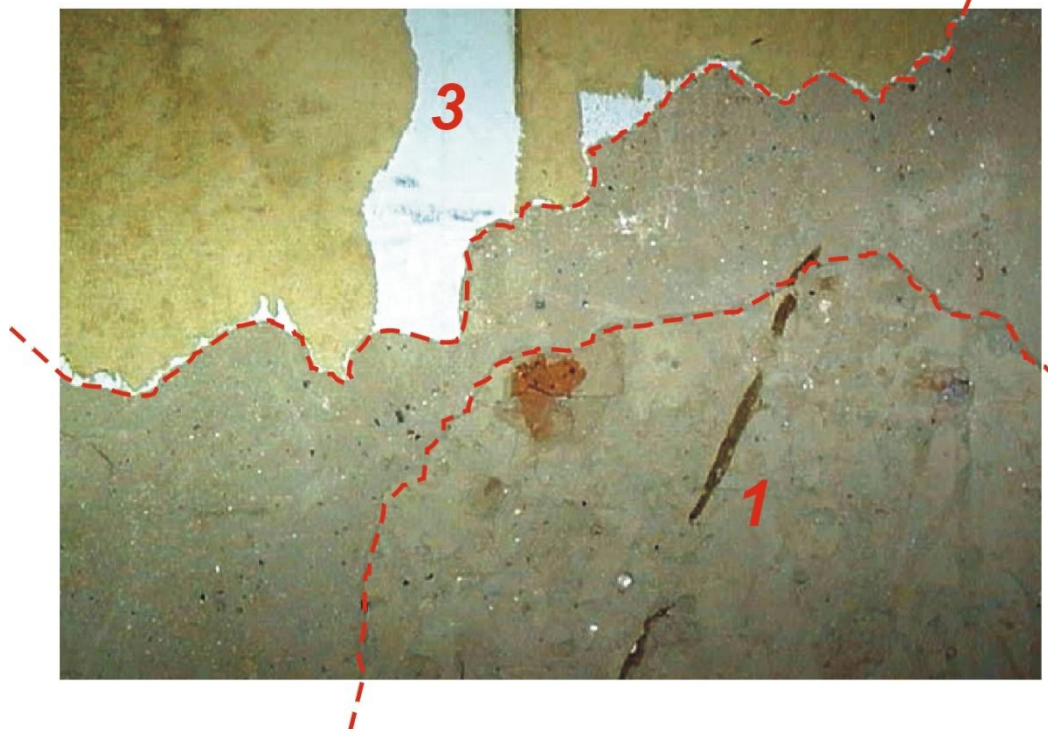
**Sequence of render and plaster on internal walls
Graham Lodge**

In an internal room (described as the lower floor sitting room or the storage room of NBLC) of *Graham Lodge* some areas of the walls have been degraded for the purposes of additional shelving. This has caused sections of the internal lining, eg. render, to be broken away from the internal brick walls (Figure 9). This degradation has exposed bricks and therefore the materials used in the manufacture of the bricks, the mortar, and the three coats of render demanded by James Graham from Charles Moore during the construction of the house in 1861. According to a *Memorandum of Agreement* between James Graham of Greenhill and Charles Moore of Nowra, Moore agreed to '... to do all the plastering of his new house at Greenhill ... giving the same three coats of plaster ... at the rate of 1/- per square yard ...'. (Florance in Freeman et al. 1999).

The second layer of render is approximately 10 mm thick and is a less coarse composition with less shell content than the first layer. The sand may have been sourced from the finer sediments of Pig Island. Identification of the shellfish remains present in the render may indicate the source of the sand. It is important to identify the properties of the primary material used in the render to establish the sources of material. This in turn would establish areas of resources that were exploited in the landscape during the establishment of *Graham Lodge*. Establishing these locations may lead to the locations of other archaeological sites such as quarries, clay pits for brick making etc.

The third and finer layer of render is primarily a plaster or Portland cement. It is smooth in texture and white in colour. Several coats of paint (and wallpaper, in certain areas) have been applied to the surface.

It is recommended that one of the rooms of *Graham Lodge* should be set aside in the condition in which it remains today. It should be set aside as a display room for the building methods employed in the construction of *Graham Lodge*. Areas that clearly show construction methods and examples of paint and wallpaper over the entire period of the occupancy of *Graham Lodge* should be preserved. Sections of slate, battens and nails from the original roof should be included in the display. A reconstruction of the method of fixing and fitting the original roof should be included.

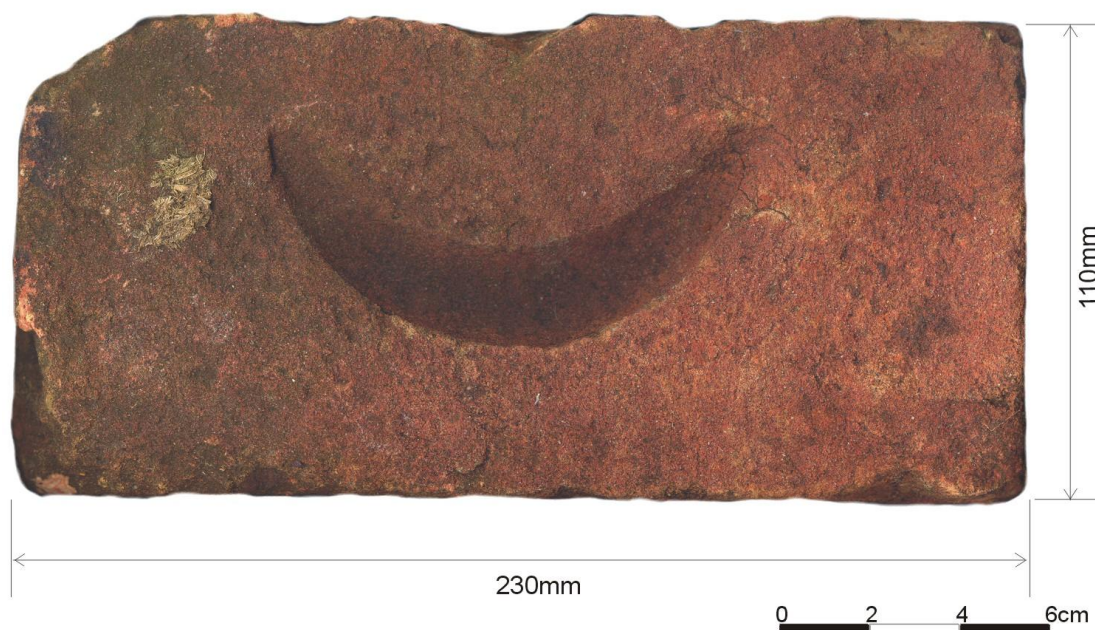
Clay Brick with Crescent frog - GH03

Figure 10: The extant remains of a building **GH04**, were located and comprise a pile of broken sandstone and bricks bearing the crescent shaped frog. A remnant of a similar brick was located on **GH06**.

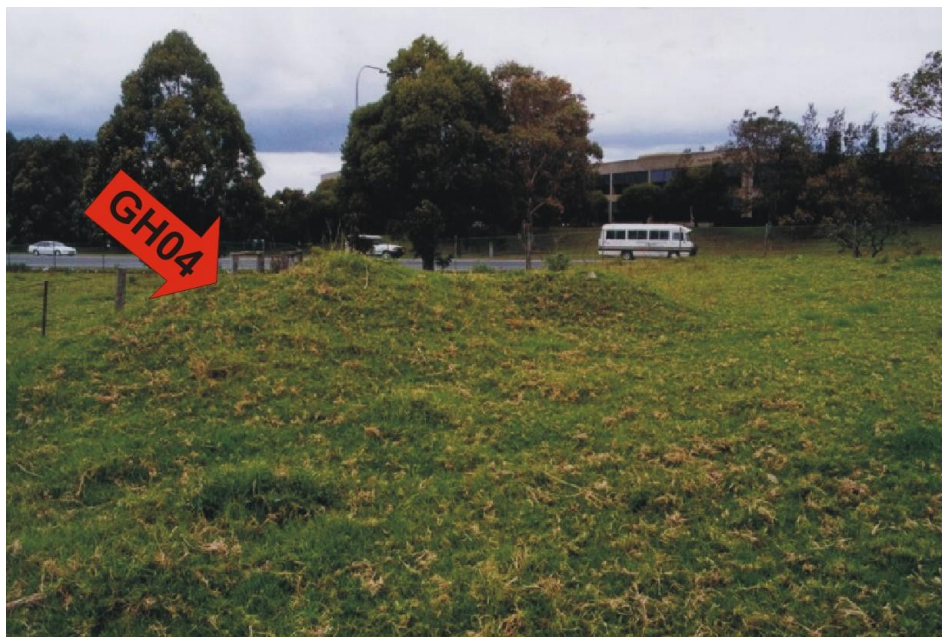
Figure 11: The remains of a building **GH04**, containing the bricks with the crescent shaped frog.

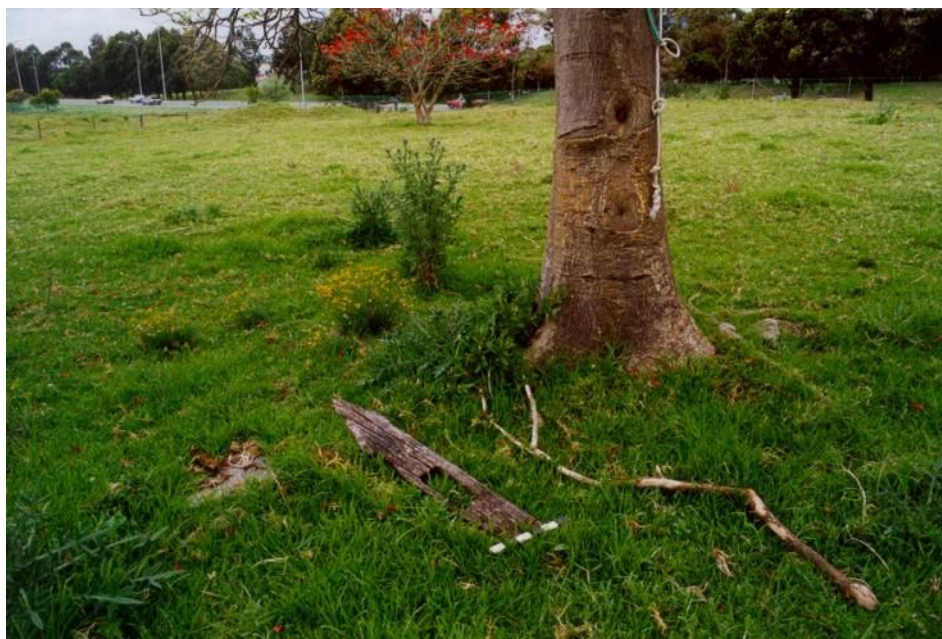
Figure 12: The remains of a building, containing bricks with the crescent shaped frog. Also present is a section of split rail fencing. Split rail fencing is included on several of the historical paintings of *Graham Lodge*.

The remains of several other buildings in this area also contain similar red clay bricks with a crescent shaped frogs (Figure 12). Arguably the fragment of red clay brick,

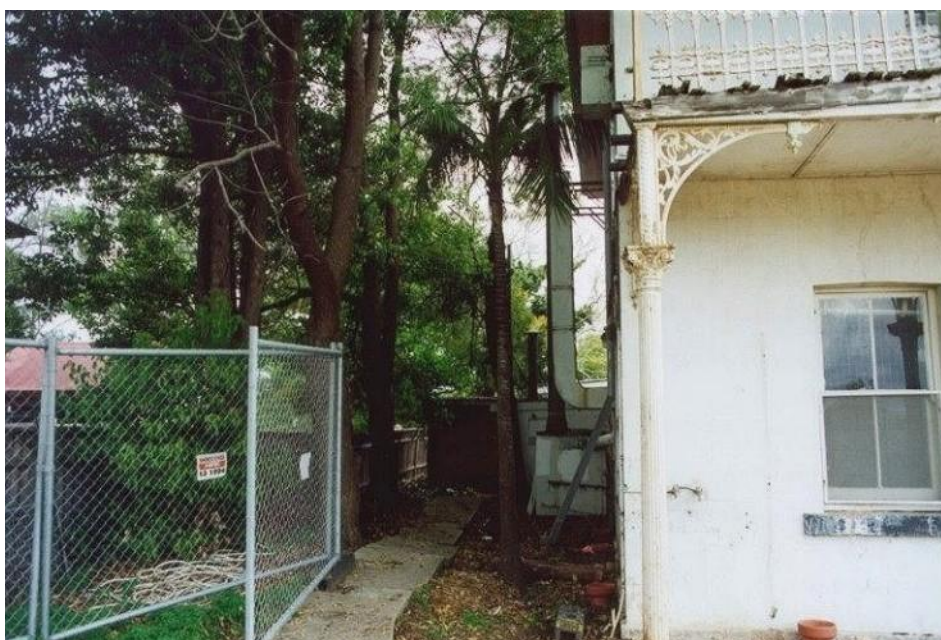
Figure 14: Site GH05

Relics from GH05 - (Remnant of Garden)

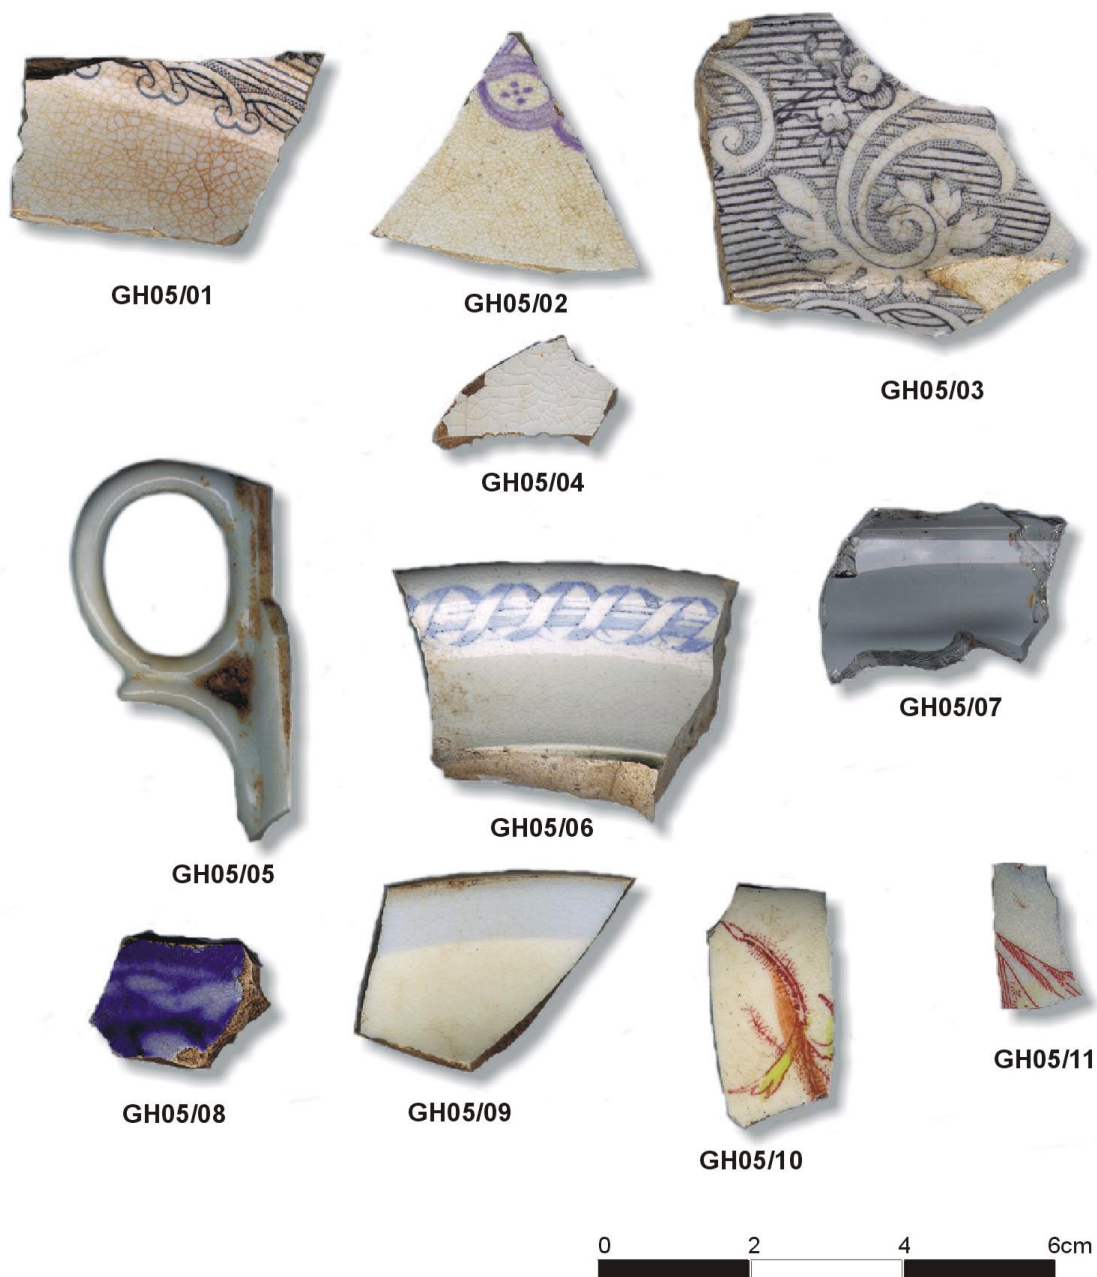
Figure 15: Examples of relics of domestic use digitised on site. Leaf litter covers many relics on site.

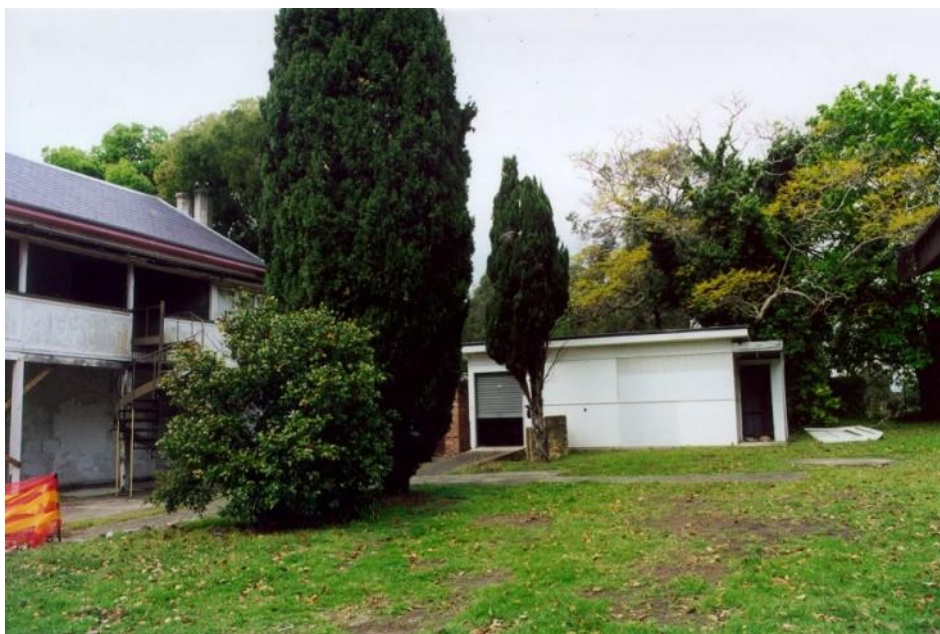
Figure 16: Show the sites **GH06** and **GH07**. The sandstone pathway is immediate to the rear of *Graham Lodge*.

Immediately behind *Graham Lodge* two buildings used as a toilet and storeroom (Figure 16). Immediately beside this structure is a concrete path that partially covers

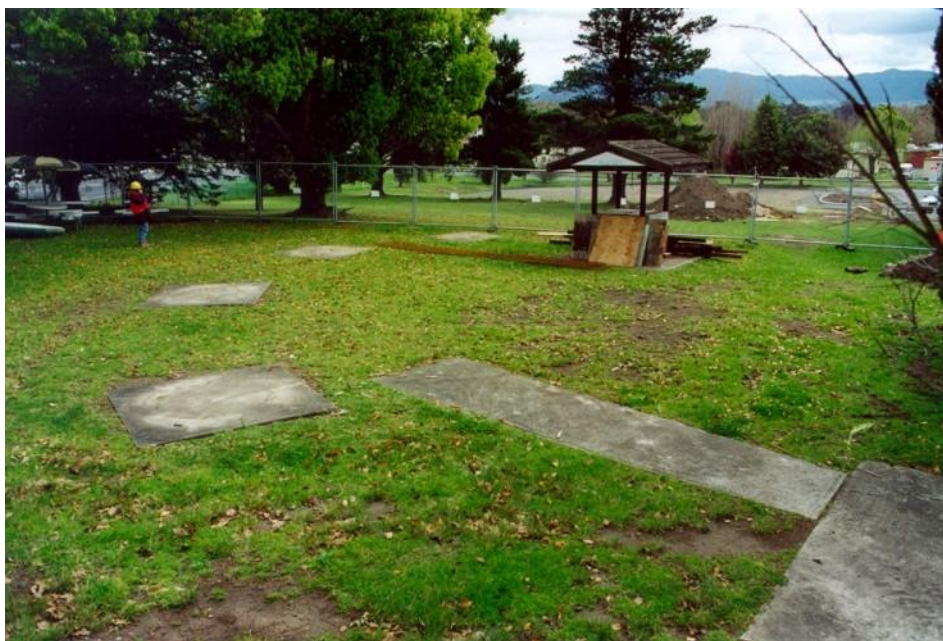
There is a open grassed area immediately to the west of *Graham Lodge* (Figure 17). Relics are present in most areas. Disturbance must be kept to a minimum until test excavations are completed in this area.

Figure 17: The rear garden site **GH08**. The removal of the concrete slabs should be undertaken as part of the test excavations. Relics are present in the grassed area.

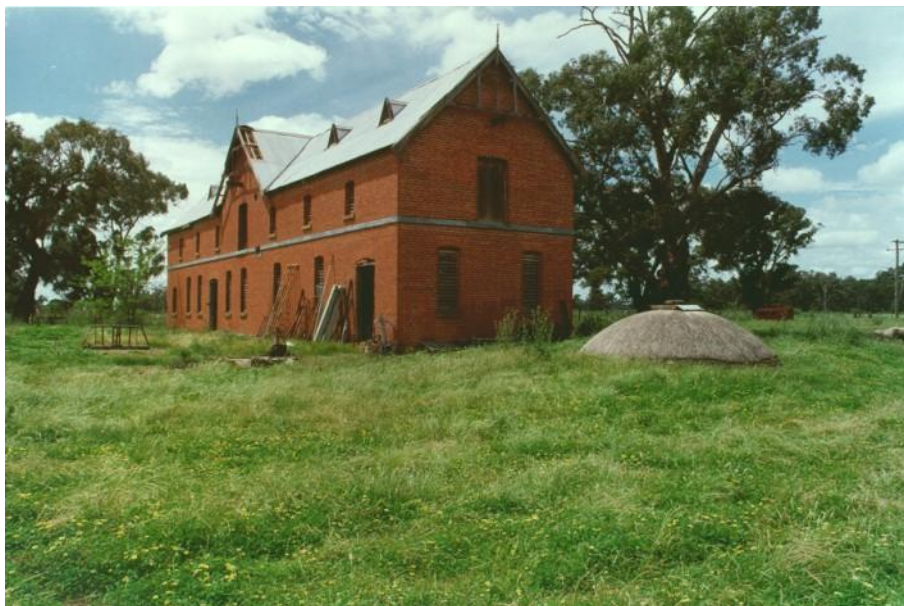
Figure 19: (above) An extract of the painting c1869 shows a feature that appears to be a domed well. This feature is to the rear of *Graham Lodge*.

Figure 19: (below) An example of domed well of a similar period on *Kirndeem, Culcairn NSW*.

In the immediate vicinity of this garden and to the west, is an indentation, approximately one metre in diameter, in the ground. The indentation has been backfilled. It is considered that this indentation is part of an early disused well. The 'domed' well is depicted in the painting, *Greenhills* c. 1869. An example of the construction of a domed well of a similar period is shown in Figure 19.

Test excavation in this area may also reveal the presence of the earthen floor of an early structure in close association with the well. This may have been the original dwelling of James Graham and Mary Gardner, later possibly used as a kitchen / quarters for *Graham Lodge*. Such a structure is depicted in the painting noted above (Figure 19).

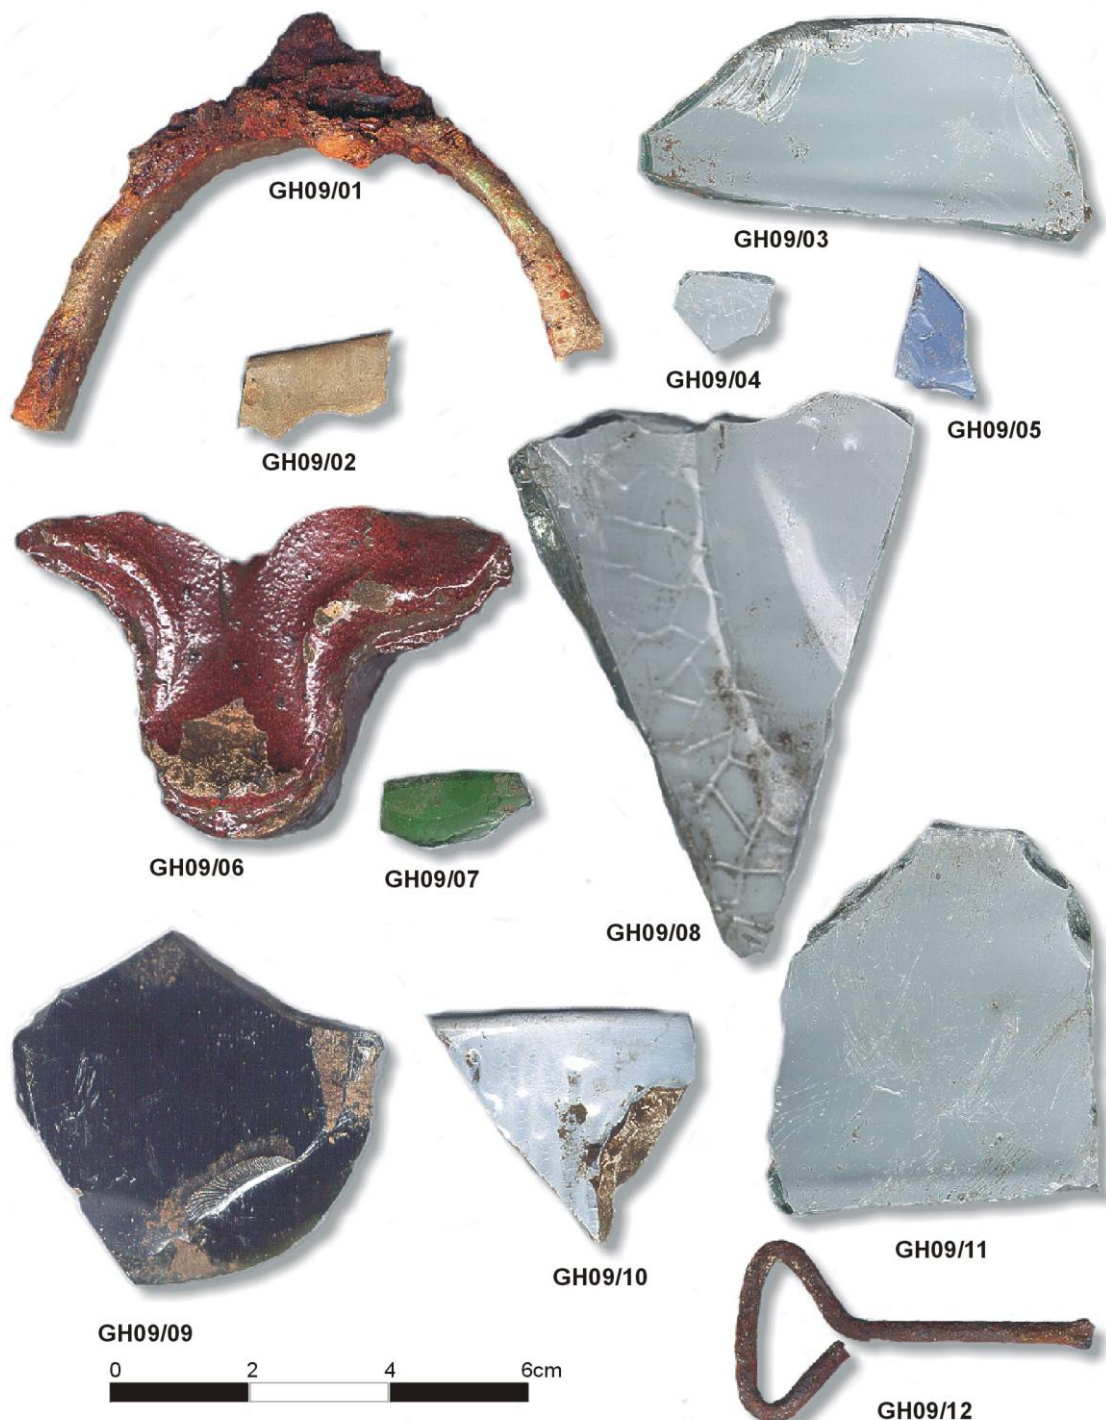
Relics from GH09 - (Front Garden [north])

Figure 20: Relics of domestic use, garden edging and a possible iron spur site for the backfilling of concrete pads for the various constructions.

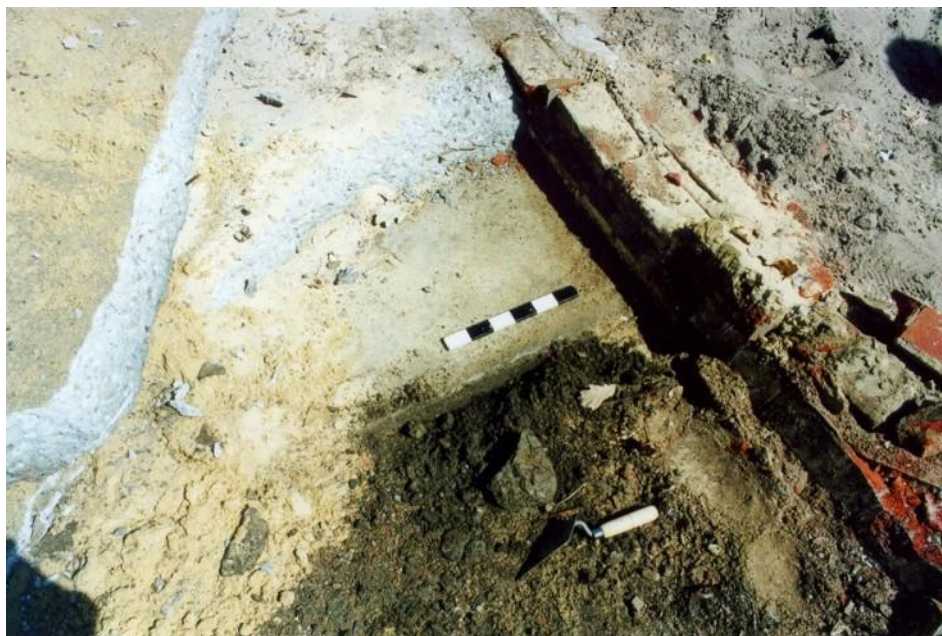
Figure 21: (top) Shows the four layers of concrete covering most of the site. The original ground layer and possible posthole can be seen in the lower right of the photograph near the trowel.

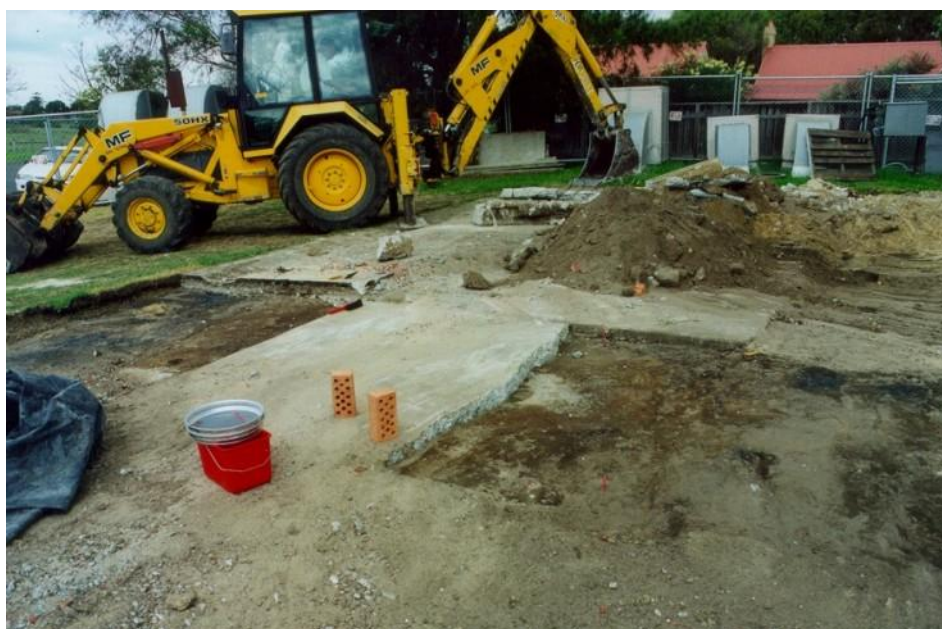
Figure 21: (middle) The lowest layer of concrete. The original ground surface can be seen to the left and right of the slab of concrete remaining in place.

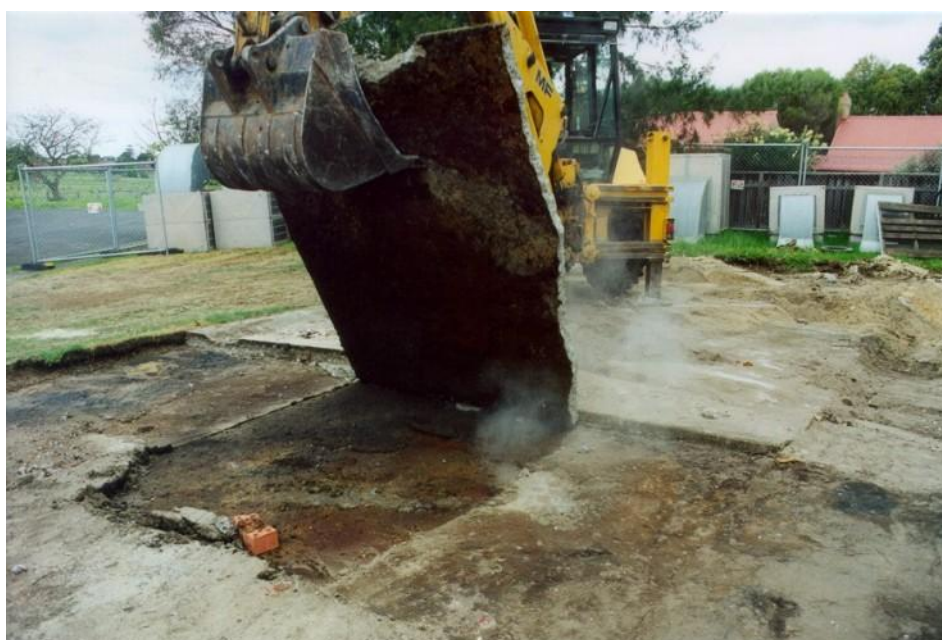
Figure 21: (bottom) The remaining slab was carefully removed. Domestic relics were located under this slab. Holes filled with a charcoal mixture are seen in the lower right hand corner of the photograph. It is possible that this may represent an early building site.

Test excavation may confirm the presence of an early structure.

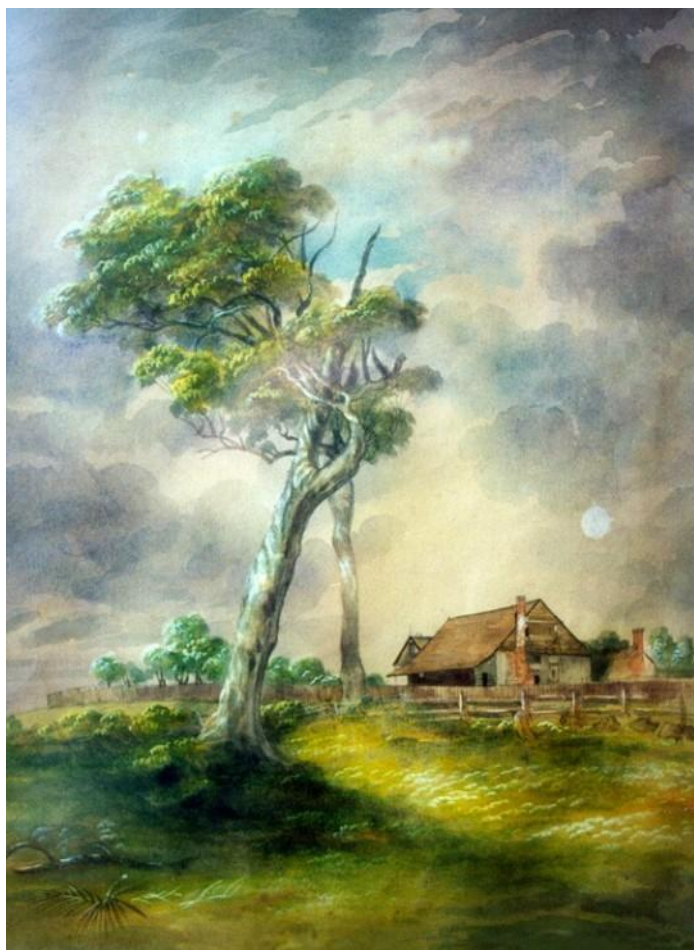
Figure 22: Painting from the estate of Alice Elyard, considered to be the first building on *Greenhills*. The postholes present (see Figure 21) may be associated with a building located where the structure is depicted in the painting.

Secondary historical evidence in the form of painting from the estate of Alice Elyard was noted. The painting was loaned for evaluation and copying (Figure 22). The painting depicts a structure reputed to be the original building on the site occupied by *Graham Lodge*. While some contention exists as to this painting representing the *Graham Lodge* site the position of the main fireplace must be considered in respect to the archaeological remains noted on site. The position of the fireplace in the painting closely aligns with the location of the archaeological relics exposed when the concrete was lifted from the garden area **GH09** (Figure 21).

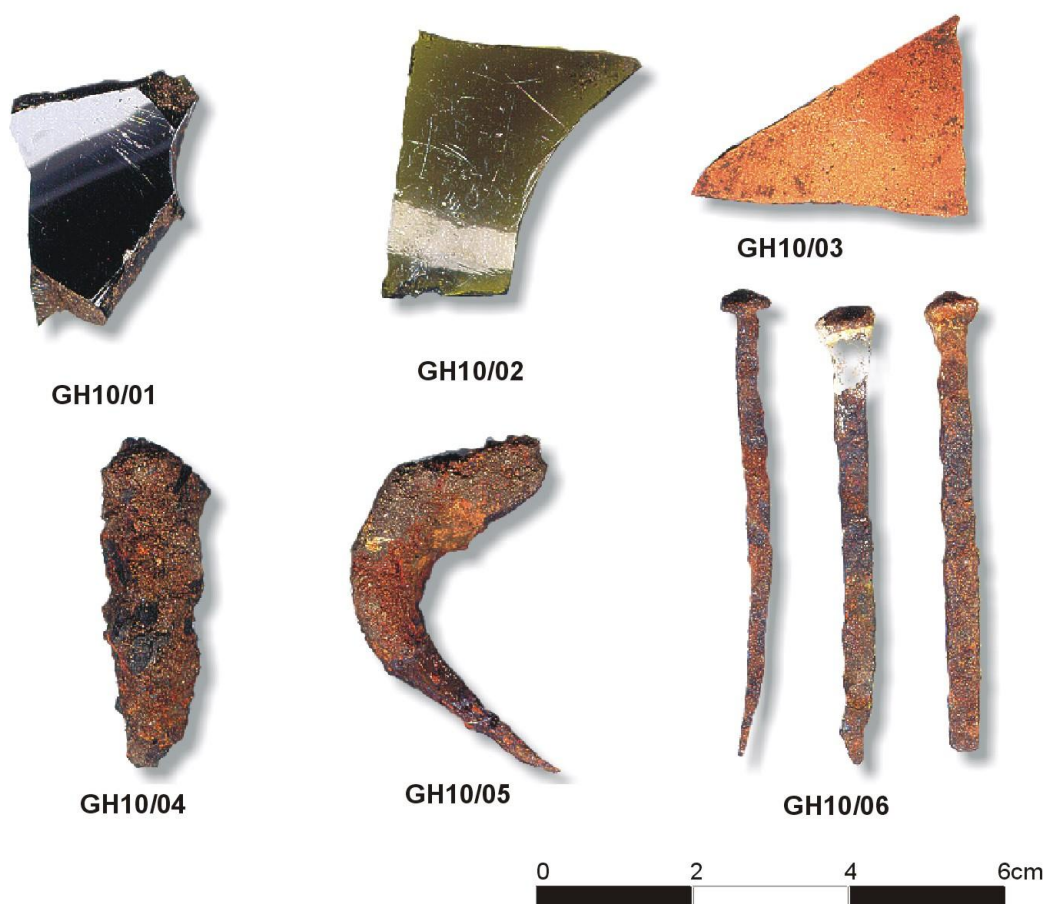
Relics from GH10 - (Front garden [south])

Figure 23: The relics are interesting in that they do not represent domestic use. The steel and iron relics are building fixings. The glass and pottery (the only piece of fired clay pottery located on site) are associated with alcoholic beverages.

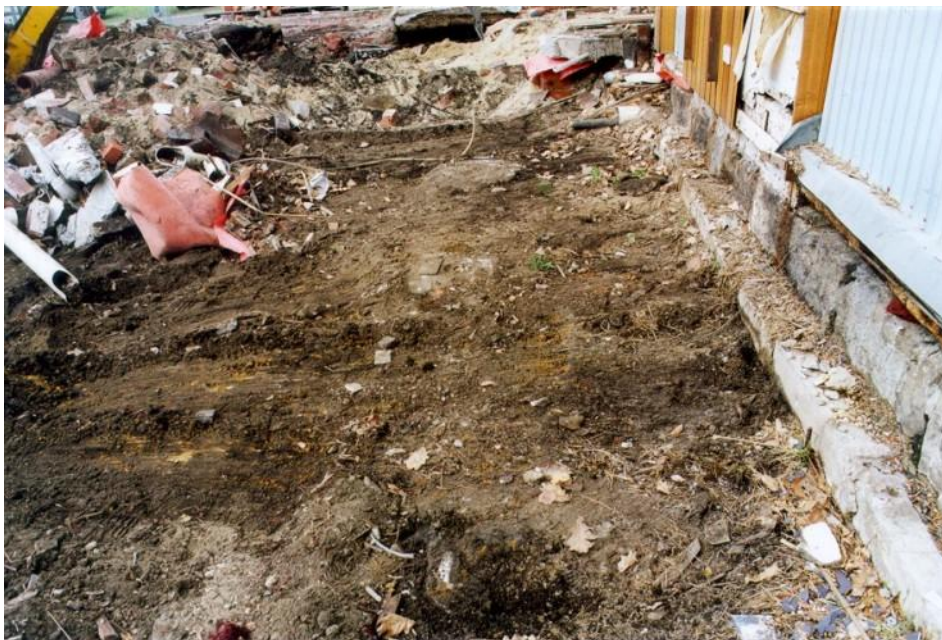
Figure 25: The footings of the foundations of the old Prague Lodge were left in place during the demolition. It is considered that the original ground layer associated with *Graham Lodge* is present. Relics are present in this area.

This area has been subject to previous disturbance during the construction of *Prague Lodge* and other construction events. This area has been greatly disturbed on the surface and rubbish from various commercial activities is present. However, there are several areas in which the original ground surface considered to be associated with the occupation of *Graham Lodge* can be identified (Figure 25).

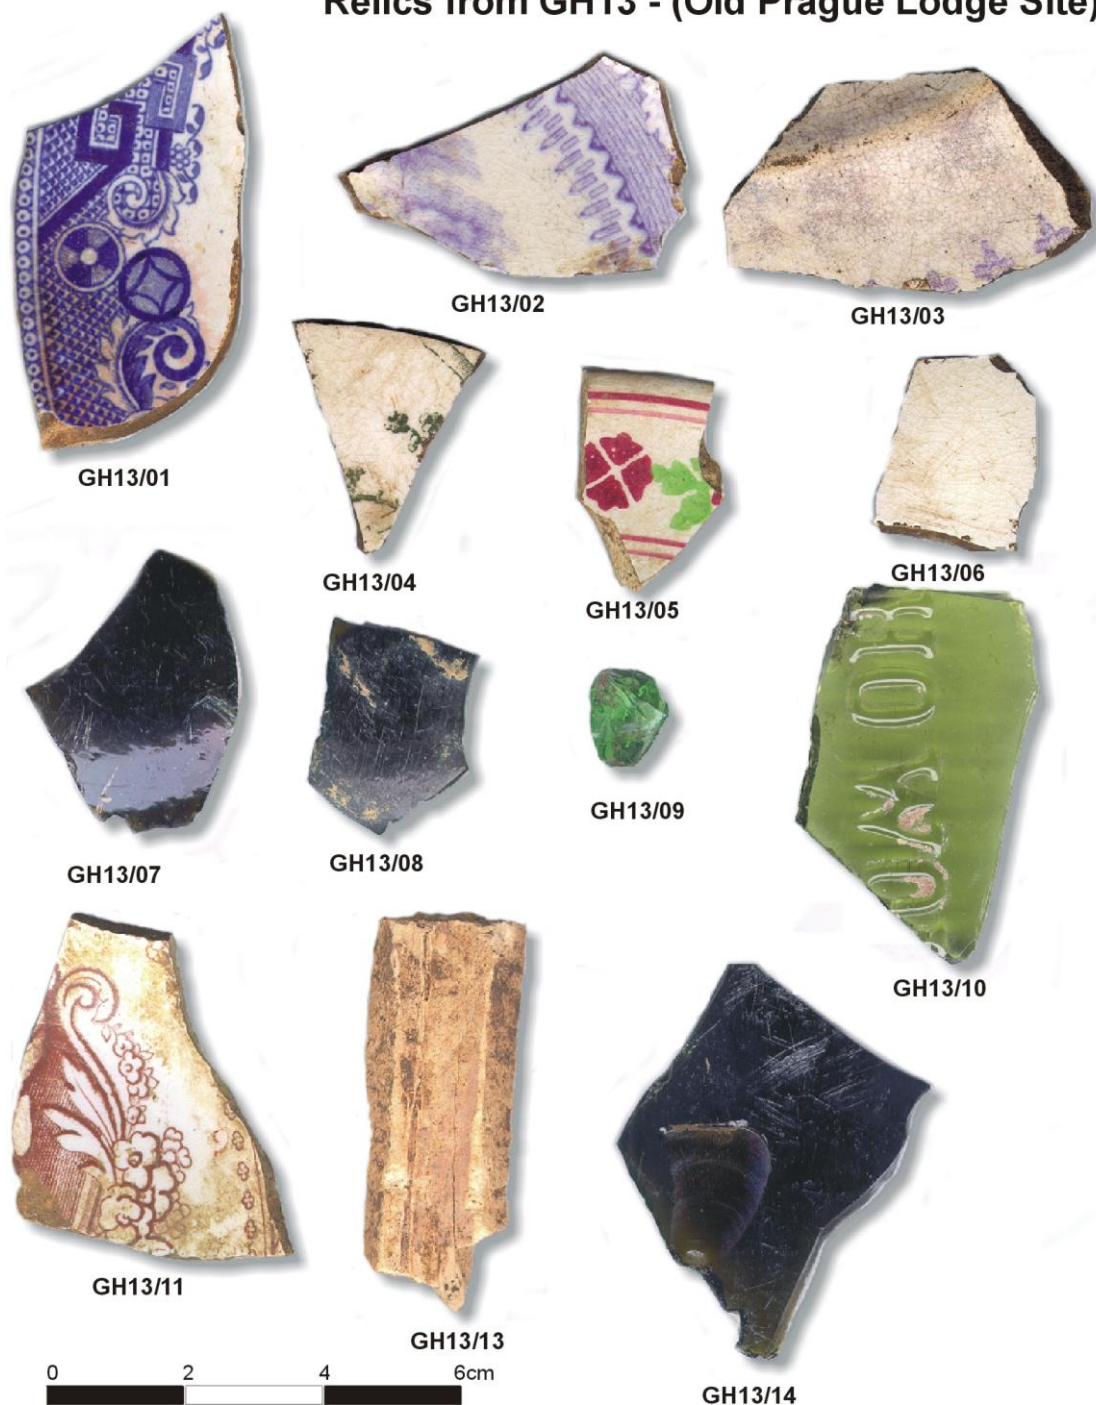
Relics from GH13 - (Old Prague Lodge Site)

Figure 26: Relics are present on the surface in this area. They include relics of domestic use, alcoholic beverage bottles and animal bones. Test excavation in this area is essential.
