An initial assessment of the archaeological heritage of *Greenhills* Nowra, NSW.

September 1999

Heritage Archaeology

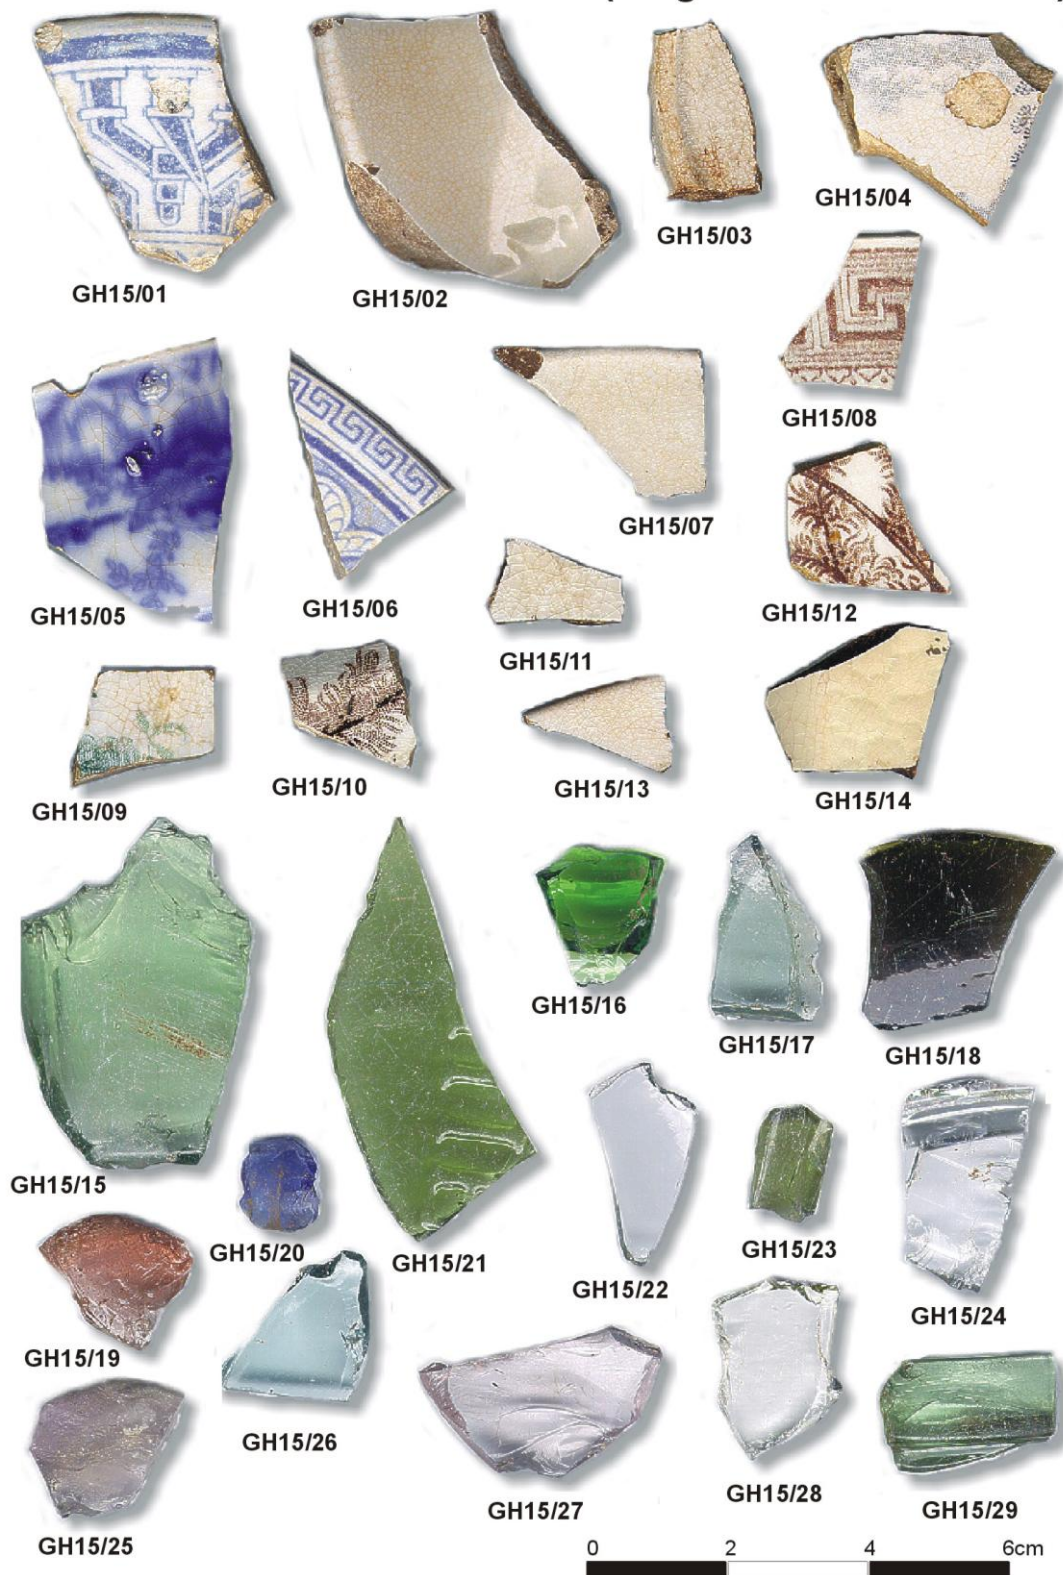
Relics from GH15 - (Verge to Hawthorne Ave)

Figure 28: Installation of electrical cable or grading of the car park has disturbed relics in this area. Test excavation may confirm the original context of the relics.

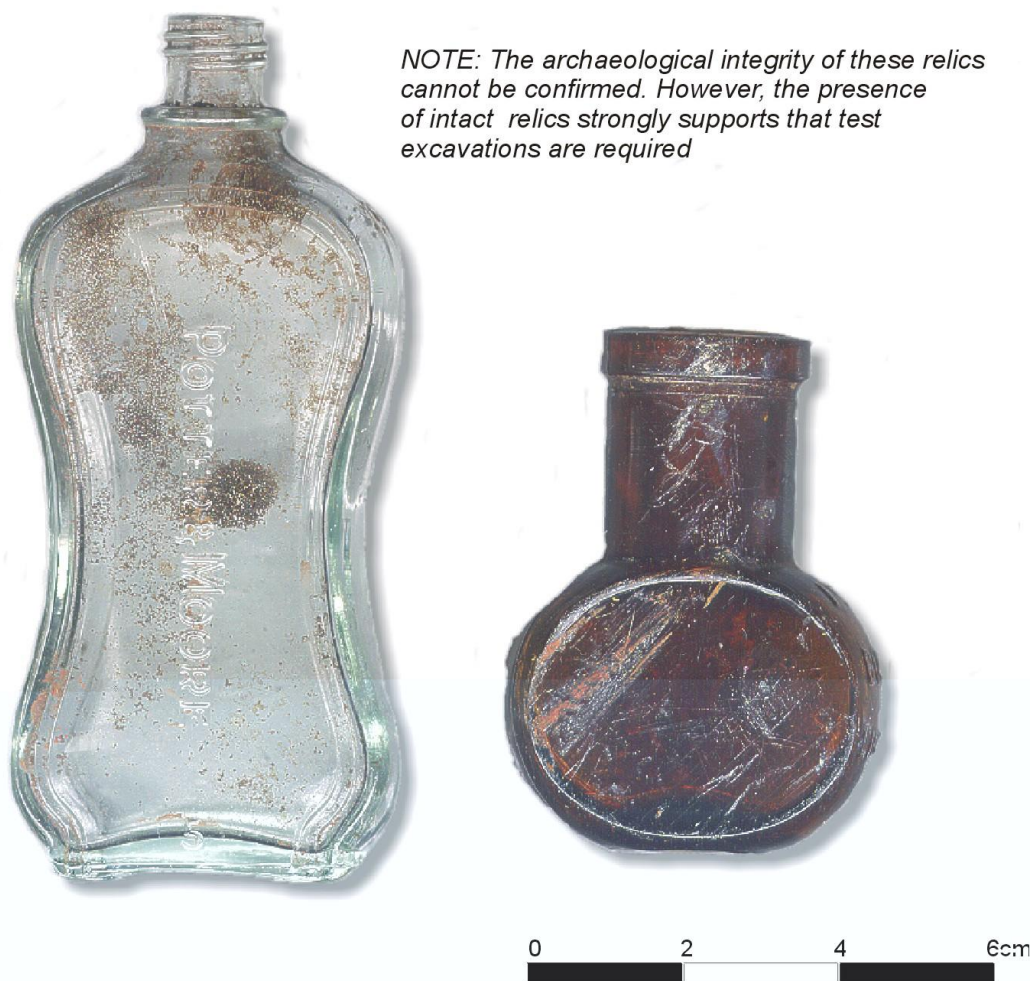
Intact bottles recovered from fill dug from footings for foundations

Figure 29: Complete relics were identified on site. The digging of trenches for footings for buildings had exposed these relics.

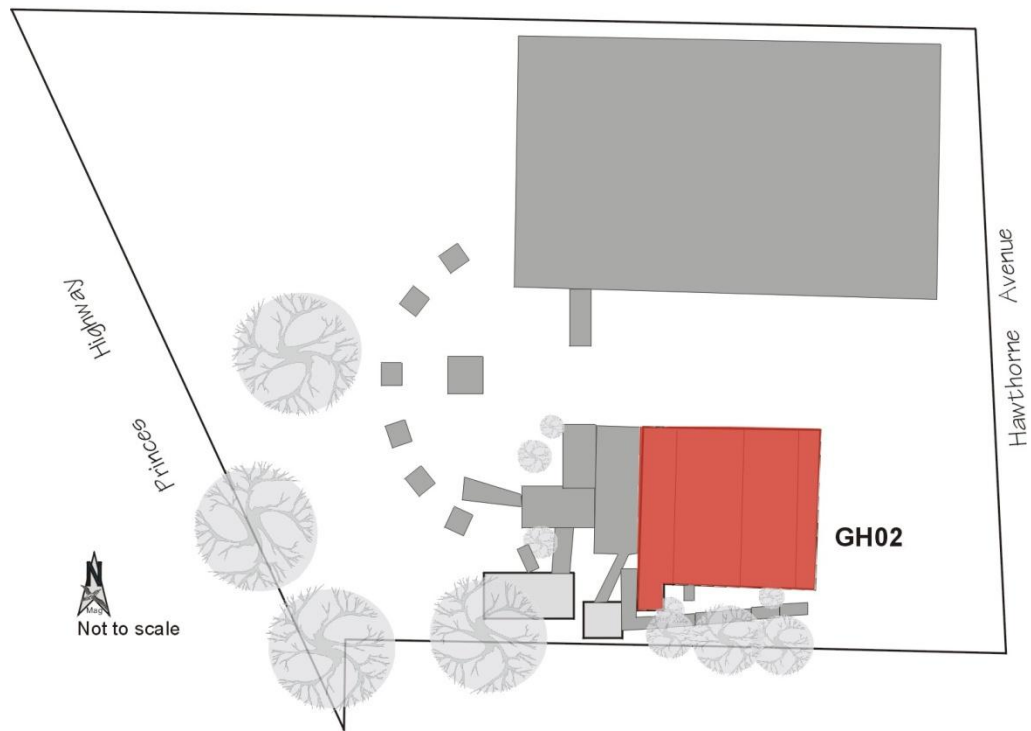
Location Sketch of GH02

GH02 Graham Lodge:
Relics are present on the surface in this area.

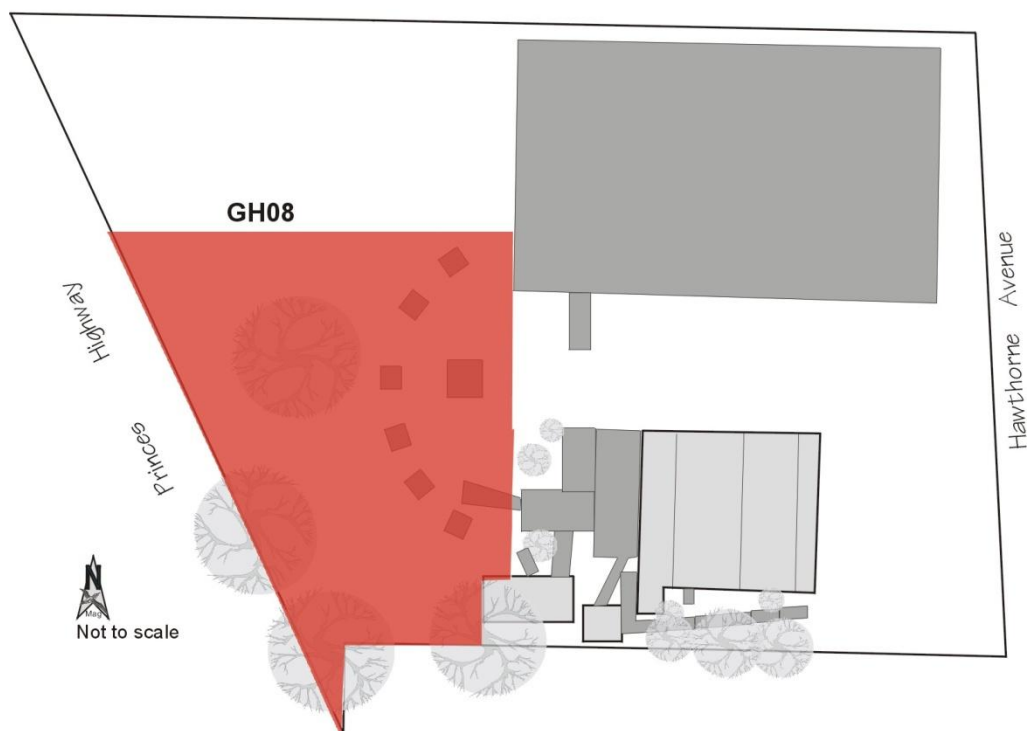
Location Sketch of GH08

GH08 Rear Garden:

Relics are present on the surface in this area. This area is comprised of a large open grassed area with the remains of six concrete slabs formerly used to support umbrella tables. The slabs should be removed while an archaeologist is present, and preferably as part of the test excavations. Testing should also be undertaken near the existing garden. Several historical paintings depict outbuilding in this location.
