MUIR HOUSE AND STABLES
BERRY NSW

**CONSERVATION MANAGEMENT
PLAN**

SHOALHAVEN CITY COUNCIL
BRIDGE ROAD NOWRA NSW

AUGUST 2001
REF: 0103: CMP

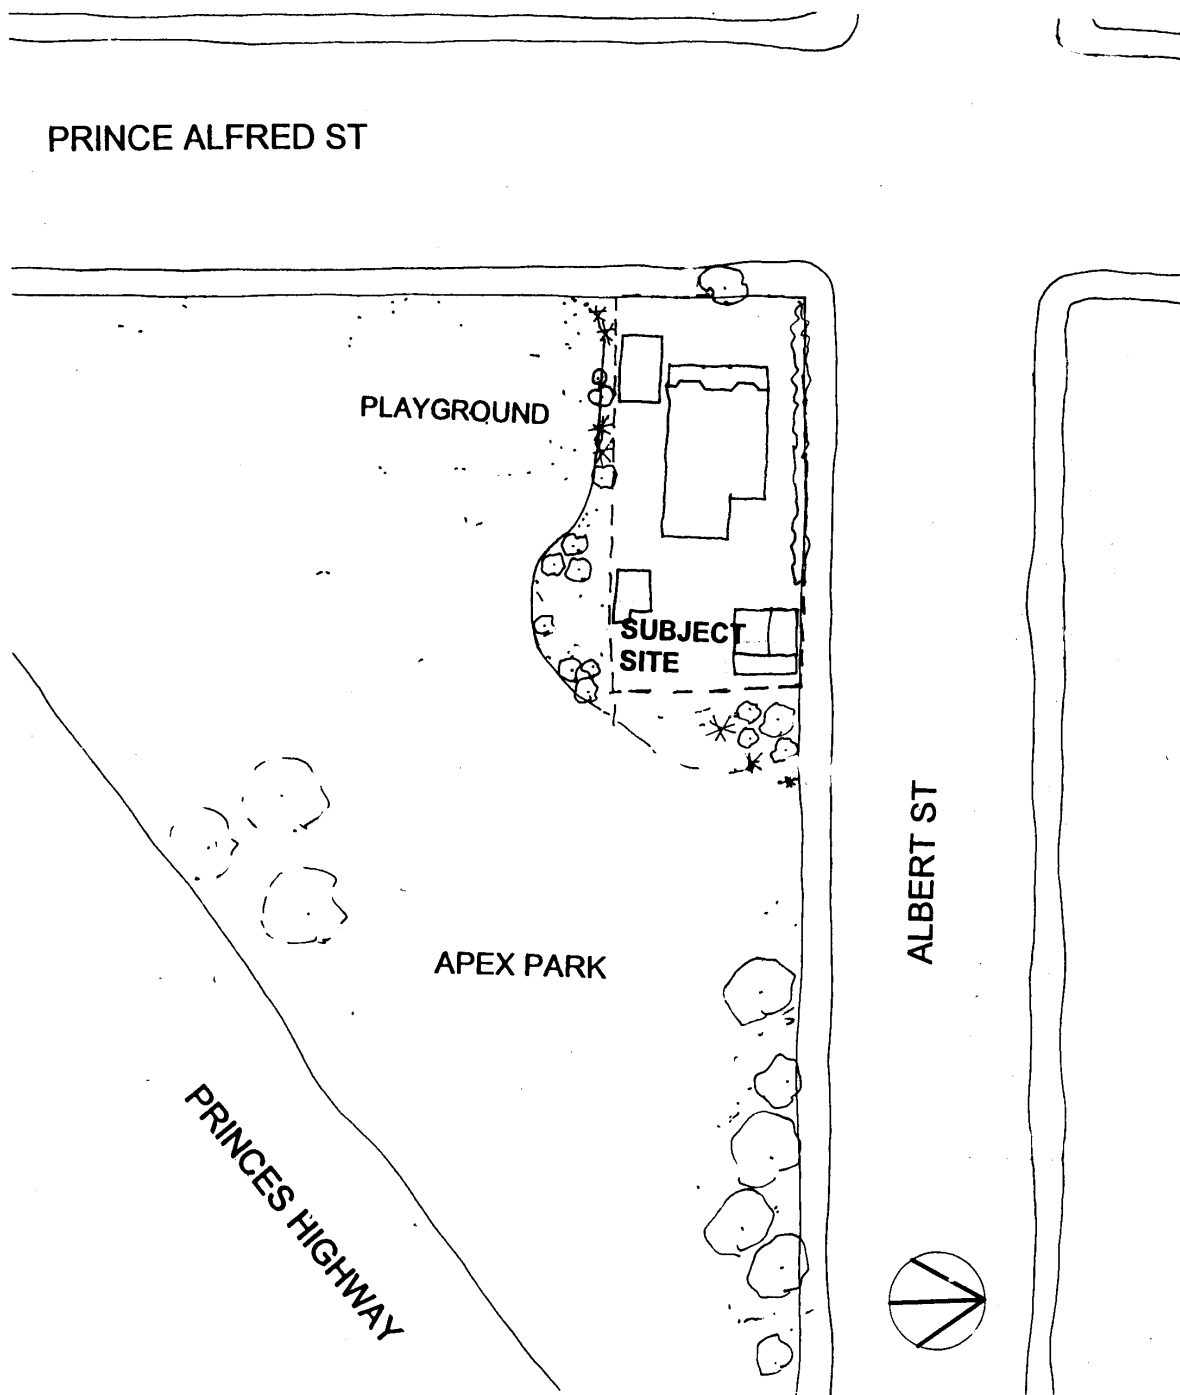
Figure No.2: Subject site

The subject site consists of a block of land at the intersection of Albert Street and Prince Alfred Street. The site contains the subject buildings (Muir House and stable building) and a concrete slab located to the rear of Muir House which is the remains of the laundry and attached toilet/bathroom. A weatherboard garage has been constructed to the south of the Muir House.

The site is fenced to Prince Alfred Street by a timber paling fence and to Albert Street by an early privet hedge (*Ligustrum lucidum*).

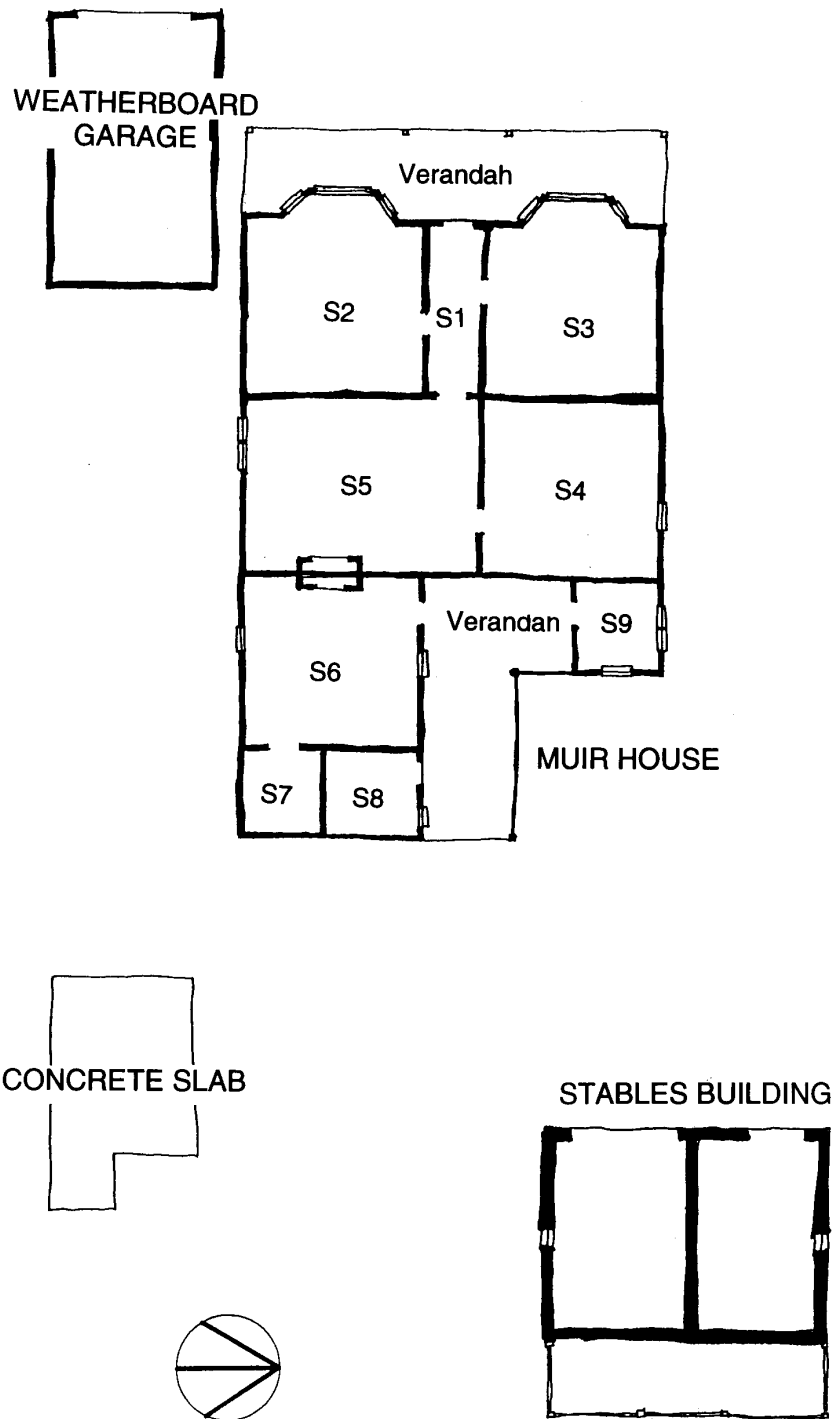
Figure No. 3: Subject Buildings

The interior of the stables building is divided into three spaces. It appears to have been rendered which indicates a previous use as a place for storing perishable substances; in this case the building was possibly used as a creamery. An iron leg rope ring for tying either a horse or cow is present in the northern end of the building. The flooring is of hardwood timber which has been circular sawn.

Please refer to Figure No.3

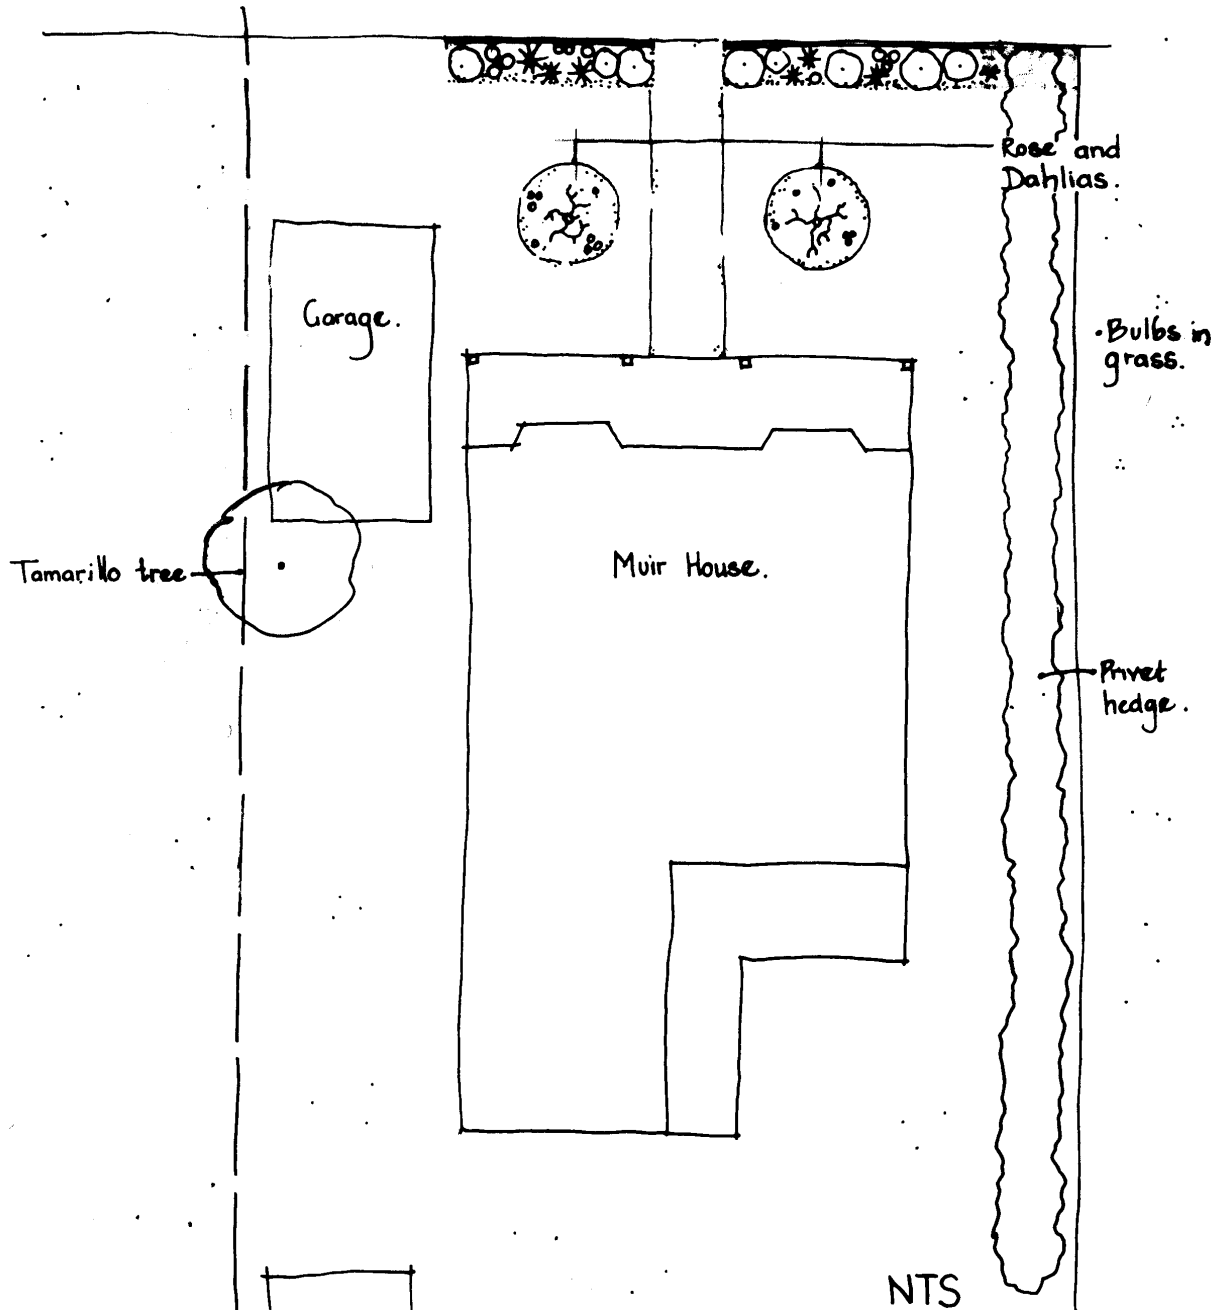
Figure No.6: Proposed garden

8.3.9 A small cottage garden should be established to the front of the Muir House.

Please refer to Figure No.6

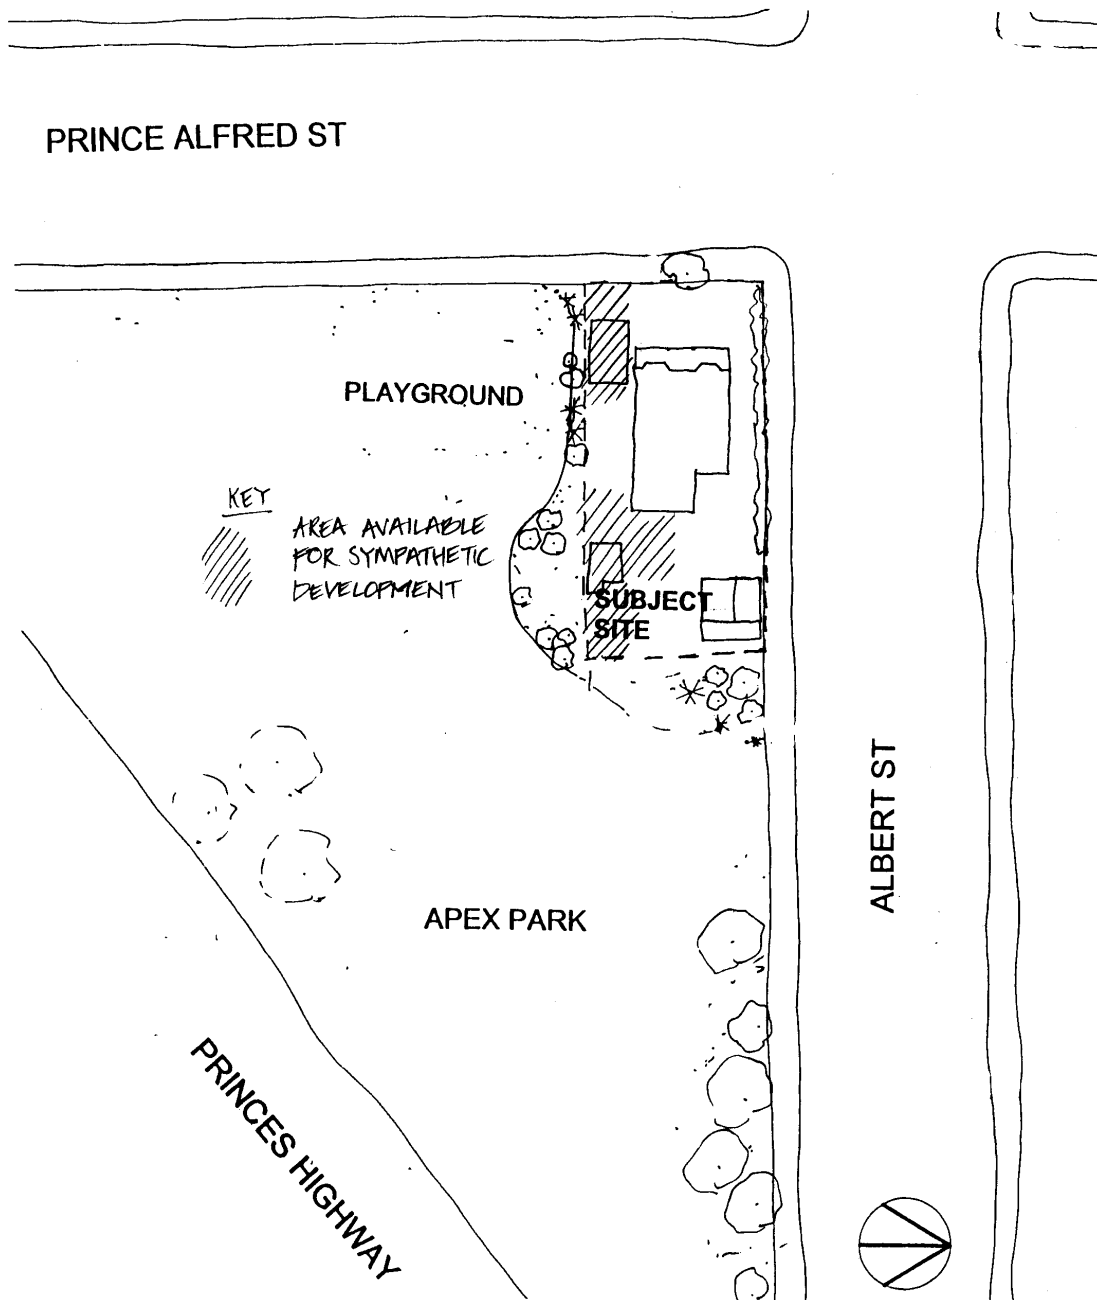
Figure No.7: Options for future use

Note: If the Muir House is to be used as a public building disabled access to the building should be provided. Access may be made available via a pathway running down the northern side of the garage with a ramp onto the verandah.

Please refer to Figure No.7

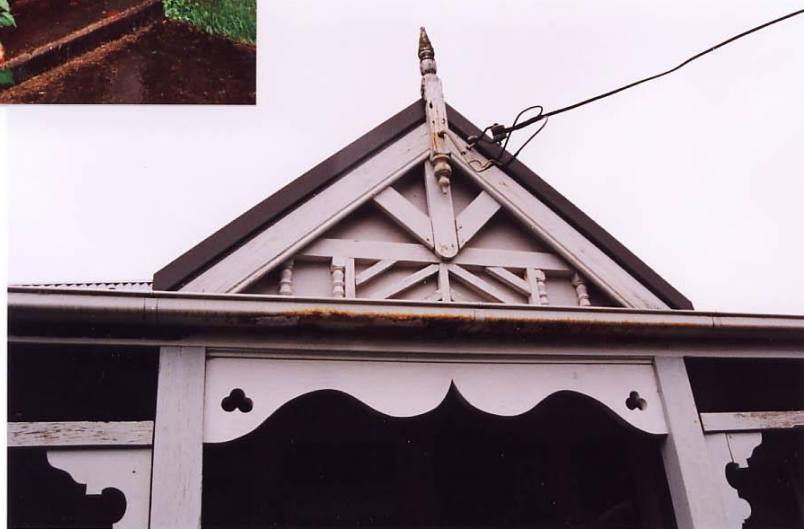
Figure 18 Western veranda of house.
Figure 19 Timber detail of eastern veranda, note rusted gutter.

9.1.3 The leaking gutter located to the front of the subject building over the steps should be immediately repaired.

2.3.5	Ensure that gutters are checked and cleaned at least every 3 months
2.3.6	Replace gutters if needed in future with rolled edge profile TME Note: Replace gutter above front entry

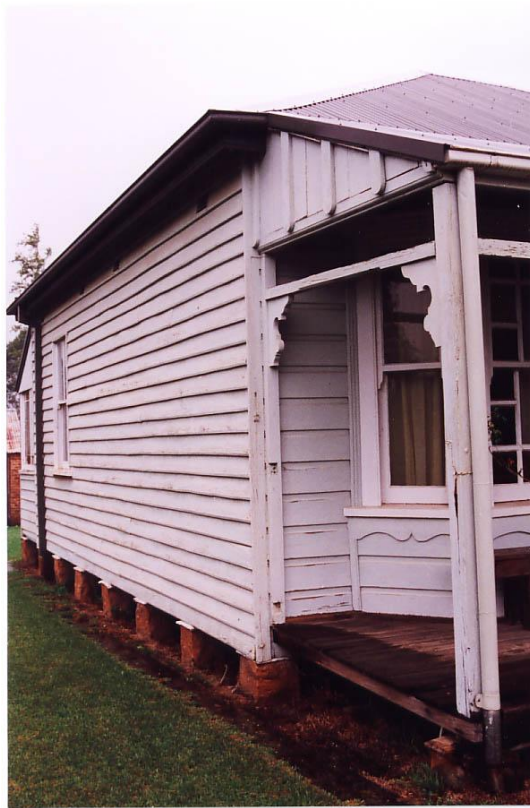
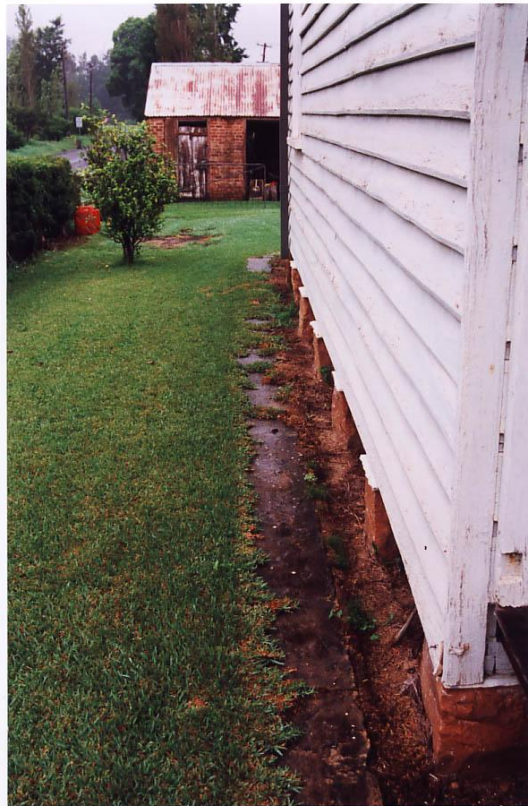
Figure 21 North elevation. Note notched sections in posts for possible original timber balustrade.
Figure 22 Northern elevation. Note concrete lawn edging along wall.

NO.	ITEM
2.2	ELEVATIONS
	NORTH ELEVATION
2.2.1	Reinstate balustrading to end of verandah to future research and detail
	EAST ELEVATION
2.2.2	Remove metal handrail and replace with sympathetic timber post and rails TME balustrade
	SOUTH ELEVATION

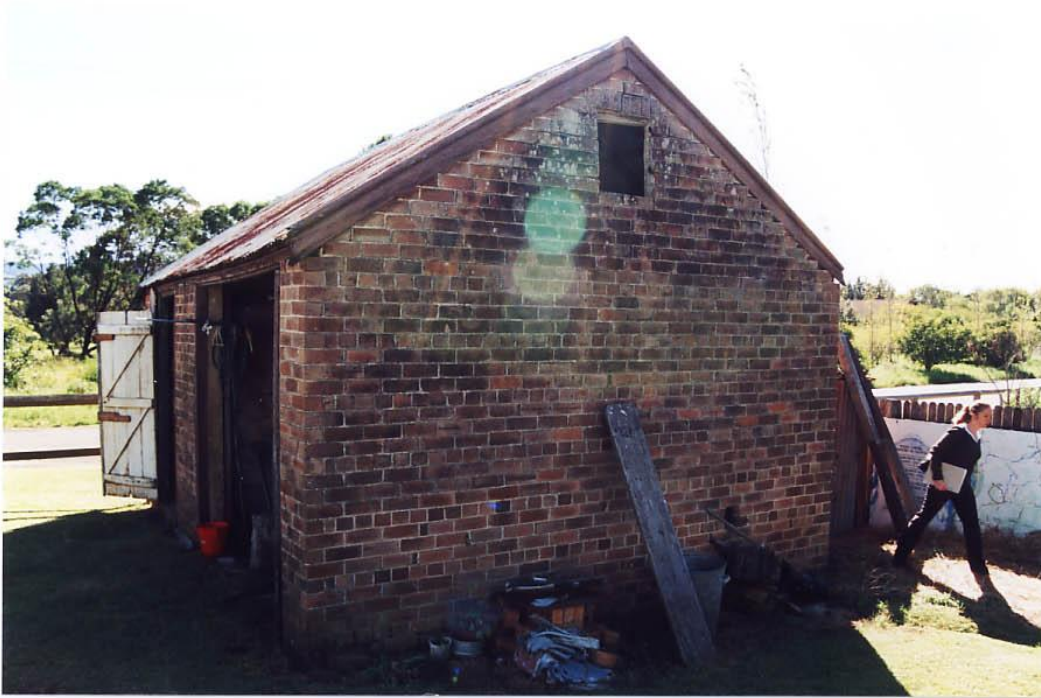
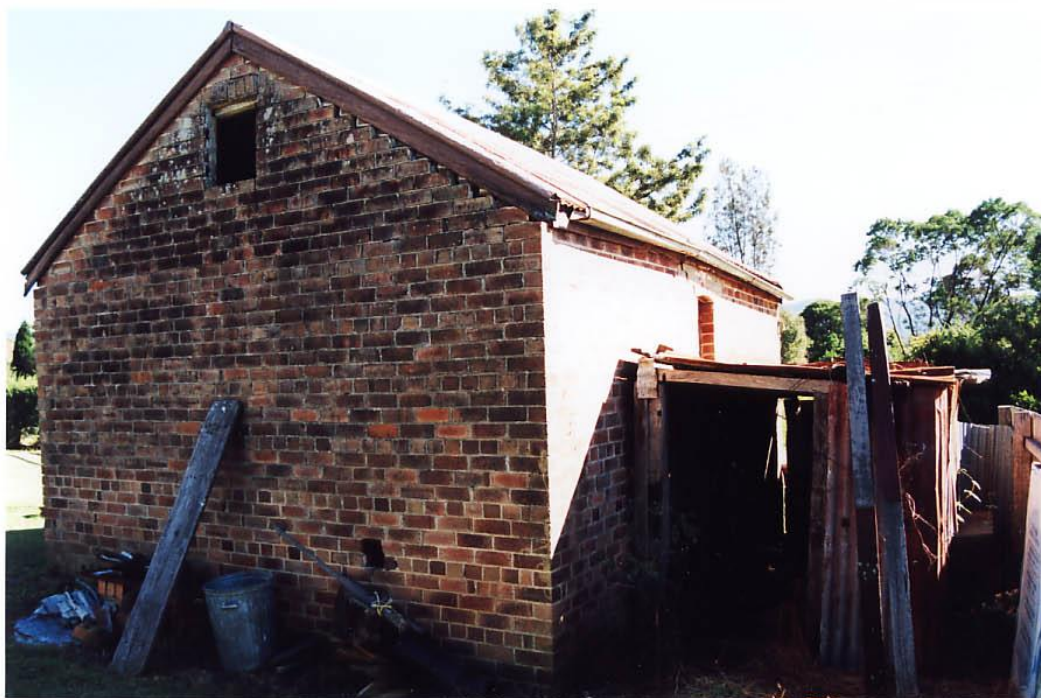
The general condition of the house building appears to be sound. The southern wall of the stables building shows evidence of a major structural fault.

Figure 53 South elevation of cart shed and stables.
Figure 54 South/ East corner of cart shed and stables. Note brickwork has shifted.

NO.	ITEM
4.1	GENERAL
4.1.1	Check footings and repair where necessary. Note: Jack up wall and secure in south west corner
4.1.2	Refix timber wall boards internally with fixings TME
4.1.3	Remove debri from inside the stable and cart shed to allow floor to be cleaned
4.1.4	Refix cladding to all external walls and replace where necessary TME
4.1.5	Supply and hand new door to cart shed and paint to SCS
4.1.6	Refix corrugated iron roof sheeting to roof and replace where necessary TME fixings and sheeting
4.1.7	Install guttering to both east and west elevations
4.1.8	SUBTOTAL STABLES AND CART SHED \$15,000

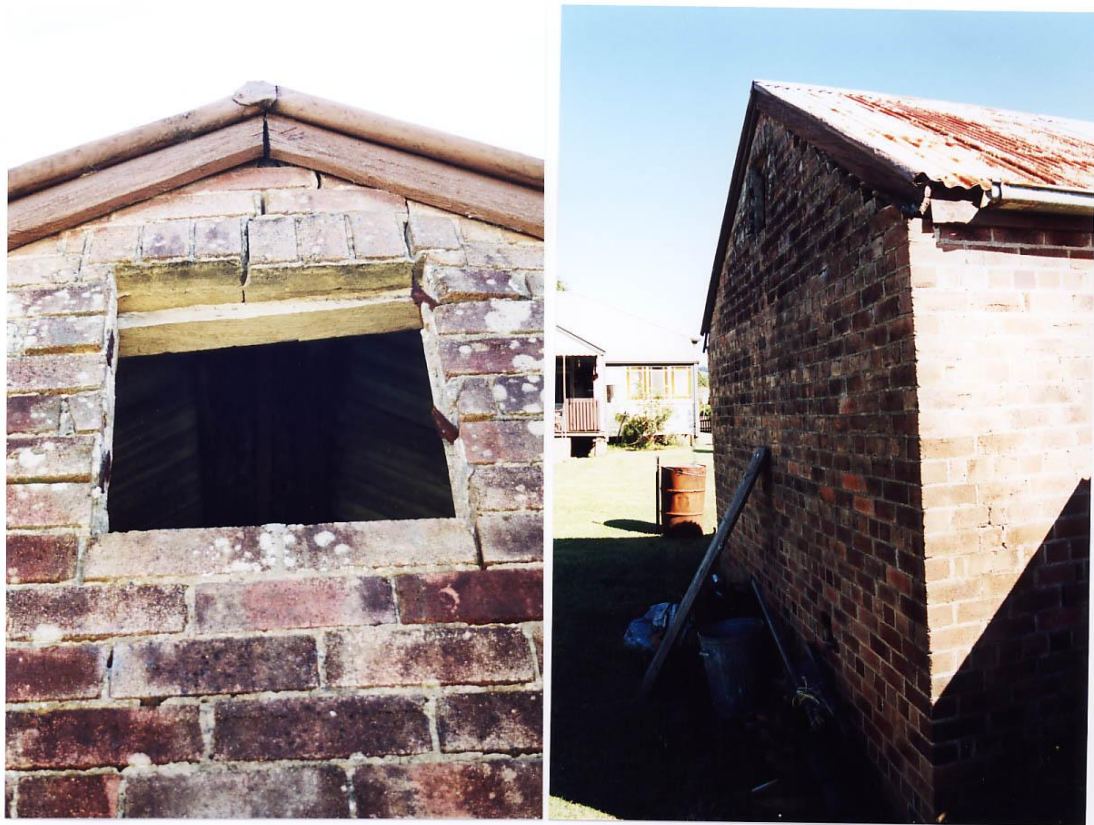
Figure 59 South elevation detail showing space for window – now missing.
Figure 60 South elevation wall.

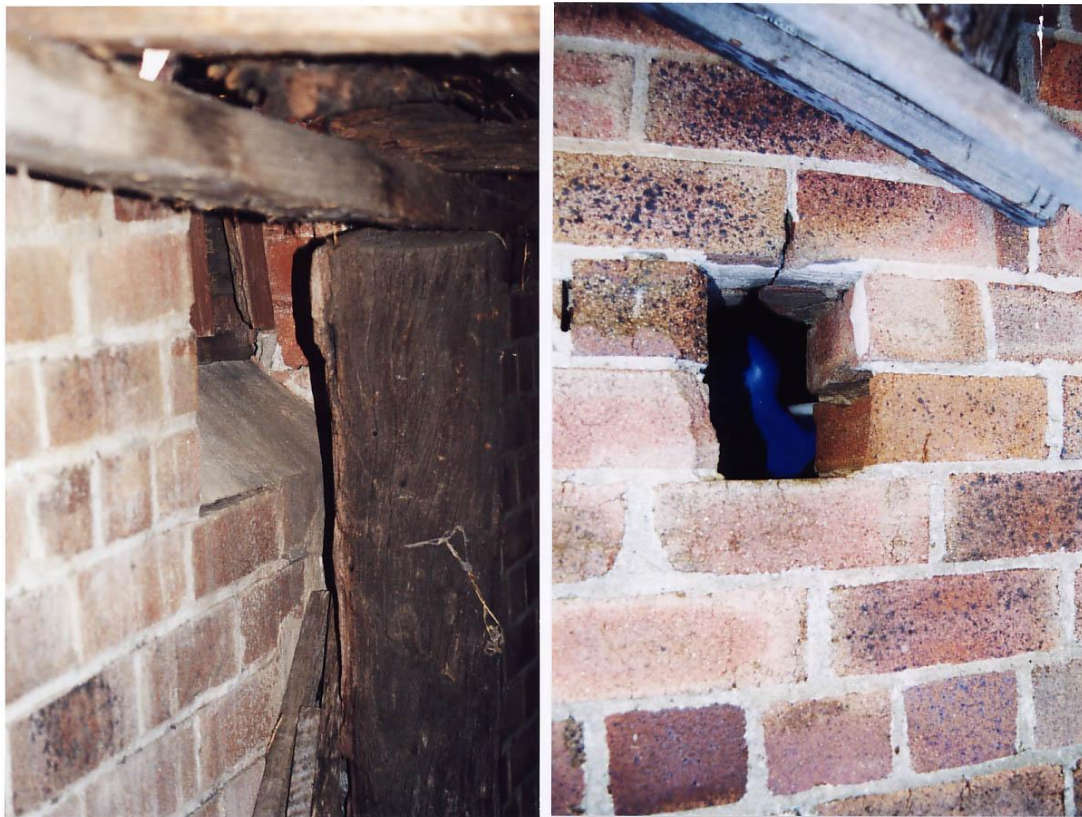
Figure 61 Ventilation hole in east wall.
Figure 62 Black Smiths bellow hole in south wall.
