BERRY SCHOOL OF ARTS

Conservation Management Plan 2000

prepared for
Shoalhaven City Council

Susan Jackson-Stepowski
Heritage Planning Consultant

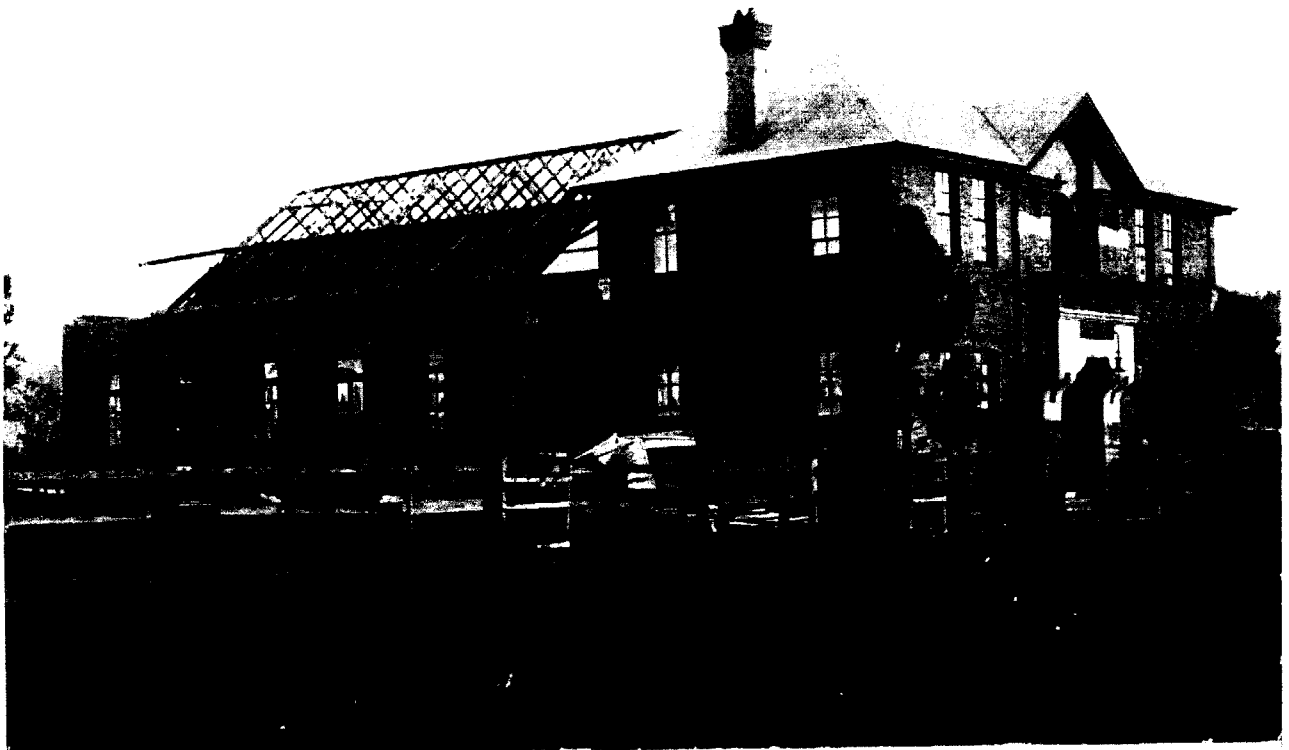
Photograph: 5a.

Berry School of Arts c1906

Showing wind damage to the rear section of the building. The result of this damage is still evident in the hall above the edge of the stage where there is a join in the ceiling lining boards and the two lots of boards vary in size.

Shortly after its completion, the new building was struck by a severe gale, causing damage that required the expenditure of £130 for repairs whilst scenery valued at £23 was completely ruined.⁶⁸ Minor modifications were found necessary as the committee settled into its new home. In 1906 kerbing, guttering and asphalt were used to seal the approach to the front of the building for the comfort of the members⁶⁹, but also maybe because the building contained the Council offices. This treatment lasted for more than twenty years but in July 1930 Mr Schofield reported that *the footpath in front of the institution, recently resurfaced, had suffered considerable damage from heavy rain*. A kitchen with a copper and benches was installed in 1911 at a cost of £17/12/-. The supper room, mooted in 1914, was a later addition to the building.⁷⁰

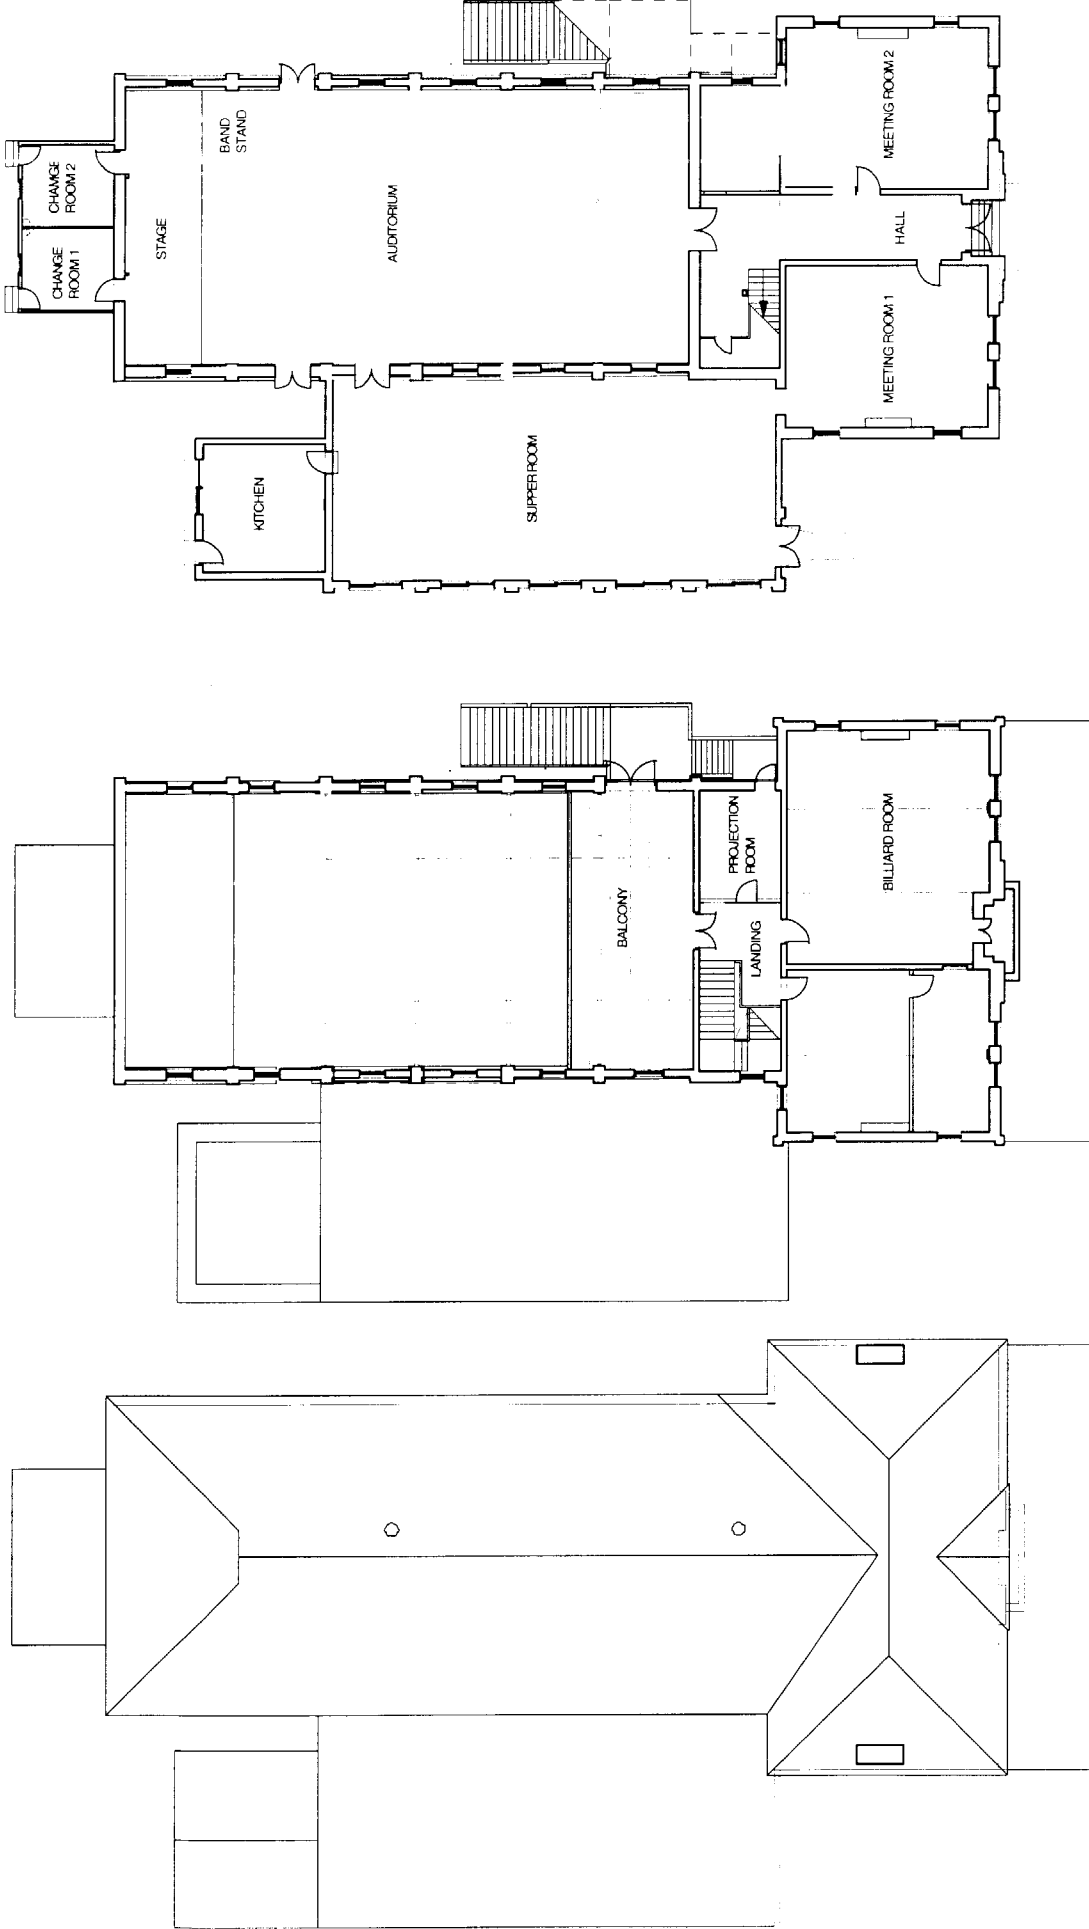
Figure 7.1
BERRY SCHOOL OF ARTS: AS BUILT 1906

GROUND FLOOR PLAN

FIRST FLOOR PLAN

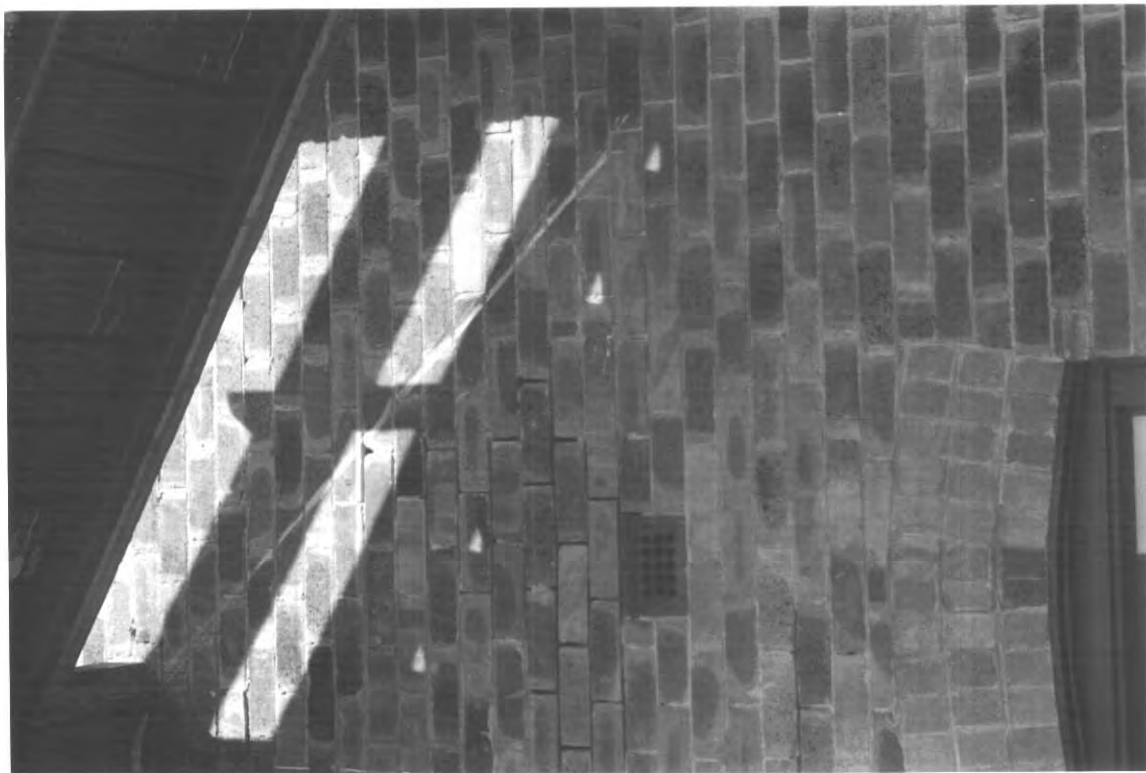
Bottom: Line showing evidence of earlier timber stair to Projection Room. Evidence of damp.

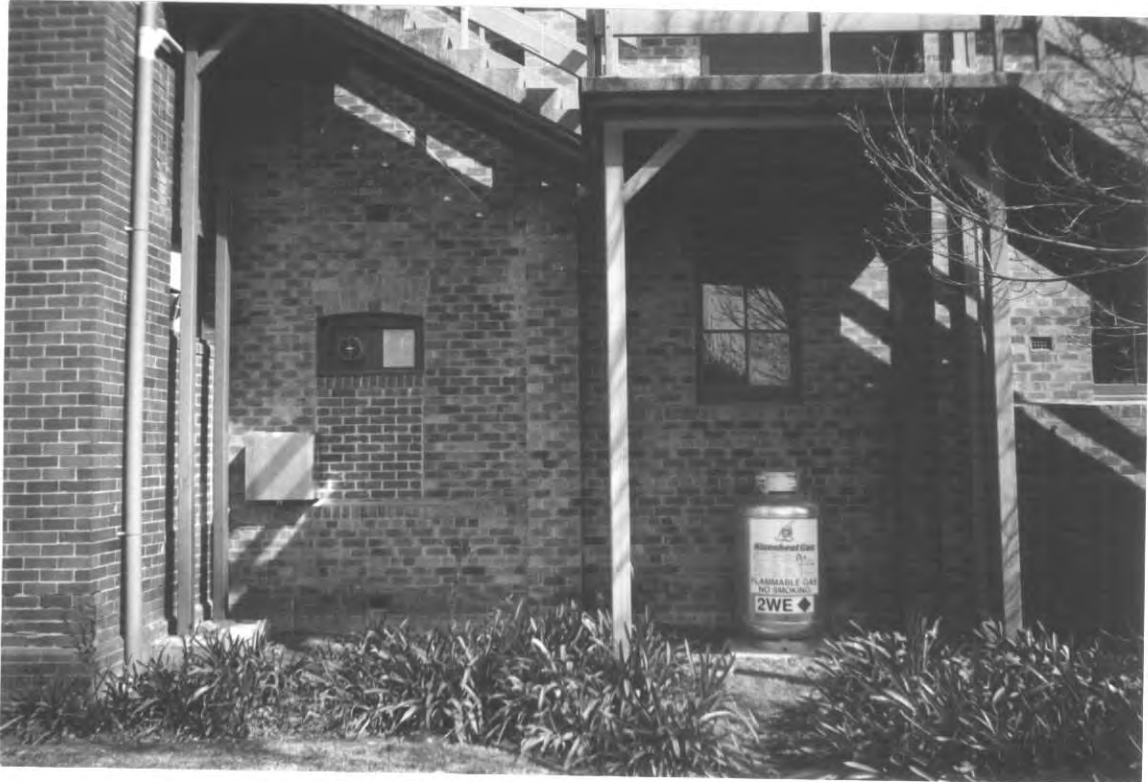
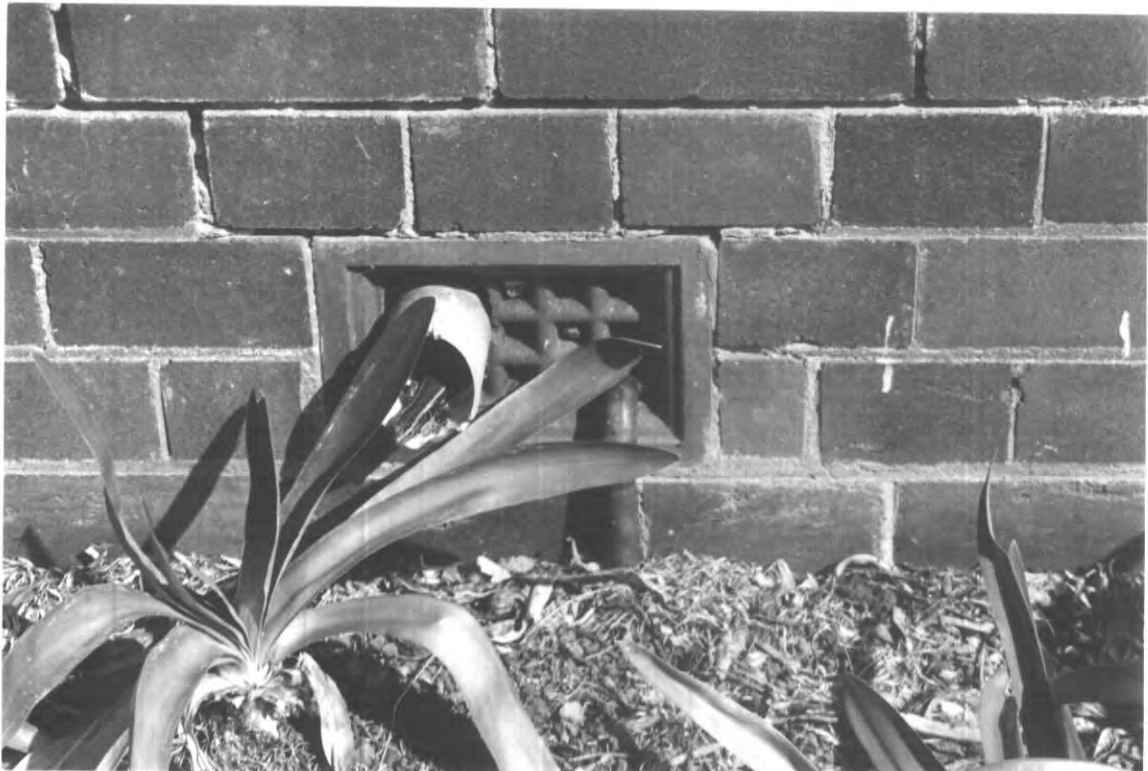
Top: Detail of visually obtrusive services to north Auditorium elevation.

Bottom: Evidence of fabric degradation: Dry waste through terra cotta vent, diminishes effect of vent. Mortar degradation.

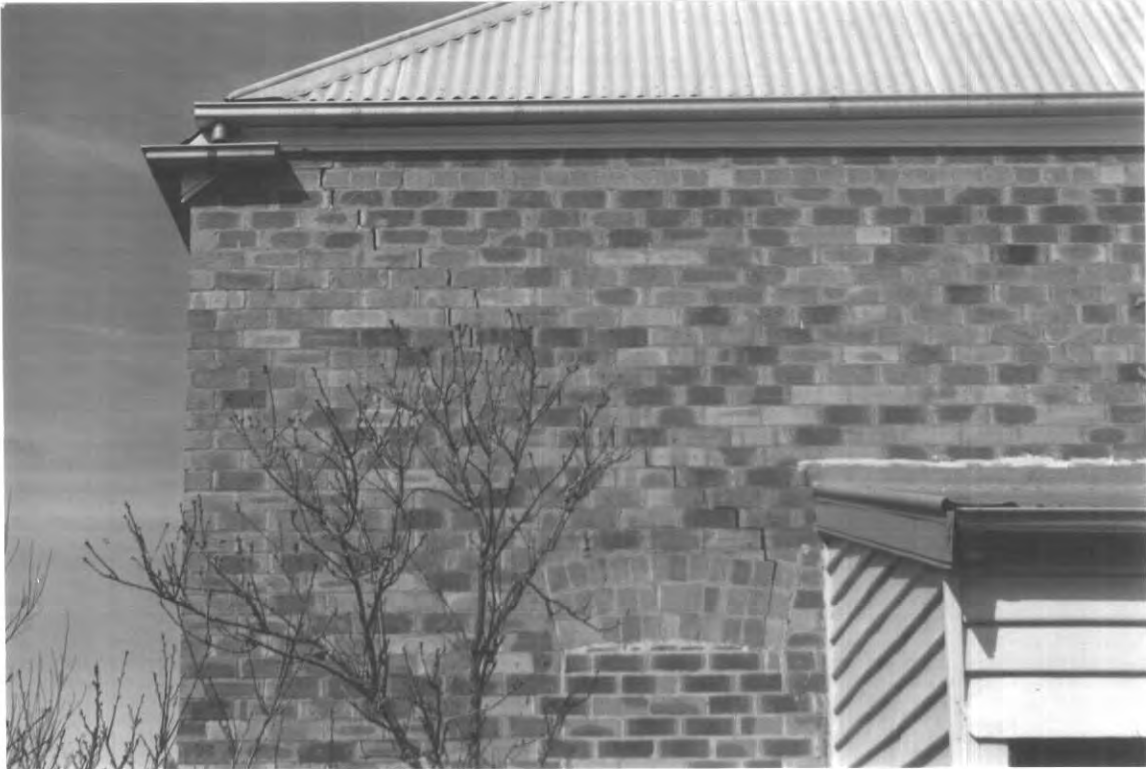
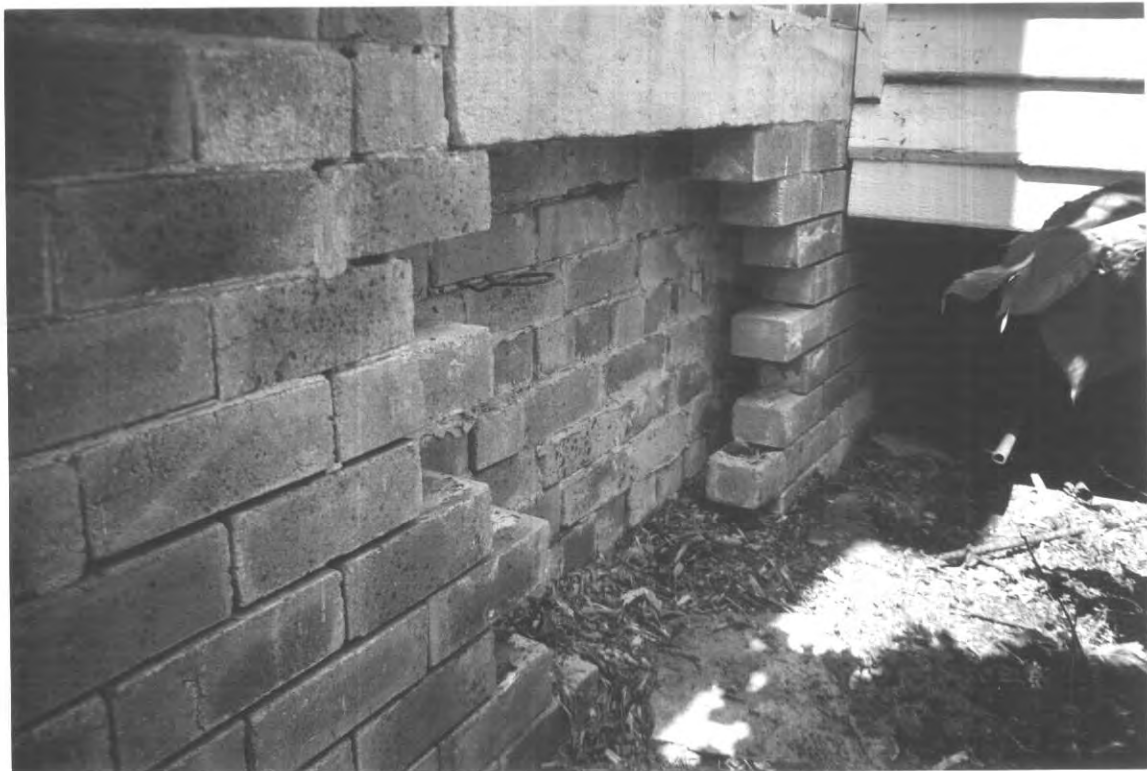
Top: Rear elevation detail showing settlement crack and head of original exit door.

Bottom: Threshold to above door and removed bricks showing cavity.

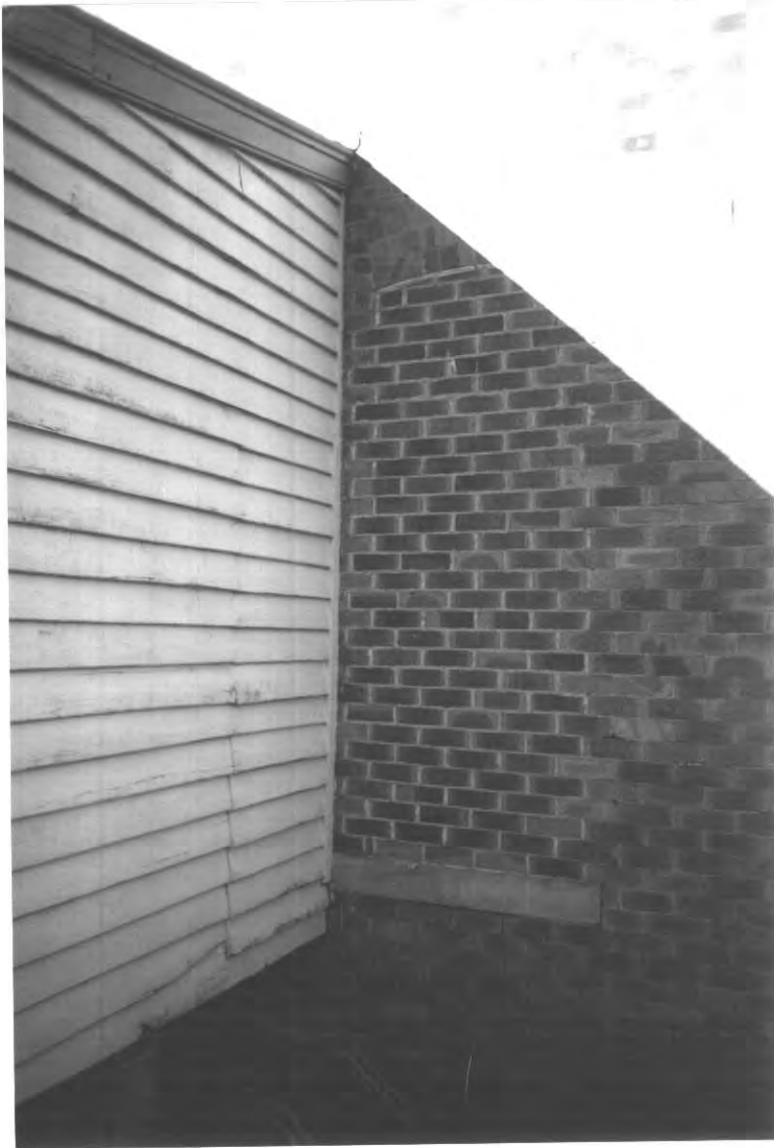
Bricked up exit to stage and filled in side entry door to Dressing Room with timber recycled from cut for replacement door at rear.

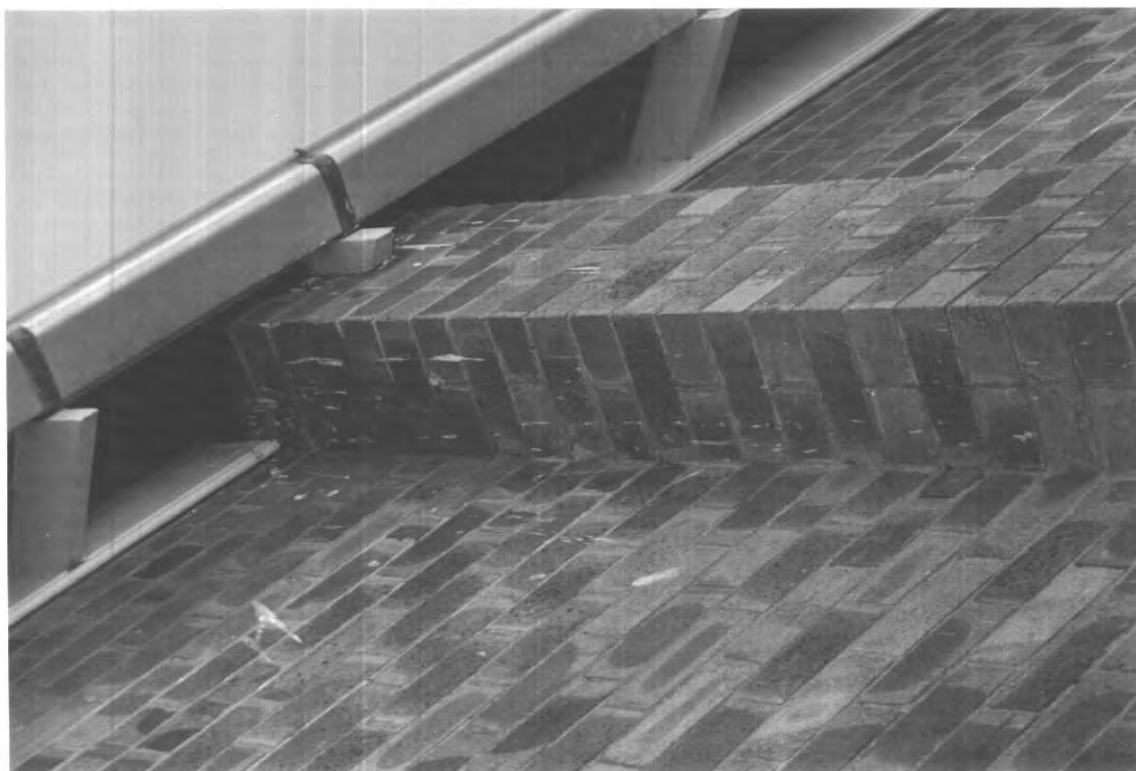
Bottom: Detail of eaves to Auditorium showing bird damage.

Detail of side wall to Stage. Covered roof addition needs to be set back from the rear elevation and be given careful consideration as to how it is attached to the side.

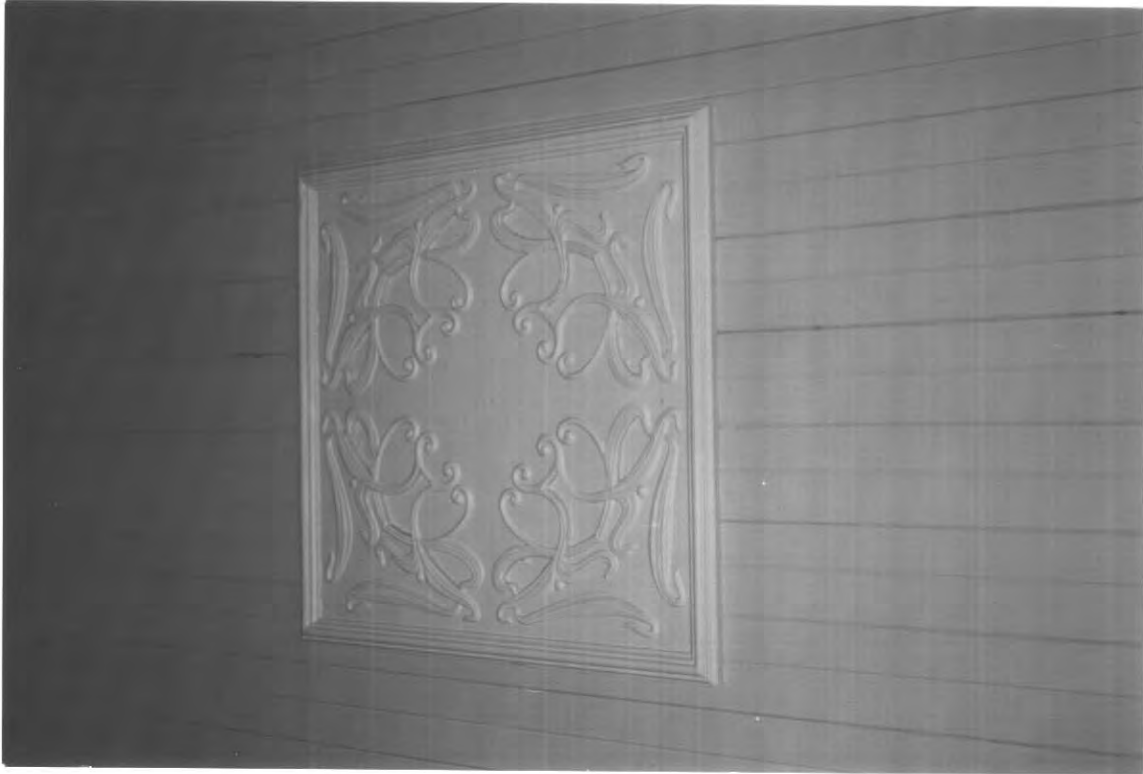
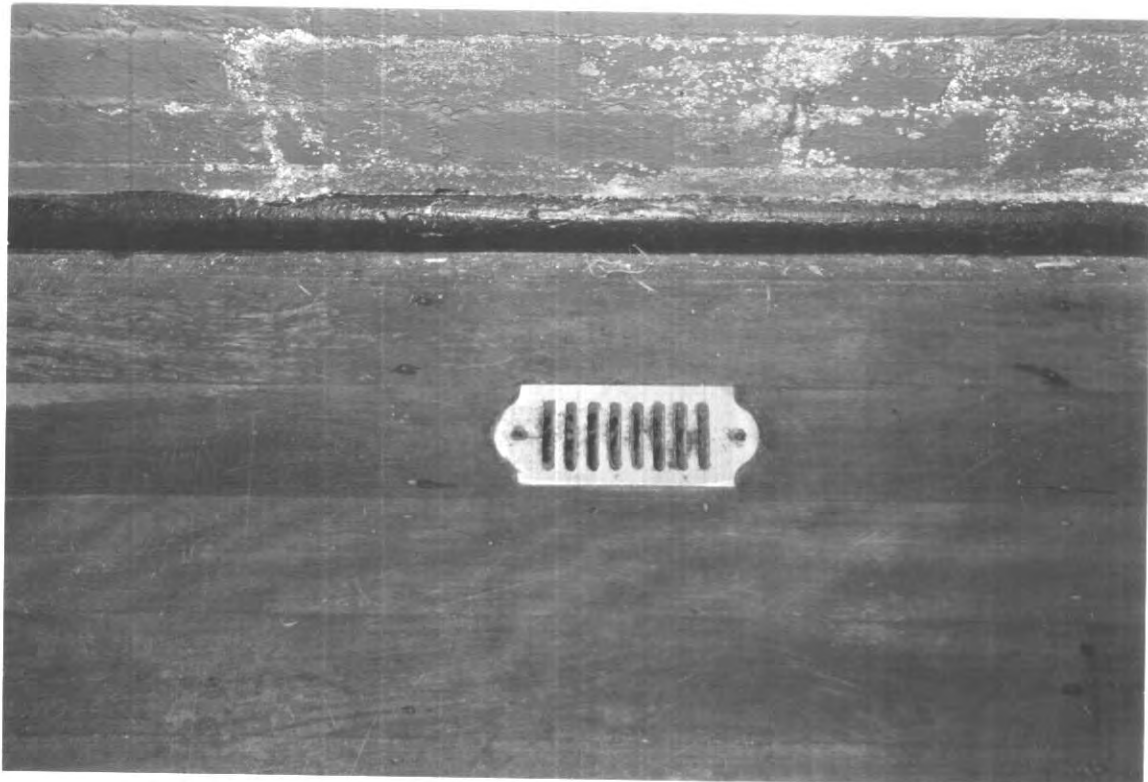
Top: Detail of ceiling vent, original holes to vent gas fumes have been filled in.

Bottom: Detail of floor vent (now not in use).

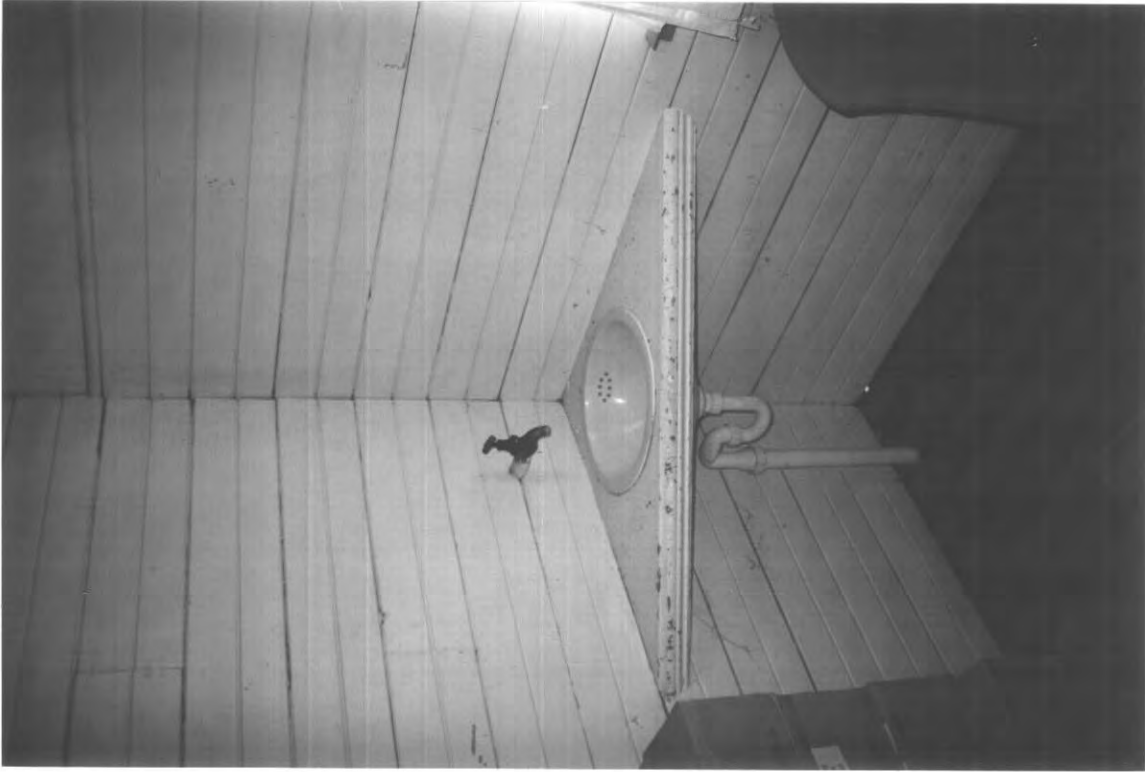
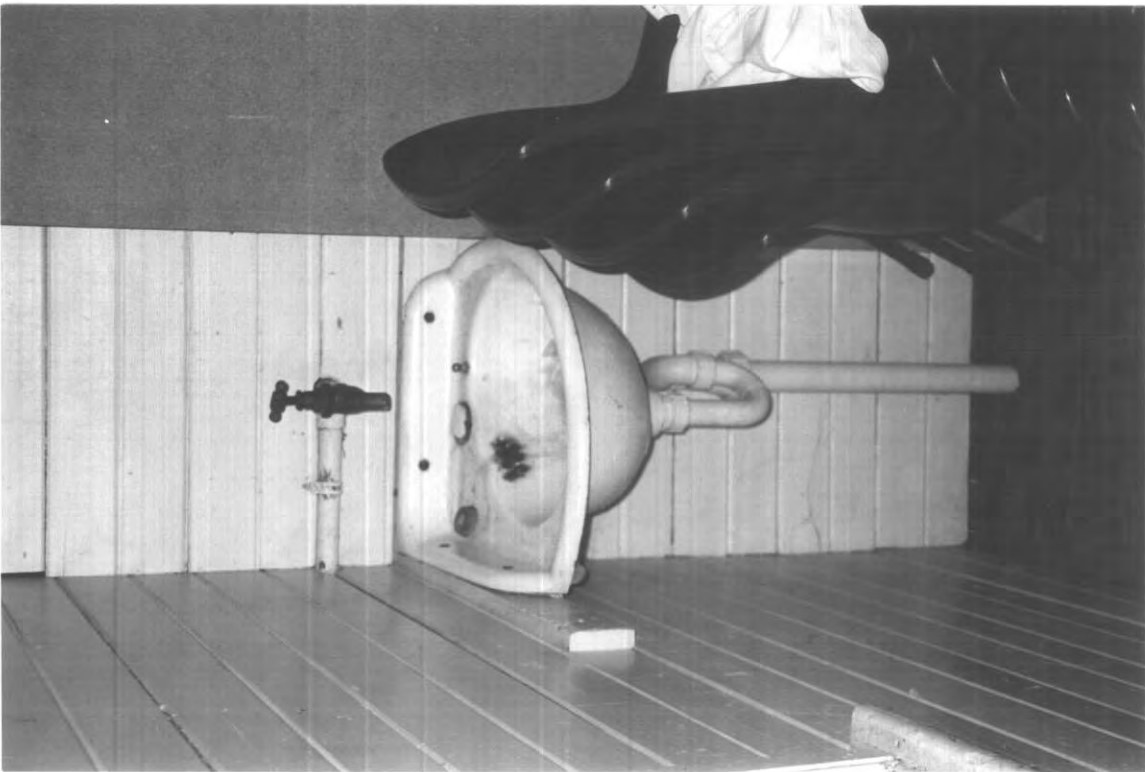
Bottom: Replaced basin in south Dressing Room.

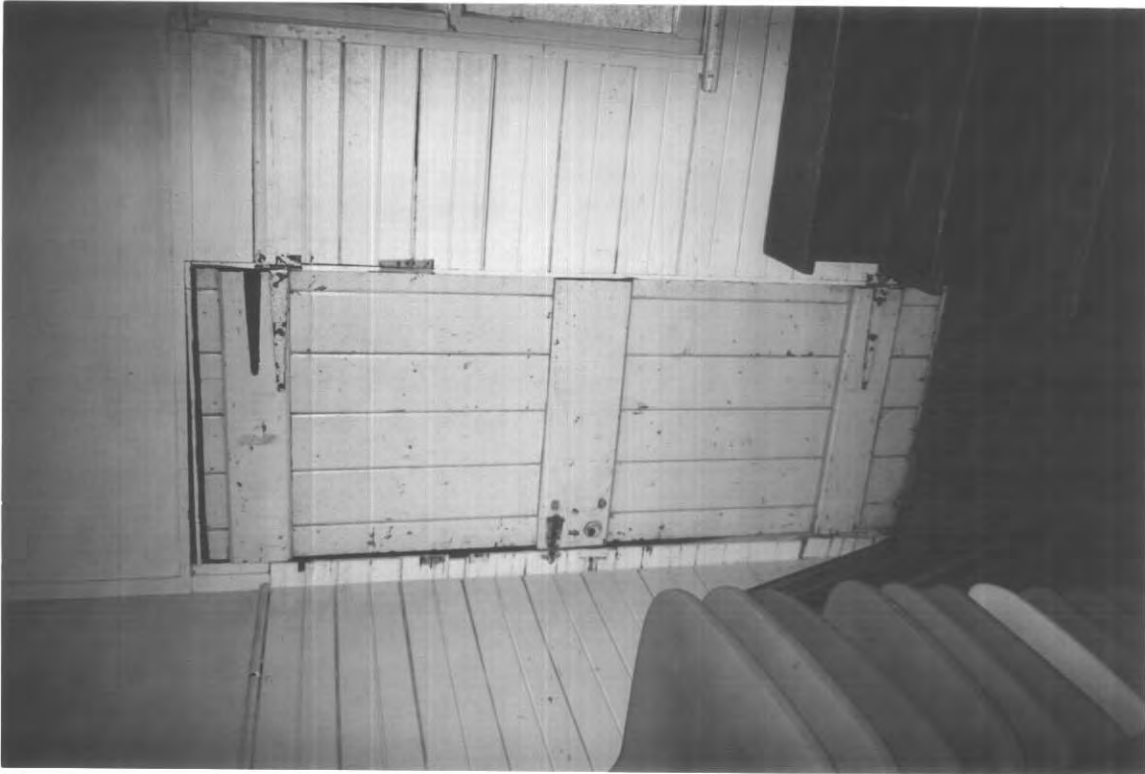
Top: Relocated external door to south Dressing Room.

Bottom: Relocated internal door to south Dressing Room, note cut on side wall indicating original external door.

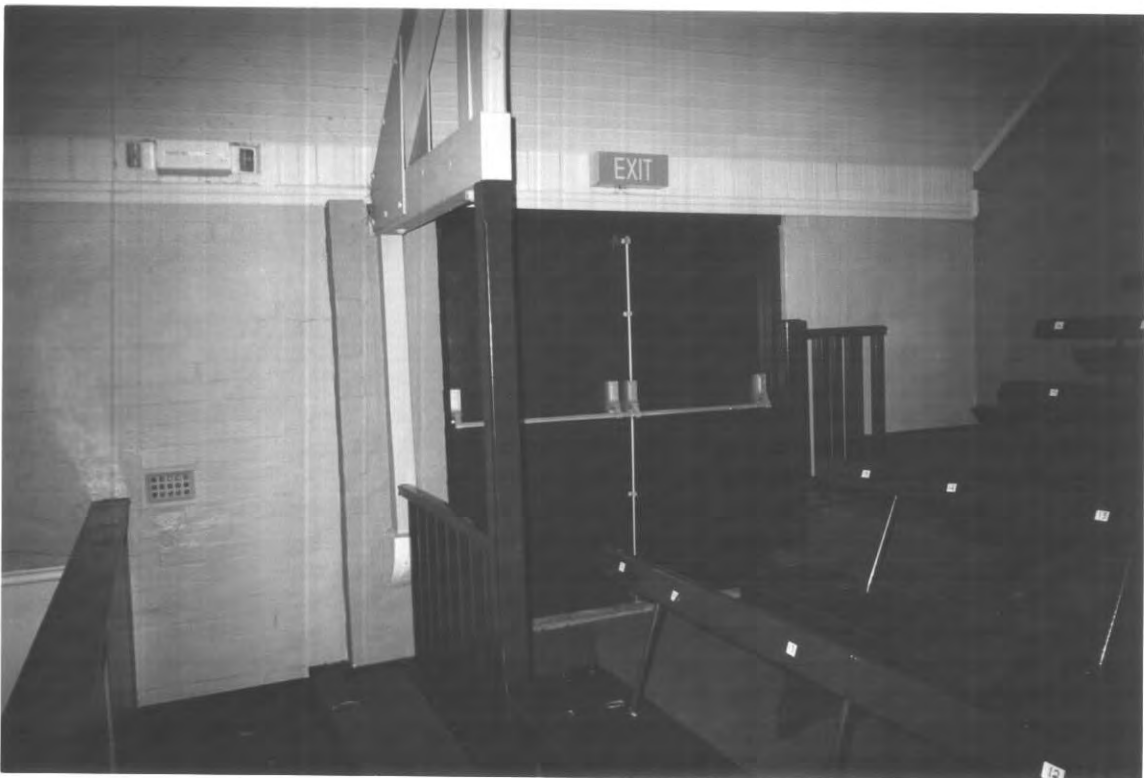
Top: Boxed in area below Mezzanine to accommodate access to Fire Stair.

Bottom: Fire exit, Mezzanine.

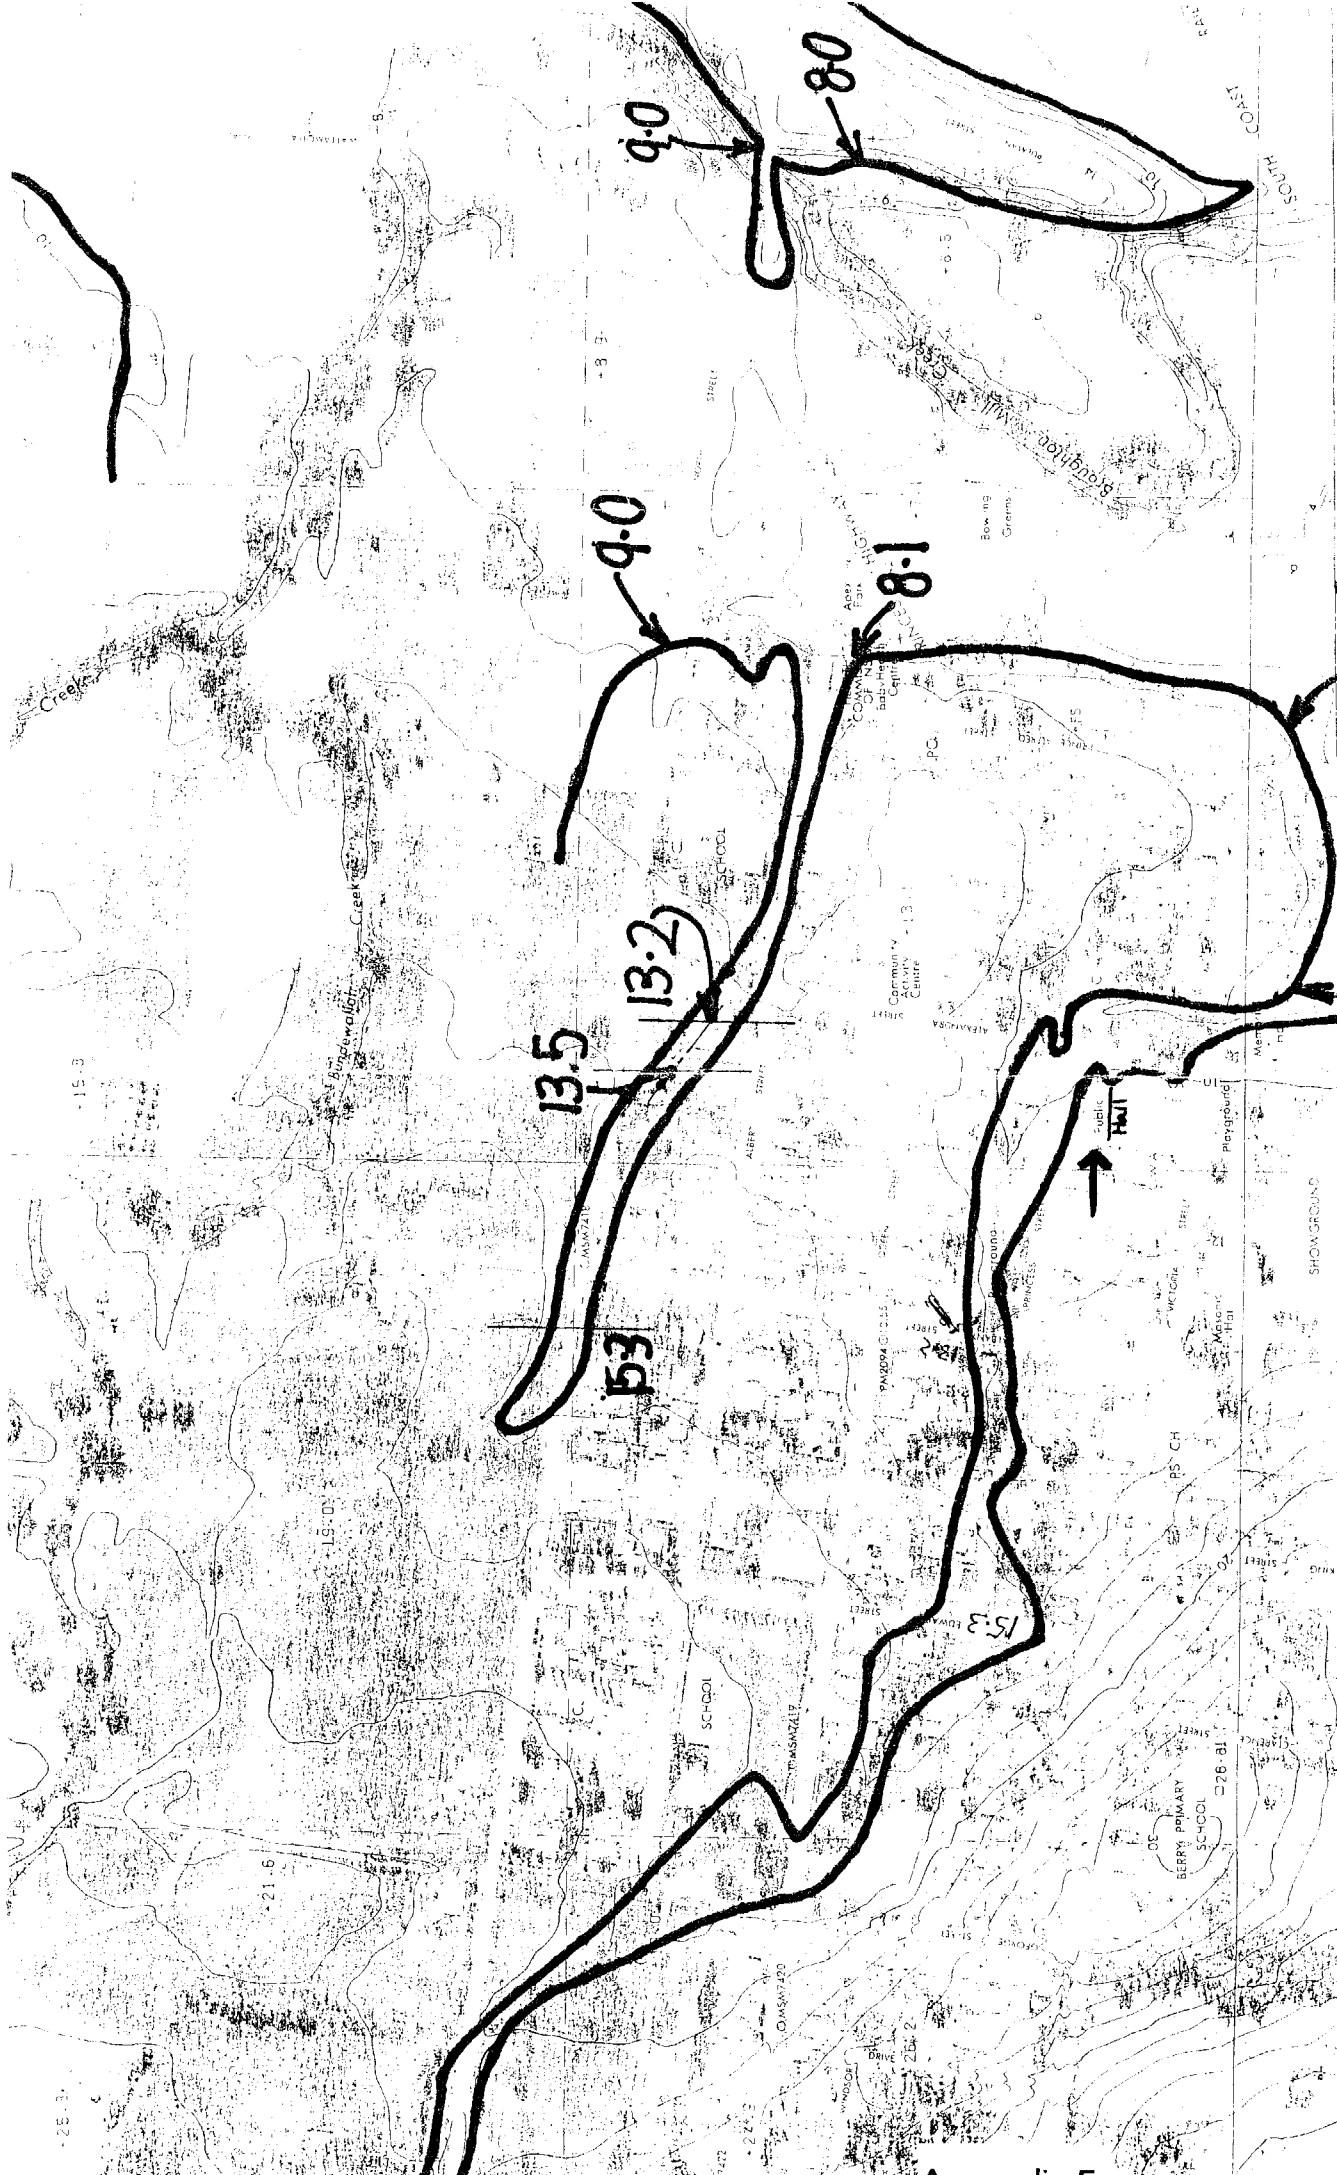
Key: Approximate extent of 1:100 year flood level
 Circa 1980's following 1970's floods
