JARMAN'S COTTAGE
NOWRA NSW

CONSERVATION MANAGEMENT PLAN

June 2002
REF: 0150: CMP

TROPMAN & TROPMAN ARCHITECTS

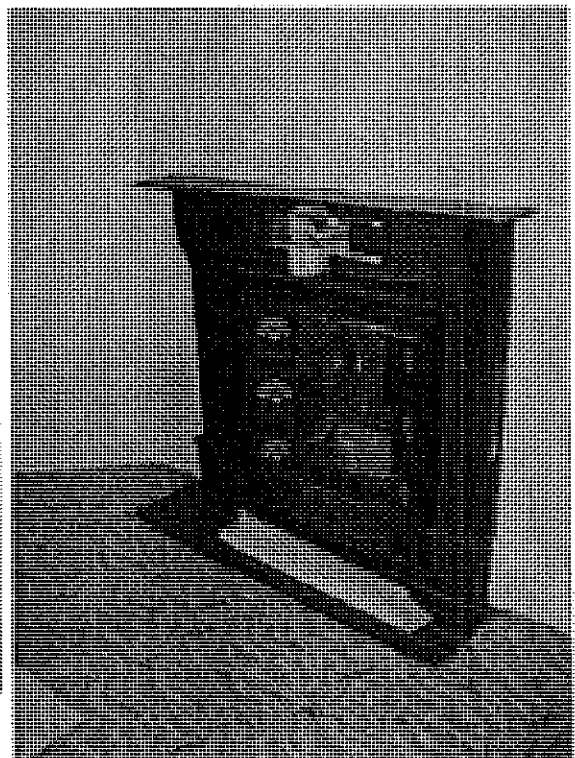
- Figure No 14: Drawing room and master bedroom doors from entry foyer.
Figure No 15: Drawing room from front door.
Figure No 16: Drawing room from entry foyer.
Figure No 17: Drawing room fireplace.

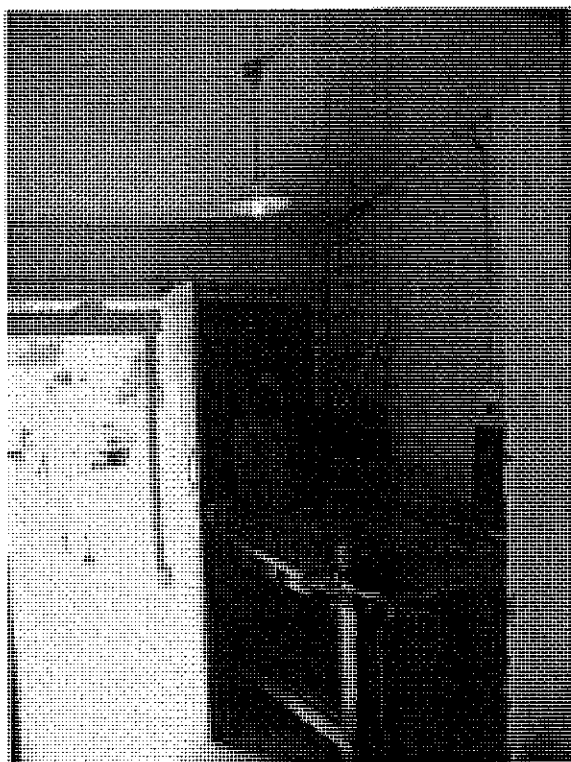
Figure No 22: Rear entry hall
Figure No 23: Bathroom cupboard.
Figure No 24: Bedroom 2
Figure No 25: Master bedroom.

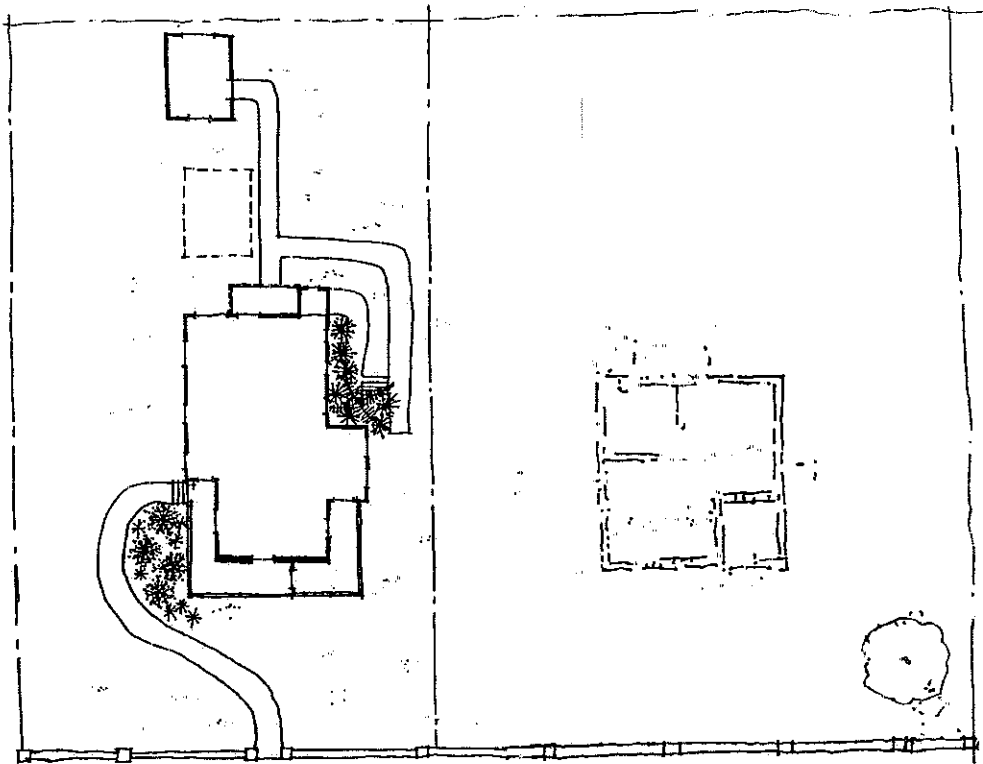
Figure No 30: Surrounding curtilage of the subject site

The adjacent southern property forms an appropriate surrounding curtilage. (Refer to Figure No.30).

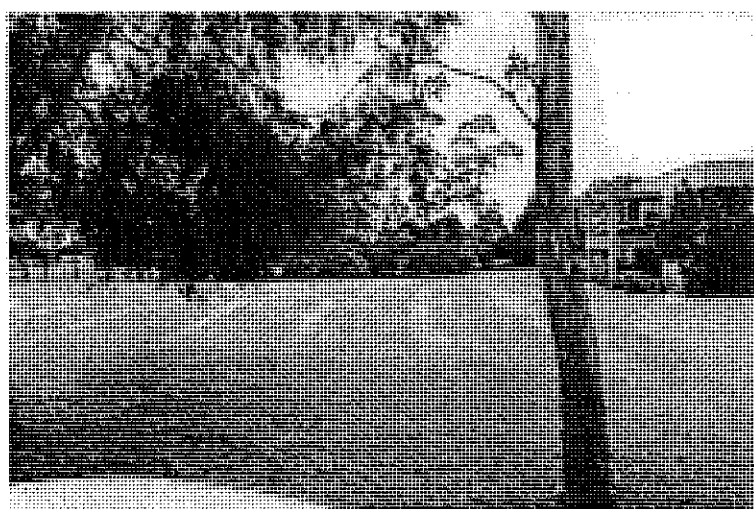
- Figure 4: Jarman's Cottage and adjoining property to the north of the site with right of way.
Figure 5: Jarman's Cottage and adjoining property to the south of the site and civic centre behind.
Figure 6: View towards civic centre from rear of cottage.

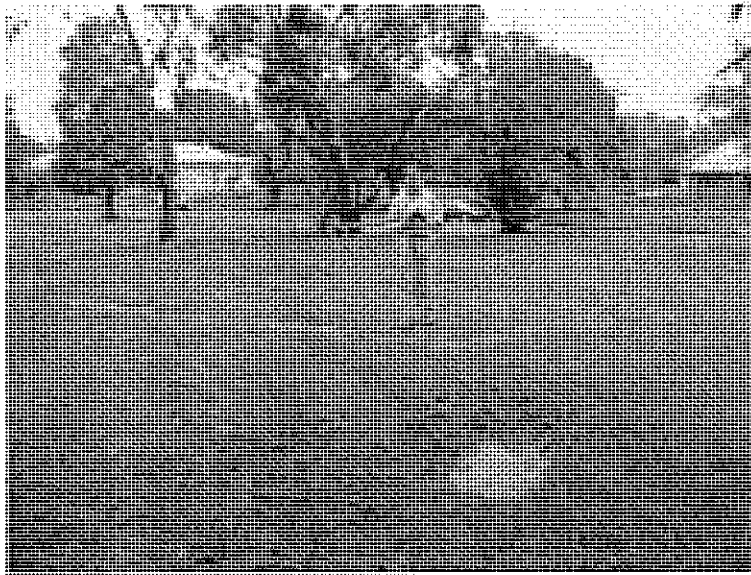
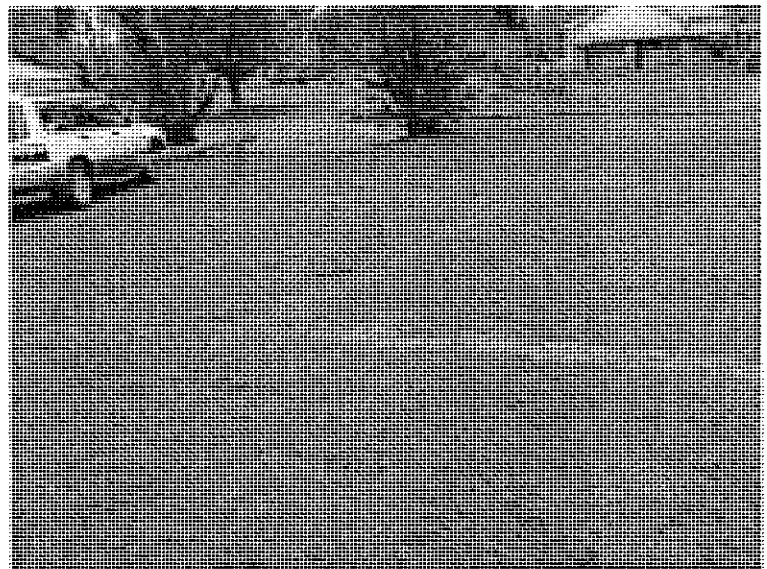
Figure 7: Footings of cottage on south side of subject site.
Figure 8: Footings of cottage on south side of subject site.
Figure 9: View of cottage from far side of Bridge Road.

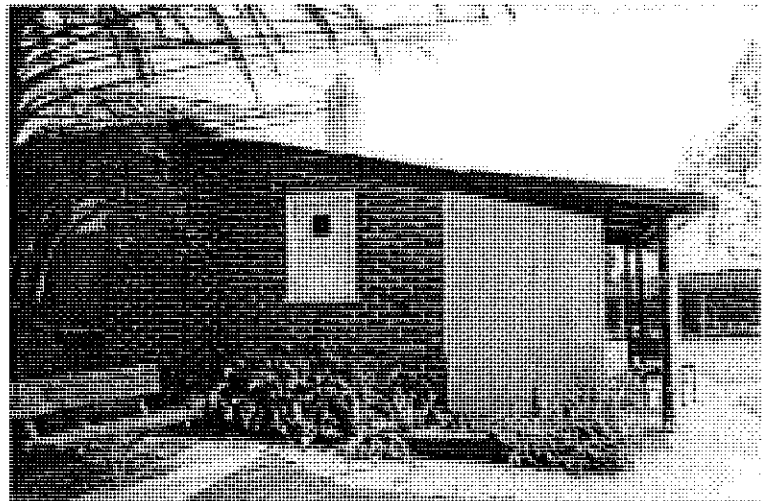
Figure 19: South elevation of cottage.
Figure 20: South elevation – bathroom window and toilet addition.
Figure 21: North elevation of cottage.

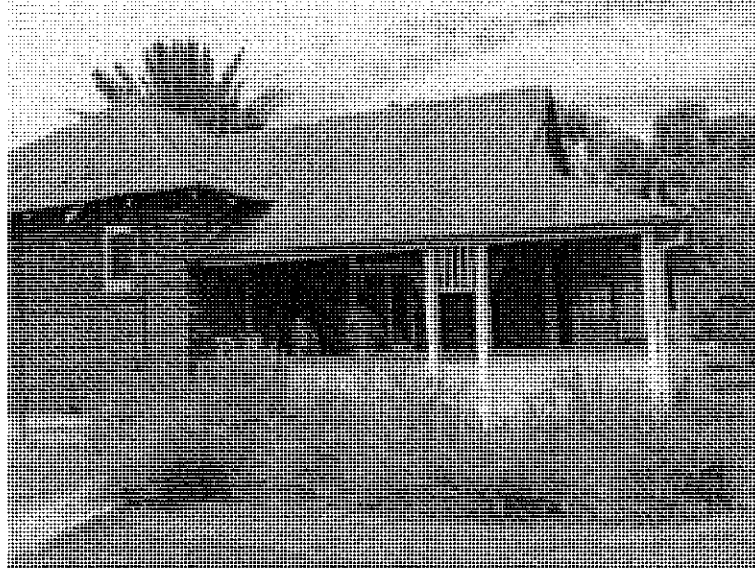
Figure 22: Existing front garden.
Figure 23: Entry foyer lead light window.
Figure 24: Verandah brick base and board detail.

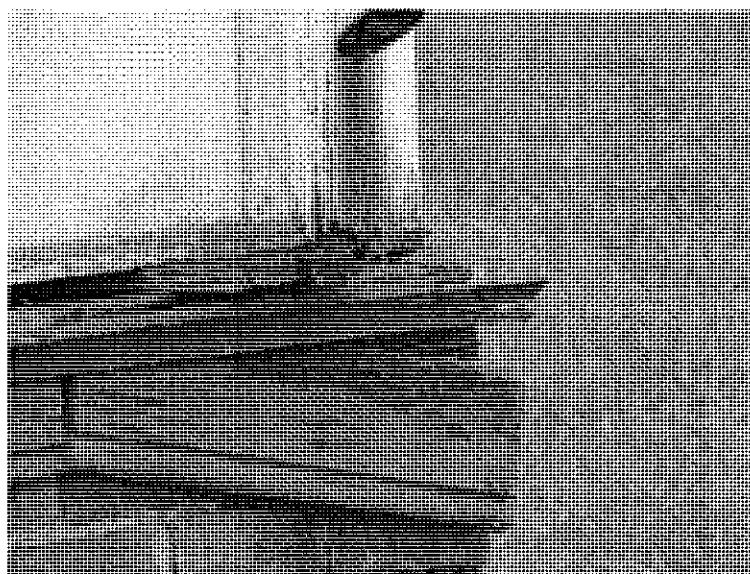
- Figure 25: Damage to verandah detail.
Figure 26: Entry door from north-west corner of verandah looking east.
Figure 27: Drawing room and enclosed verandah door from north-west corner of verandah looking south.

3.1.10	Check over verandah floors and balustrading and repair or replace wher necessary TME	
3.1.11	Prepare and paint any prepainted surfaces to selected colour scheme unless otherwise directed by the HCA

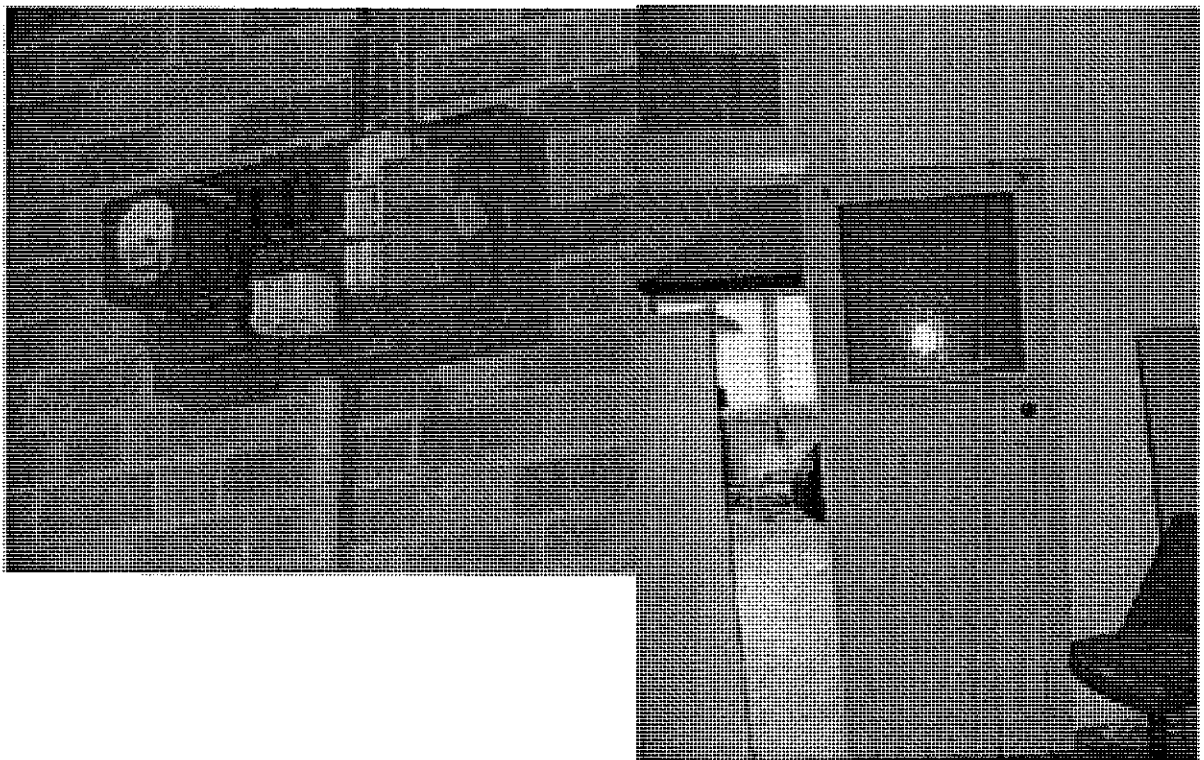
- Figure 30: Marble threshold to master bedroom from internal verandah.
Figure 31: Enclosed verandah from master bedroom.
Figure 32: Fuse box.
Figure 33: Door to enclosed verandah.

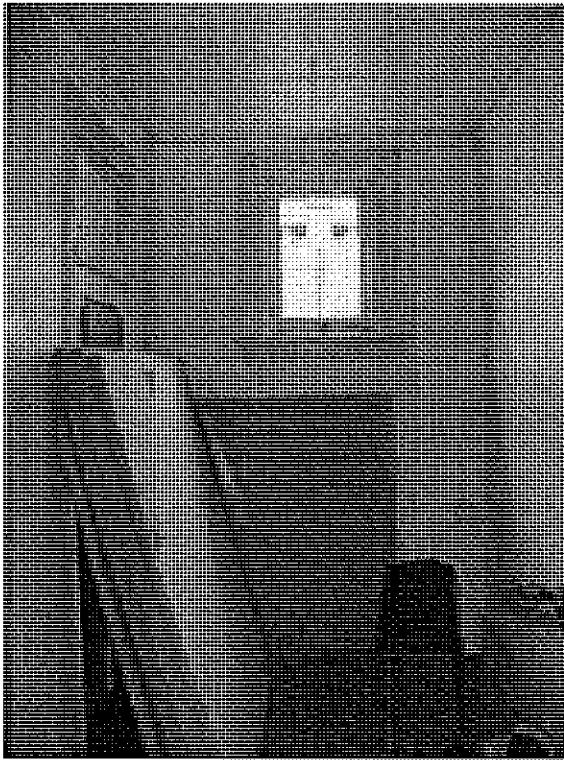
- Figure 34: Entry foyer interior with lead light awning window.
Figure 35: Doors to master bedroom and drawing room from entry foyer.
Figure 36: Drawing room door and window to enclosed verandah.

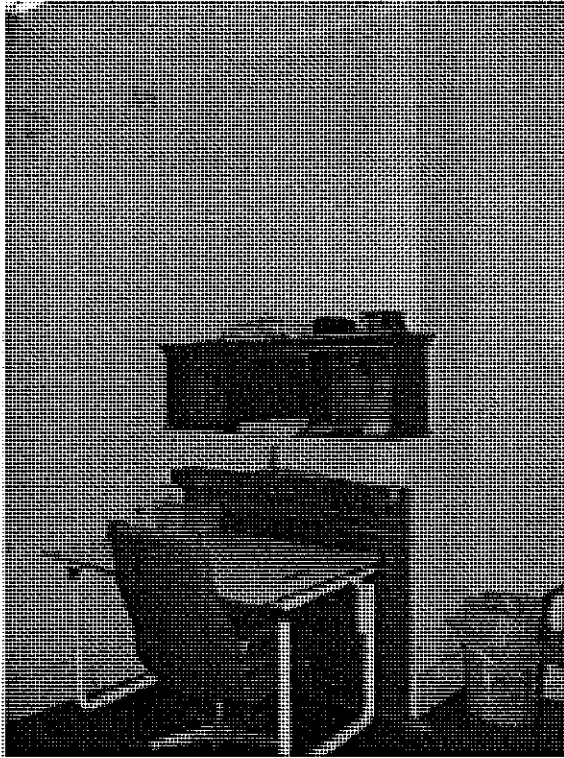
- Figure 40: Dining Room shelves and fireplace.
Figure 41: Dining Room showing door to bedroom 2 and doorway to rear entry hall.
Figure 42: Dining Room window.
Figure 43: Dining Room ceiling and light fitting.

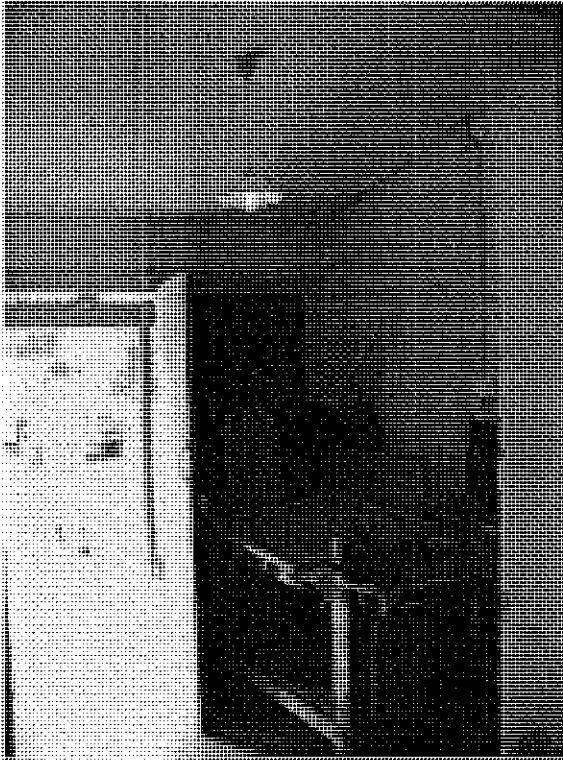
Figure 48: Rear entry hall looking east.
Figure 49: Rear entry hall showing dining room and kitchen doorways.
Figure 50: Shower and gas heater.
Figure 51: Bathroom cupboard.

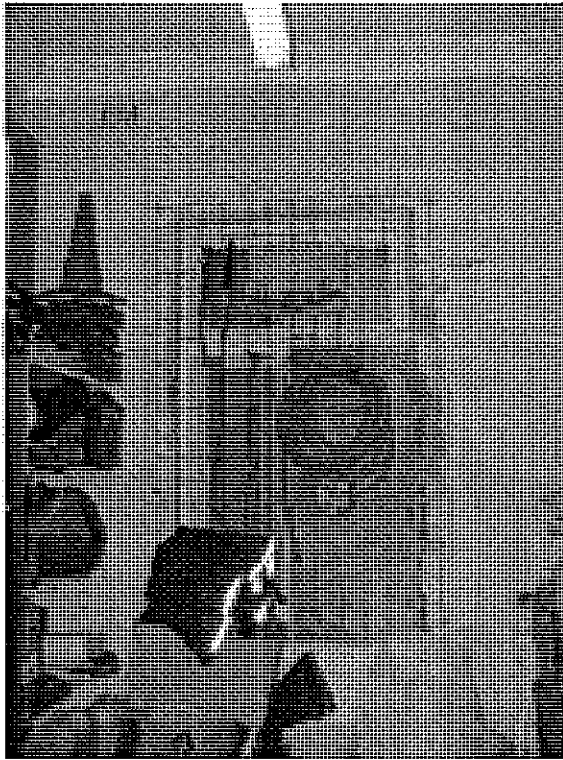
Figure 52: Bedroom 2 window.
Figure 53: Bedroom 2 cupboard.
Figure 54: Bedroom 2 ceiling and cornice.
Figure 55: Bedroom 2 cornice detail

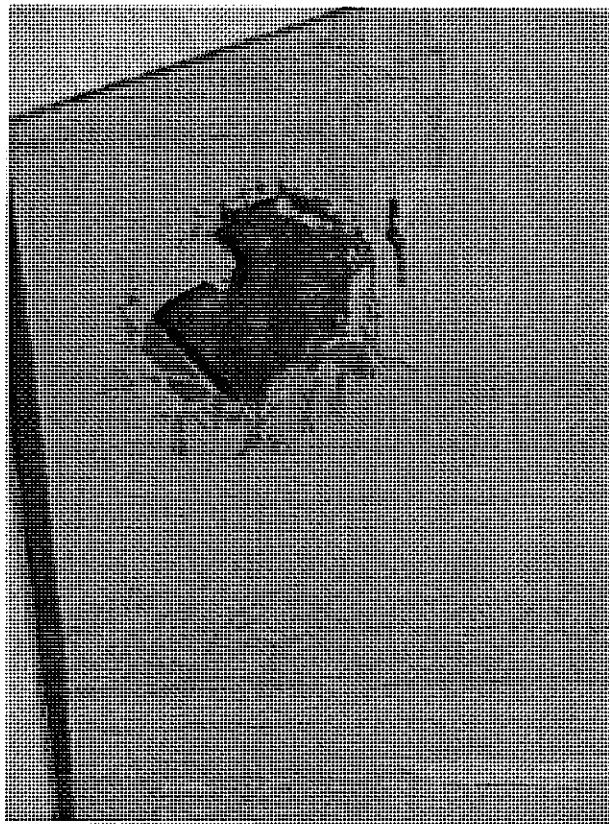
Figure 58: Master bedroom decorative Australiana ceiling.
Figure 59: Damage to master bedroom ceiling.

9.1.7 Remove all suspended ceilings and repair decorative ceilings and cornices where necessary

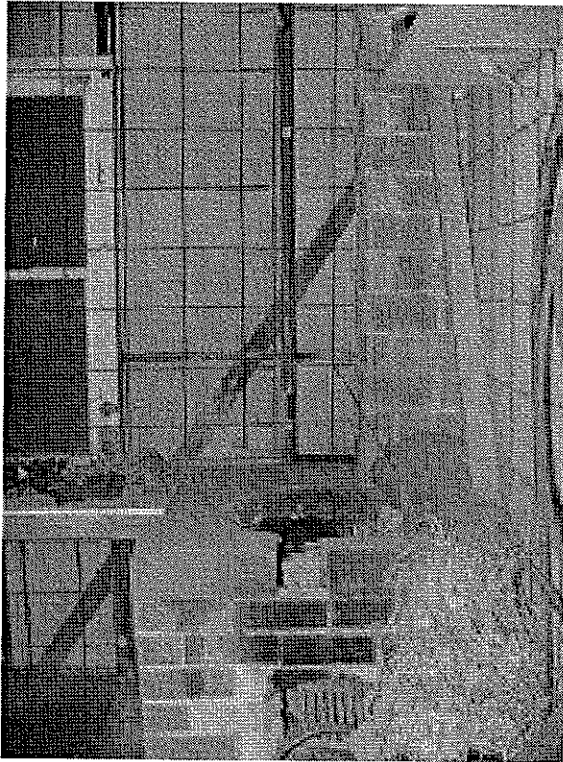
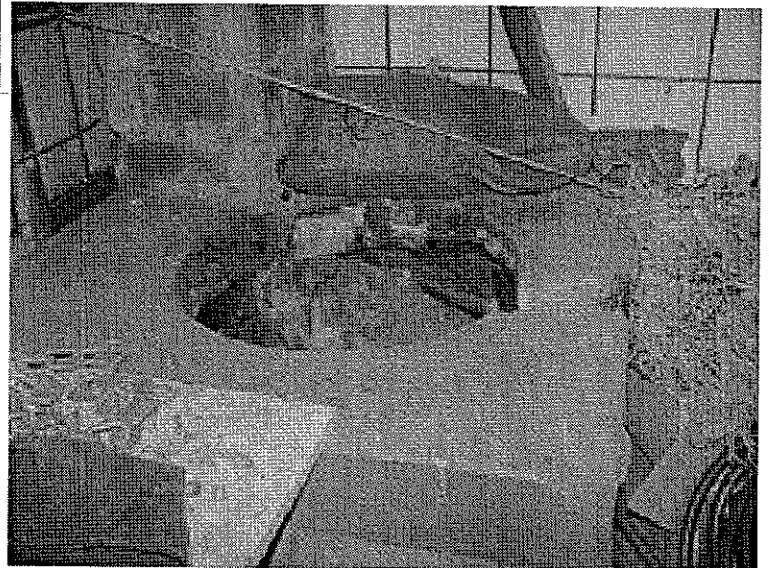
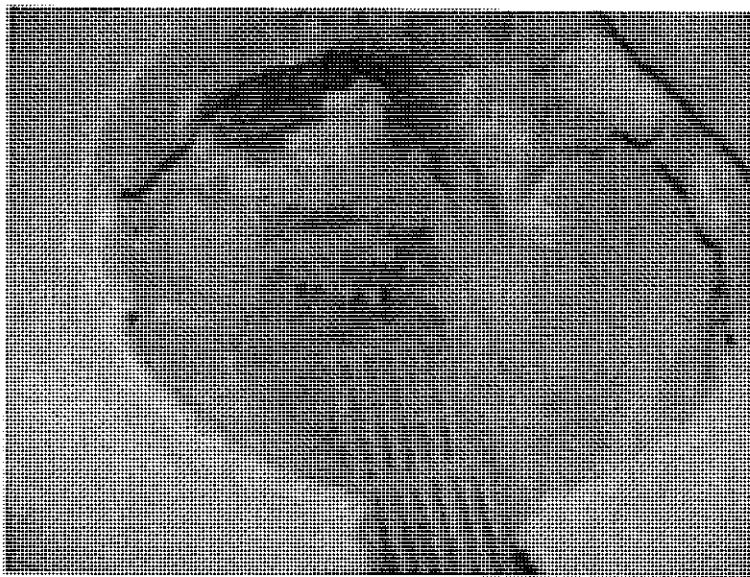
Figure 60: Copper and chimney in laundry shed.
Figure 61: Top of copper.
Figure 62: Internal view of copper showing grate.

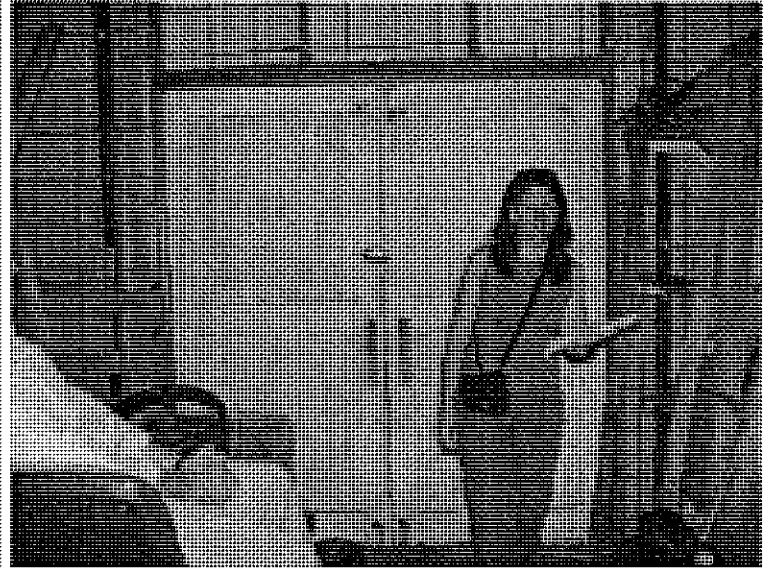
Figure 63: Logo on corrugated iron roof of laundry shed
Figure 64: Timber boarded doors to rear of laundry shed.
Figure 65: Timber boarded floor to laundry shed.
Figure 66: Window and bench in laundry shed.

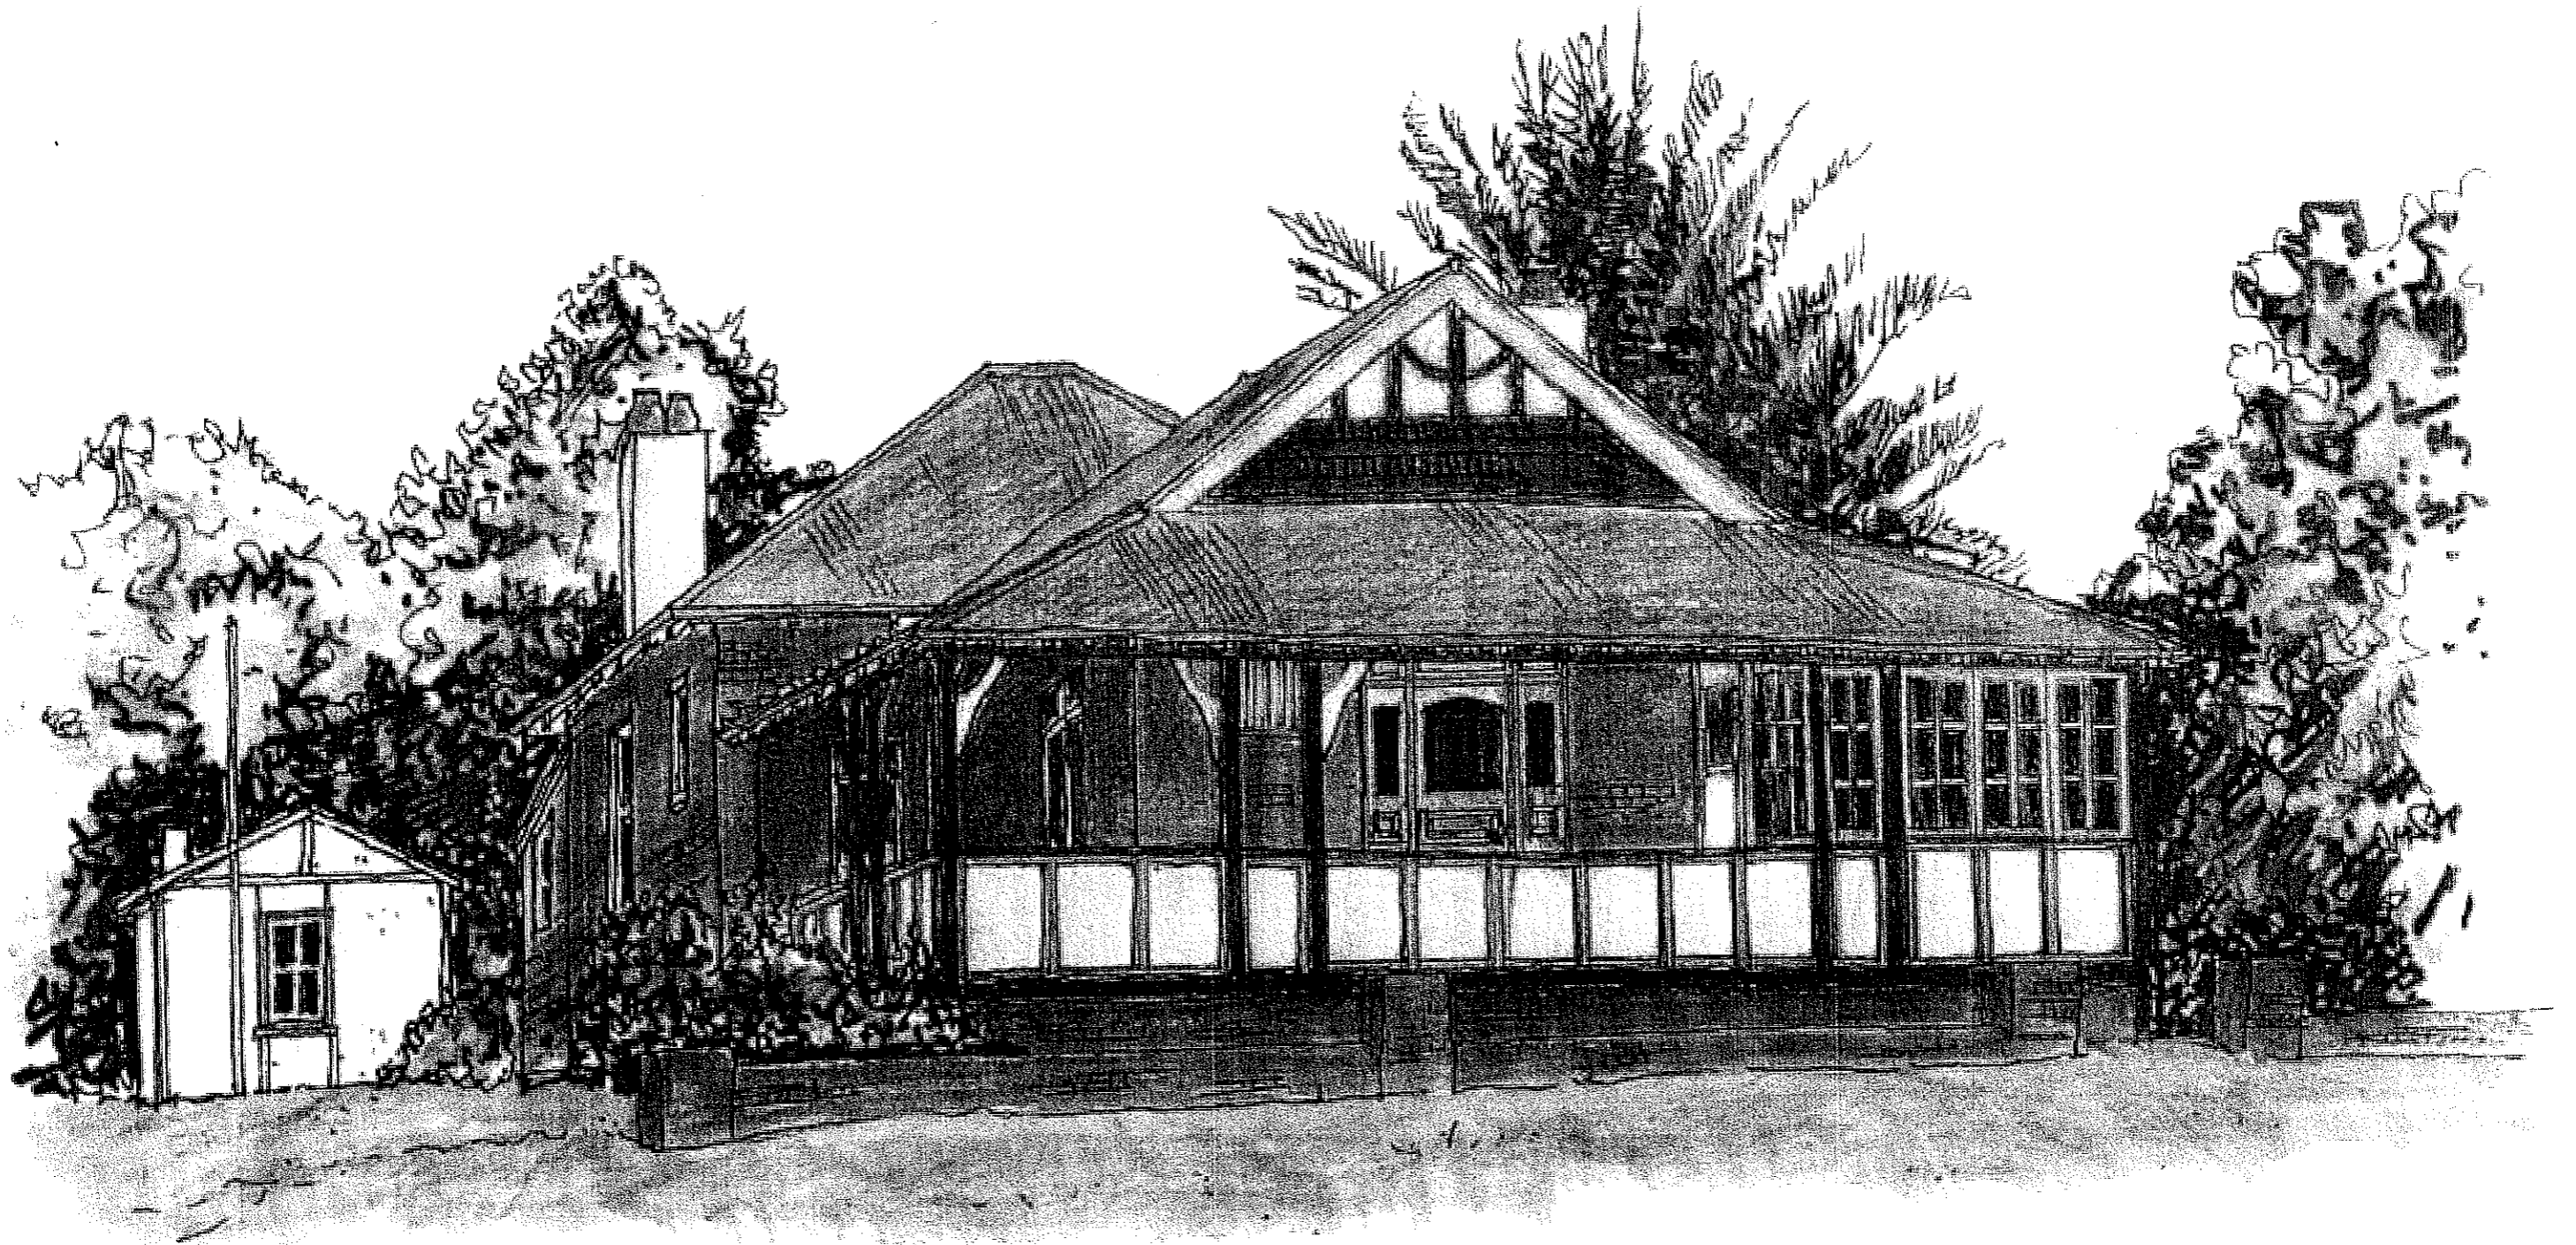
Figure CS1: Jarman's Cottage and associated buildings proposed colour scheme

Element	Australian Standard's Colour
FC wall sheeting	Deep Stone Y55 (2700)
Timber cover strips	Deep Stone Y55 (2700)
Timber Barge boards	Sandstone Y53 (2700)
Face brick chimney	Do not paint
Timber door	Sandstone Y53 (2700)
Timber frame and architrave	Deep Stone Y55 (2700)
Timber window sash	Deep Stone Y55 (2700)
Timber window sill and architrave	Deep Stone Y55 (2700)
