**SHOALHAVEN DAIRY INDUSTRY • STAGE 1
ARCHAEOLOGY OF THE MILTON & KANGAROO VALLEY AREAS**

**VOLUME 2 • PART 1
INVENTORY BASED DESCRIPTION OF DAIRY INDUSTRY SITES**

**PETER FREEMAN PTY LTD
CONSERVATION ARCHITECTS & PLANNERS**

**EDWARD HIGGINBOTHAM & ASSOCIATES PTY LTD
ARCHAEOLOGY, HISTORY & HERITAGE**

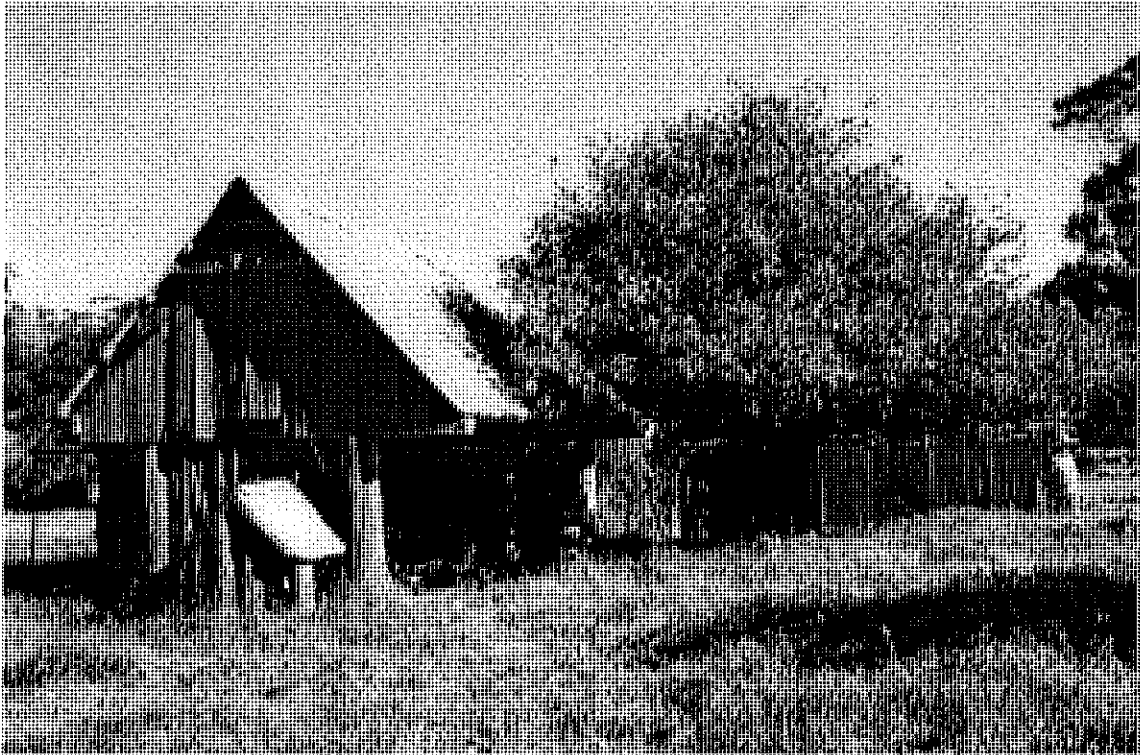
Kendall Dale milking bails. Source: MH 1997 photograph

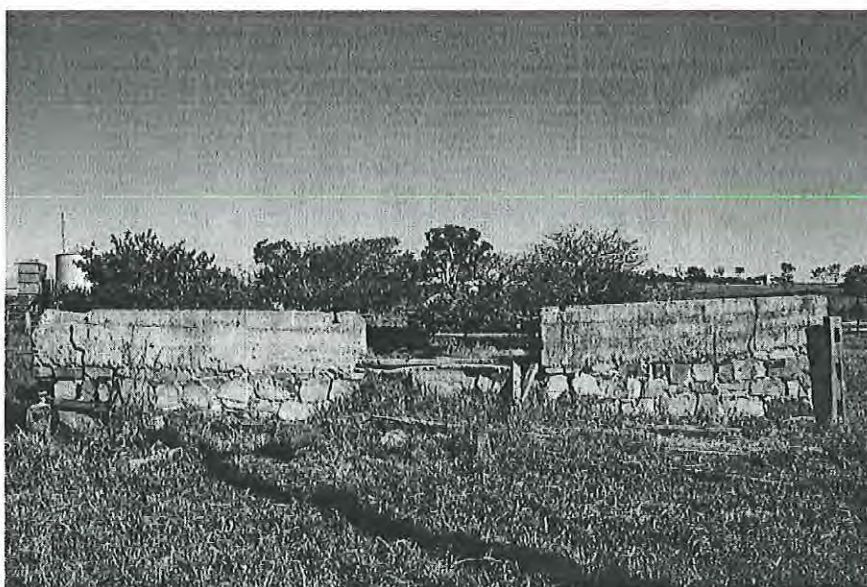
Feed stalls with formed concrete feed bins along outer walls, concrete plinths for timber posts as stall divisions, central aisle to feed storage areas at southern end. Looking south
MH 1997 photograph 11.12

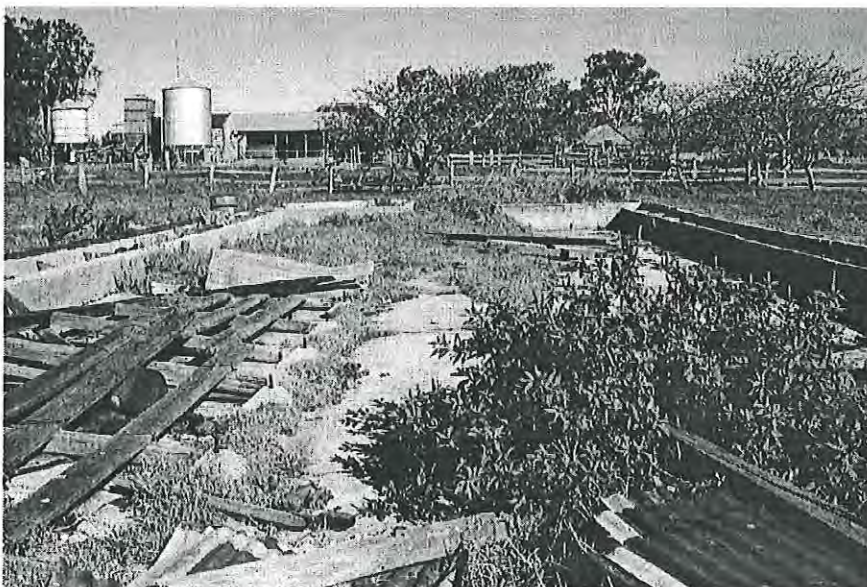
Large timber frame, corrugated iron hay and feed storage, post and triple rail timber fence. Looking south-west
MH 1997 photograph 11.15

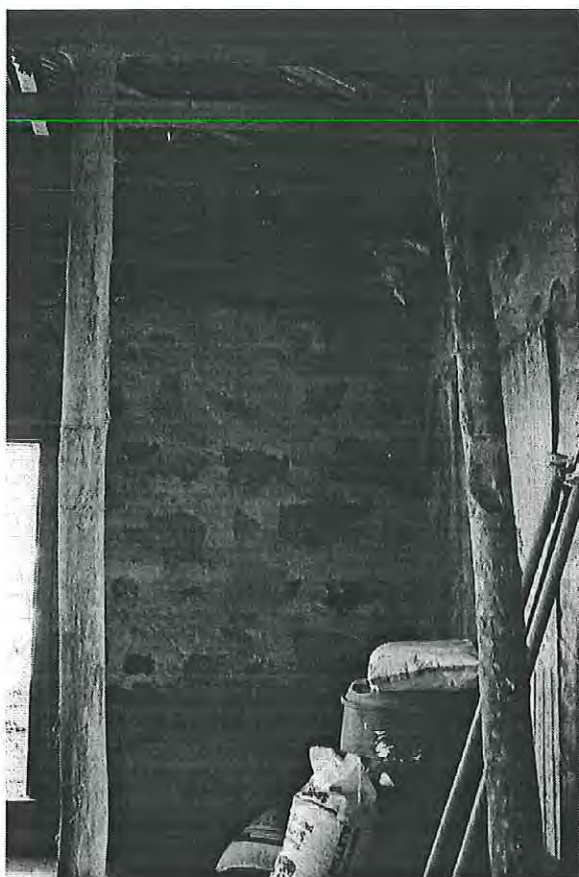
Above left: 1918 dairy interior showing concrete floor and base to walls, sapling posts sawn roof timbers.
MH 1997 photograph 11.21

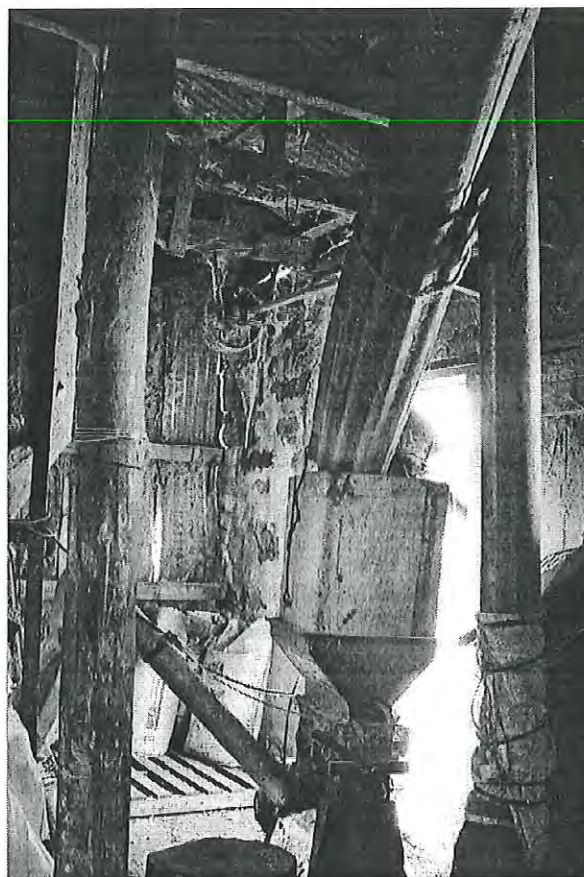
Above right: 1918 dairy interior showing remnant drive shaft with pulley supported by bracing from roof, used to drive cream separator and other equipment.
MH 1997 photograph 11.22

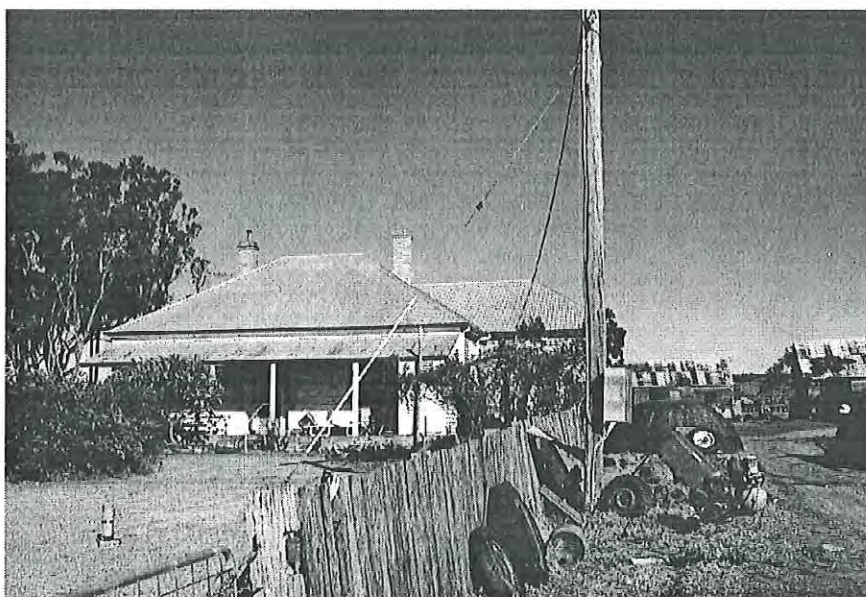
1884 dairy (creamery), north elevation. Looking south
MH 1997 photograph 11.24

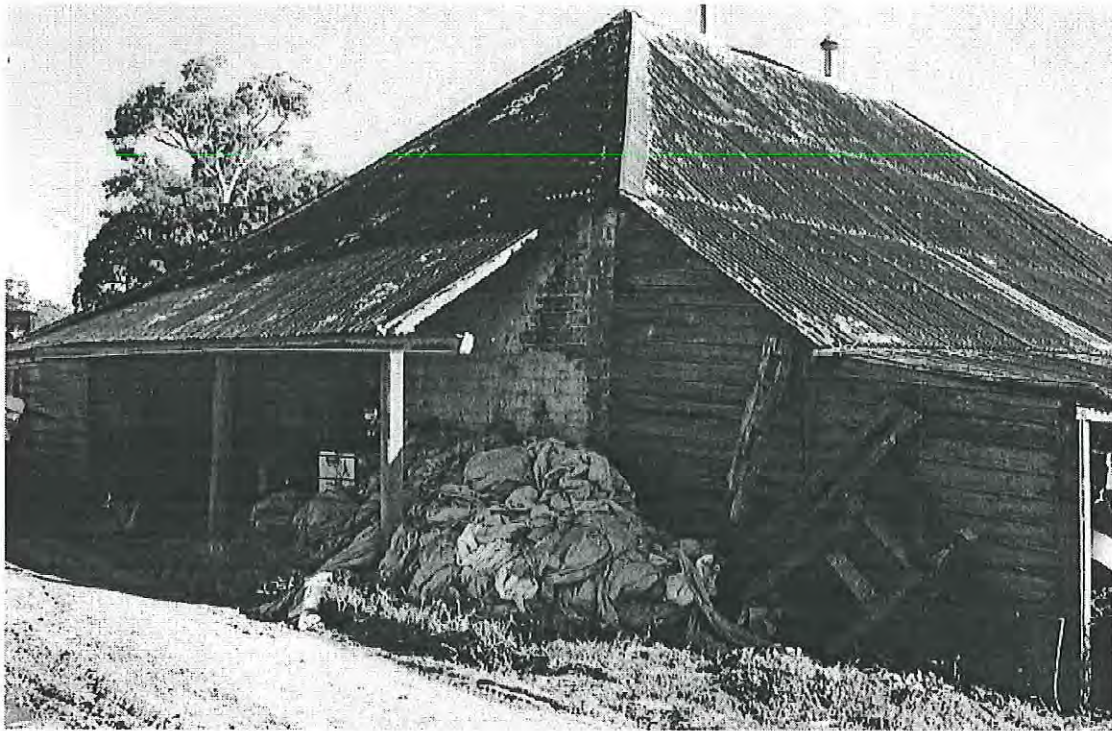
Above: Dairy - eastern elevation.
MH 1997 photograph 12.4

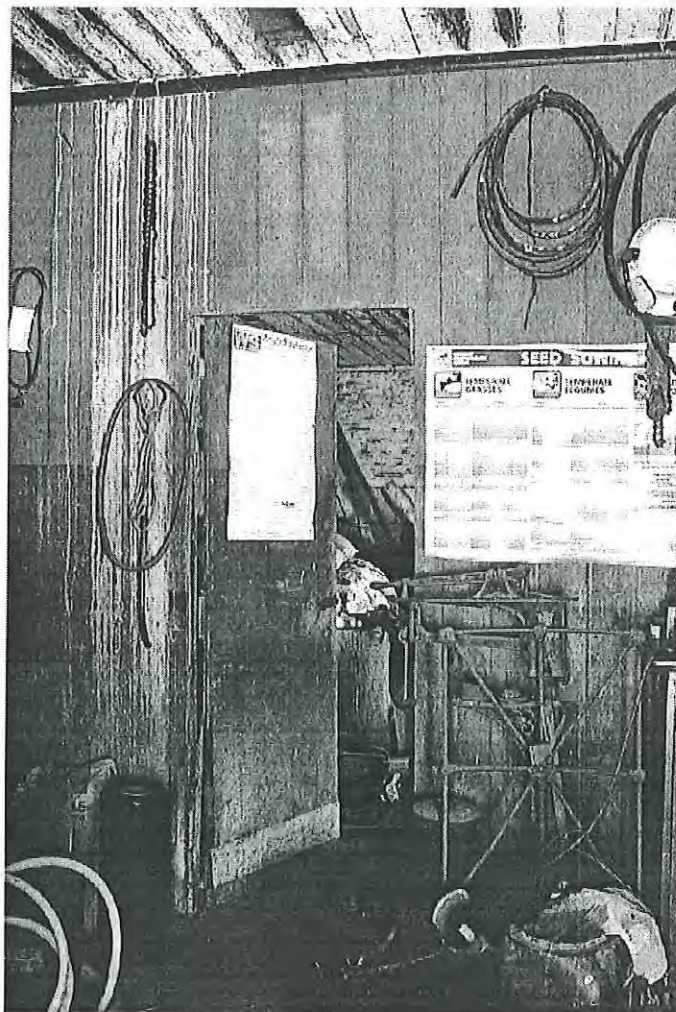
Above left: Milk room
interior whitewashed
vertical board partition wall
and ceiling and brick wall
Looking east
MH 1997 photograph 12.6

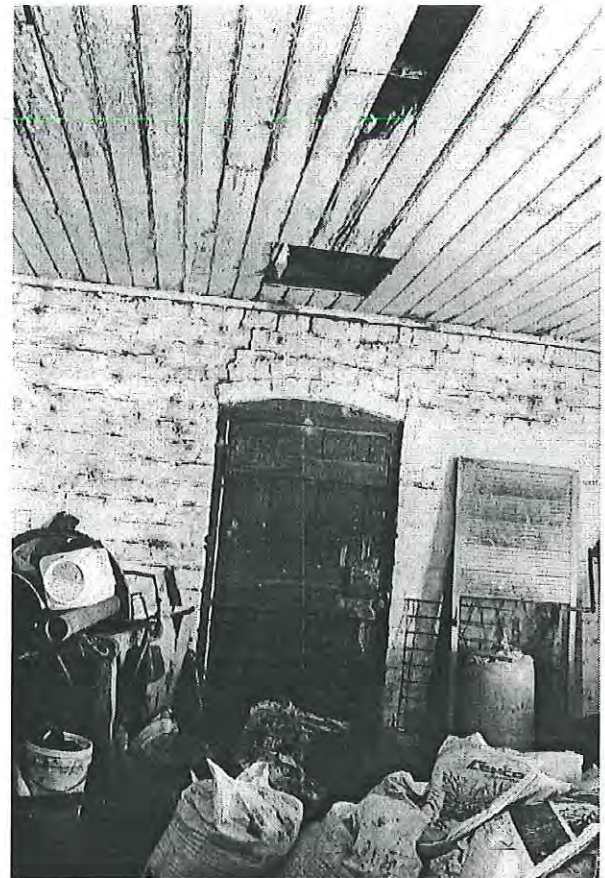
Above right: Western wall
of milk settling room
MH 1997 photograph 12.7

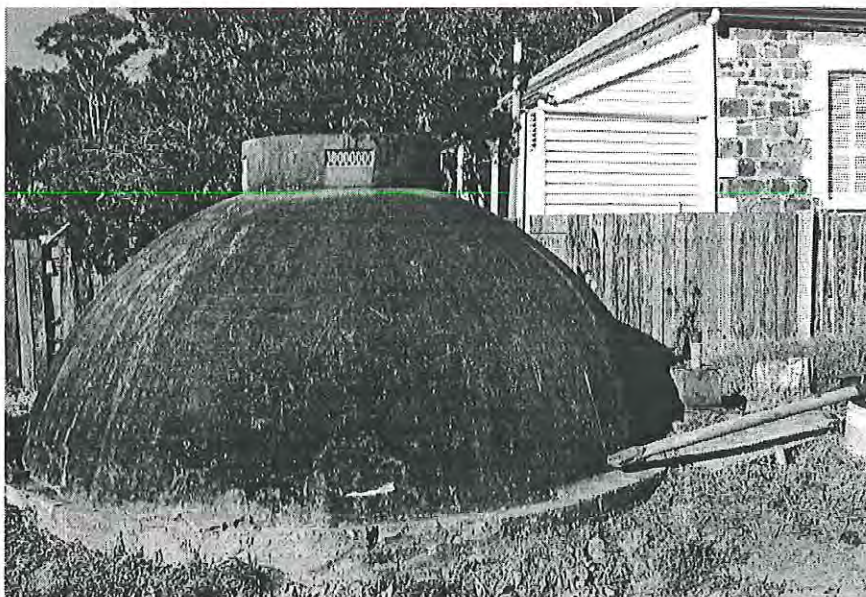
Dome top brick and render well similar to Mimosa Farm.
MH 1997 photograph 12.9

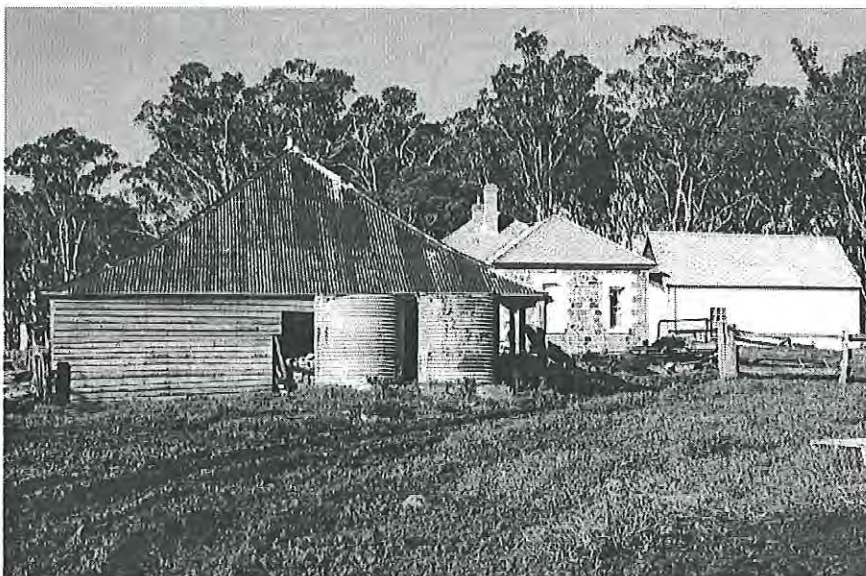
Western elevation dairy, enclosed verandah, house in background. Looking east
MH 1997 photograph 12.10

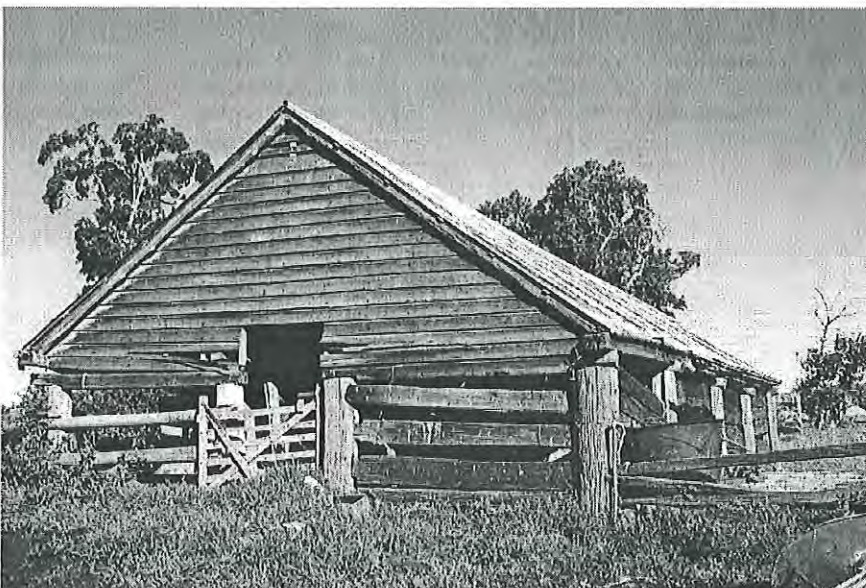
Pig sty northern weatherboard gable end, natural round posts, squared top plates, split timber horizontal slabs; western wall held in vertical grooves down length of posts (drop log construction). Tallow pot used as water trough.
Looking south
MH 1997 photograph 12.11

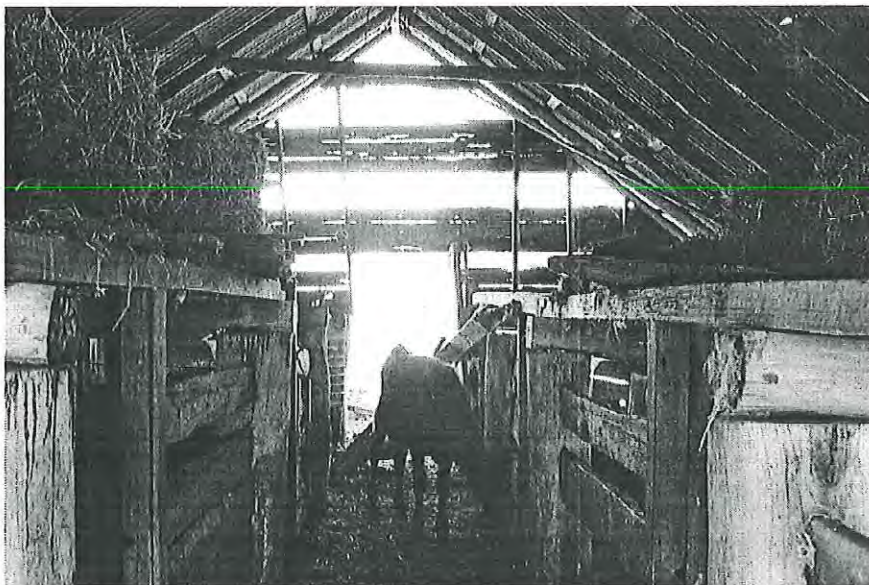
Eastern yards to pens, note
drop log wall construction.
Looking south
MH 1997 photograph 12.14

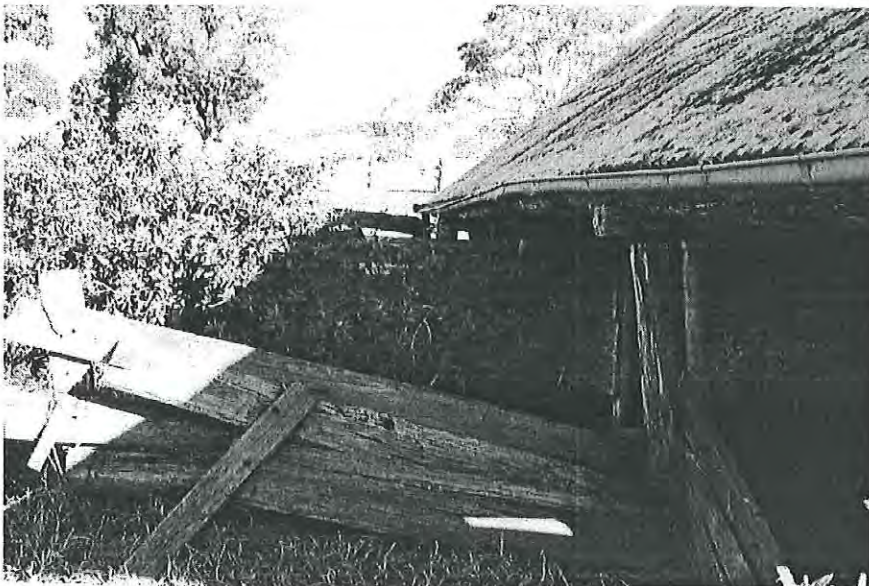
House western elevation,
coursed random rubble with
rendered quoins, shallow
eaves, weatherboard pavilion
extension with vertical board
infill.. Looking east
MH 1997 photograph 12.15

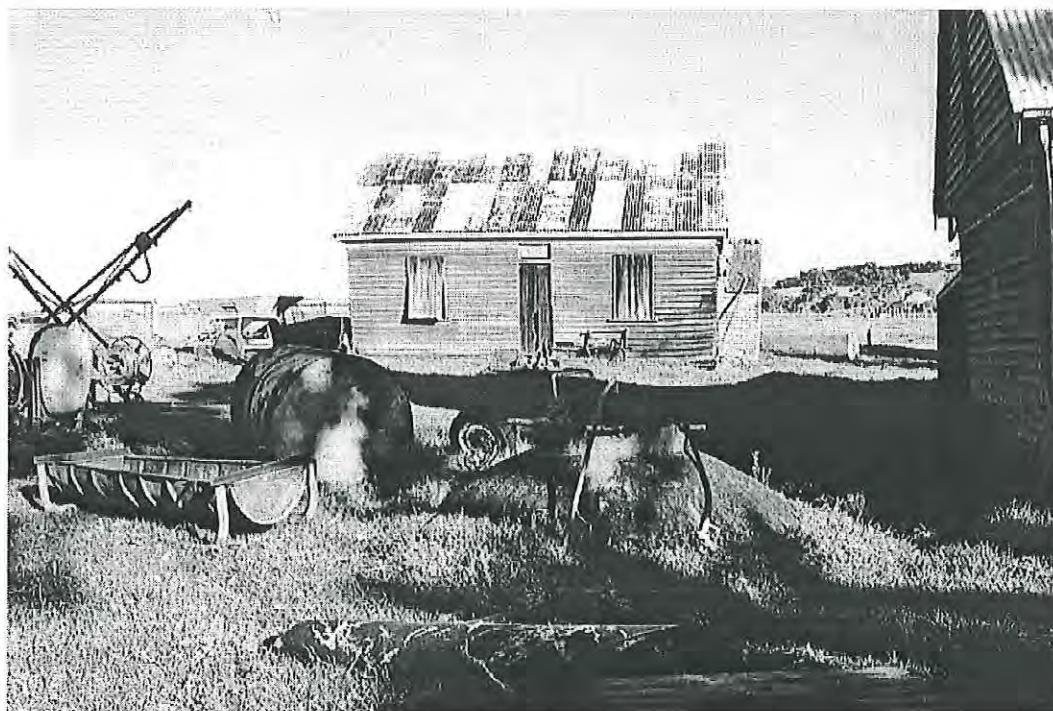
Boys accommodation western
elevation. North western
corner is dislodged. Looking
east
MH 1997 photograph 12.21

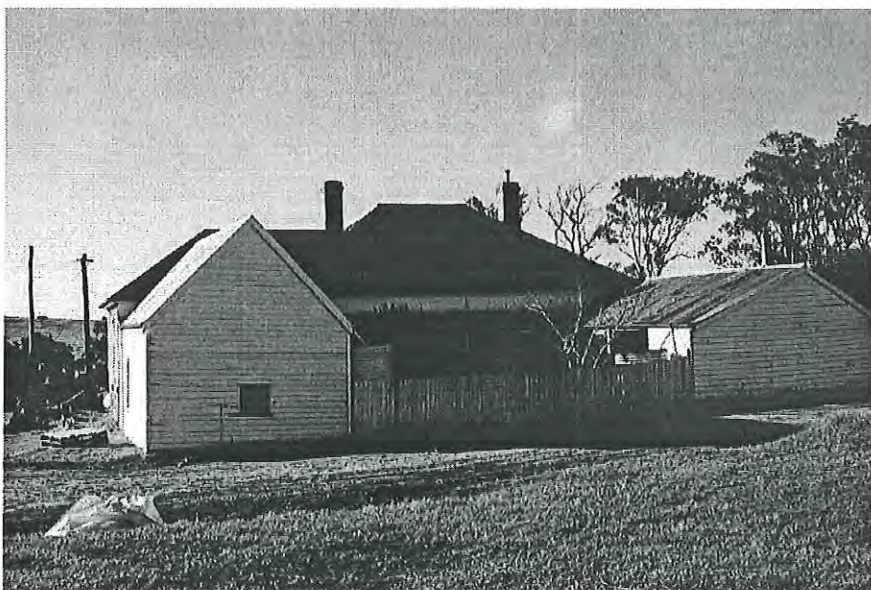
Dairy southern elevation
showing alteration to roof to
provide access to recent
double garage doors. Looking
north
MH 1997 photograph 13.2

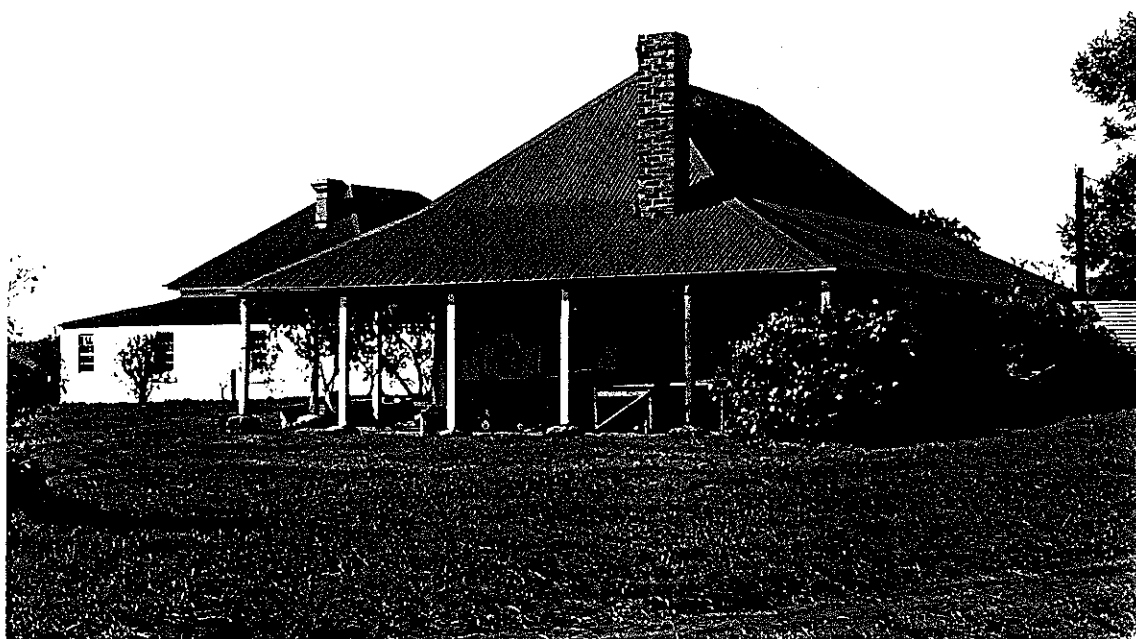
Narrawilly, early house,
 used as dairy (creamery); now
 accommodation. Painted
 brick with encircling
 verandah, enclosed at rear,
 stone floor, Looking south-
 west
 MH 1997 photograph 2.10

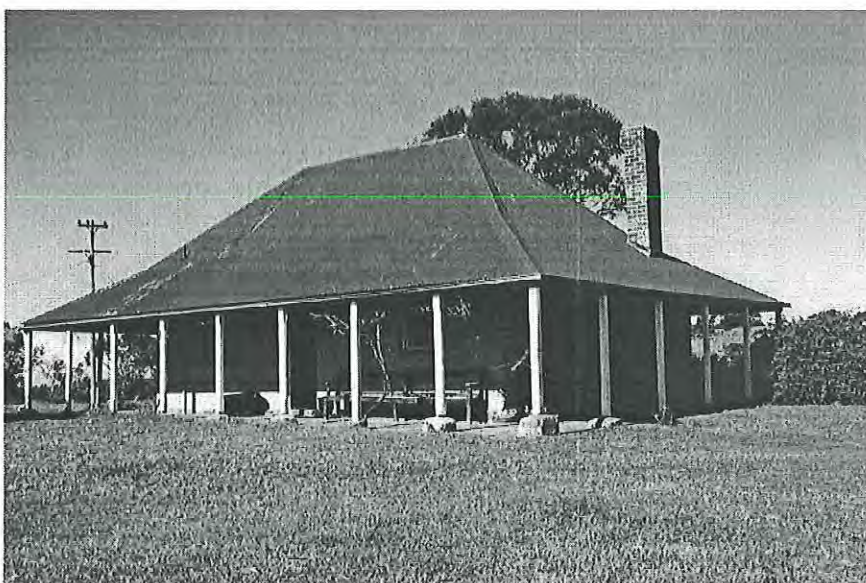
Farmhouse, rendered brick,
 encircling verandah, enclosed
 apart from front (east).
 Recent sympathetic extensions
 to south. Looking south
 MH 1997 photograph 2.11

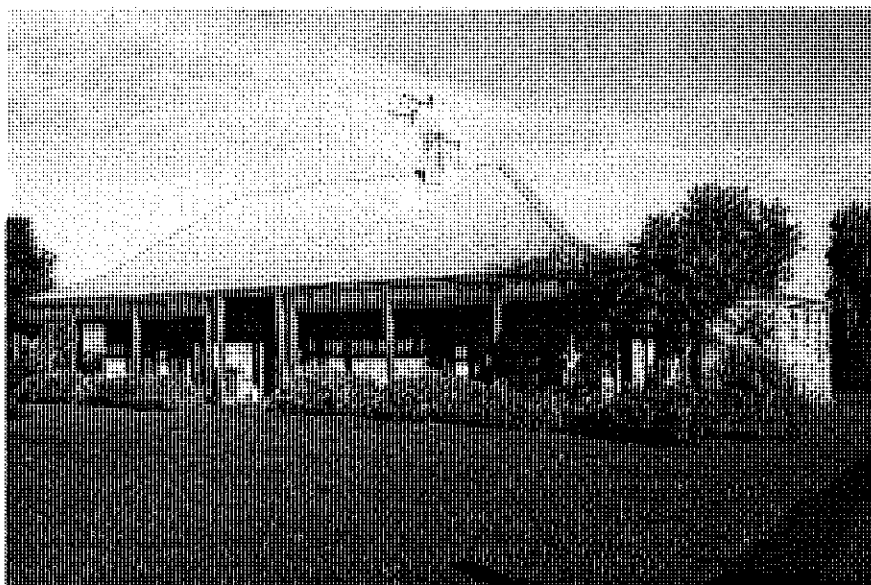
'Claydon Park' original stone section of house with stone rear extension, new timber verandah and new corrugated iron sheeting roof. Original roof was shingled. Metal tiles (Moorewood and Rogers, patented 1856) were on eastern hip of roof. Looking south-east.
MH 1997 photograph 1.3

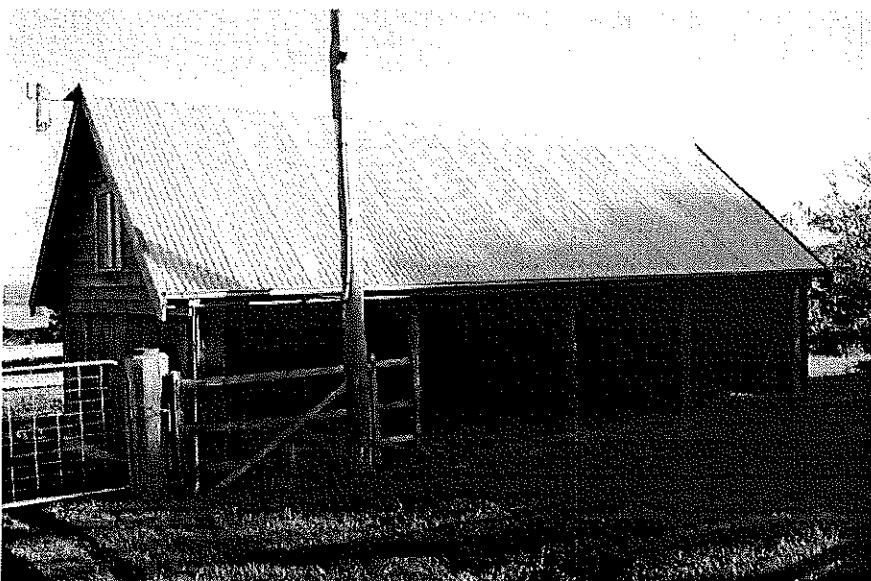
Walk through dairy, renovated. Southern rear wall filled in with recycled timber slabs. The pulley is still present for loft. Looking south
MH 1997 photograph 1.5

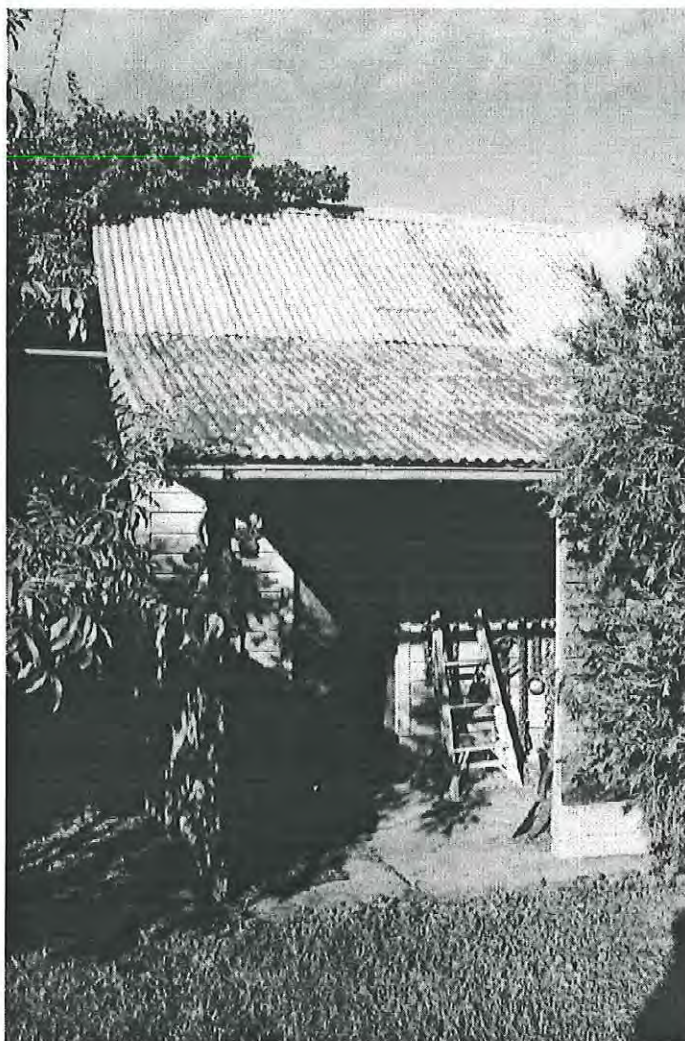
Right: Original dairy (creamery), hardwood weather board, early circular saw marks. Timber name plate above dairy door 'E (Elizabeth) Wood' - Registered Dairyman'. Looking south-east
MH 1997 photograph 1.6

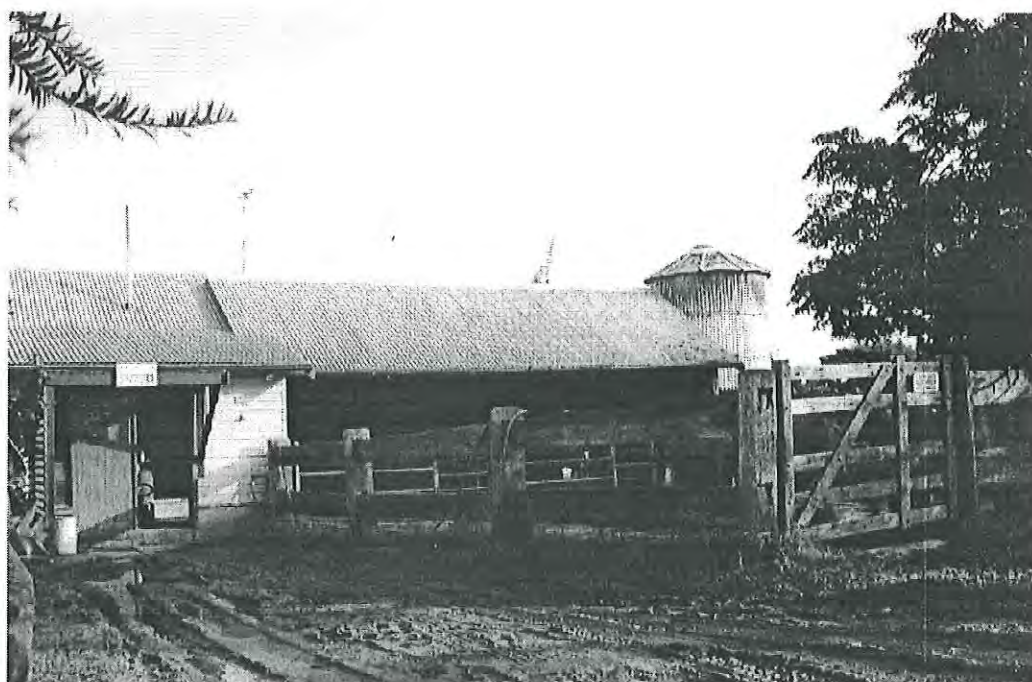
Below: 1949 Machine milk dairy, modernised. Rebuilt post and rail fences. Looking south
MH 1997 photograph 1.7

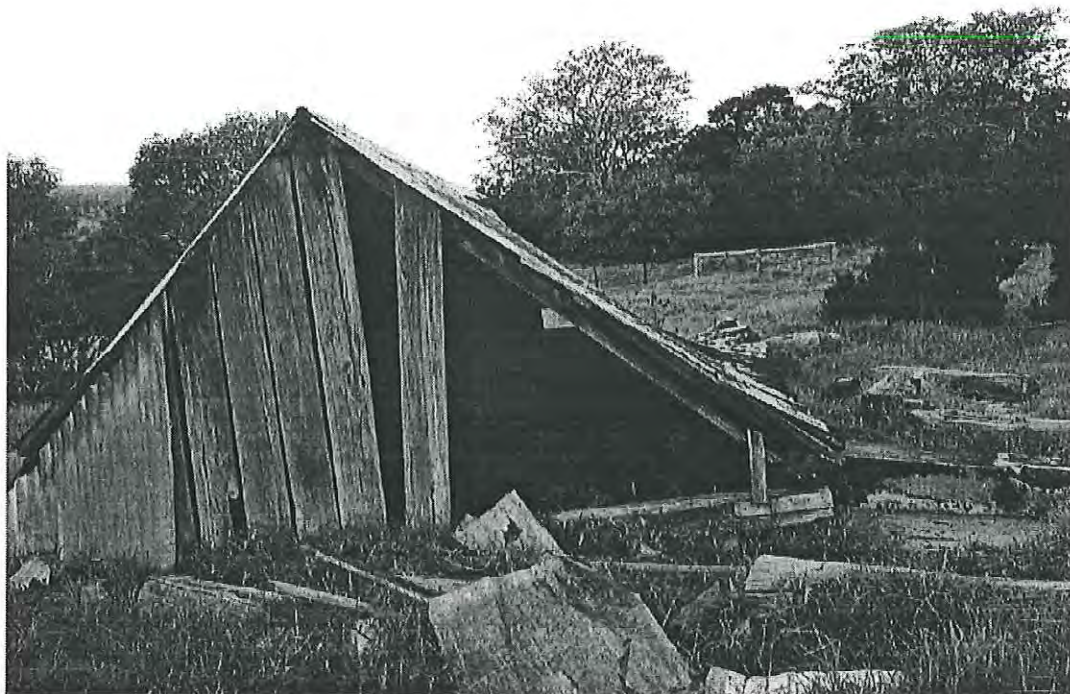
Milking bails collapsed.
MH 1997 photograph 14.4

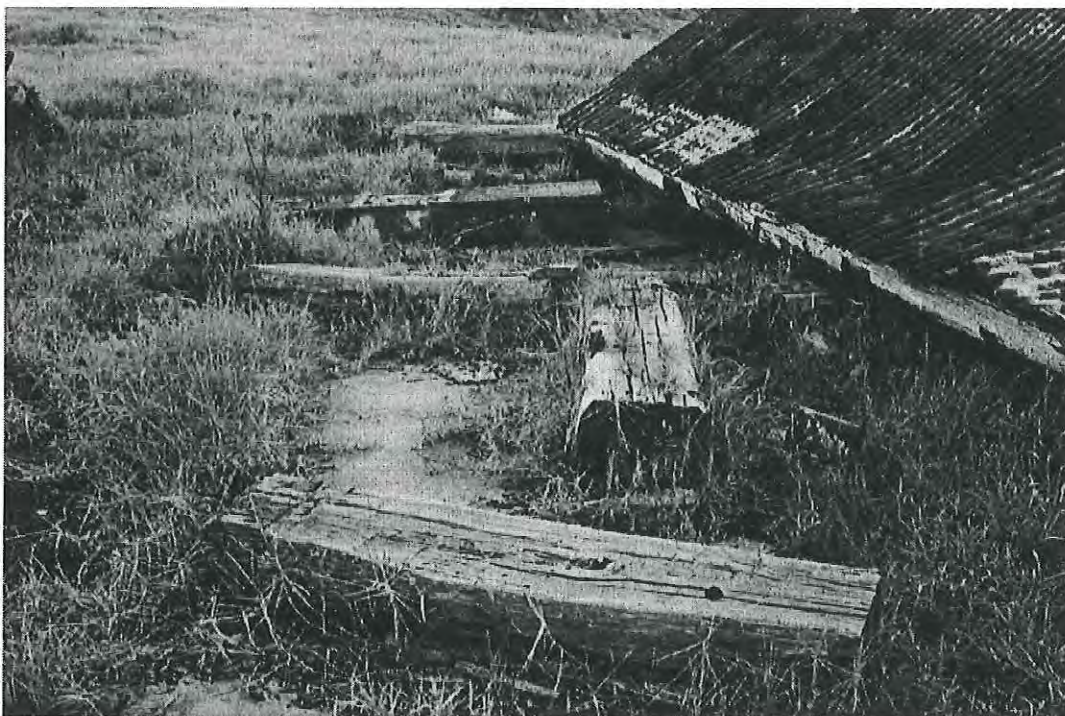
Roughly squared posts from bails, concrete floor for milking area; brick and concrete engine mount
Looking north
MH 1997 photograph 14.5

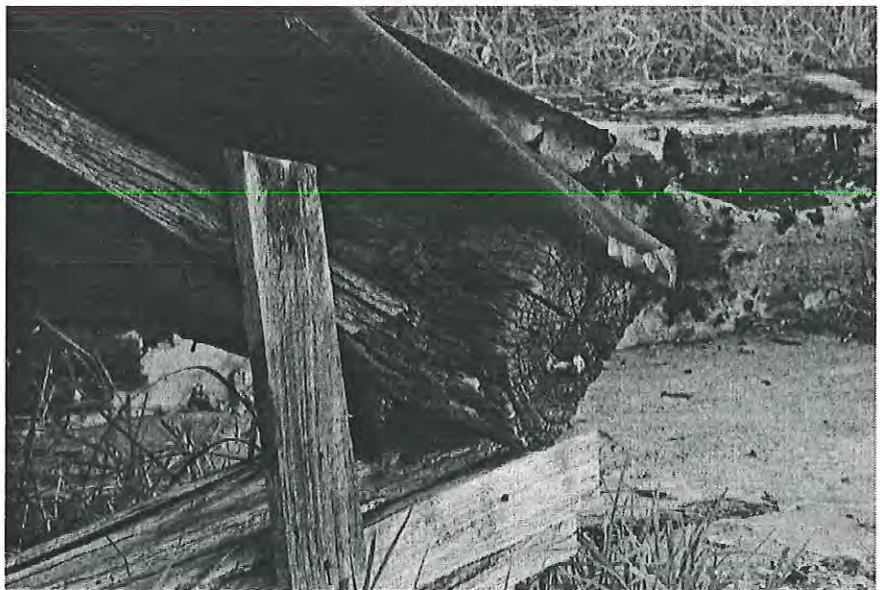
Detail of timber pegs used in
construction of milking bails.
MH 1997 photograph 14.8

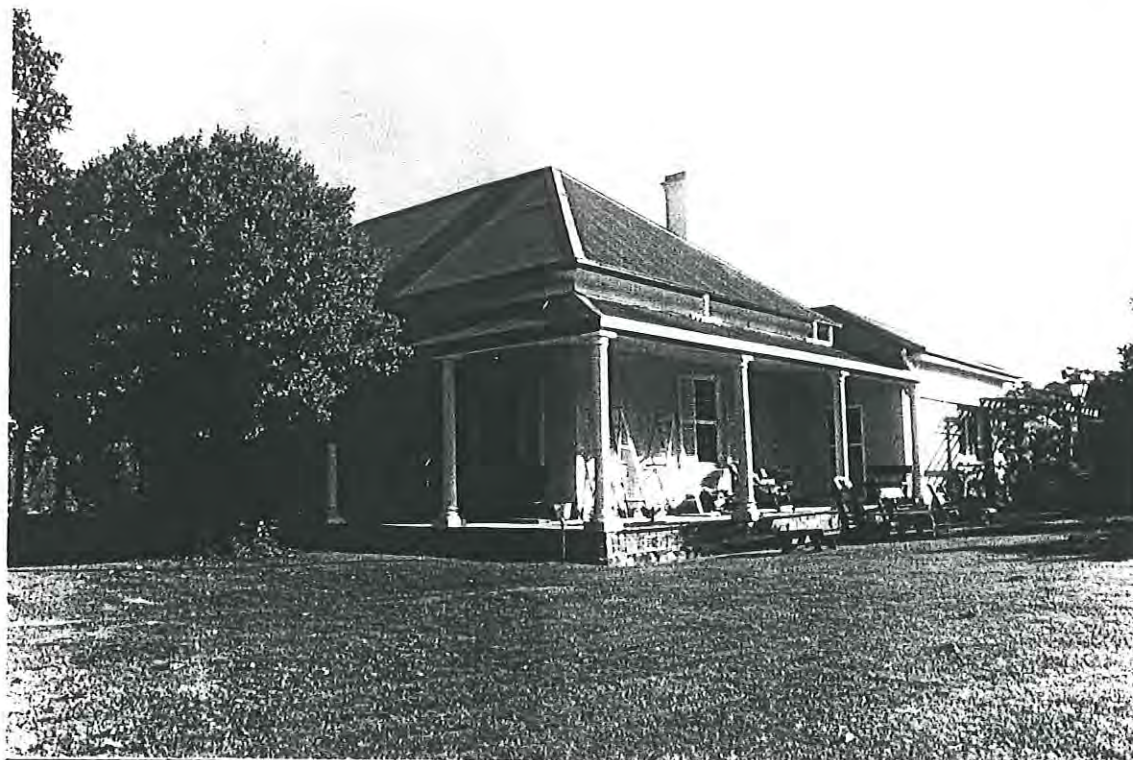
Description: Fine single storied Victorian Georgian residence with earlier section at rear. Rear section rectangular with low-pitched hipped roof. Front section parallel with medium pitched hipped iron roof and boxed eaves. Constructed of rendered random rubble. Tall rendered chimneys. Verandah with separate pitched roof returns to sides. Raked verandah soffit and Tuscan columns. Double-hung twelve-paned windows with louvred shutters. Unpainted timber interior and timber mantles.
Modifications: The original shingles have been replaced with corrugated iron with modern profile. Verandah floor possibly replaced.

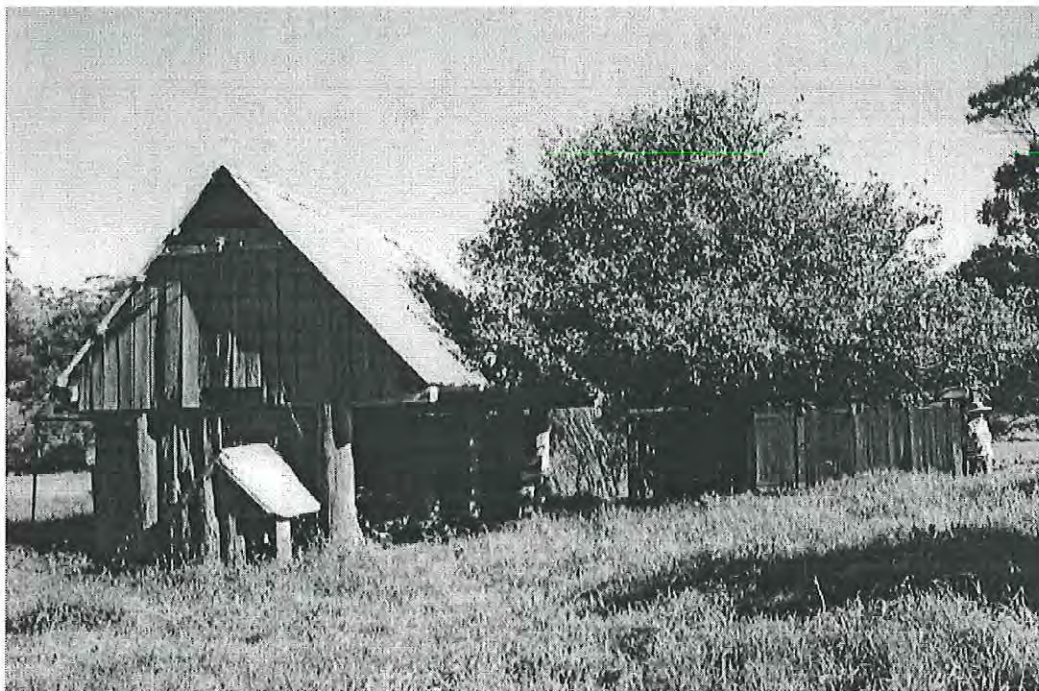
Above: Kendall Dale.
Milking bails, hand milking,
apple tree, more recent
equipment storage
background. Looking west
MH 1997 photograph 8.4

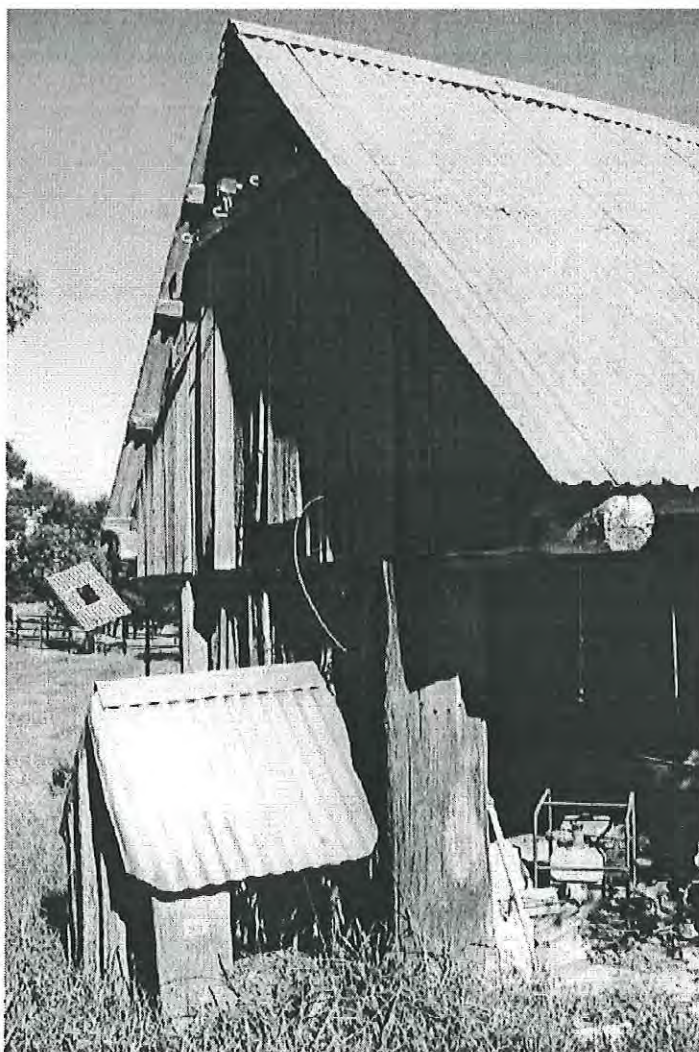
Right: Milking bails, detail
natural round timber posts,
split timber slab lower level,
sawn timber boards, gable,
corrugated iron roof.
Looking south-west
MH 1997 photograph 8.5

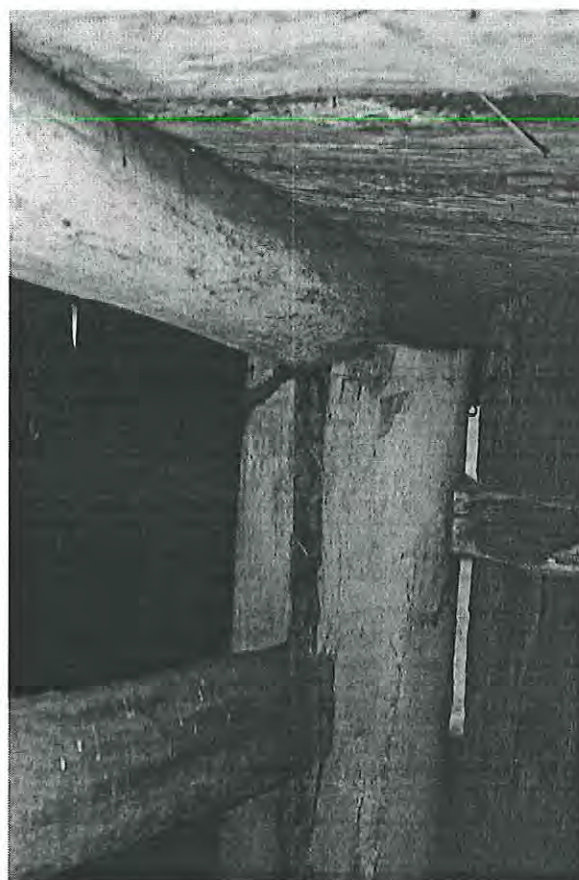
Above right: Detail stall partition. Looking south
 MH 1997 photograph 8.7

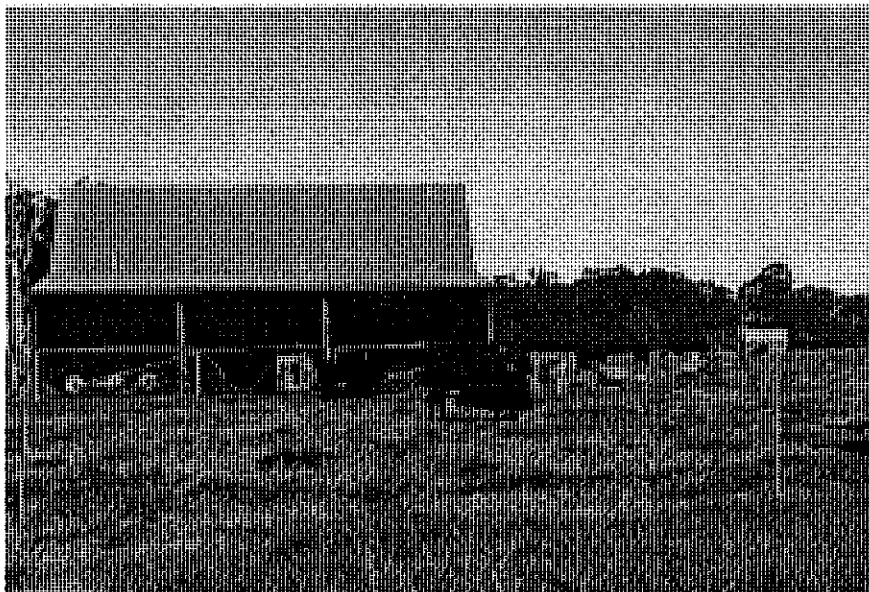
Below: East elevation.
Looking west
MH 1997 photograph 8.8

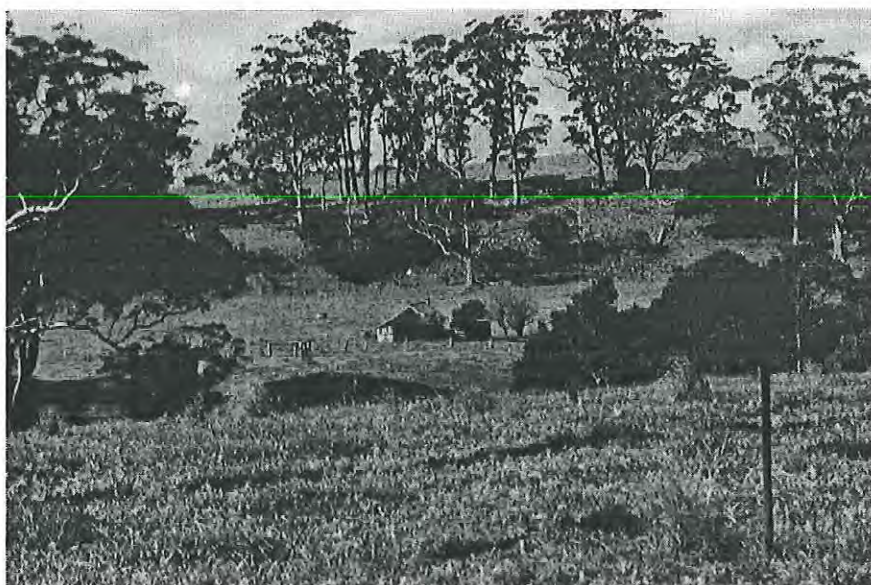
Distant view, vertical slab and batten cottage (as seen from Kirmington). Looking east
 MH 1997 photograph 8.24

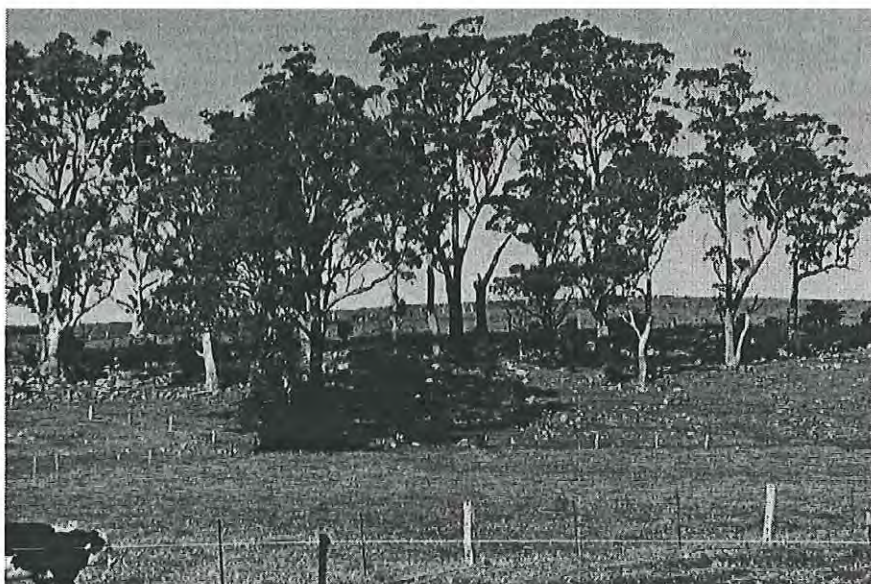
Hill to south east of hand milking bails, source of paving stones. Looking south-east.
 MH 1997 photograph 8.12

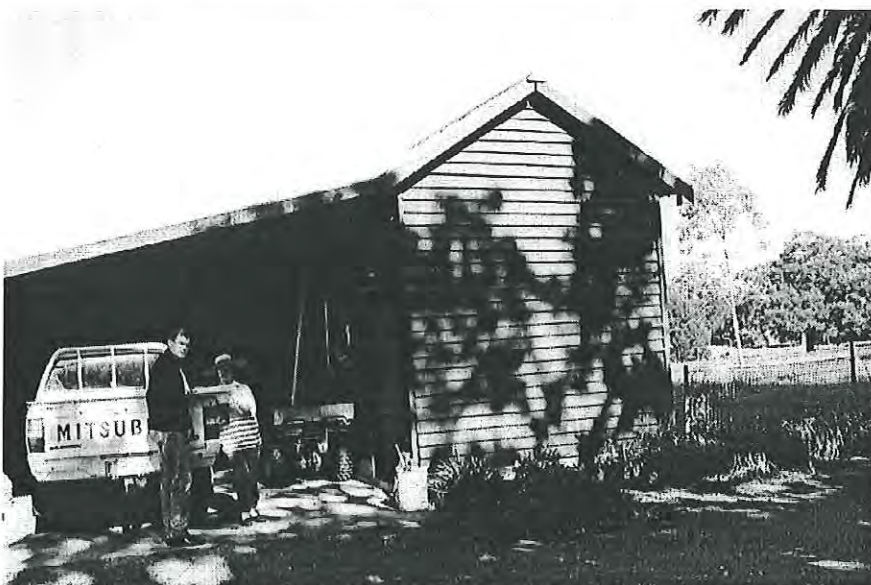
Pre- 1940's milk room.
 Looking south-west.
 MH 1997 photograph 8.13

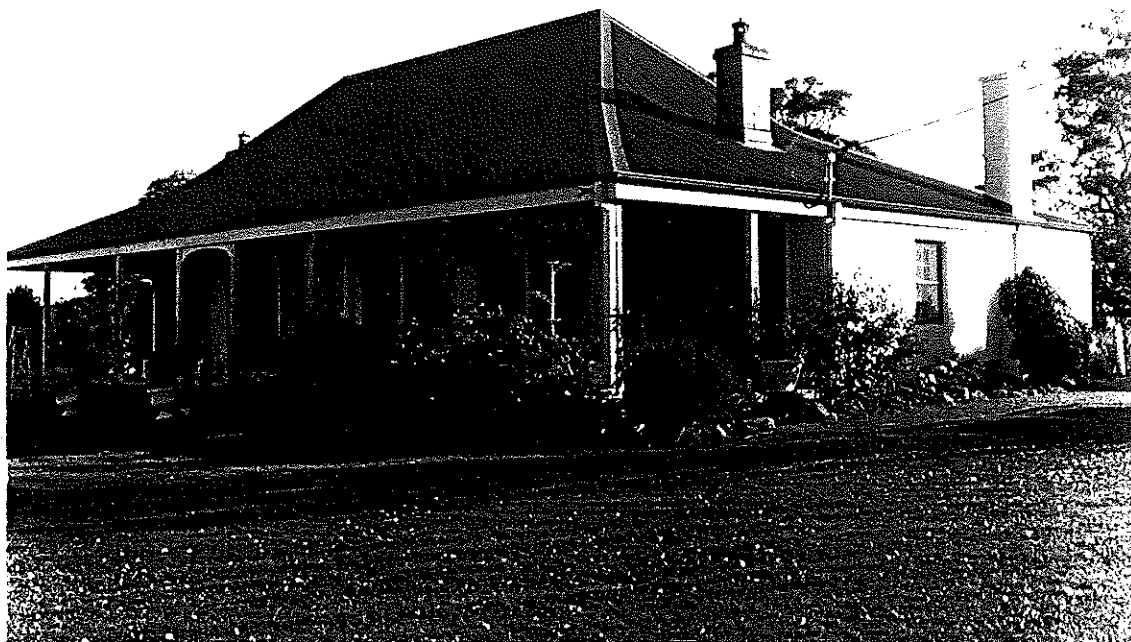
Description: Single storey Victorian Georgian residence. Rectangular plan with bellcast iron roof over wraparound timber verandah. Constructed of rendered masonry with ashlar ruling. Sturdy brick chimneys with single pots, one at each end. Tall external brick chimney to rear. Central entrance door with tapered architraves. Two sets of french doors to either side. Multi-paned glass doors with margin glazing. Louvred timber shutters to french doors.
 Modifications: Loss of verandah detail indicated. Screen door. Verandah enclosures to rear are longstanding, if not original. Roofing replaced.

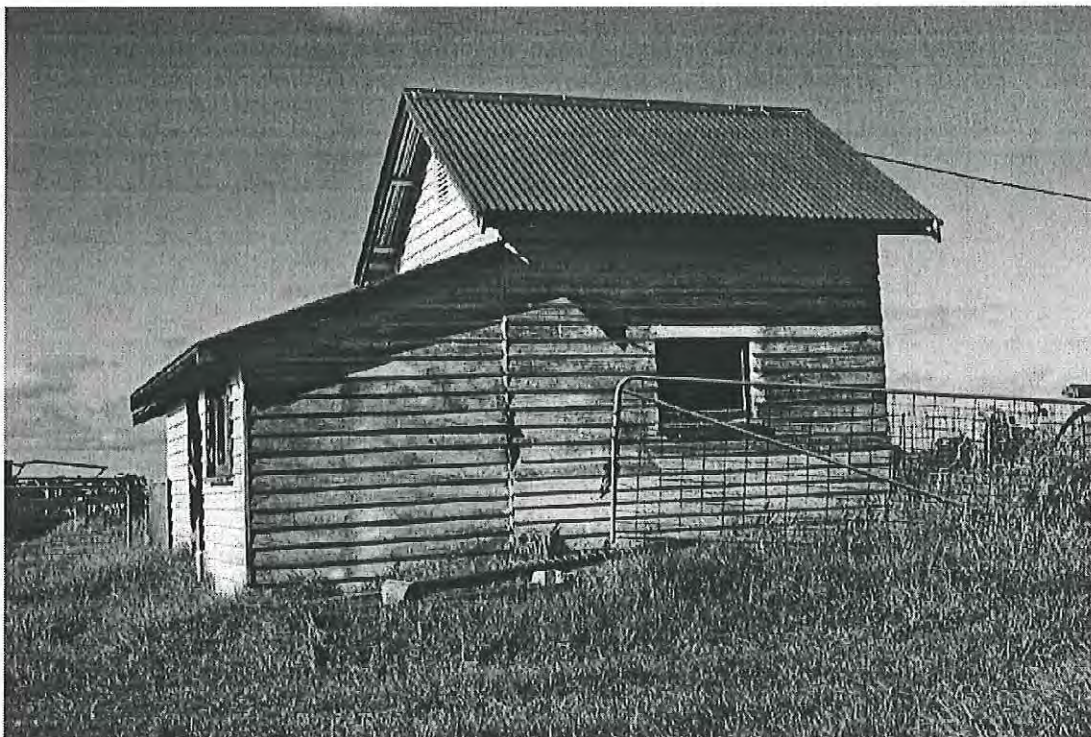
Above: Milking bails area, bails and milking machines removed and walk-through doors have been boarded up. Looking south-east. MH 1997 photograph 8.18
