**SHOALHAVEN DAIRY INDUSTRY • STAGE 1
ARCHAEOLOGY OF THE MILTON & KANGAROO VALLEY AREAS**

**VOLUME 2 • PART 1
INVENTORY BASED DESCRIPTION OF DAIRY INDUSTRY SITES**

**PETER FREEMAN PTY LTD
CONSERVATION ARCHITECTS & PLANNERS**

**EDWARD HIGGINBOTHAM & ASSOCIATES PTY LTD
ARCHAEOLOGY, HISTORY & HERITAGE**

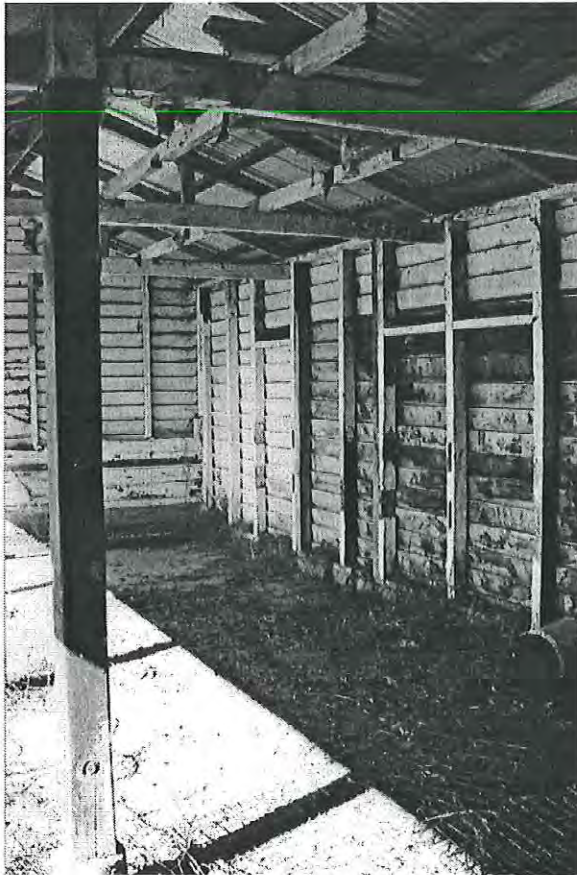
Western elevation milk room with enclosed verandah used as wash-up area. Looking east.
MH 1997 photograph 8.16

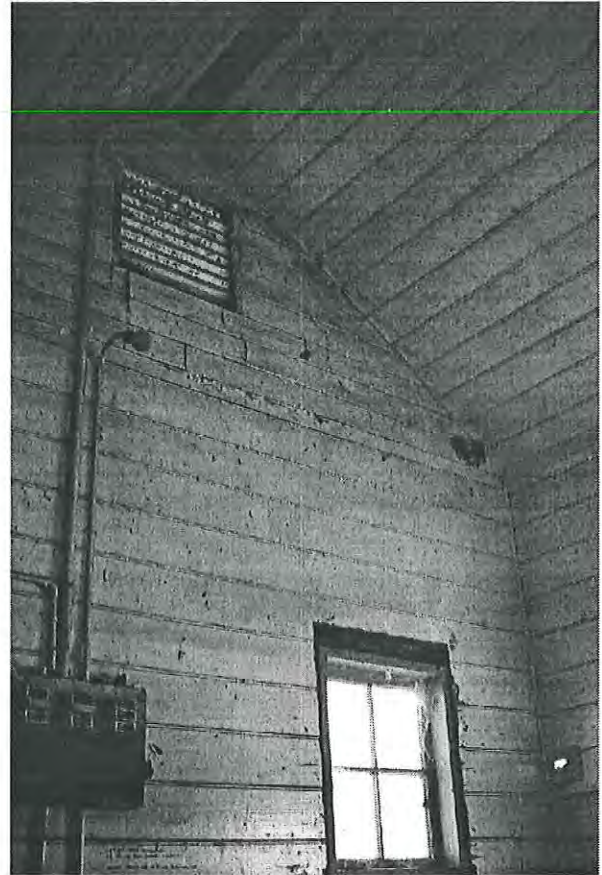
Above right: Interior of milk room, beaded board lining, ridge line and gable ventilation; replacement window in south wall, painted. Looking south-west. MH 1997 photograph 8.19

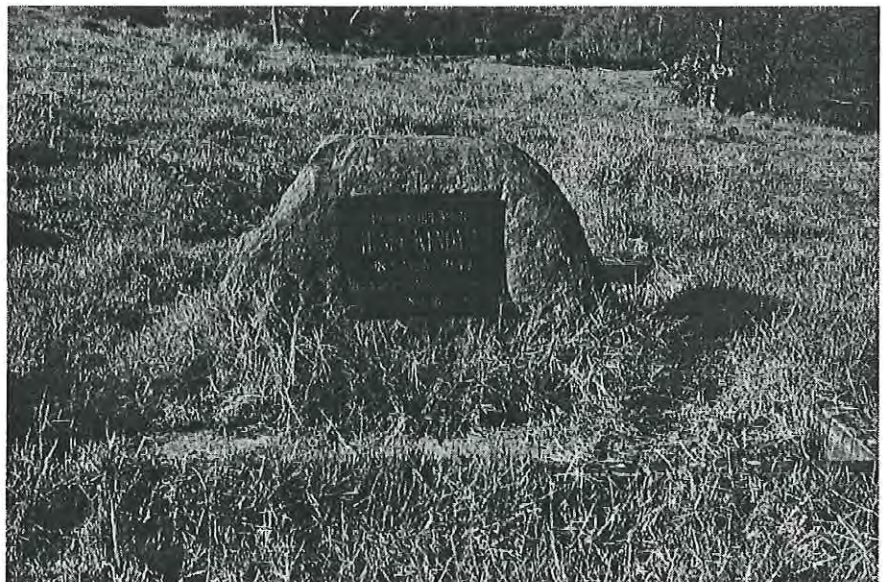
Right: Stone monument on site of cottage where Henry Kendall was born. Replaces earlier stone cairn monument (stones used in causeway). Looking east. MH 1997 photograph 8.22

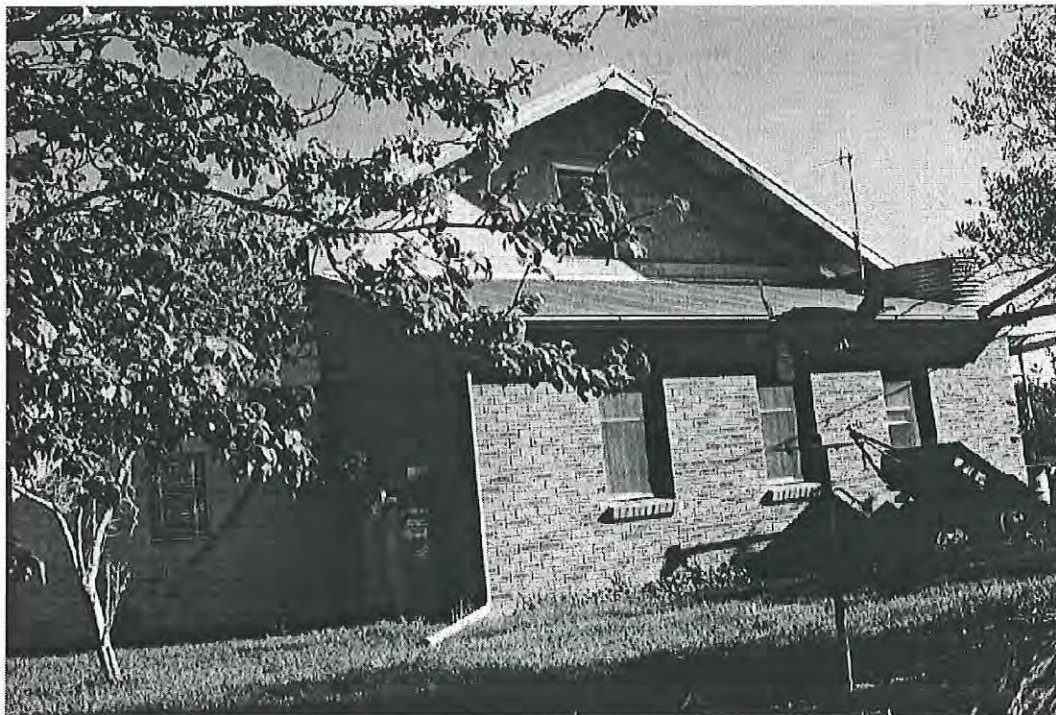
Top: Eastern/rear elevation, Gable ends replaced with curved roof on southern cheese making building. Square water pond used in water sculpture but possibly a tank from earlier separating occupation Looking west
MH 1997 photograph 1.19

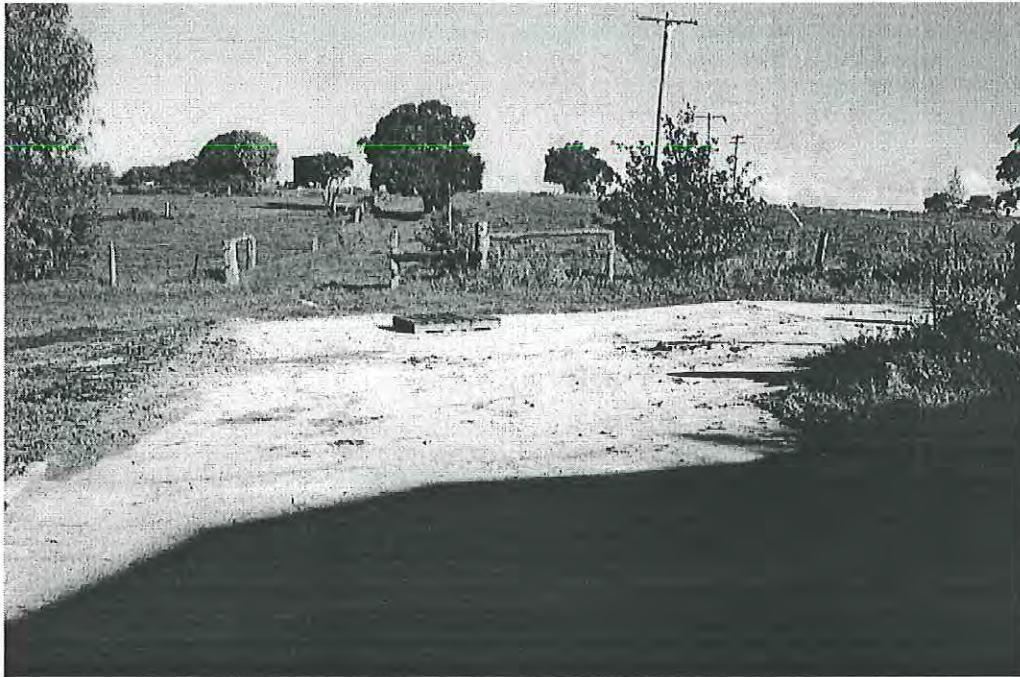
Above: Whoppindally, concrete base of earlier milking bails, 4 bails, dish drain along eastern edge, (LHS) cows entered from east. Former natural round timber post construction, post holes filled in. Distance shows lane way from paddock to this set of bails. Looking south. MH 1997 photograph 2.16

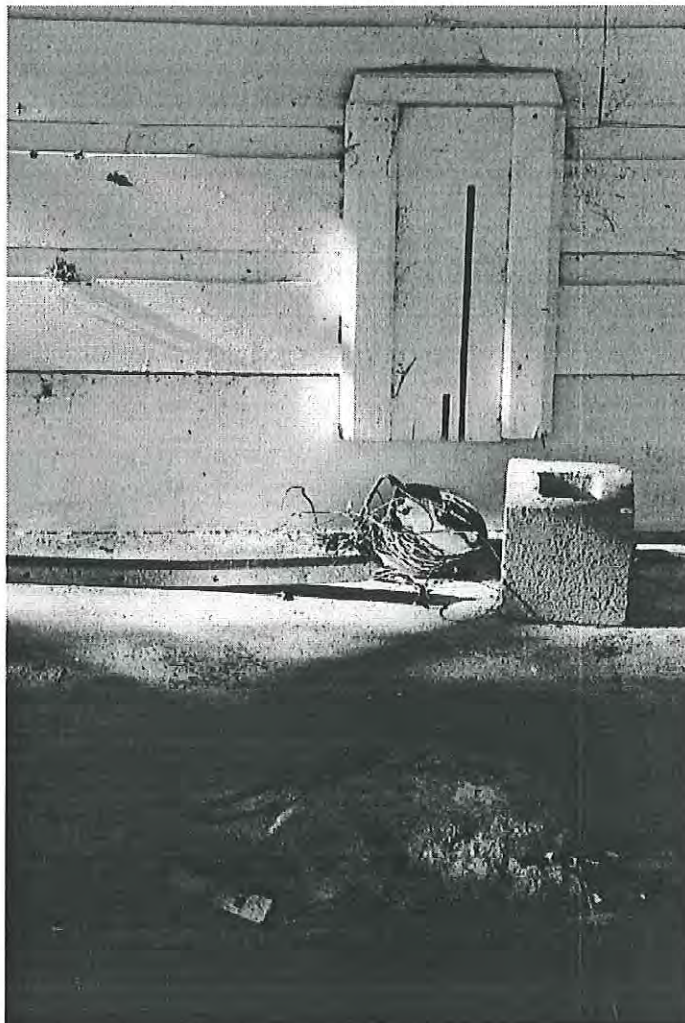
Right: Dairy (creamery), engine mount and belt slits in sliding panel, western wall. Concrete engine mount for motor to power separator. Looking east. MH 1997 photograph 2.17

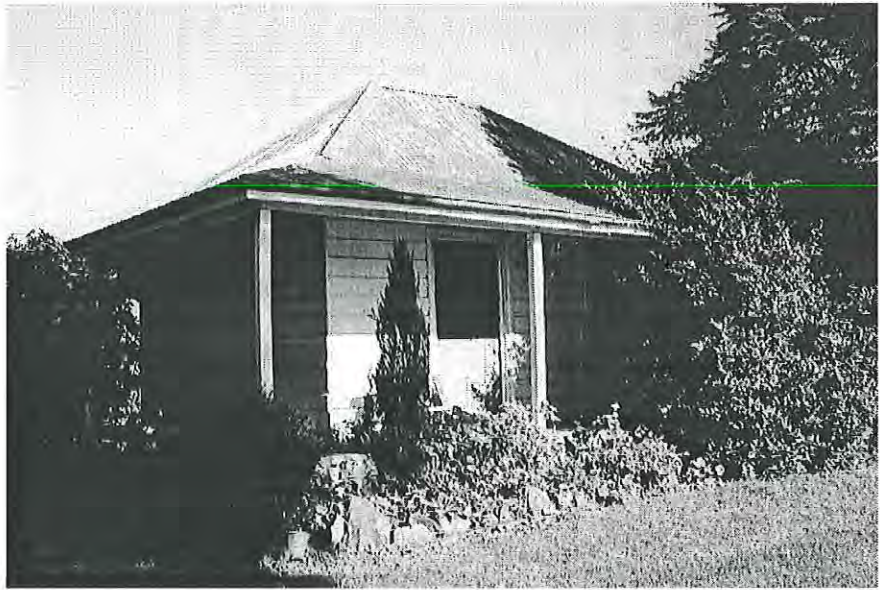
Weather board dairy,
 rusticated weather boards.
 Encircling verandah, stone
 flagging, 6 pane double sash
 window & stable style door
 in north elevation, identical
 window & door in south
 elevation. New timber frame
 roof, verandah resurfaced in
 concrete and walls refixed in
 position after severe winds
 blew dairy apart, 1979.(date
 in concrete) Looking south-
 west
 MH 1997 photograph 2.18

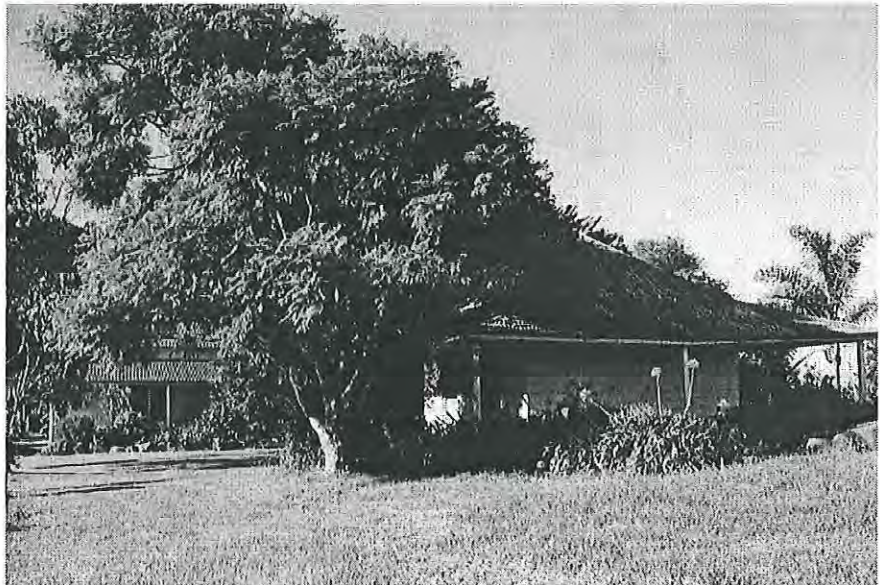
Dairy and house behind
 showing traditional close
 proximity of buildings which
 were generally the women's
 responsibility. Looking east
 MH 1997 photograph 2.19

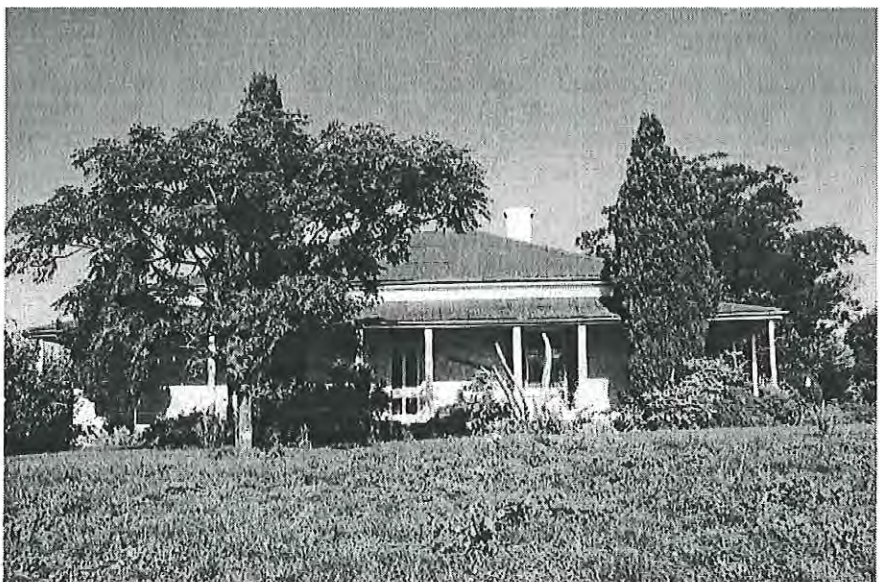
Whoppindally (Whopidally)
 built by stonemason, James
 Poole for Robert Kendall,
 1867. Looking south
 MH 1997 photograph 2.20

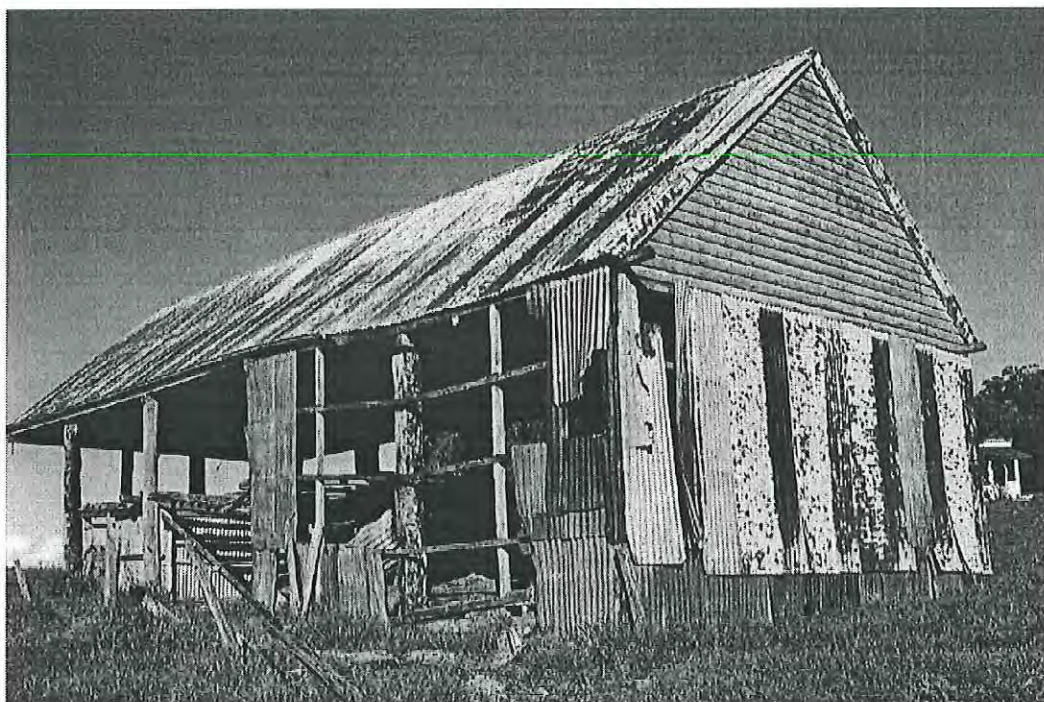
Above: Chaff cutting shed and fodder store on raised timber floor. Natural round timber post have been scorched in fire, sapling beams. Weather board gable, replacement sheet iron all cladding. Looking south
MH 1997 photograph 2.21

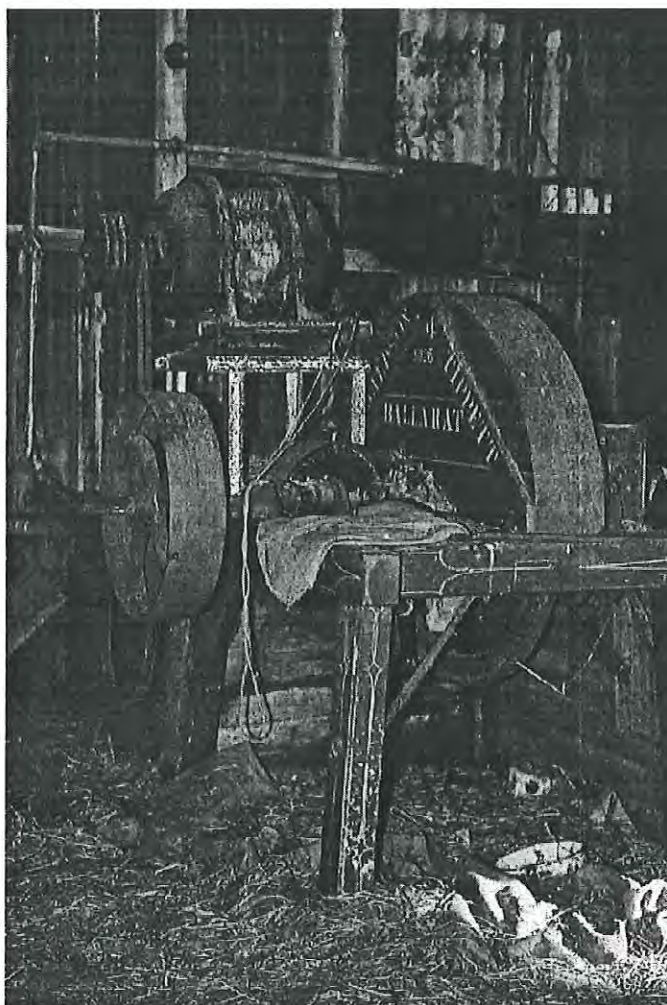
Right: Chaff cutter, electric, Ronaldson & Tippett, Ballarat, in situ.
MH 1997 photograph 2.23

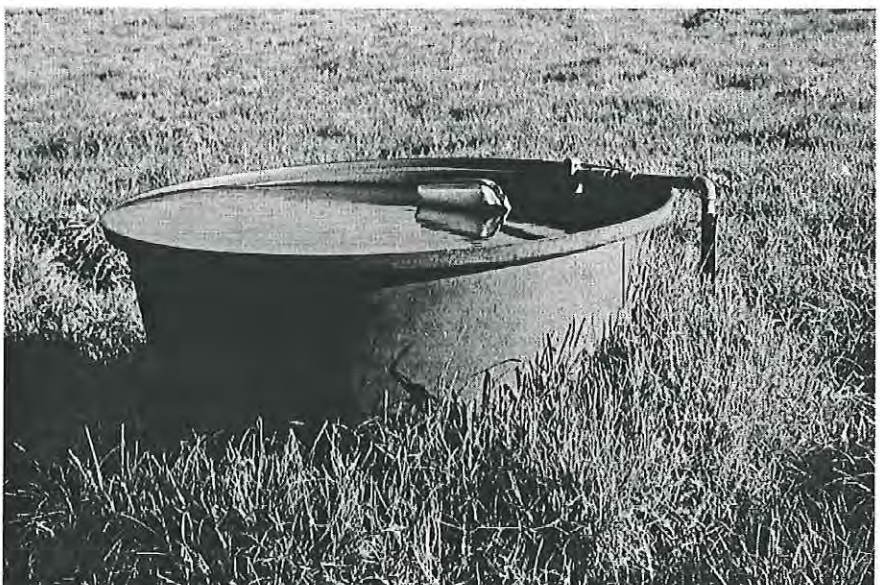
Boiling down vat (tallow pot) relocated, was used for pigs, concrete floor of sty survives in situ to NW of house. Looking south
 MH 1997 photograph 3.3

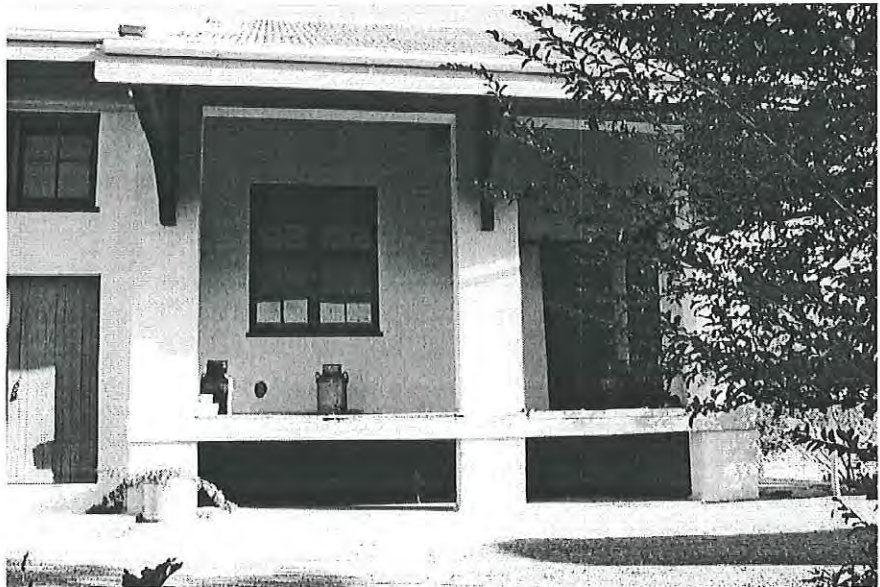
Loading dock, timber frame
 and door, north elevation,
 sliding doors hinged on rails.
 Looking south.
 MH 1997 photograph 13.5

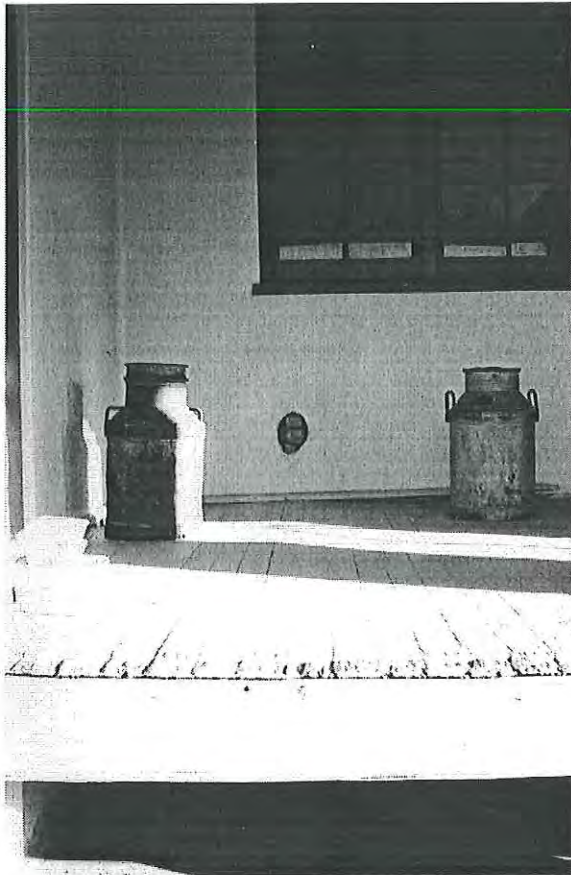
Above: Detail loading dock, funnel hole for milk in wall, angle iron edge to dock is missing.
MH 1997 photograph 13.6

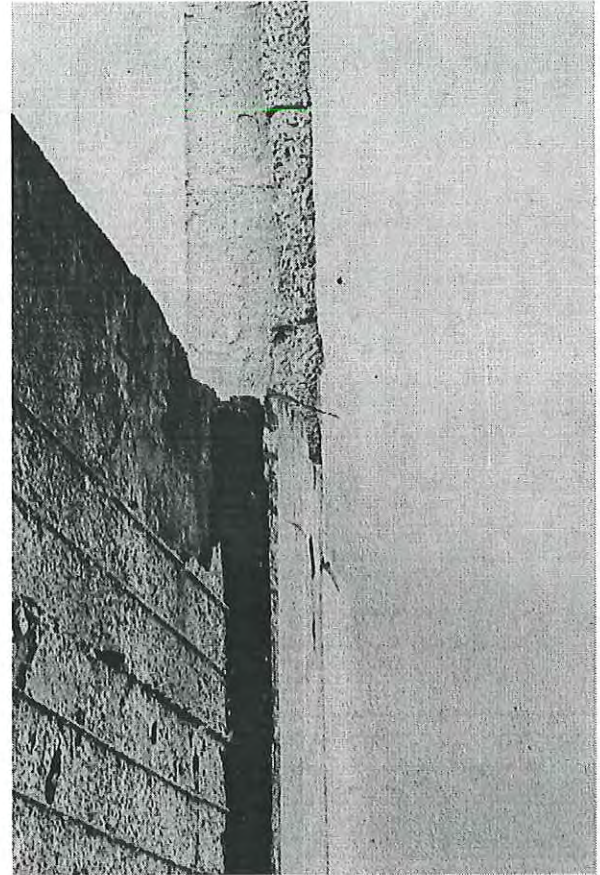
Above right: Cork insulation in cool room.
MH 1997 photograph 13.9

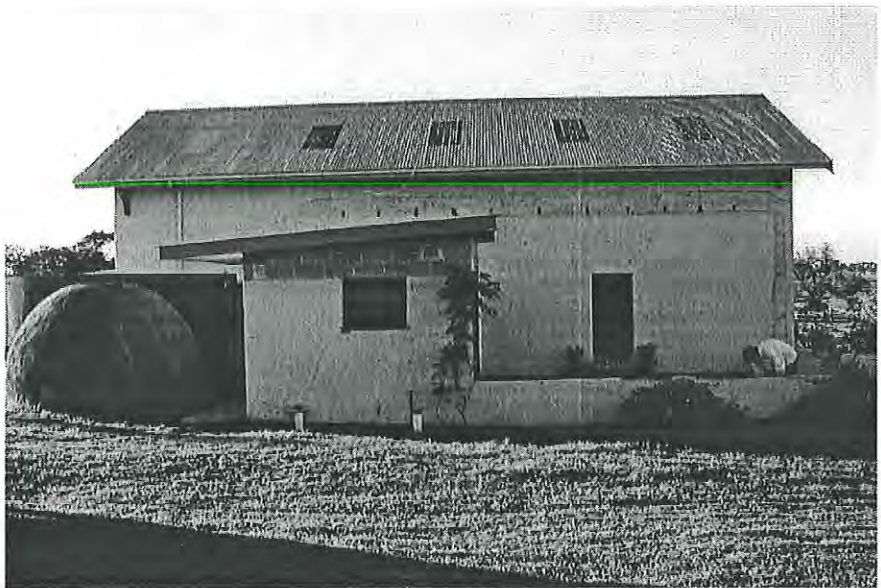
Southern elevation dome topped well, recent conversion of southern room to toilet block. Cool room walls reduced to dwarf wall height.
MH 1997 photograph 13.16

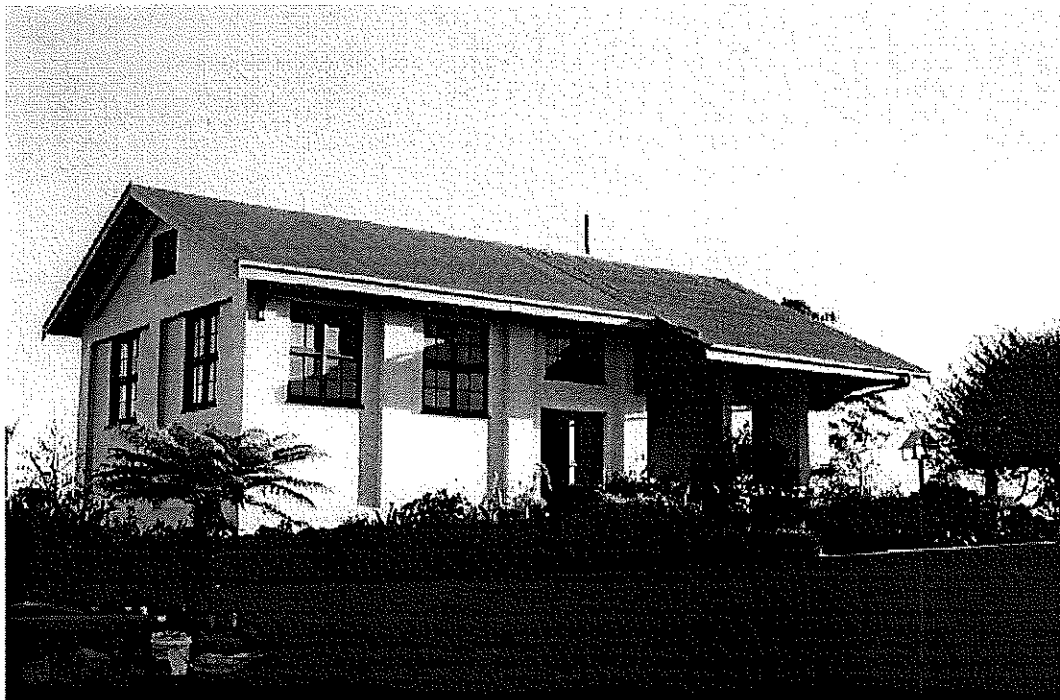
Factory - initially painted.
Looking south-west
MH 1997 photograph 13.20

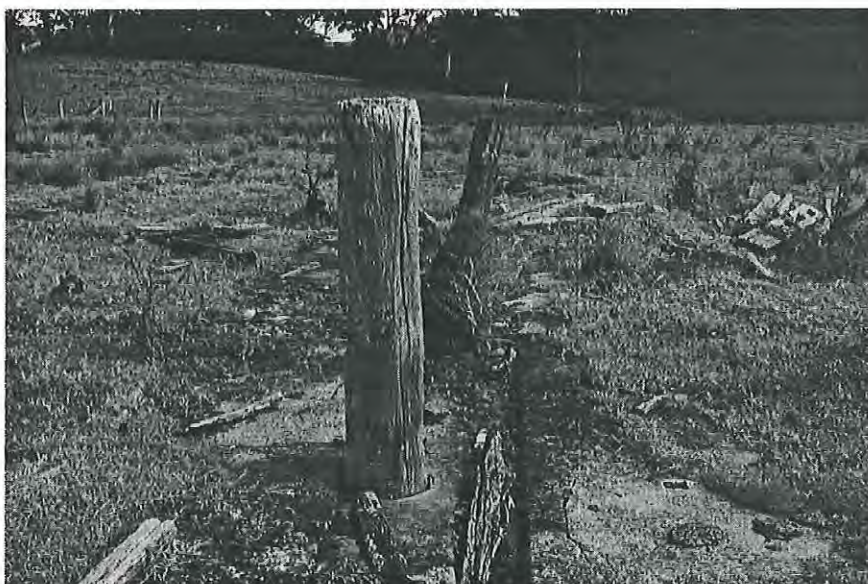
Site of milking bails. Looking
west
MH 1997 photograph 10.4

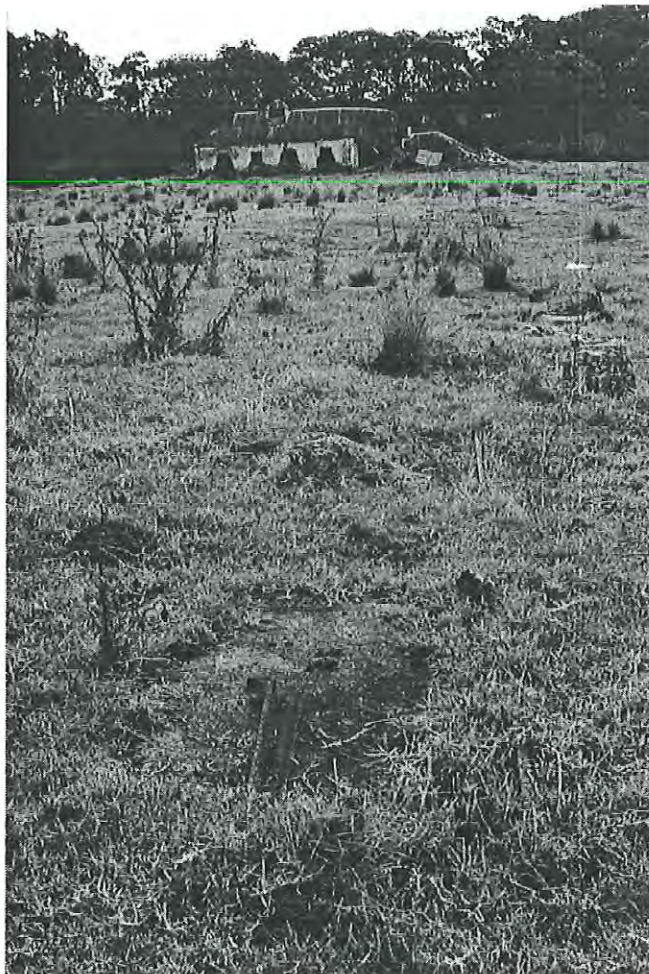
Trolley tracks from milking
bails (possibly to dairy/
creamery due to extensive
distance between structures,
approx 70m.)
MH 1997 photograph 10.6

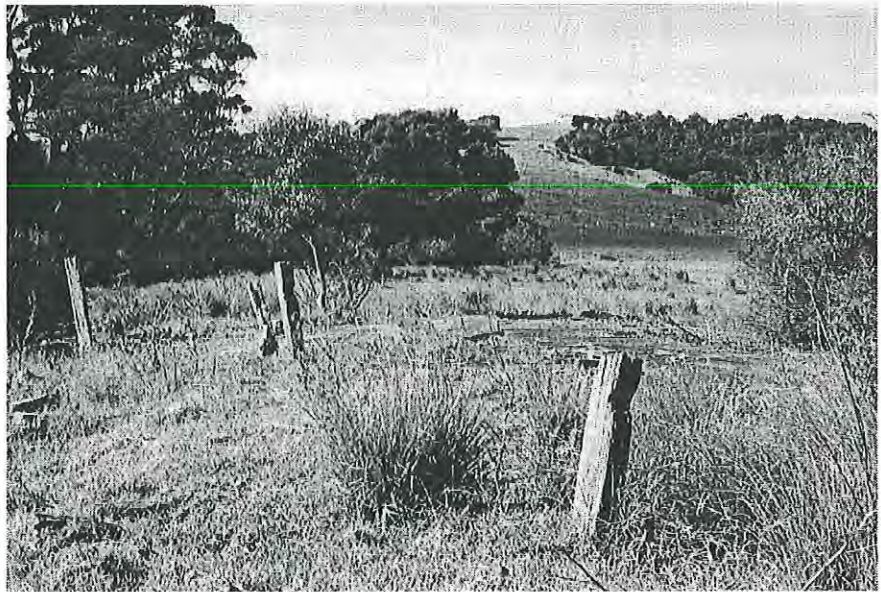
Site of pigsty, remnant
concrete base and posts.
Looking east
MH 1997 photograph 10.9

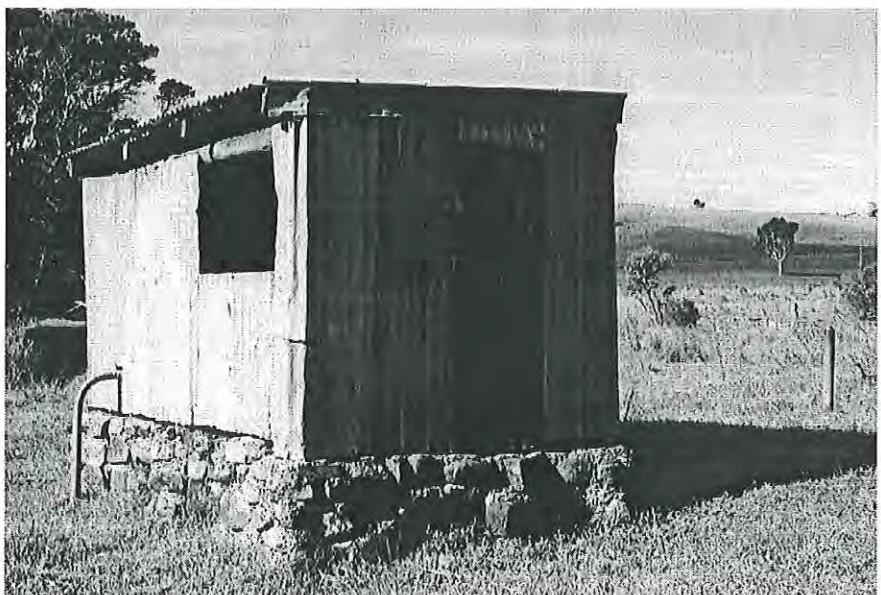
Modern pump house. Looking
south-east
MH 1997 photograph 10.11

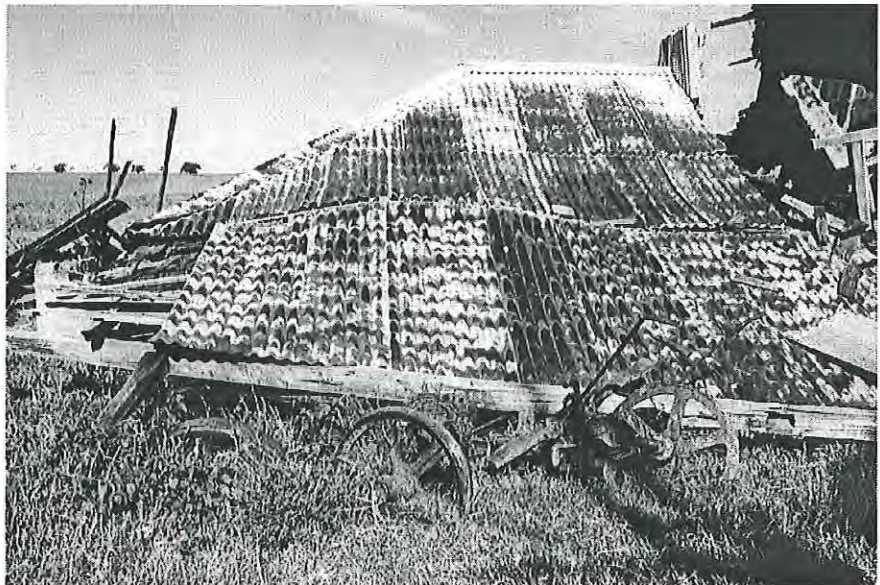
Collapsed eastern roof
section dairy - cream and
butter. Looking south
MH 1997 photograph 10.13

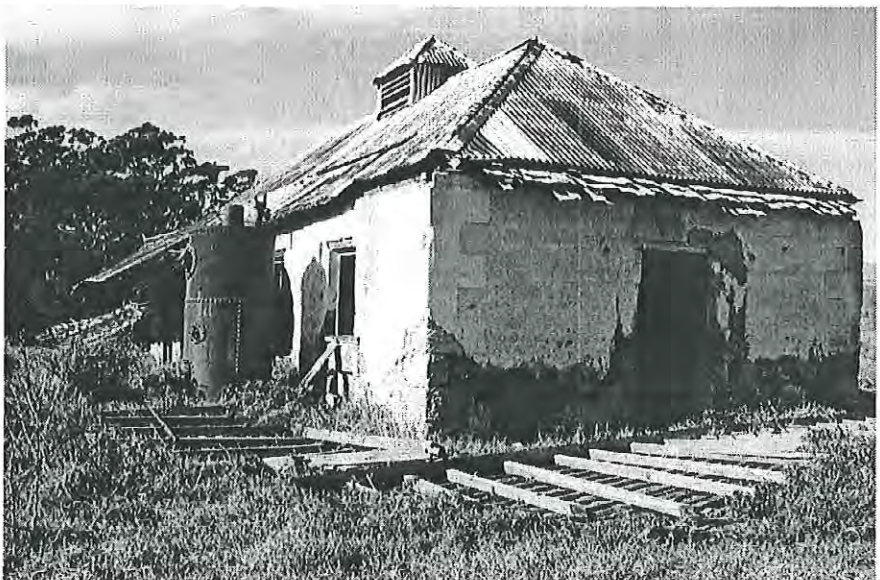
Dairy, rubble stone with
roughly formed quoins, rough
cast render with the quoins
delineated in the render.
Render washed away
indication flood and rising
damp levels. Collapsed
verandah roof exposing
shingles and shingle battens.
Roof ventilation shaft, the
eastern equivalent has
collapsed. Riveted vertical
boiler. Looking east
MH 1997 photograph 10.14

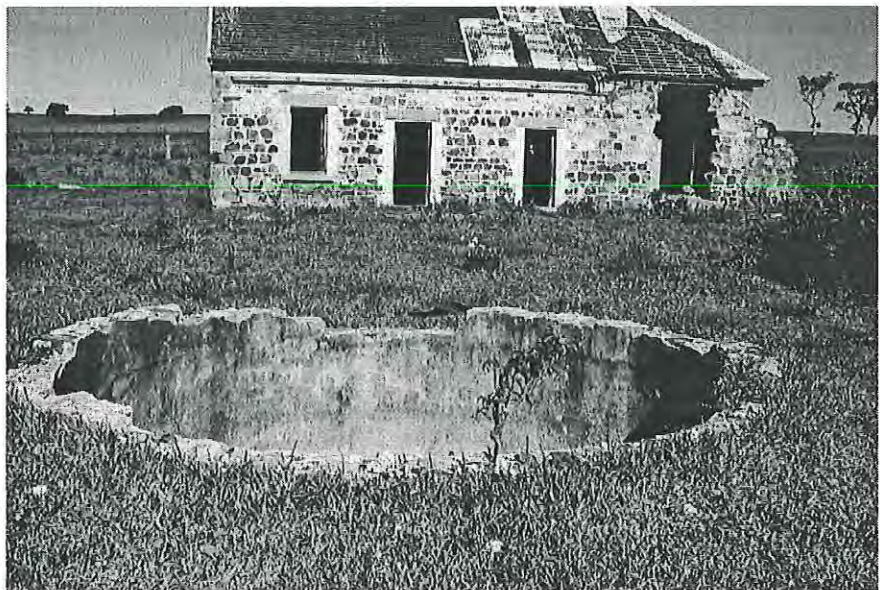
Brick and rendered well
 north of house. Looking
 south
 MH 1997 photograph 10.18

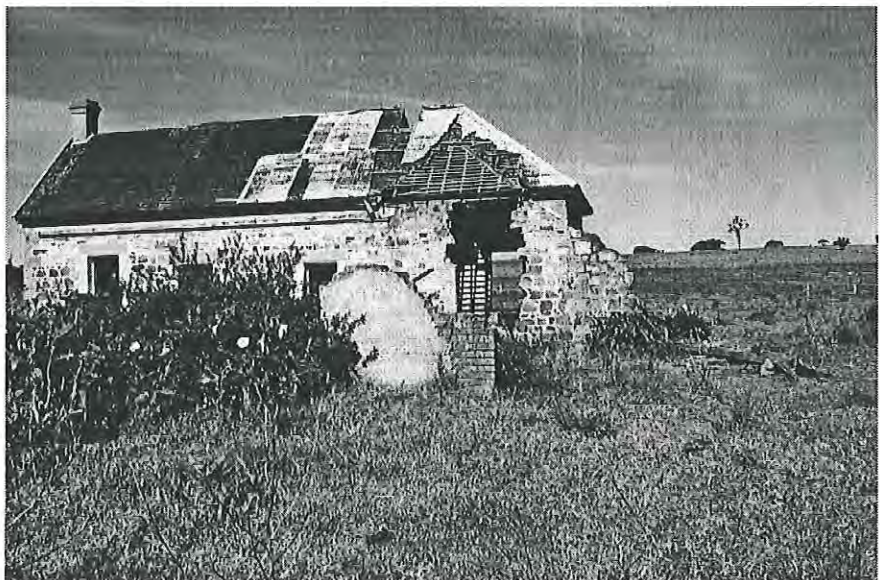
House - stone rubble roughly
 coursed, exposed shingles and
 remnant verandah fixture.
 Northern wing collapsed,
 ridge pole lying on ground
 RHS. Northern wing was
 keyed into a western hip
 extension of the original
 house. Looking south
 MH 1997 photograph 10.23

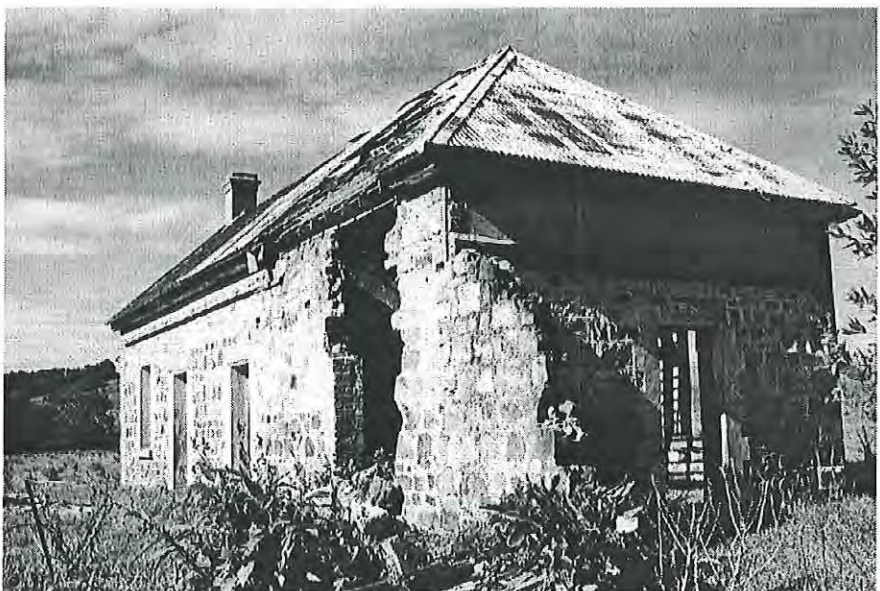
House northern and western
 elevation.
 MH 1997 photograph 10.24

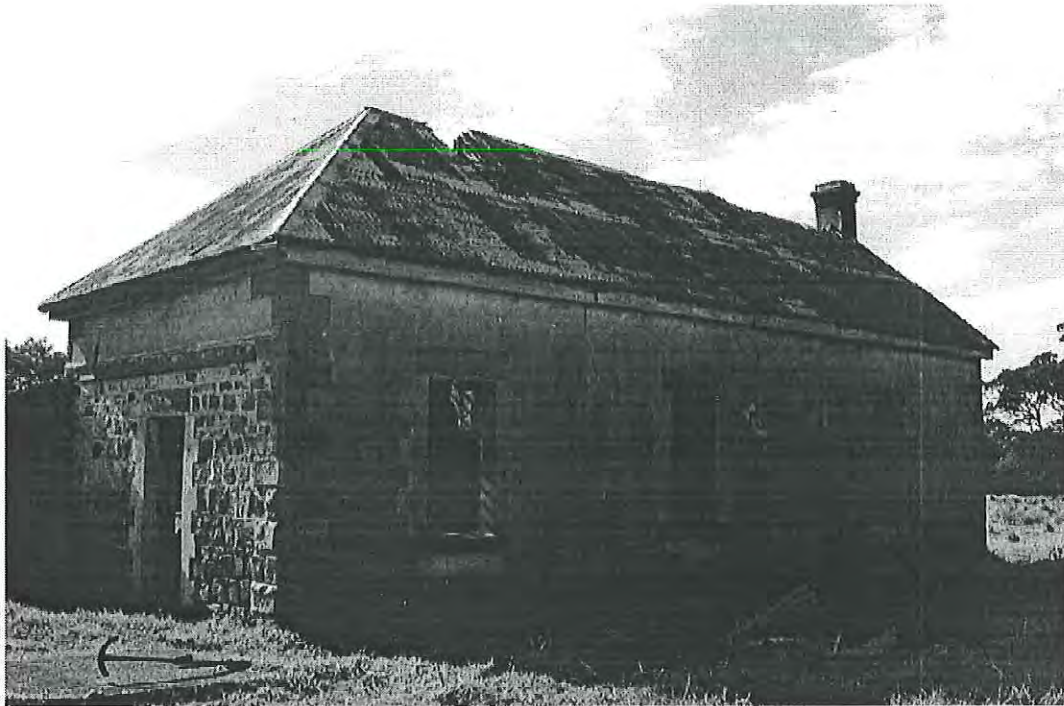
Above: House: southern elevation showing rendered finish and stone quoins, lintels and sills. Concrete tank stand LHS. Looking north-east
MH 1997 photograph 11.1

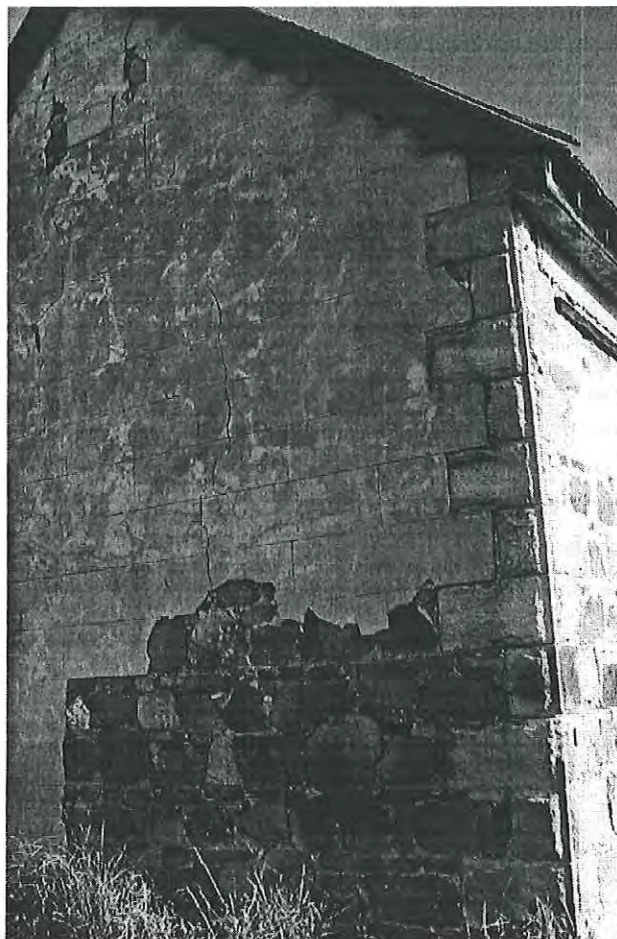
Right: House wall detail showing alternate large and small stone coursing, decorative barge board, small eaves, date? plate on gable. Looking south-west
MH 1997 photograph 11.3

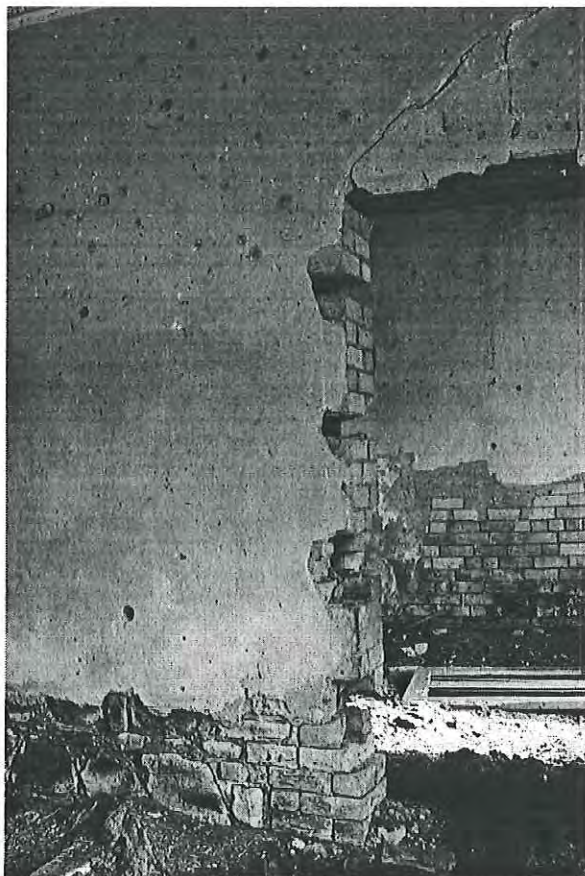
Looking through doorway to
western extension showing
use of brick.
MH 1997 photograph 11.5
