**Zone 4: Under-pruning of mature trees and removal of tall shrubs**

# **APPENDIX C    OPTIONS PROPOSED DURING CONSULTATION AND SUPPORTING FACT SHEETS**

Searching for a compromise at Collingwood Beach

## THE COLLINGWOOD BEACH STORY — A CO-OPERATIVE EFFORT

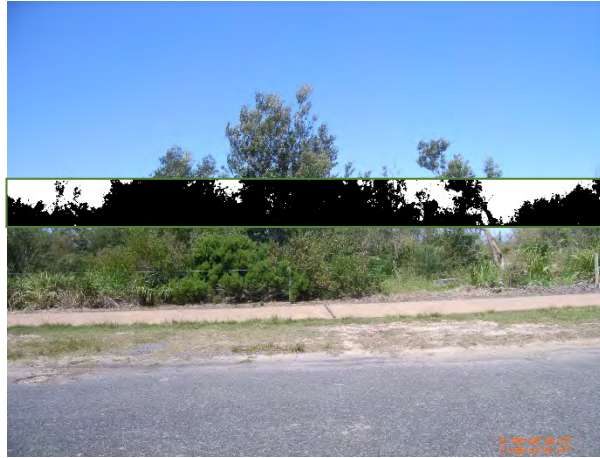
Before foliage cover percentage: 70%

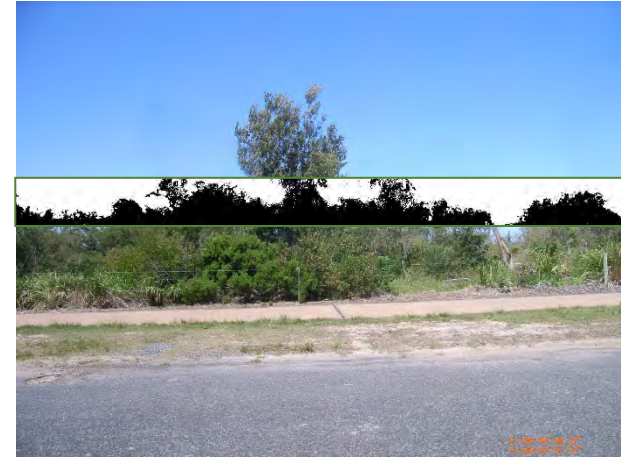
After foliage cover percentage: 50%

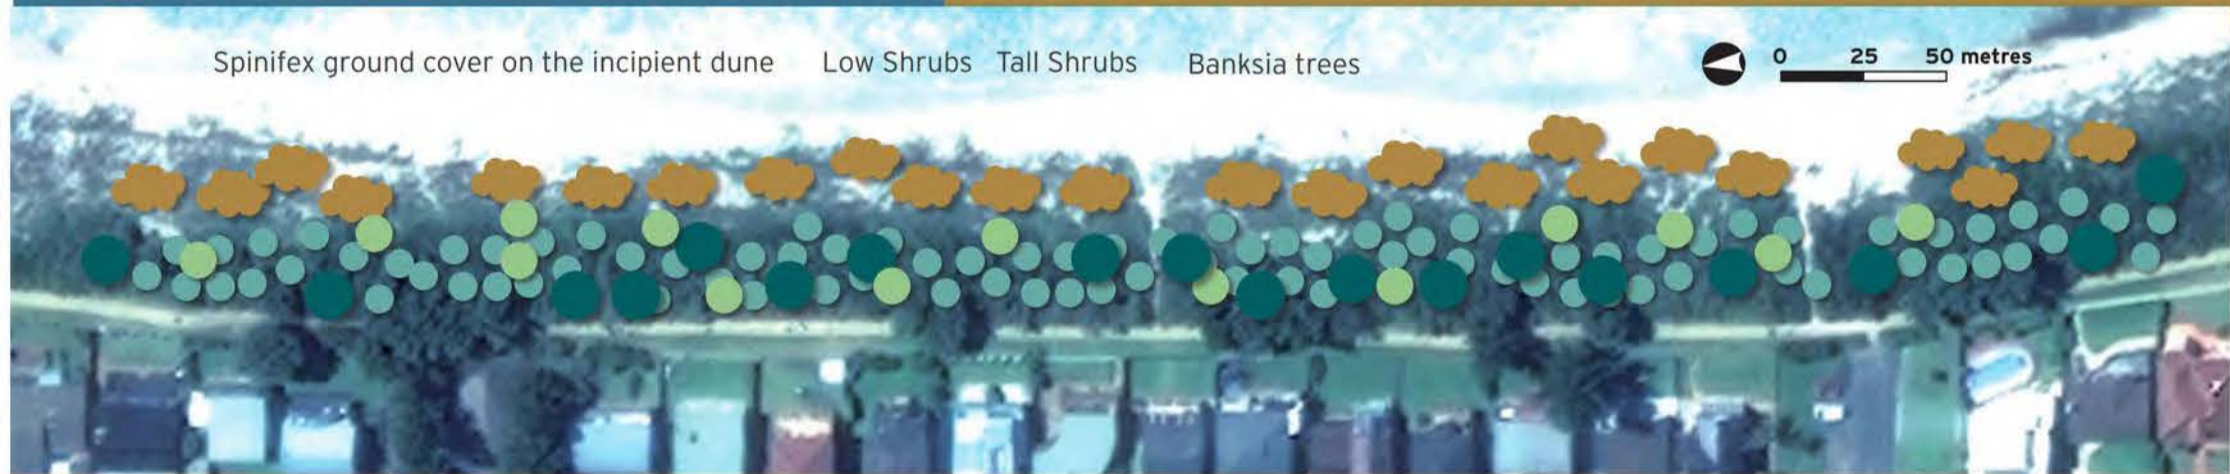
Spinifex ground cover on the incipient dune    Low Shrubs    Tall Shrubs    Banksia trees

0    25    50 metres

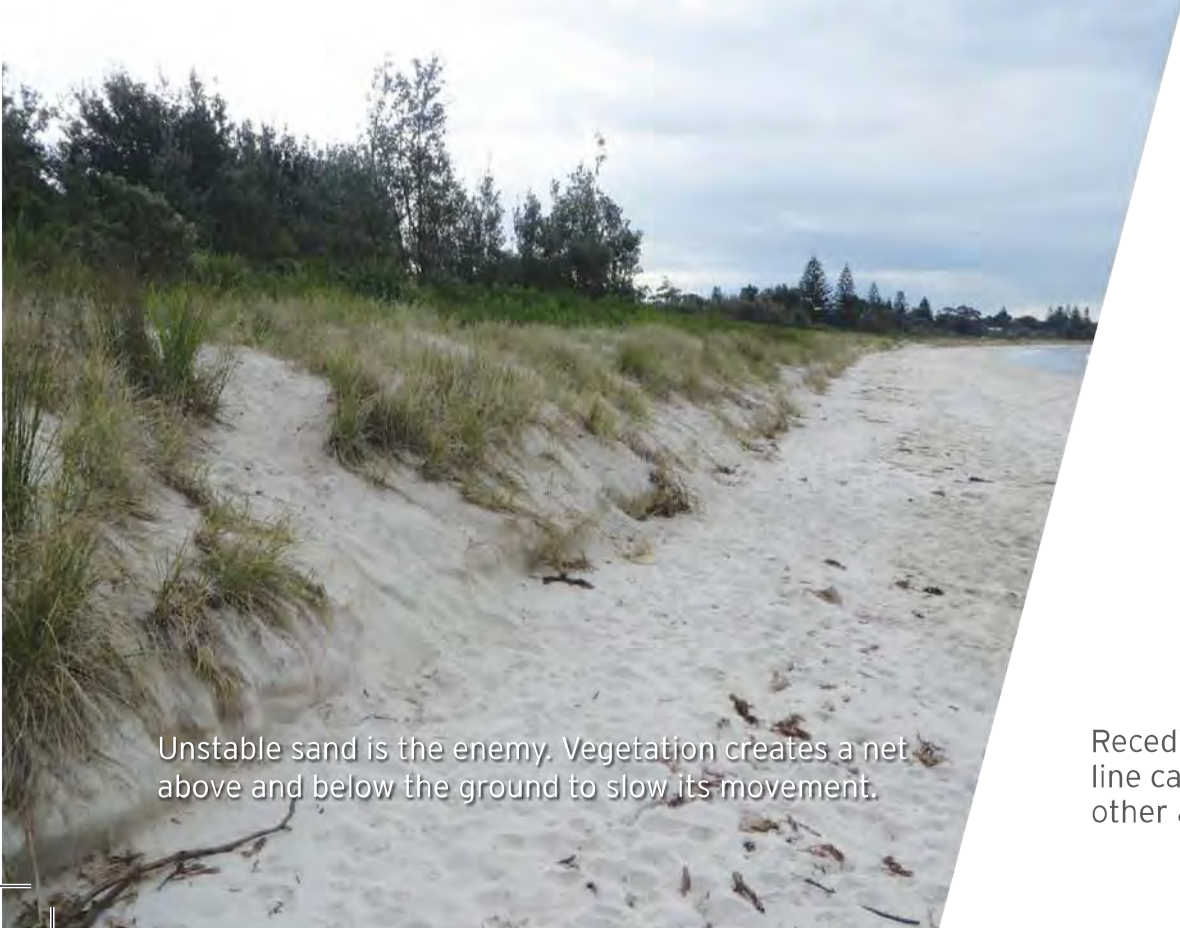
Unstable sand is the enemy. Vegetation creates a net above and below the ground to slow its movement.

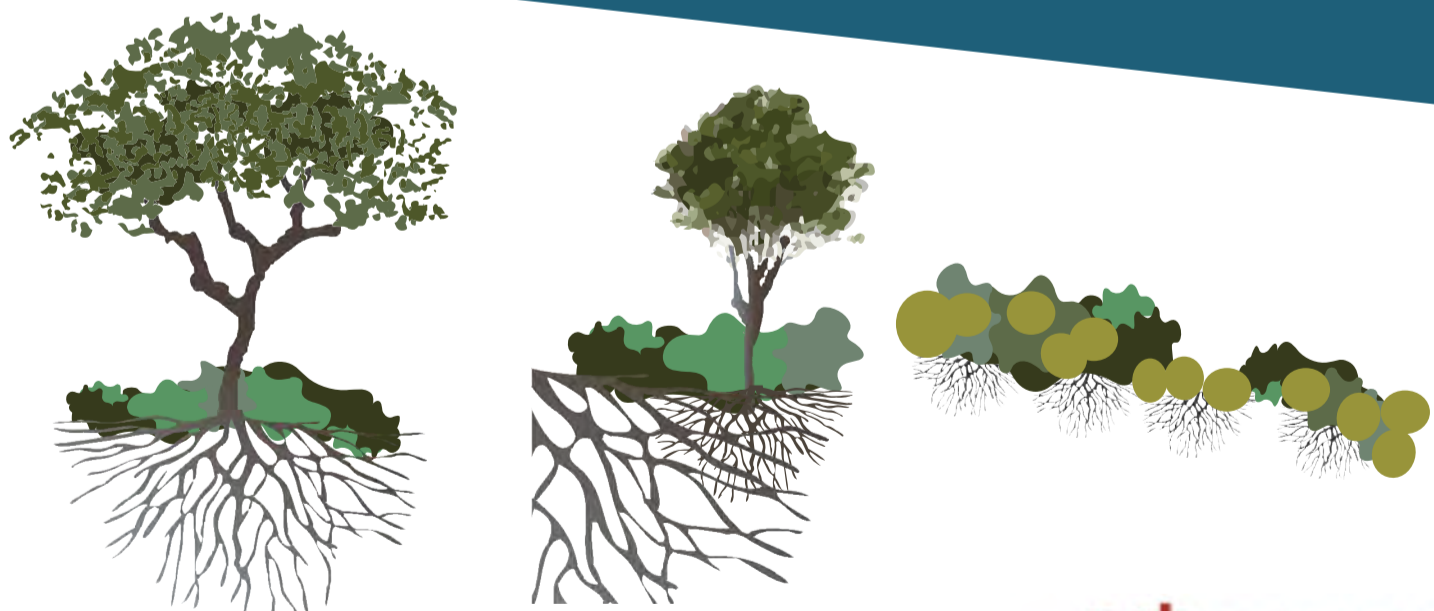
Comparative root systems and above ground height of trees, shrubs and ground covers at Collingwood Beach.

- Trapping airborne sand and salt - vegetation height and density is important to achieve this. The higher and denser the vegetation, the more sand and salt will be kept seaward, away from houses and public assets.
- Trapping sand at the ground surface - vegetation structure is important to achieve this. Grasses that cover the ground surface and act as a net, hold sand in place and increase stability.
- Trapping sand beneath the ground surface - root structure is important for this. The deeper the roots penetrate and denser they are, the more stable the overall land form will be.

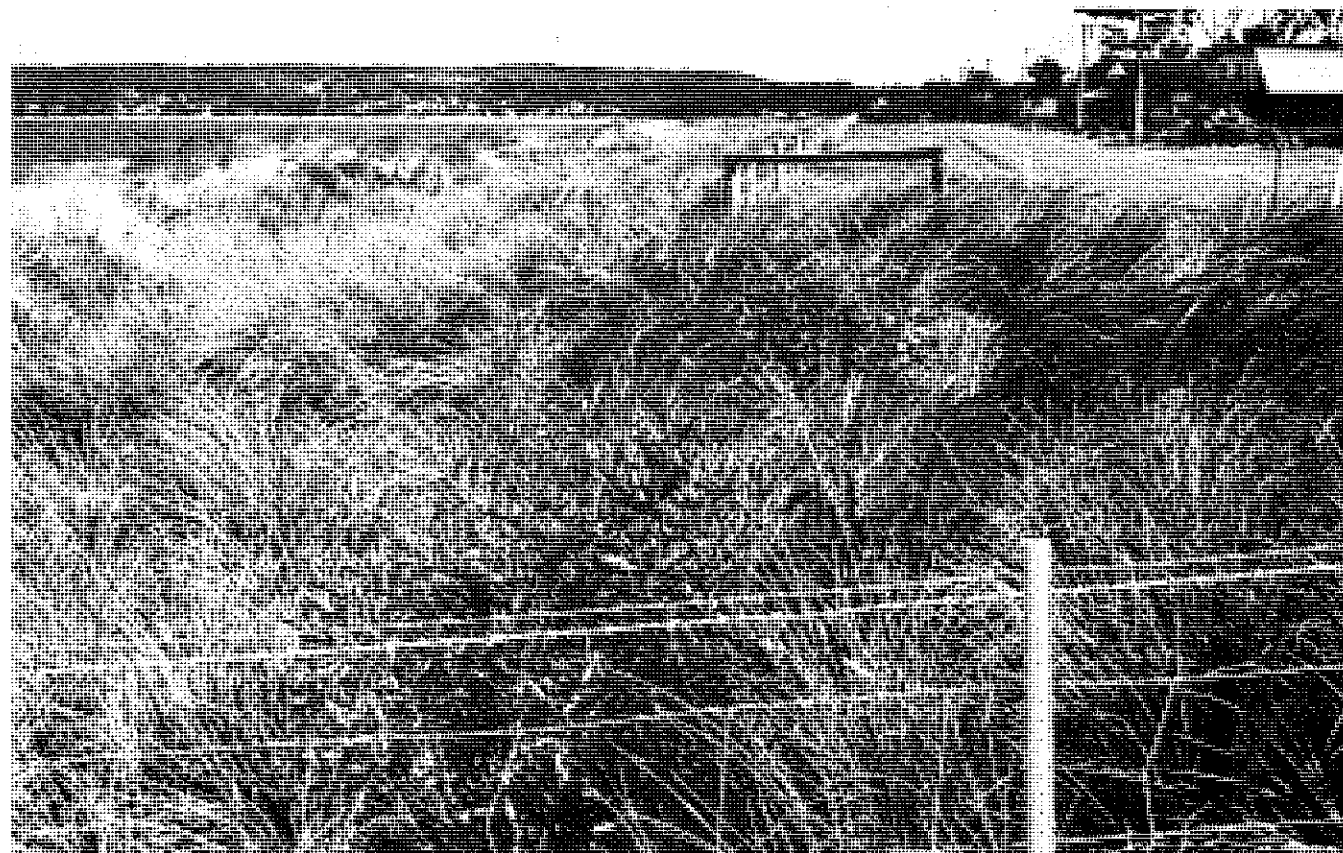
Figure 10—Secondary planting of tree species (Coast Wattle) on an area stabilized by marram grass.

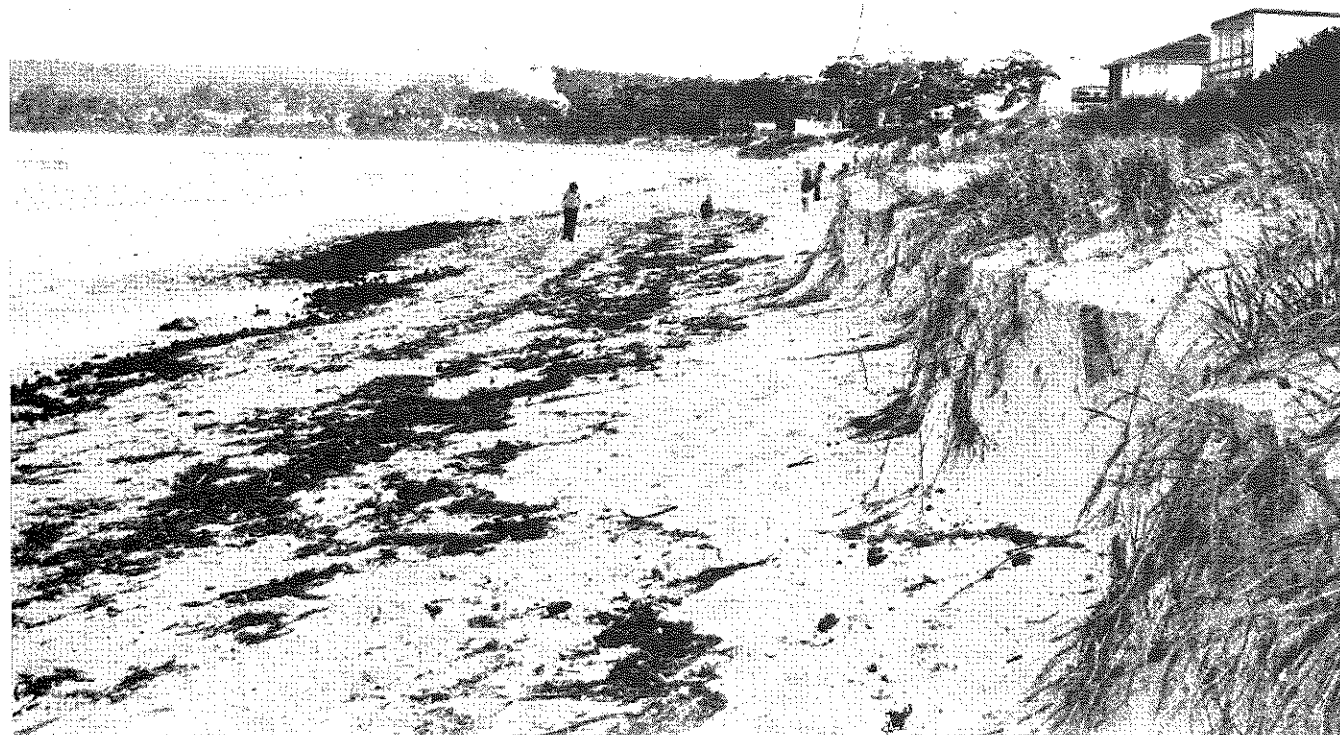
Figure 1—Storm damage at southern end of Collingwood Beach, 1977.

This article describes a restoration programme carried out under difficult conditions: difficult, because the dunes had been largely destroyed by a series of severe storms leaving the beach in an unstable condition. As a result of this, sand drift inland from the beach became active. Thus the restoration programme had to be implemented on a greatly reduced dunal system (figure 1).

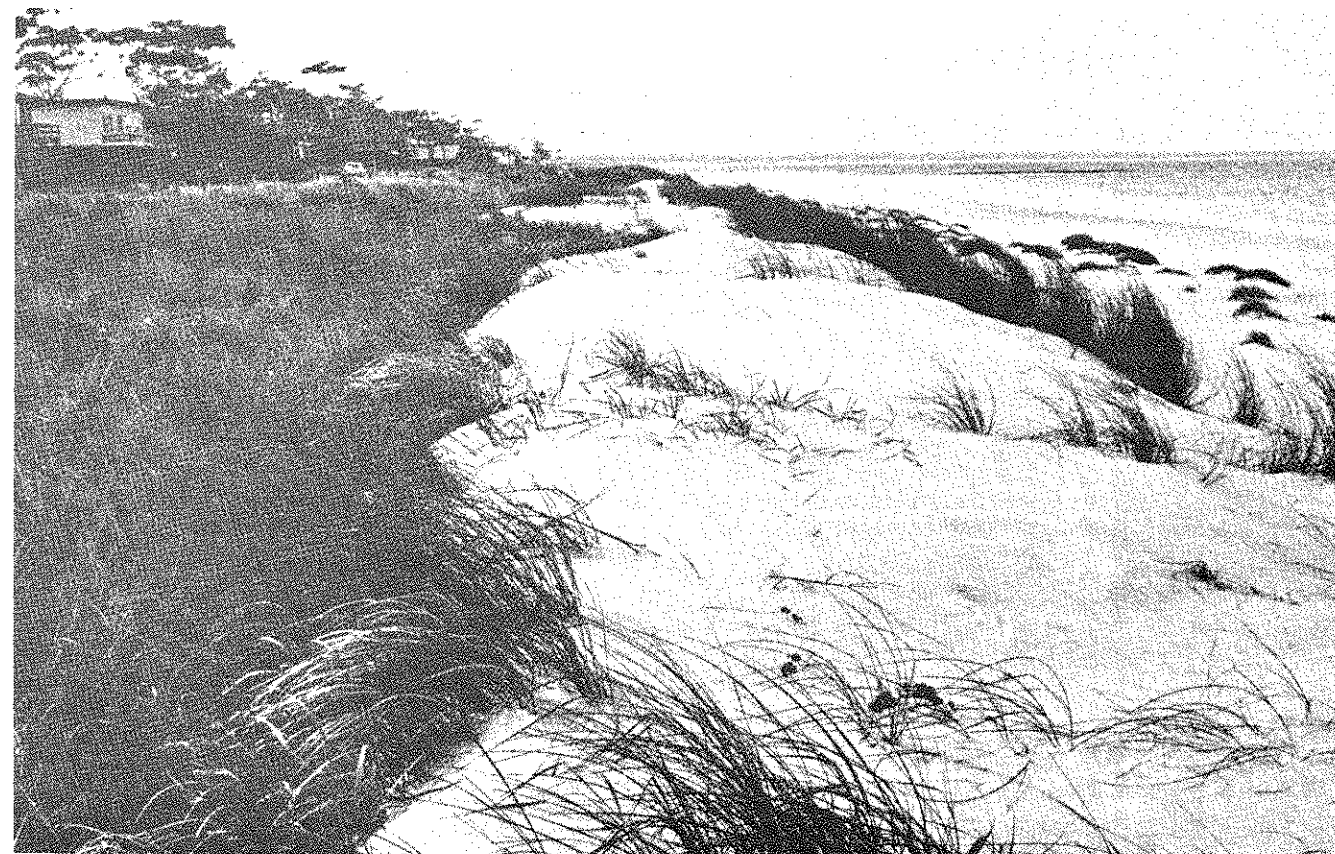
Figure 9—Vigorous vegetation effectively trapping wind borne sand, and promoting dune formation.

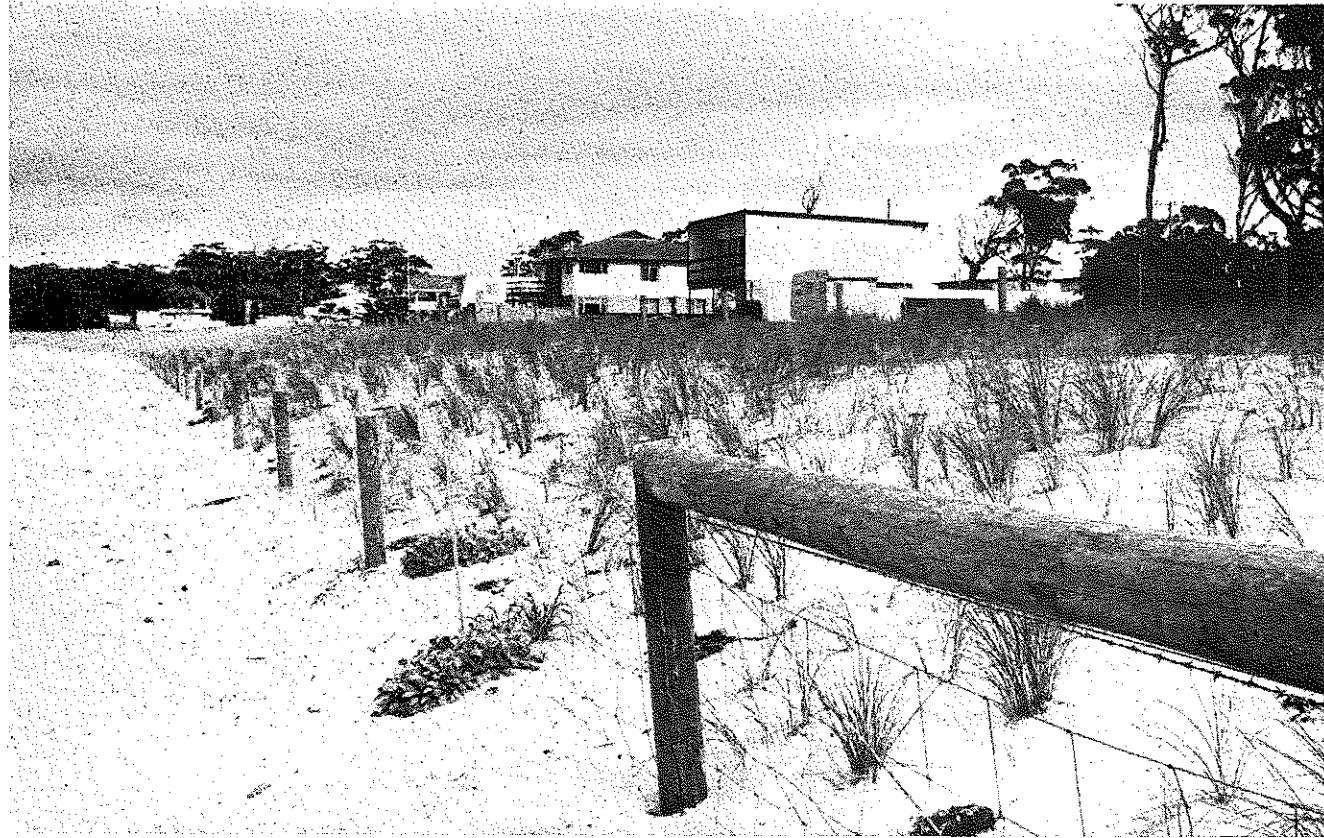
Figure 7—Southern end of restoration works, six months after implementation of the scheme.

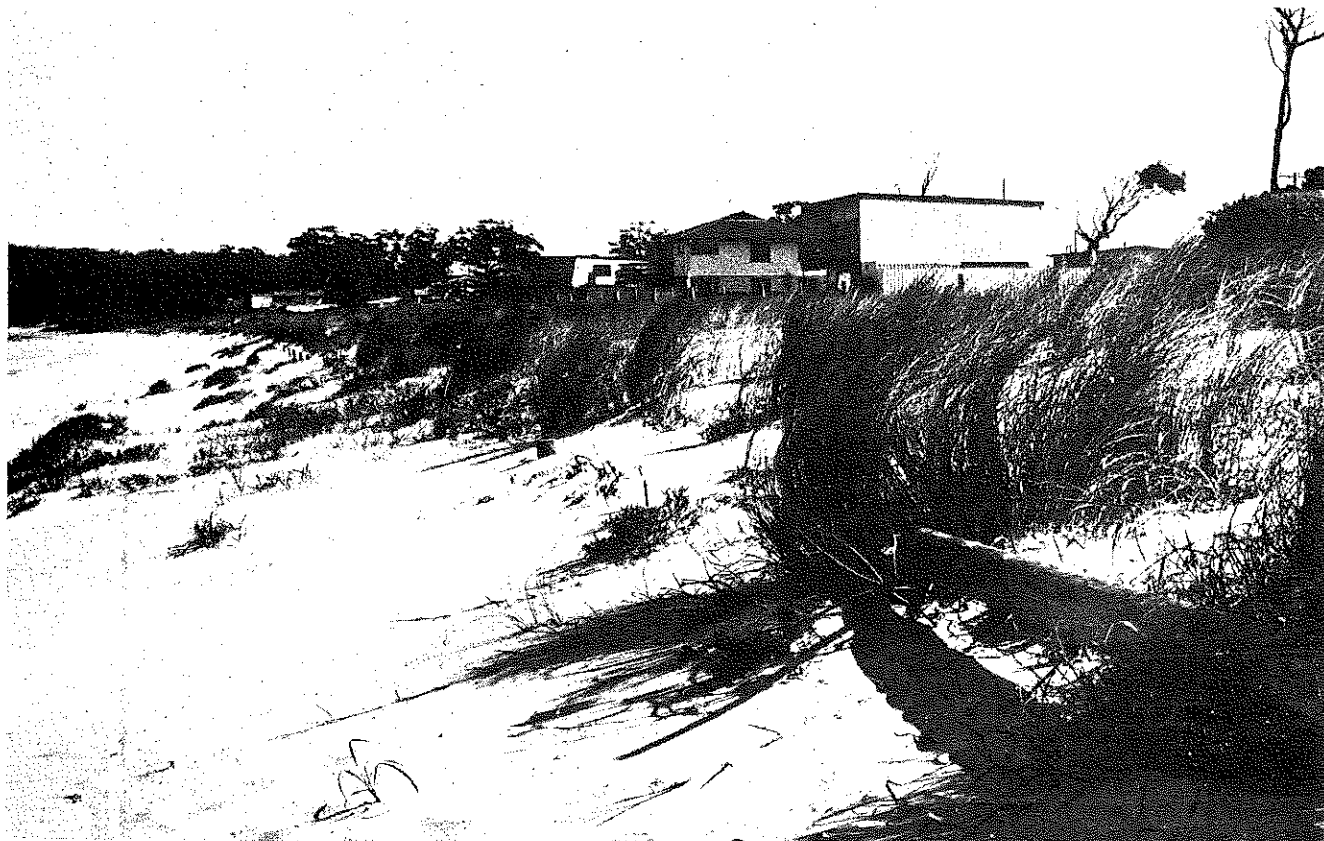
Figure 8—Same area as in Figure 7, fourteen months later. The buried fence posts indicate the considerable sand accretion.

The natural dune reformed rapidly within the planted area. In less than a year after completion of the works, sand accumulation from drift sand along the beach had covered much of the front dunal fence and, even at that early stage, the beach was in a much more favourable condition to withstand erosive storms. Since then, it has been necessary to increase the fence height as the dune built up (figures 6 and 8).

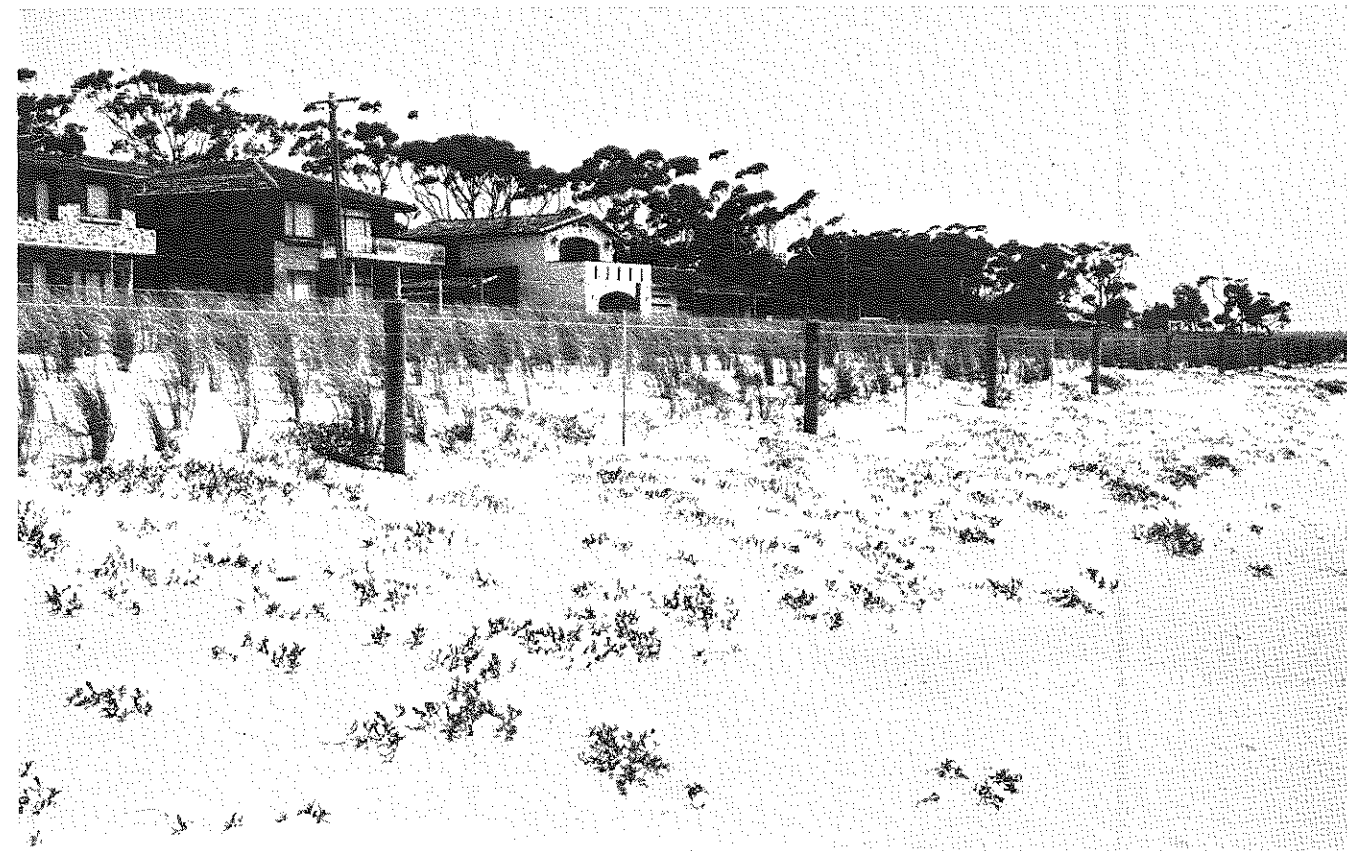
Figure 5—Northern section of Collingwood Beach, six months after restoration works had been carried out.

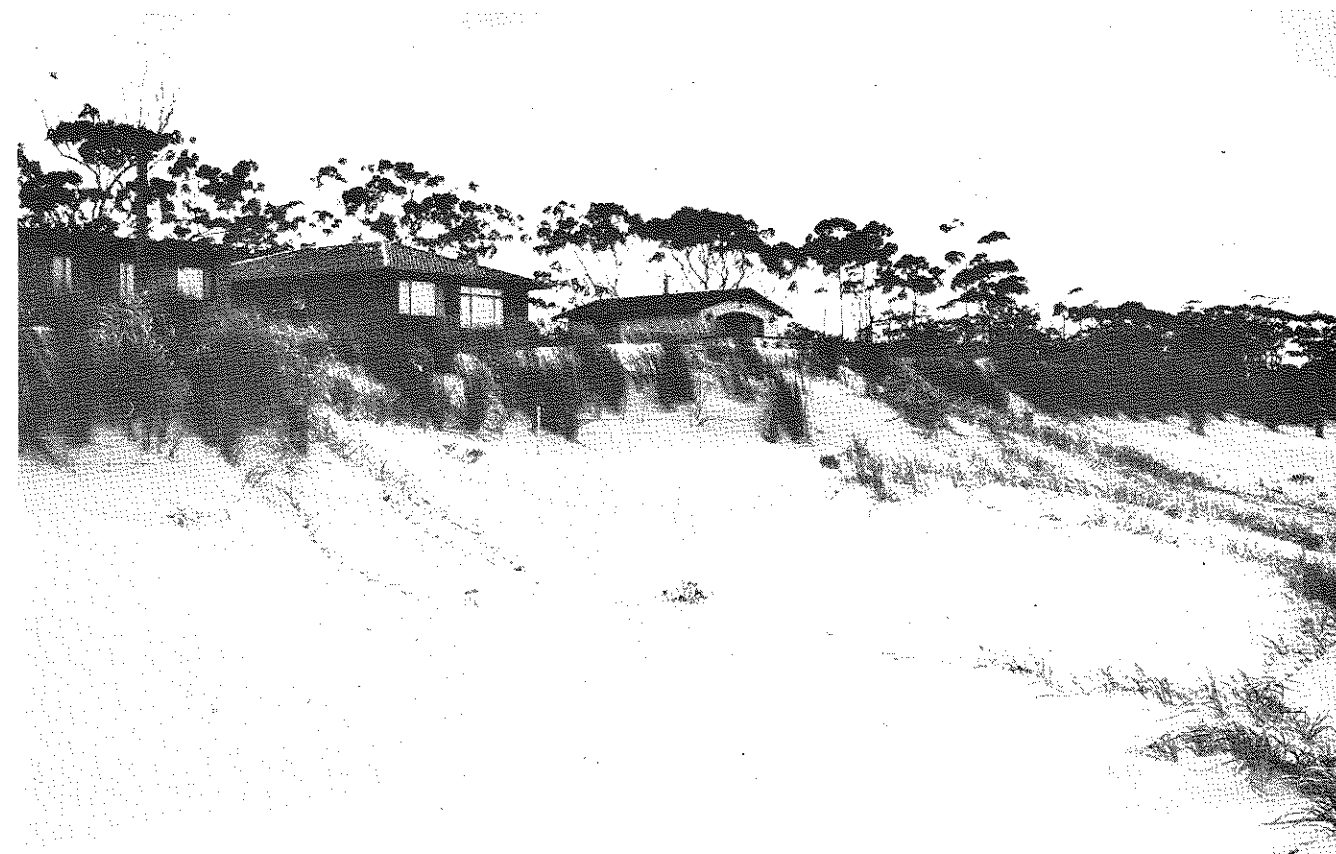
Figure 6—Same area as in Figure 5, fourteen months later, showing return of natural dune formation.

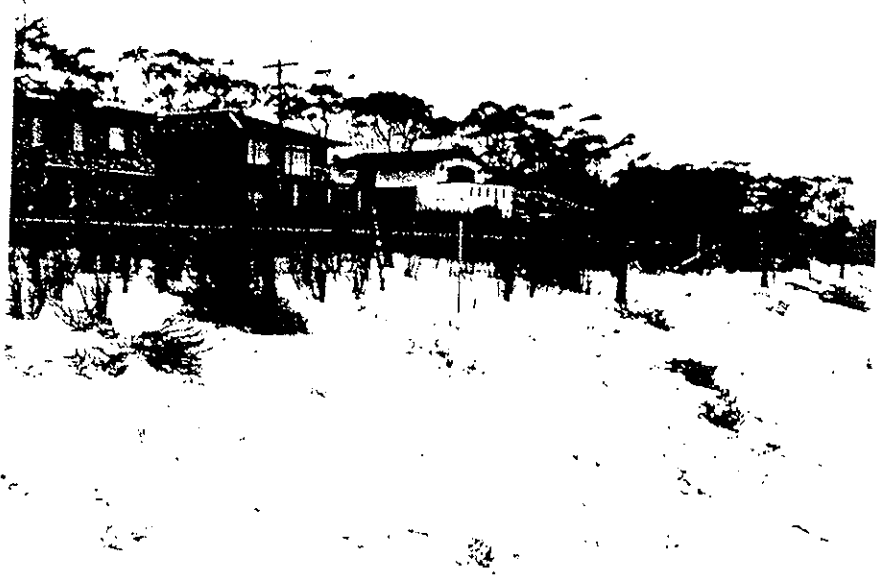
Figure 4. Northern section of Collingwood Beach six months after restoration work (December 1978).
