# Tabourie Lake Floodplain Risk Management Study and Plan

Delft 3D Model Verification Report

49913170

Prepared for  
Shoalhaven City Council

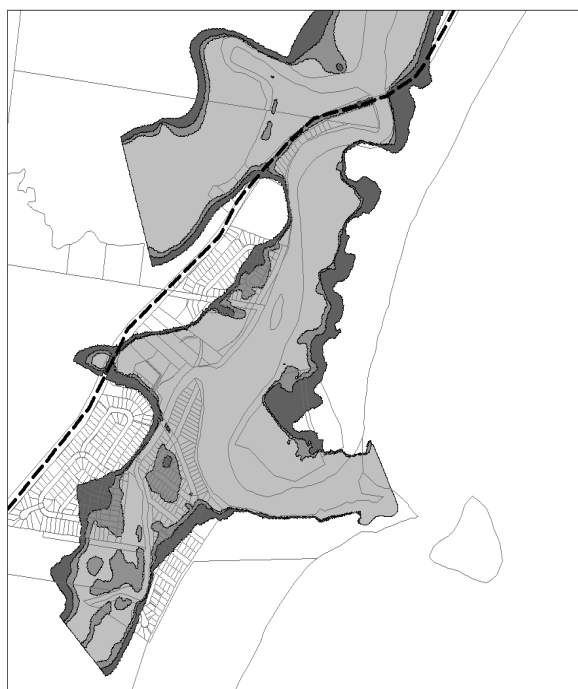
The probable maximum flood extent (extreme flood) for the Tabourie Lake catchment is shown below.

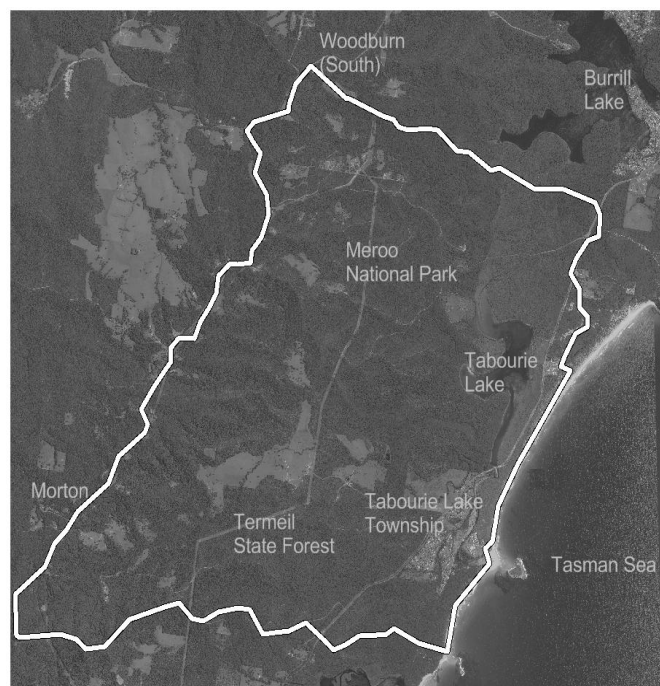
Catchment Area

The study area comprises the Tabourie Lake catchment, incorporating the Tabourie Lake Township and surrounding areas. The Tabourie Lake catchment area covers approximately 48 square kilometres (see below). The Tabourie Lake Broadwater is fed primarily by Lucy Kings Creek and Munno Creek. Other tributaries include Branderee Creek, Tabourie Creek and Lemon Tree Creek. The Lake has an outlet, adjacent to the Tabourie Lake Township to the Tasman Sea.

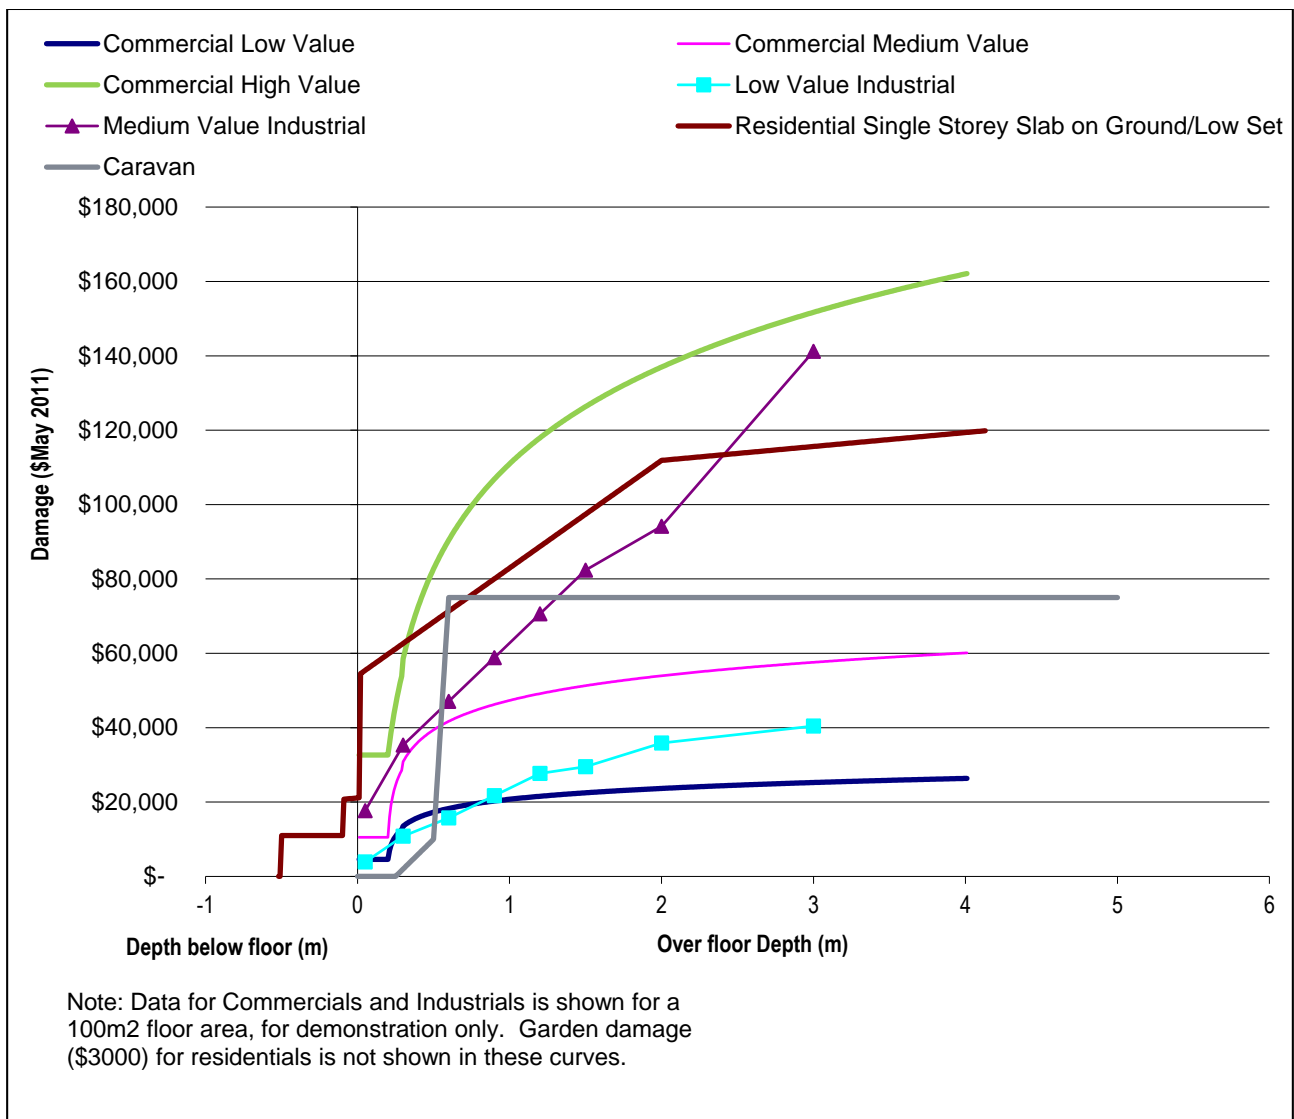
**Figure C-2 Adopted Damage Curves**

The adopted damage curves are shown in **Figure C-1**. For purposes of illustration, the residential and commercial damage curves are shown for a property with a floor area of 150m<sup>2</sup>, although the size will be individually determined for each residential and commercial property when calculating catchment damages.

(Damage data sourced from FLDamage, and plotted for a 100m<sup>2</sup> property. Refer Section C.1 and Section C.2 for further details)

- No damage up to 0.25m (a typical axel height)
- Linearly increasing damages up to 0.5m to a nominal \$10,000 (minor damages to undercarriage)
- A sharp rise to full damages at 0.6m of \$75,000. Caravans have shown to become mobile in flood depths of >0.6m. At this point, it was assumed that the caravan would require replacement. The replacement costs were determined for a mid-range caravan.
- Caravan locations were determined from aerial imagery
