Greenwell Point Heritage Stone Wharf

Statement of Heritage Impact

Greenwell Point Heritage Stone Wharf Statement of Heritage Impact

Cosmos Archaeology Job Number J15/37

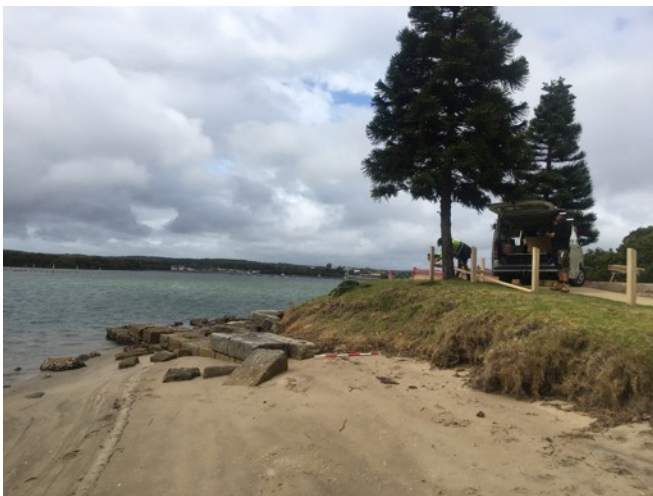
The remains of the Greenwell Wharf are situated in ANZAC Park to the south of Greenwell Point Road at Greenwell Point (Figures 3.1 and see Figure 1.1). A comparison with an image from 2006 (Figure 3.2) taken from a similar position shows a similar profile for the grassed bank overlaying the western part of the wharf, though there appears in 2015 to be less (ca. 0.5 m) sand cover. The other differences between 2006 and 2015 images are the planting of pine trees for the War Memorial and the installation of timber posts as part of a safety barrier.

Figure 3.1: Looking towards Greenwell Wharf (left of shot) from the north in December 2015 (Source: Cosmos Archaeology)

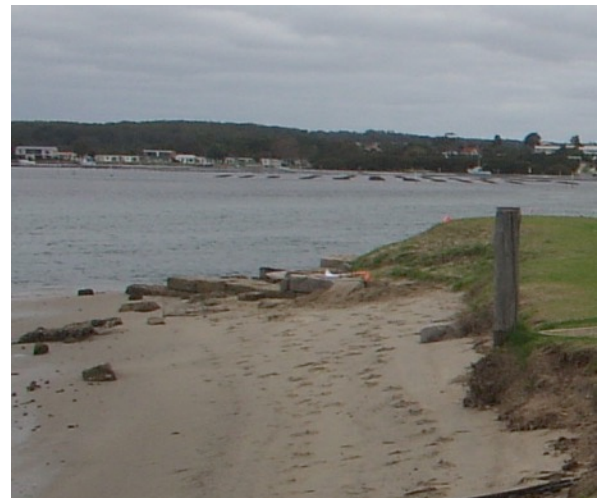
Figure 3.2: Looking towards Greenwell Wharf (left of shot) from the north in July 2006. (Source: Cosmos Archaeology)

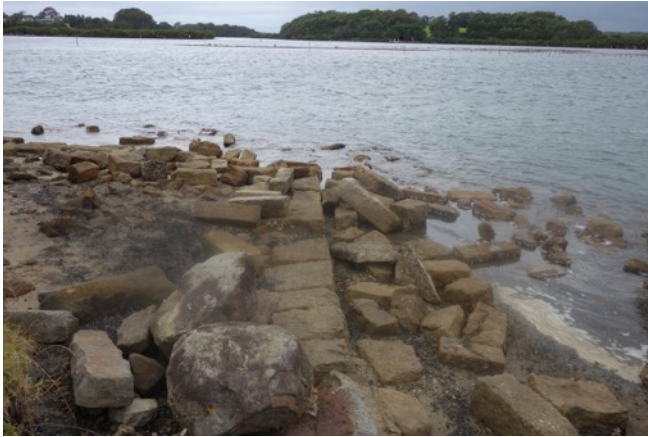
Figure 3.3: Rubble scatter on the eastern and southern edges of Greenwell Point Wharf in December 2015. Looking towards the south east and viewed at a rising tide. The intact section of wall is Wall 1 – see below and Figure 3.6 (Source: Cosmos Archaeology)

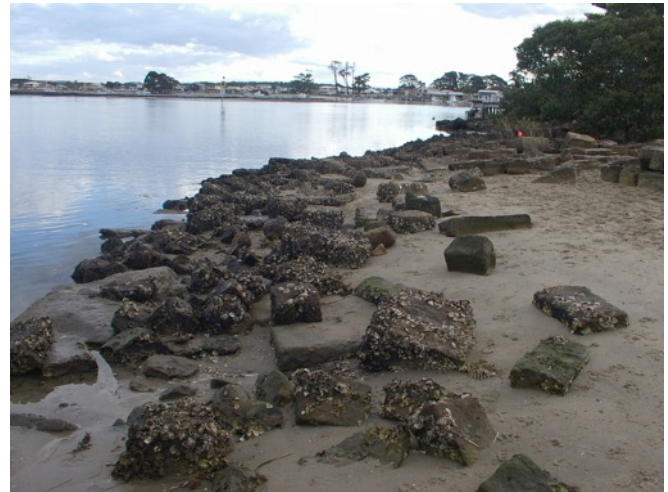
Riverward of the grassy bank – which is composed of fill (see below) - is an extensive scatter of sandstone blocks laying within the intertidal zone on coarse riverine sands (Figures 3.3 and 3.4). Discernable amongst the scatter are the lower courses of possibly five separate walls composed of un-bonded sandstone blocks. These walls have been constructed at different times and represent modifications and additions to the wharf throughout the 19th and 20th centuries. One of these walls survives to a height of around 1 m and retains the southern side of the grassy bank.

Figure 3.4: Rubble scatter on the eastern and southern edges of Greenwell Point Wharf in July 2006. Looking westwards and viewed at a low tide. (Source: Cosmos Archaeology)

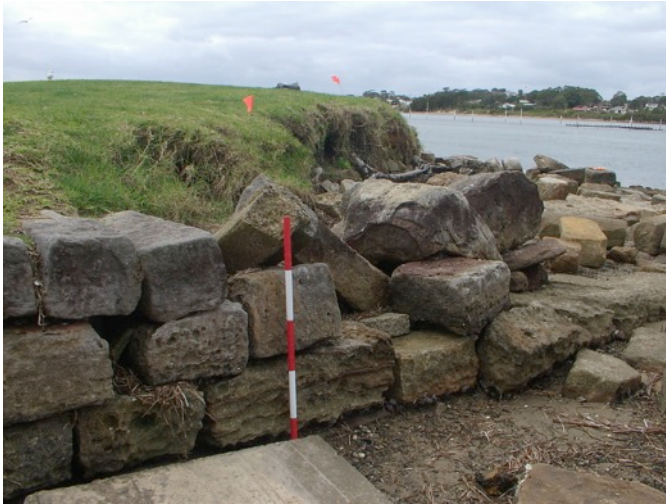
Located at the southern portion of the site, this wall, running in a NNW-SSE axis, is the best preserved wharf wall presently visible (Figures 3.7 and 3.8). Composed of squared sandstone blocks, it is preserved to around 1m above the ground level on the southern side. The wall retains the bank/fill on its northern side (Figure 3.9 and 3.10).

Figure 3.7: Wall 1 in July 2006 looking north. Scale in 200 mm increments. (Source: Cosmos Archaeology)

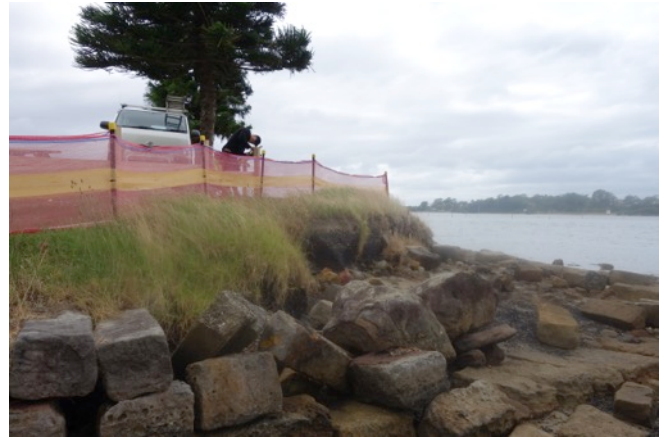
Figure 3.8: Wall 1, in foreground, in December 2015 looking north. Shows little or no movement of the dislodged blocks since 2006. Also the grassed bank in the foreground seems to have encroached on the blocks of Wall 1 while the same bank in the background seems to have receded slightly. (Source: Cosmos Archaeology)

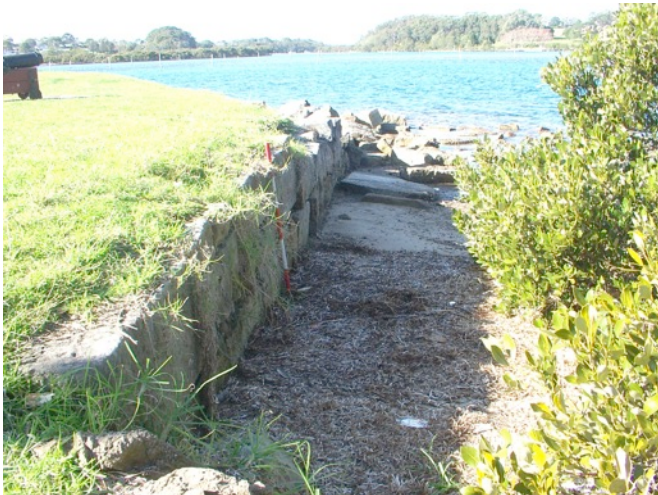
Figure 3.9: Wall 1 in July 2006, looking east. (Source: Cosmos Archaeology)

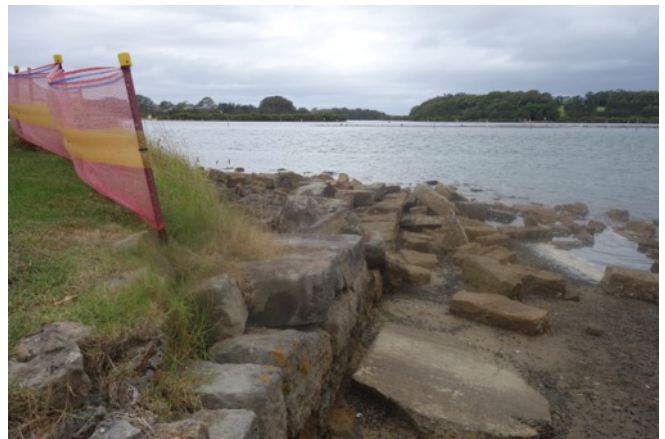
Figure 3.10: Wall 1, in foreground, in December 2015, looking east. (Source: Cosmos Archaeology)

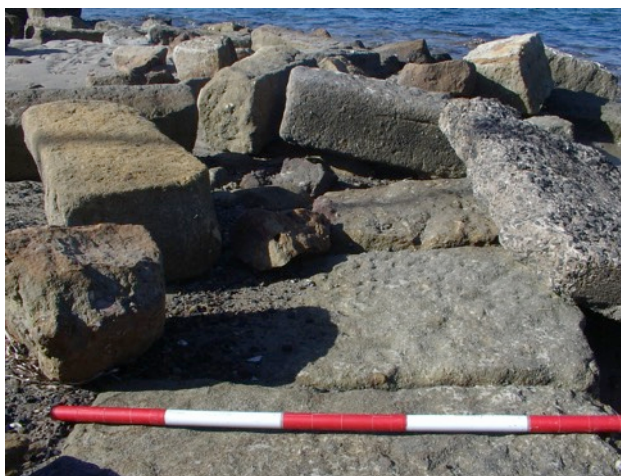
The visible length of the wall is 17.5 m and is preserved up to four courses at the western end and one course high at its extreme eastern end (Figure 3.11). The approximate width of the wall is 90 cm. The dimensions of the blocks in the lower course range from 100 x 45 x 20 to 90 x 50 x 30 cm. The size of the blocks in the upper most courses range from between 90 x 80 x 25 to 40 x 40 x 35 cm.

Figure 3.11: Extreme visible end of Wall 1 in July 2006, looking east. Note the concrete slab on the right side of the image. Scale in 200 mm increments. (Source: Cosmos Archaeology).

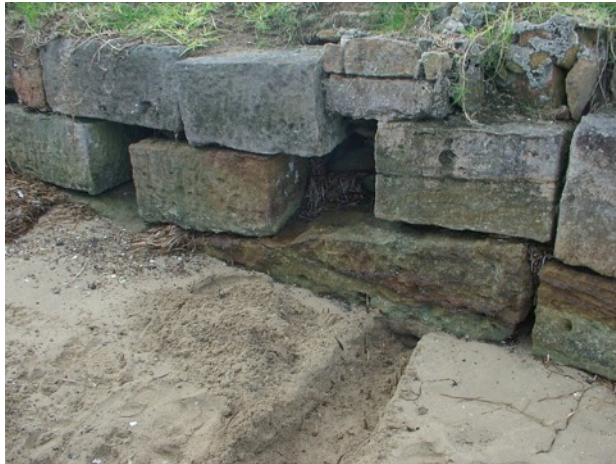
The wall has undergone repairs over time, with the latest repairs consisting of concrete rubble being laid atop of the upper courses (Figure 3.12). There is also possible evidence of the application of 'sacrificial mortar' (sandy matrix mixed with shell grit), on the external facing of the wall.

Figure 3.12: View of Wall 1 in July 2006 with concrete rubble repairs in the top right corner of shot, looking north (Source: Cosmos Archaeology).

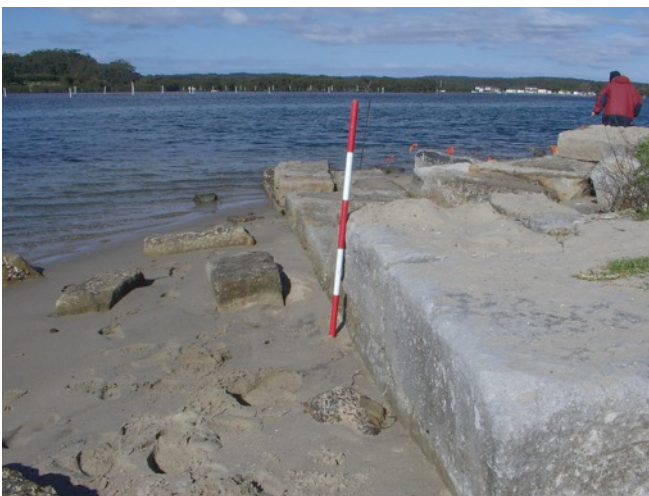
This wall is located at the northern end of the wharf site and lies on NNE – SSW axis. The wall is composed of squared sandstone blocks preserved to around 0.5 m above the ground level, on the northern side (Figures 3.13 and 3.14). The sand level is flush with the top of the extant wall on its southern side.

Figure 3.13: Wall 2 in July 2006, looking south east. Scale in 200 mm increments. (Source: Cosmos Archaeology)

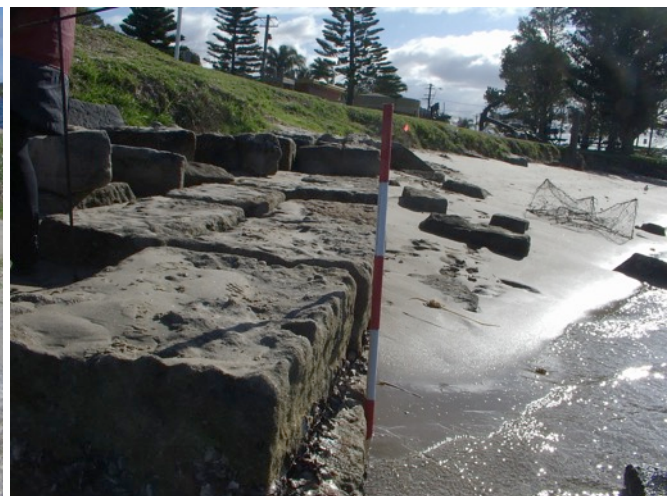
Figure 3.14: Wall 2 in July 2006, looking north west. Scale in 200 mm increments. (Source: Cosmos Archaeology)

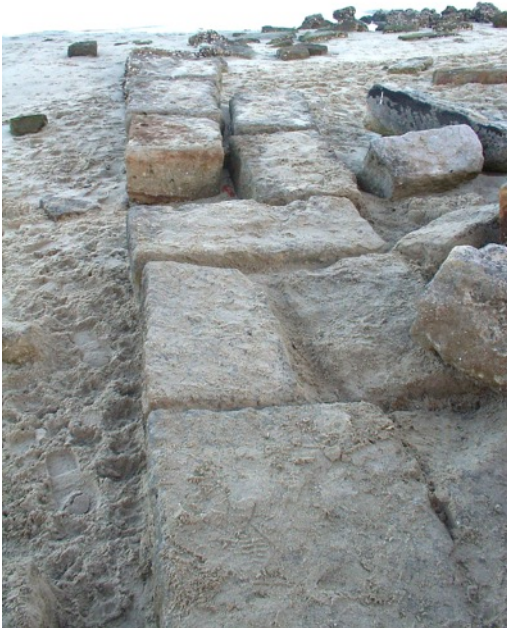
The extant remains of the wall measures 12.4 m in length and approximately 1 m, and is two blocks wide (Figure 3.15). Up to three courses are preserved at the western end, with one course visible at the extreme eastern end (Figure 3.16). The dimensions of the blocks are similar to those of Wall 1 and some evidence of 'sacrificial mortar' was also observed.

Figure 3.15: Wall 2 in July 2006, looking east.
 (Source: Cosmos Archaeology)

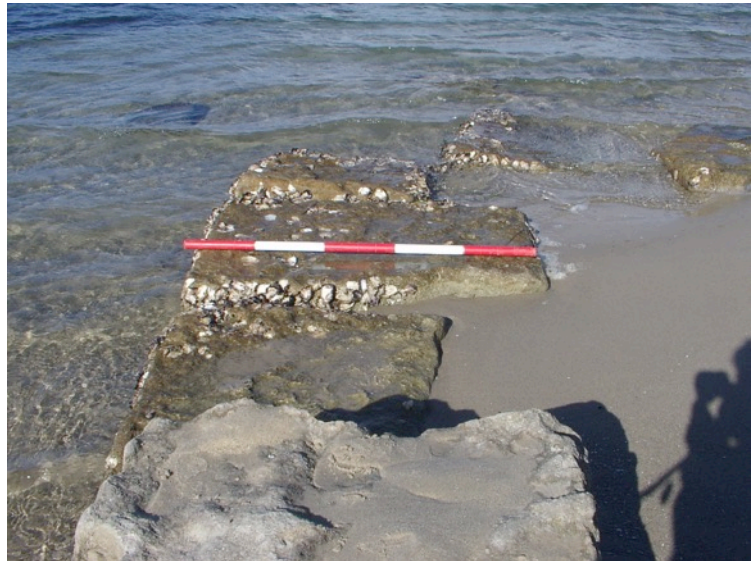
Figure 3.16: Eastern extremity of Wall 2 in July 2006, looking east.
 Scale in 200 mm increments. (Source: Cosmos Archaeology)

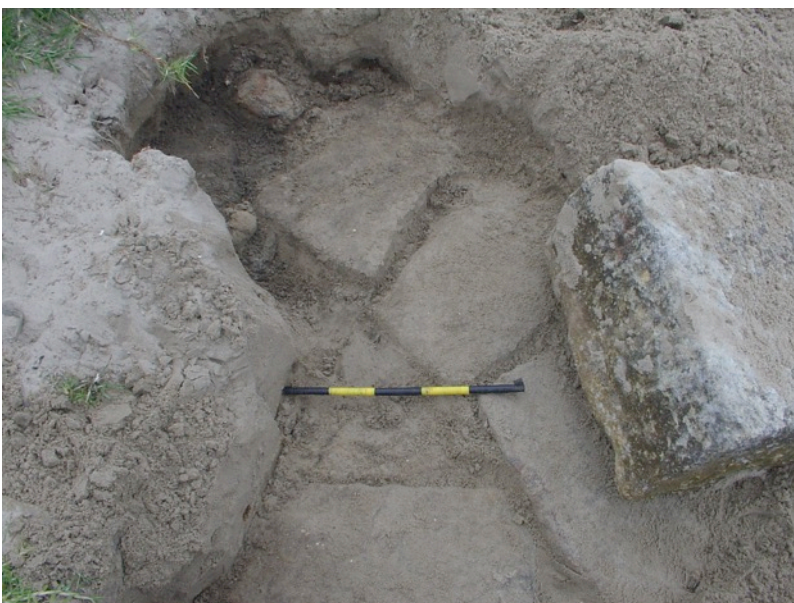
As with Wall 1, this wall has been dismantled with some of the blocks laying nearby possibly being associated with this feature. Probing conducted in July 2006 eastward of the eastern most block indicated that there were possibly buried blocks along the alignment up to the edge of the rubble/fill batter. The removal of sand at the western end of the wall also revealed three sandstone blocks which formed a curve veering to the west, disappearing under the grass bank (Context 10 and Figure 3.17). This arrangement of blocks may have formed a return keying point for another wall running NW-SE, which connected to Wall 2 (see **Section 4.0**)

Figure 3.17: Continuation of Wall 2 at its western end before it enters the grassy bank – Context 10.
 Scale in 100 mm increments.
 (Source: Cosmos Archaeology)

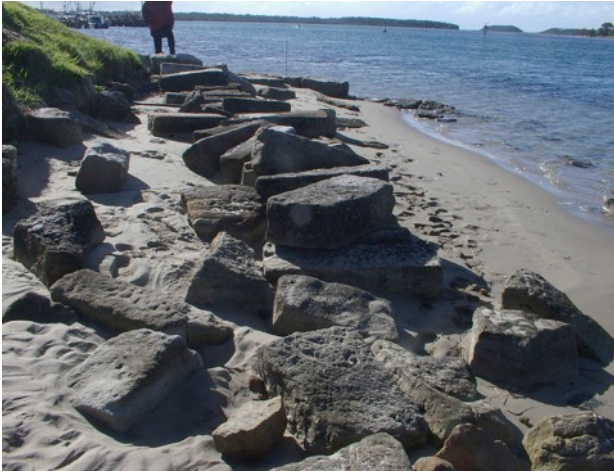
This wall is located in the centre of the site at the base of the grassed bank. The wall runs in a NE – SW direction for a distance of 13.35 m and is composed of sandstone blocks (Figures 3.18 and 3.19).

Figure 3.18: Wall 3 in July 2006, looking north.
 (Source: Cosmos Archaeology)

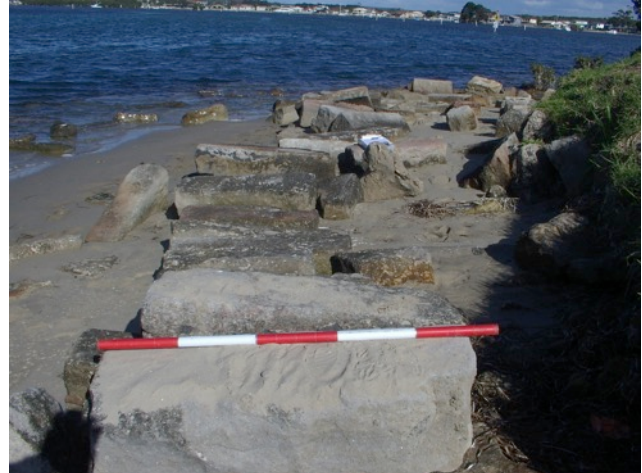
Figure 3.19: Wall 3 in July 2006, looking south. Scale in 200 mm increments. (Source: Cosmos Archaeology)

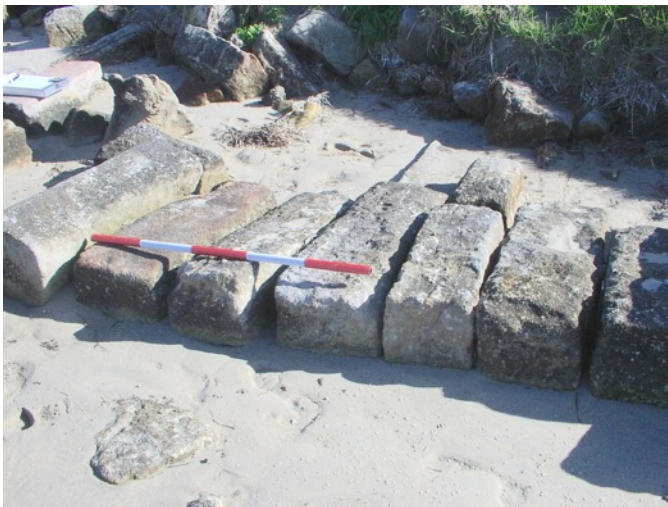
The blocks, measuring between 66 x 23 x 23 and 98 x 35 x 30 cm, are roughly laid in a single row with their longest sides abutting (Figures 3.20 and 3.21). One course is visible, however, the blocks lay on a lower course mostly buried in the sand.

Figure 3.20: Wall 3 in July 2006, looking west. Colour adjusted to remove shadow in background. Scale in 200 mm increments. (Source: Cosmos Archaeology)

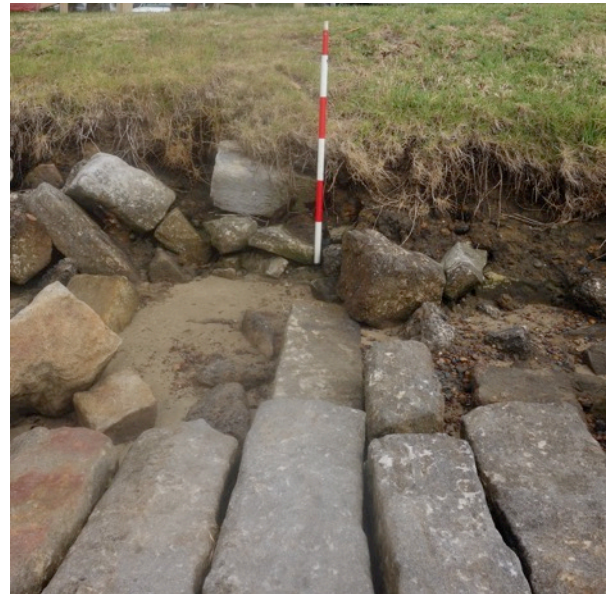
Figure 3.21: Wall 3 in December 2015, looking west. Note the reduction of sand levels between the wall and the grassed bank – ca. 0.25 to 0.40 m. The bank itself has slightly eroded –perhaps by 0.25 m. Scale in 200 mm increments. (Source: Cosmos Archaeology)

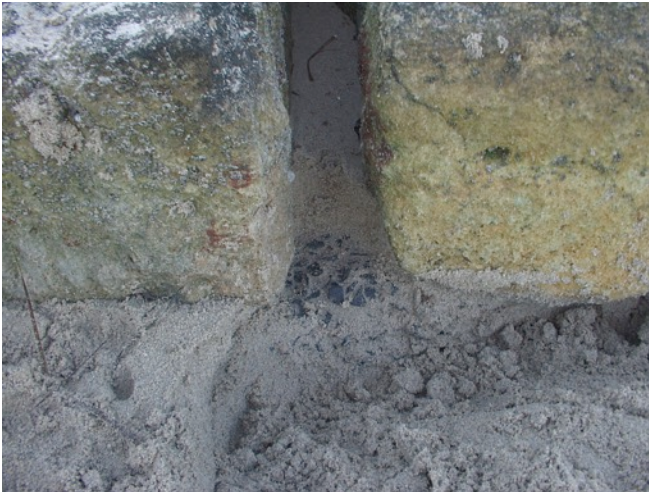
A closer examination of this course revealed that it contained lumps of concrete with bluestone aggregate (Figure 3.22). The wall rests on fill (Context 12) similar to that observed at the eastern end of Wall 1. The fill in this location is red-brown sandy silt mixed with sandstone 'chips', 'clinker' (boiler ash) and many fragments of glass – clear window glass, 'gin' bottle glass and light amber coloured glass - that appeared to date to the 19th century.

Figure 3.22: Wall 3 in July 2006. Sandstone blocks sitting on lower course of concrete with bluestone aggregate. (Source: Cosmos Archaeology)

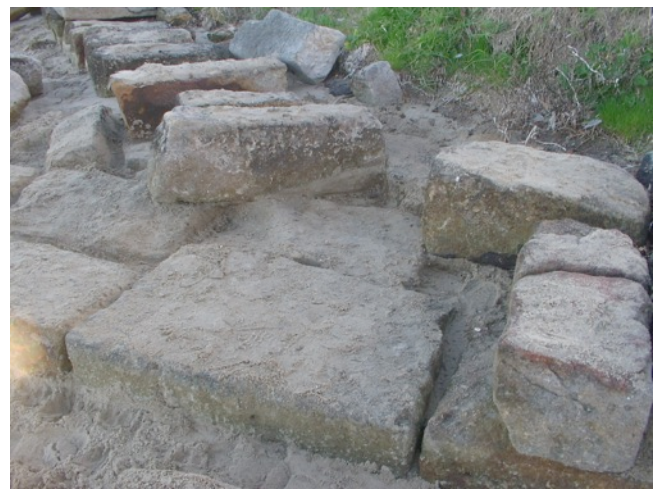
The use of concrete, the 'rough' nature of the wall, and the fact that it overlays Wall 2 suggests that Wall 3 is a later construction and not part of the wharf structure (Figure 3.23).

Figure 3.23: Relationship between Wall 3 (background) and Wall 2 (foreground) in July 2006. Looking south (Source: Cosmos Archaeology)

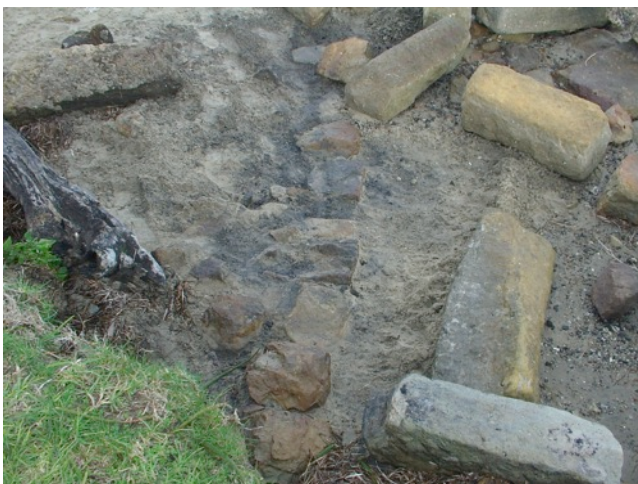
To the north of, and almost running parallel to, Wall 1 is a line of twelve (visible) very roughly worked sandstone blocks (Figures 3.24 and 3.25). They are smaller in size than the sandstone used in the other walls, measuring approximately 35 x 35 x 15 cm.

Figure 3.24: Wall 5 in July 2006, looking south east. (Source: Cosmos Archaeology)

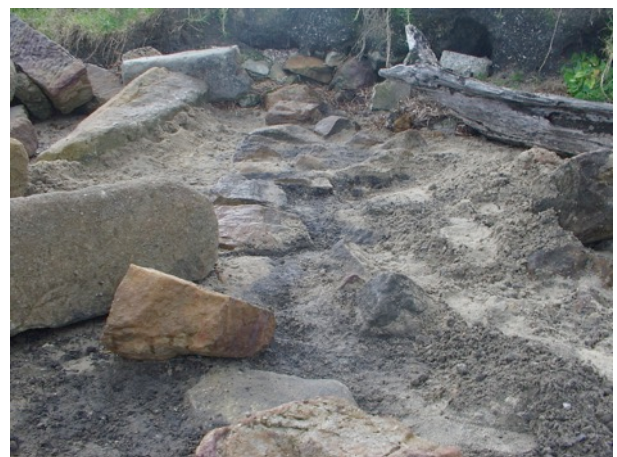
Figure 3.25: Wall 5 in July 2006, looking west. (Source: Cosmos Archaeology)

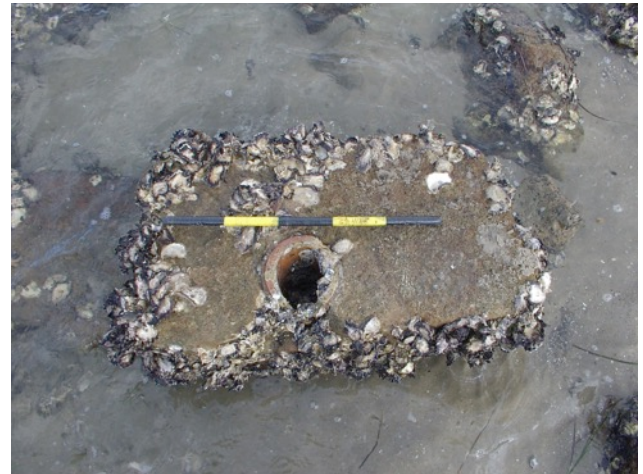
This block is situated to the north of Wall 4. This block formed part of the wharf wall, with the ceramic pipe performing the function of draining water that accumulated in the fill behind the wall (Figure 3.27).

Figure 3.25: Block with ceramic pipe inserted (Context 7), in July 2006. Scale in 100 mm increments. (Source: Cosmos Archaeology)

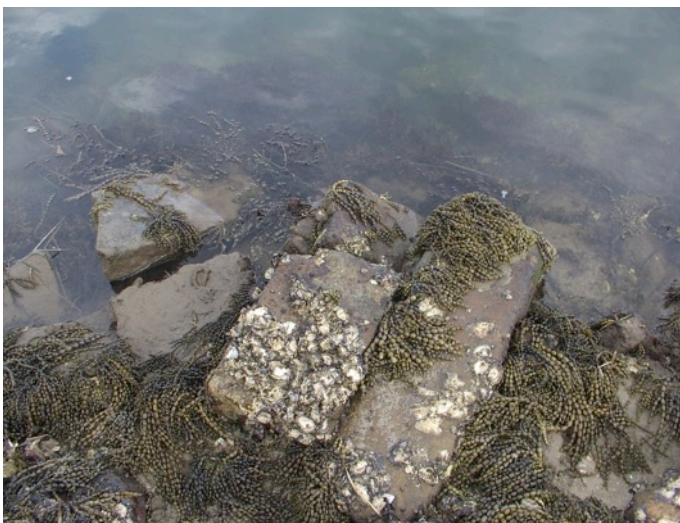
Two sandstone blocks, 80 x 76 x 28 cm and 100 x 70 x 25 cm, appear to be *in situ* – though moved slightly – and may be part of a wall alignment; the other blocks that would form the wall having been removed or are buried (Figure 3.26). These blocks are located on the edge of the rubble/fill batter.

Figure 3.26: In situ blocks (Context 9), in July 2006. Scale in 100 mm increments. (Source: Cosmos Archaeology)

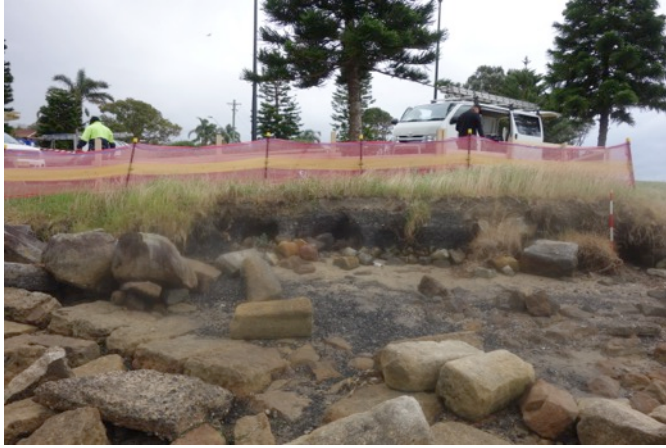
The observable fill that comprises the grassed bank and is retained by Walls 1 and 2 – and to a failed extent Wall 3 – consists of a series of loose brown silt mixed with clay and sand (Context 11) and includes a thick layer of coal ash (Figures 3.27 and 3.28).⁴⁴ The ash layer appears to be overlaying loose rock rubble (see Figures 3.28 and 3.29) and Wall 5 (see Figure 3.32). Fragments concrete can be seen around the exposed face of the fill but they are likely to have been put there to arrest erosion (see Figure 3.28).

Figure 3.27: View of fill (Context 11) that comprises the grassed bank exposed from erosion in December 2015. Looking north west. (Source: Cosmos Archaeology)

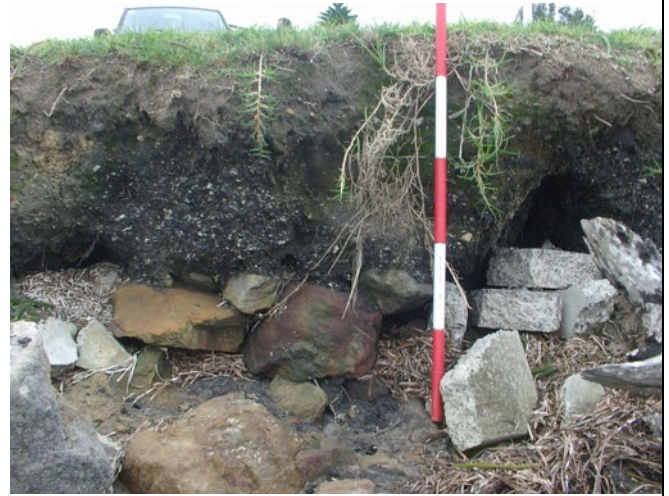
Figure 3.28: View of fill (Context 11) in July 2006. Looking north west. Scale in 200 mm increments. (Source: Cosmos Archaeology)

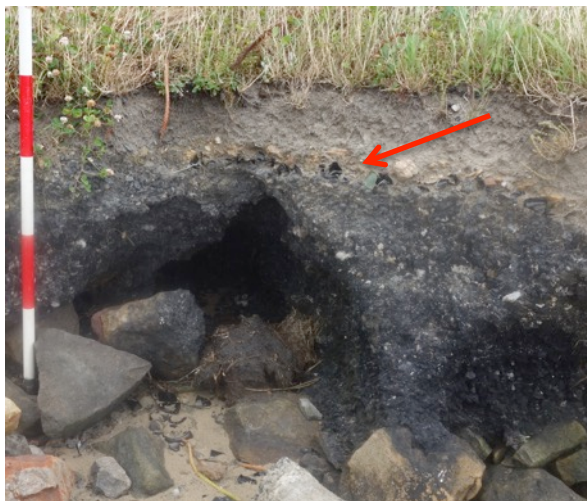
Above the ash layer there is a mid brown loamy sand layer approximately 200 mm thick. At one location along the exposed fill strata is a thin layer of broken dark green bottle glass which are eroding out of the fill (Figure 3.29 and 3.30). The varying angles and orientations of the glass suggests that they were deposited in a single event as part of the filling process rather than being deposited over time over a hardened walking surface (in which case they would be lying flat).

Figure 3.29: View of fill sequences, which comprise the grassed bank (Context 11) in December 2015. Glass layer shown with red arrow. Note cavity in centre of image. Scale in 200 mm increments. (Source: Cosmos Archaeology)

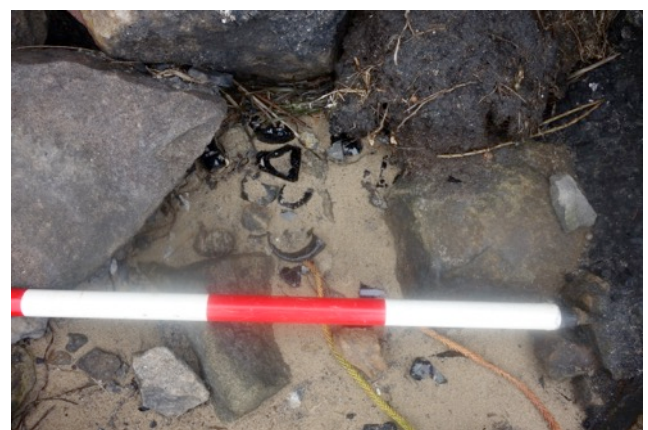
Figure 3.30: Dark green bottle glass eroding out of (Context 11), in December 2015. Scale in 200 mm increments. (Source: Cosmos Archaeology)

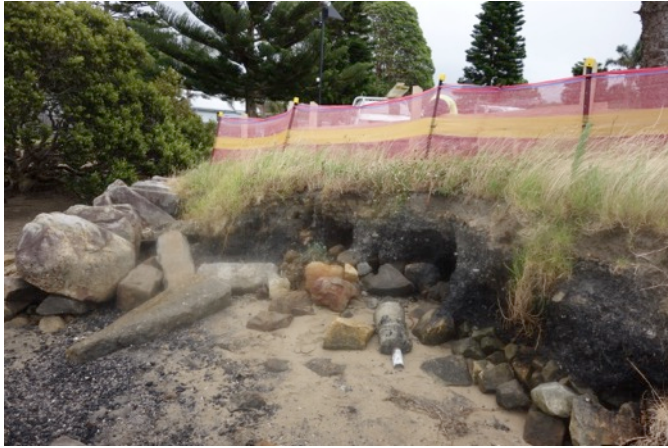
The grassed bank has undergone limited erosion since the July 2006 inspection, possibly up to 0.5 m in places (compare Figure 3.31 with Figure 3.32). There appears in places within the fill, cavities up to 1 m deep, which are recent (see for example Figure 3.29). It is difficult to tell whether this is due to erosion or to burrowing by bottle collectors. Whatever the cause, these cavities destabilise the formation and will likely accelerate its erosion and collapse.

Figure 3.31: View of eroding grassed bank in December 2015. Looking west. (Source: Cosmos Archaeology)

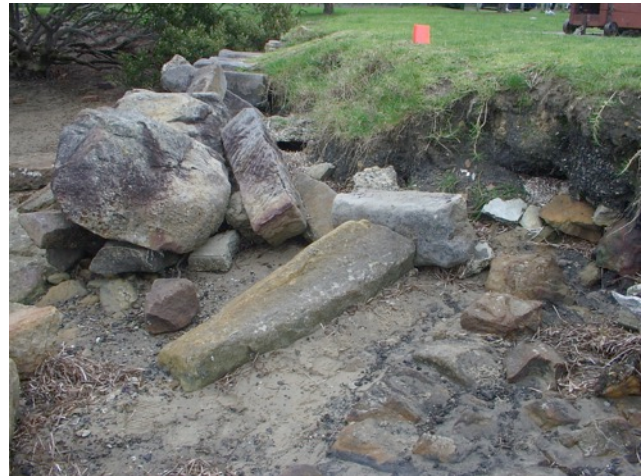
Figure 3.32: View of eroding grassed bank in July 2006. Looking west. Note the exposed remains of Wall 5 in the foreground. (Source: Cosmos Archaeology)

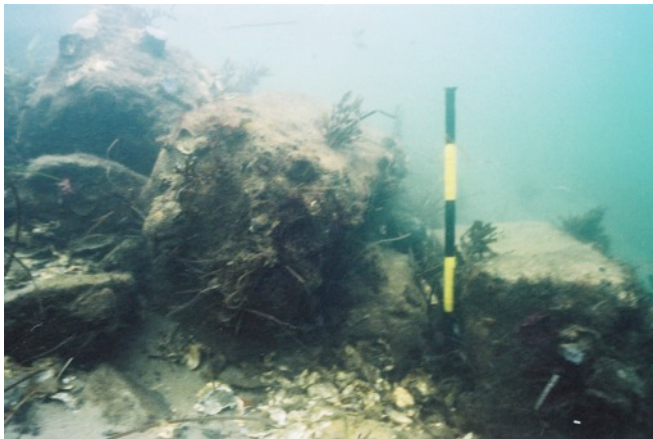
Figure 3.33: Possibly in situ blocks in line with Wall 1 in July 2016. Scale in 100 mm increments. (Source: Cosmos Archaeology)

In 2006 diving was undertaken on the east and south of the wharf site. No definitive evidence of intact wharf walls were identified apart from three blocks, which appeared to follow the alignment of Wall 1 (Figures 3.33 and 3.34). However these three blocks are arranged in a stepped fashion rather than forming the flush face which weakens the argument that they are a continuation of Wall 1.

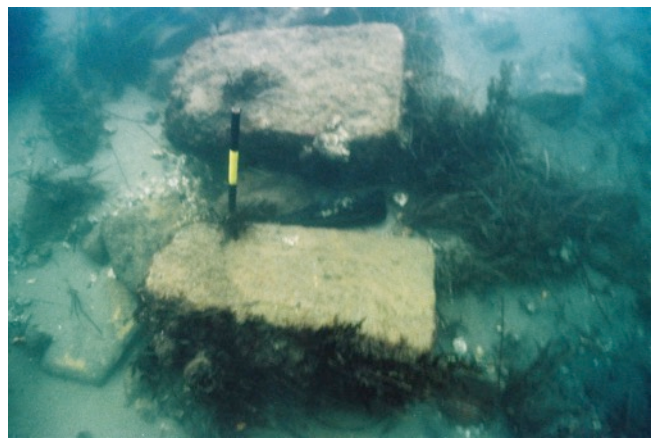
Figure 3.34: Possibly in situ blocks in line with Wall 1 in July 2016. Bottle visible between the two blocks. Scale in 100 mm increments. (Source: Cosmos Archaeology)

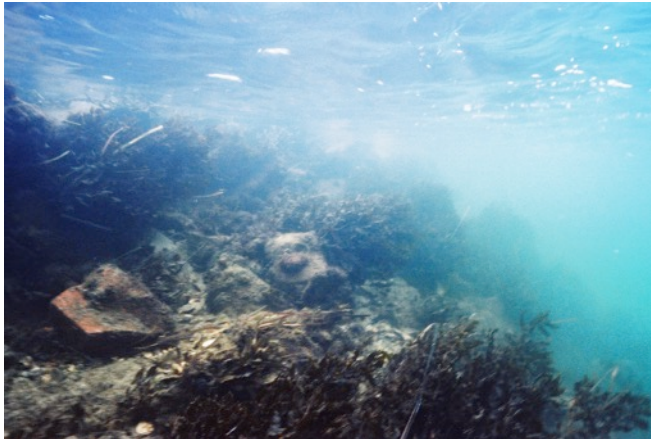
Observations suggest that the wharf walls were built on fill, composed of mostly sandstone rubble (Figure 3.35). This means that the rubble is not derived from the collapse of the wharf walls. The incline from the top edge of the rubble down to the sandy seabed is relatively steep – 3 m over an average distance of 3 m (approximately 45°). Observed within the crevices of the rubble face were the occasional complete or fragmentary bottle and ceramic vessel (Figures 3.36 and 3.37). Some of these artefacts appeared to date to the 19th century and their ‘exposed’ presence is highly unusual for such a site. It indicates that (diving) bottle hunters have not regularly visited the site and therefore the archaeological potential of the site is considerably enhanced. This observation should not be published. The final version of the 2006 report omitted references to the bottles.

Figure 3.35: 30 Example of rubble slope in July 2016.
 (Source: Cosmos Archaeology)

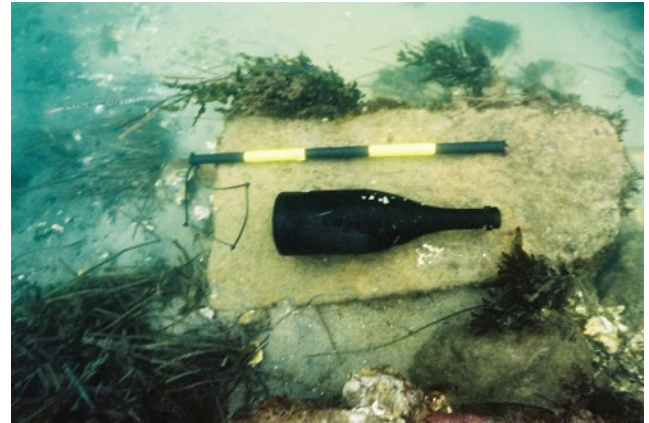
Figure 3.36: 19th century dark green “black” glass bottle in July 2016. Scale in 100 mm increments.
 (Source: Cosmos Archaeology)

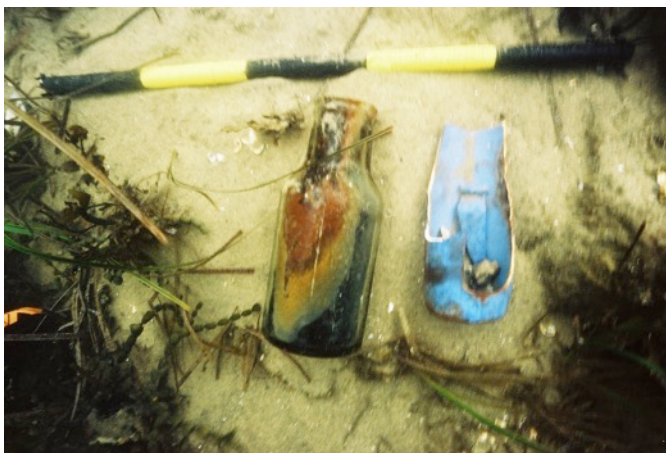
Figure 3.37: “Pickle jar” and fine walled ceramic jar/bottle with pale blue glaze. Scale in 100 mm increments. (Source: Cosmos Archaeology)

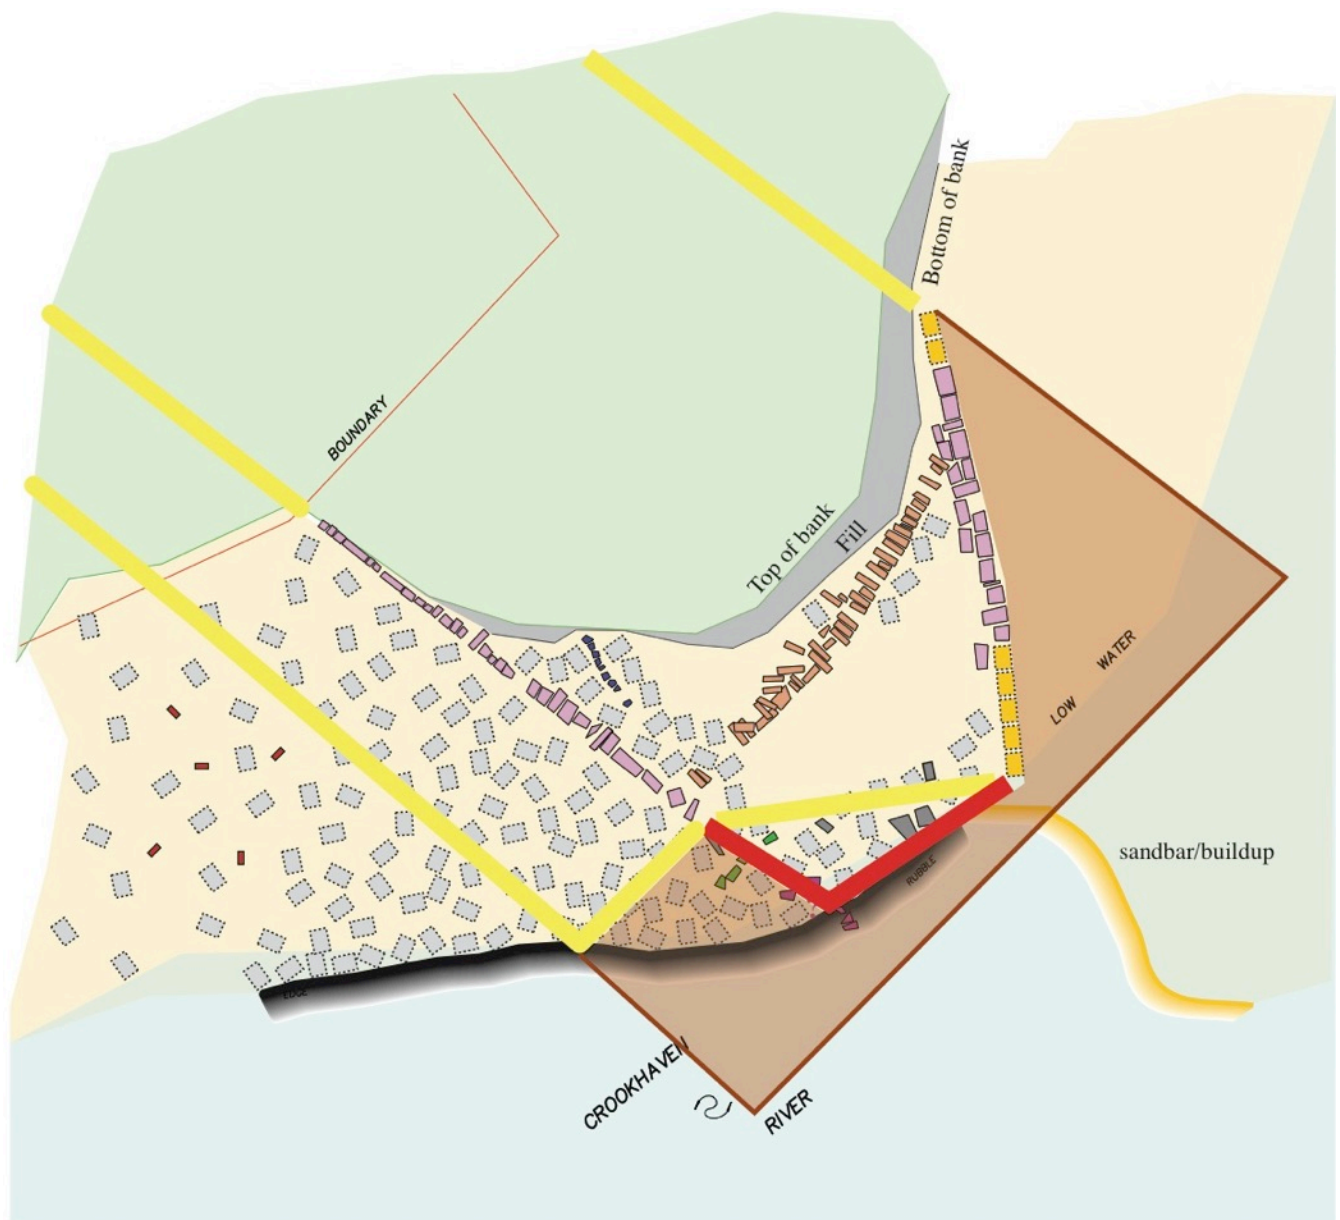
An alternative alignment of the missing section of wall – that would link Walls 1 and 2 – has been proposed. This is based on the observation that some sandstone blocks amongst the rubble along the top edge of the batter appear to be in alignment with Wall 1 – the southern parallel wall of the 1903 plan. This proposal has the southern parallel wall (Wall 1) continuing to the top of the rubble batter before turning northwards – following the top of the batter – to link with Wall 2. The apparently *in situ* blocks of Context 9 would have formed part of this wall (Figure 4.3). Such a configuration however would have provided only marginally deeper water access – due to the batter - for vessels to tie up against the wharf. This proposal is based on tenuous visible evidence and would require extensive removal of sand and loose surface rubble to substantiate. This proposal also cannot be reconciled with what is depicted on the latest and only detailed plan of the wharf.

KEY	
	Walls 1 and 2
	Blocks possibly associated with Wall 1
	Wall 3
	Wall 4
	Wall 5
	Blocks with unique features
	Sandstock (< 1870s) bricks
	Random block (not surveyed)
	Possible blocks under sand (By probing)

Possible alignments of 'missing' walls based on 1903 plan of Wharf

Possible alignments of 'missing' walls based on tenuous visible archaeological evidence

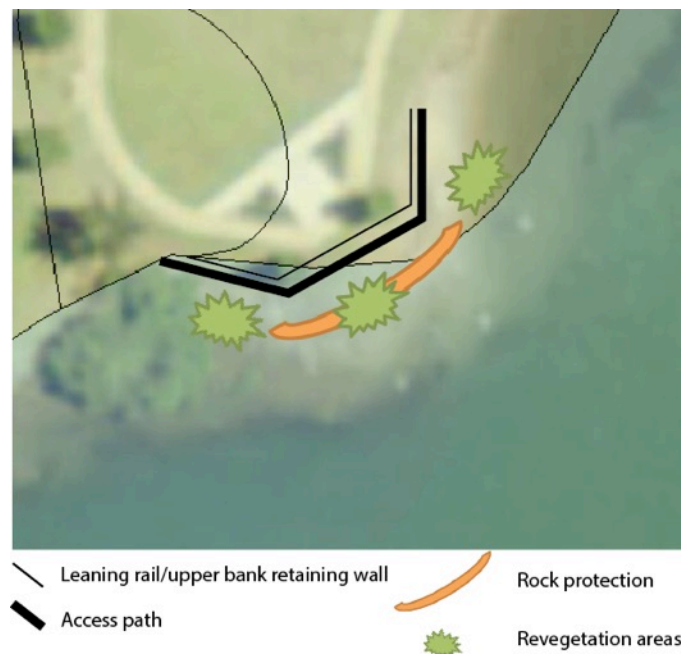
Figure 7.1: Option 1 for stabilisation of embankment above Heritage Stone Wharf at Greenwell Point.
 (Source: SCC)

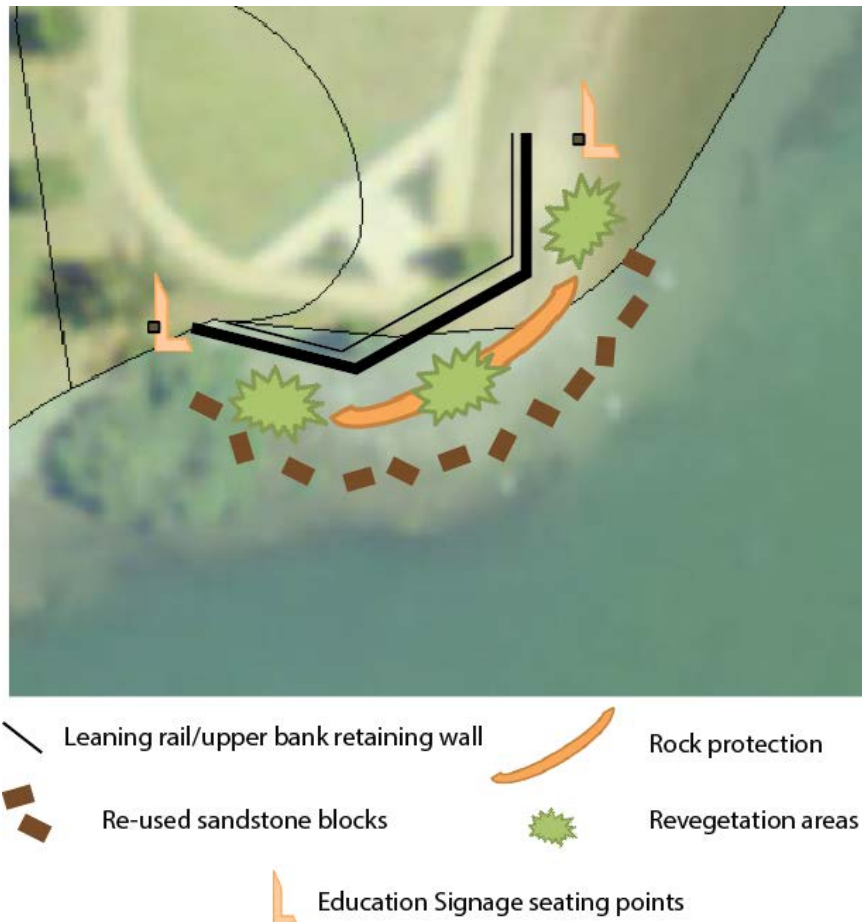
Figure 7.3: Concept Option 3 for stabilisation of embankment above Heritage Stone Wharf at Greenwell Point. (Source: SCC)
