Berry Showground Agricultural Pavilion

Berry NSW

CONSERVATION MANAGEMENT PLAN

June 2002
REF: 0149: CMP

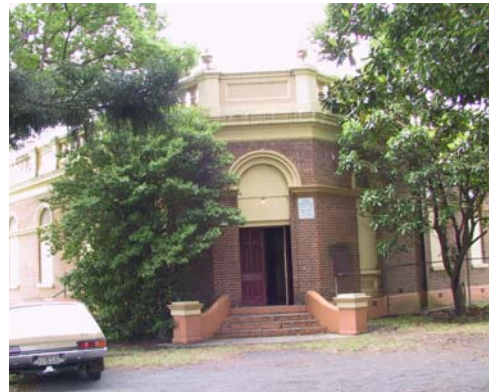
The Agricultural Pavilion is a late Victorian L-shaped building which was constructed of red brick in 1888. The façade of the building features urns upon a parapet and a moulded string course which runs around the building. The urn upon the south-western corner of the building has been removed. The roof of the subject building is of corrugated iron.

The windows to the northern and western elevations are 'dummy' windows which have arched fanlights above.

Many of the cast iron vents have been removed. **Figure No.8:** Front elevation of subject building

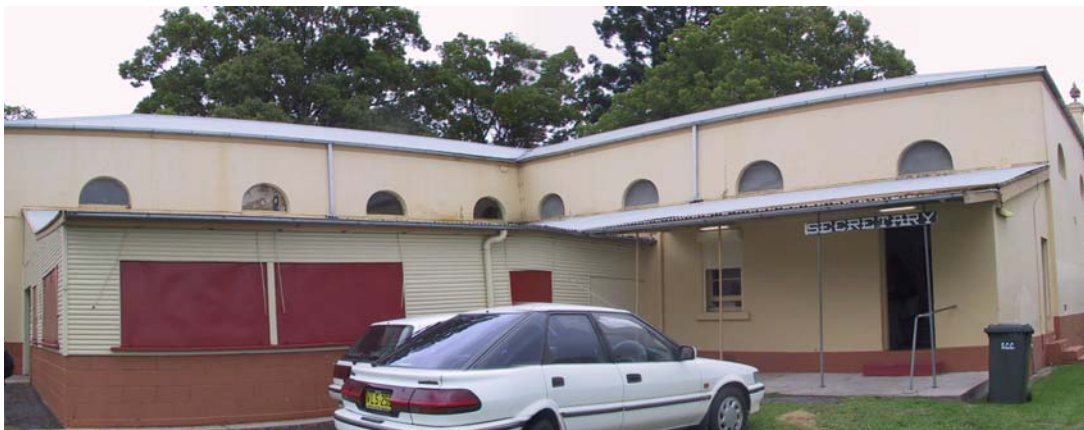
Figure No.10: Rear elevation of subject building

To the rear of the subject building is an enclosed lean-to addition. This addition has a corrugated iron roof with cement block and timber walls. The walls of the addition are punctuated by a number of window openings and a roller door. Also to the rear of the subject building is the brick Secretaries Office which itself has a corrugated iron verandah addition.

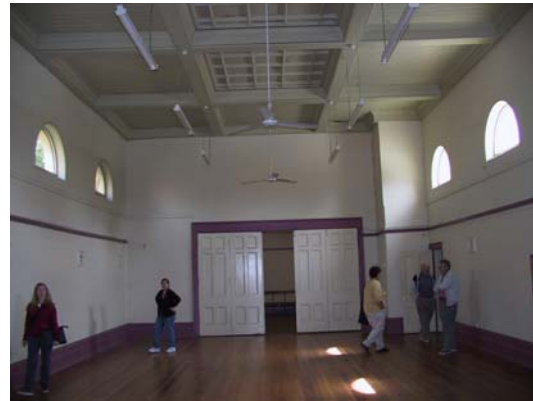
Figure No.11: The Lodge Room

The ante room, Lodge room and Supper room all have double picture rails and skylights. The ceiling consists of skylight panels and panels of timber boarding. The original coloured glass of the skylights appears to have been replaced with metal.

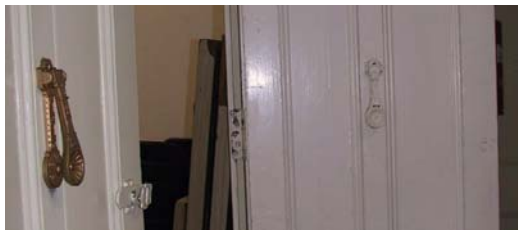
Figure No.12: Door Hardware

The doors from the ante room (S1) into the Lodge room (S2) and Supper room (S3) are timber panelled folding doors, most of which retain their original door hardware.

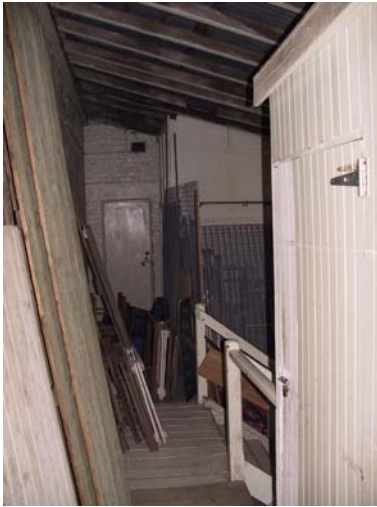
The rear addition (S5) includes a small enclosed area used as a kitchen and storage space by the Masons. The flooring of the rear addition is concrete and the corrugated iron roof is supported by timber beams. This area is roughly divided into two sections by timber posts.

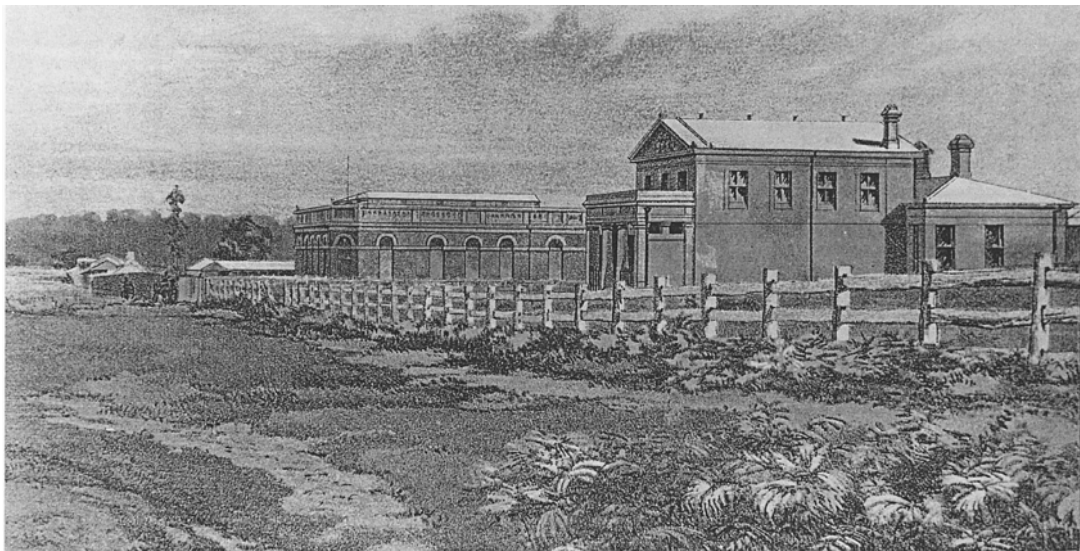
Figure No.18: Photograph taken in 1899

the second part of the enclosed rear addition. This early photograph shows the rear addition a being open. It is known that the rear addition was originally to act as a shelter area for buggies and other conveyances. The lantern lights are visible at the top of the subject building and the walls are not rendered as they are today.

The above photograph (taken from the *Berry Estate Book, Sands, Sydney, c1892*) shows the lantern lights and the flagpole to the entrance of the building.

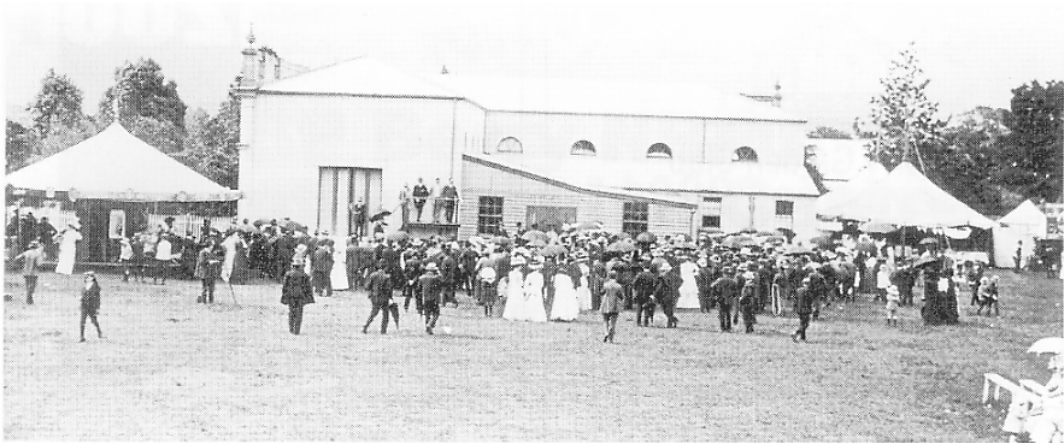
Figure No.20: Photograph taken in 1901

The above photograph was taken at the opening of the Berry Show in 1901. The lantern lights have been removed by this stage. The urn to the parapet of the southern western end of the building is visible. This urn is no longer in place. The materials and openings to the rear addition are clearly visible. The announcement stage is also visible. This is the location from which the winners of prizes were announced and other general announcements were made before the introduction of loudspeaker systems.

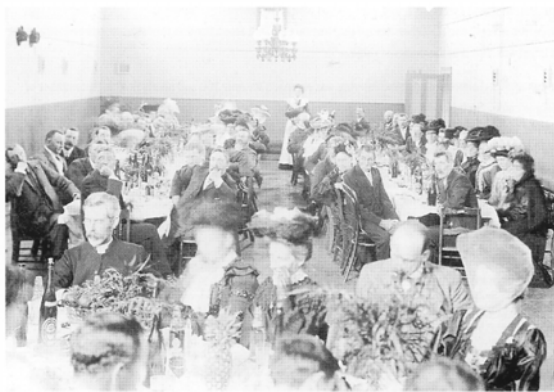
This photograph (taken from *Berry Centenary of Federation Municipal Picnic – Programme*) is of the lodge room being used to host a meal and shows a large chandelier.

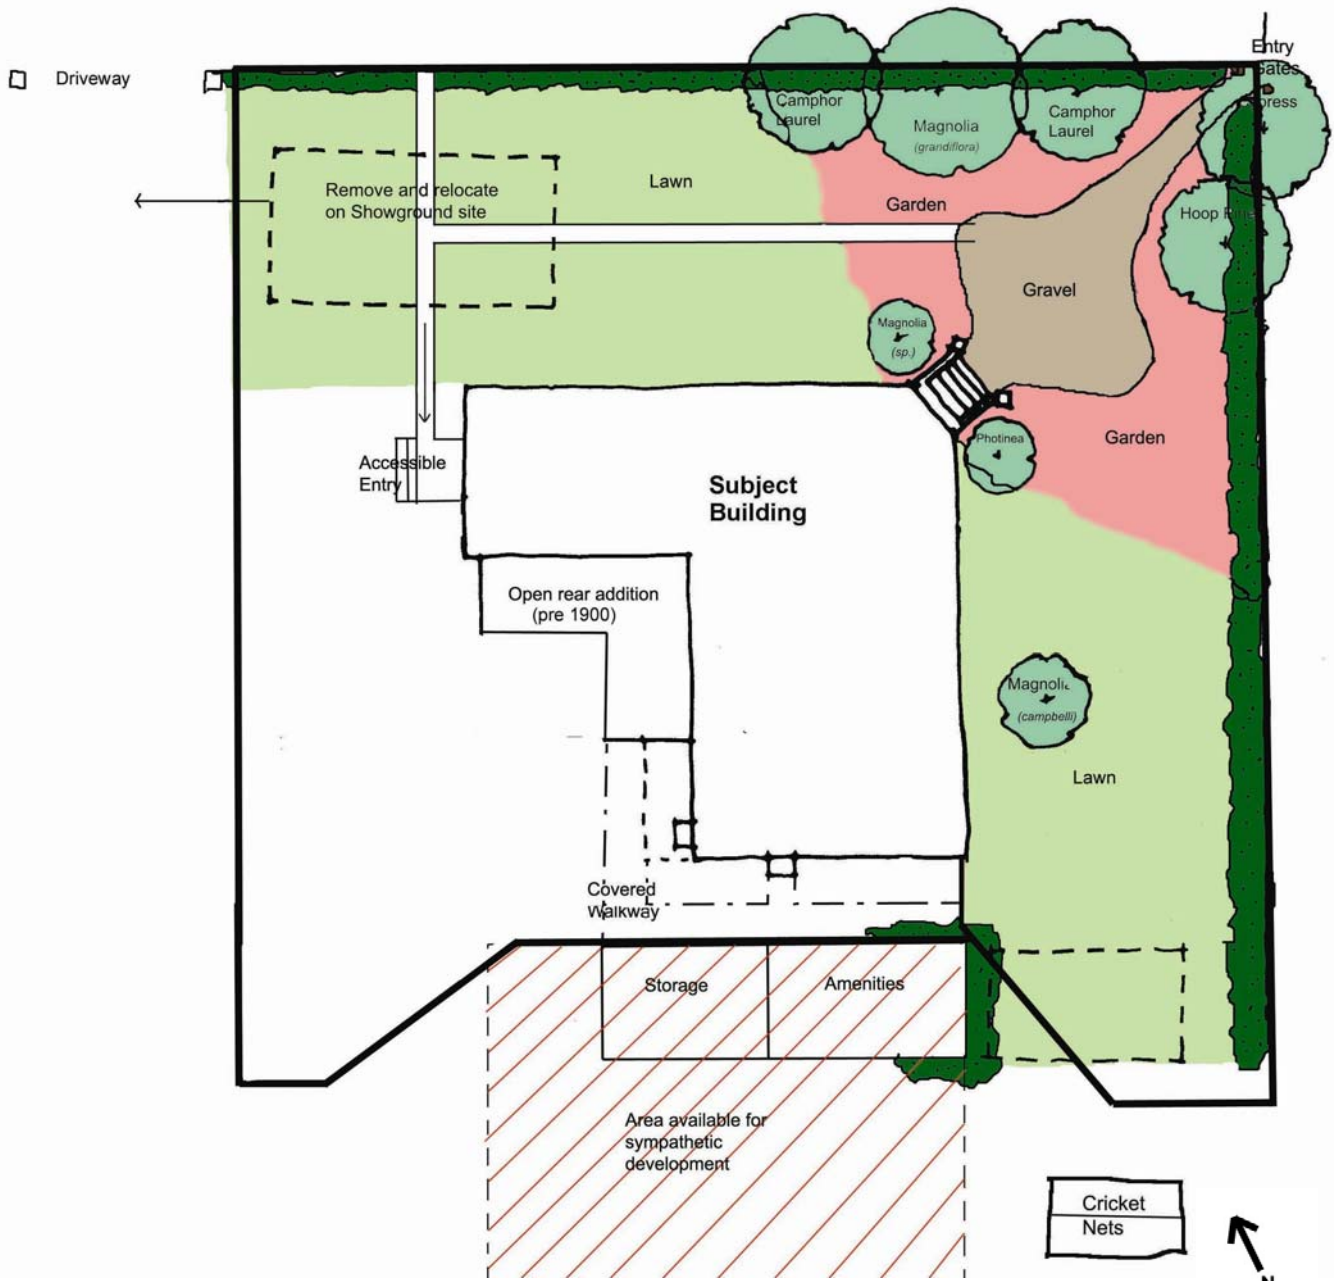
Figure No.29: Options for future use

Following is a diagram showing the potential locations of future development on the subject site.

The diagram also indicates an appropriate landscape layout for the site. The landscaping for the site should be of a late nineteenth century style. Plants which may be used in this landscape include, but are not limited to clivias, ferns and camellias.

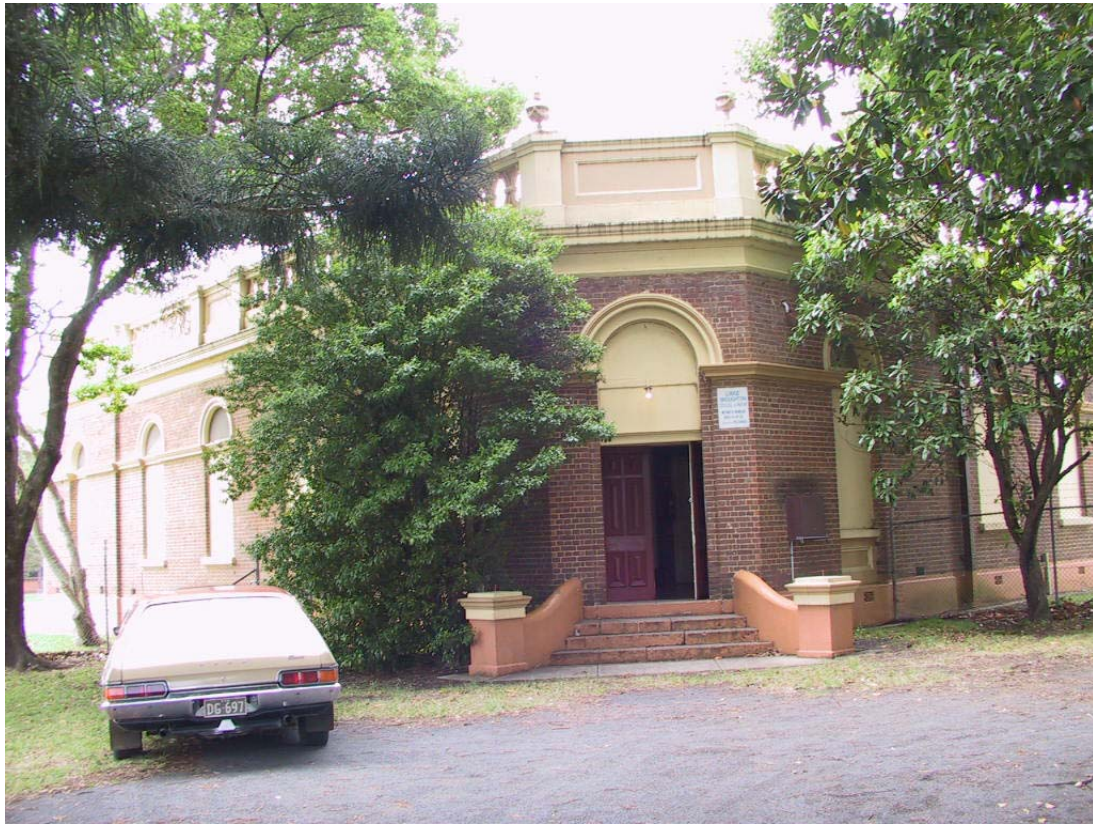
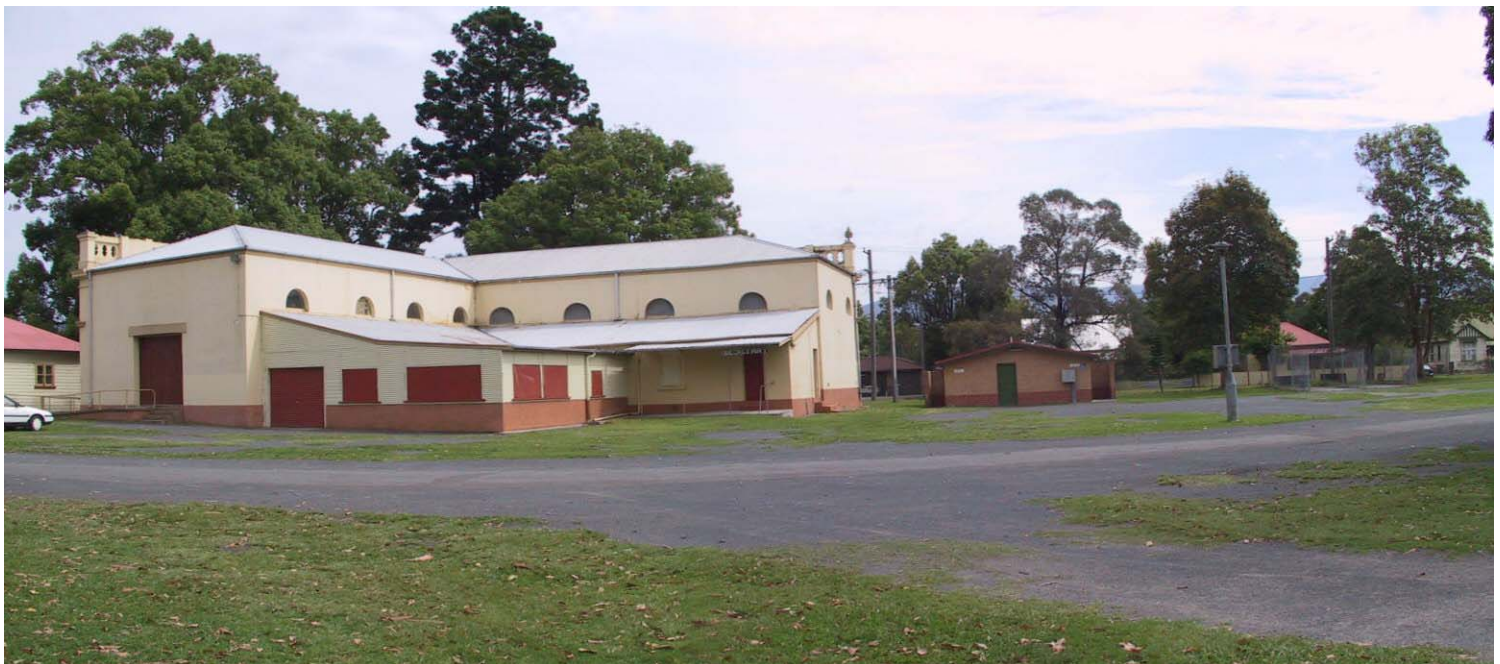
Figure No.13: The front (north-eastern) elevation of the subject building
Figure No.14: The rear (south-western) elevation of the subject building

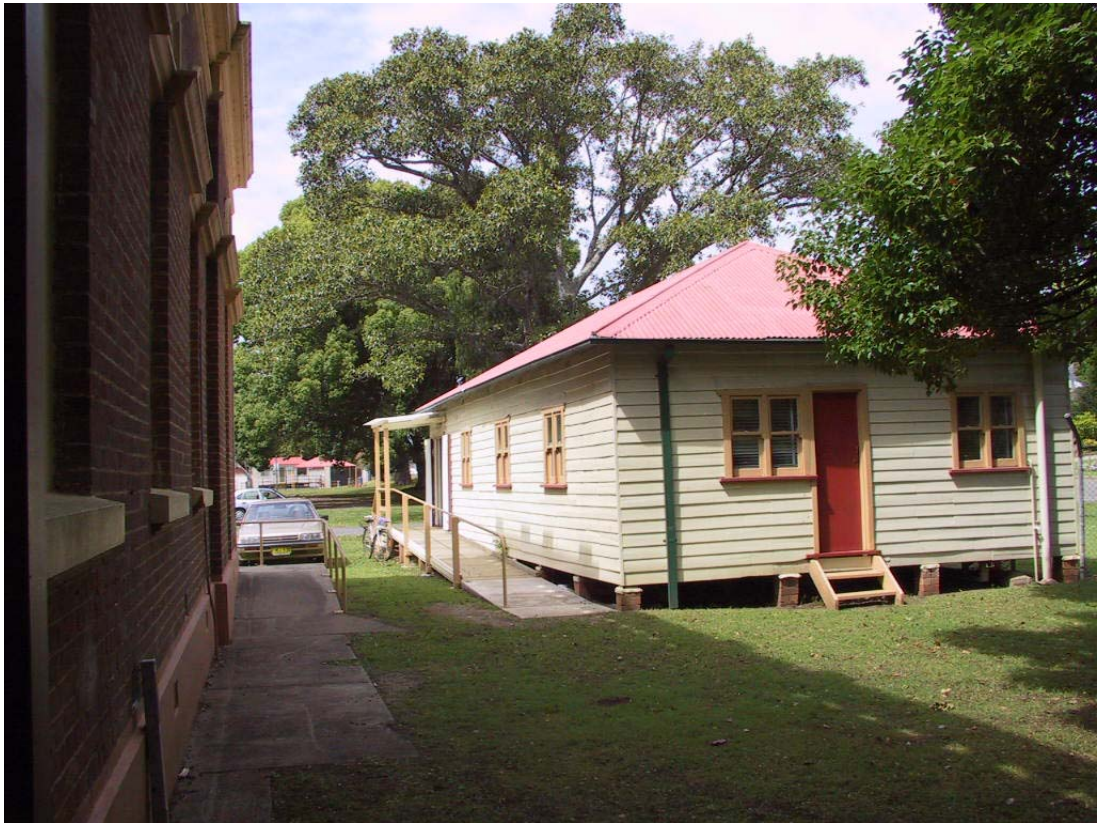
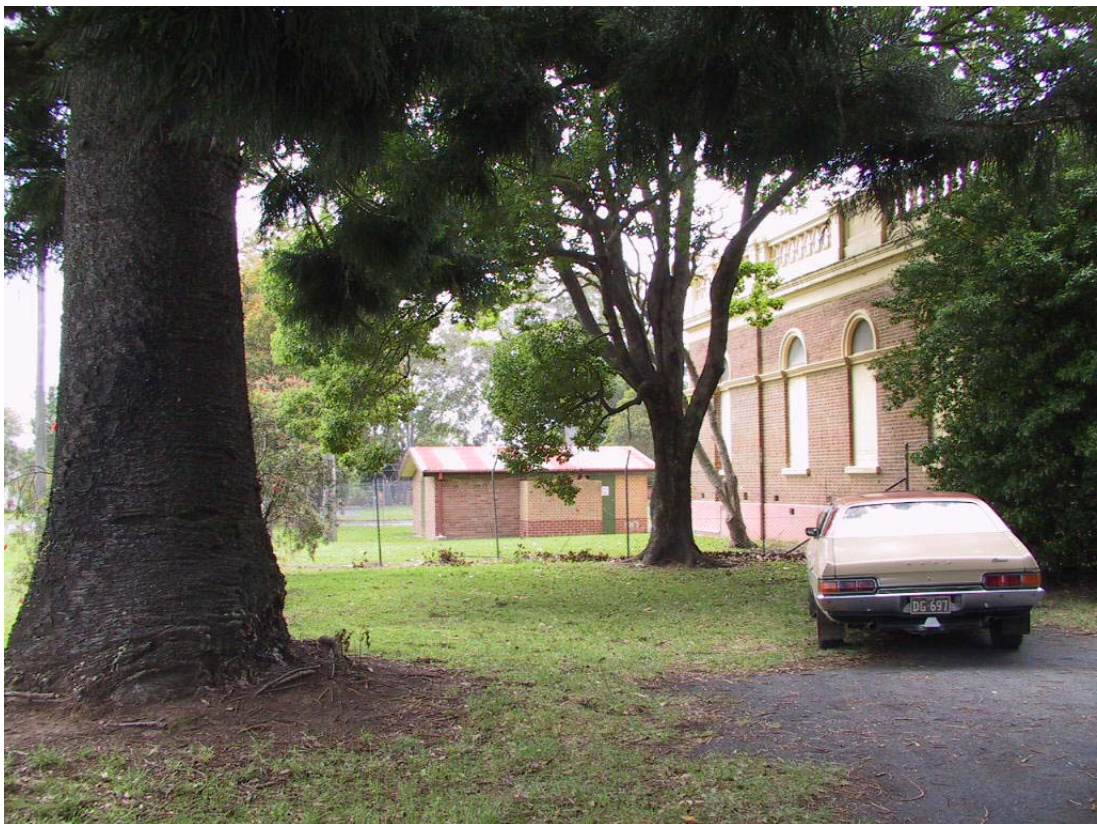
Figure No.15: The Rural Youth Hall, located to the south of the subject building
Figure No.16: The area to the east of the subject building. Note the unsympathetic wire mesh fencing and the car parked in the entry area.

The area in the immediate vicinity of the subject building is fenced with wire mesh topped with barbed wire from the building to both Albany Street and Victoria Street. It is believed that this is to prevent unpaid access to the showground during show time.

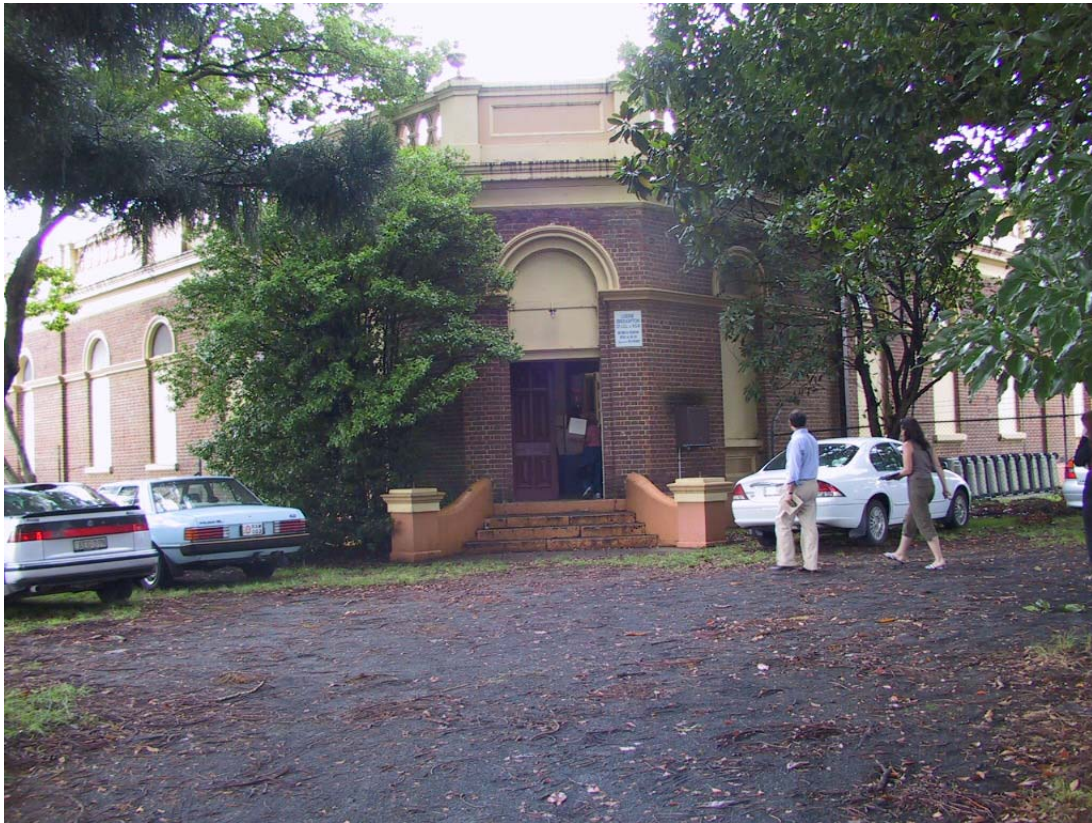
Figure No.17: The entry area to the subject building. Note the cars parked on the gravel, probably resulting in the compaction of the trees roots.

Immediately to the front of the subject building is a gravel area which is currently used for car parking.

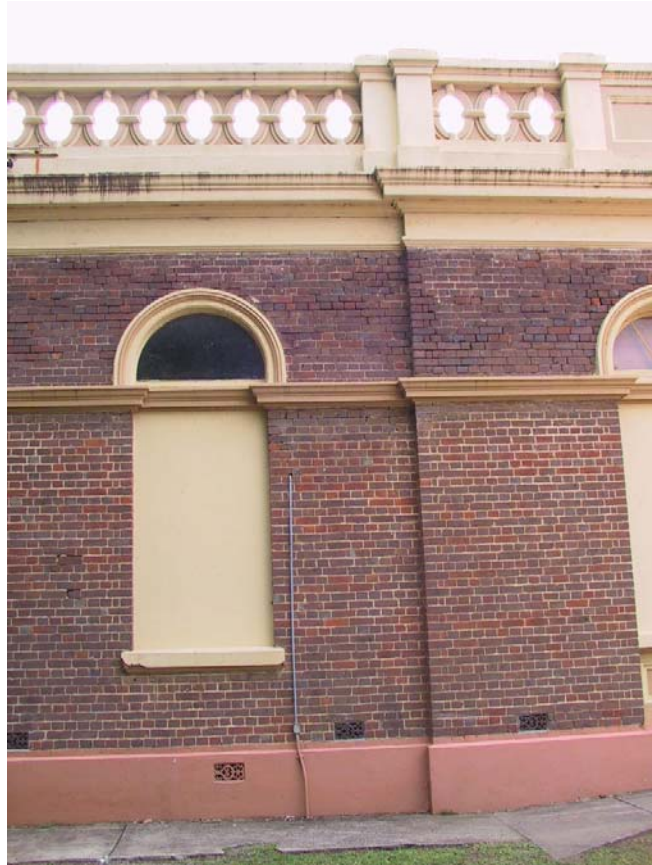
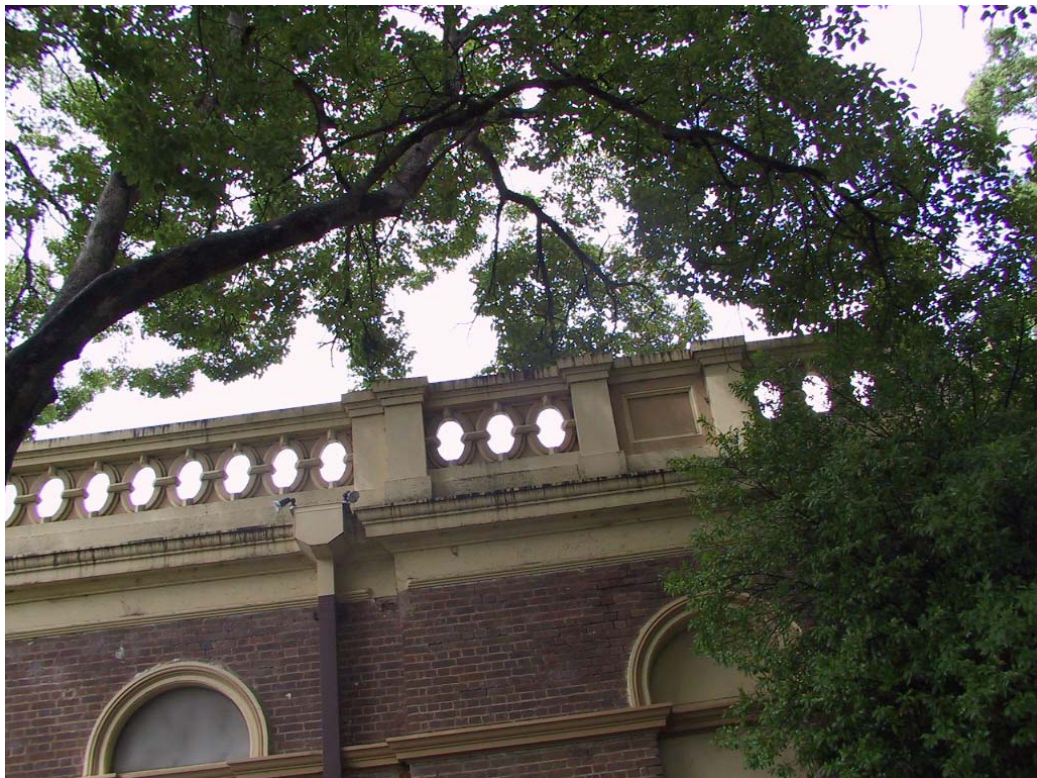
Figure No.19 & 20: The subject building showing the parapet

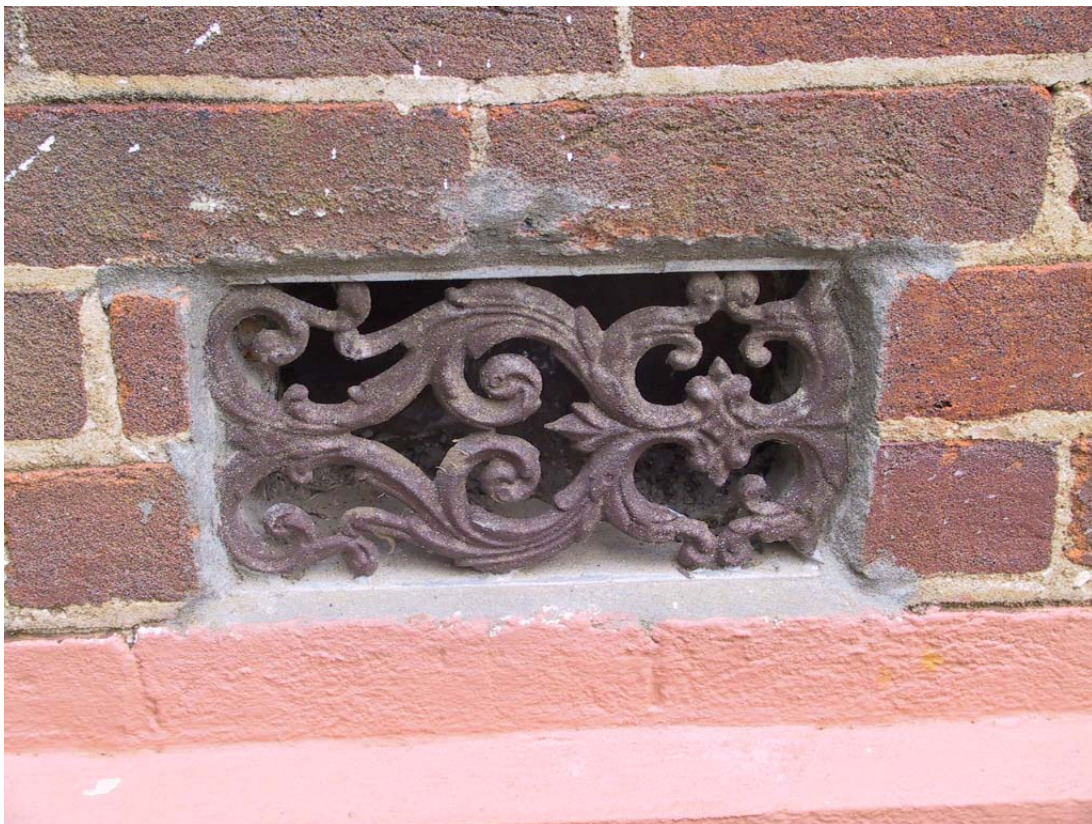
Figure No.21: Decorative urn to parapet

Figure No.22: Example of typical external vent

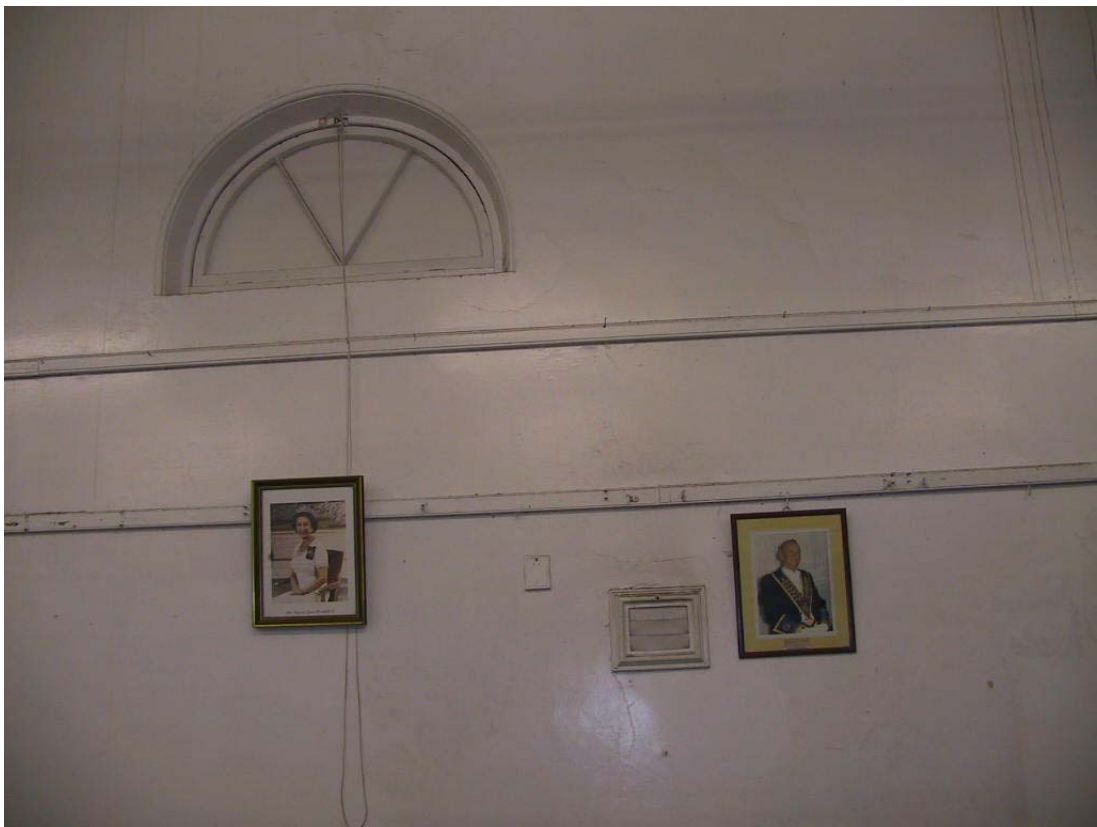
Figure No.31 & 32: The skylights in the Lodge room which were formerly coloured glass.

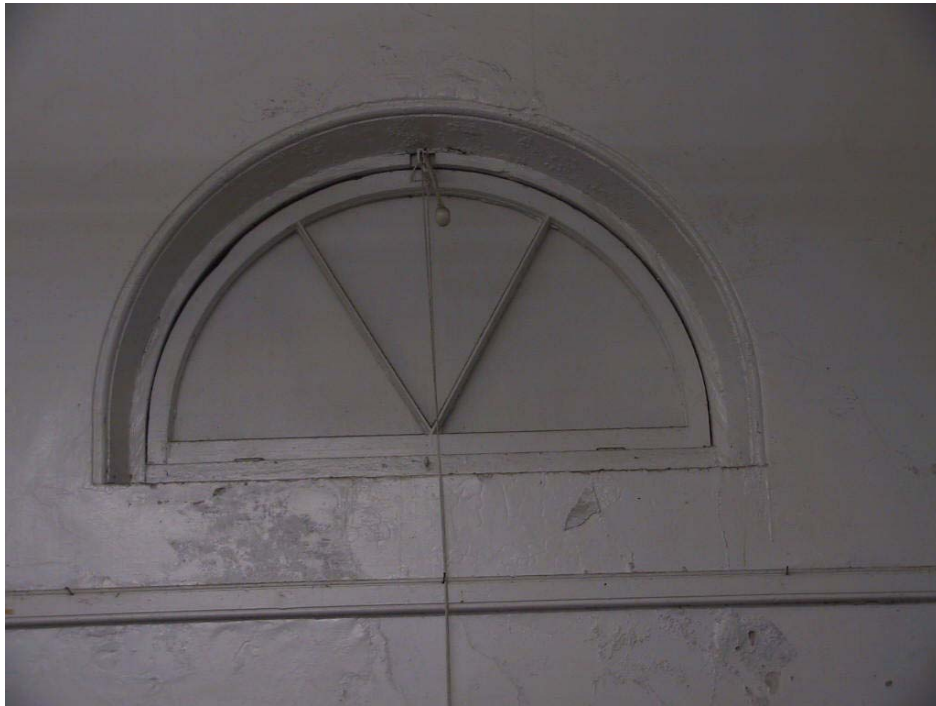
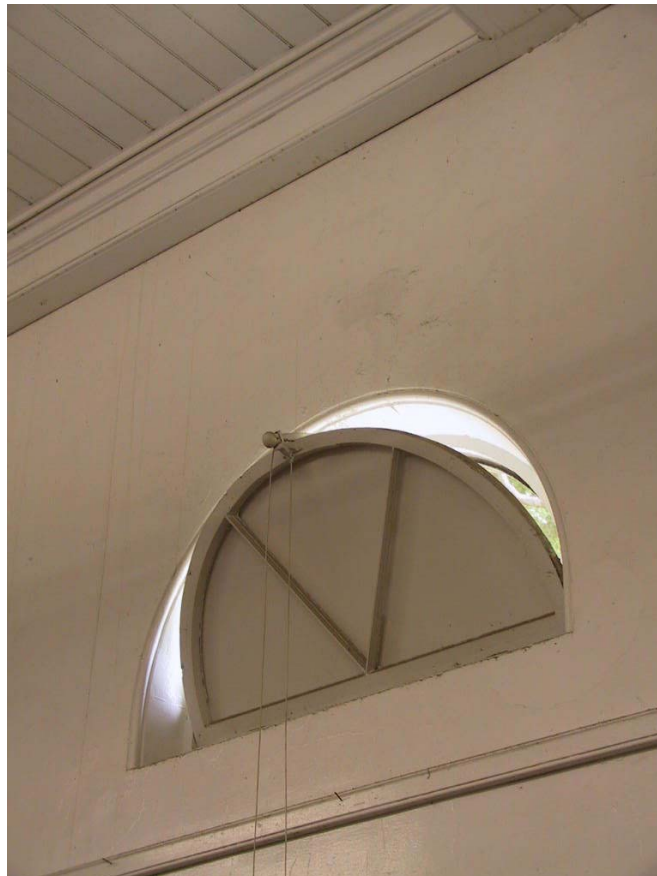
Figure No.35 & 36: Details of typical semi circular windows located in the Lodge room

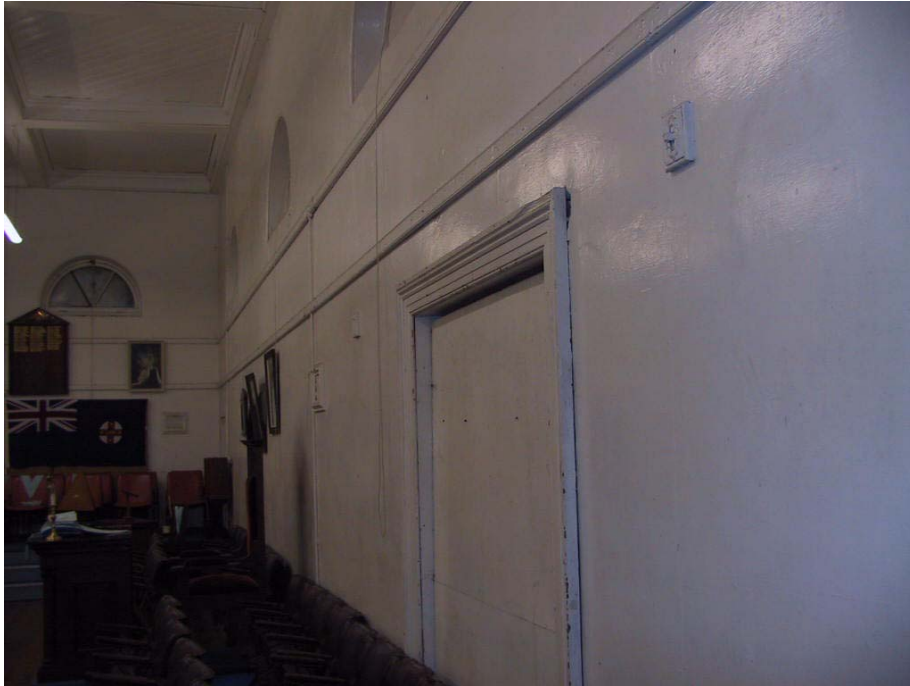
Figure No.37: The western wall of the Lodge room showing the door to the rear addition which is no longer in use.

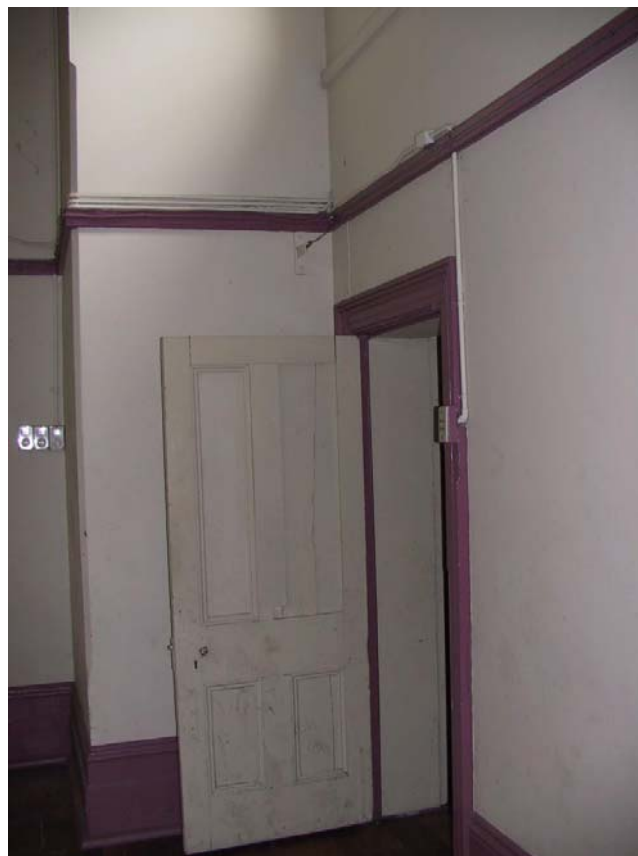
Figure No.38: The door from the Lodge room to the rear addition passage.

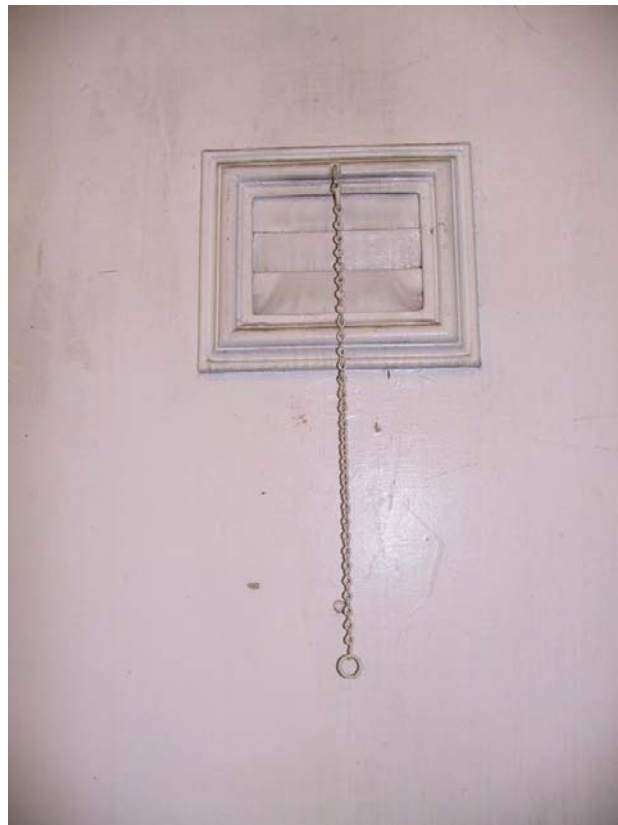
Figure No.40: Example of a typical vent in the Lodge room

3.1.6	Check metal air- vents and repair and replace where necessary TME ensuring that they are clear.
3.1.7	Check over all doors and door hardware and repair where necessary

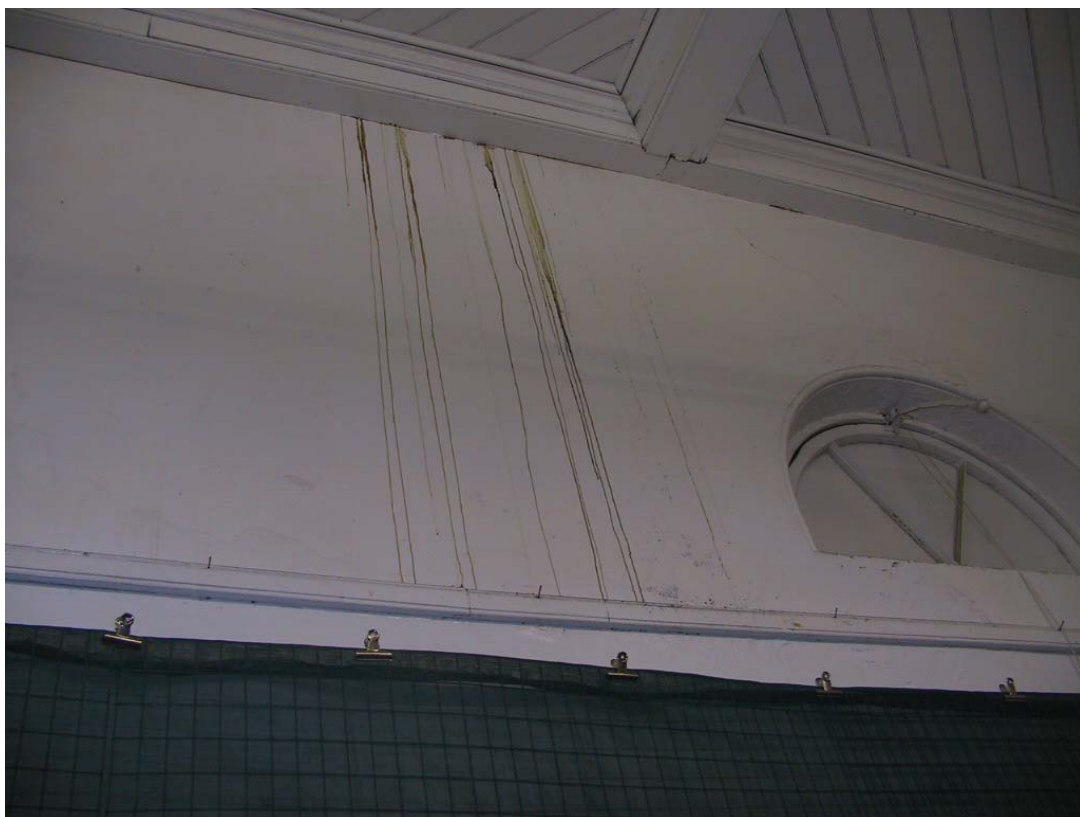
Figure No.41: Falling damp in the Lodge room

Water damage is evident in the subject building, caused by leaks, falling and rising damp as well as inadequate guttering. The interior of the building has been affected by damp, in particular along the north wall of the Lodge Room (S2).

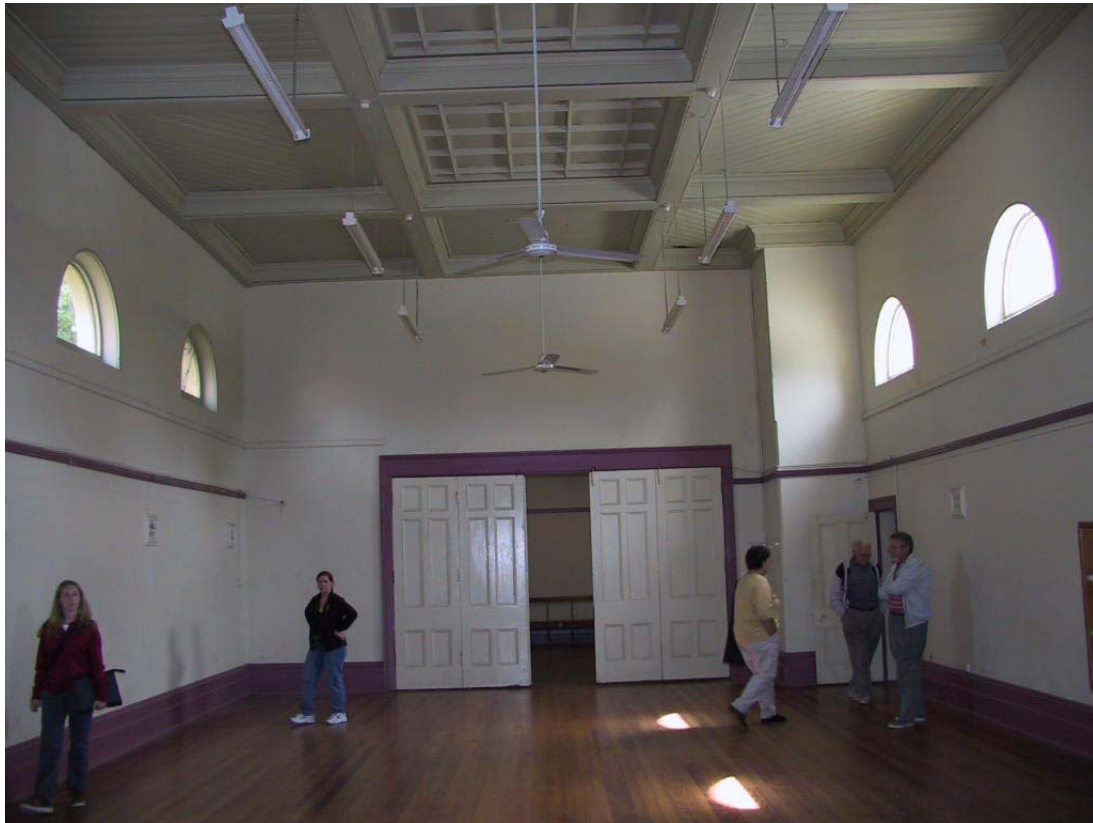
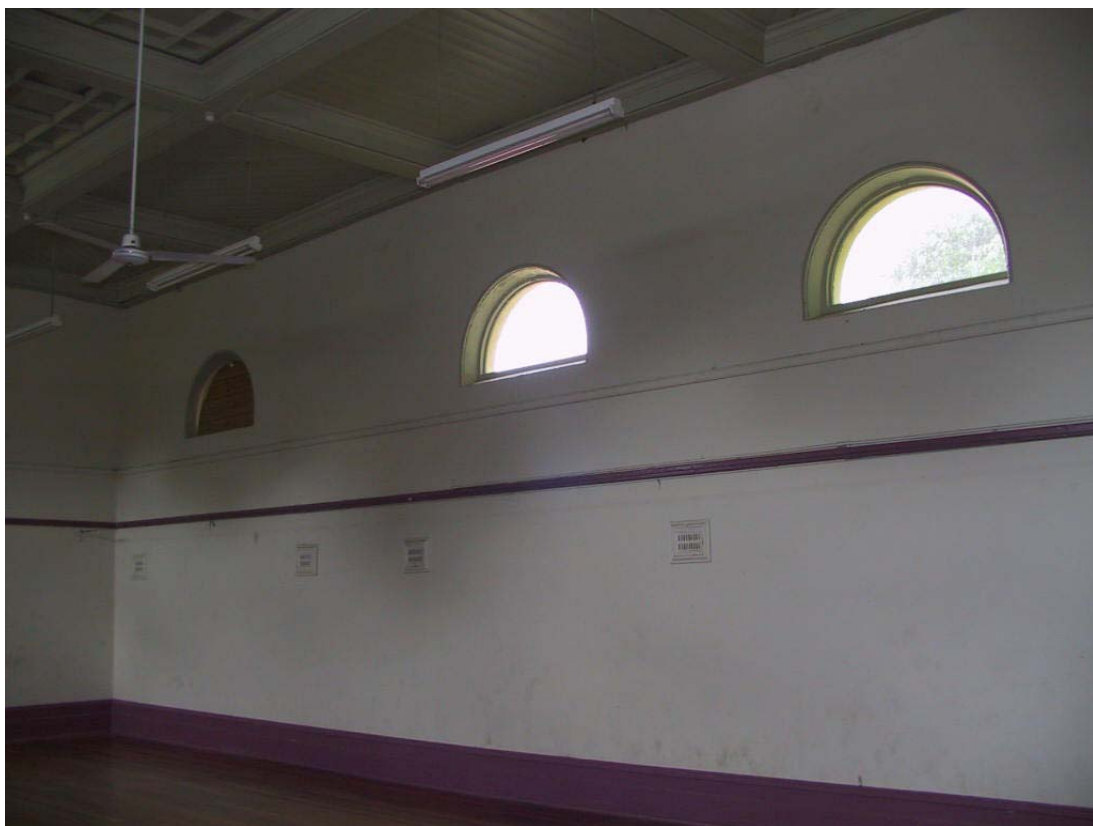
Figure No.43: The semi-circular windows in the Supper room. Note they are missing their glazing bars

The window highlights to the main rooms are semi circular in shape with leading dividing the windows into three equal sections. The windows open inwards and have been either painted over or broken and covered over or replaced with a single sheet of glass.

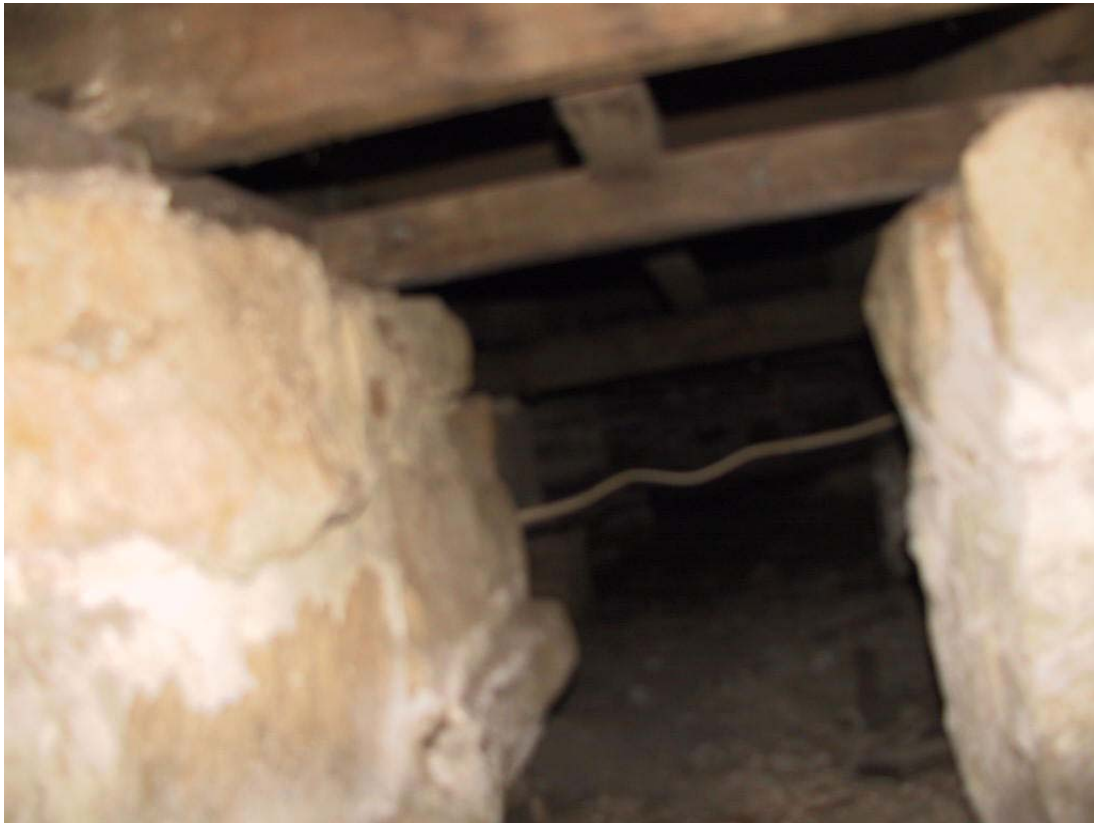
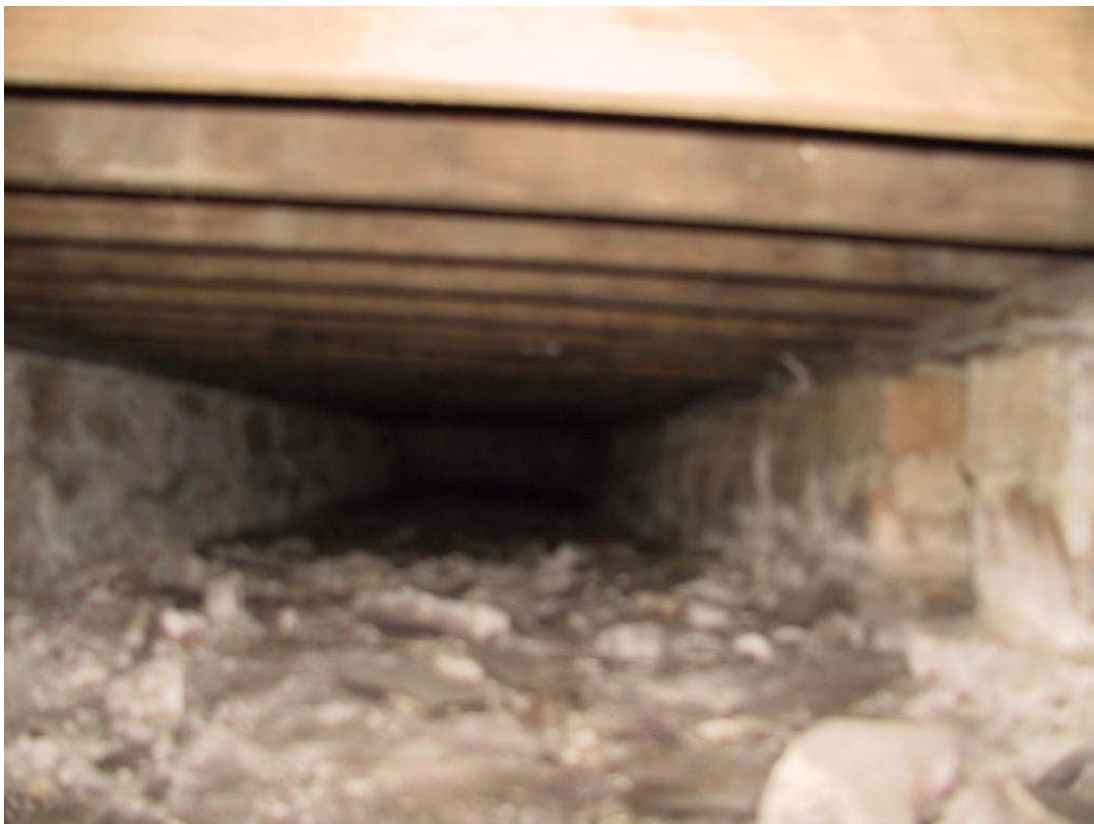
Figure No.44 & 45: The sub-floor area below the supper room

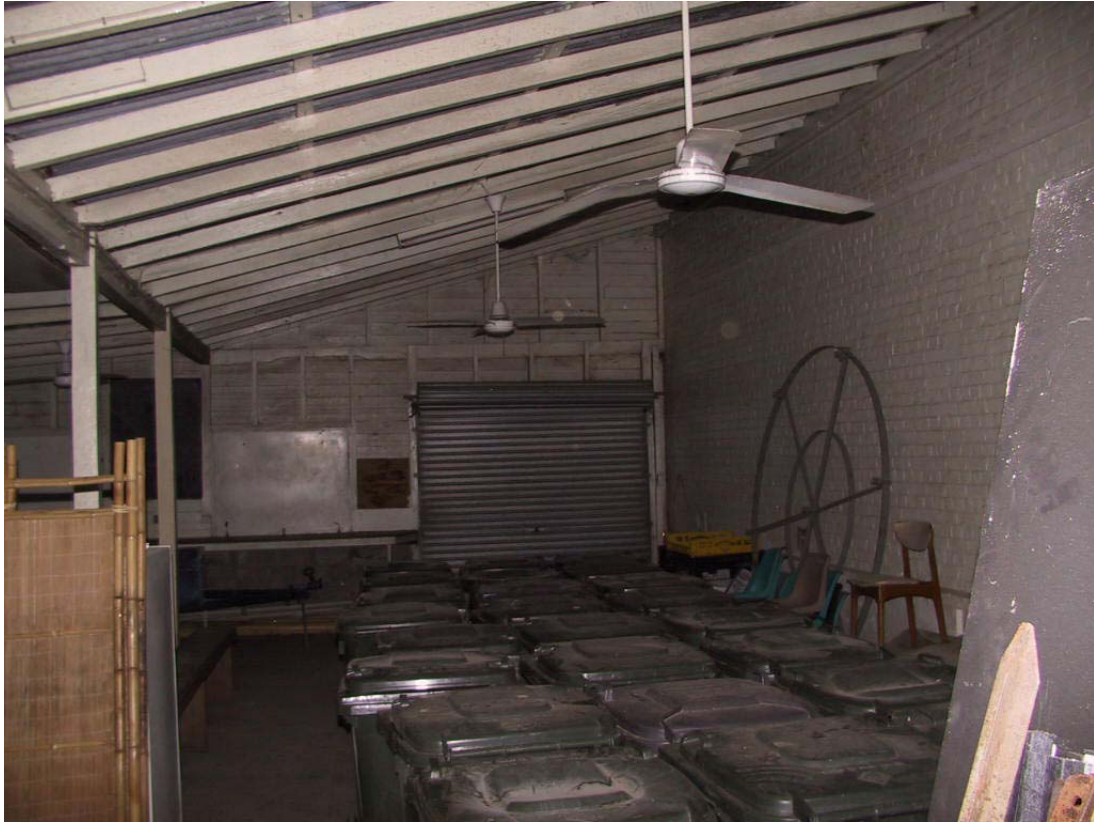
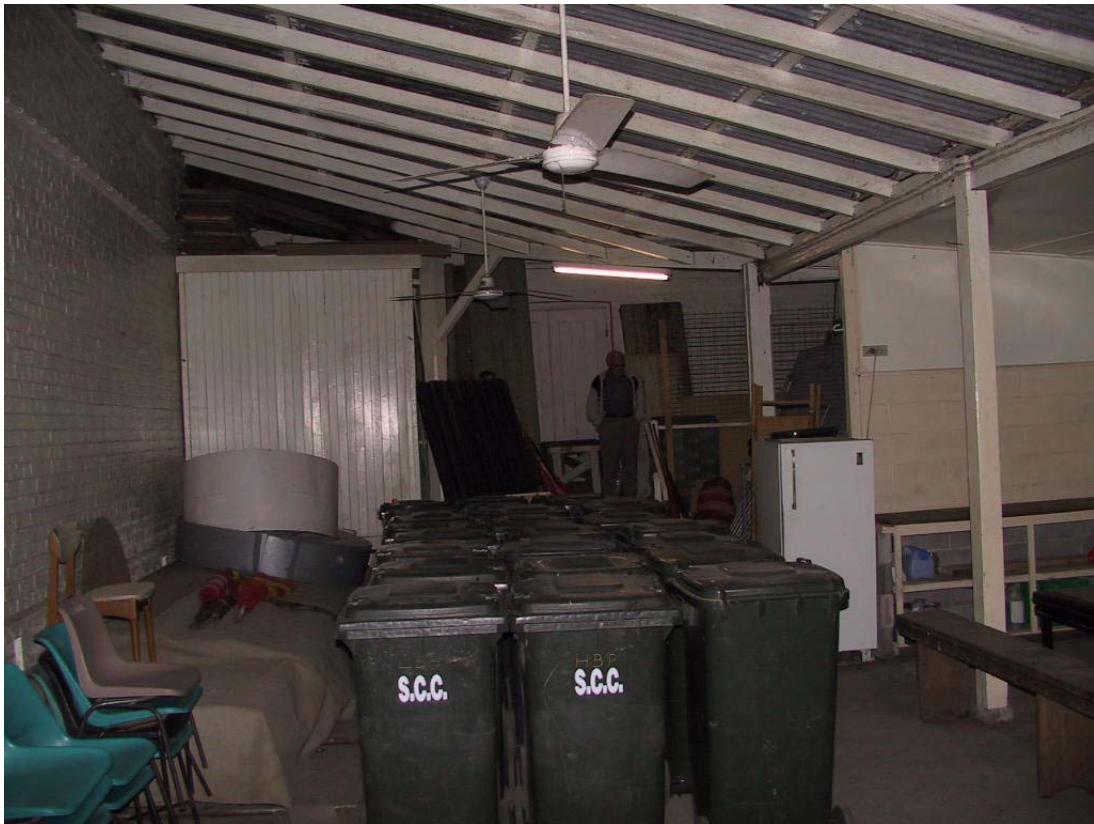
Figure No.46: The rear addition looking towards the west. Note the stored garbage bins.
Figure No.47: The rear addition looking towards the east and the Lodge 'tea room'.
