Berry Showground Agricultural Pavilion

Berry NSW

CONSERVATION MANAGEMENT PLAN

June 2002
REF: 0149: CMP

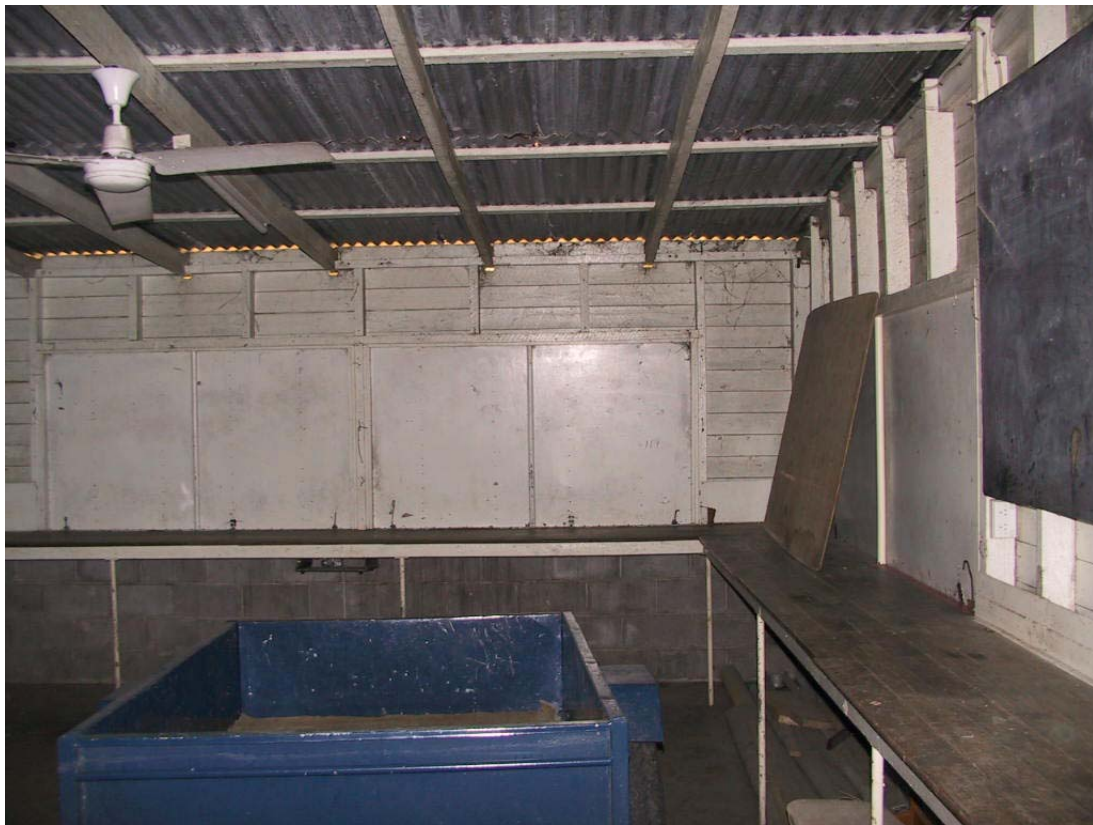
Figure No.48: The servery area of the rear addition.

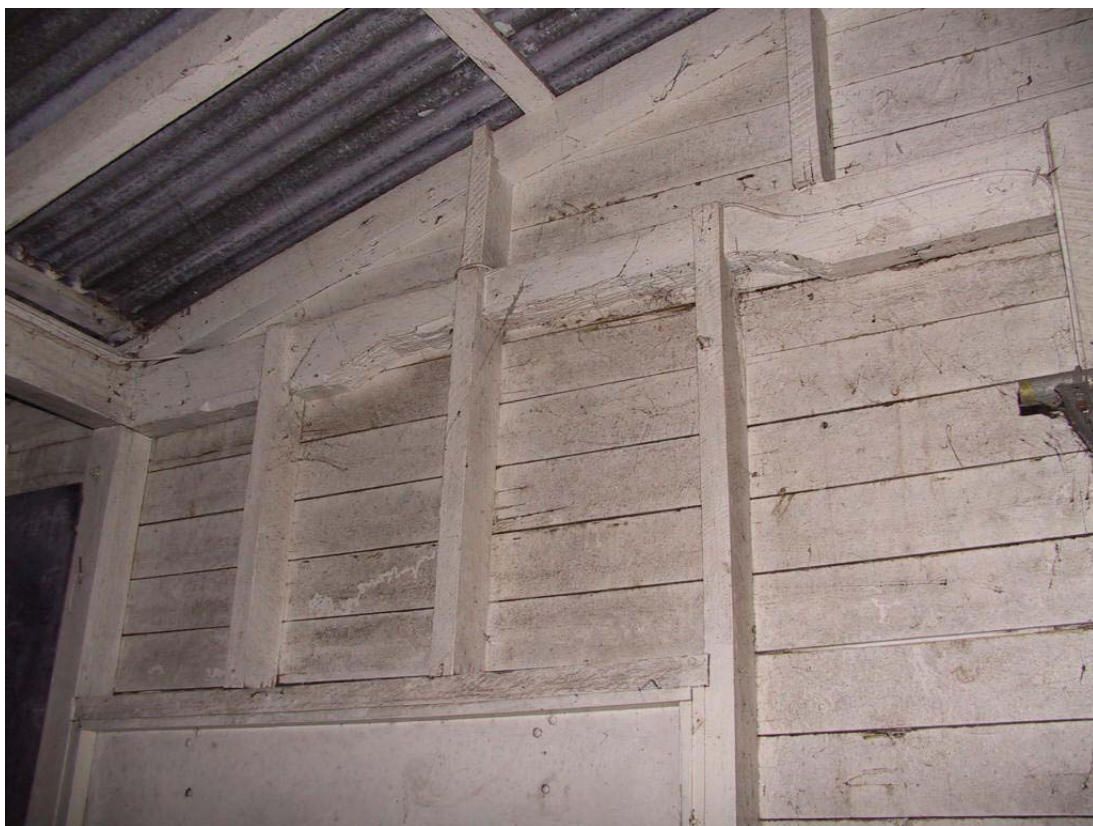
Figure No.49: Detail of the northern wall of the rear addition

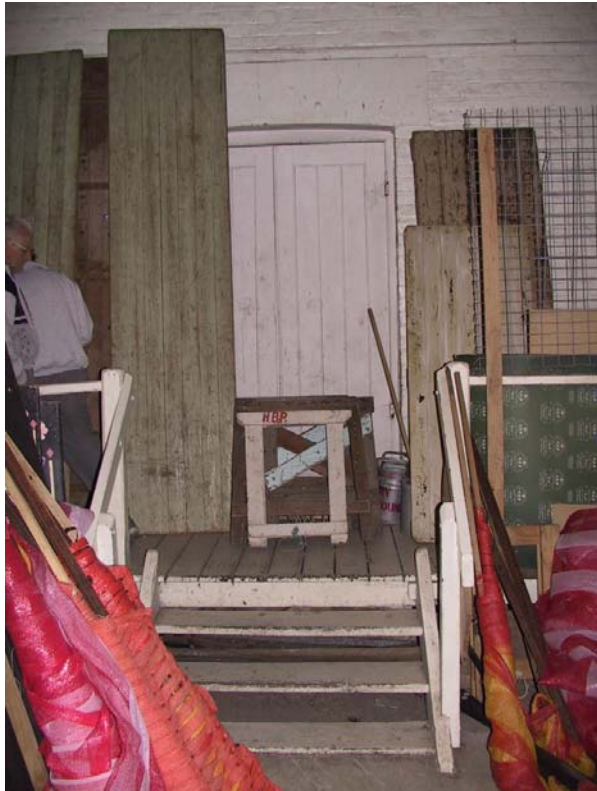
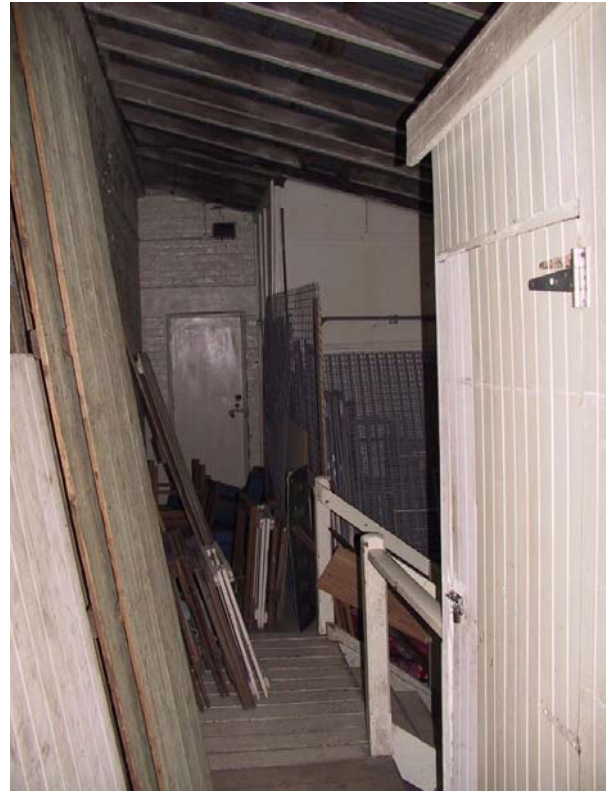
Figure No.50: The steps leading from the door (now closed over) leading to the Lodge room
Figure No.51: The view from the Lodge 'tea room' to the south

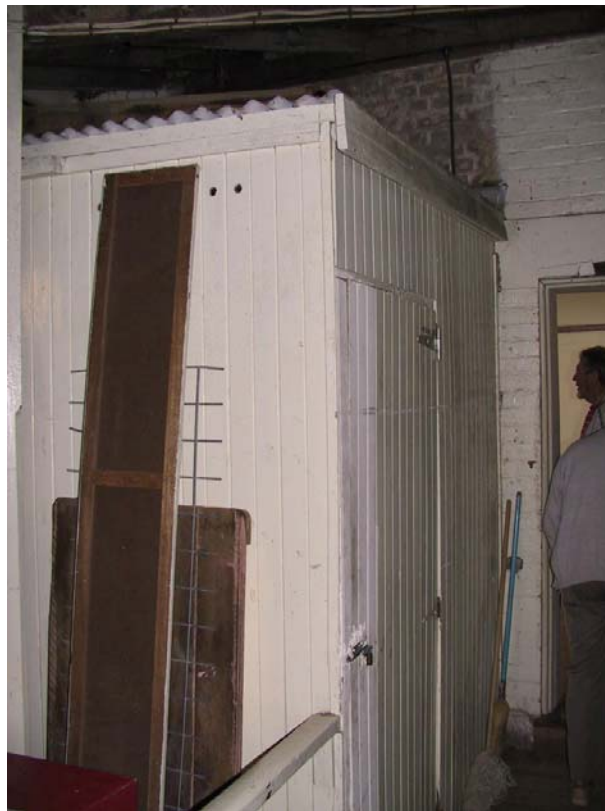
Figure No.53: The Lodge 'tea room'

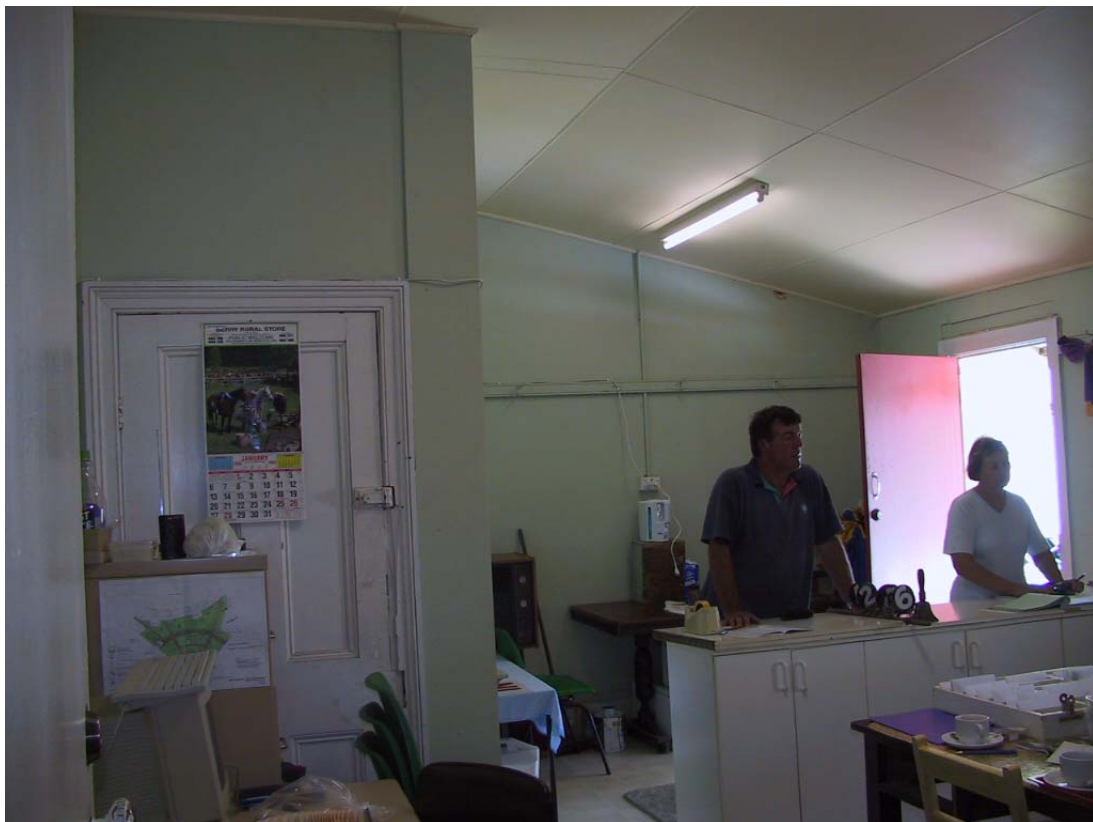
Figure No.54: The Secretaries Office, part of the rear addition

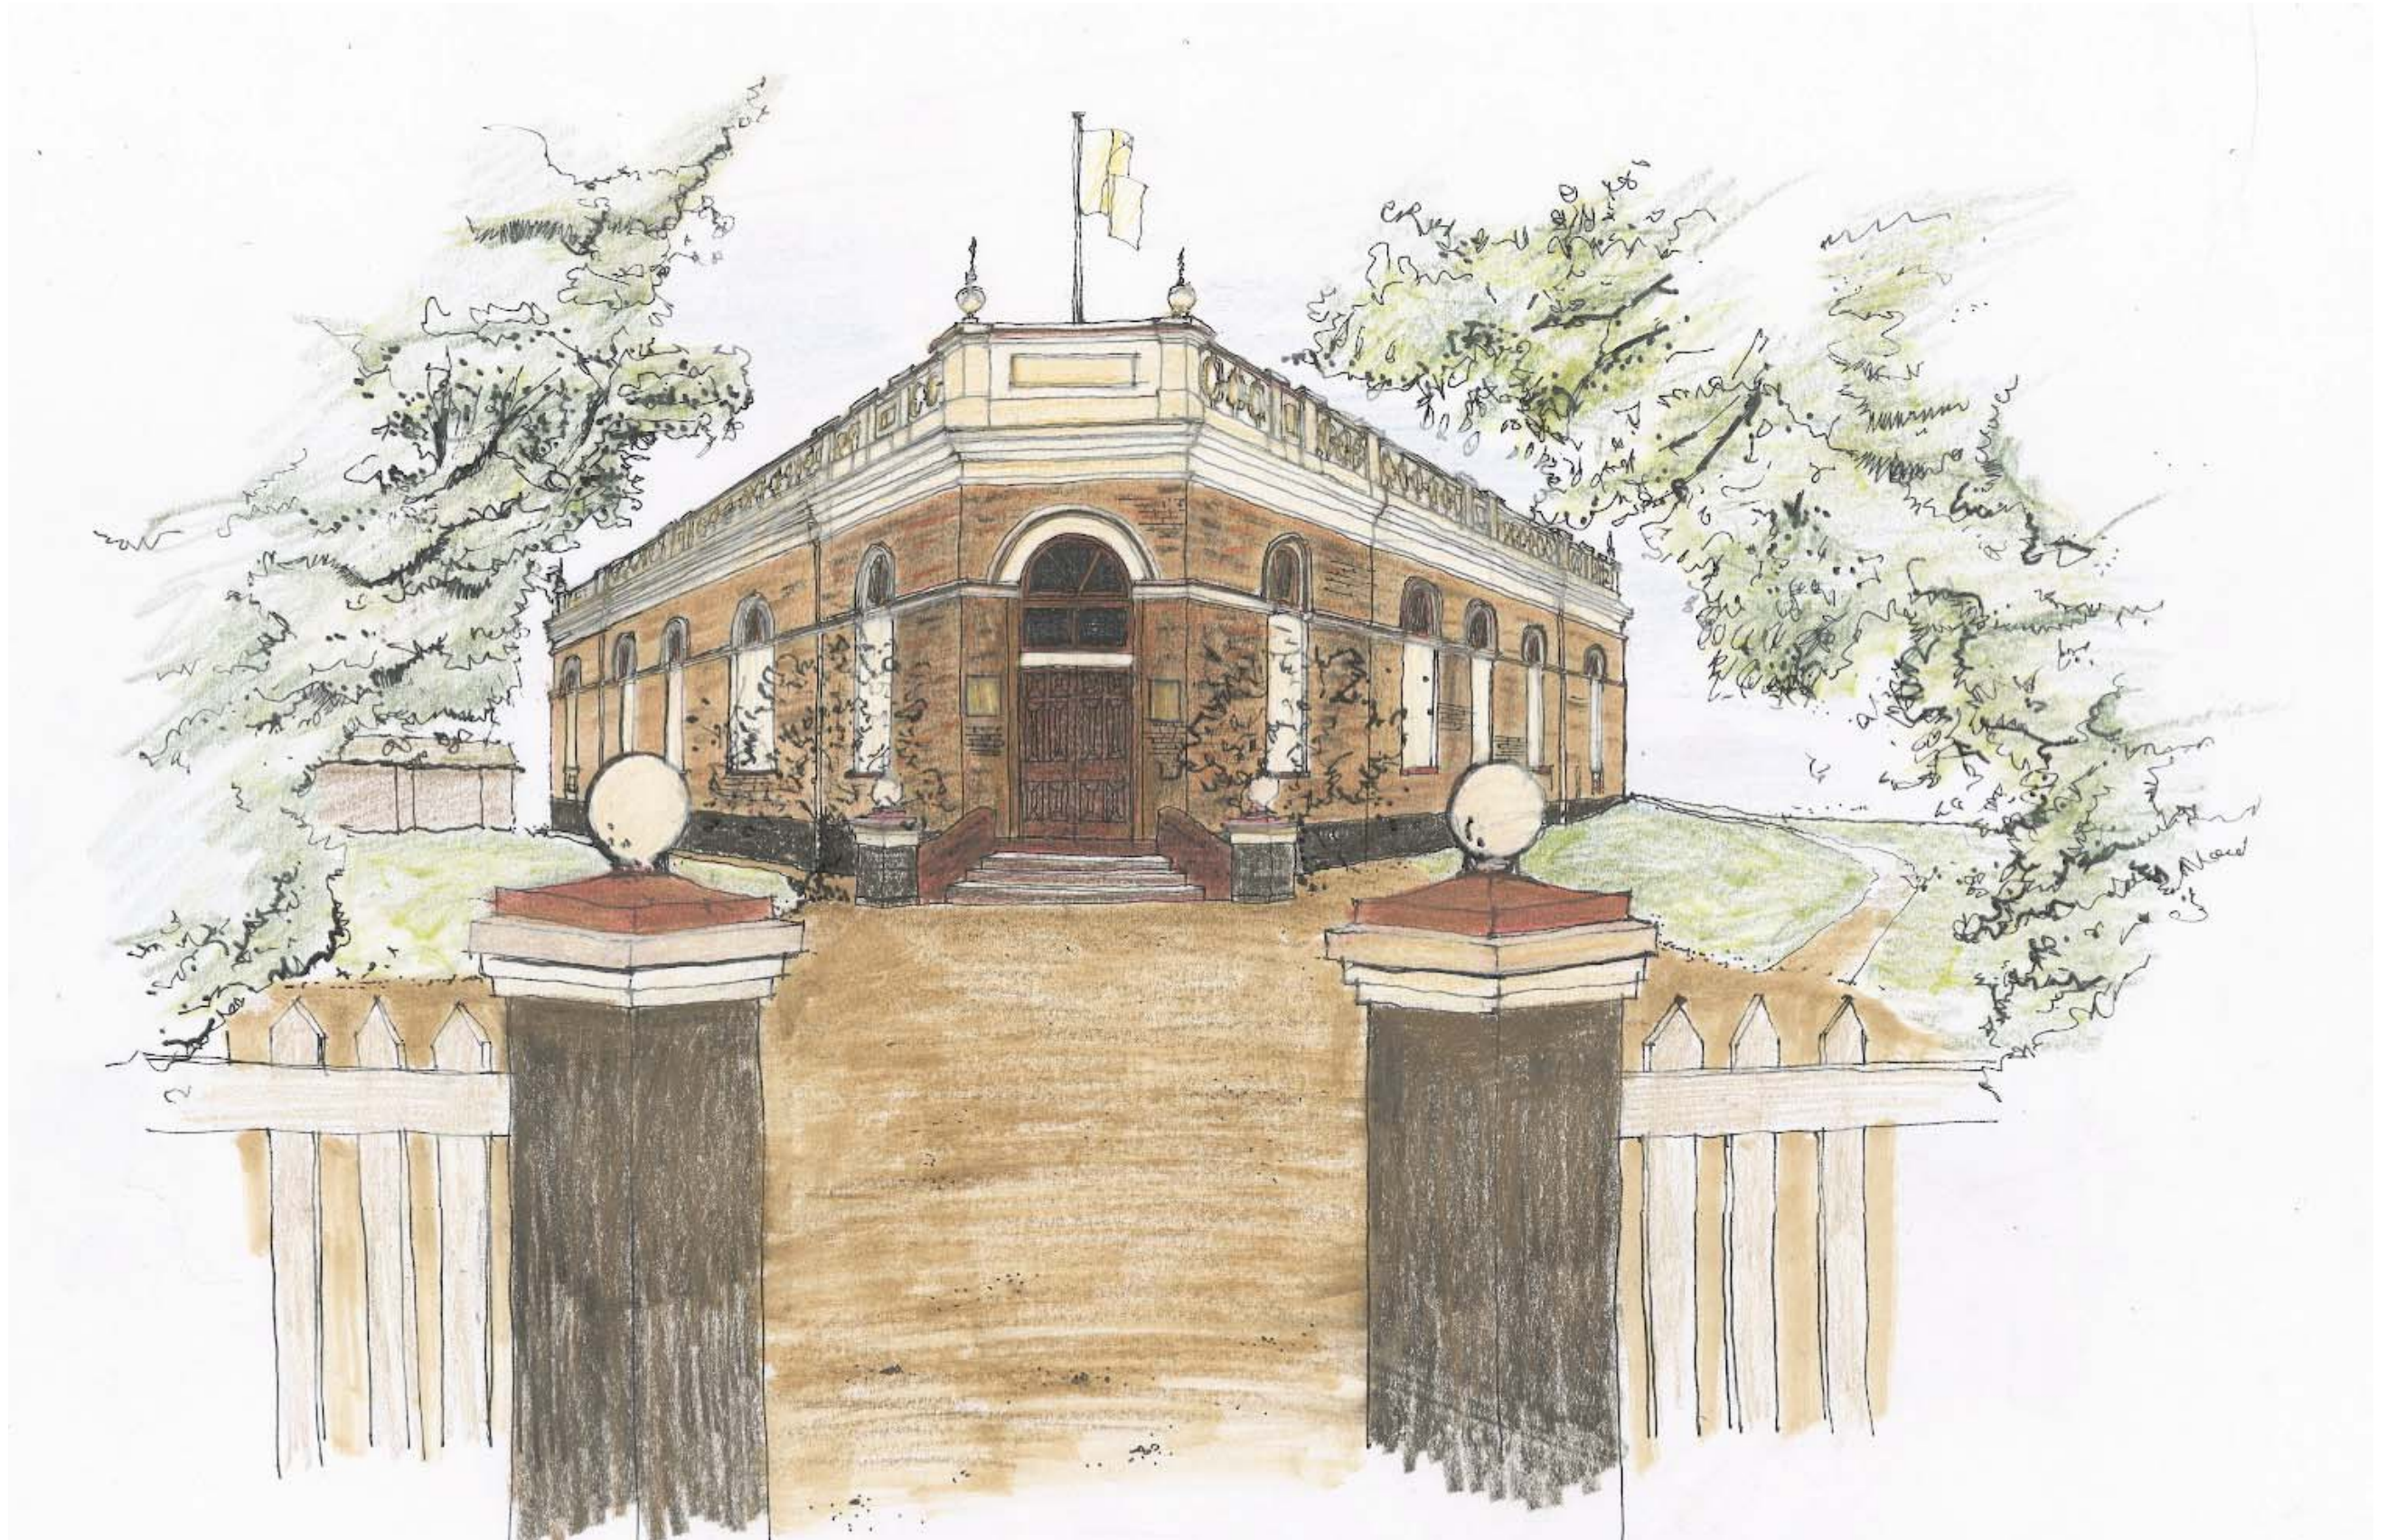
Figure CS1: Proposed Colour Scheme for the Berry Showground Agricultural Pavilion.

Element	Australian Standards Colour
Walls	
Masonry rendered plinth	Iron Bark X63 (2700)
Face brick wall	Do not paint
Masonry rendered inserts	Deep Stone Y55 (2700)
Masonry rendered insert sill	Maroon Y56 (2700)
Rendered Masonry Wall	Deep Stone Y55 (2700)
Rendered Window architrave	Maroon Y56 (2700)Merino Y56 (2700)
Wall Cornice	Maroon Y56 (2700)Merino Y56 (2700)
Parapet	
Rendered masonry cornice	Merino Y56 (2700), Deep Stone Y55 (2700)
Rendered masonry Pilasters	Merino Y56 (2700)
Rendered masonry capping	Merino Y56 (2700) Maroon Y56 (2700)
Rendered masonry circular infills	Merino Y56 (2700)), Mushroom pink R34 (2700)
Rendered masonry framed infills	Mushroom pink R34 (2700), Merino Y56 (2700)
Urns	Mushroom pink R34 (2700),
Rear Verandah	
Timber posts	Maroon Y56 (2700)
Timber weatherboards	Merino Y56 (2700)
Steps	
Concrete steps	unpainted
Rendered masonry rails	Maroon Y56 (2700)
Rendered masonry newels	Deep Stone Y55 (2700), Mushroom pink R34 (2700), Merino Y56 (2700) Maroon Y56 (2700)

Urns	Mushroom pink R34 (2700),
Doors	
Timber Door Architrave	Deep Indian Red R64 (2700)
Timber Door leaf	Deep Indian Red R64 (2700)
Windows	
Timber Window body	Deep Indian Red R64 (2700)
Timber Window Sash	Deep Indian Red R64 (2700)
Timber Window sill and frames	Deep Indian Red R64 (2700)
Timber window sill of front highlight window	Maroon Y56 (2700)
Roof	
Corrugated iron Roof Sheeting	Unpainted
Metal Guttering	Maroon Y56 (2700)
Metal Downpipes	Maroon Y56 (2700)
