Currarong Creek

Entrance Management Plan

SCC File No. 12406

adopted July 2007

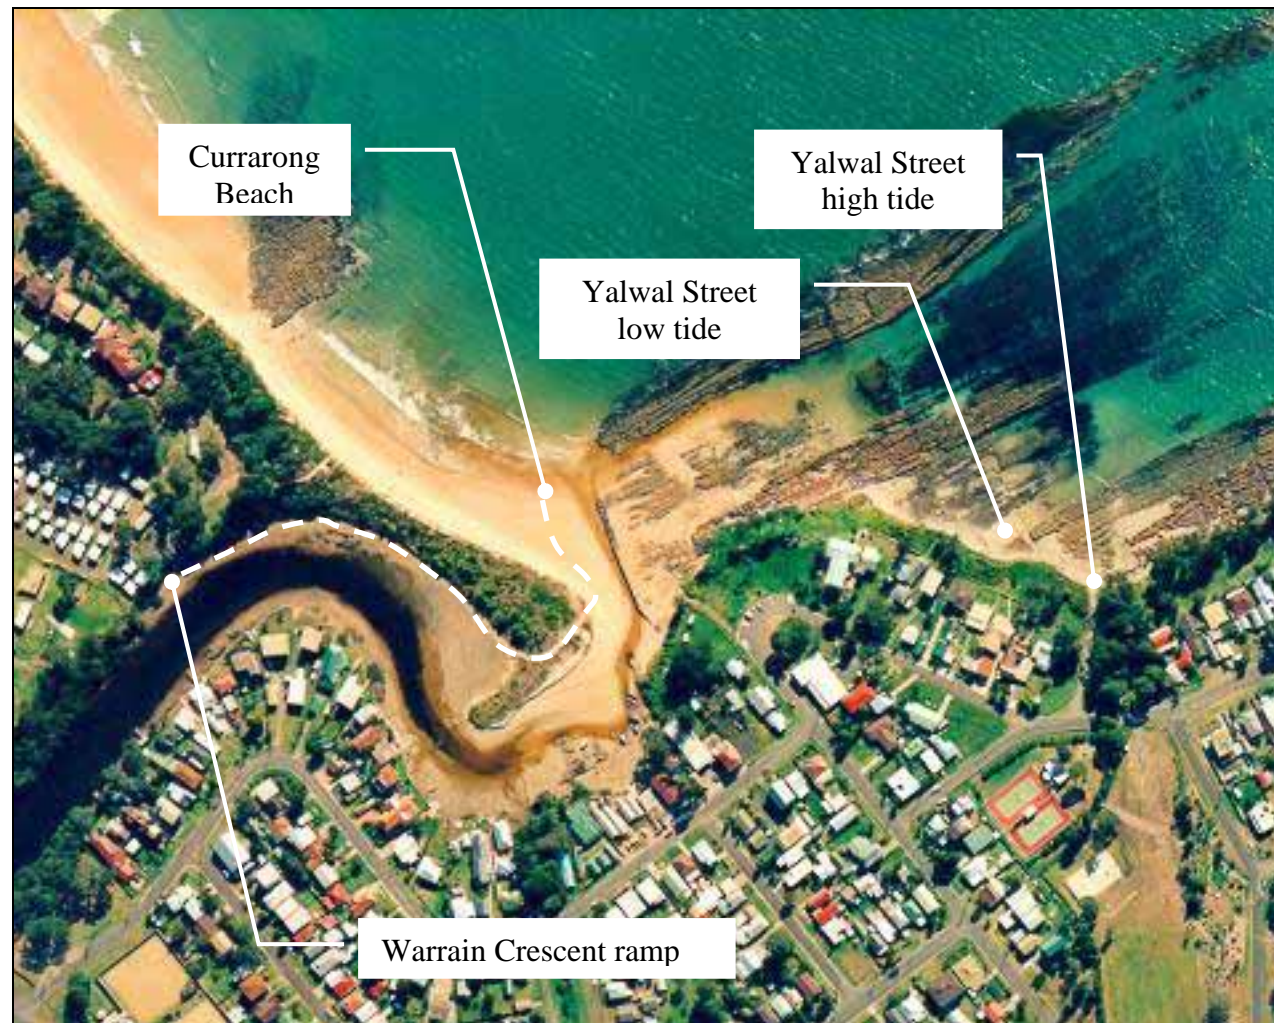
Figure 12. Existing boat launching areas at Currarong. The dashed white line shows the route by which people drive to and from the beach launching site.

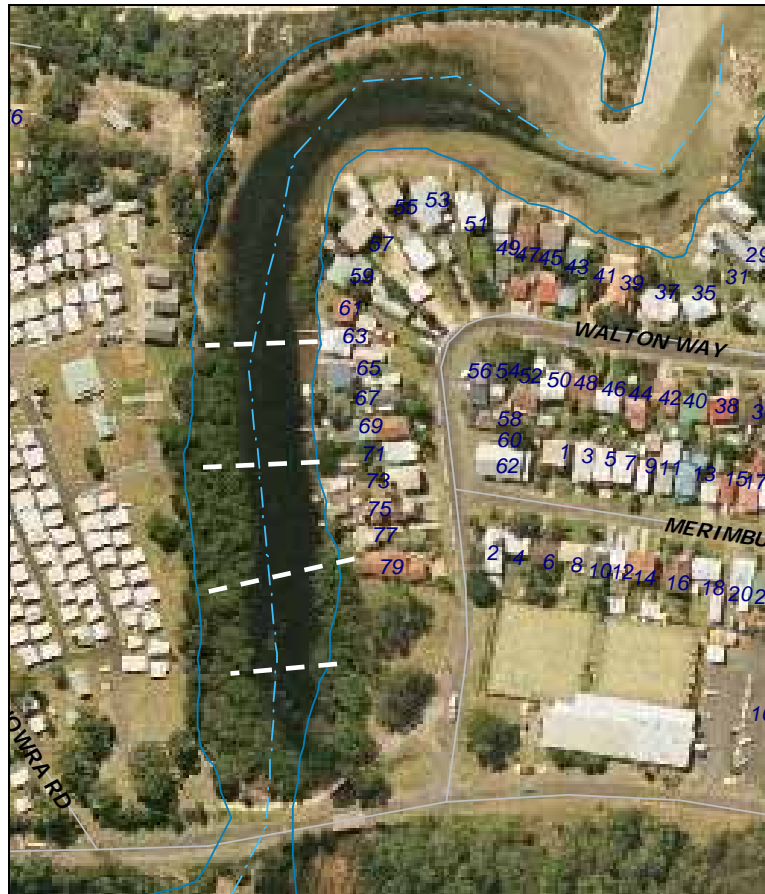
Figure 13. Cross-sections locations (dashed white lines) surveyed in 1978 were at approximately 50 metre intervals adjacent to house numbers 63, 71 and 79 and the public reserve near the bridge.

From Table 3, Mean Low Water in 1996 was approximately 0.14 below AHD. If that was the water level in 1978 then there would have been about 160 millimetres water depth, on average, at low tide. (Note, though, that the actual water level at low tide varies greatly from time to time - see Section 3.3).
