## Report

# HUSKISSON ANGLICAN CHURCH – GPR INVESTIGATION

Date: 1 October 2019  
Job Number: GBGA2304  
Author: Benjamin Wilkins  
Reviewed: Jamie Speer

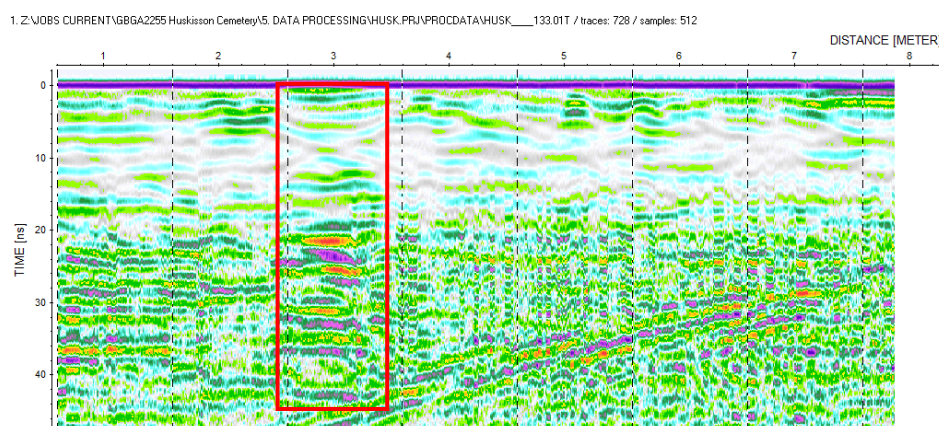
A radargram profile is built up of scans collected along a selected line path. A sample radargram has been selected from the data and is shown in Figure 2 below. Each profile consists of an enhanced radargram that provides subsurface information based on the variations in the dielectric constants (the electrical conductivity and resistivity) of materials. The recorded reflections can be analysed in terms of shape, travel time, signal amplitude and phase to provide information about a target's size, depth and orientation in relation to the material around it.

Figure 2: Sample radargram showing a suspected grave from a previous survey.

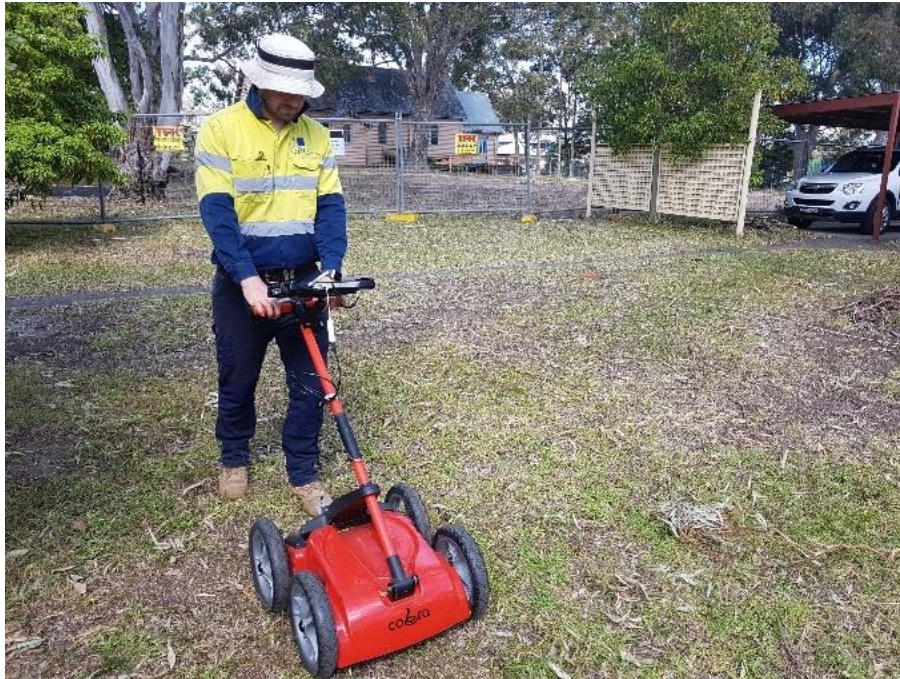
The data for this investigation was acquired using a Cobra GPR data acquisition system with a Dual Frequency antenna. Chainages along the profile line are logged by an odometer, which tracks the chainage and ensures scans per trace are evenly distributed along a profile. Data was acquired using 500MHz and 900MHz simultaneously, providing both high resolution at the near surface and significant depth to approximately 3.5m below ground level. The survey equipment is shown in Figure 3 below.

*Figure 3: A section of the survey area with scan in progress. Tapes were used to ensure correct line separations and directions were achieved.*

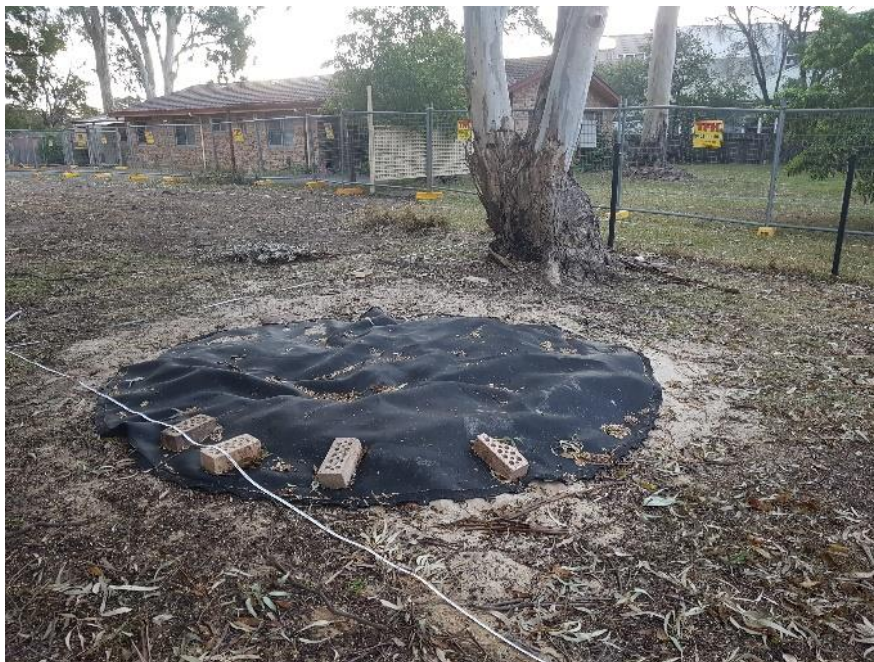
*Figure 4: An example of obstacles impeding data acquisition during a transect recording.*

The GPR data was collected as a series of parallel longitudinal profiles in an approximate north-south direction perpendicular to the expected east-west orientation of the graves. Some sections along the profile lines were not scanned due to the presence of obstacles such as trees and fences. There were also areas of disturbed ground that interfered with the results such as the sand pit as illustrated in Figure 4 above. The extent of the survey area, and profile locations are shown in drawing file
