Berrara Creek Water Quality and Estuary Health Study

Shoalhaven City Council

9 June 2023

PROJECT 311015-00158 -ENV-REP – 002: Berrara Creek Water Quality and Estuary Health Study

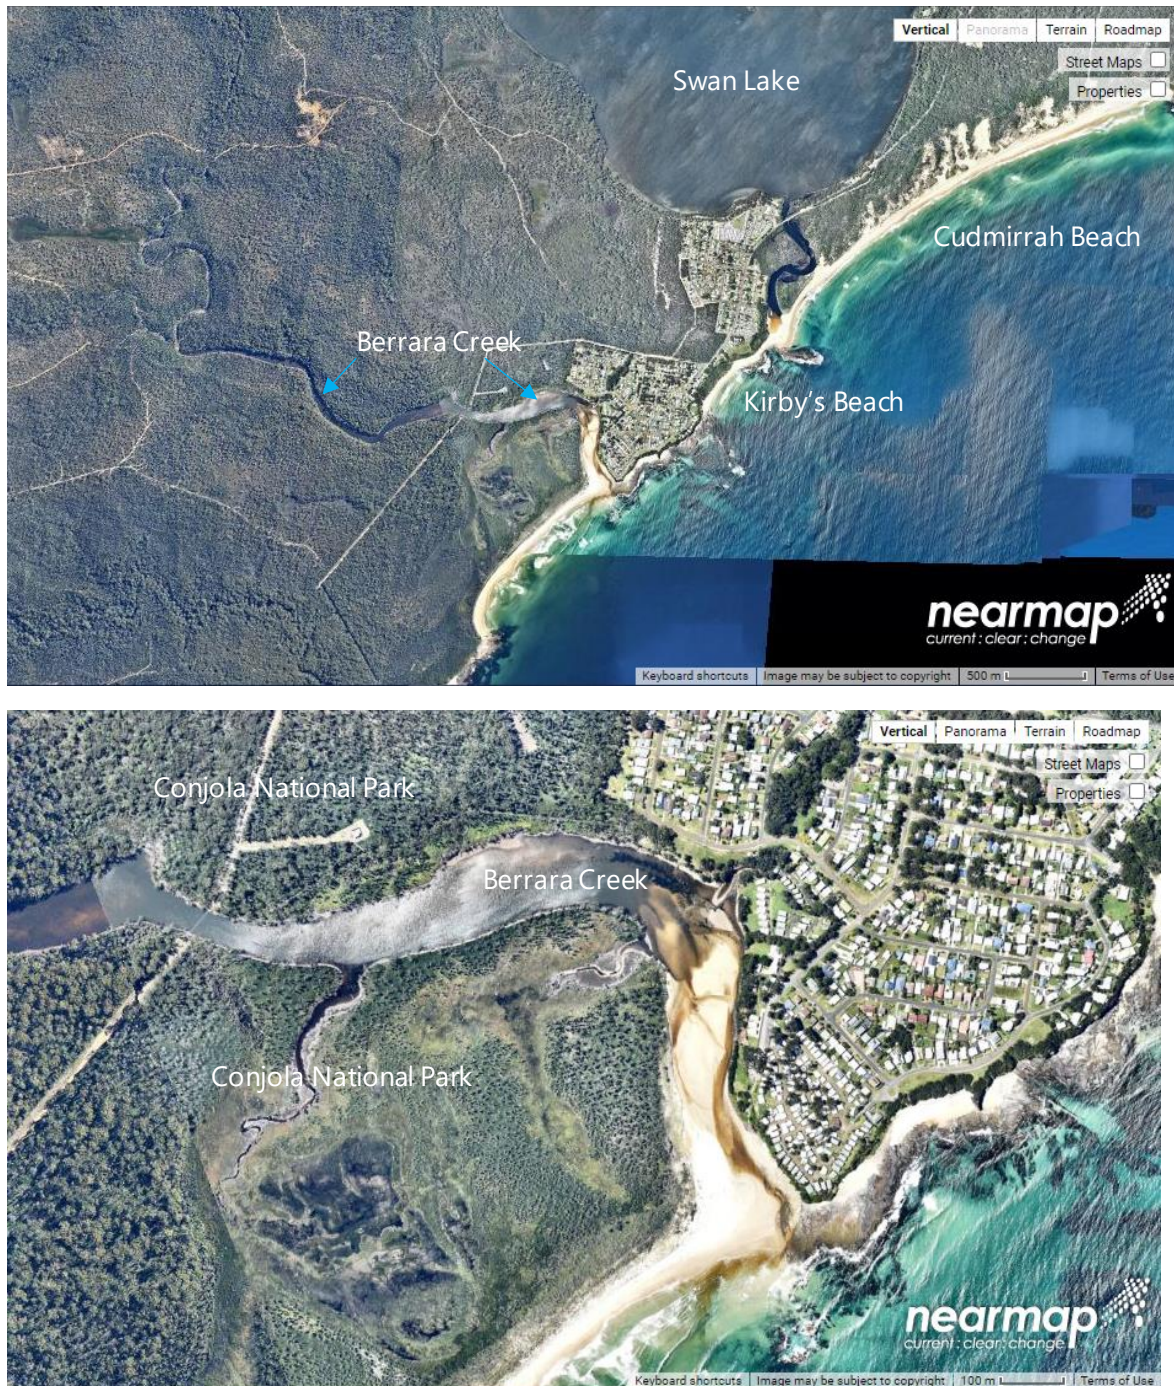
Figure 1-1 Location of Berrara Creek (top) and entrance area to Berrara Creek (bottom) in December 2021 (Nearmap 2022).

Berrara Creek is located 2 kilometres (km) south of Swan Lake on the New South Wales (NSW) south coast (Figure 1-1). It has an estuary volume of 131.7 ML, estuary area of 0.3 km², average depth of 0.5 m and a catchment area of 35 km² (DP&E 2022a). It is an Intermittently Closed and Open Lake and Lagoon (ICOLL) with a predominantly open entrance, with the entrance having been observed to be closed occasionally (**Appendix A**). A conceptual model of an ICOLL, including key zones, is provided in Figure 1-2. The lower 3 km of Berrara Creek normally behaves as a tidal estuary, however, the mouth of the estuary does occasionally close to the sea (see the almost closed entrance area in December 2021 in Figure 1-3 and images in Figure 1-4). Information on known openings is only available prior to 2001 with additional information known about an artificial opening by the public mid-February 2020 following the bushfires and the associated first flush flood event that followed. The details of these openings are provided in **Appendix A**. The behaviour of the entrance affects the estuaries characteristics such as its estuarine ecosystem, water quality, flooding patterns and aesthetics. Despite its name, Berrara Creek is officially classified as a lagoon for the purposes of water quality and estuary health assessments against guideline trigger values (DPIE 2016).

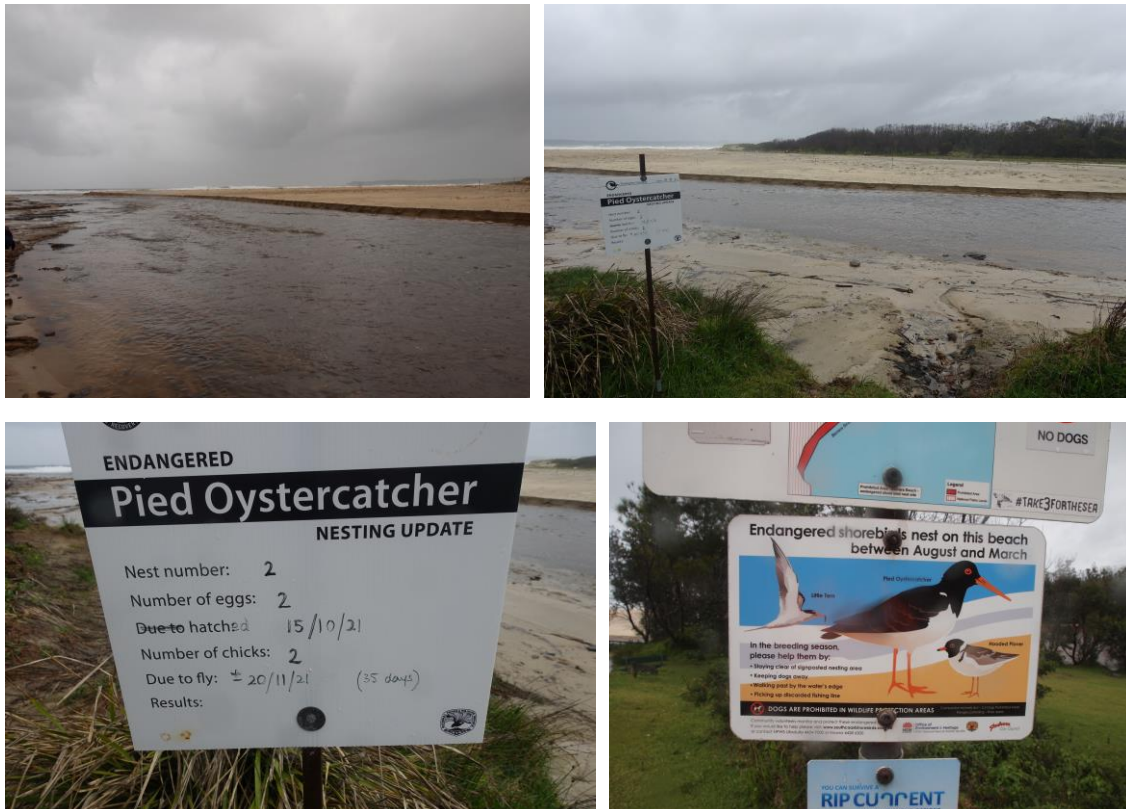
Figure 1-3 Images of the Berrara Creek entrance area (showing the endangered pied oystercatcher nesting area) in November 2021 (Advisian).

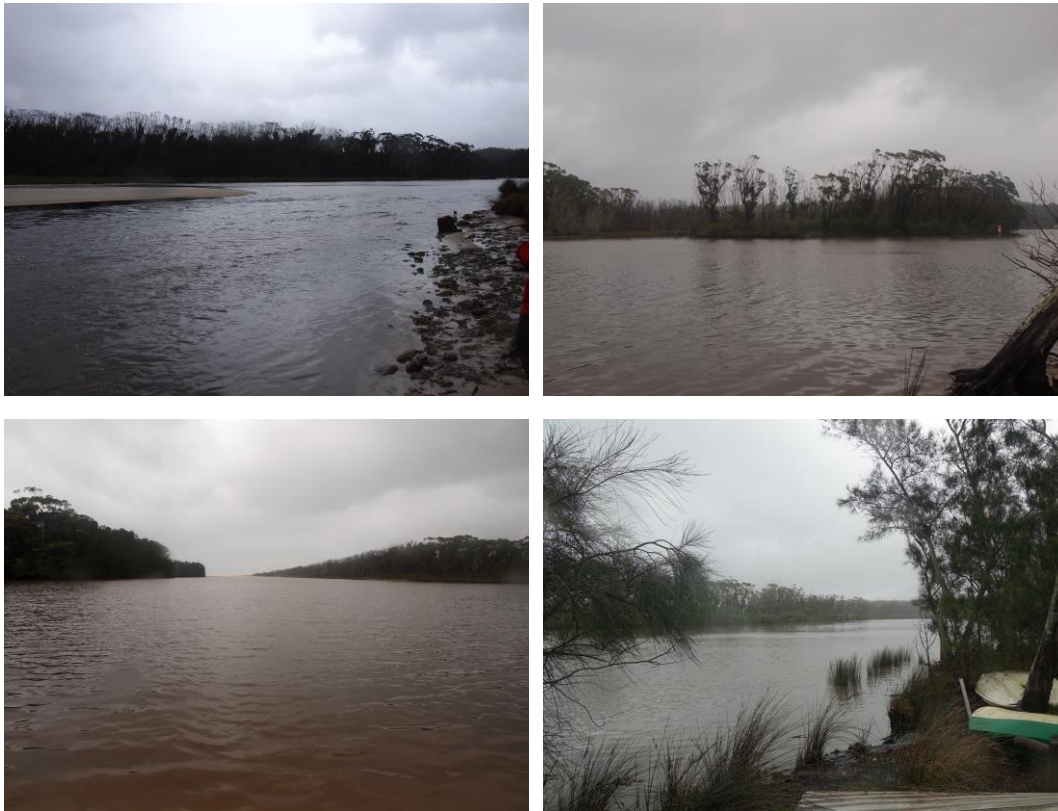
Figure 1-4 Images of greater Berrara Creek in November 2021 (Advisian).

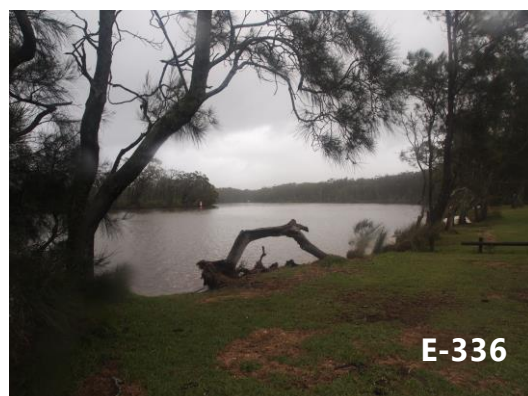
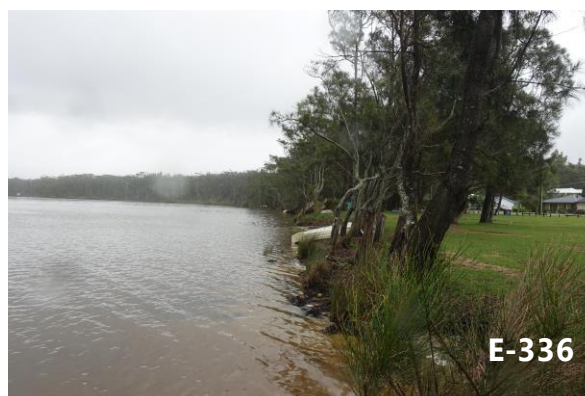
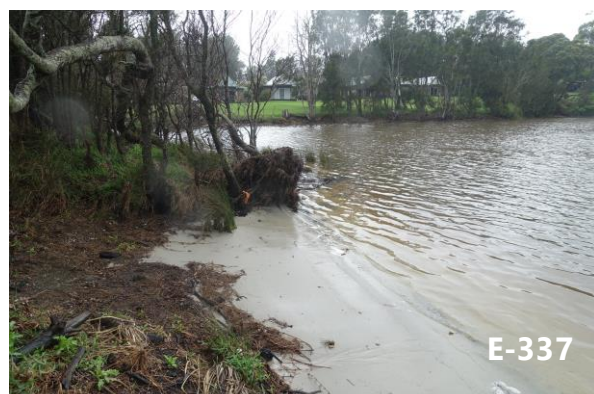
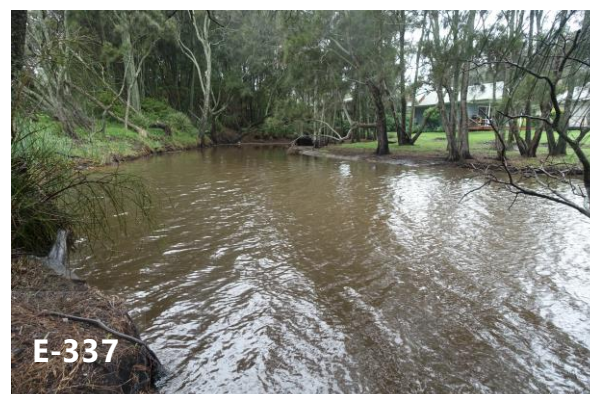
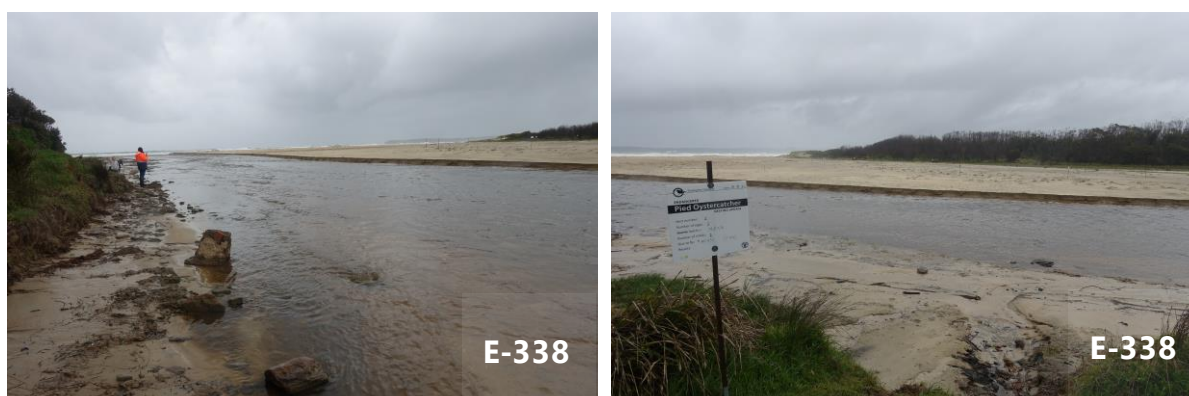
Figure 3-2 Images of Berrara Creek water quality monitoring locations E-336 (top), E-337 (middle) and E-338 (bottom) in November 2021 (Advisian 2021).

The location of monitoring sites included in the review for Berrara Creek are shown in Figure 3-1. Images of sites E-336, E-337 and E-338 (at the entrance to the lagoon from the ocean) are provided in Figure 3-2.

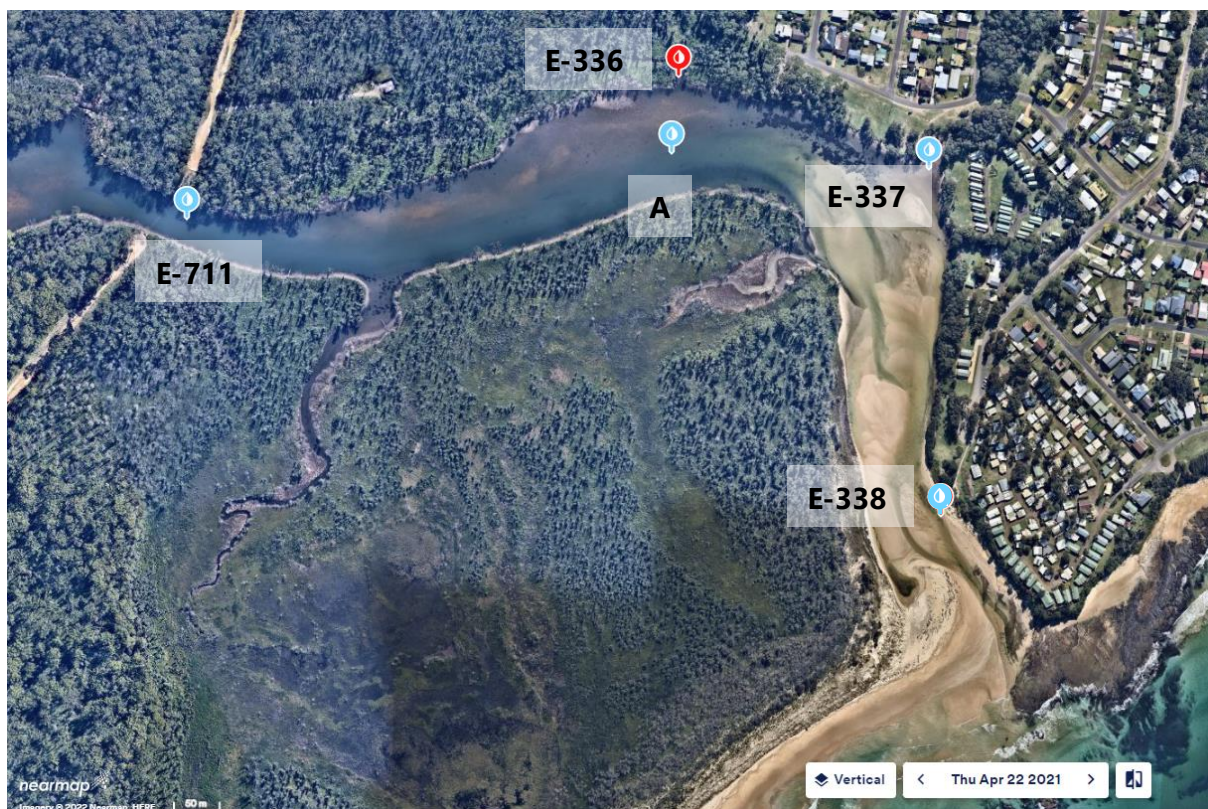
Figure 7-1 Recommended monitoring sites for ongoing water quality sampling. Blue = recommended for inclusion; red = recommended for exclusion. Note: site A is from the DP&E estuary health program.

Recommended monitoring sites for inclusion in future sampling is shown in Figure 7-1 and a summary of the recommended program is provided in Table 7-2.

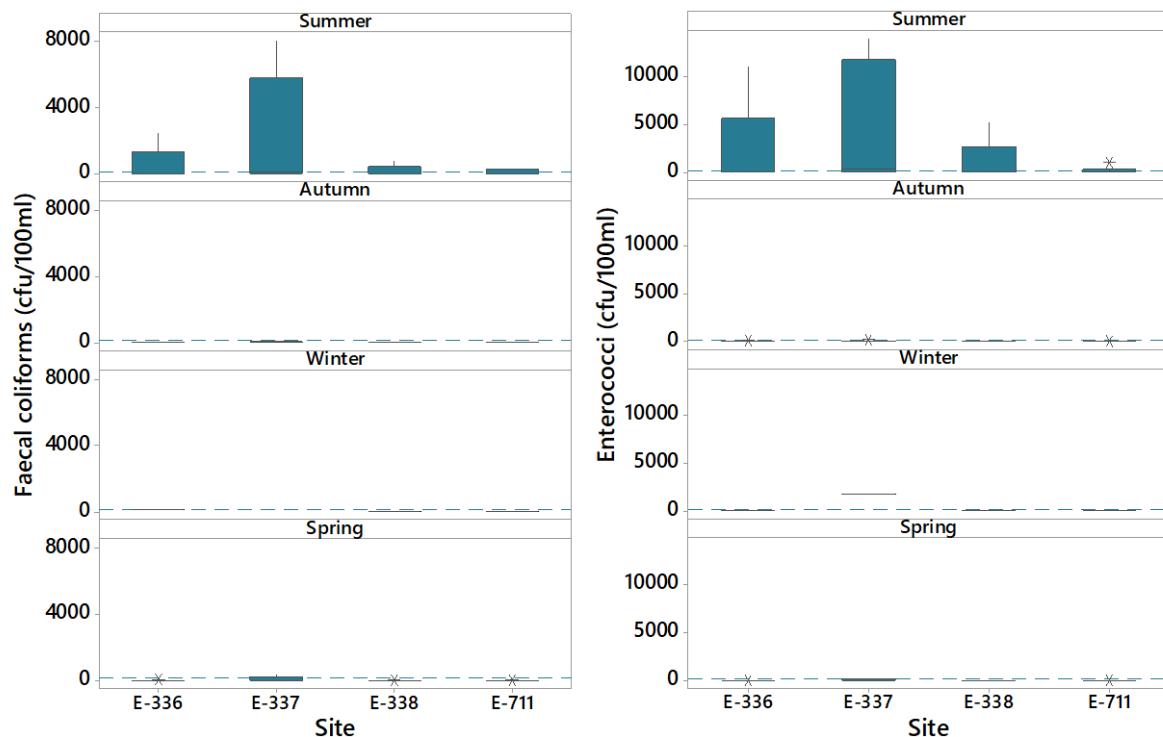
Figure 8-3 Faecal coliforms (cfu/100ml) and enterococci (cfu/100ml) by season in Berrara Creek from January 2010 - October 2021. The dotted line on the graphs shows the NHMRC (2008) Primary Recreational Guidelines, for comparison to median faecal coliform values and 95%ile enterococci values at recreational sites.
