PROJECT PROGRESS VALUE ASSESSMENT

Review of records and substantive progress and assessment against a contemporaneous first principles cost estimate

West Nowra Bioelektra resource recovery facility – Shoalhaven City Council

August 2023

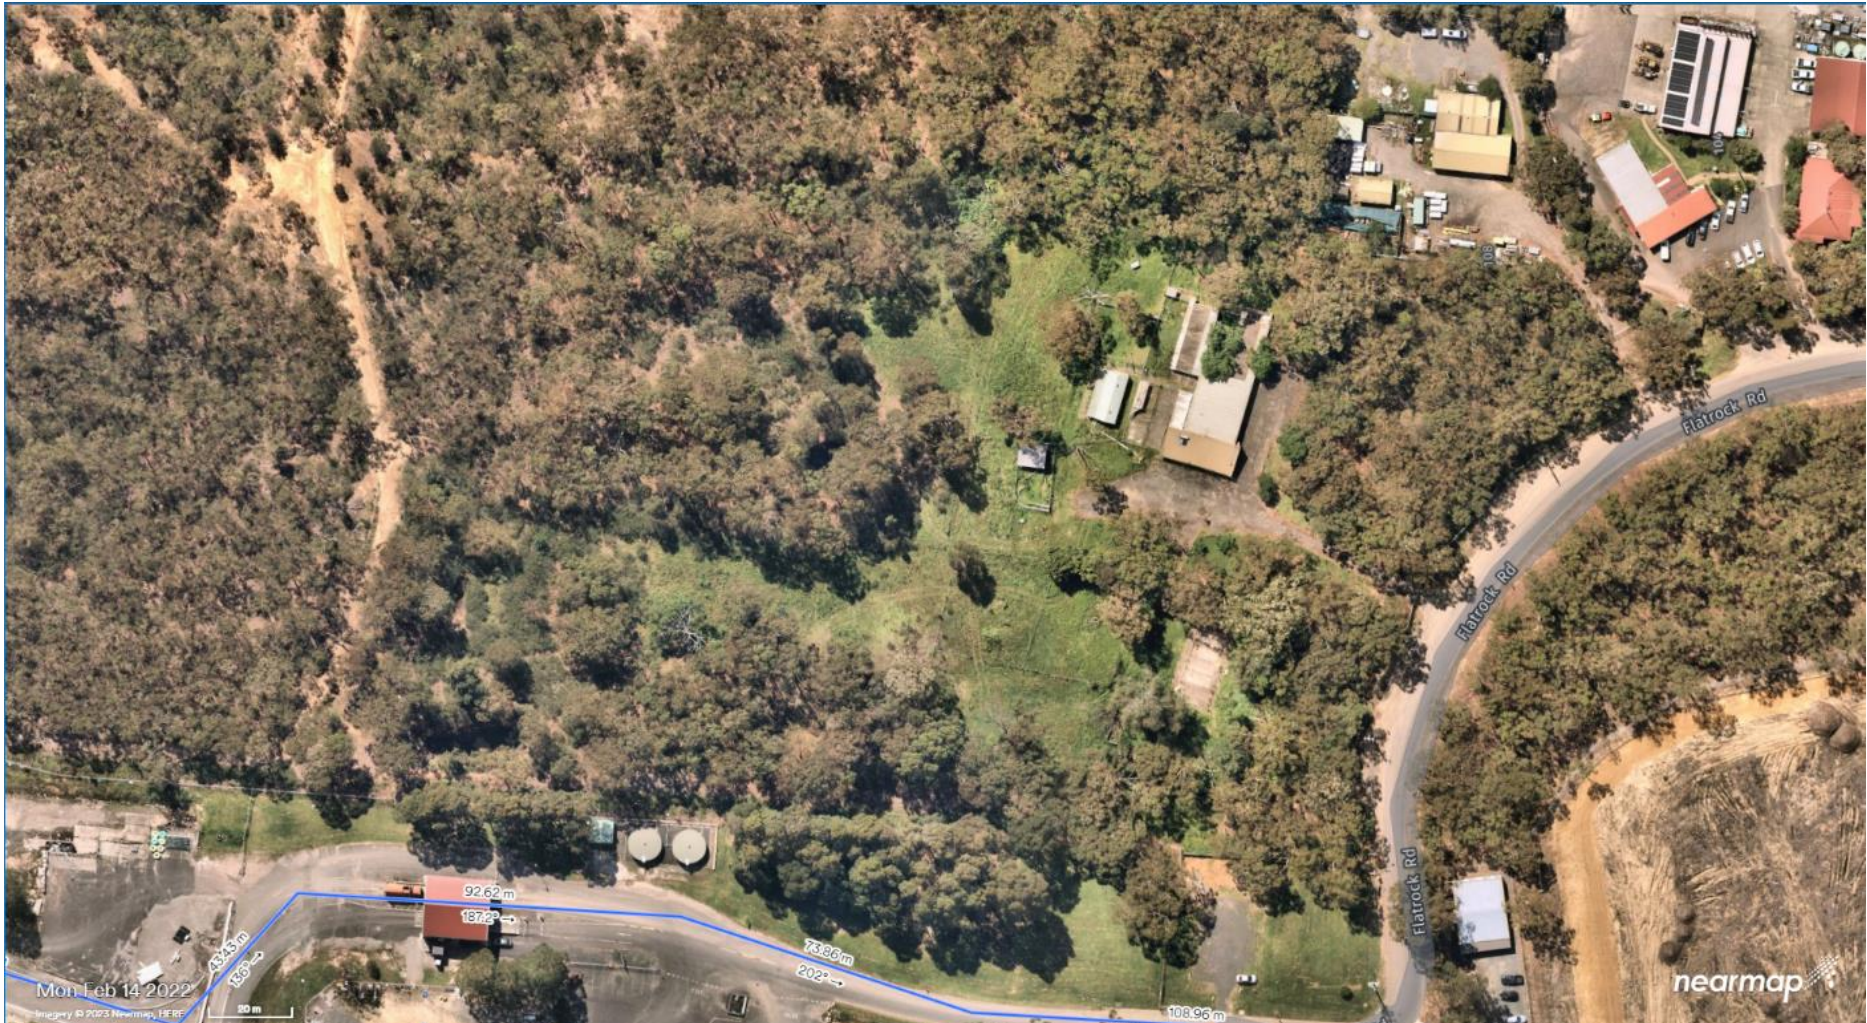
Figure 2, Aerial image of site - 14/02/2022

Date	Phase	Completed works	Construction activities
02/02/2023	Pre-construction	Nil	Nil
24/06/2022	Construction	<ul style="list-style-type: none"> ▪ Site establishment – evidence of site sheds, mobilisation of equipment etc. ▪ Erosion and sediment control – evidence of sediment fence installation. 	<ul style="list-style-type: none"> ▪ Clearing and grubbing. ▪ Demolition – ancillary structures being demolished.
30/07/2022	Construction	<ul style="list-style-type: none"> ▪ Erosion and sediment control – stabilised site access. ▪ Demolition – all structures demolished. ▪ Clearing and grubbing – all vegetation has been cleared. ▪ Topsoil stripping. ▪ Stockpiling of material. The image shows five material stockpiles. The north-western stockpile is coloured a darker black/brown than the other stockpiles. Further discussion on material stockpiles is provided below. 	Earthworks cut/fill and importation of fill appear to have recently commenced.

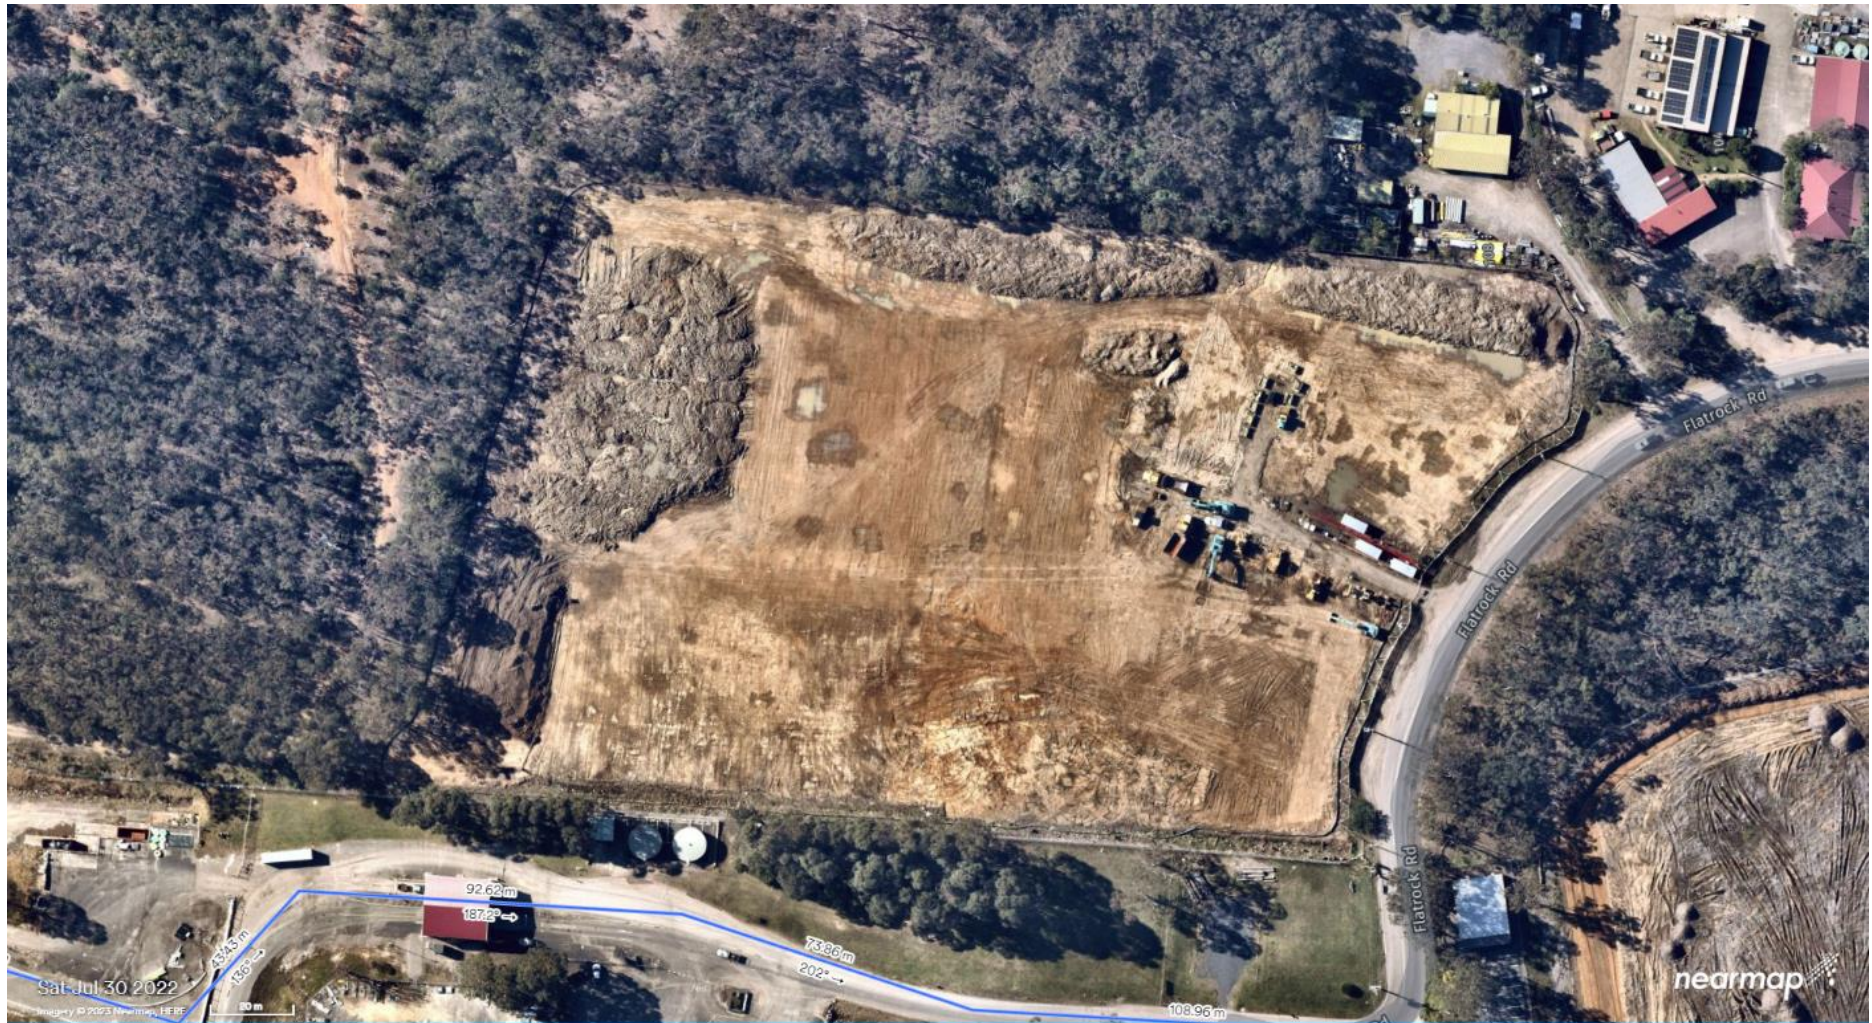
Figure 4, Aerial image of site - 30/07/2022

As noted in Table 3, aerial imagery shows evidence of topsoil stripping and handling between 30/07/2022 and 02/02/2023. Aerial imagery and the as-built survey show five stockpiles following the completion of works on site. Based on Table 3 and the site walkover, it is assumed that the south-eastern and north-western stockpiles consist of topsoil.

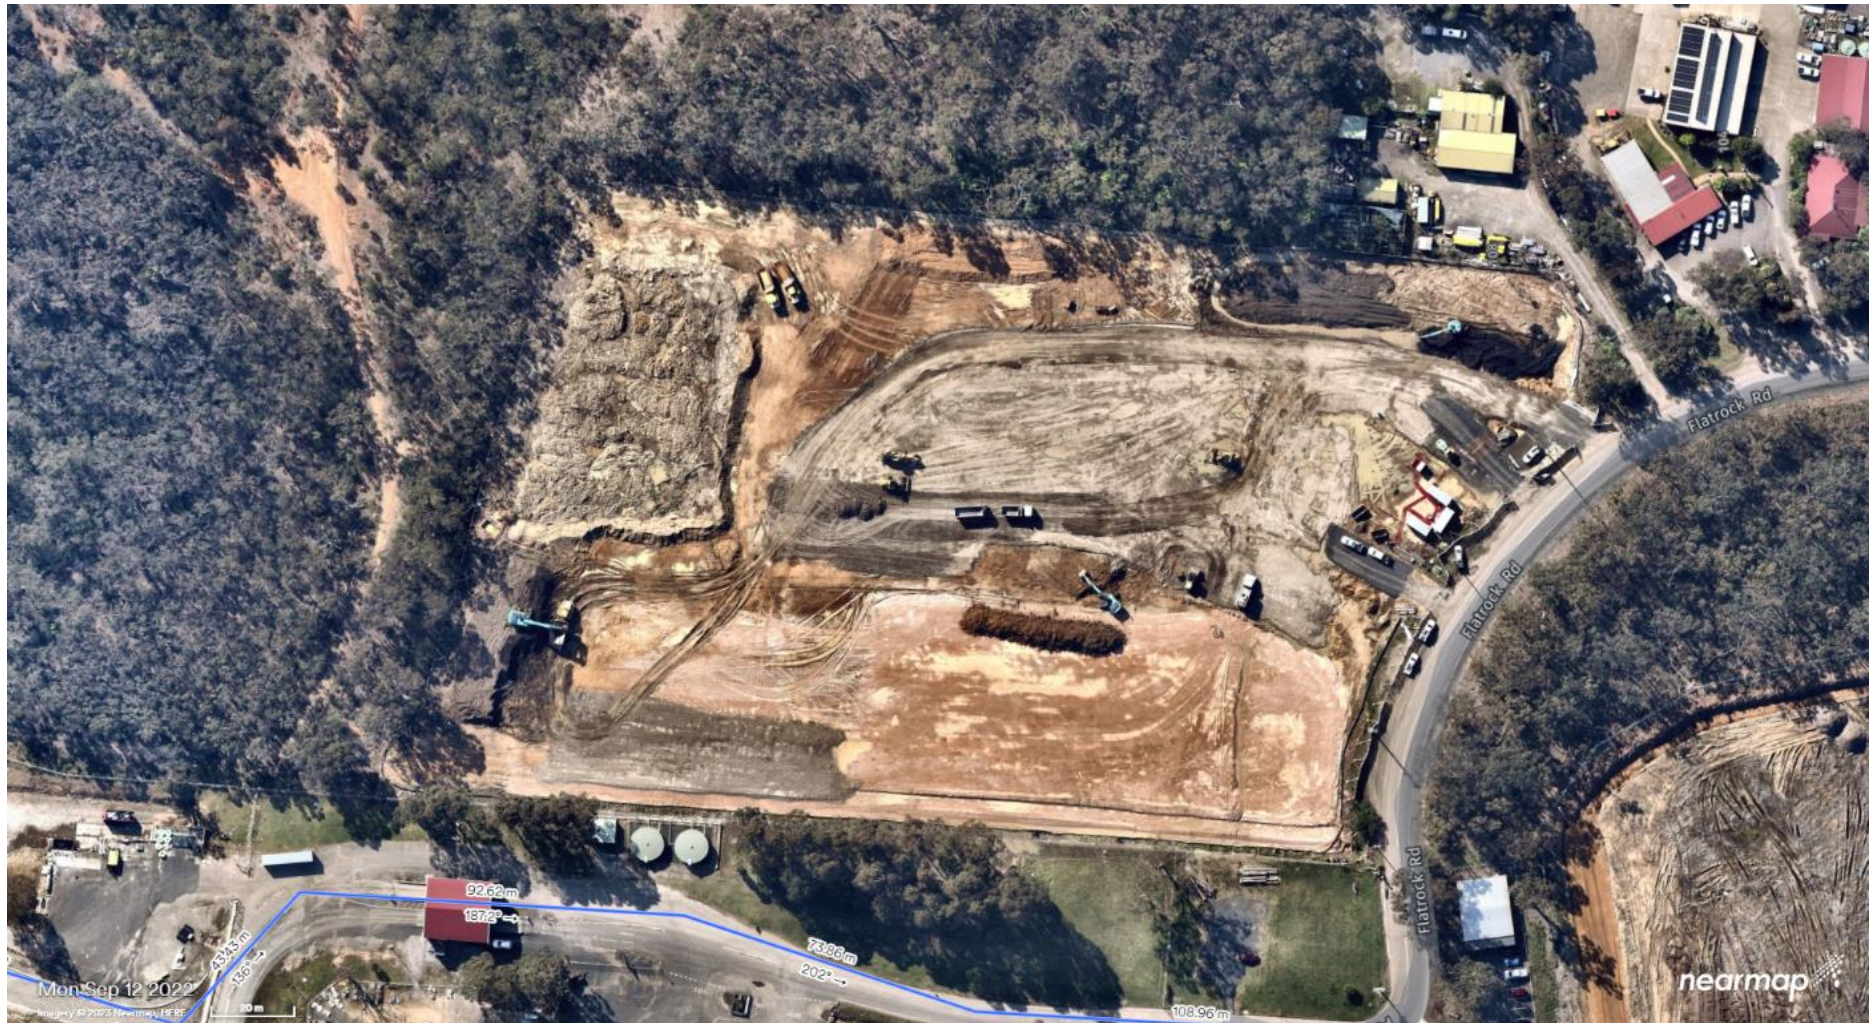
Figure 5, Aerial image of site - 12/09/2022

12/09/2022	Construction		<ul style="list-style-type: none"> ▪ Topsoil handling – Excavators appear to be handling topsoil into two stockpiles at the south-east and north-west of the site.

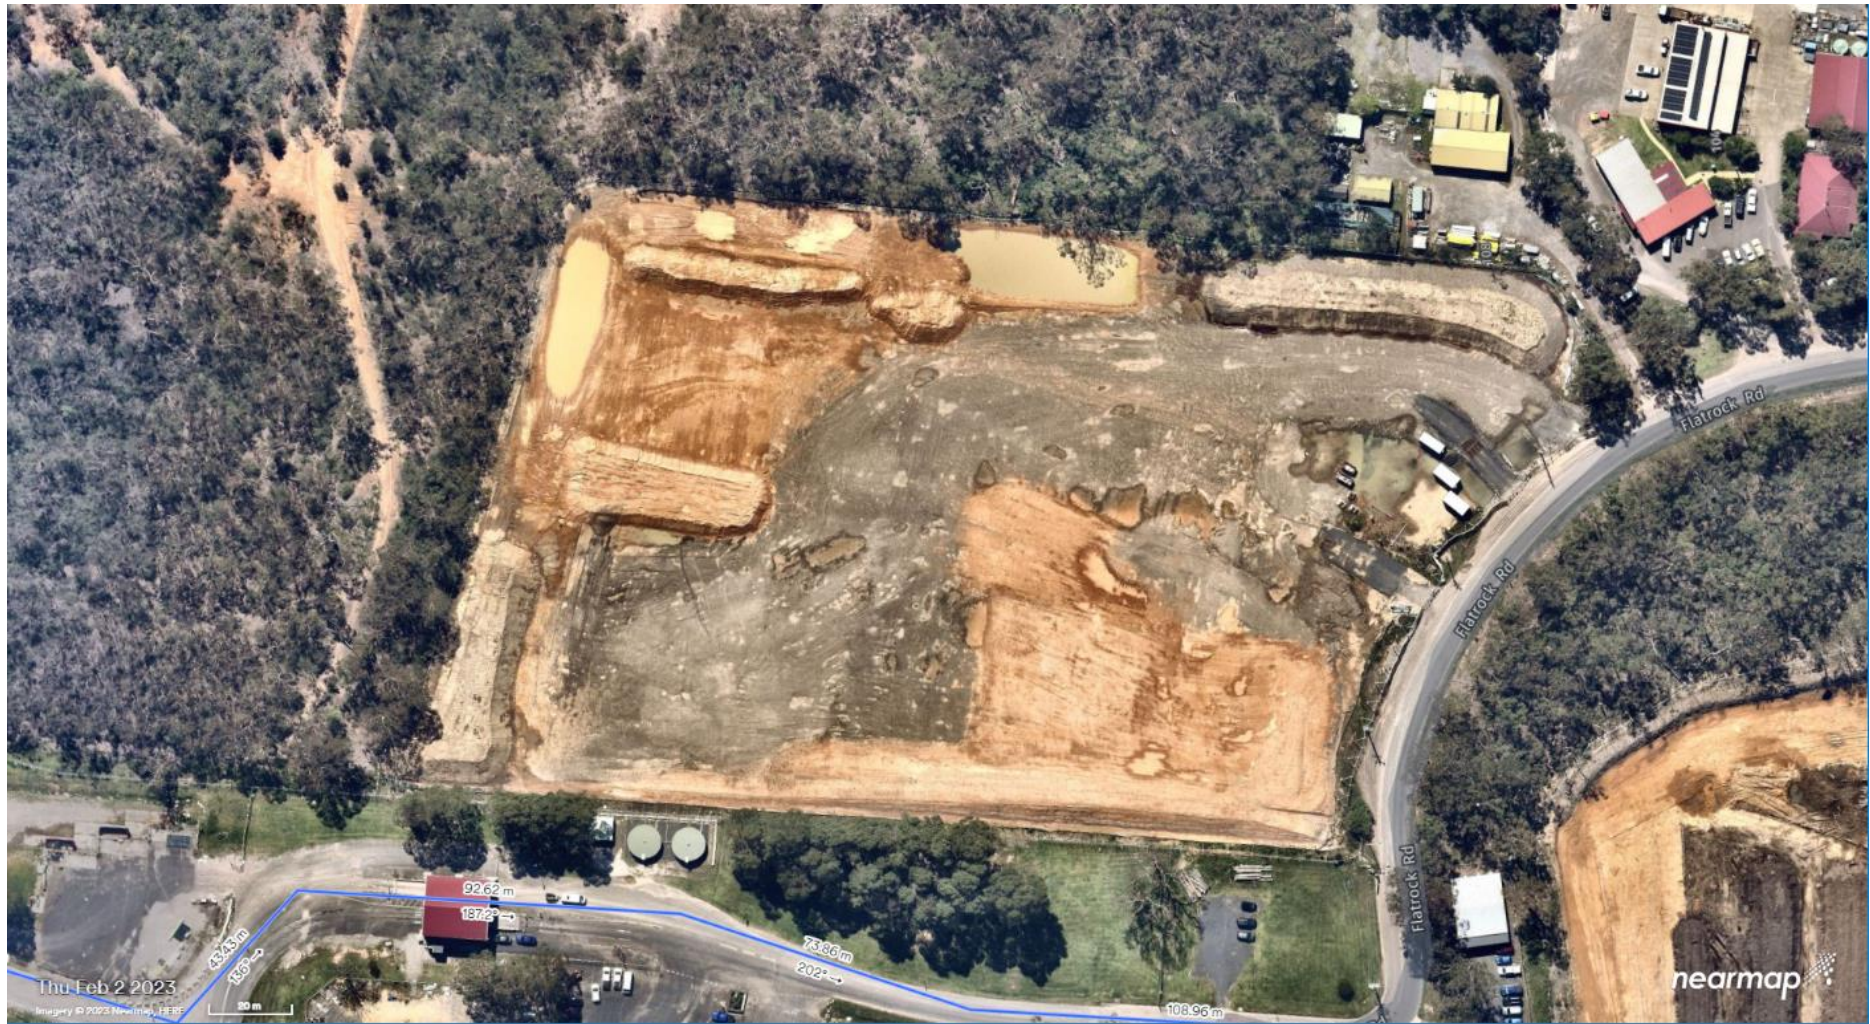
Figure 6, Aerial image of site - 02/02/2023

Date	Phase	Completed works	Construction activities
			<ul style="list-style-type: none"> Access construction – the existing access has been removed and two accesses are under construction onto Flatrock Road.
02/02/2023	Post construction	<ul style="list-style-type: none"> Excavation of a wet sediment basin on the eastern boundary of the site. Excavation of two borrow pits/temporary sediment basins at the north-eastern corner of the site. Note, these are holding water on the aerial imagery, however, were dry during the site walkover. Expansion of the two stockpiles from the previous image (assumed to be topsoil). Creation of three additional stockpiles towards the northern portion of the site. Refer below for discussion on stockpiles. Earthworks operations. There is evidence of a grey material placed for part of the site. 	
30/05/2023	Post construction	<ul style="list-style-type: none"> 3 x site sheds removed. Shaker grid removed.

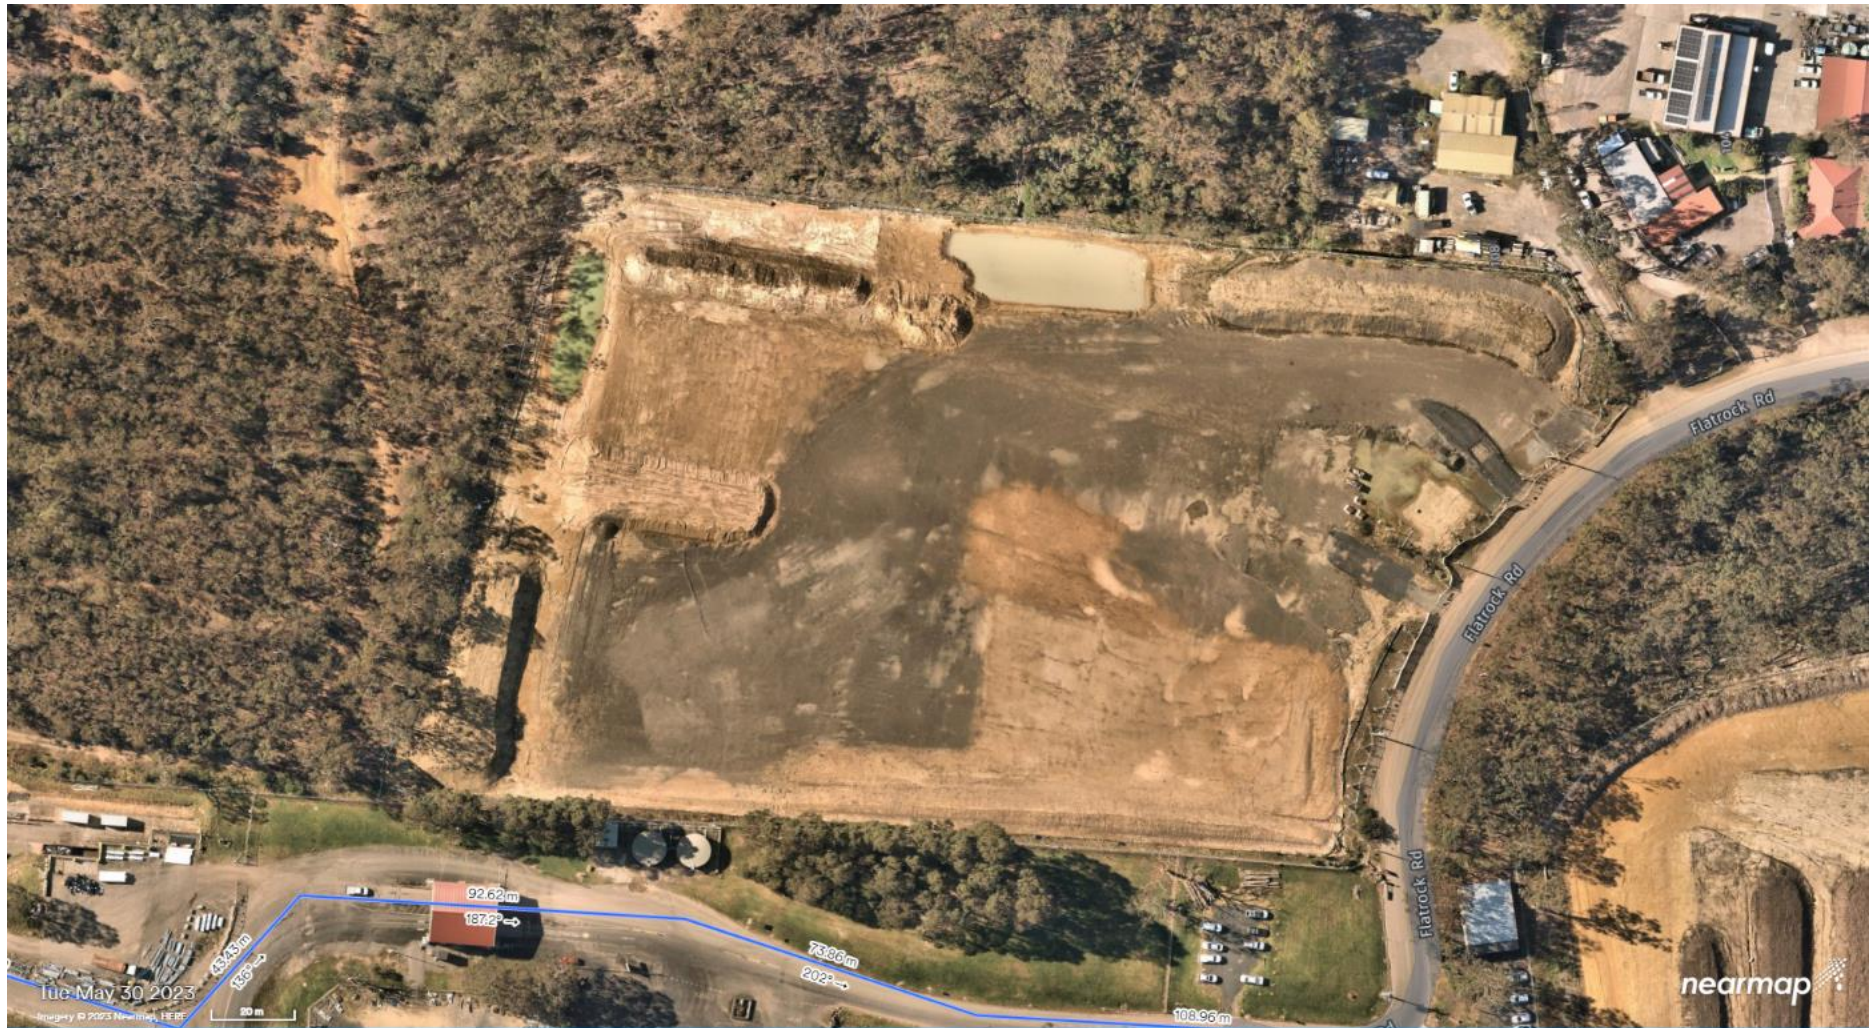
Figure 7, Aerial image of site - 30/05/2023

30/06/2023	Post construction	<ul style="list-style-type: none"> Removal of remaining skip bins and material.
