Report

HUSKISSON ANGLICAN CHURCH – GPR INVESTIGATION

Date: 30 April 2019
Job Number: GBGA2255
Author: Ben Wilkins
Reviewed: Taylor Willick

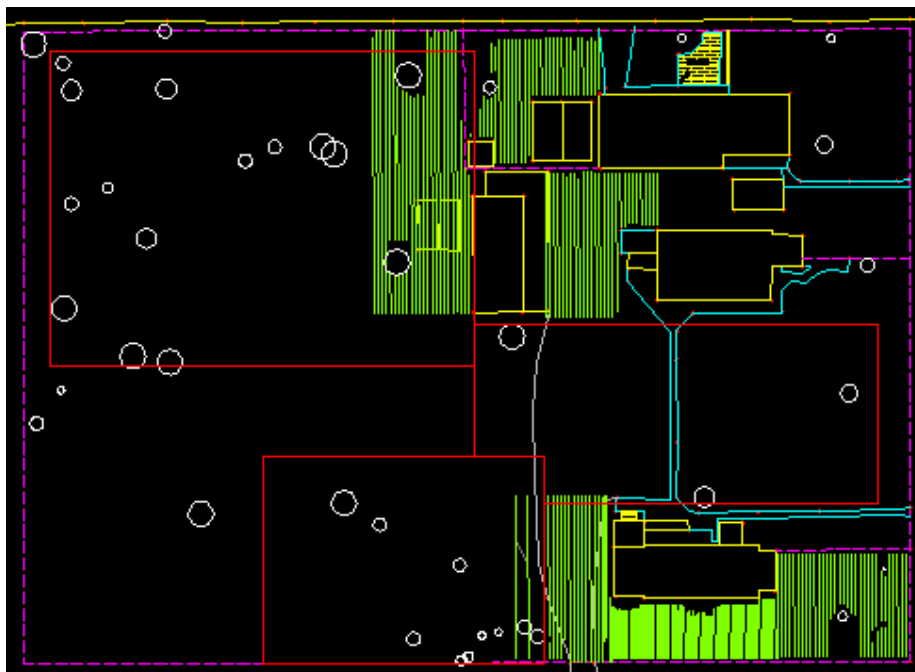
Huskisson is located approximately 140 km south of the Sydney CBD. The church grounds are approximately 10,000 m² and are bounded by Bowen, Hawke, and Currambene Streets. The areas investigated are summarised in figure 1 below. Areas bounded in red were surveyed previously (report reference GBGA1800 and PEA report). Lines surveyed recently presented in this report shown in green.

Figure 1. CAD drawing of the Church grounds. Areas surveyed by GBG and PEA previously shown in red. Lines surveyed recently presented in this report shown in green.

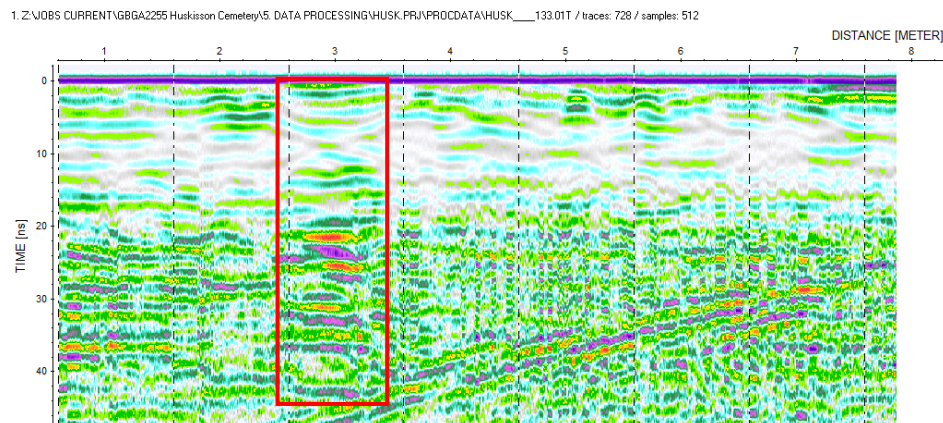
A radargram profile is built up of scans collected along a selected line path. A sample radargram has been selected from the data and is shown in Figure 2 below. Each profile consists of an enhanced radargram that provides subsurface information based on the variations in the Dielectric Constants (the electrical conductivity and resistivity) of materials. The recorded reflections can be analysed in terms of shape, travel time, signal amplitude and phase to provide information about a target's size, depth and orientation in relation to the material around it.

Figure 2: Sample radargram showing suspected grave within the survey area.

The typical response from a GPR profile running perpendicular over a grave is a hyperbolic signal of increased amplitude, the peak of which gives the depth to the top of the grave and an indication of the size and width of the grave. With the GPR method it is quite often that features associated with graves are imaged, rather than the graves themselves. This may include depressions in the soil layers above the grave, vertical discontinuities in the soil profile caused by the grave trench and a mottled GPR signal above the grave due to the unconsolidated nature of the fill material.

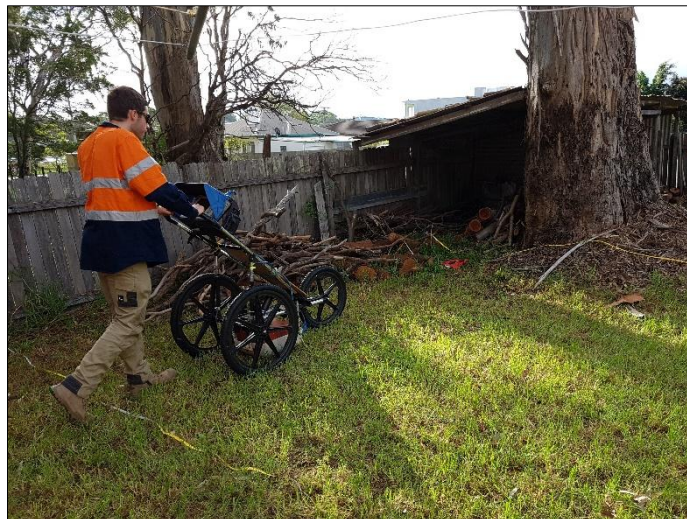
The data for this investigation was acquired using a GSSI SIR3000 GPR data collection system with a ground coupled antennae. Chainages along the profile line were logged by a calibrated distance measuring device attached to the antenna with an accuracy of better than $\pm 0.5\text{ m}$ every 100 m. The previous investigation trialed both the 400 and 270 MHz antennae at the site, however the 400 MHz antenna was deemed to give the best combination of depth of penetration and resolution. Therefore only the 400 MHz was used on site on this occasion. The survey equipment is shown in Figure 3 below.

Figure 3. A section of the survey area with scan in progress. Tapes were used to ensure correct line separations and directions were achieved.

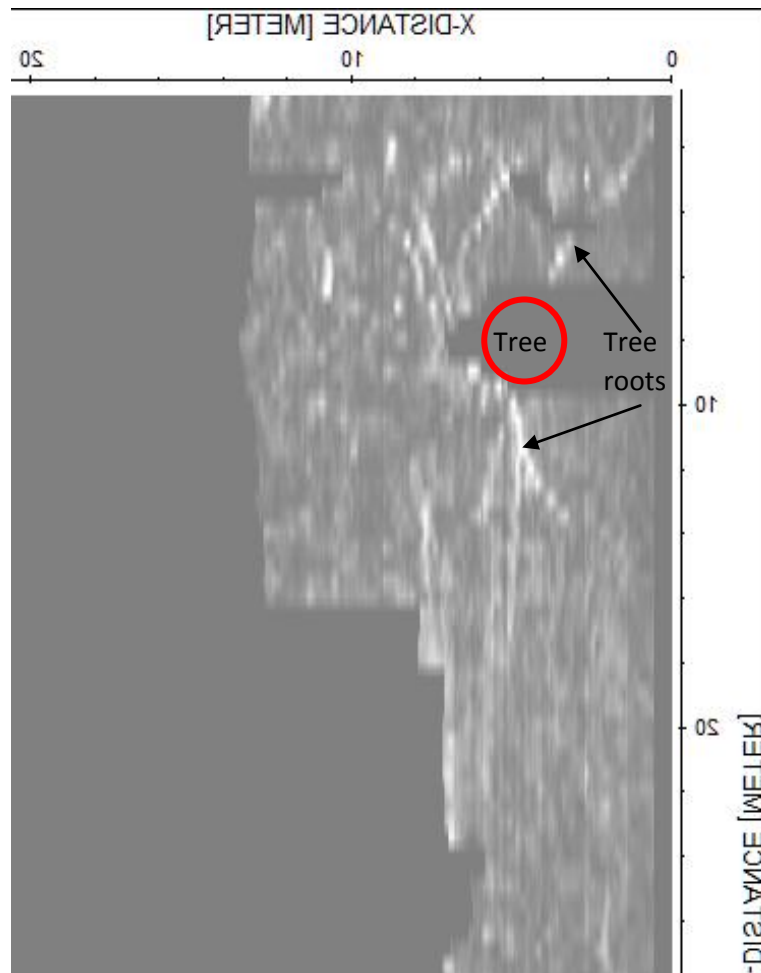
The area to the east, south and west of the church building were surveyed. The data here showed tree roots very clearly, such that they were able to be displayed on a 3D cross section of the data (shown in Figure 4 below). On site there were a number of depressions in the ground (marked with a red cross in the drawings). Depressions are common surface expressions of subsurface collapse due to grave stability degrading slightly over time. These depressions aligned with anomalies in the data. One area showed a strong anomaly with significant dipping layers and high amplitudes at depth. This has been reported as an orange rectangle on the drawings to signify a possible grave with a high level of confidence. Surrounding that anomaly were two others. The anomaly that corresponds to the other depression is much weaker and so has been marked as a blue rectangle to show lower confidence in being a grave. The final anomaly is also shown in blue as there was no surface expression and the signal appears very close to a large tree root. It is uncertain what impact the tree root is having on the data here, but the anomaly is of the shape expected from a grave, so it has been plotted.

Figure 4: timeslice of the 3D rendering of the data surrounding the church (slice at 150mm) Tree roots are visible in the top section (east to the top).

- The area that had been cleared before surveying showed no evidence of graves.
- The area in the backyard of the rectory showed no evidence of graves
- The driveway area between the rectory, church hall and metal building showed two weak subsurface anomalies. These were subsequently investigated and are not the result of graves.
- The area surrounding the church showed some evidence of one grave being present, and the possibility of another two next to it.
