Review of Environmental Factors

Proposed Boat Launching Facility

Lot 7308 DP 1144810
Havilland Street
Conjola Park

PROPONENT: SHOALHAVEN CITY COUNCIL

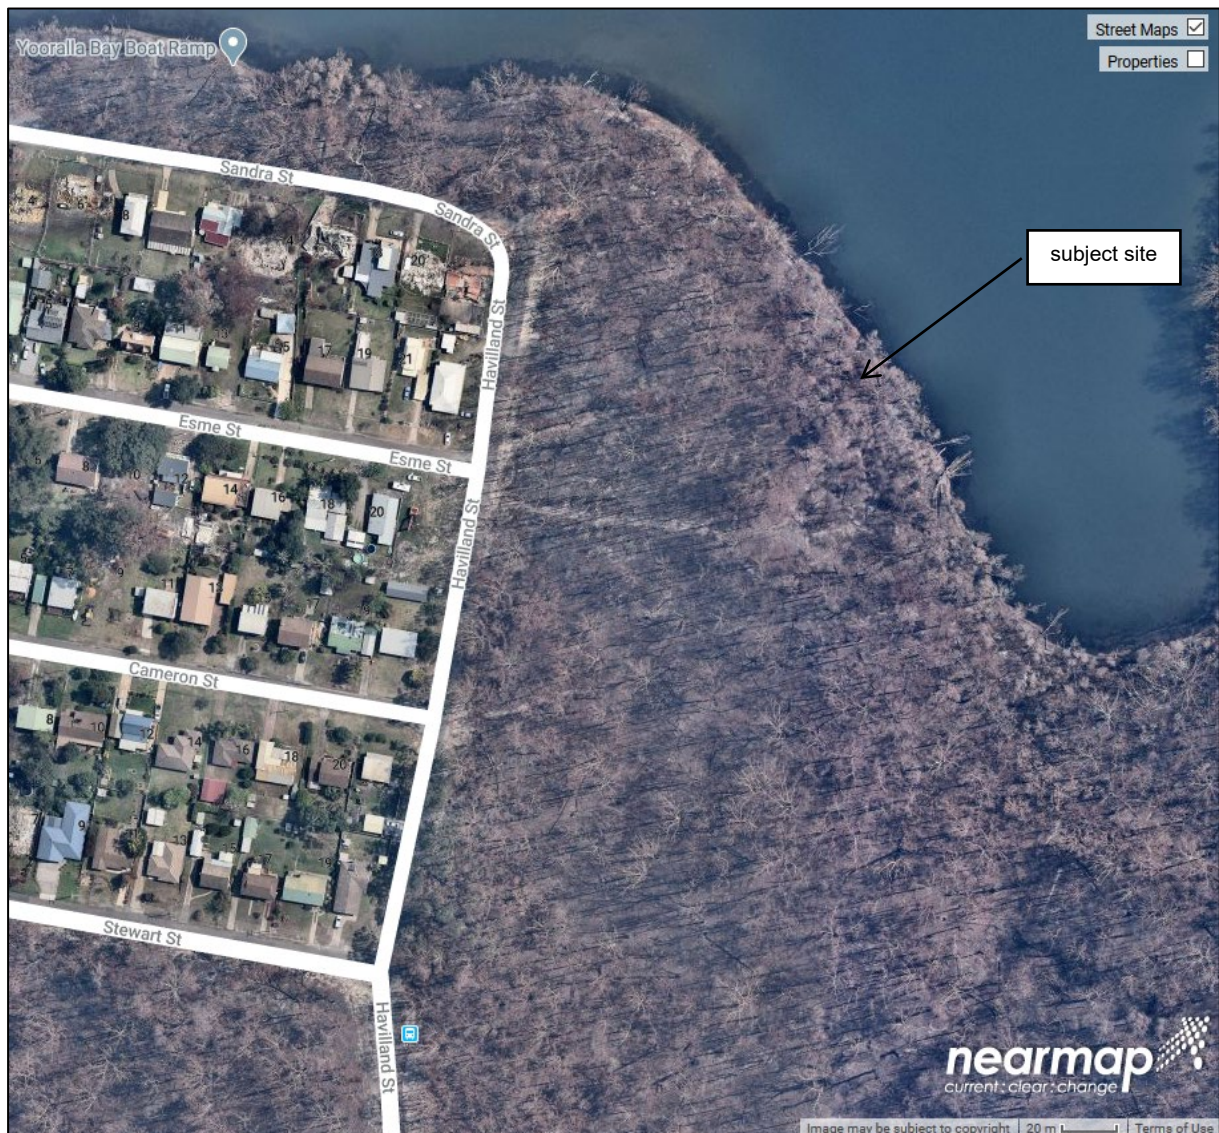
Figure 9. Post-fire air photo of the site.
Air photo taken 31 January 2020 © nearmap www.nearmap.com.au

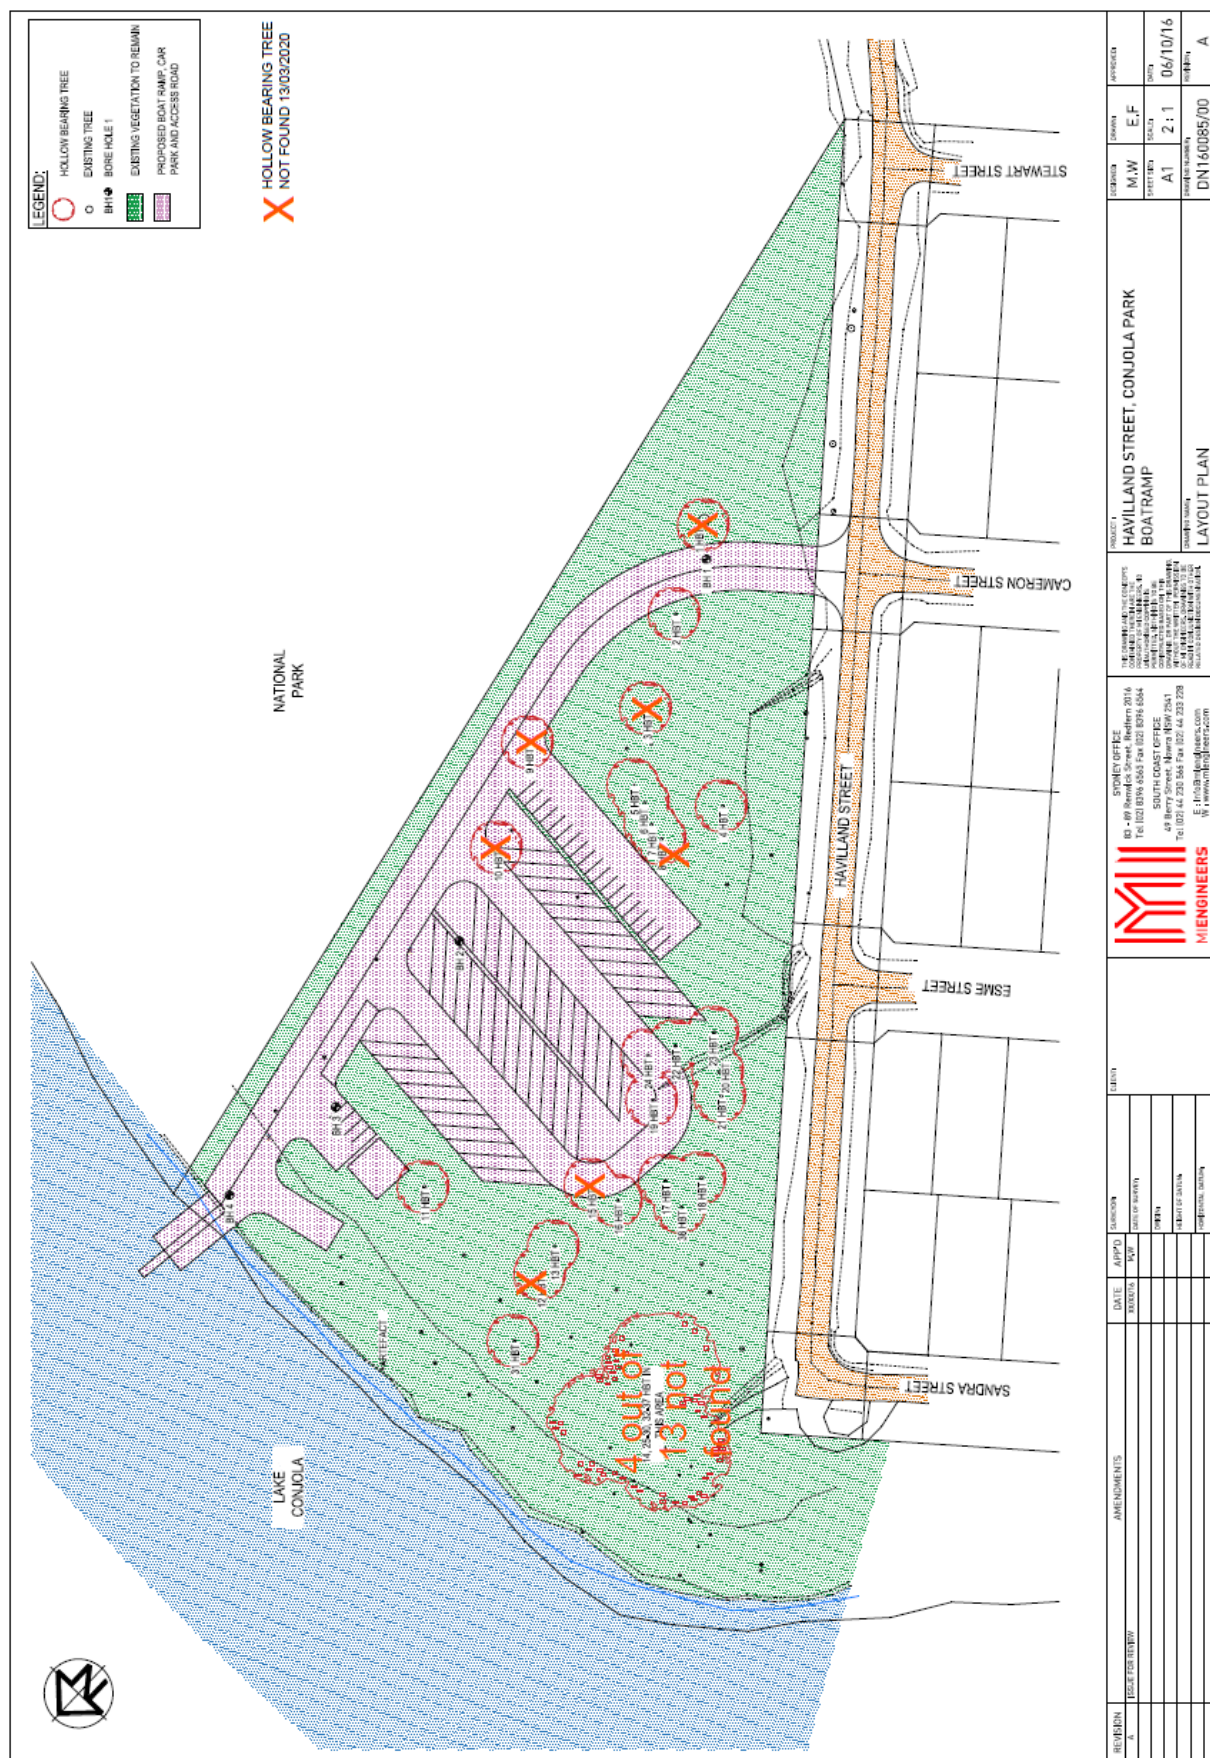
Figure 1. Results of resurvey of hollow-bearing trees in March 2020 following December 2019 bushfire. Layout of the proposed facility shown on this drawing has been superseded as shown in Figures 2 and 3.

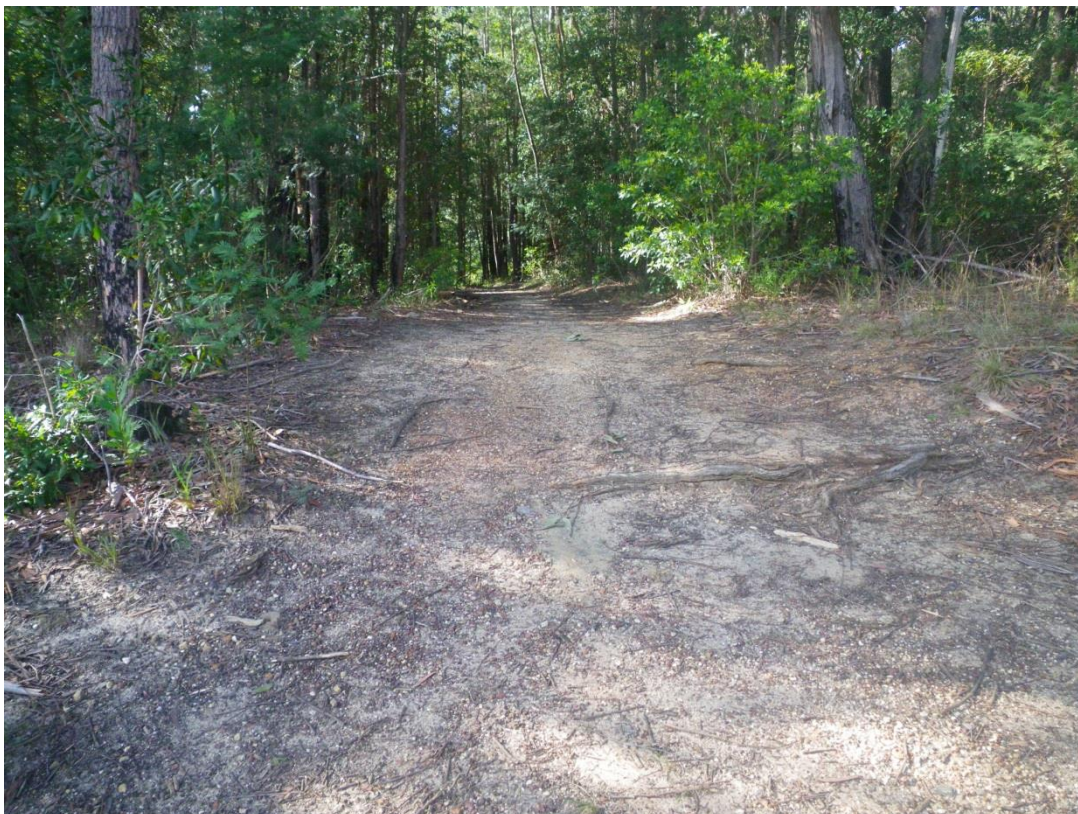
Figure 5: A typical informal vehicle track in subject area

Numerous vehicle tracks criss cross the area, linking Havilland St with various locations along the water's edge where people launch their boats or go fishing (Figure 5).

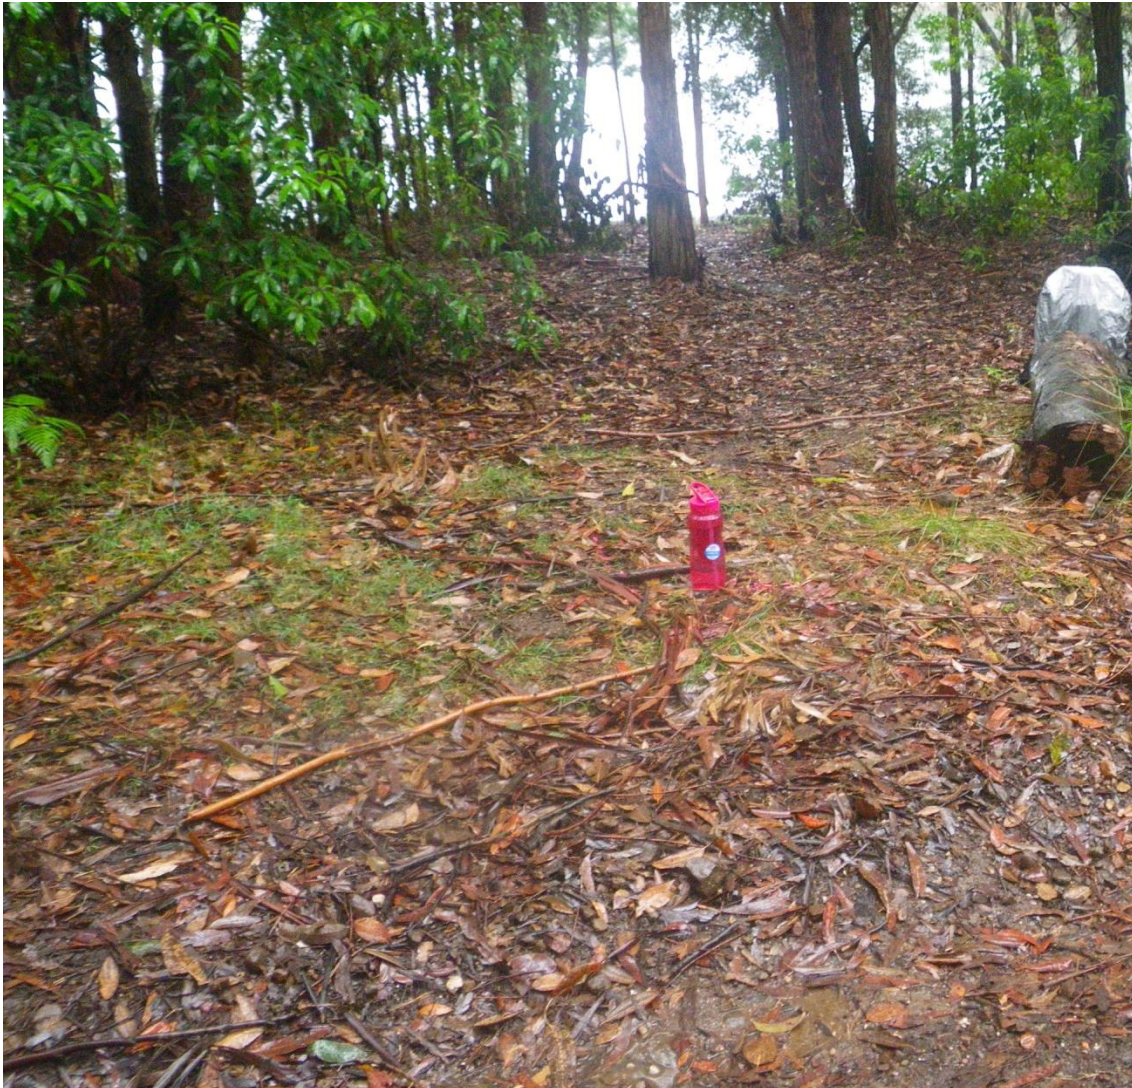
Figure 1: Location of Bore Hole 3.
