4.5 Local Area Plan: Jervis Bay Area

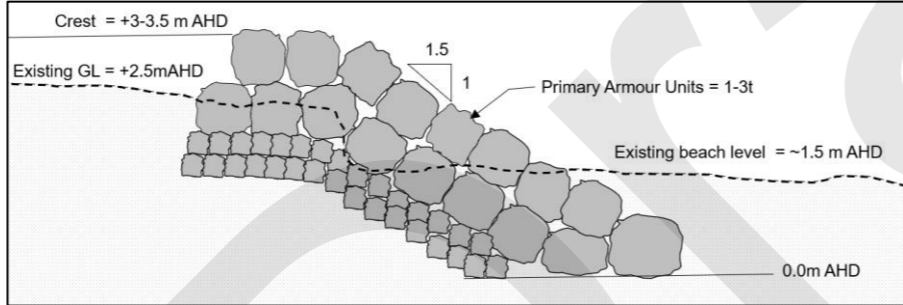
ID	Location	Action Name	Action Description	Risk Being Addressed	Lead Agency	Support Partners	Priority	Timing	Performance Measures
CL.03	Callala Bay	Sheaffe Street stormwater improvements	The drainage at the road head to be collected and discharged to the beach in a manner which minimises its erosive impact at the back beach embankment and the beach berm. A vegetated grass swale could be constructed in between the road head and the dune - in order to capture excess storm water, recharge the dune aquifer, and prevent road runoff from worsening beach erosion.	SER.9.5 SER.9.6 SER.9.7	SCC	N/A	Medium (12)	Within 4-7 years	Works completed.
CL.04A	Callala Bay	Sailing Club Coastal Protection Works - Stage 1: Design and Approvals	<p>The Stage 2 risk assessment has indicated that the Sailing Club building is a high value public asset considered to be exposed to a high level of coastal erosion risk. The existing coastal protection works in front of the sailing club building are comprised of informal and ad hoc placement of rock bags.</p> <p>This informal structure should be replaced with a formal design of coastal protection works, including renewal/replacement of the existing timber Sailing Club launching ramp. An approximately 30m long, low crested revetment will be constructed to protect the building from undermining due to coastal erosion impacts under present day and future sea level rise.</p> <p>This scope of works is to include:</p> <ul style="list-style-type: none"> Undertake concept design and associated design investigations - such as foreshore survey, services location and geotechnical investigations to determine the subsurface conditions around the structure, and the presence of any underlying bedrock strata. Prepare a detailed design for the coastal protection works – which also includes renewal/replacement of the existing timber Sailing Club launching ramp. Undertake any required environmental assessments and approvals <p>A reference design has been prepared using preliminary coastal engineering analyses and is provided below. These design parameters would be refined as part of the detailed design process.</p>
