Report

HUSKISSON ANGLICAN CHURCH – GPR INVESTIGATION

Date: 1 October 2019
Job Number: GBGA2304
Author: Benjamin Wilkins
Reviewed: Jamie Speer

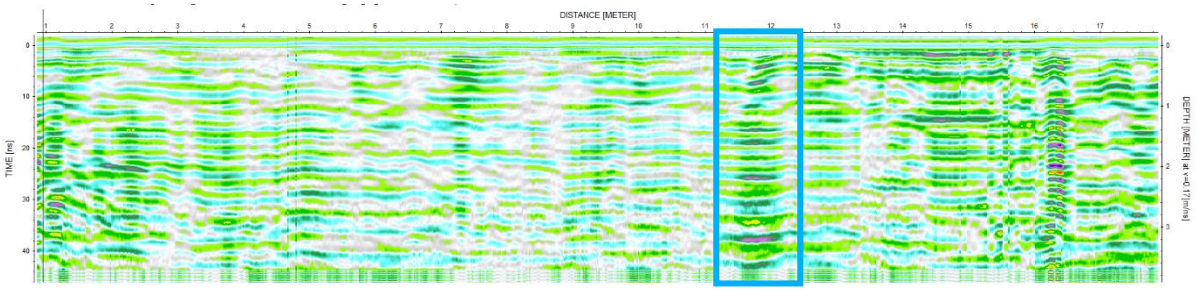
The area previously covered by the metal shed (used as the church administration building) was overlain with a reinforced concrete slab until this survey. The survey over the area after its removal showed one small anomaly near the western edge of the area. This anomaly (seen in Figure 5) shows a shallow dip in the near surface (0.3 m) across two lines. The dip has a high amplitude, and that zone of higher amplitude extends to the depth of the record. The signal might be ringing off a shallow conductor sitting just under the surface (perhaps some metal buried under the newly disturbed soil) but there is the possibility that the dipping is because of an anomaly buried deeper (0.6 m). It is recommended that this anomaly be investigated further to determine its cause. Because of the length not exceeding 1 m this anomaly has not been marked as a suspected grave.

Figure 5:Anomaly at site of metal shed.

Two anomalies of note were found. Under the site of the metal shed a small, shallow but high amplitude anomaly was detected. Another anomaly was detected near the Hawke Street boundary, to the south – towards the church. This anomaly was larger, deeper and weaker than the first. It is our recommendation that these anomalies be investigated further with ground truthing to determine their cause.

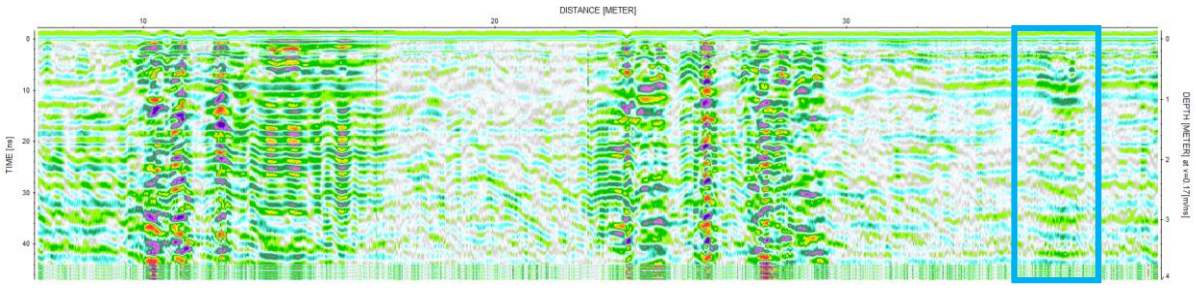
The lines along the front of the property along Hawke Street found one anomaly near the church building (see Figure 6). The anomaly may continue past the extent of the survey and knowing its size might have allowed GBG to narrow the likely cause of this anomaly. As it stands it is an area 1.2 m by at least 1.5 m in size. The GPR response is dipping above a slightly higher amplitude response at ~ 0.8 m. The response is shallower than responses presented as graves in previous reports and also a weaker amplitude, these factors and because of the size being uncertain, this anomaly has not been characterised as a possible grave, but it is recommended to investigate the cause of this anomaly closer. Caution is urged as there is some possibility that this is a service running into the property and only the trench is visible.

Figure 6: Anomaly near Hawke Street, near church building.
