Preliminary Arboricultural Impact Assessment

Prepared for
**Ulladulla Civic Centre
Princes Highway,
Ulladulla 2539 NSW**

For the proposed development at
**Shoalhaven City Council
36 Bridge Road
Nowra NSW 2541**

**Prepared: 20th July, 2012
Reference No: D1988**

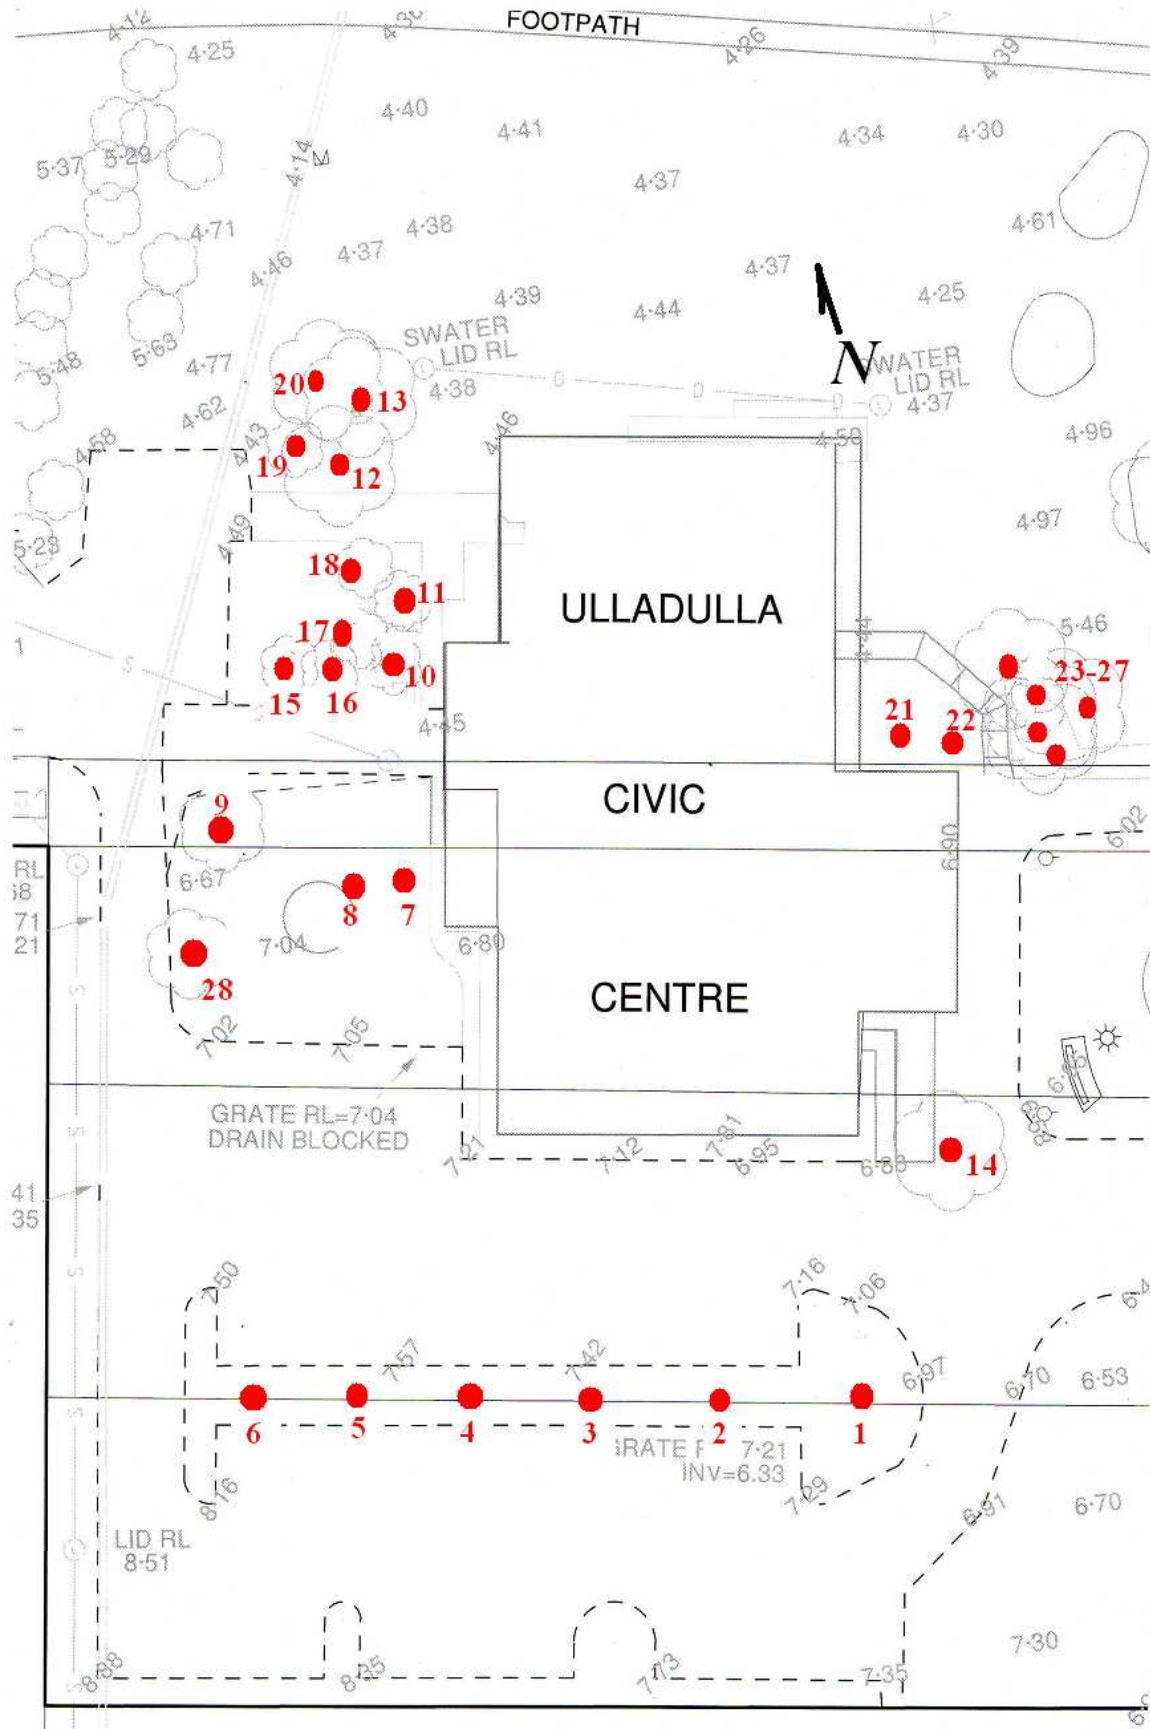
5.0 Plan 1 - Trees relative to site

Note: Trees no. 1-8, 21 and 22 have been omitted from this survey, however due to the size, have been considered to be required for inclusion within the Arborist report. The location has been plotted onto Plan 1 by Allied Tree Consultancy. Allied Tree Consultancy is not a registered surveyor and however the accuracy of the survey is attempted, the true positions of the trees plotted onto Plan 1 may marginally deviate.
