# **E S & A BANK**

### **Conservation Management Plan**

**PREPARED FOR**  
**Shoalhaven City Council**

**BY**  
**SIMPSON DAWBIN Associates Architects and Heritage Consultants**

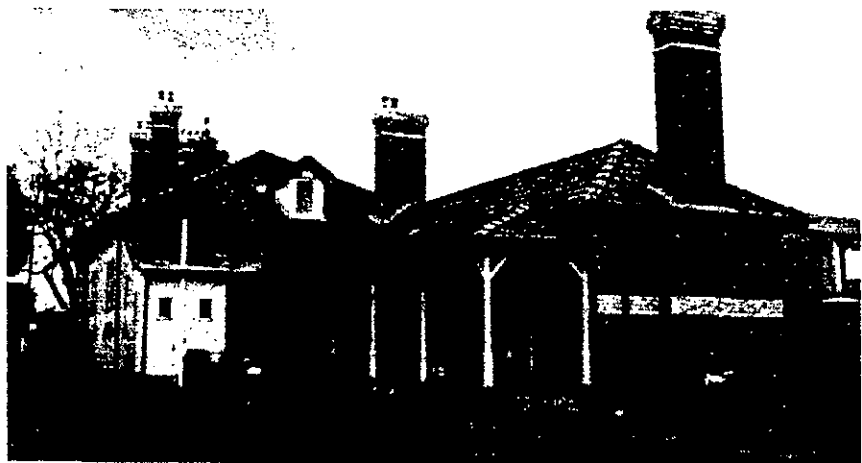
Fig 13:  
Bank from the rear

The rear of the building was formerly the private quarters of the bank manager with a verandah and several doors of the residence opening into the back yard. The fibro wc enclosure in the verandah detracts from the original form of the building. Generally the rear section of the building is in greater need of maintenance than the remainder of the building

The side wall facing the Post Office show evidence of damage to brickwork from rising damp from the ground and falling damp from roof and gutters. The wall has been painted, probably an unsuccessful attempt to deal with the damp penetration.

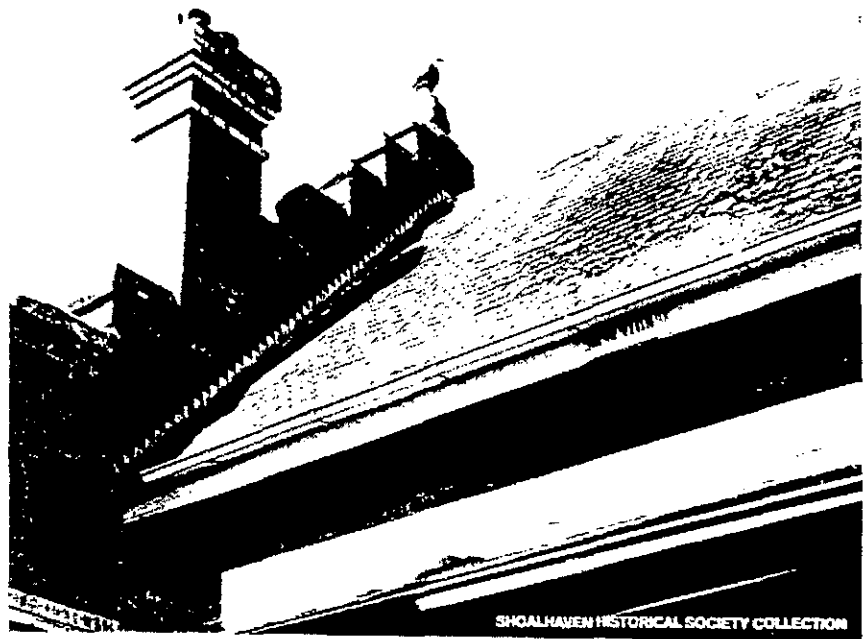
Fig 14:  
Detail of slate roof

Fig 15:  
South façade

The manganese colour French pattern terra cotta tiles replaced the original slate roof in 1970. Water penetration has occurred in the past at parapets, chimneys and dormer indicating failure of flashings. Generally in sound condition however following recent remedial work.

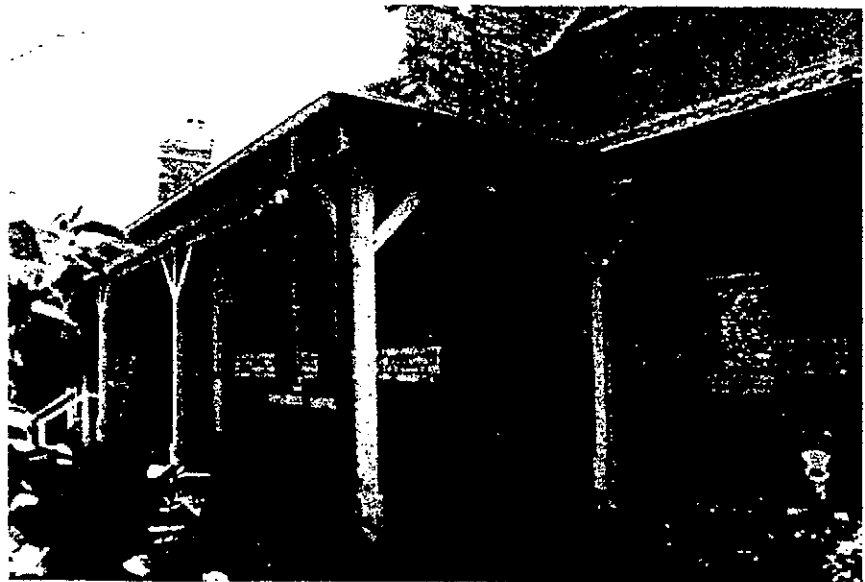
Fig 16:

Verandah and garden to west side of the residence. Main entry to the residence on left

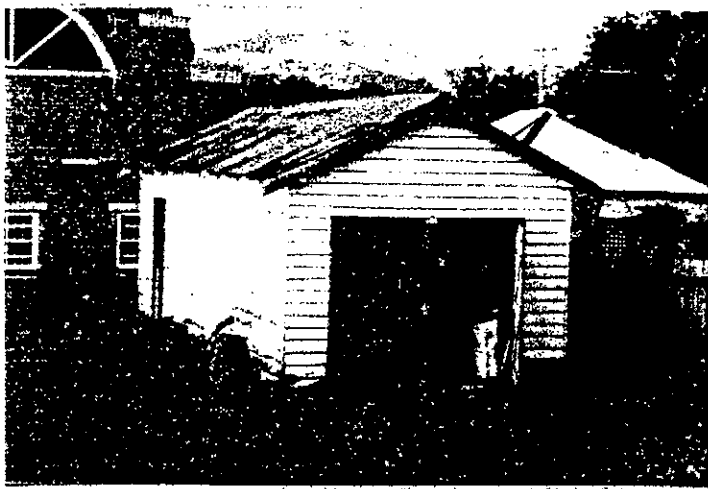
Fig 17:  
Garage

A simple weatherboard and iron garage is located at the rear of the yard. It is used as storage for items salvaged from the building including four panelled internal doors and a set of glazed doors.

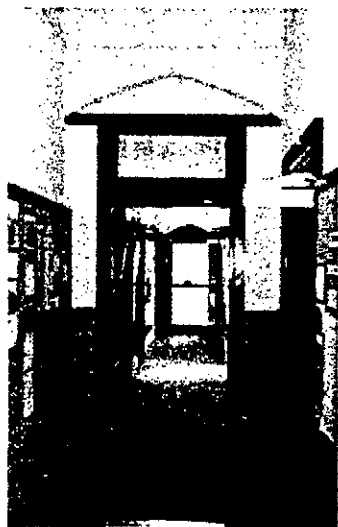
Fig 23: Hallway to Residence

A door frame and highlight without door originally separated the private residence from the staff working areas. The pointed arch is consistent with the Wardell Gothic detailing of the building. A second screen was installed in the 1930's to allow direct access to the Staff Room without encroaching on the residence. The missing doors to the original first screen are possibly the pair now in storage in the garage at the rear. Textured wallpaper now painted over extends to a height of 1500 above floor level to the full length of the hall.

A skylight diffuser is located near the door to kitchen. A dormer window penetrates the roof at this point.

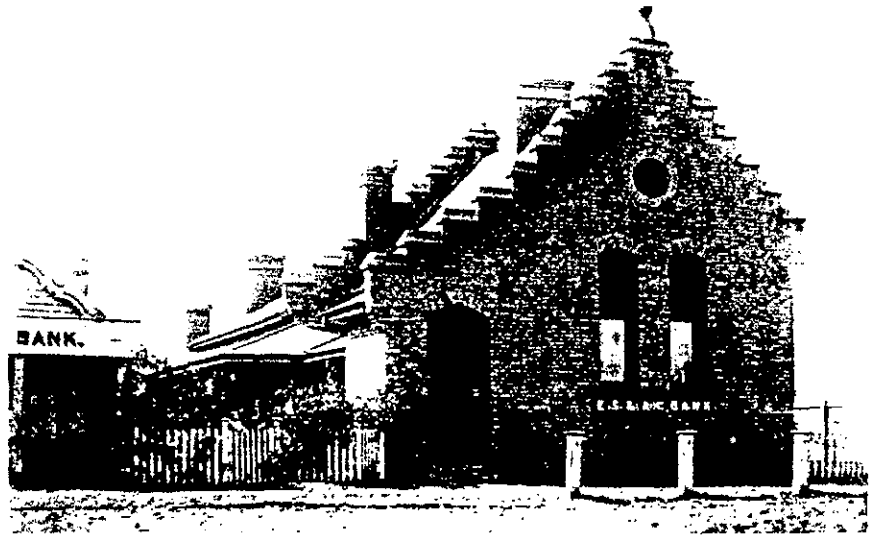
Early photographs of the building taken in 1896 and 1913 clearly indicate some detail of the garden in the open areas to each side of the residence. The 1896 photograph (Fig 29A) indicates fairly unruly growth of bushes and shrubs to the west side of the garden, while on the opposite side of the building the space is left clear. By 1913 (fig 29B), a well tended garden on both sides is well established with some bushes and trees reaching maturity. A diversity of plants is evident, mostly of exotic species as was fashionable in Victorian and Edwardian gardens. Visible species identified by a botanist include *Araucaria*, *Camellia*, *Populus*, and *Archontophoenix cunninghamiana*, and several *rosa spp.* The garden would have been 19 years old at the date of this photograph and is significant in terms of providing a guide for future garden planning.

Fig 29A :  
ES&A Bank and garden in 1896

Fig 29B :  
ES&A Bank in 1913, from verandah of Berry Hotel  
Illustrating well planned and established garden
