Pryda Reference Number: 10430

Inspection Report

Address: Mollymook Surf ClubDate of inspection: Thursday, 26 July 2007

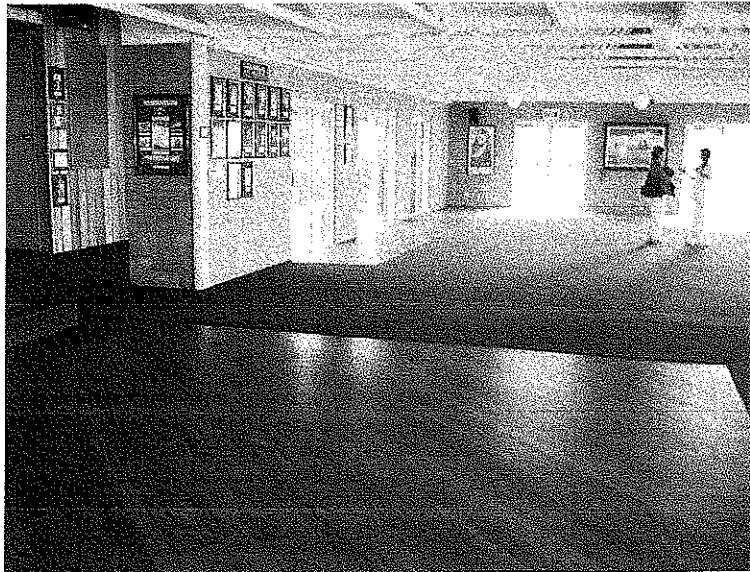
Existing function room

The existing function room is in need of a refurbishment. Whilst the outlook from the function room is without doubt the best in the region, there are a number of refurbishment options that would significantly improve the amenity and atmosphere of the function room. These are in addition to the new ceilings required as a result of the new roof proposed under it 5.2 above.

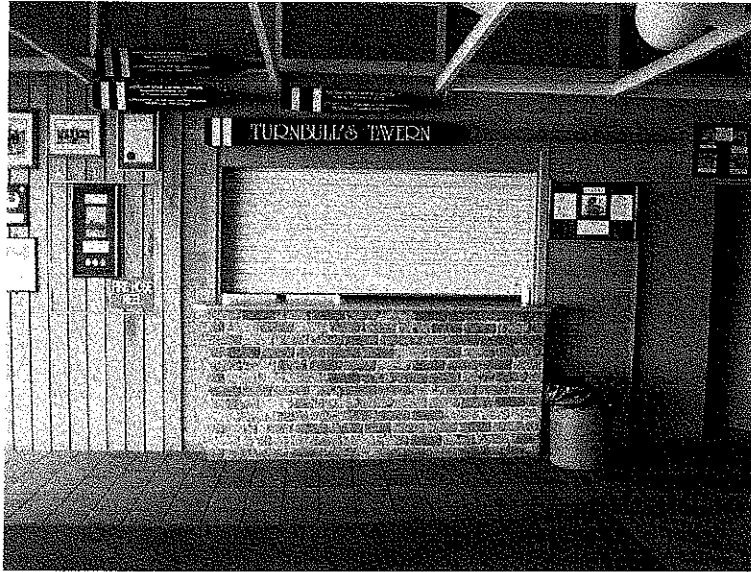
Approach View to potential northern entrance

The bar front and customer approach to the bar needs upgrading.

- Frame out existing bar front and provide joinery facing. In order to avoid significant plumbing and bar service changes, the new bar front should wrap out and around the existing footprint.
- Provide new stone bar top
- Provide new projecting bulkhead over bar front with pendant decorative lighting in order to provide a focal point for the bar.
- Potential upgrade of bar security pending condition of existing shutter
