SHOALHAVEN DAIRY INDUSTRY • STAGE 1
ARCHAEOLOGY OF THE MILTON & KANGAROO VALLEY AREAS

VOLUME 2 • PART 2
INVENTORY BASED DESCRIPTION OF DAIRY INDUSTRY SITES

PETER FREEMAN PTY LTD
CONSERVATION ARCHITECTS & PLANNERS

NOVEMBER 1997

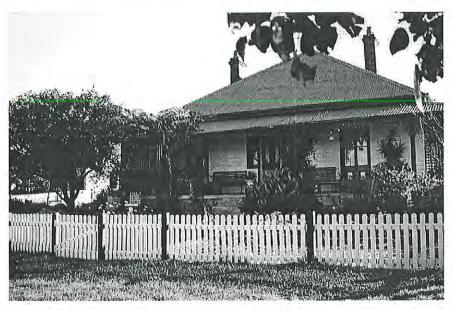
Mimosa Farm. House, formerly 'Darling Forest' faces east. Looking southwest MH 1997 photograph 9.7

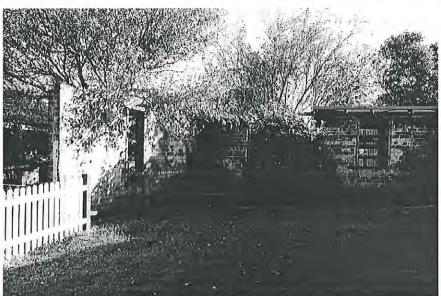
Remnant brick walls of earlier house/farm accommodation. Bricks similar to those made on site at Kendall Dale. Looking west. MH 1997 photograph 9.8

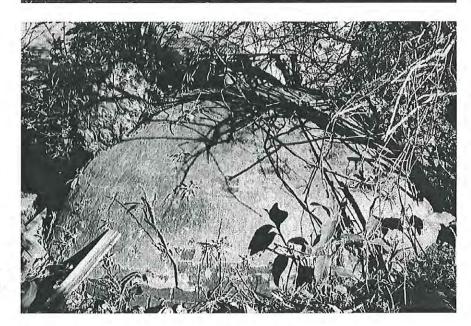
Cement rendered brick dome topped tank c.1880. Looking west MH 1997 photograph 9.11

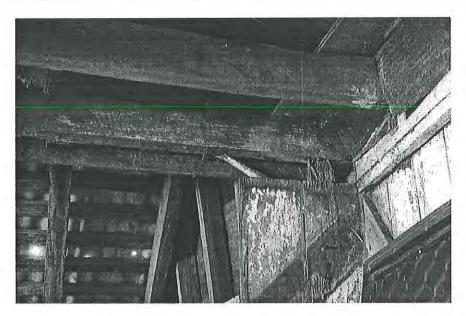
Detail of wall and roof construction, shingle battens in situ. MH 1997 photograph 9.16

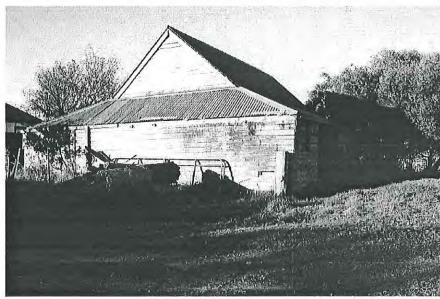
Weatherboard infill, western verandah butter factory. NB thickness of removed fence posts, presumably very early fencing. Looking east. MH 1997 photograph 9.17

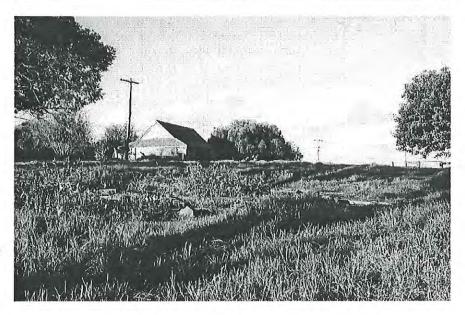
Site of recent chook pen, formerly milking bails? View to Mimosa butter factory. Looking north-east MH 1997 photograph 9.18

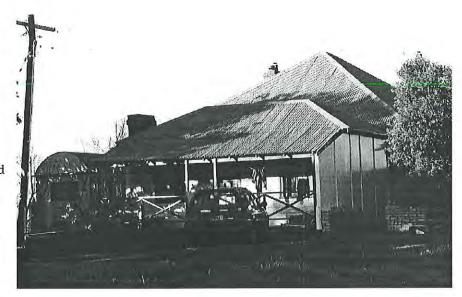
MH 1997 photograph 9.20

Western elevation of detached kitchen, early 19th century weatherboard construction, set off centre to central hallway in house, now connected to house through skillion.(Possibly relocated from elsewhere.) Looking north-east.

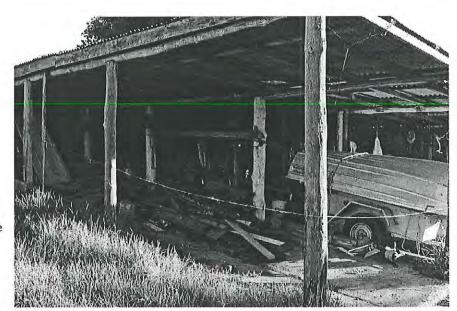
Feed stalls, sawn timber frame and corrugated iron roof, supported on natural round posts 6-8 inches diameter, concrete floor. Looking south-west MH 1997 photograph 9.23

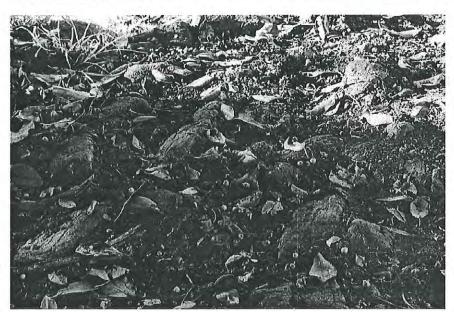
Stone paving, stones placed vertically, paving covers entire area between the house, feed stalls and weatherboard milking shed. MH 1997 photograph 9.24

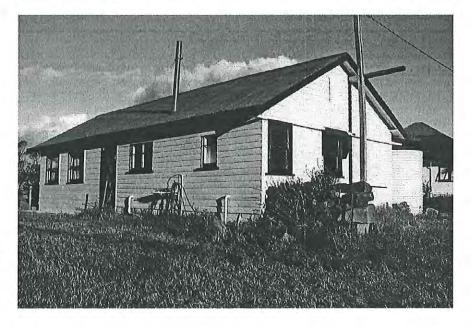
Weatherboard milking shed converted to accommodation. In ground tank 4 feet deep, adjacent to southern wall. Looking south-east MH 1997 photograph 9.25

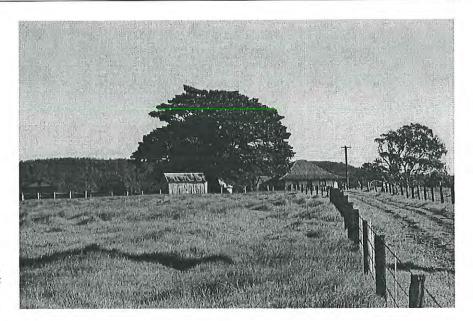
View of **Woodlands** from gate, eastern elevation. House, Morton Bay Fig, Garage, Bails (19th century) Bails (1950's) Looking west MH 1997 photograph 1.21

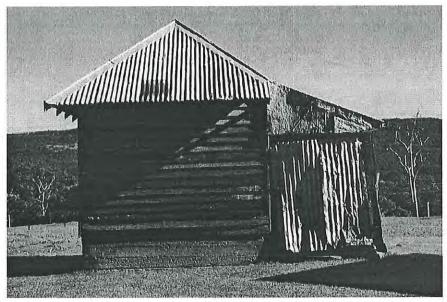
Dairy (creamery). Splayed weather boards, once painted green, timber frame, 50 cm thick concrete base. Small window in southern wall, Wide Eaves, corrugated iron sheeting. Interior, lined ceiling, white washed. Looking west MH 1997 photograph 1.22

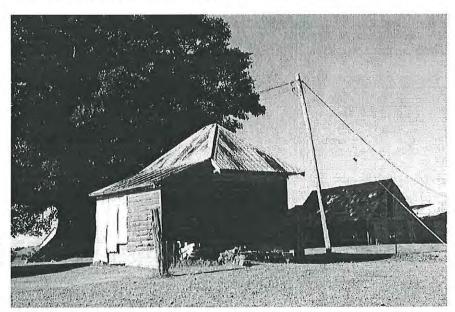
Dairy western elevation, 19th century milking bails in distance. Remnant fence posts. Looking east MH 1997 photograph 1.23

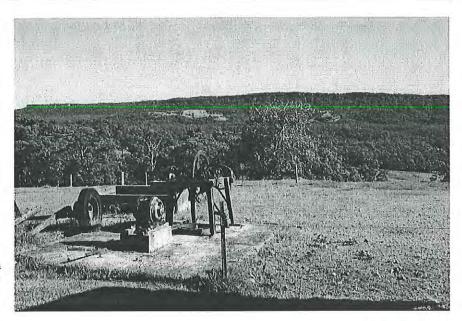
Concrete floor adjacent to former feed stalls. Engine mount for chaff cutter with General Electric Induction motor bolted in place. Ja. Smith-Ballarat chaff cutter on timber stand. Distant view to site of pig sty. Looking west MH 1997 photograph 1.24

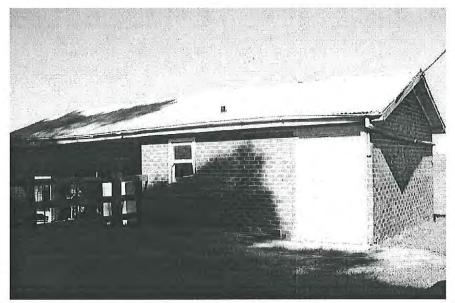
1950's red brick bails, milk room RHS, with concrete driveway for tanker. Looking south MH 1997 photograph 2 4

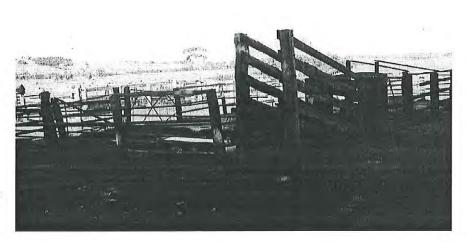
1950's cattle ramp and yards. Looking south-east MH 1997 photograph 2 5

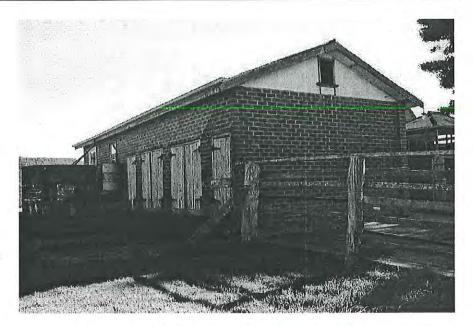
1950's bails, 2x2, 2x1, exit onto concrete, louvred gable for ventilation to roof area. Water tank for dairy use Looking north-west. MH 1997 photograph 2 6

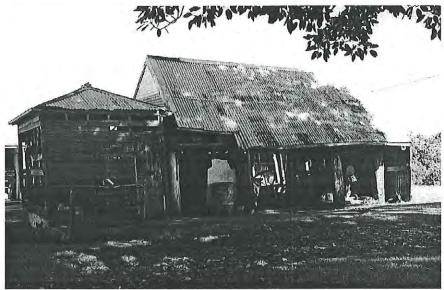
19th century bails. centre, engine room for milking machine, double up machine. Engine base extant. LHS, weather board milk can room with vertical board door. Looking south-west MH 1997 photograph 2 7

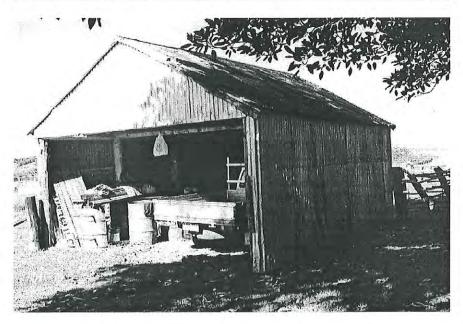
Garage, natural round posts, corrugated iron cladding, recent construction. Looking south-east MH 1997 photograph 2 8

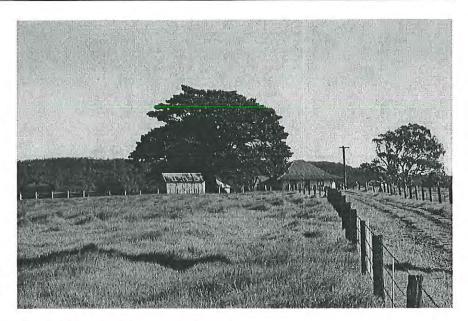
View of **Woodlands** from gate, eastern elevation. House, Morton Bay Fig, Garage, Bails (19th century) Bails (1950's) Looking west MH 1997 photograph 1.21

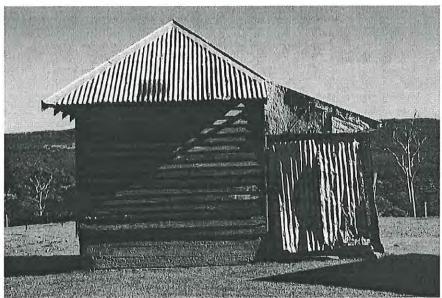
Dairy (creamery). Splayed weather boards, once painted green, timber frame, 50 cm thick concrete base. Small window in southern wall, Wide Eaves, corrugated iron sheeting. Interior, lined ceiling, white washed. Looking west MH 1997 photograph 1.22

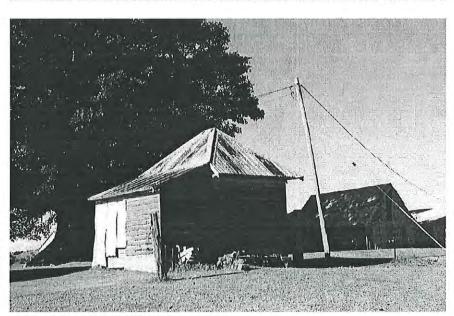
Dairy western elevation, 19th century milking bails in distance. Remnant fence posts. Looking east MH 1997 photograph 1.23

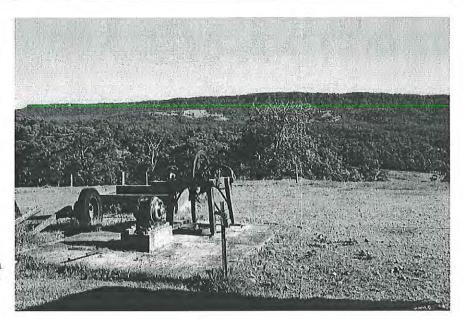
Concrete floor adjacent to former feed stalls. Engine mount for chaff cutter with General Electric Induction motor bolted in place. Ja. Smith-Ballarat chaff cutter on timber stand. Distant view to site of pig sty. Looking west MH 1997 photograph 1.24

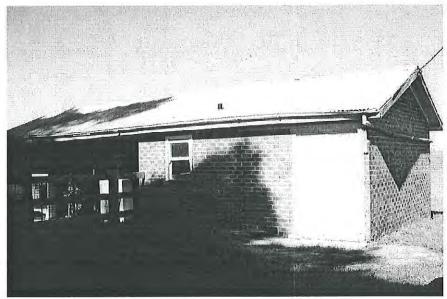
1950's red brick bails, milk room RHS, with concrete driveway for tanker. Looking south MH 1997 photograph 2 4

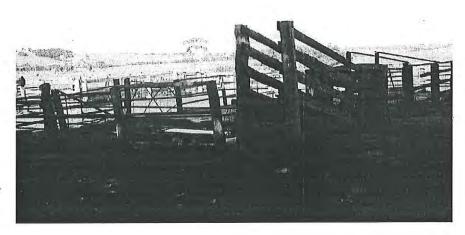
1950's cattle ramp and yards. Looking south-east MH 1997 photograph 2 5

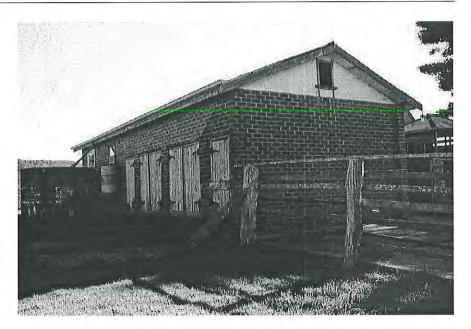
1950's bails, 2x2, 2x1, exit onto concrete, louvred gable for ventilation to roof area. Water tank for dairy use Looking north-west. MH 1997 photograph 2 6

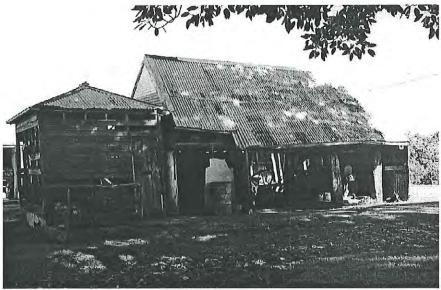
19th century bails. centre, engine room for milking machine, double up machine. Engine base extant. LHS, weather board milk can room with vertical board door. Looking south-west MH 1997 photograph 2 7

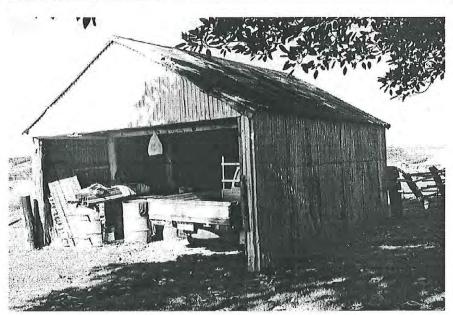
Garage, natural round posts, corrugated iron cladding, recent construction. Looking south-east MH 1997 photograph 2 8

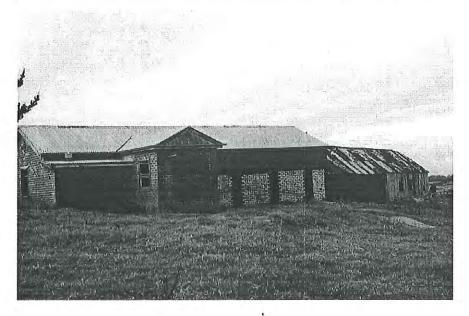
1930's/40's red brick walk through milking bails, exit doors now bricked up, new sheeting on roof. Looking north MH 1997 photograph 1.13

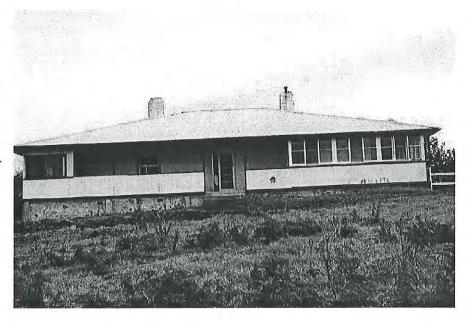
Right: Front (east) elevation of Avenal which was burnt during the 1968 bush fires and re-built on the original c.1865 foundations MH 1997 photograph 1.16

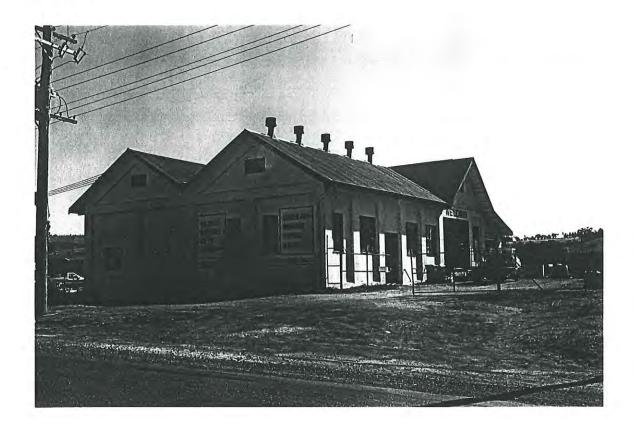
Modifications: The building has lost its equipment in recent years and the gable ventilators have been sealed.

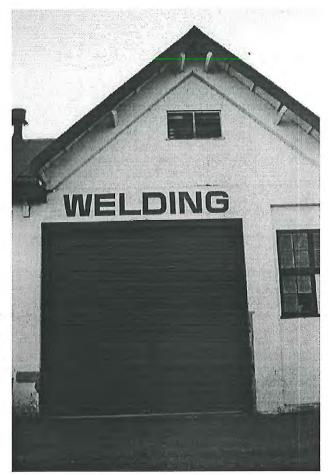
Right: East elevation, delivery receiving dock for milk to be processed. Dock has been cut to form doorway, later use of sit, ice works, fish processing, produce packaging. Looking west MH 1997 photograph 3.8

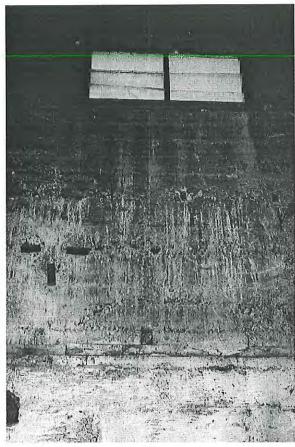
Above right: Interior wall surface, rough finish due to removal of cork lining, used as insulation. Looking north MH 1997 photograph 3.15

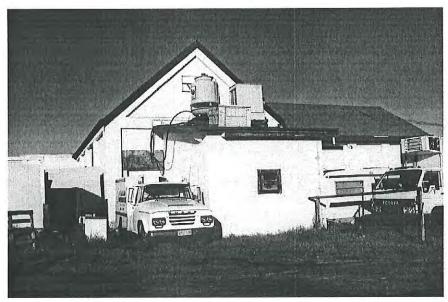
Northern elevation., additional freezer capacity from ice making occupation. Looking east MH 1997 photograph 3.12

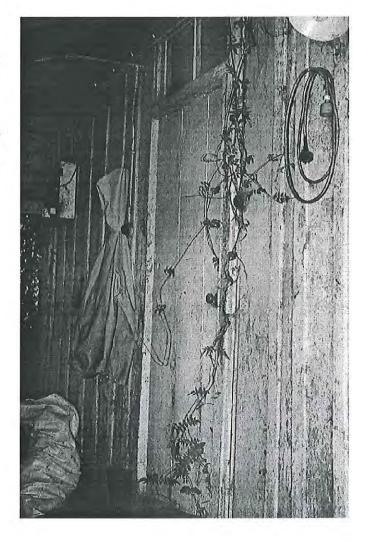
Right: Clinton Park. Mid 19th century slab and batten kitchen, chimney removed form eastern wall, skillion link to vertical sawn plank and batten house. Looking north-west MH 1997 photograph 7.3

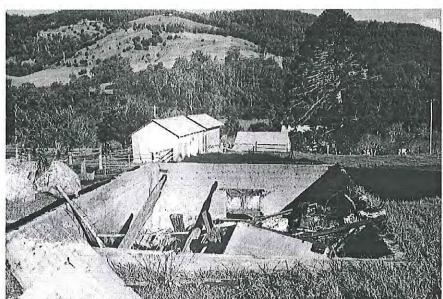
Feed bin formed in concrete with aggregate, reinforced with metal straps and metal bars, lower door to small set of stalls, now gone. Looking south. MH 1997 photograph 7.17

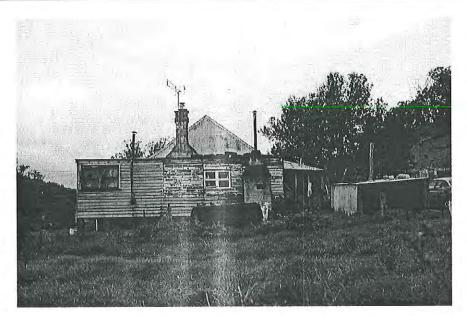
Eastern elevation of house showing 1940's weatherboard extension, the front room is accessed from front verandah. Looking south MH 1997 photograph 5.23

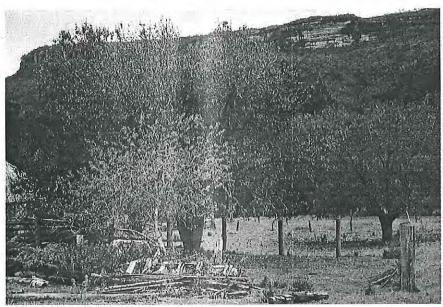
Orchard, west of house, citrus, 2 off Chinese pear, apple pear, apricot Looking east MH 1997 photograph 5.10

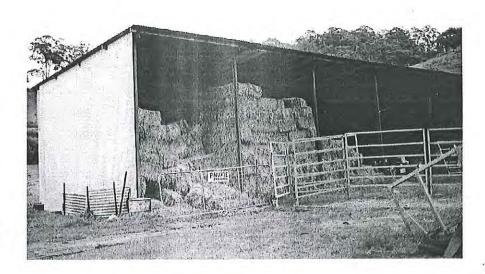
Modern hay shed for beef cattle. Looking south-west MH 1997 photograph 5.22

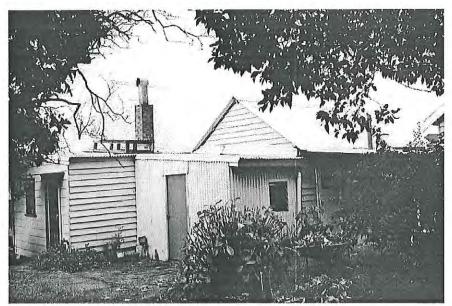
Rear of house, kitchen (original house c.1880) slab structure clad with fibro sheeting. Modern infill between house and kitchen. Looking south-east MH 1997 photograph 3.19

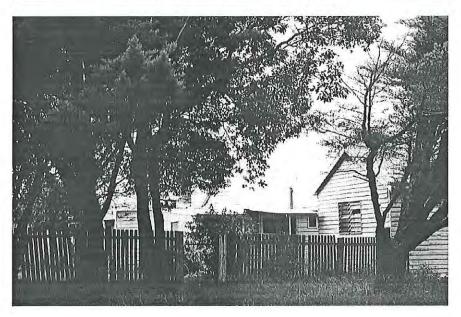
Timber picket fence & windbreak for back garden. Looking south-east MH 1997 photograph 3.20

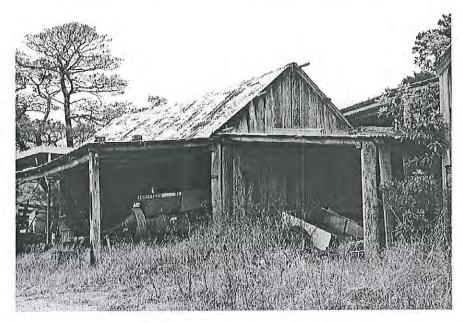
Corn shed and workshop. Looking south-west MH 1997 photograph 4.8

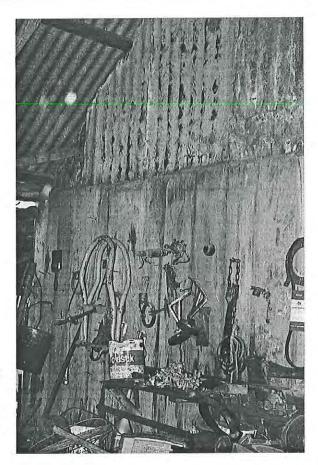
Detail of timber construction, corn store, external north, slabs nailed onto round timber frame. wall now covered workshop. Looking south-east MH 1997 photograph 4.6

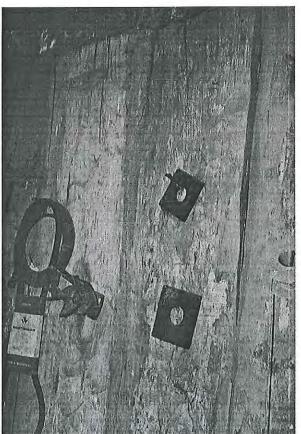
External slabs, residue newspaper. Looking southeast MH 1997 photograph 4.7

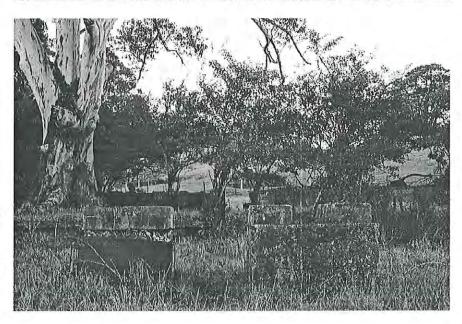
Concrete and aggregate plinths formed in ships water tank used to support shaft and flywheel between. Mounts have built in drainage funnel and drainage pipes for oil/water cooled bearings. Looking north MH 1997 photograph 7.22

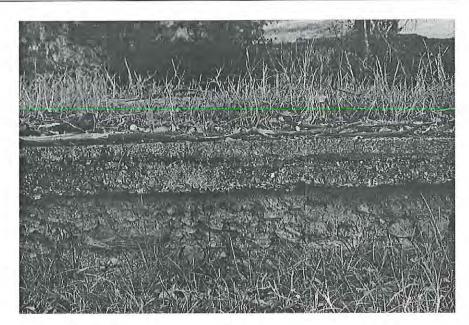
Detail of concrete factory floor on earth terrace. Looking north MH 1997 photograph 7.23

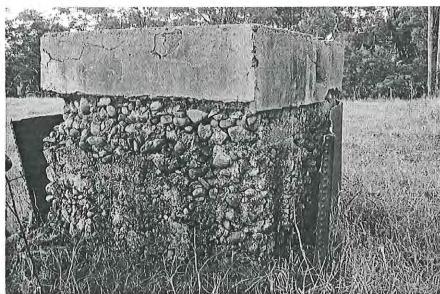
Detail of concrete and aggregate machinery mount with riveted wrought iron ships water tank form work and jacket (available 1850's). MH 1997 photograph 7.24

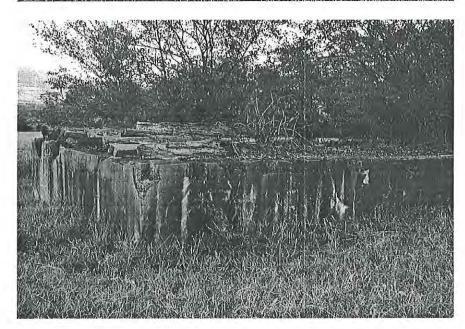
North eastern corner (refrigeration area, thick concrete base) showing recesses for joists extending north. Looking south MH 1997 photograph 7.25

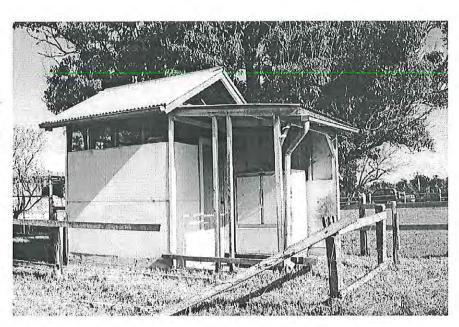
Below: Meat room, pulley mounted under verandah roof, sawn timber frame with fibro sheet cladding, concrete floor and wire screen top section of walls, no drainage or blood trap evident. Looking south MH 1997 photograph 6.21

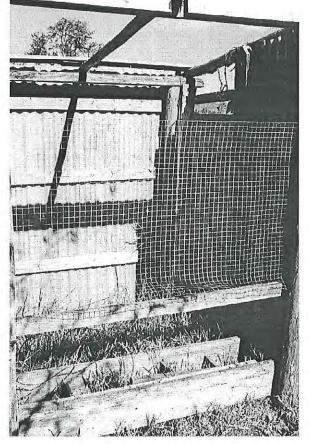
Below right: Calves pen, natural round timber posts, sawn timber frame, corrugated iron sheet cladding, timber feed box below wire mesh screen, single door entrance with roof sheeting missing. Looking south MH 1997 photograph 6.19

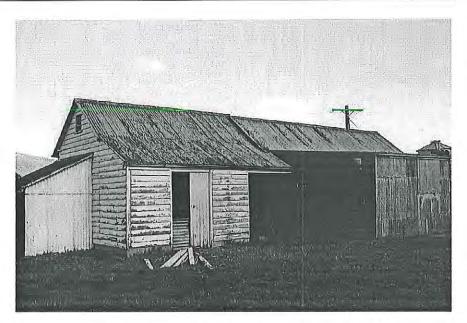
Milk room, engine room and wash-up area with recent skillion addition.Looking south-west MH 1997 photograph 6.15

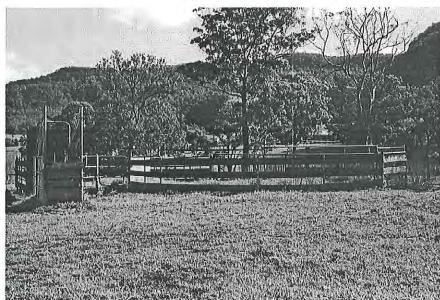
Octagonal yard leading to cattle crush and race, tubular steel frame with timber rails. Looking north MH 1997 photograph 6.16

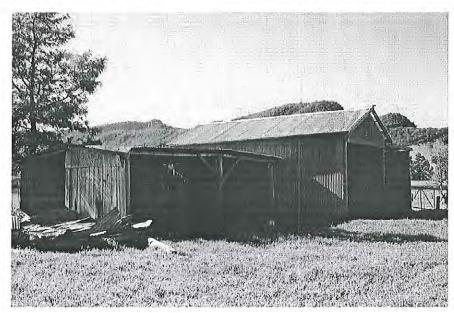
Equipment sheds, timber posts with sawn timber frames, corrugated iron sheet cladding, vertical slab wall at western end of tractor shed. Looking north-east MH 1997 photograph 6.20

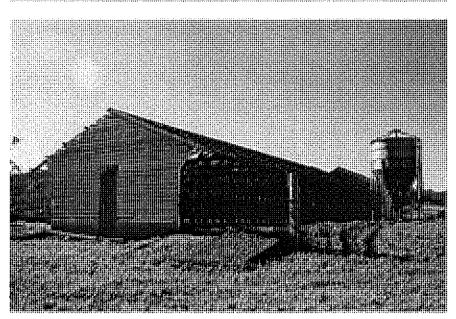
Rough concrete, with river pebble aggregate, access ramps to feed stalls. Modern sheet metal feed hopper, eastern end. Looking east MH 1997 photograph 6.4

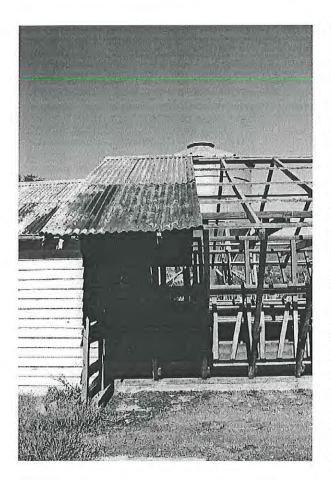
Above: Stalls section with remnant corrugated iron sheeting. Looking south MH 1997 photograph 6.2
