2016 June 4 - 7 East Coast Low Flood / Coastal Storm Event Remediation Assessment

Shoalhaven City Council
Shoreline Protection Condition Assessment
5 Year Update
Final Report

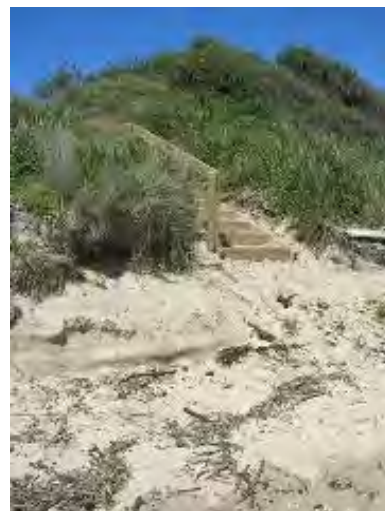
Beach access at Currarong before event. There were 8 beach access ways at Currarong Beach.

The surviving access at the western access at the end of Peel Street was repaired to maintain one safe access.

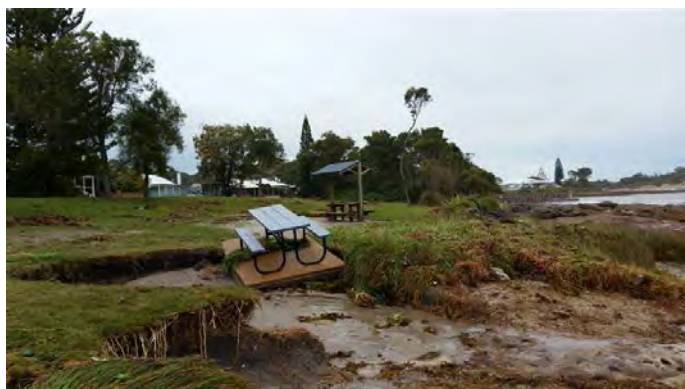
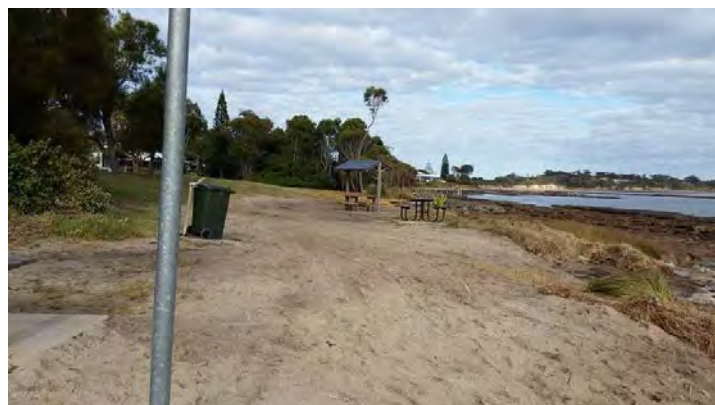
Abrahams Bosom Reserve after the event (left) and following initial clean up (right)

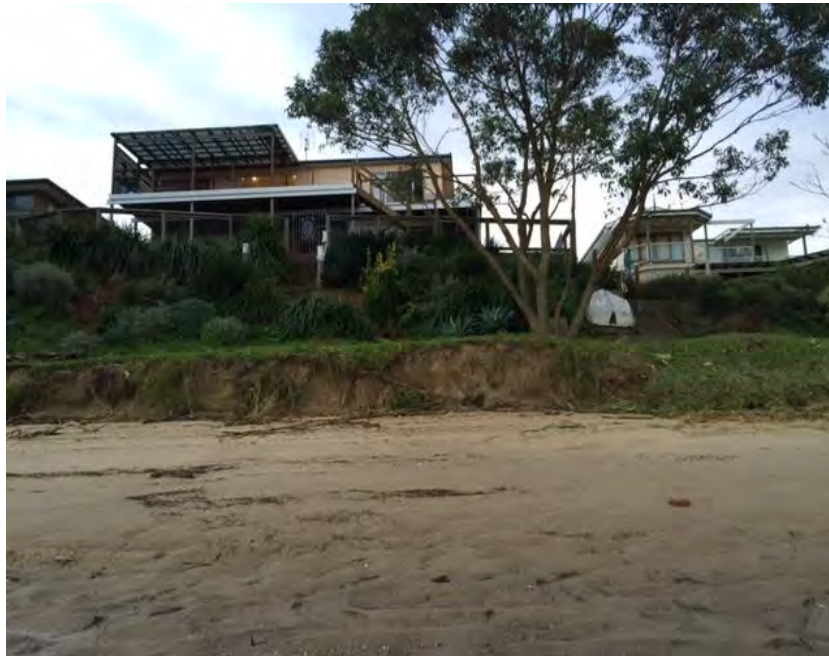
Site 1 the River Rd foreshore has moderate erosion impacts as the flood notch breached allowing significant ocean swell / king tide to enter combining with local flooding.

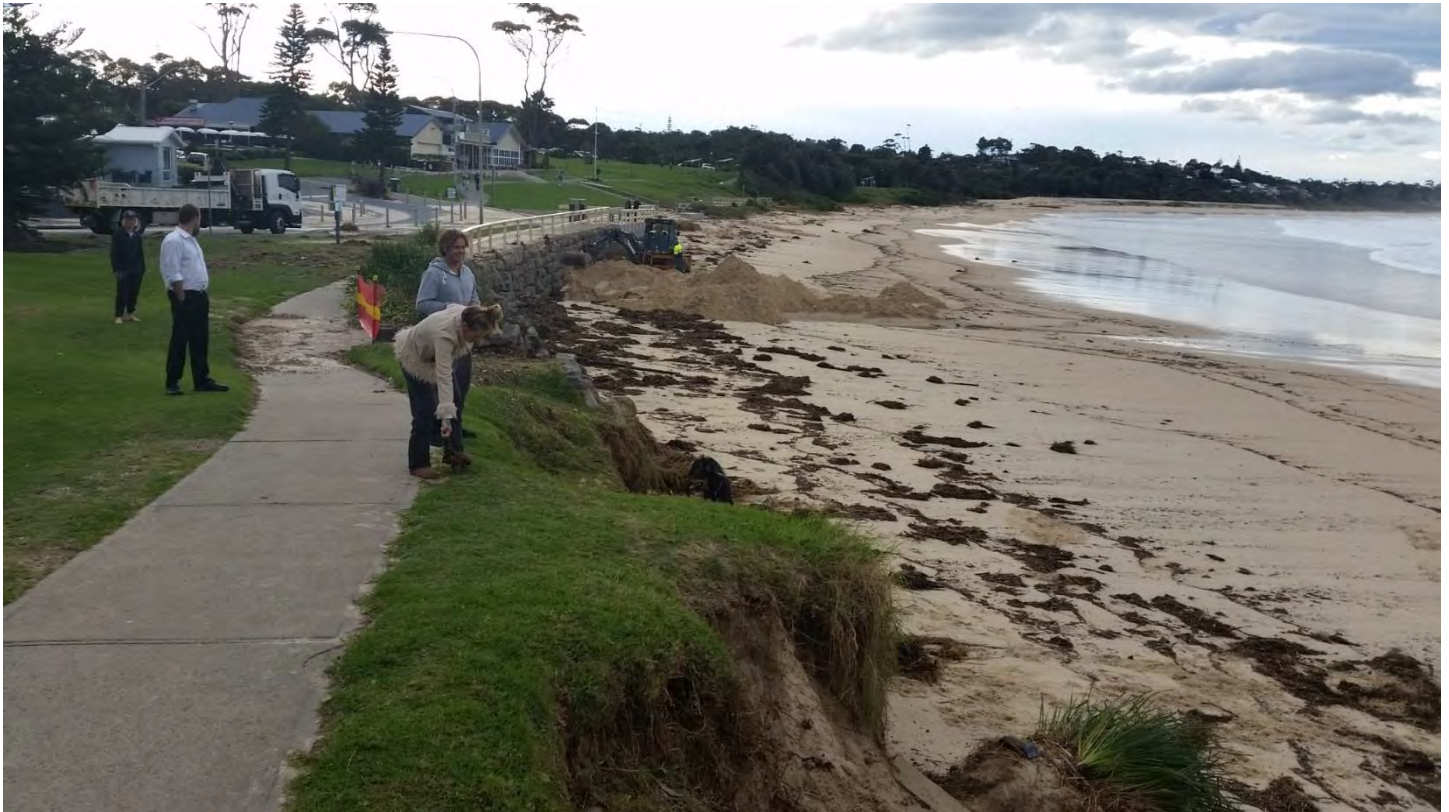
Site 1 South end damages included Golf Club gabion wall, Ocean St sandstone sea wall and sand blockage of the road stormwater system.

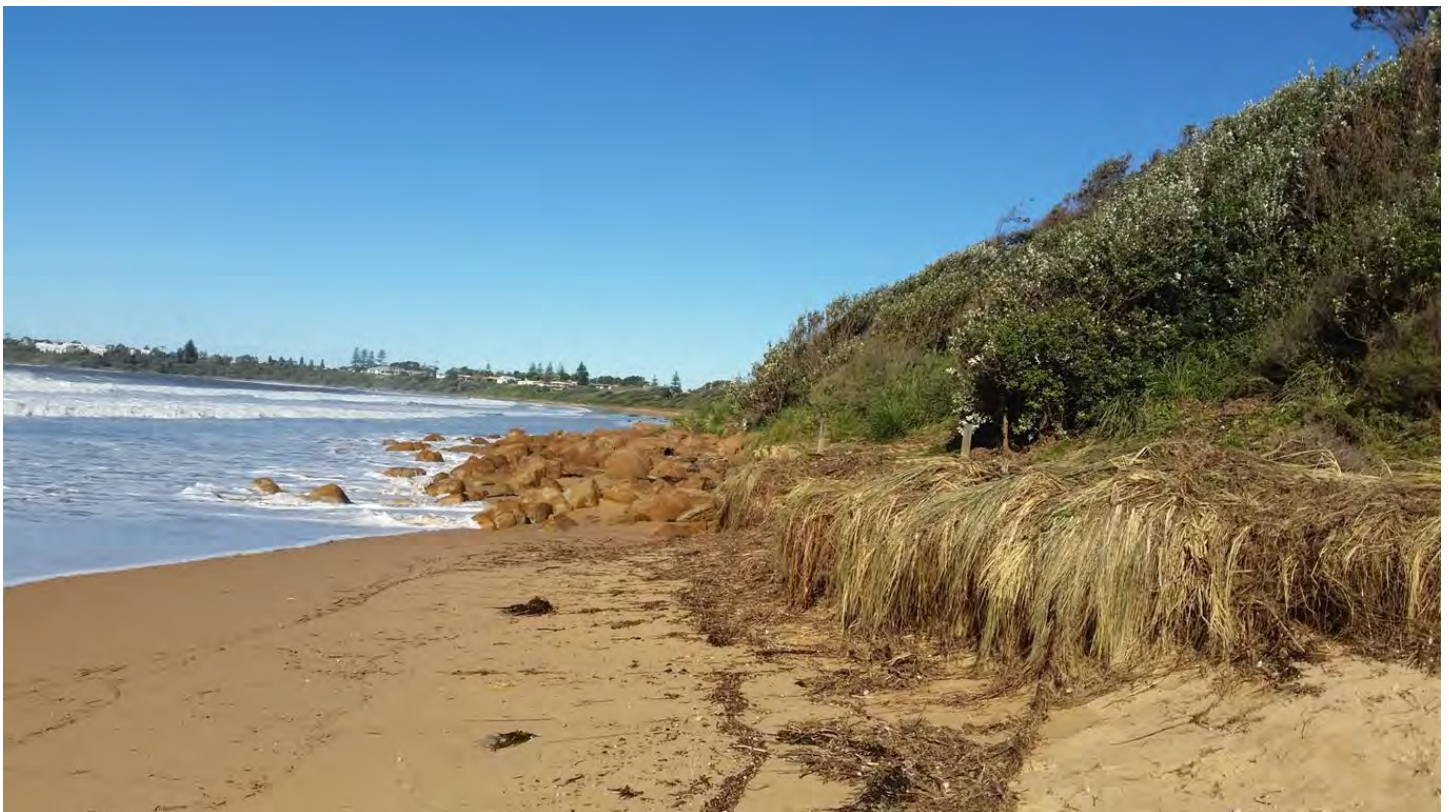
Southern beach access ways were damaged from The Haven north along the entire beach with some rock outcrops uncovered.

Short term responses include preliminary staff inspection and engagement of contractors to inspect and reshape some beach access points where feasible **\$5000**.

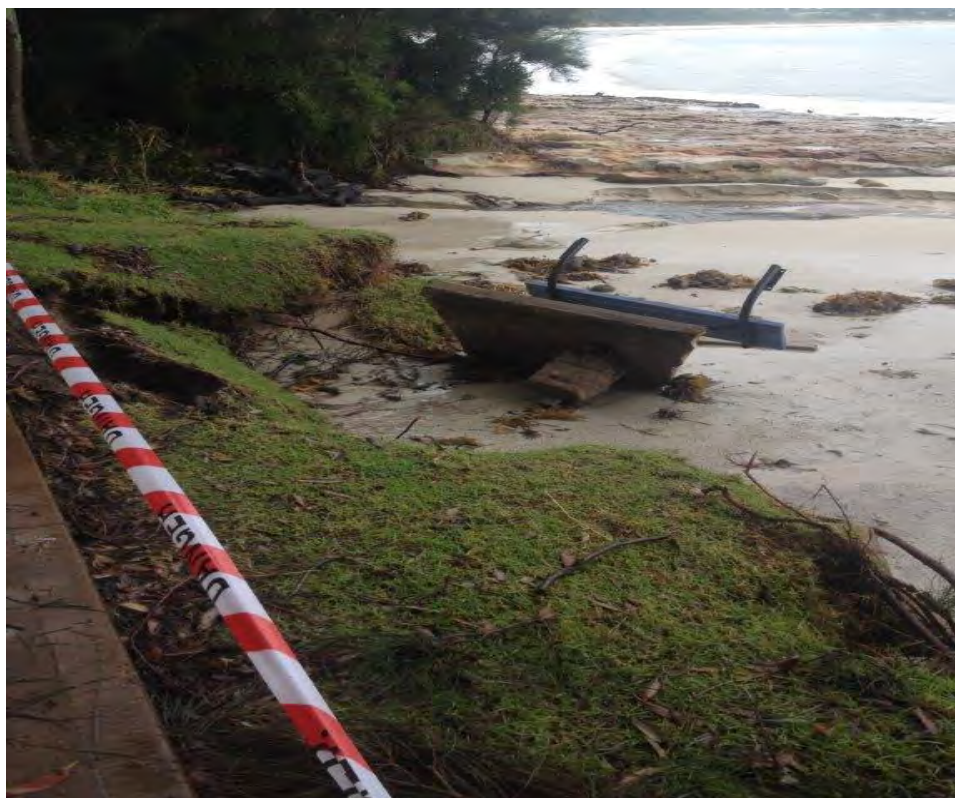
Site 1 Collingwood Beach stormwater outlets eroded and erosion fronting shared pathway along Collingwood Beach.

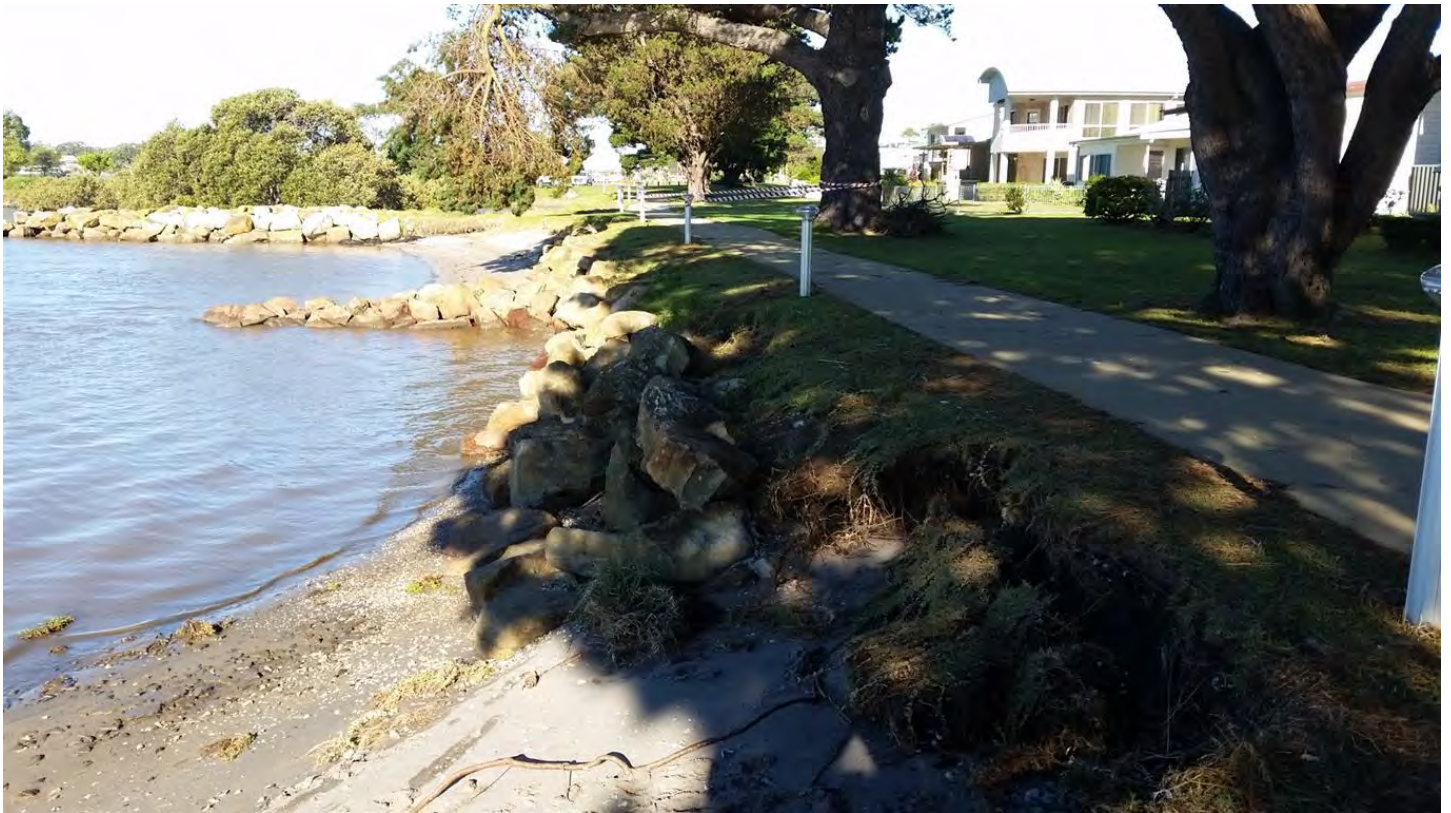
Site 1 Adelaide St minor erosion of existing shoreline protection.

Site 2 Titania Park erosion / undermining of shared footpath that will require short term remediation and long term relocation of some assets or extension of shoreline protection.

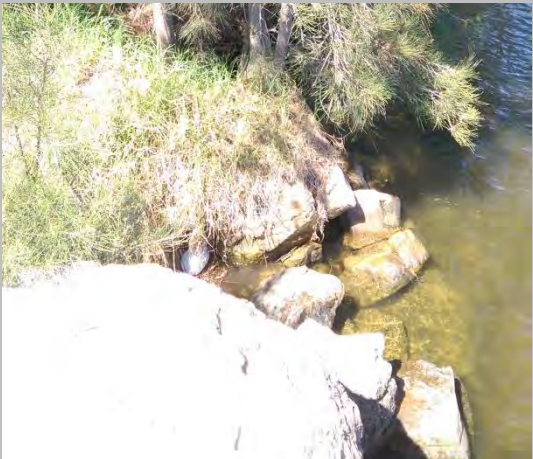
Downstream	Upstream						
034° 52' 00.0" S	034° 52' 02.7" S						
150° 35' 51.0" E	150° 35' 44.9" E						
<p>Description</p> <p>Paringa Park foreshore spans approximately 175 metres along the Shoalhaven River. Intermittent small armour rock as shown in Photo 5 is located at the toe of the bank.</p>	<p>Site Condition</p> <p>Limited coastline protection along the span of Paringa park. Areas of significant erosion of the banks along the shoreline are evident as shown in Photo 6. Trees extending from the banks are currently supporting the banks, however could cause significant bank damage if tree collapse occurs. Steep unstable banks which may erode significantly in storm events if not protected.</p>						
<p>Photo 5 Random Rock Protection</p>

<p>Recommendation and SOW</p> <p>Implement shoreline protection using rock revetment to prevent further erosion of the existing shoreline. Monitor existing overhanging trees to prevent collapse of the already significantly eroded bank and following significant flood and storm events. Potentially prevent further damage through stumping of overhanging trees to reduce lever arm.</p>							
<p>Priority Medium</p>	<p>Cost estimate \$ 180,000</p>

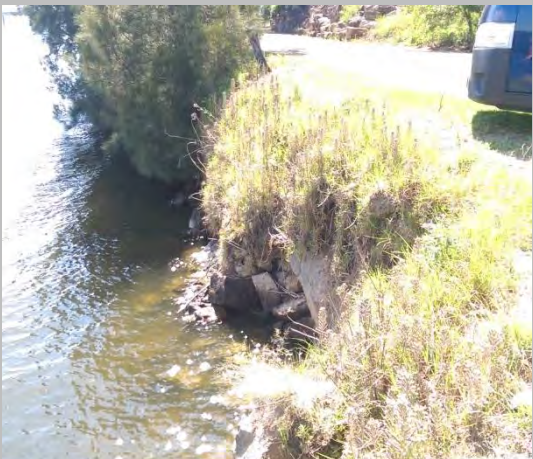
<p>Photo 6 Eroded Shoreline</p>

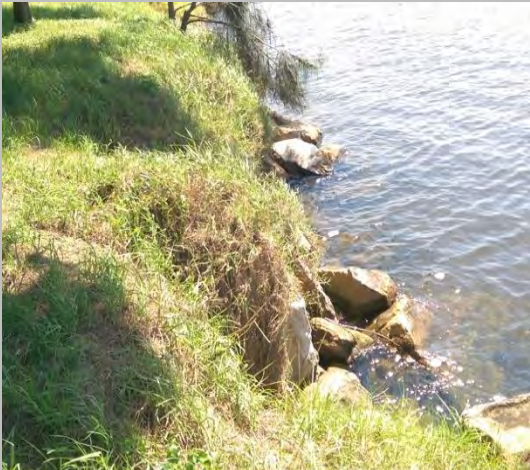
Downstream	Upstream						
034° 51' 46.0" S	034° 52' 06.6" S						
150° 35' 53.2" E	150° 35' 31.7" E						
<p>Description</p> <p>Greys Beach shoreline protection consists of approximately 800 metres of armour rock protection spanning from the Nowra Golf Club to the downstream boat-launching ramp.</p>	<p>Site Condition</p> <p>Small areas of base material are exposed because of slight collapse and displacement of the armour rock below the Nowra Golf Club parking facility. Dense grass vegetation exists over areas of shoreline protection improving bank stability. Multiple areas of steep unprotected areas and undercutting due to collapse of the bank and displacement of armour rock.</p>						
<p>Photo 7 Eroded Rock Unstable bank</p>

<p>Recommendation and SOW</p> <p>Remediate shoreline protection and eroded areas by implementing additional large armour rock to replace displaced rock to protect shoreline from additional erosion. Monitor undercutting and development of steep banks following large rainfall events until remediation is undertaken.</p>							
<p>Priority</p> <p>Low-Medium</p>	<p>Cost estimate</p> <p>\$ 20,000</p>

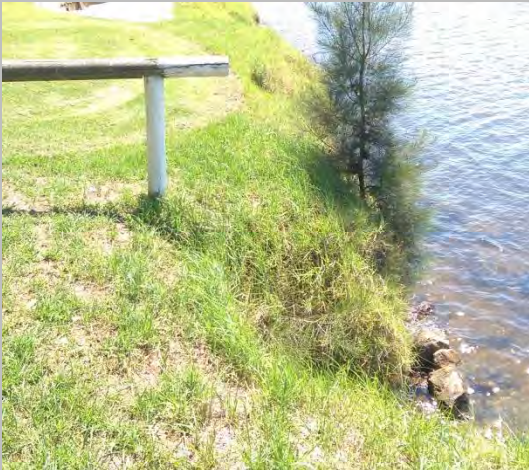
<p>Photo 8 Collapse of bank</p>

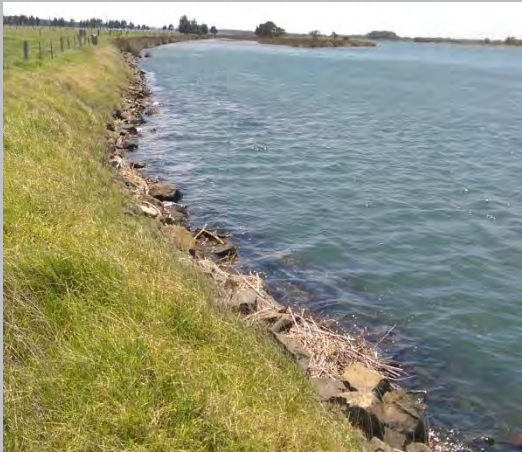
Downstream	Upstream						
034° 53' 03.6" S	034° 52' 57.4" S						
150° 42' 42.9" E	150° 42' 47.4" E						
<p>Description</p> <p>Comerong Island Ferry shoreline protection consists of medium to large armour rock spanning approximately 35 metres downstream of the access ramp and medium armour rock spanning approximately 190 metres upstream.</p>	<p>Site Condition</p> <p>The shoreline protection asset is in good condition and is functioning as intended. No areas of erosion or significant displacement of armour rock visible.</p>						
<p>Photo 10 Upstream shoreline protection</p>

<p>Recommendation and SOW</p> <p>Protection working as intended. Monitor following significant rain and flood events.</p>							
<p>Priority Low</p>	<p>Cost estimate Nil.</p>

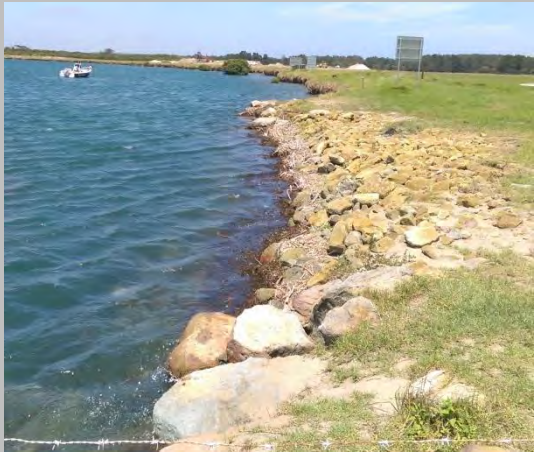
<p>Photo 9 Downstream shoreline protection</p>

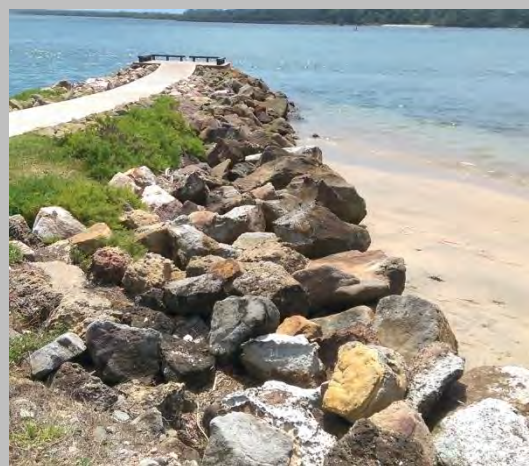
Photo 14 Armour Rock Protection

Remediate area of exposed base material as shown in Photo 13 above with medium armour rock to prevent further erosion and displacement of base material. Monitor annually and following significant rain events for erosion and displacement of armour rock.

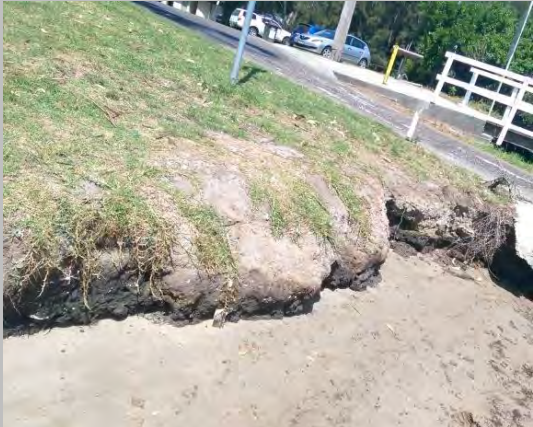
<p>Description</p> <p>Orient Point boat ramp is located on the Crookhaven River. The site consists of a jetty and a boat ramp, and limited coastal protection.</p>	<p>Site Condition</p> <p>Both banks adjacent the boat ramp and under the boat ramp are experiencing significant undercutting and erosion of the banks. The extent of the erosion is highlighted in Photo 16.</p>
<p>Photo 16 Unprotected shoreline</p>

<p>Recommendation and SOW</p> <p>Implement coastal protection using either medium armour rock or sand nourishment along exposed area to prevent further erosion and potential damage to carpark and boat ramp assets.</p>	
<p>Priority Medium</p>	<p>Cost estimate: \$ 16,000</p>

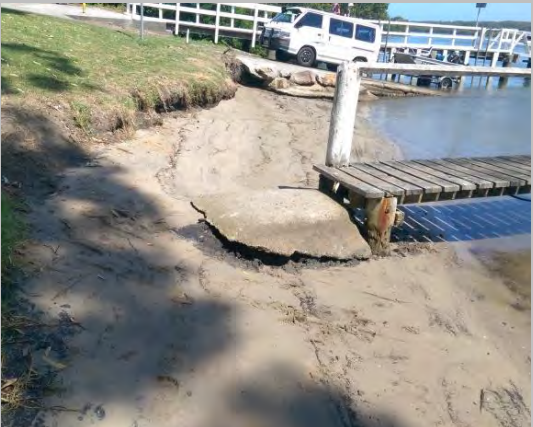
<p>Photo 15 Undercutting due to beach erosion</p>

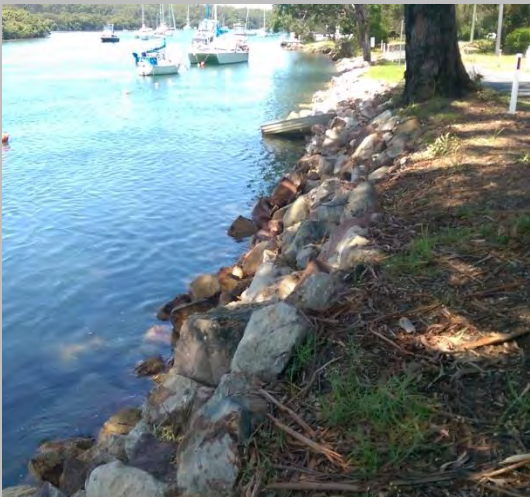
Upstream	Downstream						
035° 01' 28.9" S	035° 01' 32" S						
150° 39' 52.9" E	150° 39' 59.5" E						
<p>Description</p> <p>The protection along Currumbene Creek spans approximately 200 metres and consists of medium armour rock revetment protecting the steep bank along Coulon St to the Frank Lewis Way intersection. From this intersection to the boat ramp consists of sandstone armour rock bound by concrete.</p>	<p>Site Condition</p> <p>The recently implemented armour rock revetment located along Coulon St is in good condition and working as intended. The armour rock located between the Coulon St junction and the boat ramp has been displaced leading to erosion and exposure of the base material as well as voids in the armour rock as shown in Photo 22. Areas of no protection are experiencing undercutting.</p>						
<p>Photo 21 New rock revetment</p>

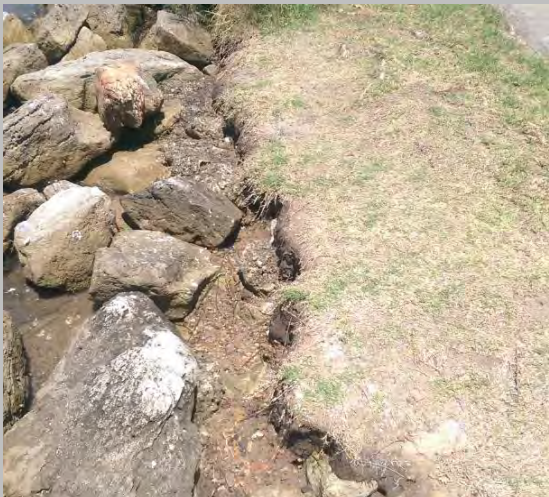
<p>Photo 22 Eroded base material</p>

<p>Recommendation and SOW</p> <p>Place medium armour rock (to match existing) along eroded area to prevent further erosion of the base material and to fill voids in existing asset. Extend existing rock armour along small unprotected areas to prevent further undercutting and erosion. Monitor exposed base material following high rainfall and flood events until remediation has been undertaken.</p>							
<p>Priority</p> <p>Low-Medium</p>	<p>Cost estimate:</p> <p>\$ 18,000</p>

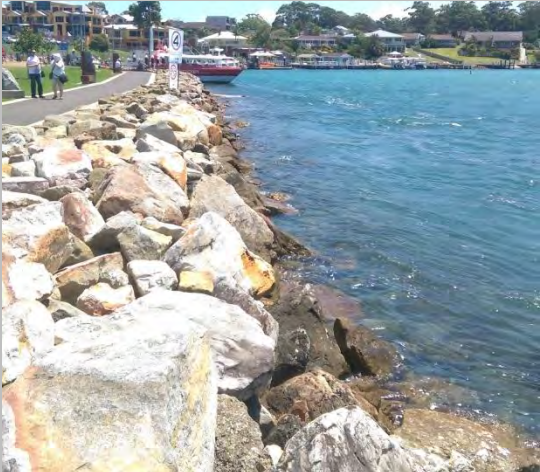
Upstream	Downstream						
035° 02' 16.9" S	035° 02' 16.8" S						
150° 40' 23.6" E	150° 40' 17.3" E						
<p>Description</p> <p>Voyager Park seawall is located at the entrance of Currambene Creek and is composed of a primary and core rock armour. The structure extends approximately 180 metres from Huskisson boat ramp beside a pedestrian footpath.</p>	<p>Site Condition</p> <p>The seawall structure is in good condition and is operating as intended. There is no evidence of scour or toe failure along the seawall and no erosion behind the armour rock wall.</p>						
<p>Photo 23 Voyager Park Seawall</p>

<p>Recommendation and SOW</p> <p>Seawall structure working as intended and is in good condition. Monitor on a biannual basis and after storm events to assess the development of voids along the seawall.</p>							
<p>Priority Low</p>	<p>Cost estimate: Nil.</p>

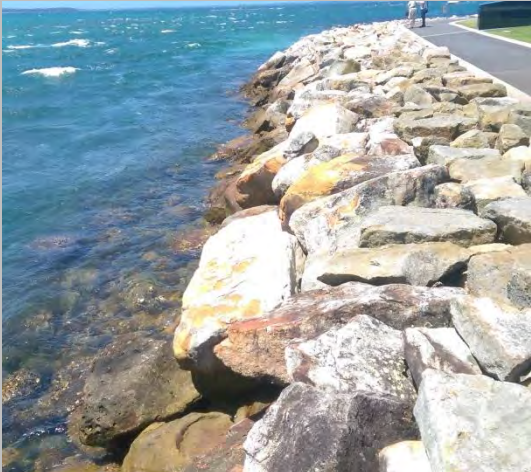
<p>Photo 24 Voyager Park Seawall</p>

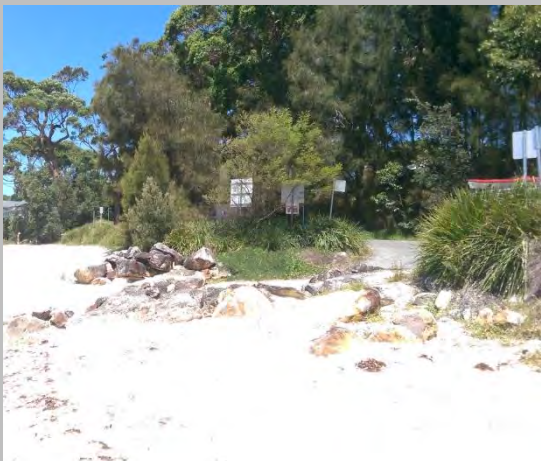
Photo 28 Boat ramp protection

Recommendation and SOW Remediate adjacent armour rock to the boat ramp and extend into a groyne-like structure to prevent beach erosion, improve usability and prevent further scour of the boat ramp. Remediate voids in existing rock revetment with primary armour to match existing along the bank to prevent further slumping failure and erosion. Consider limiting the use of the boat ramp at low tide due to drop off at the end of the ramp until remediation has been implemented.

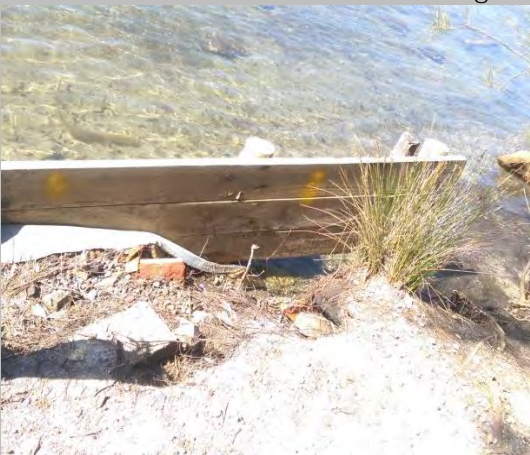
Downstream	Upstream						
035° 10' 17.3" S	035° 10' 14.2" S						
150° 35' 26.1" E	150° 35' 30.1" E						
<p>Description</p> <p>The shoreline protection spans approximately 140 metres along the front of the bowling club to the Seacrest Caravan Park. It consists of a timber plank retaining walls and four rock groynes.</p>	<p>Site Condition</p> <p>The rock groynes are functioning as intended and have no significant voids. Geotextile material and erosion is visible behind the timber retaining wall as highlighted in Photo 31 below. Exposed geotextile material also located along the shoreline. Minor erosion along the bank due to displacement of armour rock has occurred, however the protection is working as intended.</p>						
<p>Photo 31 Erosion behind retaining wall</p>

<p>Recommendation and SOW</p> <p>Remediate retaining wall (Photo 31) by implementing an additional base plank and back filling to prevent further erosion and degradation of the geotextile material. Remediate minor erosion due to displacement of armour rock as shown (Photo 30), and cover exposed geotextile material located along the bank to prevent further degradation.</p>							
<p>Priority</p> <p>Low-Medium</p>	<p>Cost estimate:</p> <p>\$ 10,000</p>

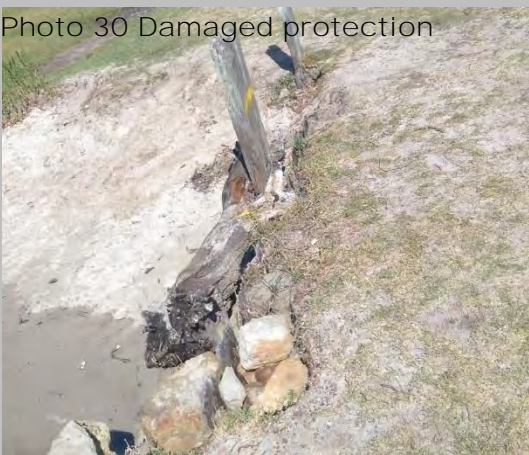
<p>Photo 30 Damaged protection</p>

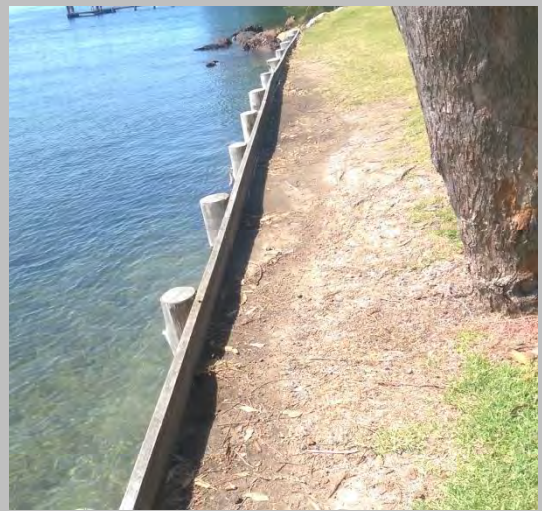
Photo 33 Timber Retaining Wall

The shoreline protection asset is in good condition along Lions Park and around the Lions Park boat ramp. One area has experienced erosion behind the wall as shown (Photo 32). The structure is operating effectively and is in good condition in all other locations.

Remediate erosion behind timber plank retaining wall as identified in Photo 32 above by filling to match existing to prevent further erosion. Cover exposed geotextile material to prevent further degradation.

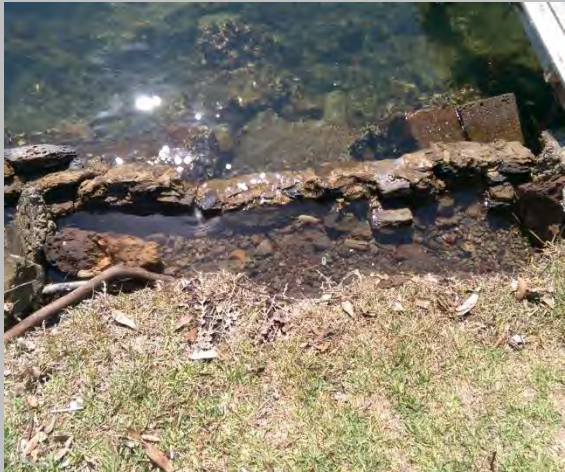
Downstream	Upstream						
035° 10' 33.2" S	035° 10' 23.6" S						
150° 35' 25.9" E	150° 35' 24.6" E						
<p>Description</p> <p>The shoreline protection at Alamein Rd Caravan Park consists of variable material retaining structures at irregular intervals spanning approximately 300 metres along the foreshore of Sussex Inlet.</p>	<p>Site Condition</p> <p>The shoreline protection is experiencing inundation in some areas - Photo 34 - where slumping and erosion have occurred. Due to the variable nature of the material, potential erosion risks are present leading to void generation and shoreline erosion.</p>						
<p>Photo 34 Inundated Protection</p>

<p>Recommendation and SOW</p> <p>The shoreline protection is experiencing areas minor of deterioration and slumping as highlighted above. Due to the variable and unknown behaviour of the builder's rubble, potential risk to the public is present and it is not considered an effective means of bank protection. Remove existing protection and implement an armour rock revetment similar to Scenic Drive Nowra along the foreshore to remove potential hazard to the public and prevent further bank erosion.</p>							
<p>Priority Medium-High</p>	<p>Cost estimate: \$ 340,000</p>

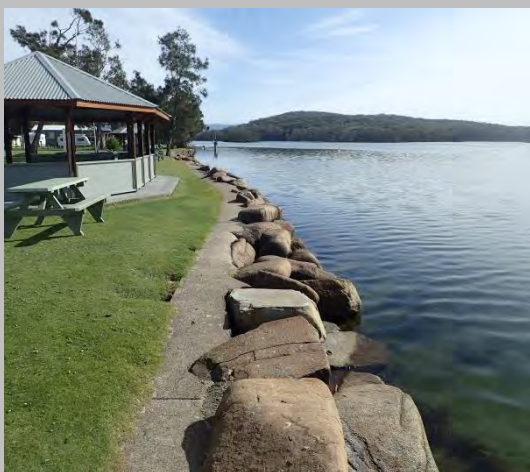
Photo 66 concrete bound armour rock

The coastal protection is operating as intended along the foreshore. The concrete binding is experiencing cracking; however, no significant displacement of the armour rock or failure of the protection is evident.

The shoreline protection is operating effectively and is in good condition. Monitor annually and following large storm and flood events.

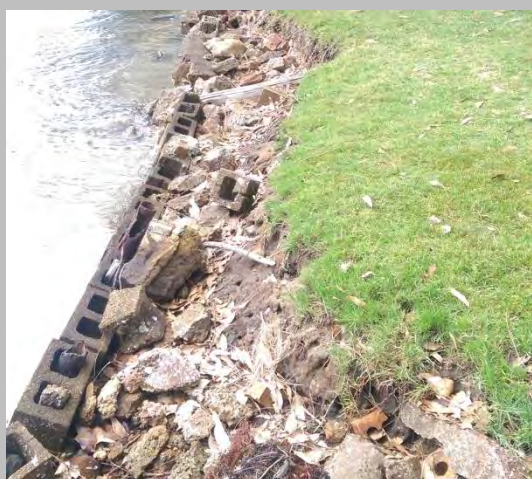
Areas of visible erosion are present along foreshore behind the intermittently placed shoreline protection as shown in Photo 39 and Photo 40 below. Visible signs of slumping are evident. Significant erosion of unprotected areas is also present.

Photo 39 Erosion behind protection

Implement armour rock along the extent of the foreshore behind existing slumping and along unprotected areas to prevent further erosion. Due to the variable and unknown behaviour of the builder's rubble, potential risk to the public is present and it is not considered an effective means of bank protection. Remove existing protection and implement an armour rock revetment. Monitor following significant flood events until protection is implemented.

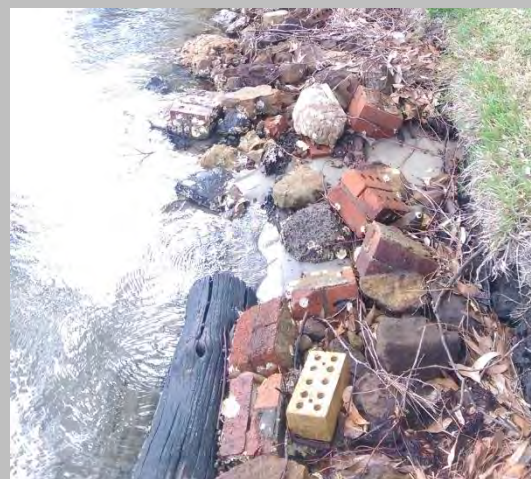
Photo 40 Randomly Placed Protection

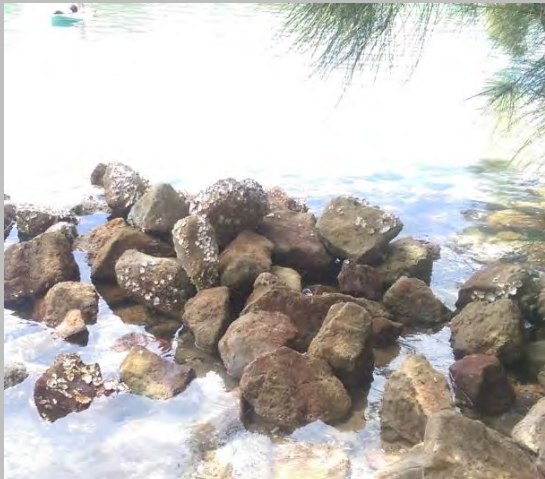
Downstream	Boat ramp	035° 18' 17.9" S	035° 18' 19.6" S	150° 28' 22.9" E	150° 28' 14.4" E		
Downstream	Boat ramp								
035° 18' 17.9" S	035° 18' 19.6" S								
150° 28' 22.9" E	150° 28' 14.4" E								
Description The shoreline protection along the bank of Narrawallee inlet consists of five rock groynes and rock revetment spanning approximately 225 metres. Smaller spans between the rock groynes are experiencing undercutting and erosion.		Site Condition Significant displacement of the armour rock is visible along the shoreline creating voids - Photo 44 - leading to significant erosion of base material and exposure of geotextile material.							
Photo 43 Rock Groyne

Recommendation and SOW Remediate by replacing armour rock to prevent further erosion and degradation. As existing armour rock is being dislodged, implement larger armour rock to fill voids. Limit pedestrian access along unprotected steep bank areas to prevent further erosion and reduce potential hazards.									
Recommended additional works Extend the rock revetment along unprotected banks upstream using large armour rock to prevent further erosion of the steep unstable banks.									
Priority	Medium	Cost estimate:	\$ 70,000

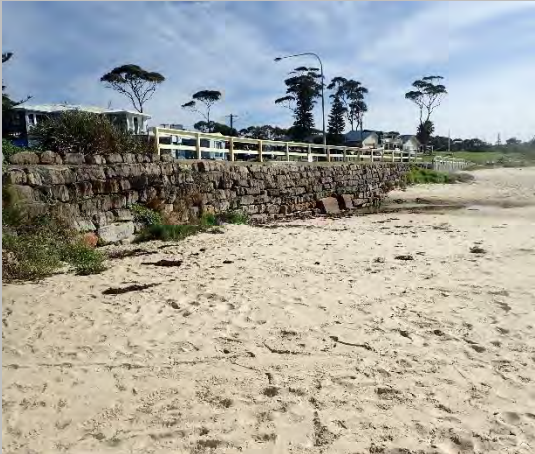
Co-ordinates Drain 035° 20' 22.2" S 150° 28' 27.6" E	Description The shoreline protection at south Mollymook Beach consists of approximately 40 meters of a vertical medium armour rock retaining wall protecting the road and adjacent footpath.	
Site Condition The rock retaining wall is working as intended and no displacement or failure of the wall is evident.		Photo 49 South Mollymook Beach

Recommendation and SOW The shoreline protection is operating effectively and is in good condition. Monitor annually and following large storm and/or flood events for significant scouring or failure of the retaining wall.
Priority Low	Cost estimate: Nil.

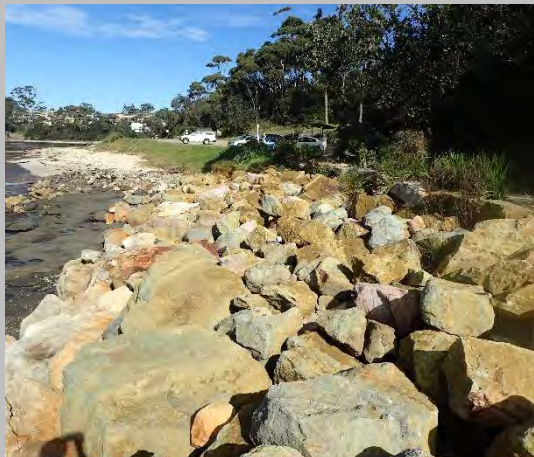
South	North	035° 20' 42.1" S	035° 20' 33.8" S	150° 28' 35.1" E	150° 28' 38.4" E		
South	North								
035° 20' 42.1" S	035° 20' 33.8" S								
150° 28' 35.1" E	150° 28' 38.4" E								
Description The shoreline protection consists approximately 70 meters of medium to large armour rock revetment along foot path.		Site Condition Minor displacement of small-medium armour rock is occurring along the however the revetment is in good condition and working as intended. A small section of geotextile material is exposed along the south end of the rock revetment.							
Photo 51 Armour rock revetment

Recommendation and SOW Consider managing pedestrian access along carpark frontage to limit further erosion by implementing designated beach access and using rubber erosion matting on designated access and fencing alternative areas to prevent further erosion of the bank. Monitor annually and following large storm and flood events.									
Priority	Low	Cost estimate:	\$ 8000

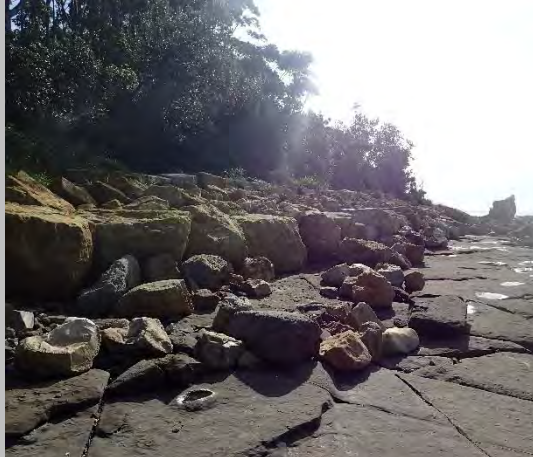
Photo 52 Displaced armour rock

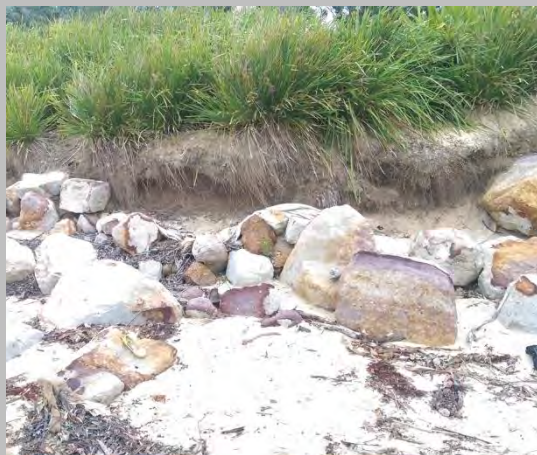
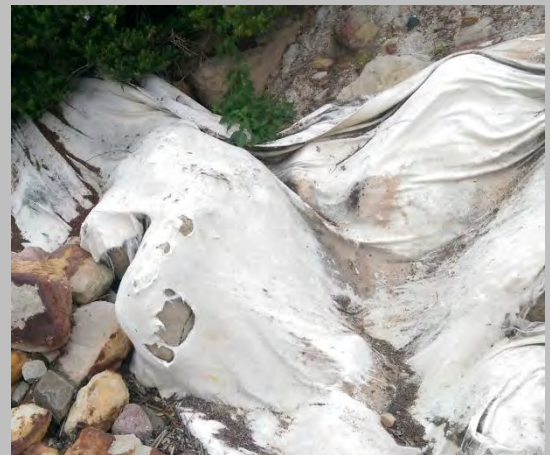
The rock armour is experiencing slumping at the toe, scour and displacement leading to the exposure of geotextile material, erosion of base material and reduction in the stability of the bank.

Photo 53 Erosion of exposed shoreline

Cover geotextile material with armour rock to prevent further degradation. Remediate voids with larger armour rock to prevent further erosion of the base material and collapse of the revetment. Rehabilitate exposed eroded areas and extend rock revetment along the bank. Monitor revetment following significant storm events.

Potentially conduct proper design of shoreline revetment to improve the sustainability of the asset. Implement bank restoration works to prevent damage to the assets being protected.

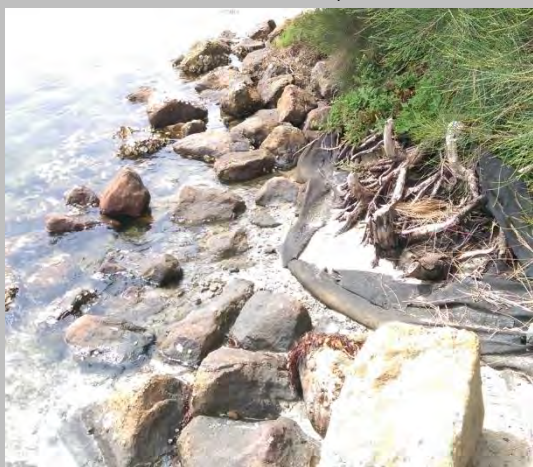
The rock toe protection is experiencing slumping. An overhanging tree - Photo 55 - has the potential to cause significant bank damage. Geotextile material is exposed in areas - Photo 54.

Photo 54 Erosion of exposed bank

To prevent further erosion of the shoreline, implement small armour rock toe protection along the extent of the shoreline and remediate exposed geotextile by sand nourishment.

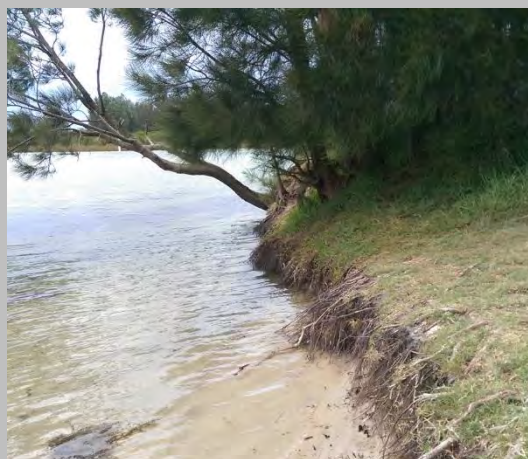
Photo 55 Overhanging tree

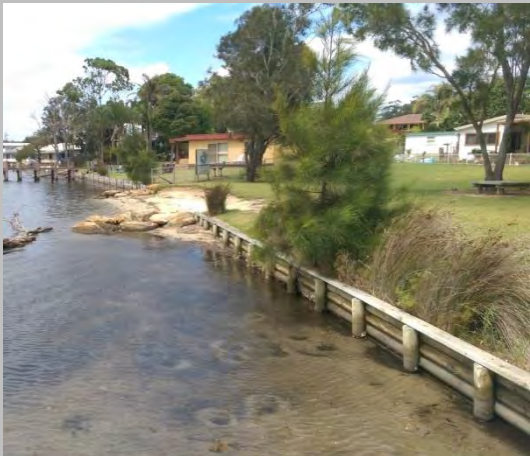
<p>Description</p> <p>The shoreline at Maria Avenue BLR is protected with two rock groynes as well as a timber log retaining wall.</p>	<p>Site Condition</p> <p>The coastal protection assets are in good condition. The rock groynes are working effectively by accumulating sand and preventing erosion.</p>
<p>Photo 56 Timber retaining wall</p>

<p>Recommendation and SOW</p> <p>The shoreline protection is in good condition and is working as intended. The shoreline is not experiencing any erosion.</p>	
<p>Priority Low</p>	<p>Cost estimate: Nil.</p>

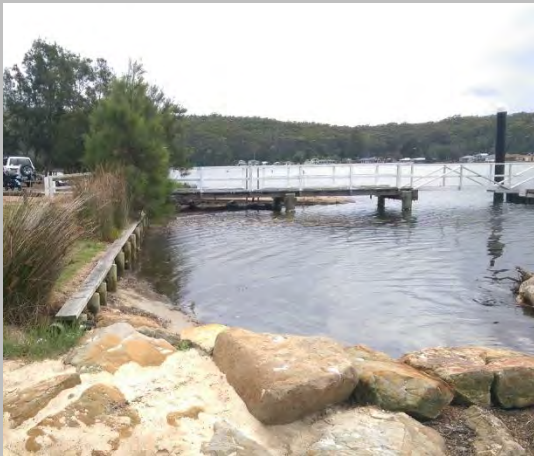
<p>Photo 57 Rock groyne protection</p>

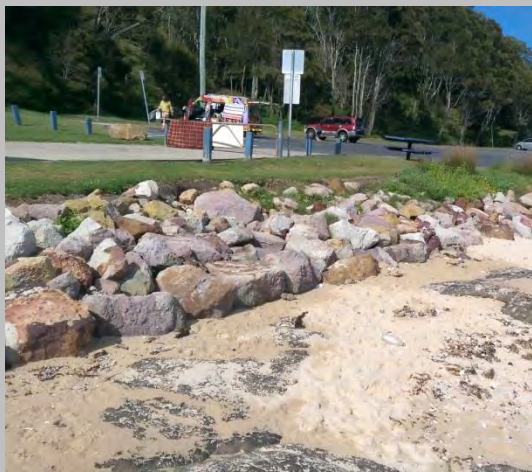
Co-ordinates			
Eastern Point 035° 33' 29.3" S 150° 22' 59.5" E		Western Point 035° 33' 29.7" S 150° 23' 01.4" E	
Description The shoreline protection spans approximately 90 metres along the frontage of the Coastal Patrol building and consists of rock armour.		Site Condition Areas of displacement of the primary armour rock leading to minor erosion of the base material, however the rock protection is working as intended.	
Photo 64 Kioloa rock revetment

Recommendation and SOW The shoreline protection implemented at Kioloa BLR is working effectively and is in good condition. Cover secondary armour rock located between the boat ramp and rock revetment with primary armour to prevent displacement during significant rainfall and flood events.			
Priority	Low	Cost estimate:	Nil.
