## **Shoalhaven Coastal Cliffs and Slopes Risk Management Recommendations Report**

Client: Shoalhaven City Council

Reference: M&APA1474R001F0.3

Date: 11 May 2018

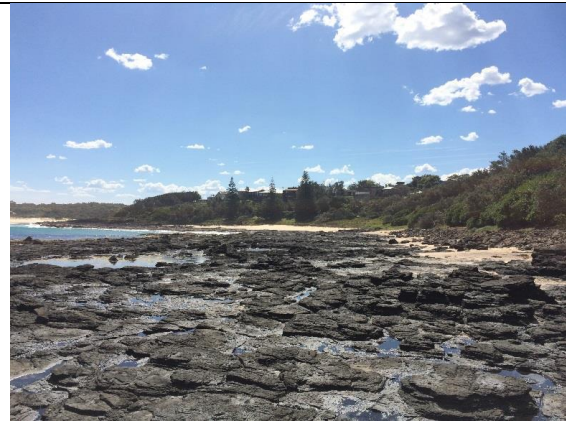
Image 22

The east facing vegetated foreshore slope was inferred to comprise colluvial soils and was typically a maximum of about 30 degrees. There was evidence of traces of old landslip features and what appeared to be a more recent landslip below 27 Sunset Strip (see Image 22).

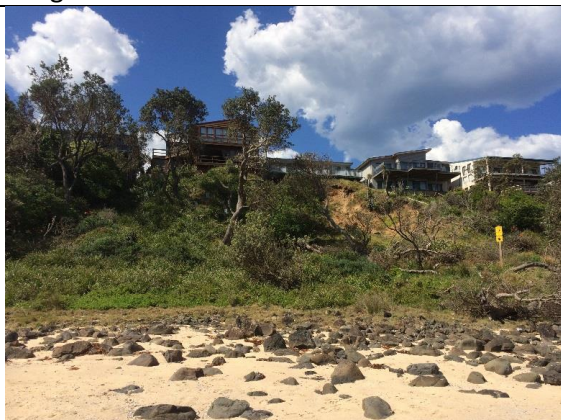
Image 23

To the west of Inyadda Point, DP previously described a 5 metre to 10 metre wide rock armour covering the wave cut platform. The rock armour lining the south facing foreshore slope was either absent or was a maximum width of about 4m (see Image 23).

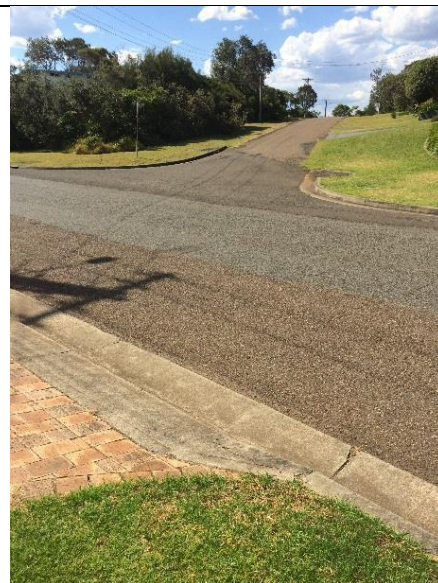
Image 24

The south facing foreshore slope was a maximum of about 35 degrees. A number of erosion gullies were evident and colluvium was exposed in the gully sides. The recent landslip that impacted 65 Sunset Strip in August 2015 was evident (see Image 24).

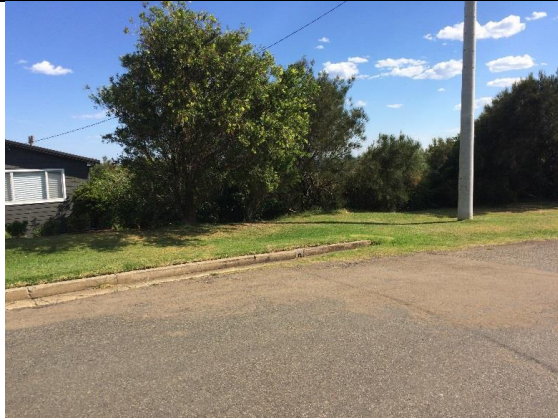
Image 25

There appeared to be an erosion gully on the western boundary of 69 Sunset Strip. The section of Sunset Strip above had been provided with a kerb and gutter but the catchment area included the slope above (see Image 25). At the south-western end of the site, 'erosion/slump chutes' described by DP were evident but overgrown. The kerb and gutter lining the seaward side of Sunset Strip above (adjacent to 113 Sunset Strip) ended at the property boundary (see Image 26).

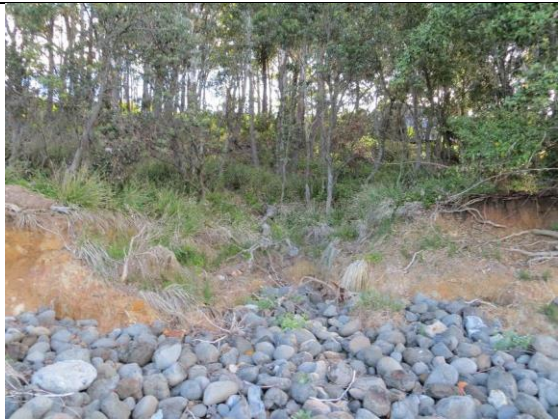
Image 27

The seaward side of Surfers Avenue was lined by a concave slope with a sub-vertical lower portion (maximum overall height about 2.5 metres high) which generally exposed colluvial clayey soils with gravel and cobbles of sandstone. A localised area of fill appears to have been placed to form the car parking area which was set back 2 metres from the crest of the slope (see Image 27). The seaward side of the road was set-back at least 7 metres from the crest of the slope.

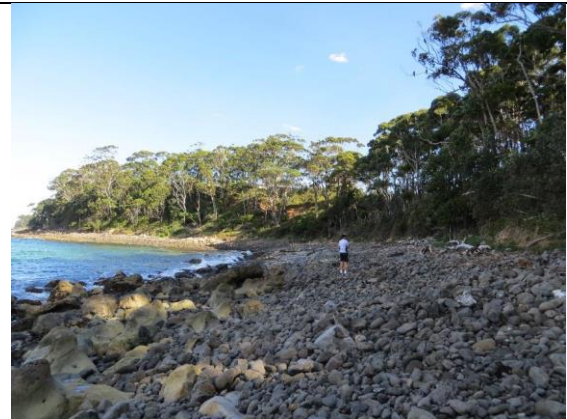
Image 28

The wave cut platform was generally covered by rounded sandstone gravels, cobbles and boulders and the platform surface either exposed residual clays, extremely weathered claystone or, locally, high strength silcrete overlying the clays and claystone. Boulders of silcrete were 'blocky' and angular in shape and appeared to have been eroded in-situ by wave action. To the south of the car park area, the colluvial soils have been eroded to form sub-vertical faces (maximum 2 metres high) and the tree root systems formed overhangs. Some trees had collapsed onto the wave cut platform. The trees covering the old landslide in the reserve area above were leaning over or had curved bases (see Image 28).

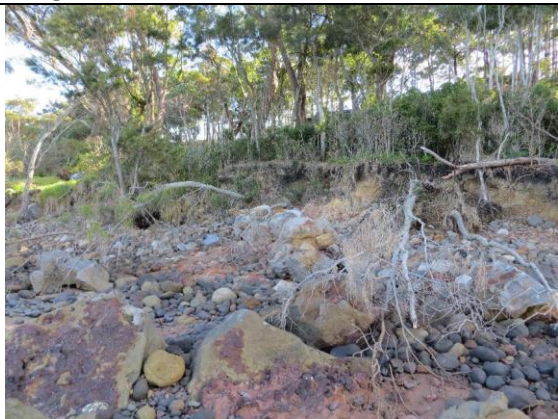
Image 29

The tree covered slope at the southern end of the site sloped down to the east at a maximum of about 35 degrees. The slope surface was uneven and the trees were leaning over or had curved bases. The slope appears to have been previously impacted by a number of landslips (see Image 29).

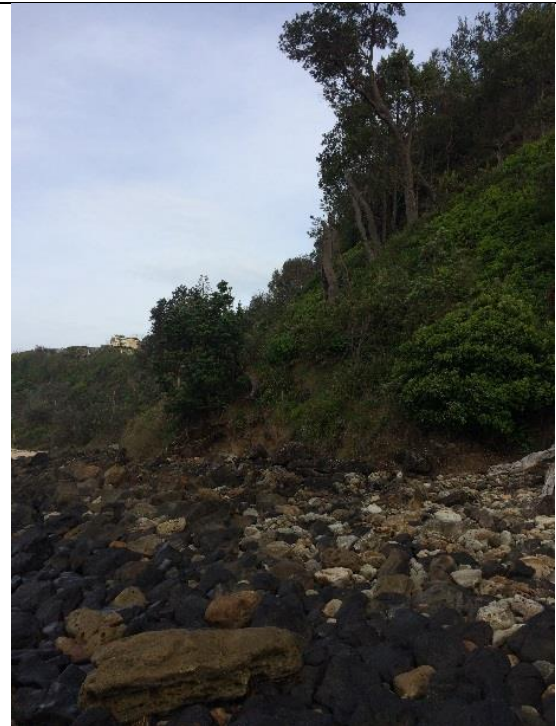
Image 32

Over the western portion of the south facing cliff face, the toe erosion of the overgrown colluvium soil profile was intermittent. At the crest of the cliff, the rear yard of what was inferred to be 168 Mitchell Parade, there appeared to be a gabion retaining wall at the crest of the cliff face and a newly planted soil slope below (see Image 32).

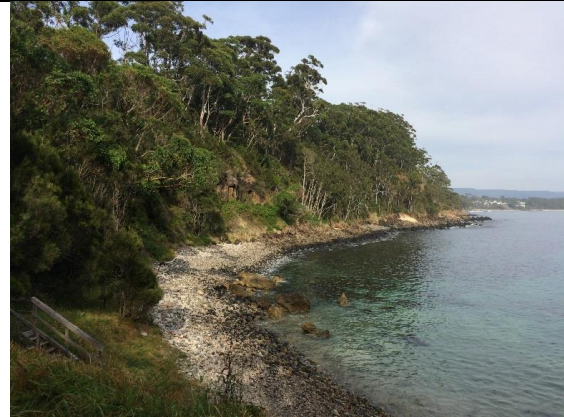
Image 41

The cliff face that extended north-west from the northern end of the headland exposed sub-vertical basalt overlying extremely weathered claystone with numerous angular and 'blocky' basalt blocks (maximum 1 metre dimension) and rounded sandstone gravels and cobbles covering the shoreline (see Image 41). The upper steep slope was tree covered with leaning trees and curved tree bases indicating creep was impacting the upper soil profile. The claystone at the base of the cliff was being eroded, resulting in undercutting of the basalt and block collapses (see Image 42).

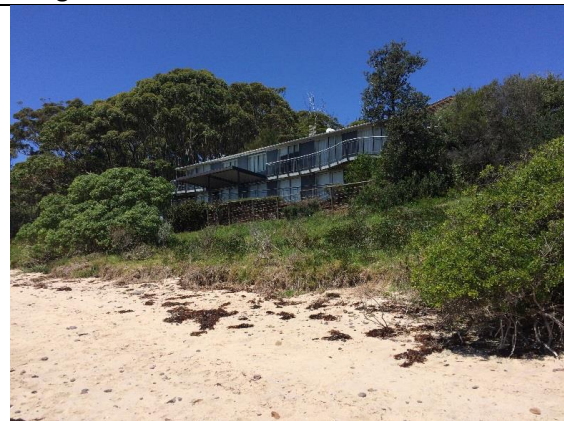
Image 43

At the north-western end of the site, the house identified by DP as being '2 metres to 3 metres above the wave cut platform' corresponded to 17 Shipton Crescent (see Image 43).

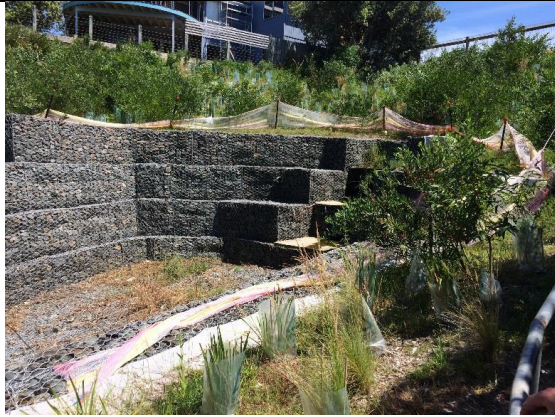
Image 48

The landslide area adjacent to the eastern boundary of 7 Rennies Beach Close and downslope of the adjacent public car park has been remediated using a gabion retaining wall (maximum 4 metres high) with a maximum 27 degree vegetated sloping backfill surface above. The stormwater pipe discharged onto a concrete base and a reno mattress had been provided over the majority of the base of the remediated area (see Image 48).

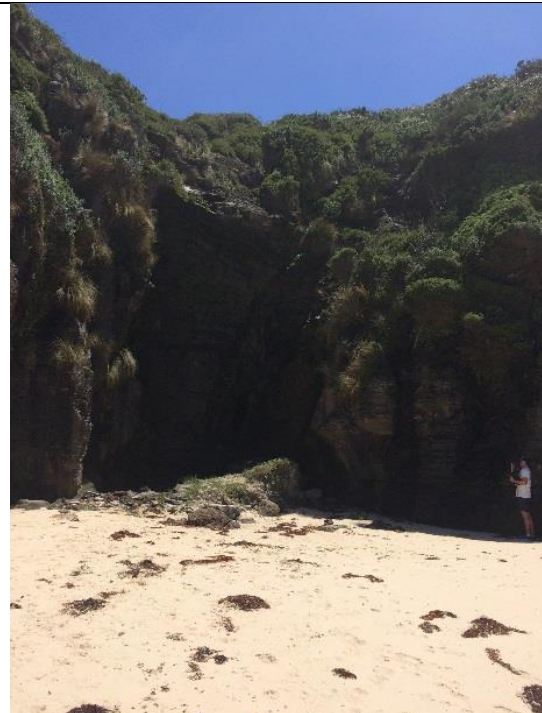
Image 51

The upper section of the cliff face within the gully to the east had been impacted by a small slump, about 5m<sup>3</sup> (see Image 51). The area of detachment appeared to be controlled by a 45 degree joint sloping down to the south and seepage was evident. There was no kerb and gutter at the eastern end of Rennies Beach Close above and there were signs of run-off erosion (see Image 52).

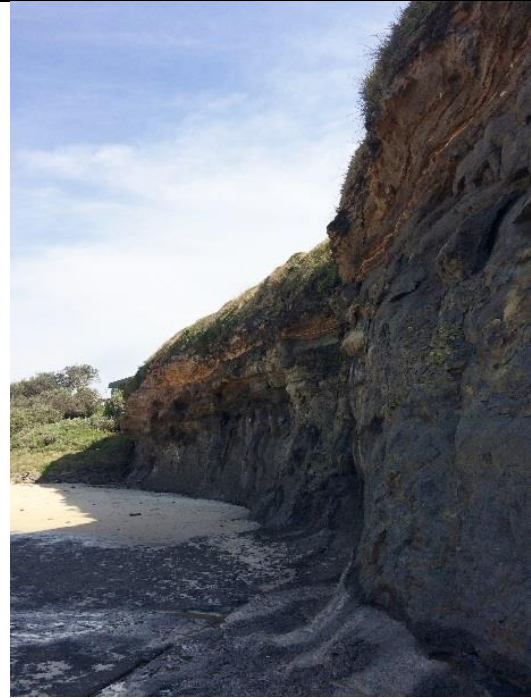
Image 53

The cliff face undercut below the south-western side of the car park at Racecourse Beach was estimated to be a maximum height of 4 metres and a 'depth' of 1.5 metres (see Image 53). There were occasional small rocks (less than 0.1m<sup>3</sup>) at the base of the cliff. The car park was set-back at least 3 metres from the crest of the cliff face.

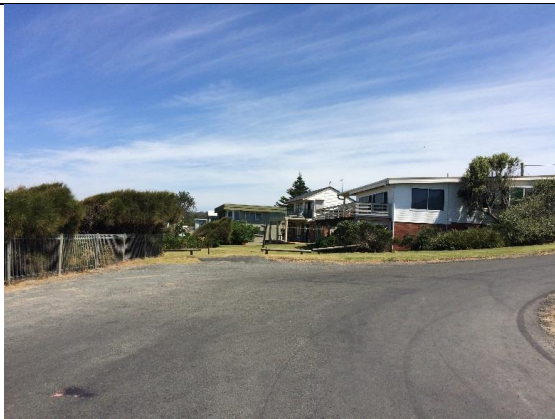
Image 54

At the north of the cliff face a marine sand and colluvial soil area sloped down to the south at a maximum of about 20 degrees. A number of erosion gullies were evident and the slope extended landward up to the rear yards of 43 to 49 South Pacific Crescent (see Image 54).

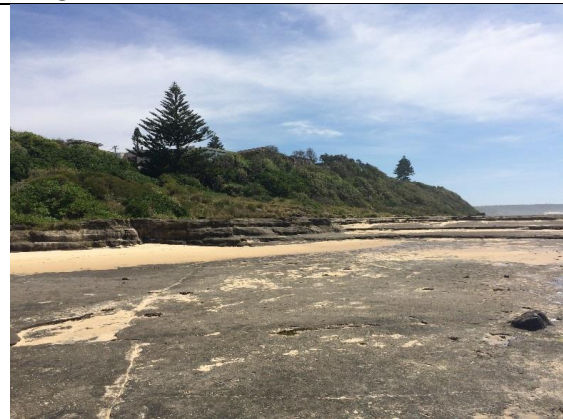
Image 55

The uneven surfaced, vegetated colluvial soil slope contained a number of erosion gullies with very little toe erosion evident (see Image 55). Some erosion of the toe of the landslide debris lobe was evident and formed sub-vertical faces (maximum about 0.3 metres high) eroding at the toe (see Image 56).
