**REPORT TO  
ROYAL HASKONINGDHV  
ON  
GEOTECHNICAL ASSESSMENT  
OF  
EXISTING FORESHORE CLIFF FACES  
AT  
VARIOUS LOCATIONS BETWEEN CULBURRA  
BEACH AND RACECOURSE BEACH, SHOALHAVEN  
CITY COUNCIL LOCAL GOVERNMENT AREA, NSW**

Date: 12 September 2019

Ref: 30016Rrpt

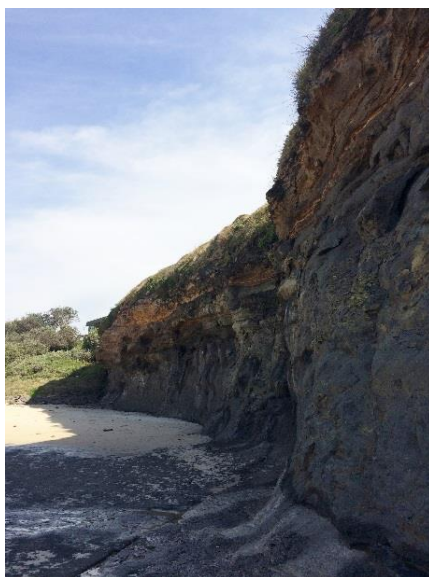
**Plate 53**

The cliff face undercut below the south-western side of the car park was a maximum height of 4m and 'depth' of 1.5m (see Plate 53). There was occasional small rocks (less than 0.1m<sup>3</sup>) at the base of the cliff. The car park was set-back at least 3m from the crest of the cliff face.

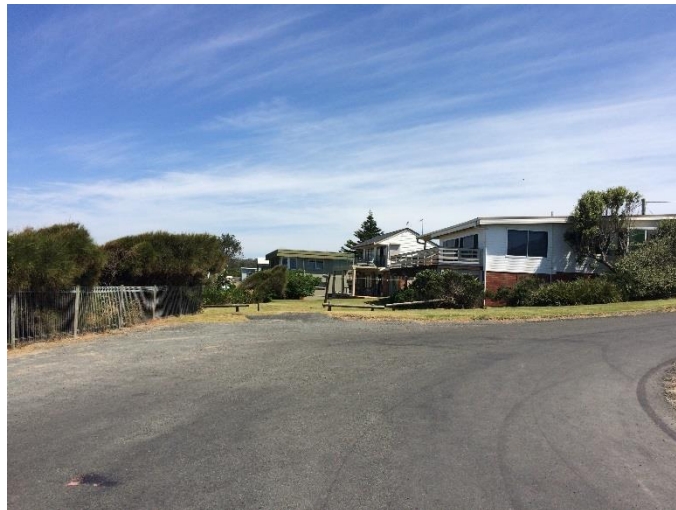
**Plate 54**

North of the cliff face a marine sand and colluvial soil area sloped down to the south at a maximum of about 20°. A number of erosion gullies were evident and the slope extended landward up to the rear yards of 43 to 49 South Pacific Crescent (see Plate 54).

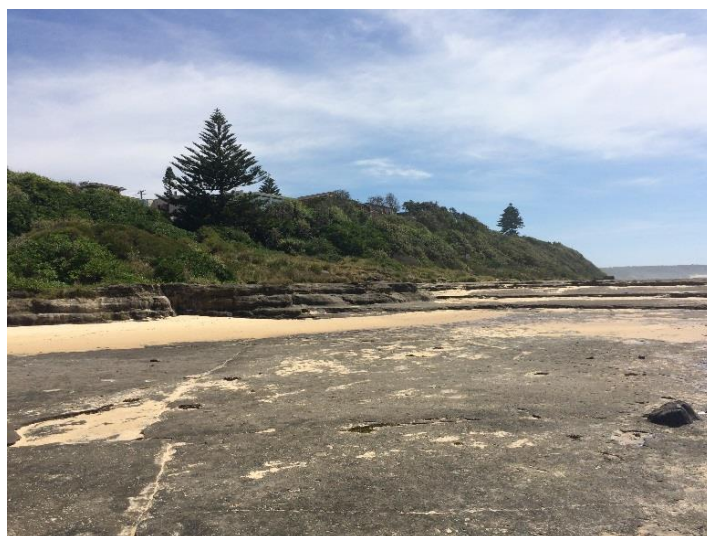
**Plate 55**

The uneven surfaced, vegetated colluvial soil slope contained a number of erosion gullies with very little toe erosion evident (see Plate 55).

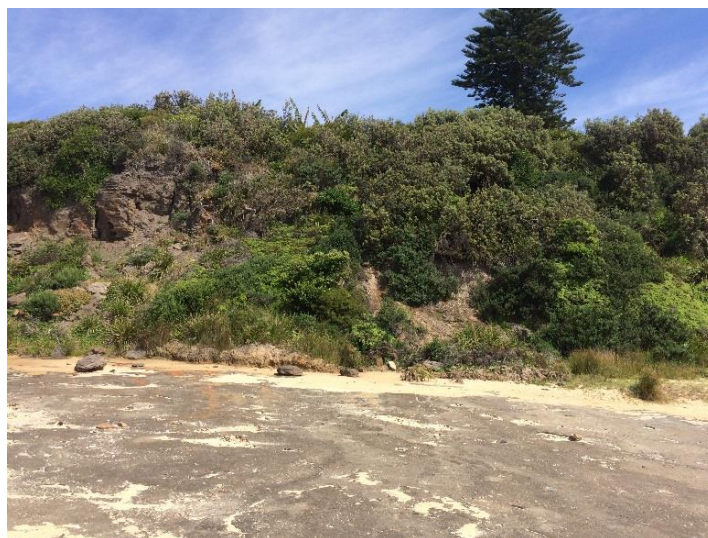
**Plate 56**

Some erosion of the toe of the landslip debris lobe (DP Photo 3) was evident and formed sub-vertical faces (maximum about 0.3m high) eroding at the toe (see Plate 56).
