FORMER E. S. & A. BANK
135 QUEEN STREET, BERRY

CONSERVATION MANAGEMENT PLAN ADDENDUM

LANDSCAPE

Ref: 0254:CMPA

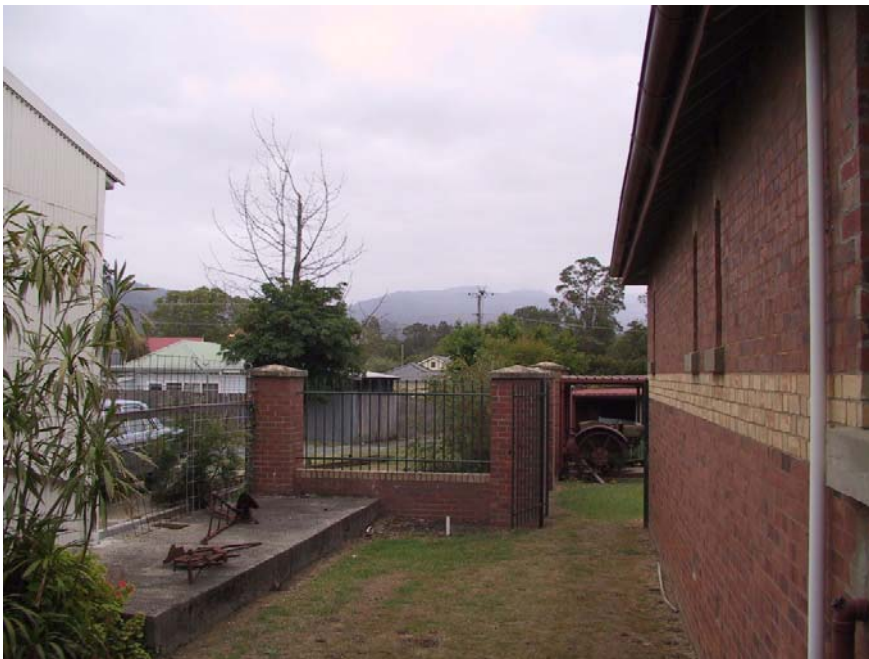
Figure No.27:
Western side
garden of
residence.

The side garden on the western side (S3) of the residence is grassed with a concrete slab covering a drainage pit which is not on land owned by the Bank. However, it is within the immediate visual curtilage of the Bank grounds. A temporary wire mesh fence runs from the neighbouring building to the brick pillar on this side.

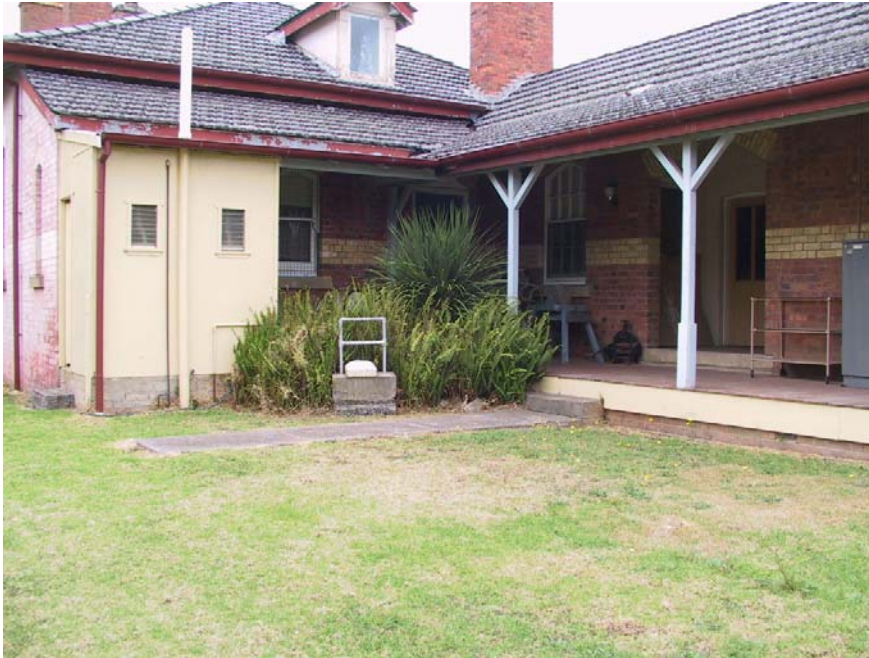
Figure No.28:
Part of rear
utility garden.
The remains of
the well have
been discovered
on the northern
side of the path.

This section of garden (S5) is an expanse of clipped lawn and contains the remains of a well and a small garden bed off the eastern verandah. There is a concrete path leading towards the driveway from the verandah and another leading from the laundry presumably to the location of the clothes line.
